Re: Annual Closed Landfill Inspection – Mission Landfill

On September 30, 2015, Engineering and Environmental Consultants, Inc. (EEC) performed the annual field inspection at the closed Mission Landfill. Mission Landfill was operated by the City of Tucson as a Municipal Solid Waste facility from 1963 through 1970. The property is currently developed with the majority of the site utilized as a Pima County Parks facility that borders the Santa Cruz River.

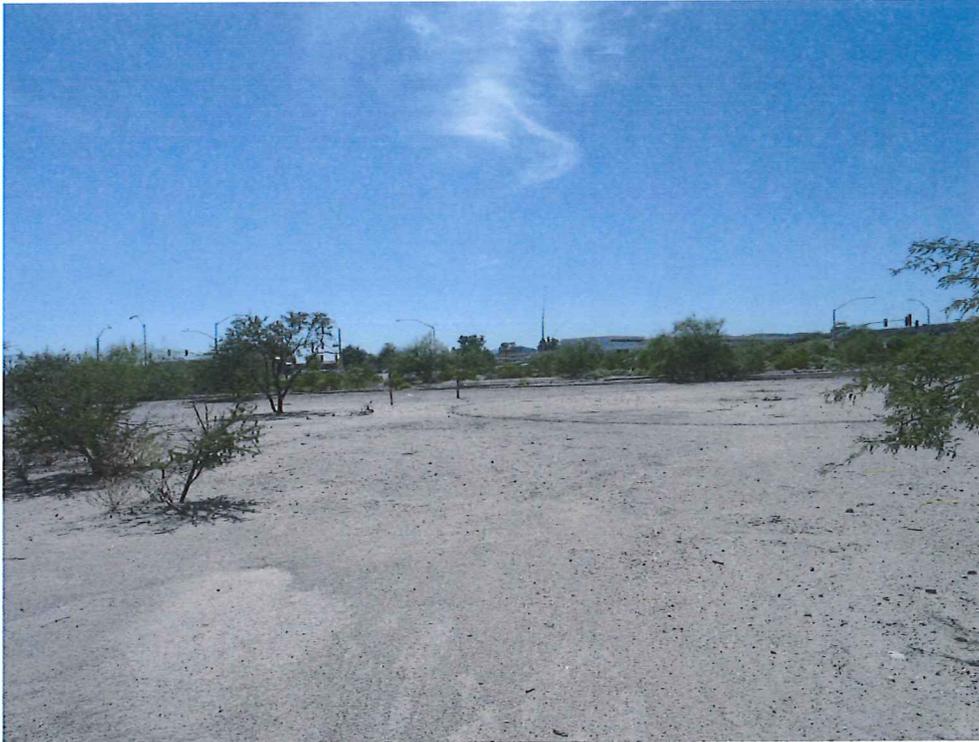
The earthen cap is generally in good condition. One open surface void (a hole) was observed just outside the landfill boundary near landfill gas monitoring probe well MS-1. This hole may present a hazard to City personnel during probe monitoring events or to other persons walking in the area.

Photo 1: Mission Landfill earthen cap, view to the south

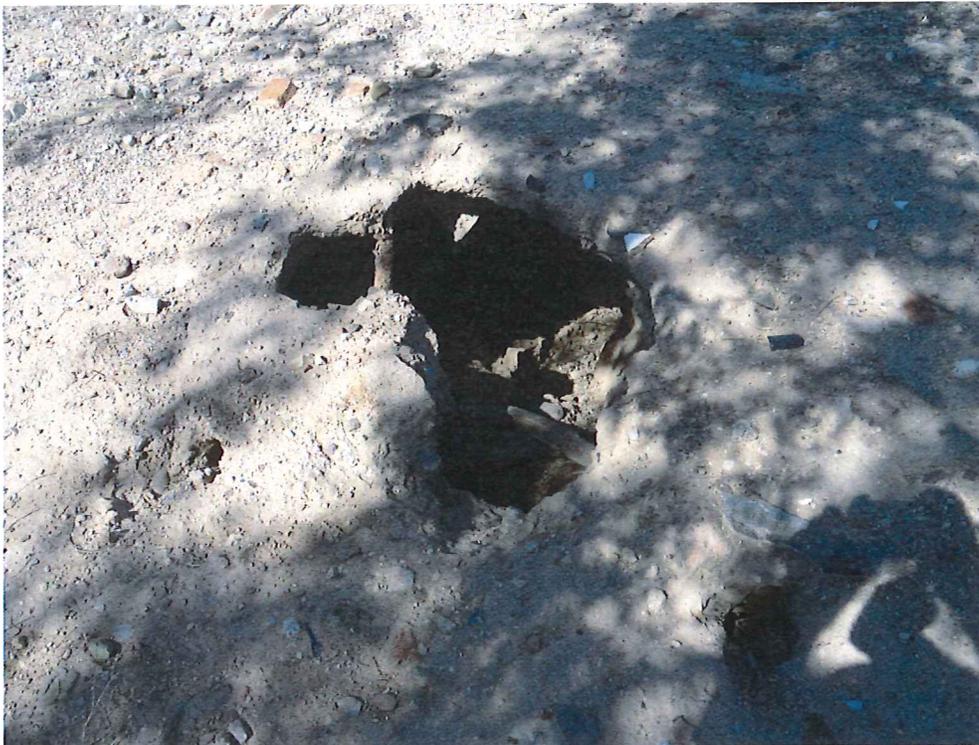
Photo 2: Hole adjacent to landfill near monitoring probe well MS-1

- It may be prudent to fill the hole near monitoring probe well MS-1 to prevent injury to persons in the area.
- Landfill gas monitoring well MS-2 was not found. It may be covered or destroyed. If this monitoring point is still needed, a search of the area with a metal detector may locate it.
