November 5, 2015

Re: Annual Closed Landfill Inspection – Rio Nuevo North Landfill

**CITY OF TUCSON ENVIRONMENTAL SERVICES
ANNUAL CLOSED LANDFILL INSPECTION REPORT
RIO NUEVO NORTH LANDFILL**

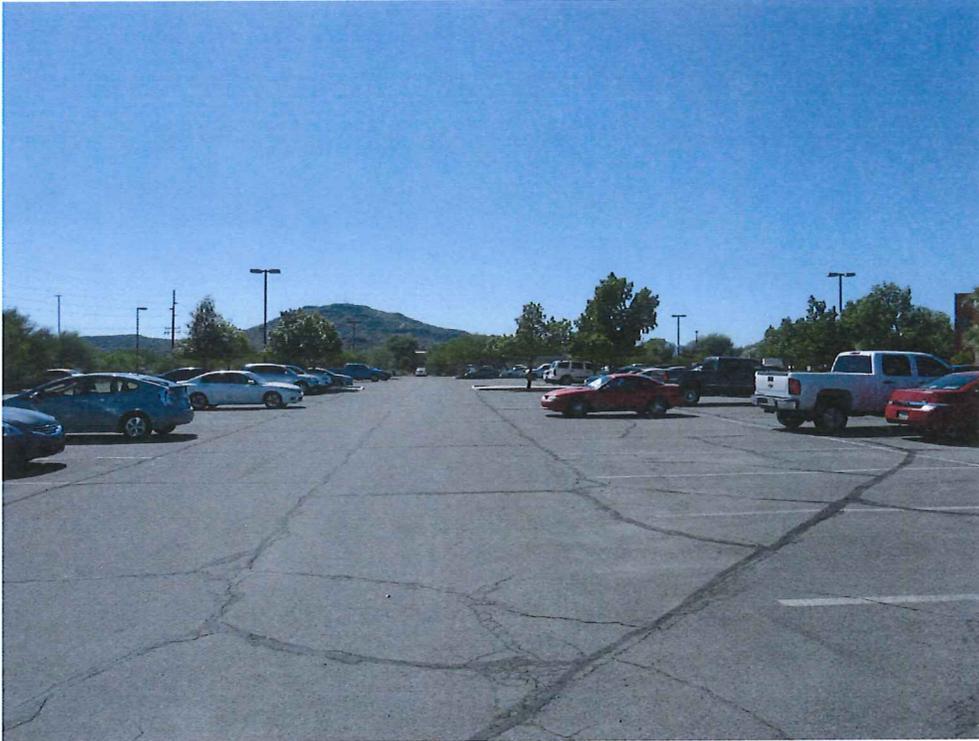
Both the north and south segments of the landfill are completed as vehicle parking lots. The parking lots are in generally poor condition due to settlement, cracking of the asphalt, and development of small sinkholes (Photos 1, 2, 3, 4, 5).

Photo 1: Widespread cracking of parking lots, some previously repaired (north lot shown)

- Crack and surface sealing of the asphalt parking lots was proposed in the last annual inspection. This work has not been completed. In addition, numerous areas on the parking lots have settled and small sinkholes have developed in at least two locations. The sinkholes have been crudely mitigated with asphalt patch or soil fill. Costs estimates should be obtained from licensed paving contractors to properly repair the parking lots.
- The support post for the overhead parking canopy at parking space #43 on the south portion of the property has settled and is noticeably leaning. This has resulted in bending and drooping of the overhead canopy. Estimates to straighten, stabilize, and repair the canopy at this location should be obtained.

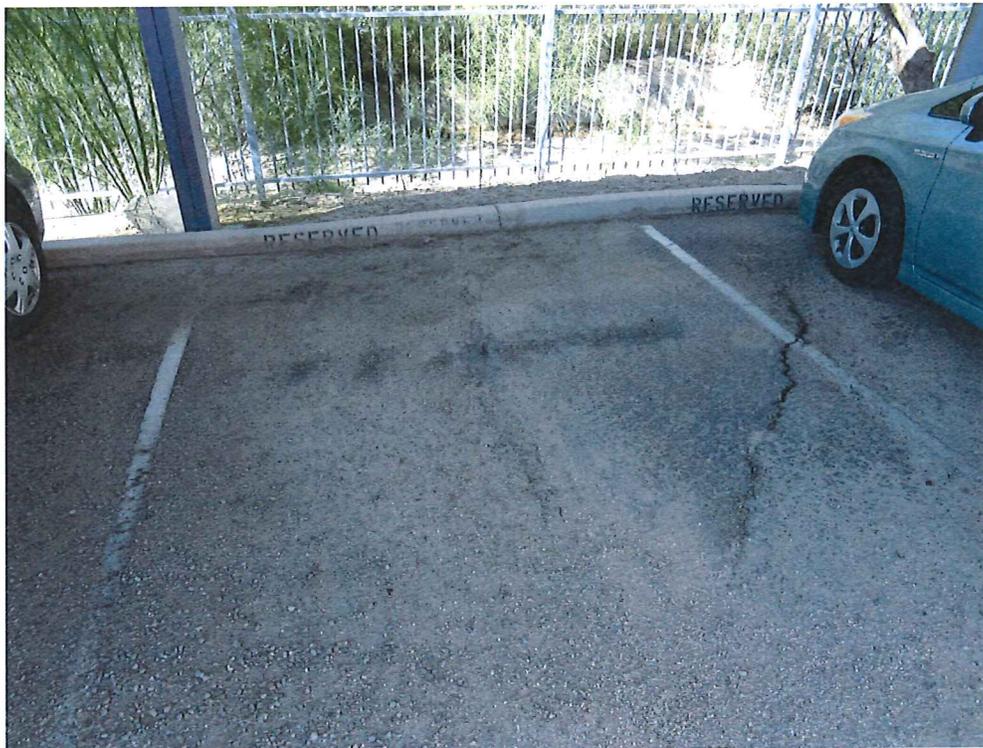
Photo 2: Cracking/settling of parking lot, south parking lot

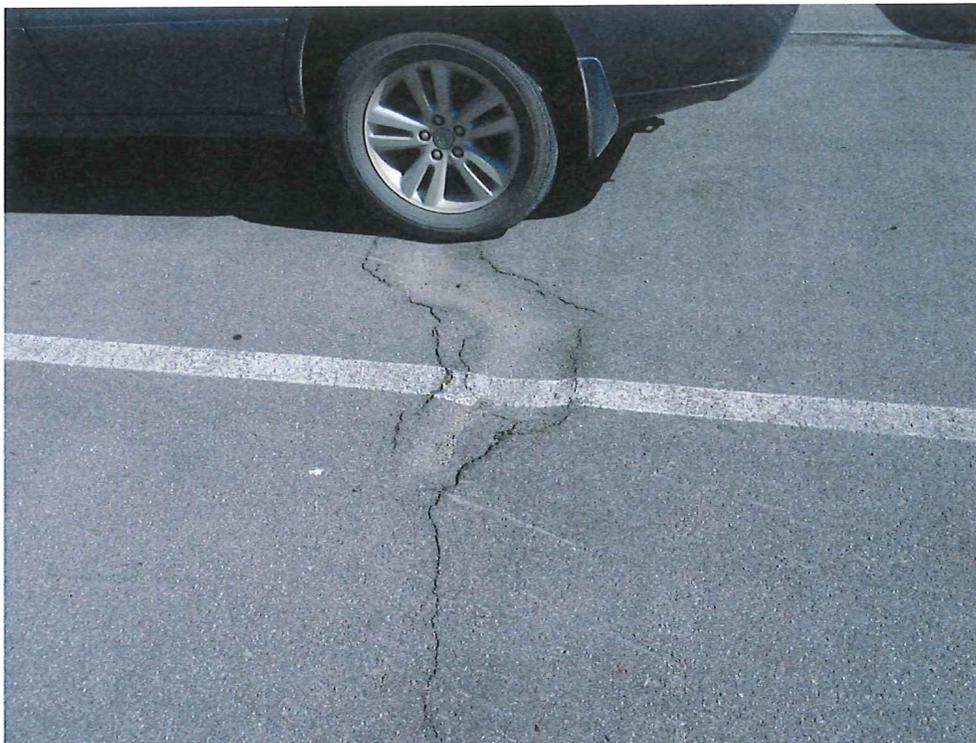
Photo 3: Cracking settling of parking lot, north lot

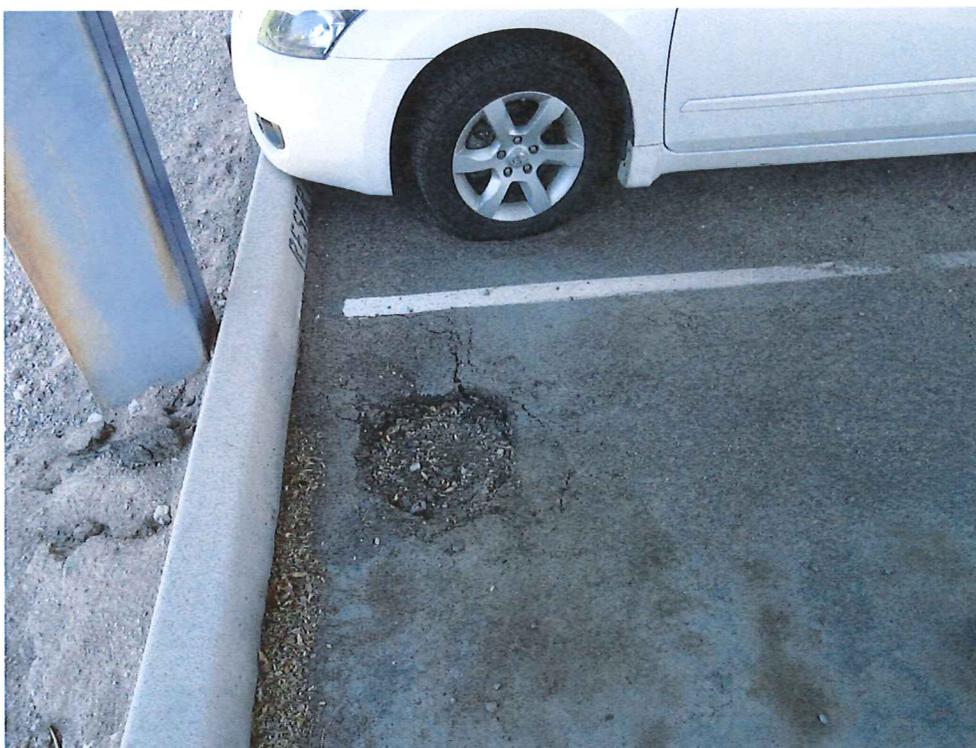
Settlement and cracking of the asphalt was observed in several locations in the parking lots. In addition, two small sinkholes were observed. These sinkholes are patched with fill material (cold patch asphalt and soil) (Photos 4, 5).

Photo 4: Sinkhole, patched with asphalt, south parking lot

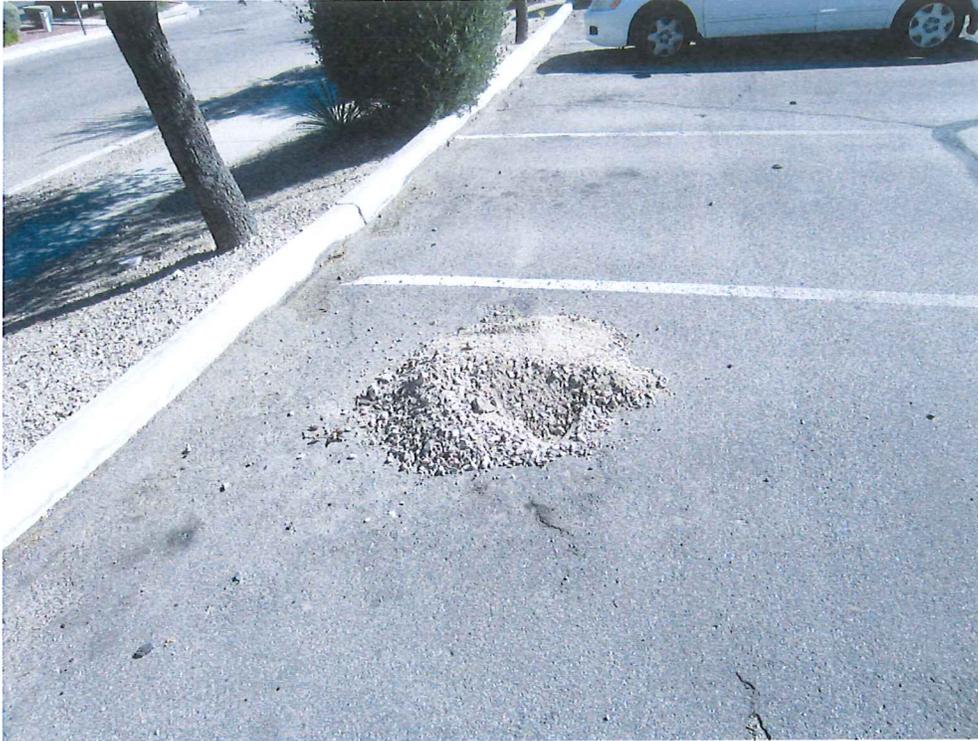
Photo 5: Sinkhole, covered with soil, north parking lot

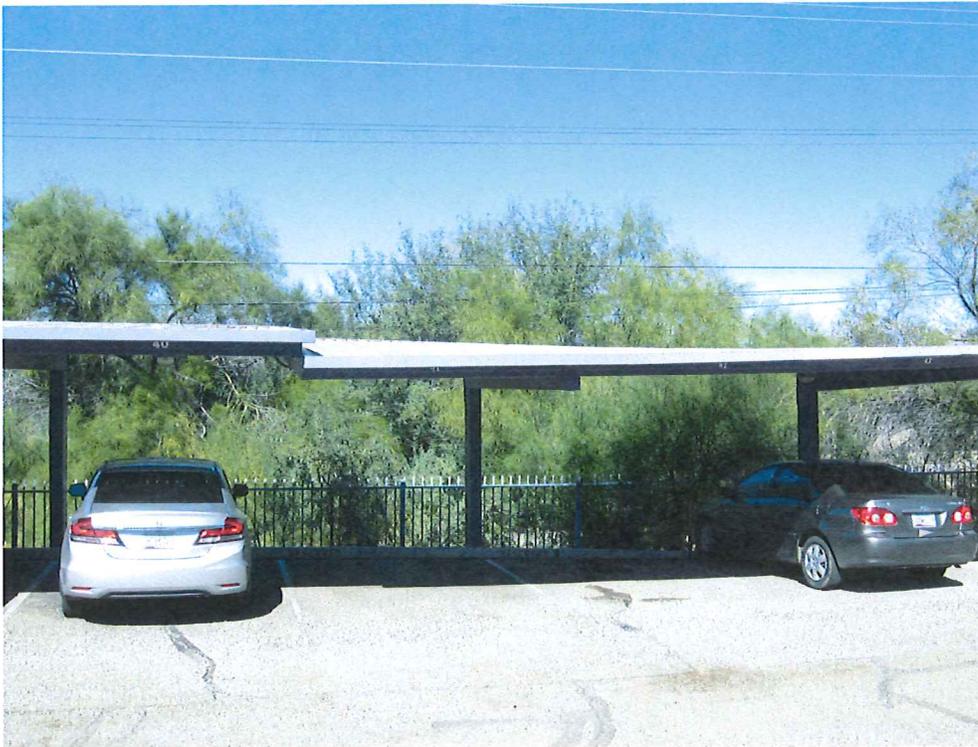
In addition, an overhead parking canopy support post has settled and is leaning slightly resulting in damage to the canopy (Photos 6, 7, 8, 9).

Photo 6: Drooping canopy at parking space #43 (south parking lot)

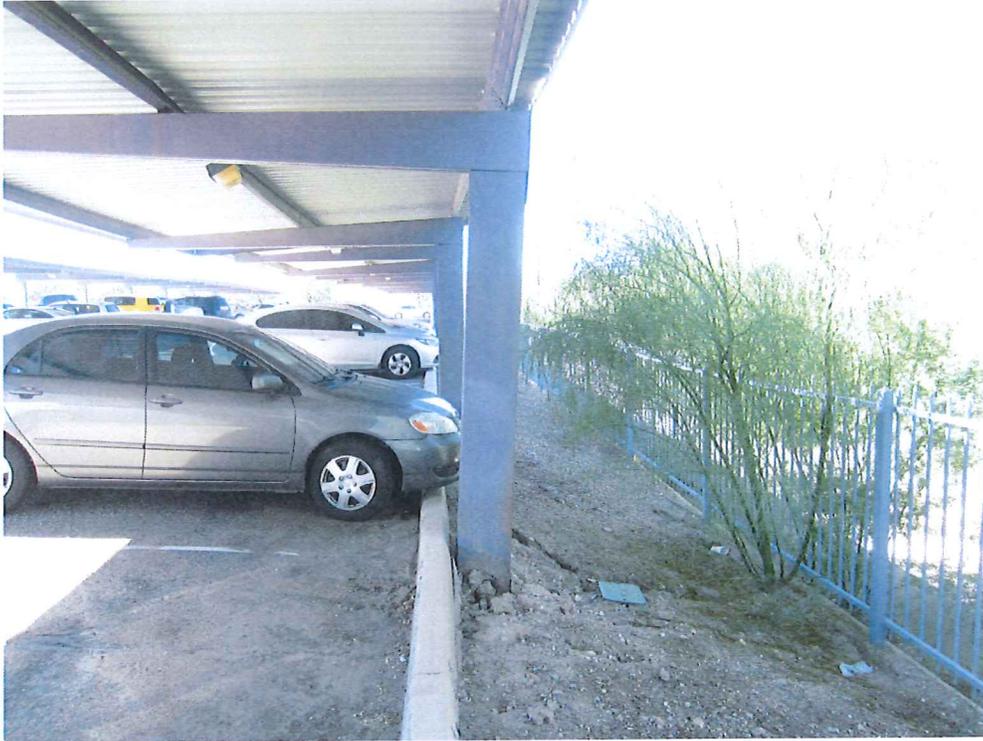
Photo 7: Support post leaning at parking space #43

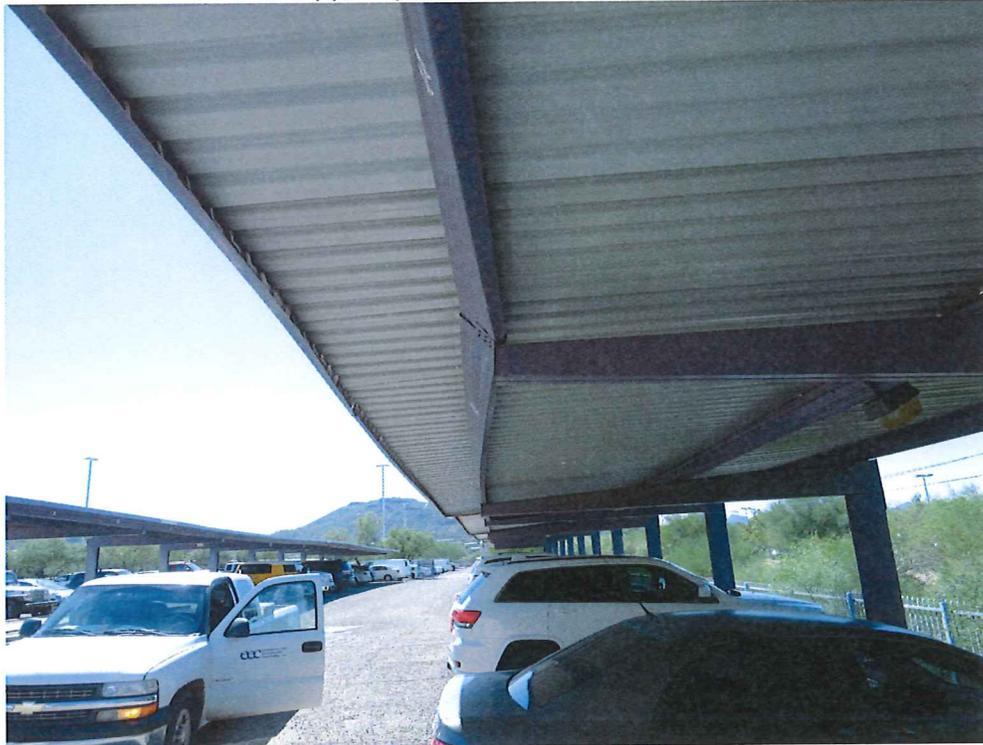
Photo 8: Damaged/bent overhead canopy at parking place #43

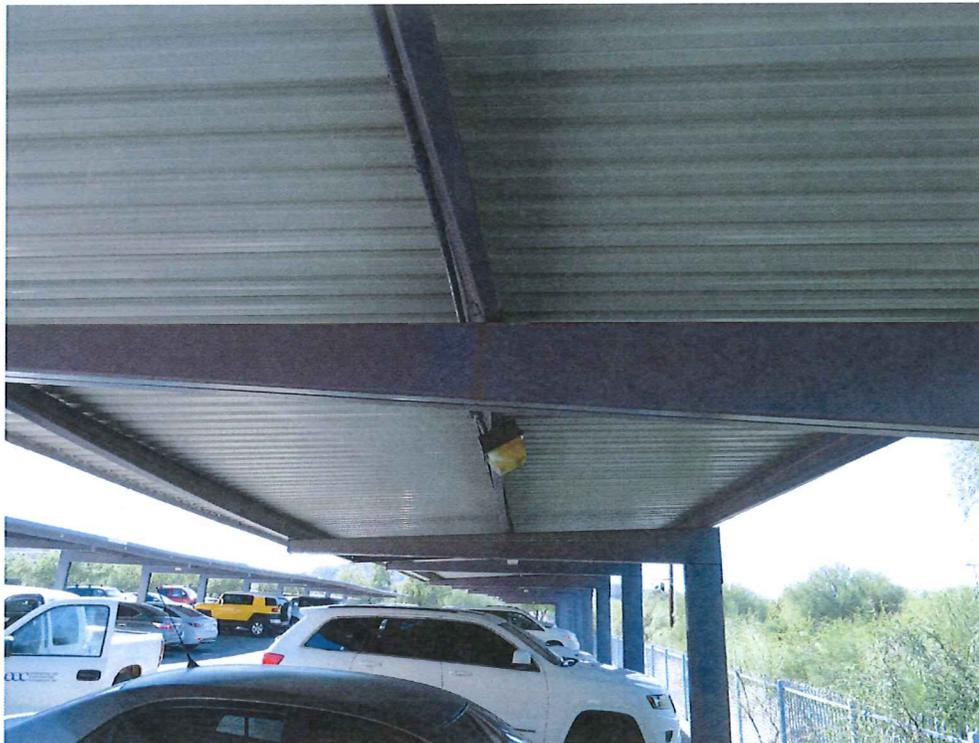
Photo 9: Damaged/bent overhead canopy at parking place #43

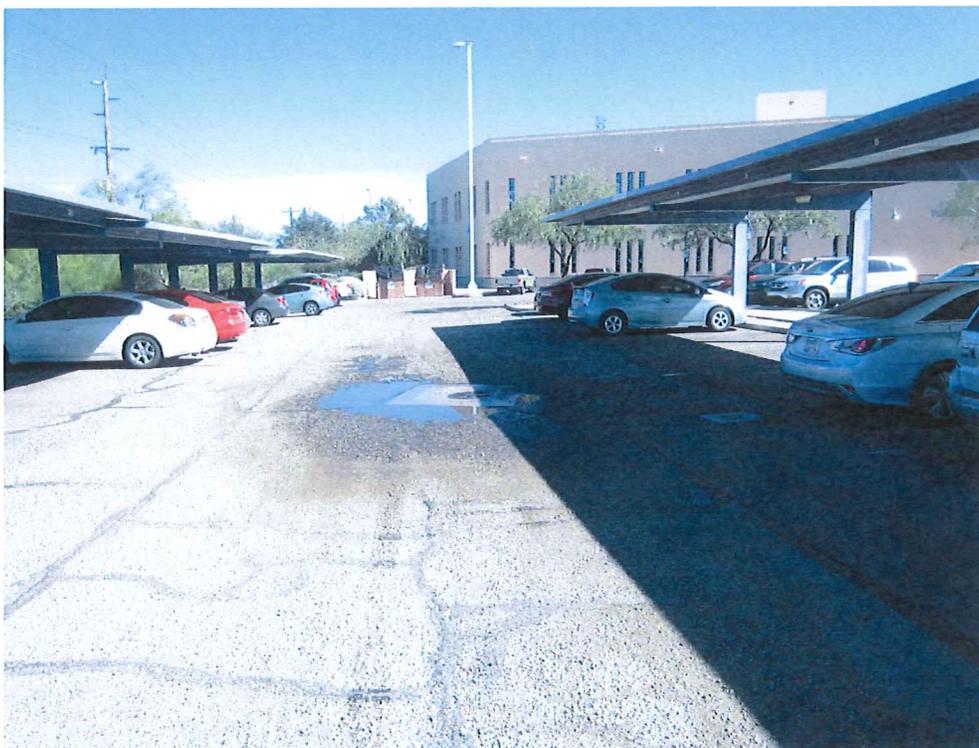
With the exception of settling at some well locations, the landfill gas extraction wells appear to be in good condition (Photo 10).

Photo 10: Settling at landfill gas extraction wellhead
