November 10, 2015

Re: Annual Closed Landfill Inspection – Silverbell Landfill

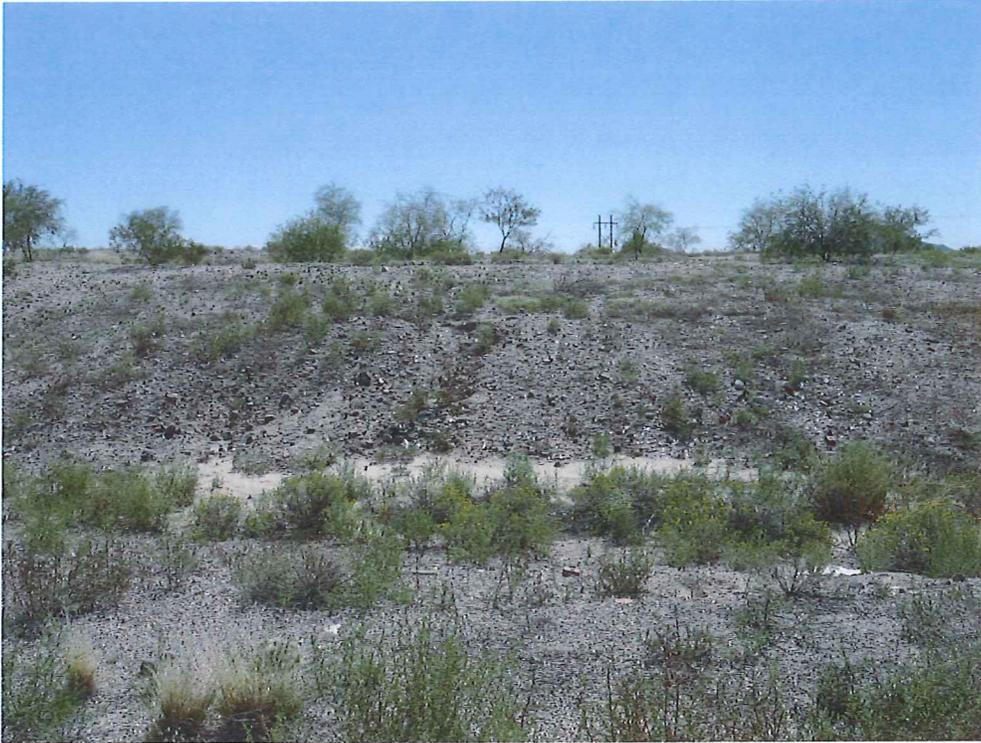
The north cell of the landfill has been developed as a public golf course and is surrounded by fencing. Access control to the north cell is excellent. There is no perimeter fencing around any portion of the south cell (Photo 1).

Differential subsidence has resulted in ponding water, damage to monitoring wells, and exposed trash in some areas (Photos 1 through 6).

Photo 1: Unsecured perimeter of south cell, looking south, note erosion with exposed trash

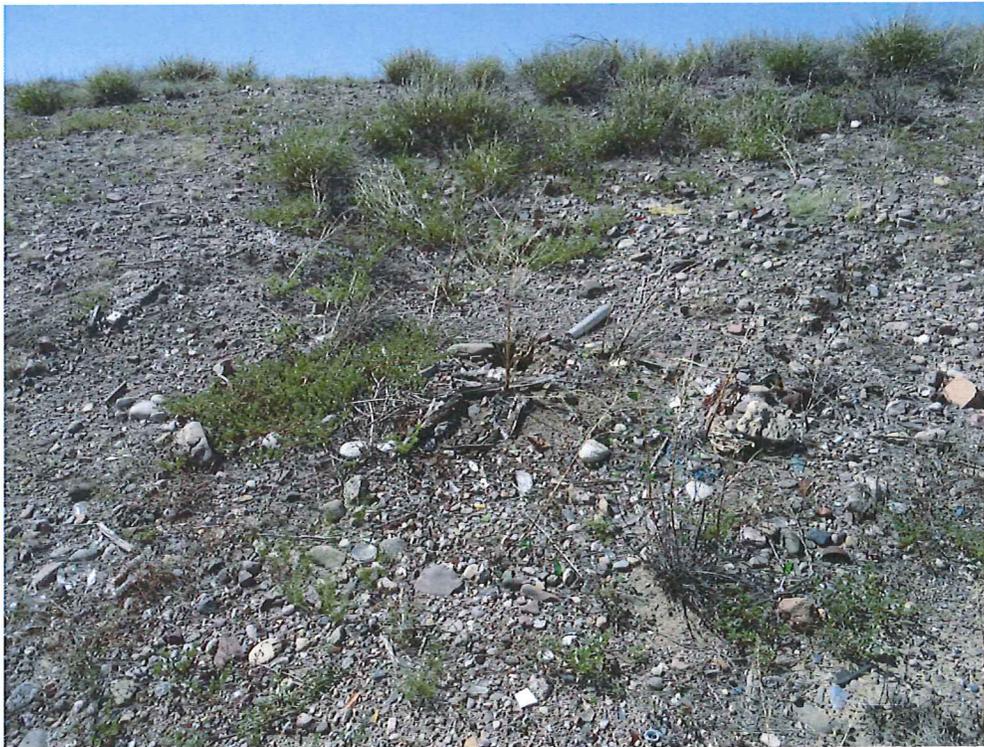
Photo 2: Exposed trash on north slope of south cell

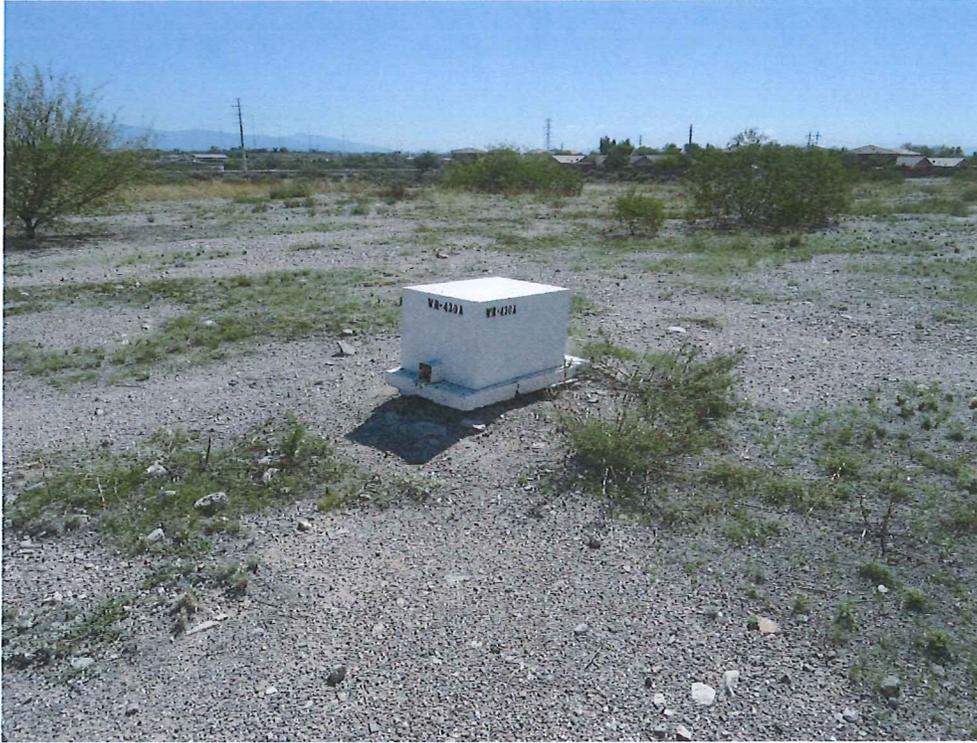
Numerous groundwater monitoring wells are damaged due to subsidence of the landfill (Photos 3, 4, 5, 6)

Photo 3: Damage to groundwater monitoring well, resulting from subsidence

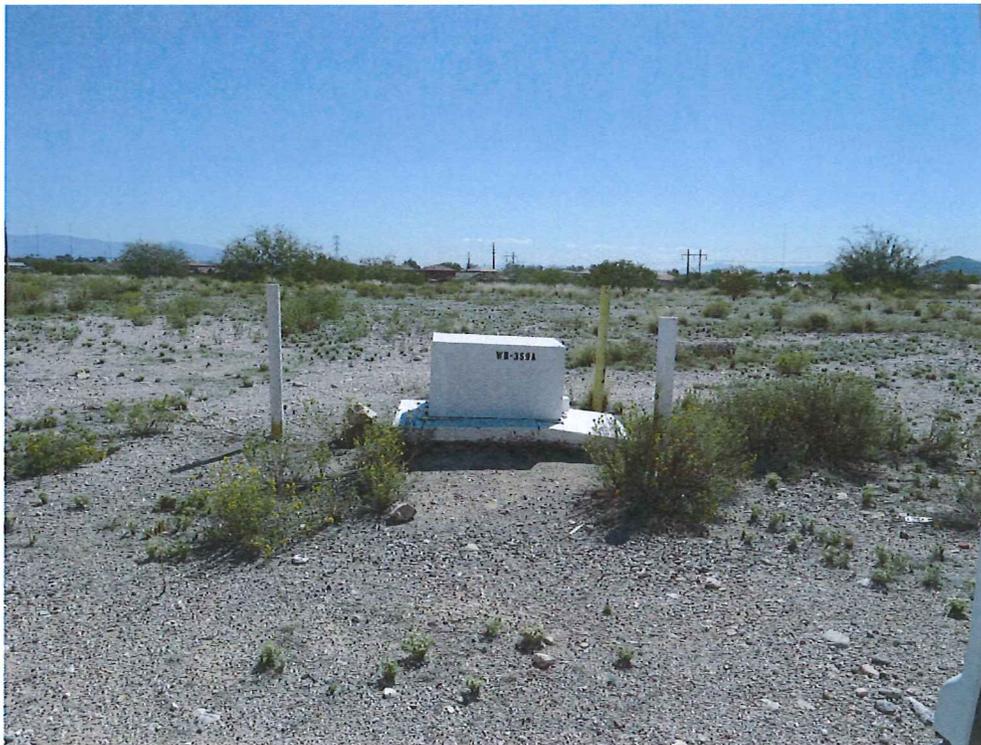
Photo 4: Damage to groundwater monitoring well, resulting from subsidence

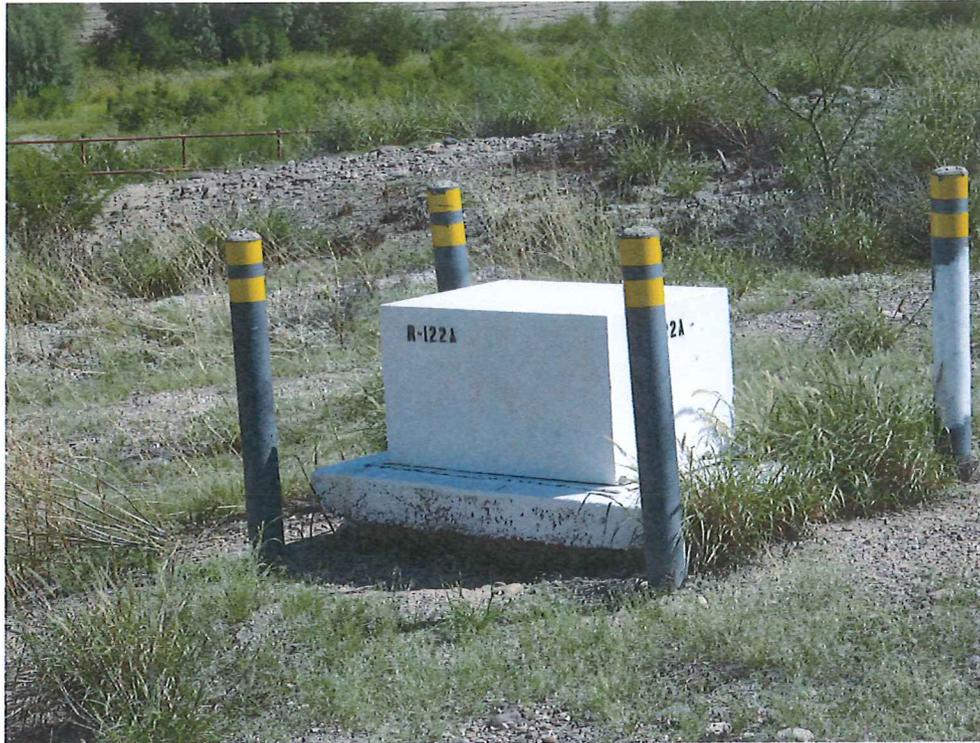
Photo 5: Subsidence at groundwater monitoring well

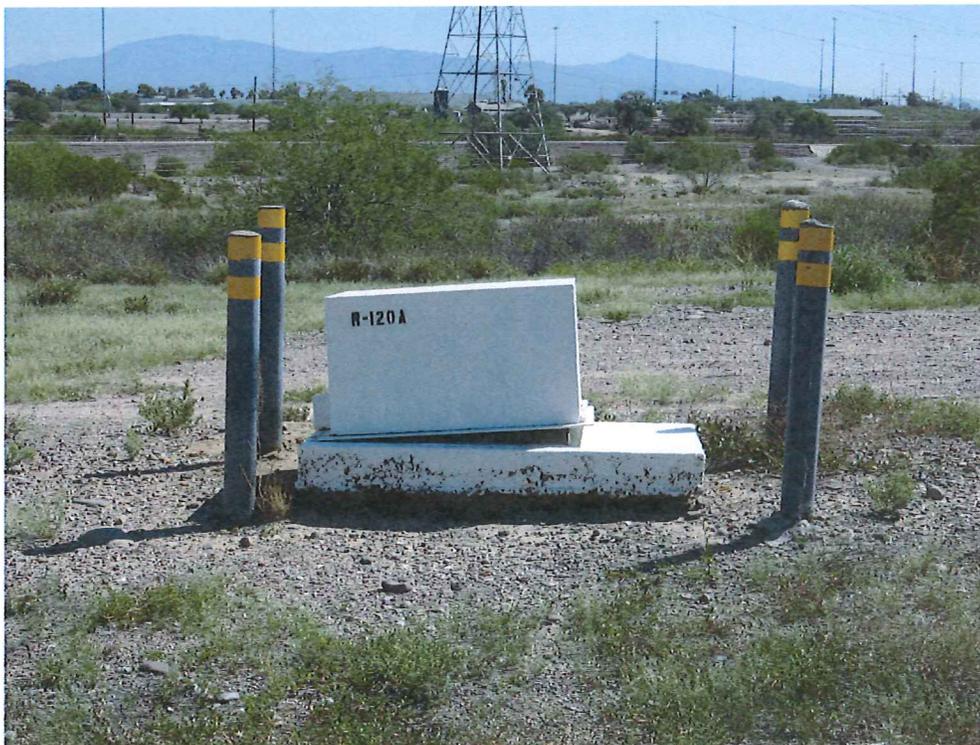
Photo 6: Subsidence at groundwater monitoring well, well casing forcing lid up

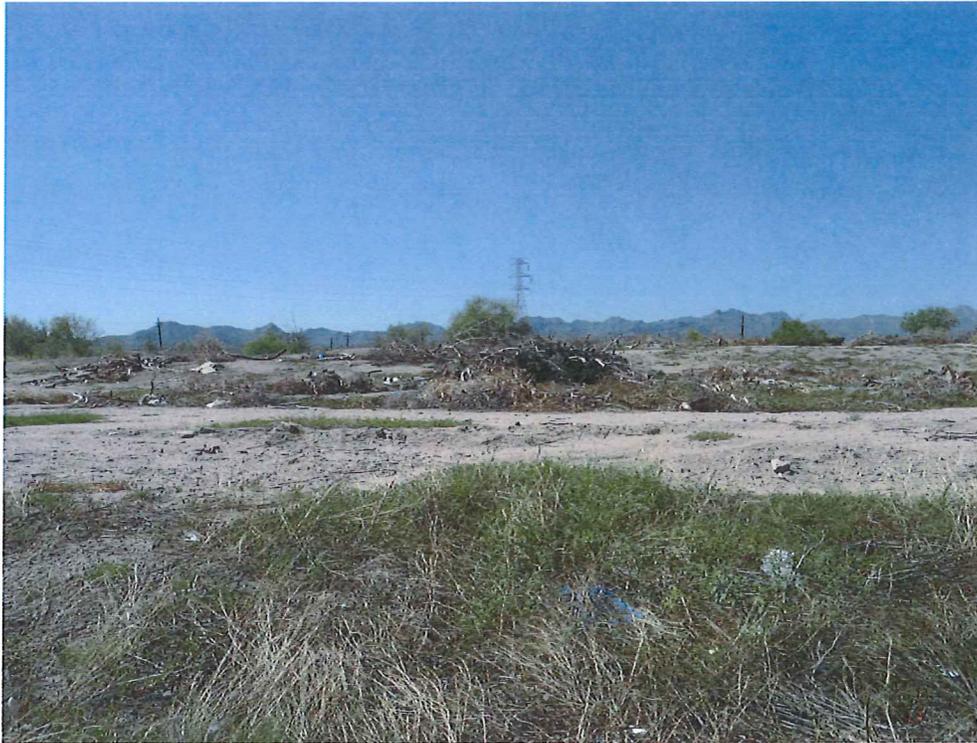
Excessive dumping was observed in some areas of the landfill, most notably the south portion of the north cell (photo 7).

Photo 7: Dumped vegetation on south portion of north cell
