Re: Annual Closed Landfill Inspection – St. Mary’s Landfill

**CITY OF TUCSON ENVIRONMENTAL SERVICES
ANNUAL CLOSED LANDFILL INSPECTION REPORT
ST. MARY'S LANDFILL**

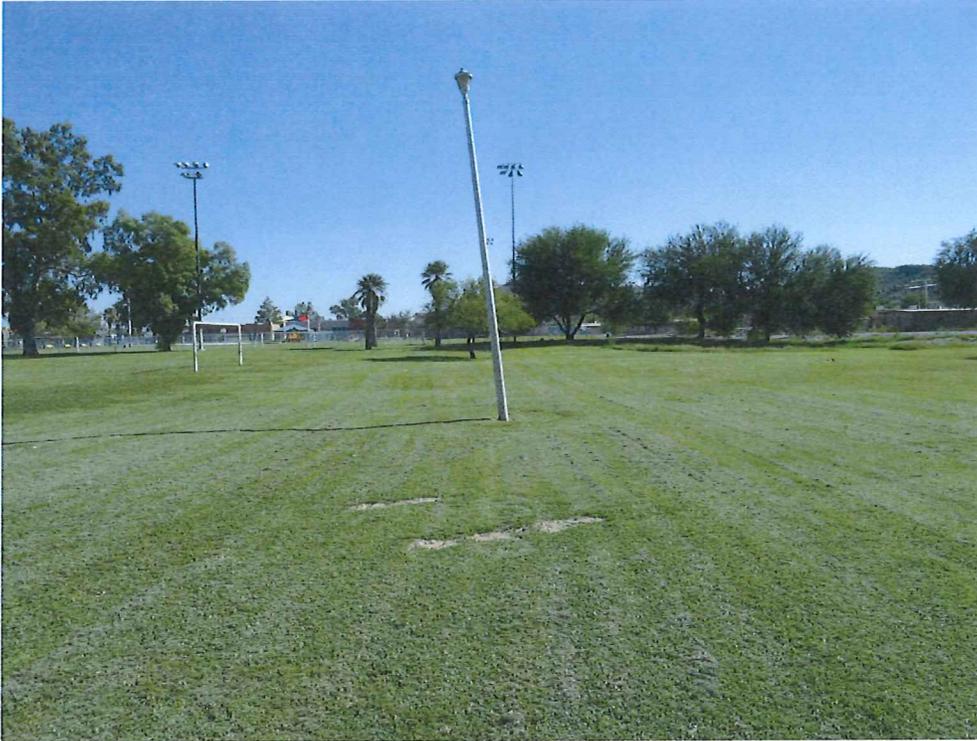
The landfill cap is covered with grass in the park areas and with parking lots in the apartment complex areas. Lamp posts in the grassy area of the park were observed to be leaning, indicating some settlement had likely occurred in those areas (Photo 1).

Photo 1: Leaning lamp post in sports field

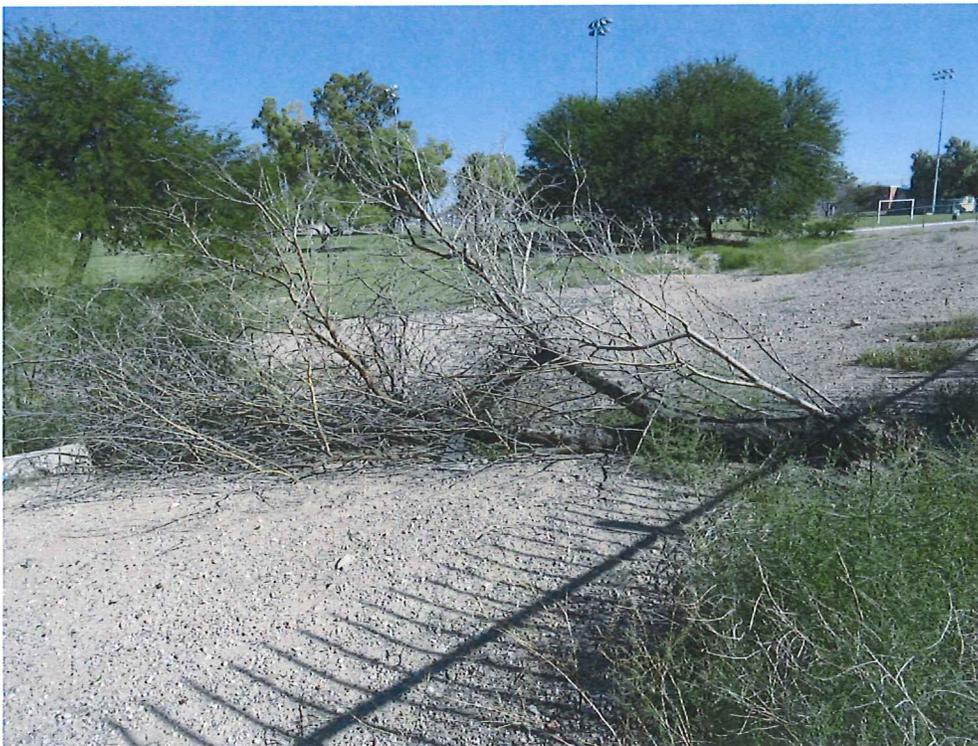
No illegal dumping was observed on the landfill, although a downed tree was observed along the west boundary of the landfill (Photo 2).

Photo 2: Downed tree on west boundary of landfill
