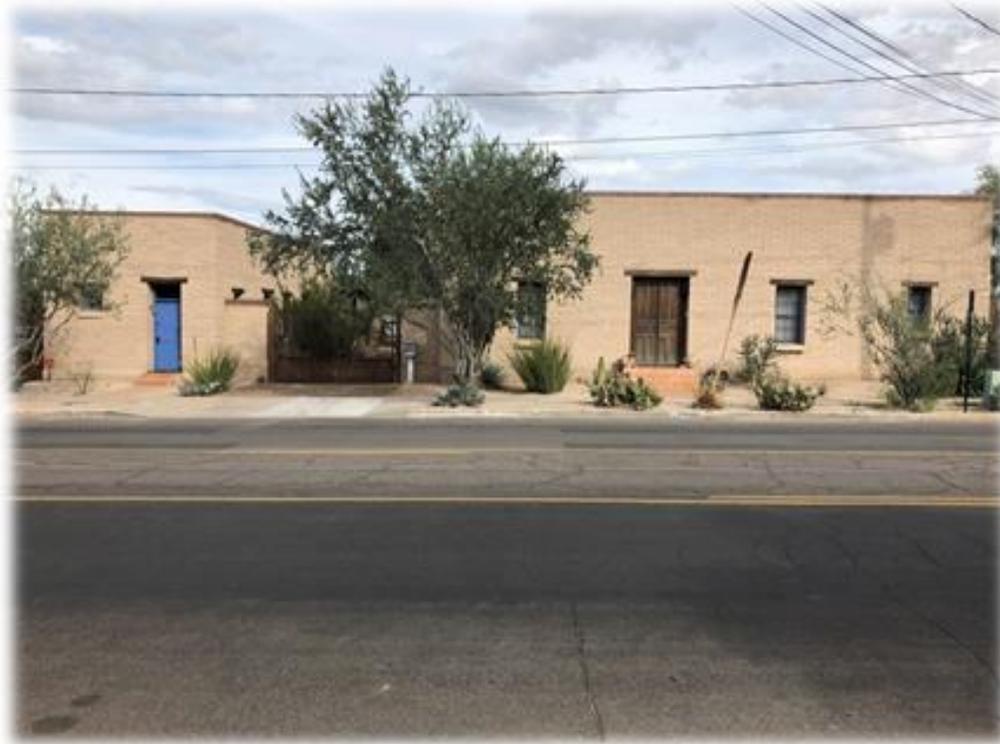
579 and 585 S Main Ave.

Sonoran row house style. Exposed stabilized adobe with parapet with brick coping. Wall height 14 ft. Tall window and door heights. Wood and metal gates. Tall wood double hung windows. Small square wood windows.

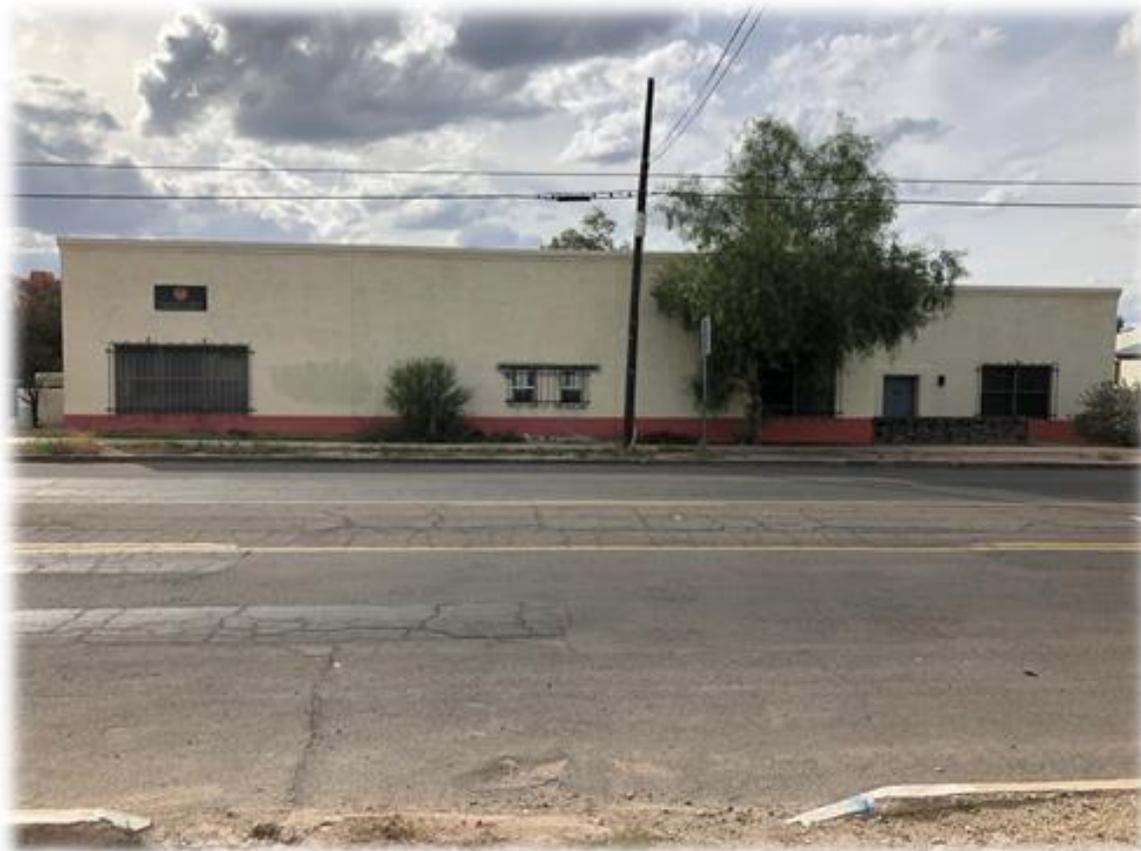
530 S. 4th Avenue CONTRIBUTING

Parapet territorial style with stucco wall finish. Wall height 12 ft. Double hung wood windows and smaller wood windows. Row house type setback.

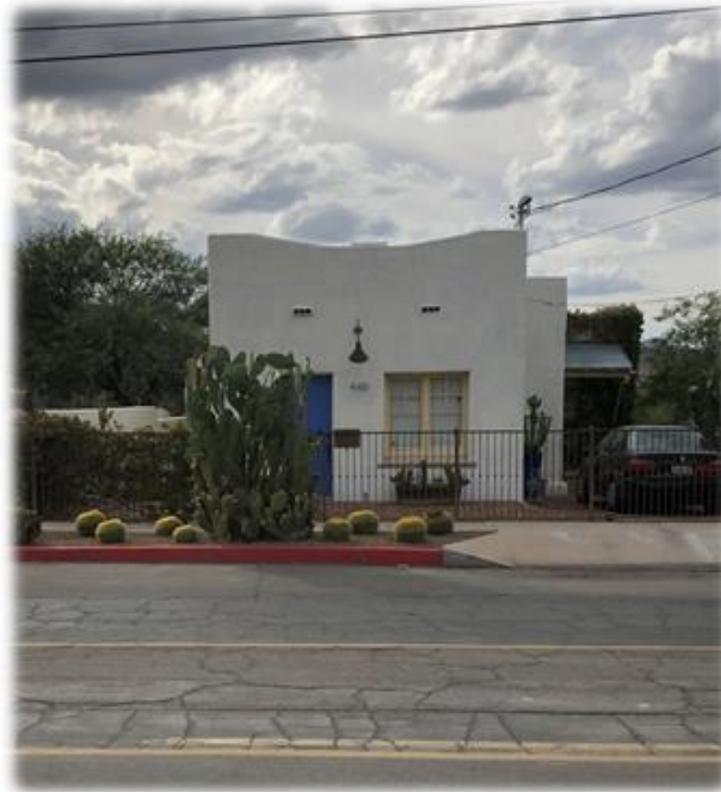
448 S. Main Avenue CONTRIBUTING

Sonoran style with sloped parapet (Art Deco) Stucco wall finish. Wall height 12 ft. Double hung wood windows. Row house setback. Wrought iron fence.

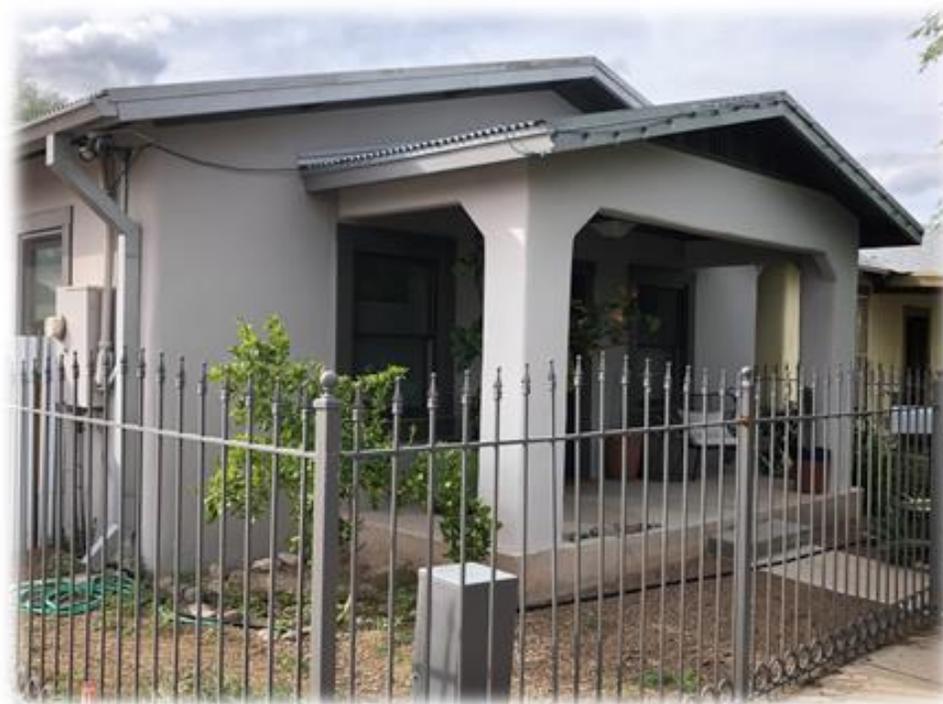
586 S. Main Ave. CONTRIBUTING

Bungalow style, smooth stucco finish with double hung windows with wood trim. Porch and house with gable roof with corrugated metal roofing.

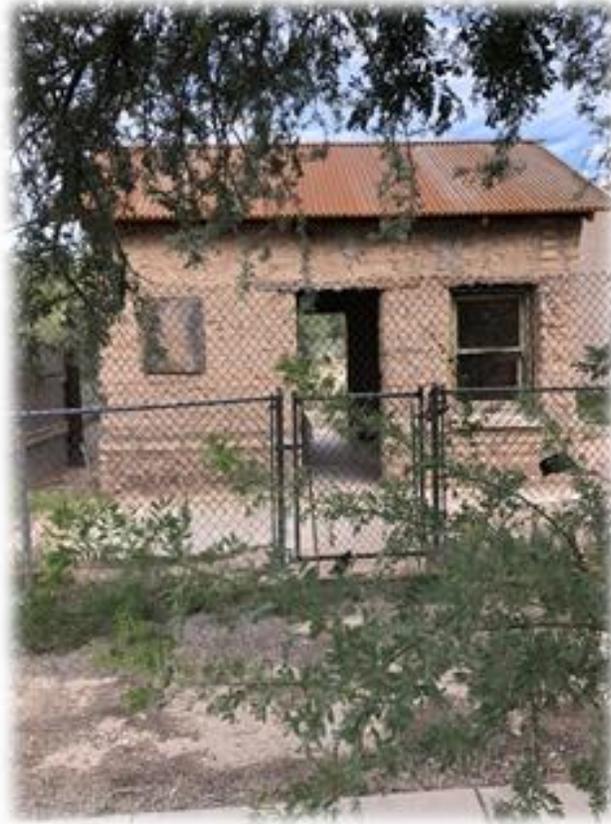
628 N 3rd Avenue Unit 1 and 2 CONTRIBUTING

Sonoran style with Gable roof (abandoned) Exposed mud adobes distressed wood double hung window no doors. windows . Gable roof with corrugated metal roofing

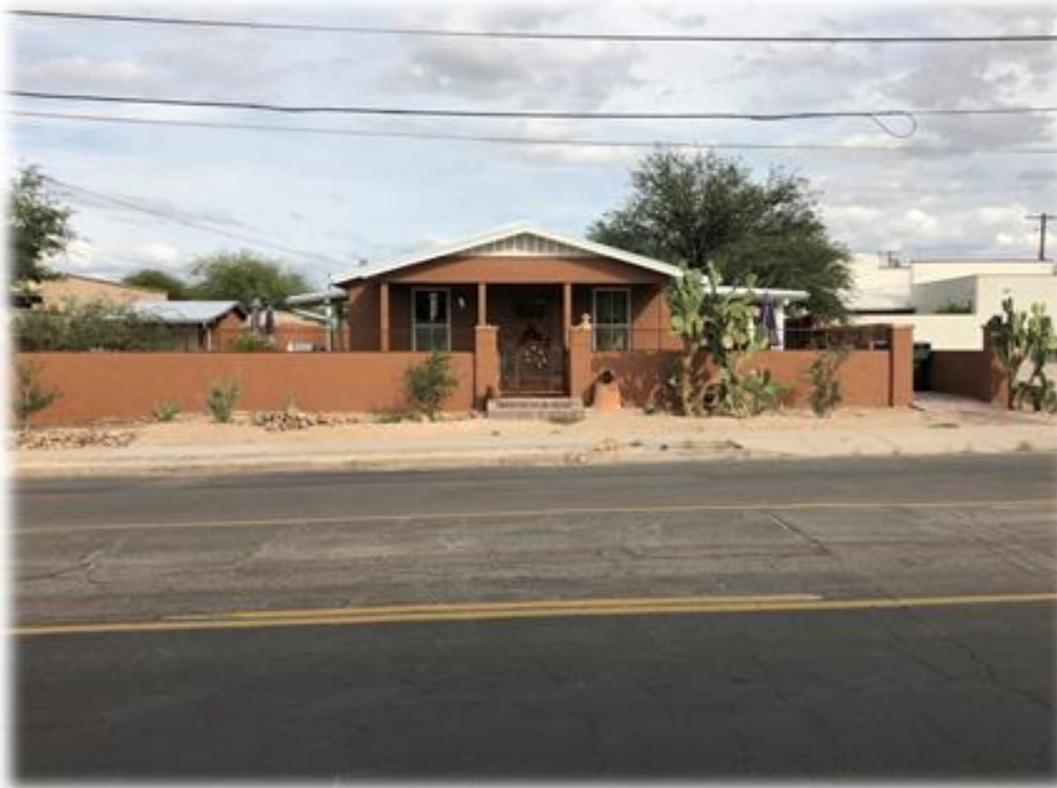
628 N 3rd Avenue Unit 1 and 2

Bungalow style with simple wood details. Stucco wall finish. Gable roof with asphalt shingle roofing. Wood double hung windows.

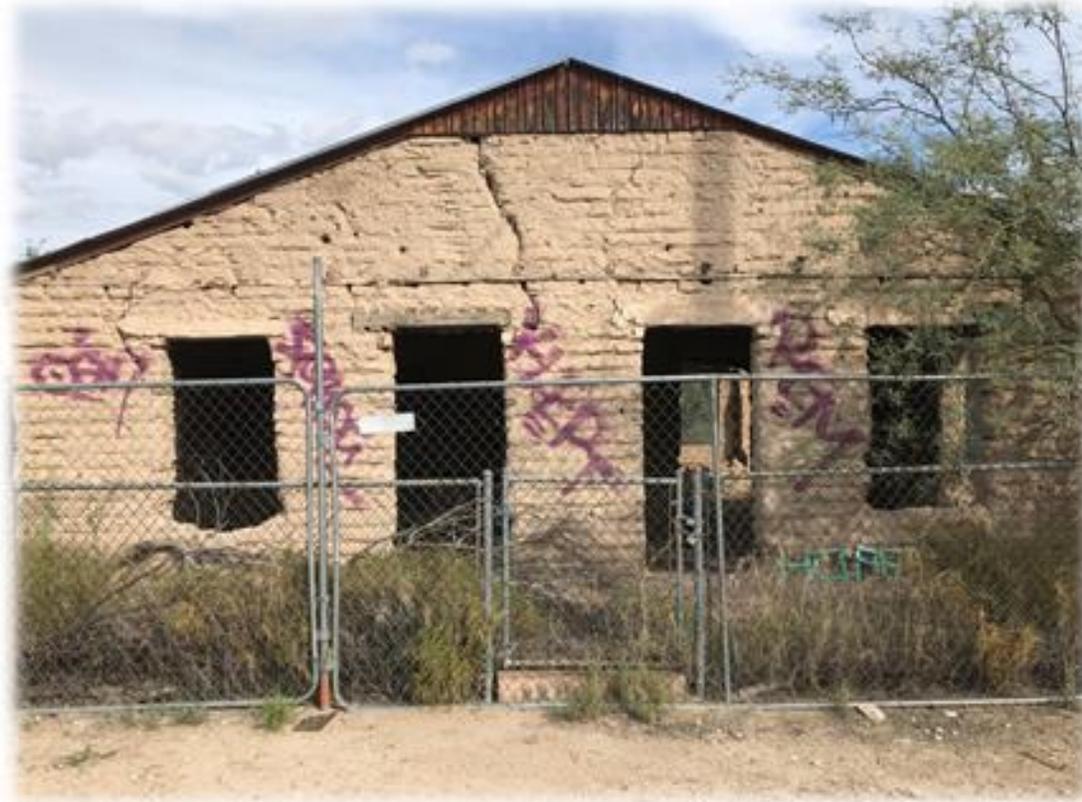
541 S Main Avenue CONTRIBUTING

Sonoran style with Gable roof (abandoned) Exposed mud adobes no windows . Gable roof with corrugated metal roofing.

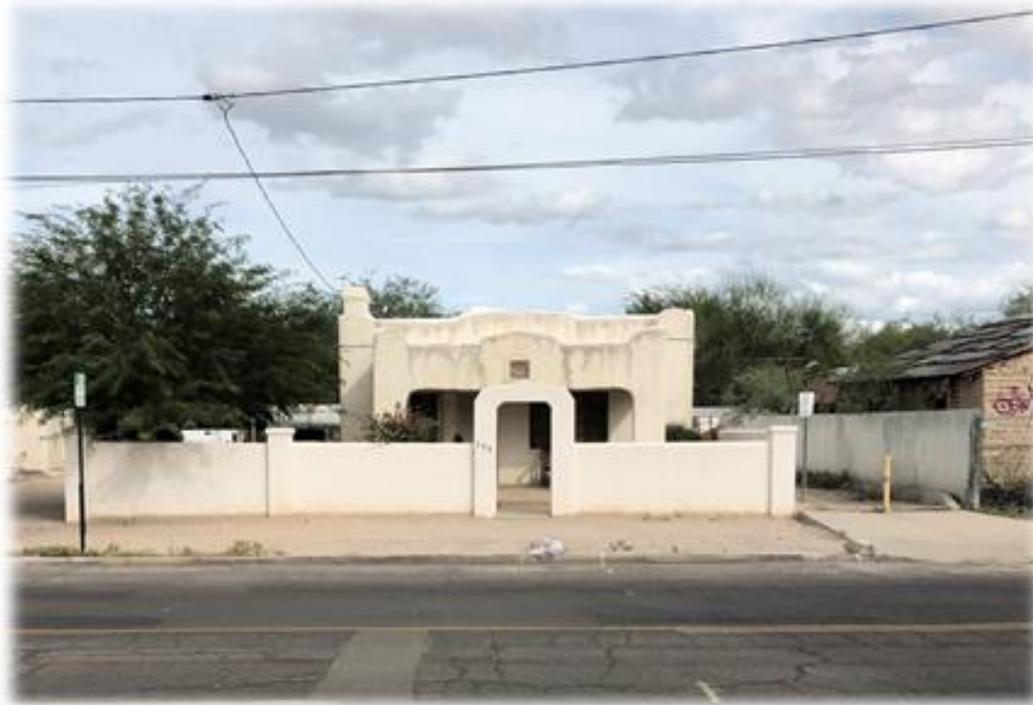
537 S Main Ave. CONTRIBUTING

Mission style with parapet on both porch and main house with stucco wall finish. Wood double hung windows. Masonry patio wall with columns and arched entrance, stucco finish.

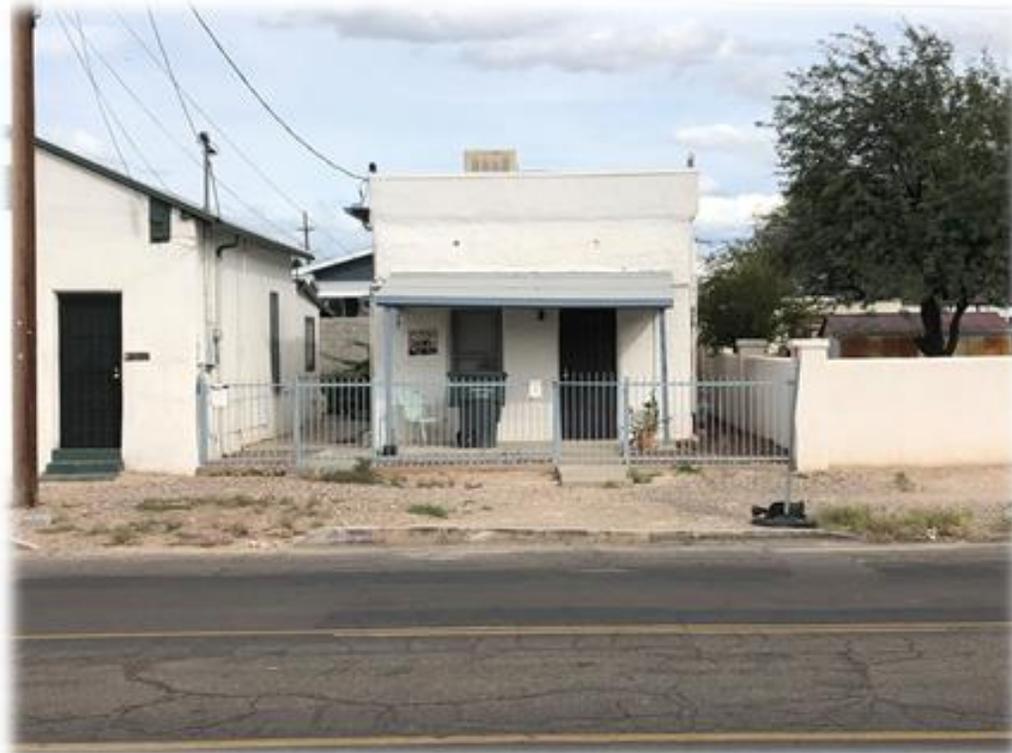
531 S Main Avenue CONTRIBUTING

*Sonoran style with simple wood shed roof porch
Stucco wall finish. Parapet roof. Wall height 11 ft.
Wood double hung windows. Wrought iron fence.*

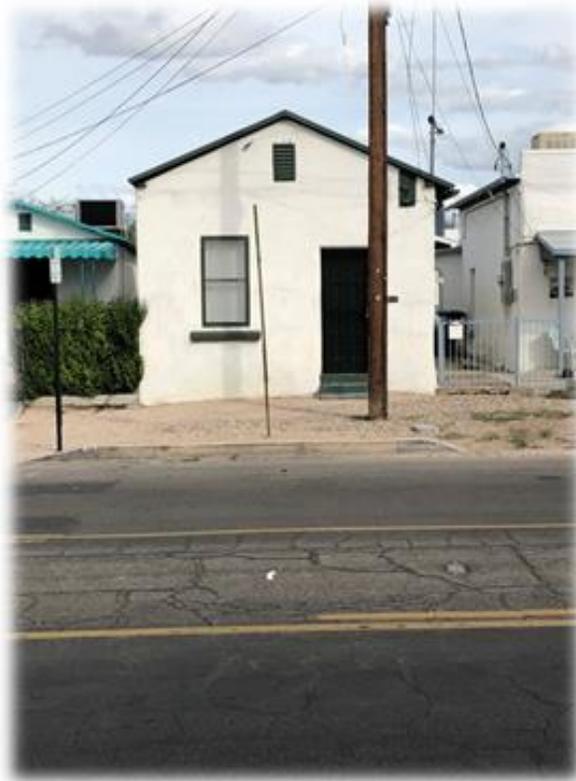
517 S Main Avenue CONTRIBUTING

Sonoran style with stucco wall finish. Simple gable roof with asphalt shingle roofing. Row house setback and entry. Wood double hung windows with stucco sill.

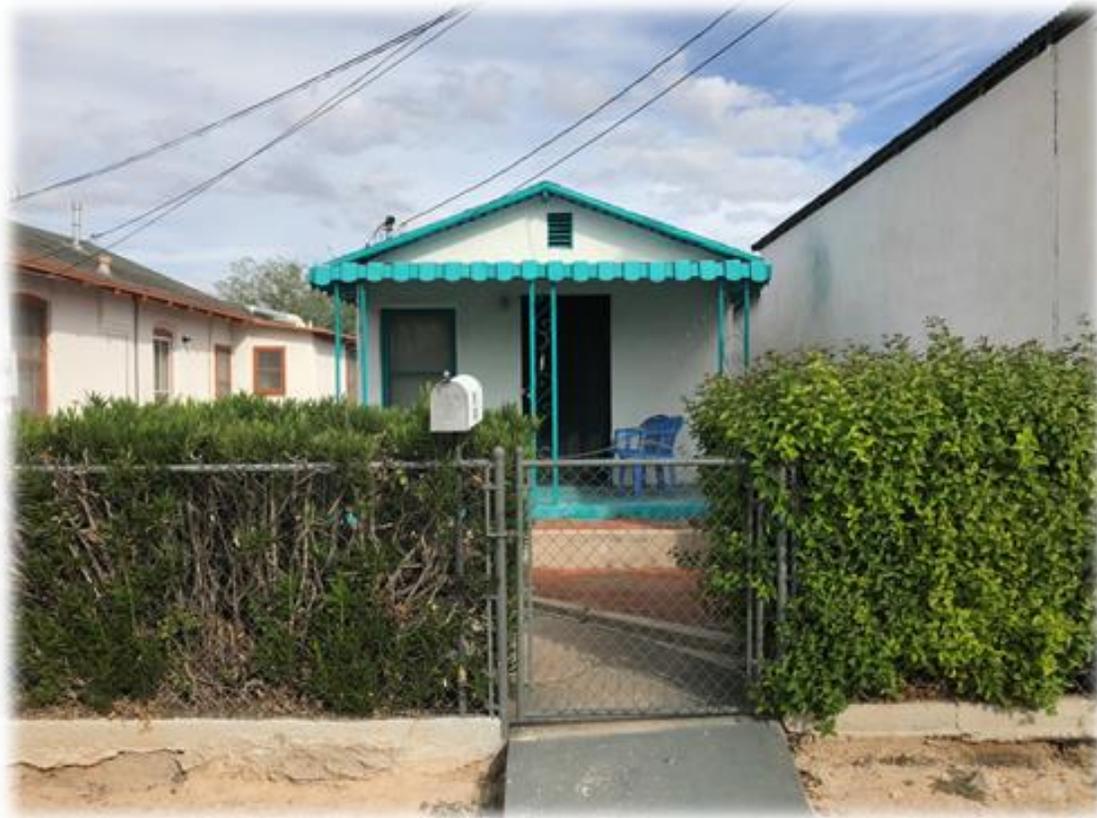
517 S. Main Avenue (Unit 2) CONTRIBUTING

Sonoran style with simple gable roof. Stucco wall finish. Manufactured metal porch.

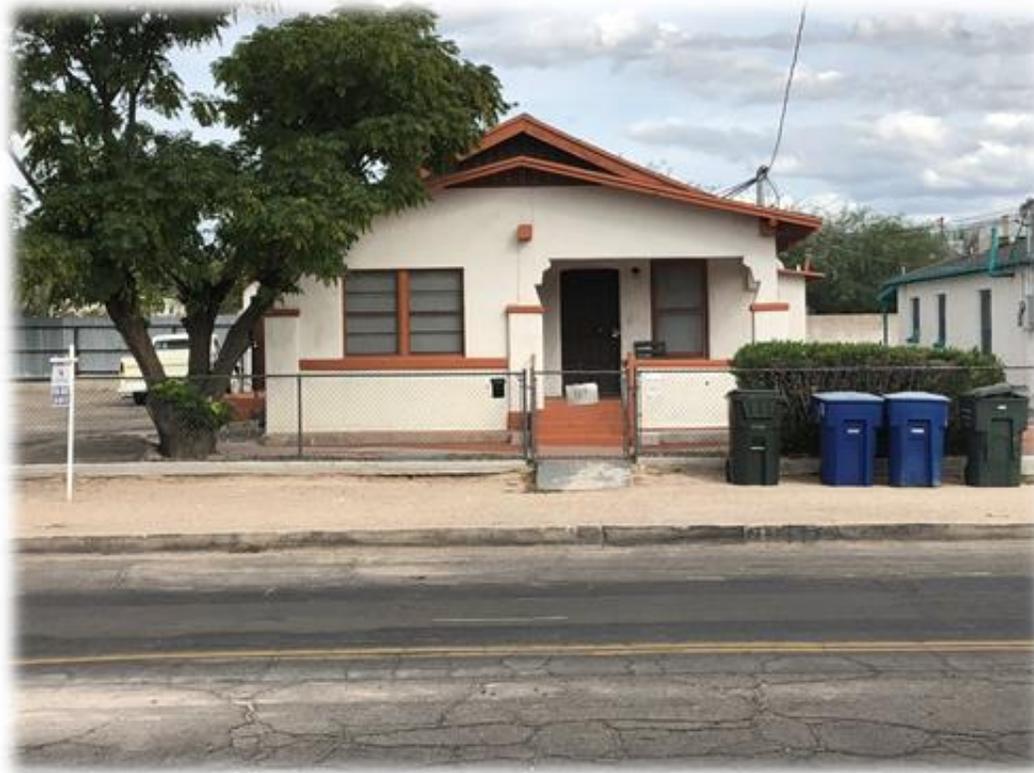
517 S. Main Avenue (unit 1) CONTRIBUTING

Bungalow style with simple plaster details. Stucco wall finish. Porch and Main House have different sloped gable roofs with asphalt shingle roofing. Double hung windows with stucco sills.

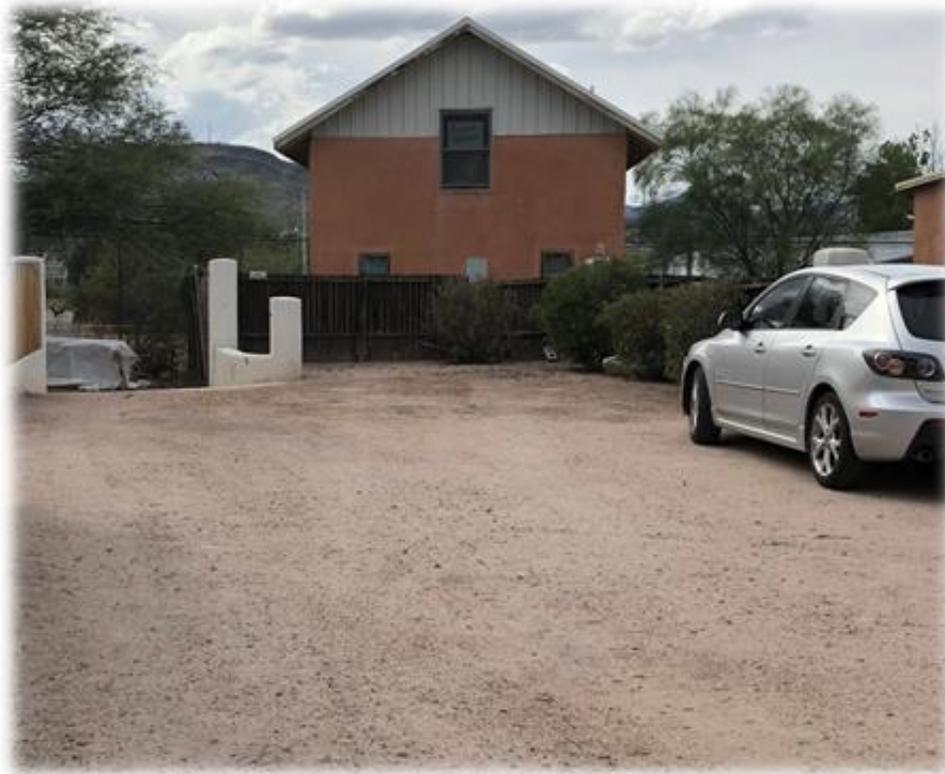
622 N. 3rd Ave. unit 1 and 2 CONTRIBUTING

Territorial style with and stucco wall finish. Gable roof with exposed rafter overhang and asphalt shingle roofing. Gable end siding.

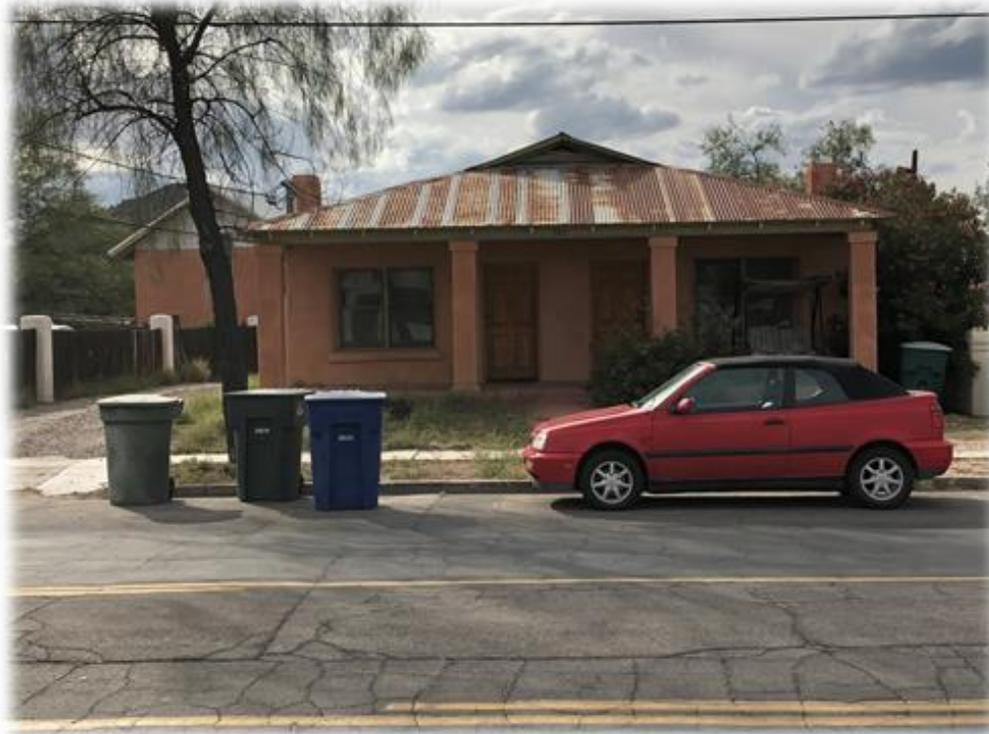
562 S. Main Avenue CONTRIBUTING

Simple territorial style with stucco finish. Double hung wood windows with stucco sills. Hip roof with corrugated metal roofing.

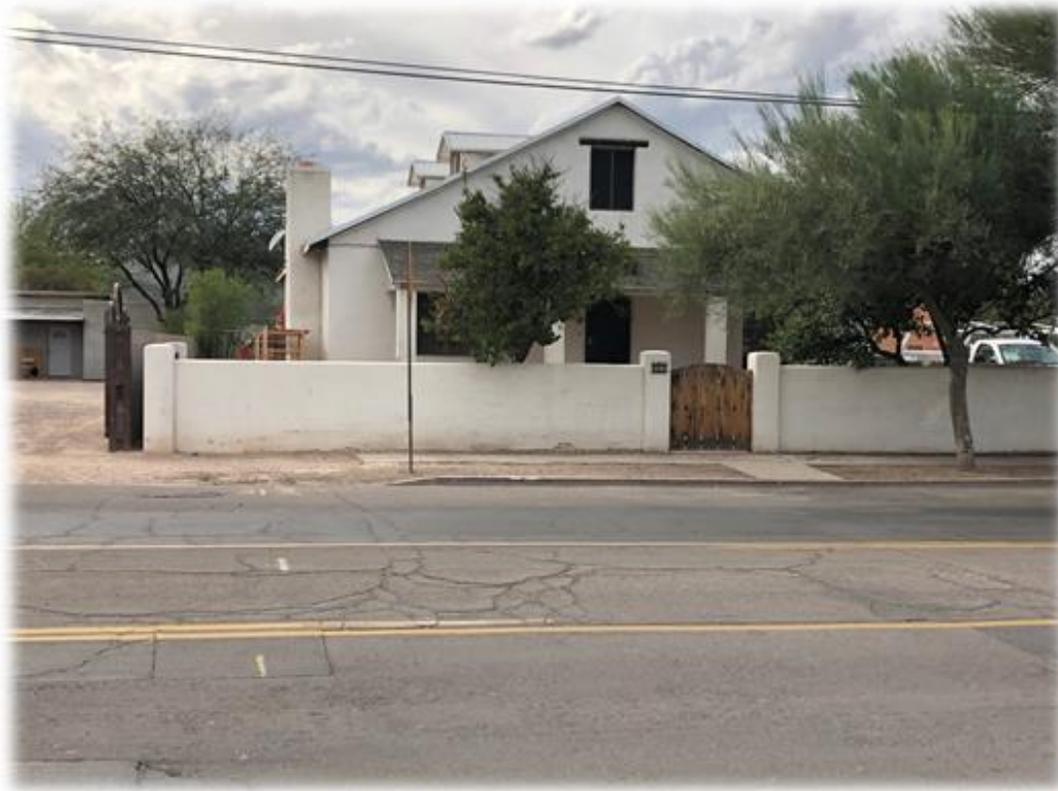
570 S. Main Avenue CONTRIBUTING

Bungalow style with simple details and stucco finish .
Two story with high windows and dormers. Gable roof
with metal roofing.

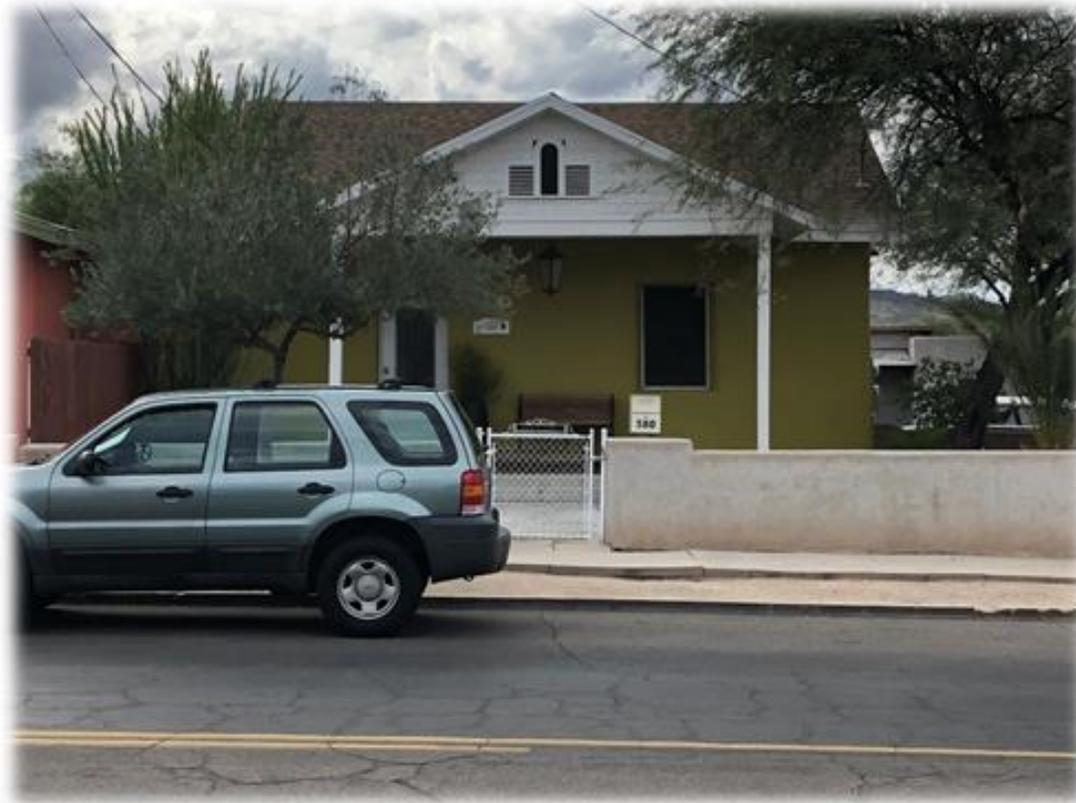
580 S. Main Avenue CONTRIBUTING

*Territorial style with exposed smooth stucco finish
Double hung wood windows. Porch with gable roof and
attic vent. Gable roof with asphalt shingles*

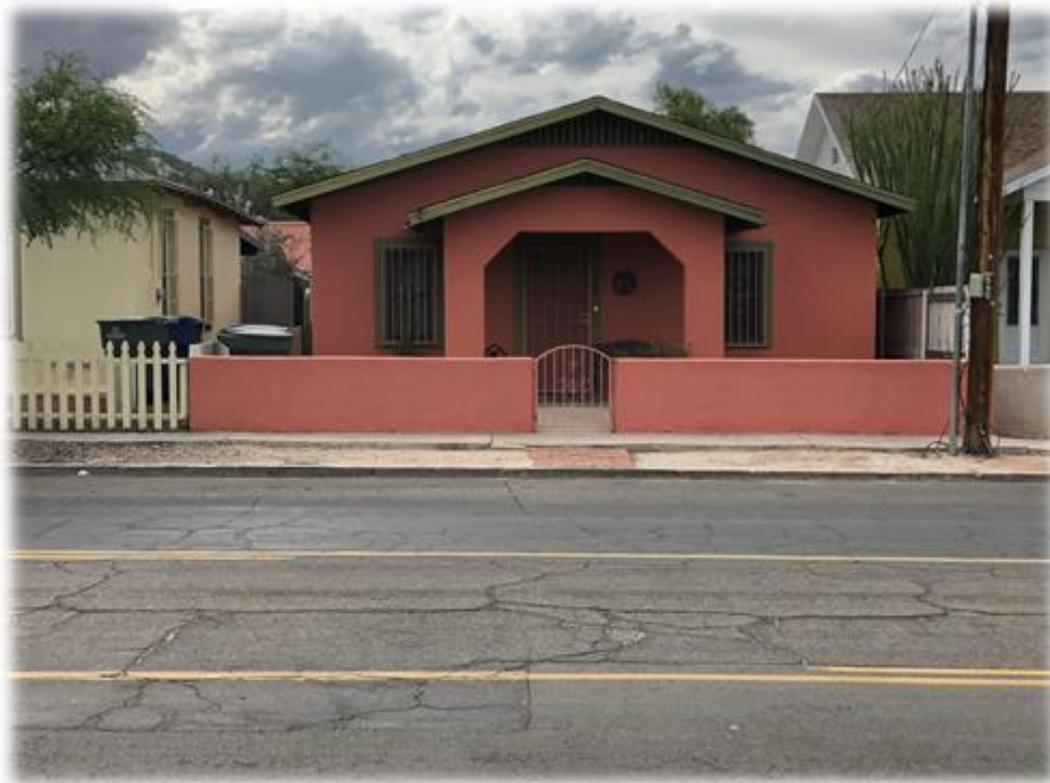
582 S. Main Avenue CONTRIBUTING

Bungalow Style with smooth trowel stucco finish. Porch and Main house with Gable roof and asphalt shingles. Double hung wood windows with wood trim. Masonry patio wall.

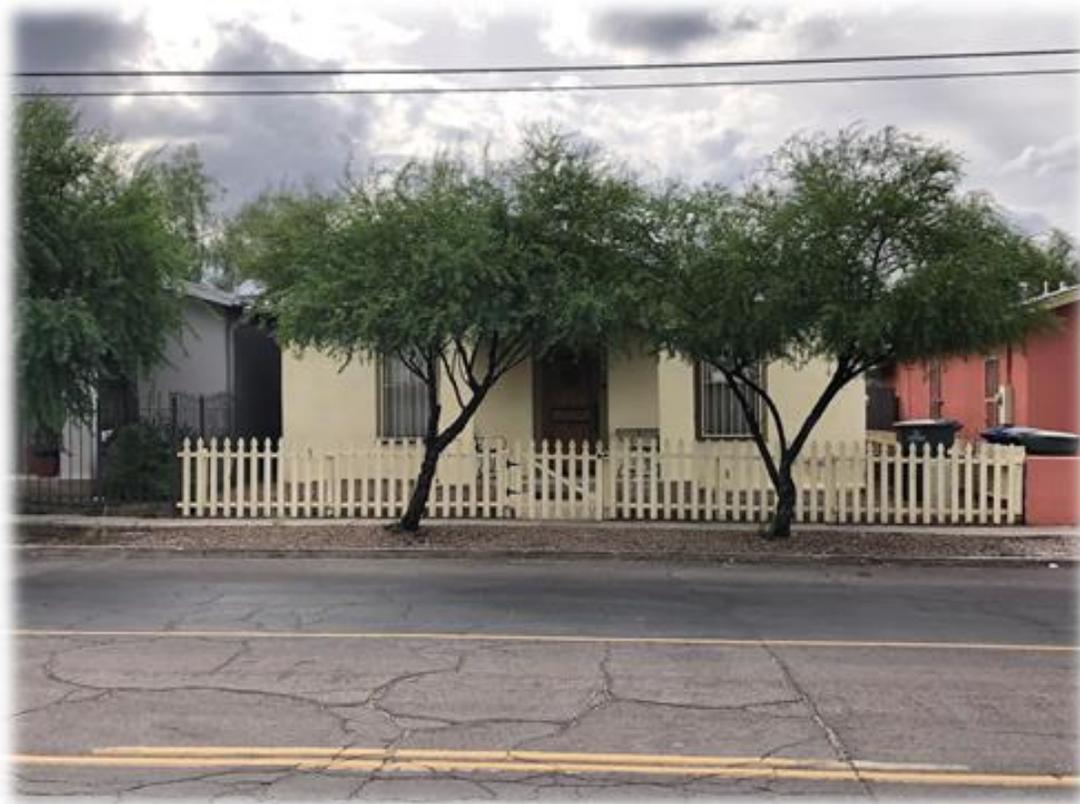
584 S. Main Avenue CONTRIBUTING

Bungalow Style with smooth trowel stucco finish. Porch and Main house with Gable roof. Double hung wood windows Wood picket fence
