Architectural Documentation of Buildings at 503 North Stone Avenue and on Parcel Number 117-05-068F, Tucson, Arizona

Technical Report 15-71
Statistical Research, Inc.
Tucson, Arizona

September 2015

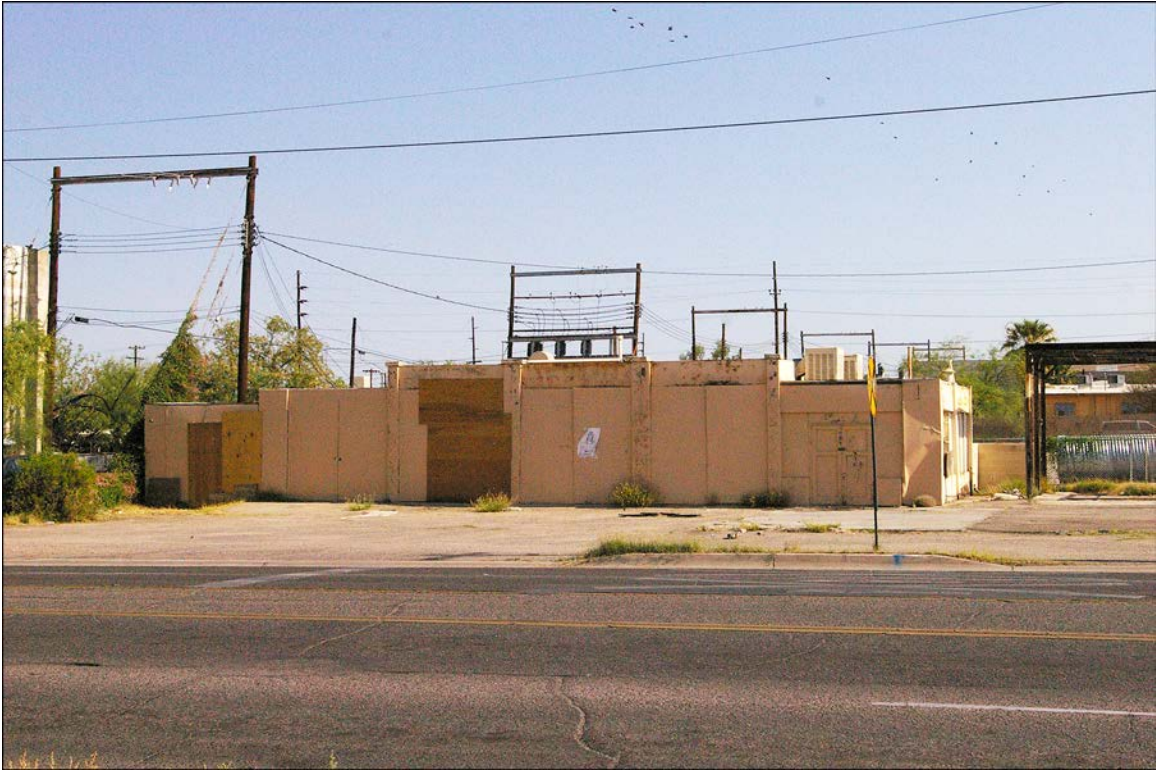
Figure 12. South elevation of service building, 503 North Stone Avenue.

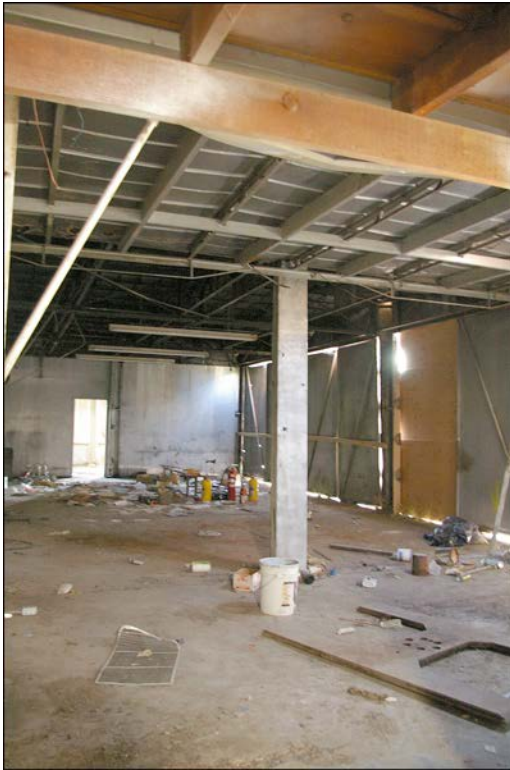
Figure 16. Interior of service building, 503 N. Stone Avenue, showing metal- and wood-frame components of the roofing system; view to the east-southeast.

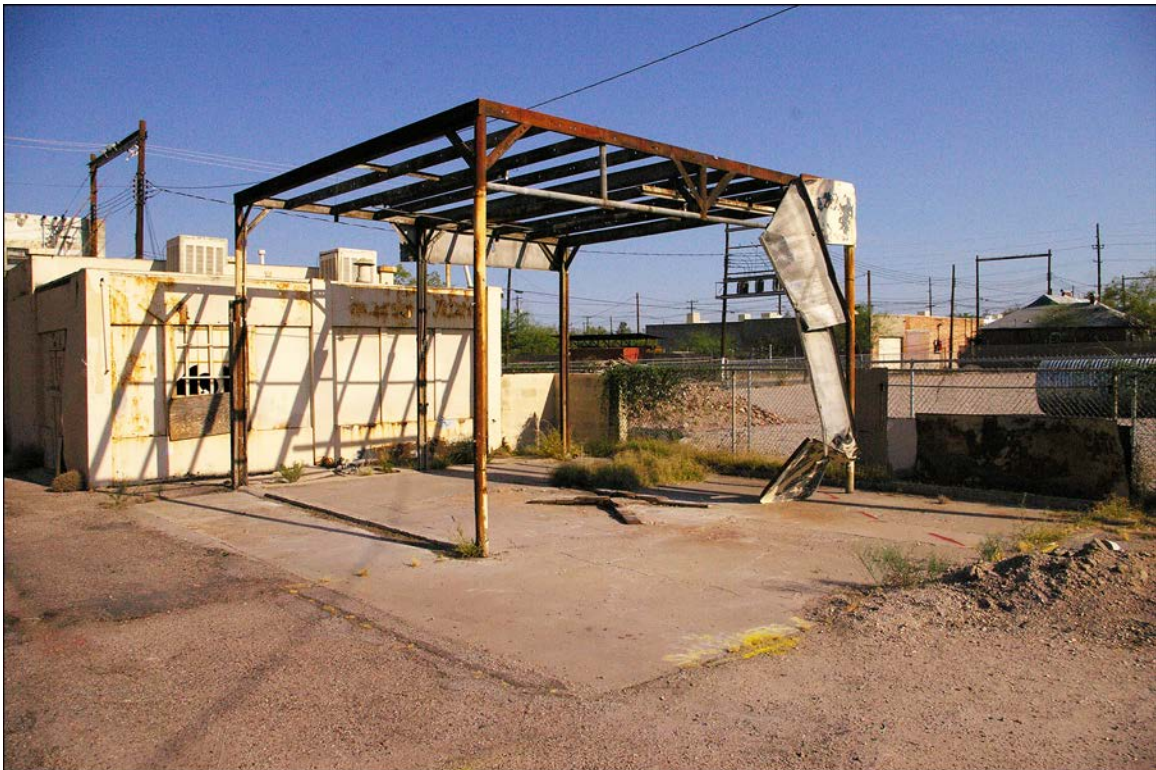
The concrete pads indicated on the 1947 Sanborn fire insurance map, one of which is outfitted with a single-post hydraulic vehicle lift and a dilapidated metal-frame shade cover, are extant (Figure 17). The vehicle lift with shade cover served as a grease rack for changing oil and lubricating automobile undercarriages. Apart from the footprints of the buildings and concrete pads, the parcel is covered with asphalt paving.

Figure 17. Remains of grease rack and metal-frame shade cover, 503 N. Stone Avenue; view to the northwest.

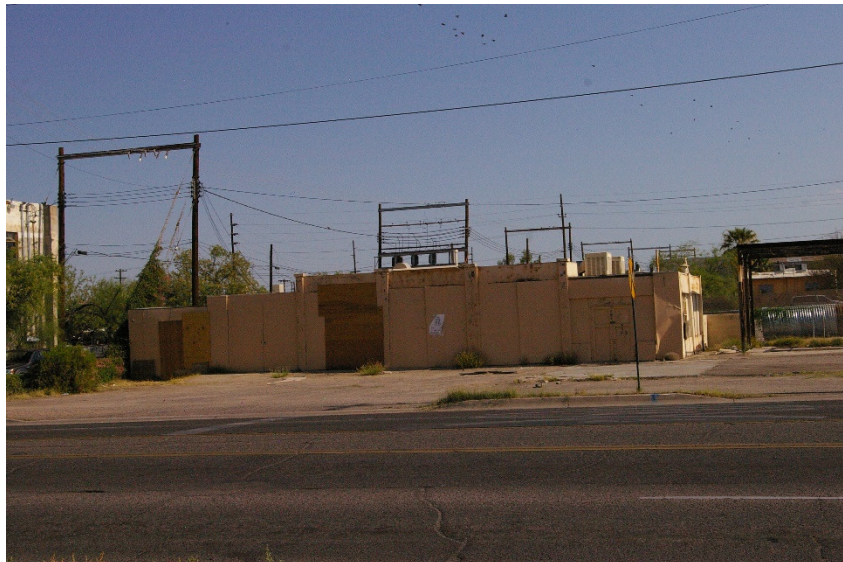
Constructed ca. 1946, the one-story, industrial-style facility at the northwest corner of the parcel functioned as an automobile repair and maintenance shop and later was used for detailing of automobile interiors and exteriors. The building exhibits elements of the early International style and appears to have been constructed in two episodes. Oriented east to west and rectangular in plan, the building has overall dimensions of 23 feet by 72 feet. The main mass of the building—which is believed to be original and incorporates four work bays and a tool/supply room—has a concrete foundation, a metal-frame superstructure with metal siding, and a flat, built-up roof with parapet walls and protruding scuppers (north facade only). The center portion of the building with three work bays has a roofline higher than the adjoining structural units to the east and west. At the west end of the building, there is an obvious addition; the date of construction is unknown. This addition rests on a concrete foundation and is lower in elevation than both the foundation and the roofline of the adjoining unit of the original building. It is of wood-frame construction, is sheathed with asbestos-cement board, and has a flat, built-up roof with parapet walls and protruding scuppers at the northwest and southwest corners. Six entrances are in use on the south (front) facade. Each of the four work bays is covered by metal double doors. One set of double doors is covered with plywood to secure the opening. The entrances to the structural units at the east and west ends of the building are covered with metal double doors and a single-light wood door, respectively. Furthermore, the wood door on the west end is covered with plywood to provide additional security. One multilight, steel-sash casement window with vertical security bars is in place on the east facade. A sheet of plywood covers the lower third of the window opening. Interior features of the original building consist of metal walls, a concrete floor, and exposed steel roofing members. The interior of the addition consists of a concrete floor, exposed wood roofing members, and unfinished walls of asbestos-cement board. With multiple holes in the roof and the metal siding showing signs of significant corrosion, the former service building is in fair condition.

South elevation of service building, 503 North Stone Avenue.
