Asbestos Inspection and Lead-Based Paint Screening

City of Tucson Water Building

1480 South 10th Avenue

Terracon Project No. 63227145B

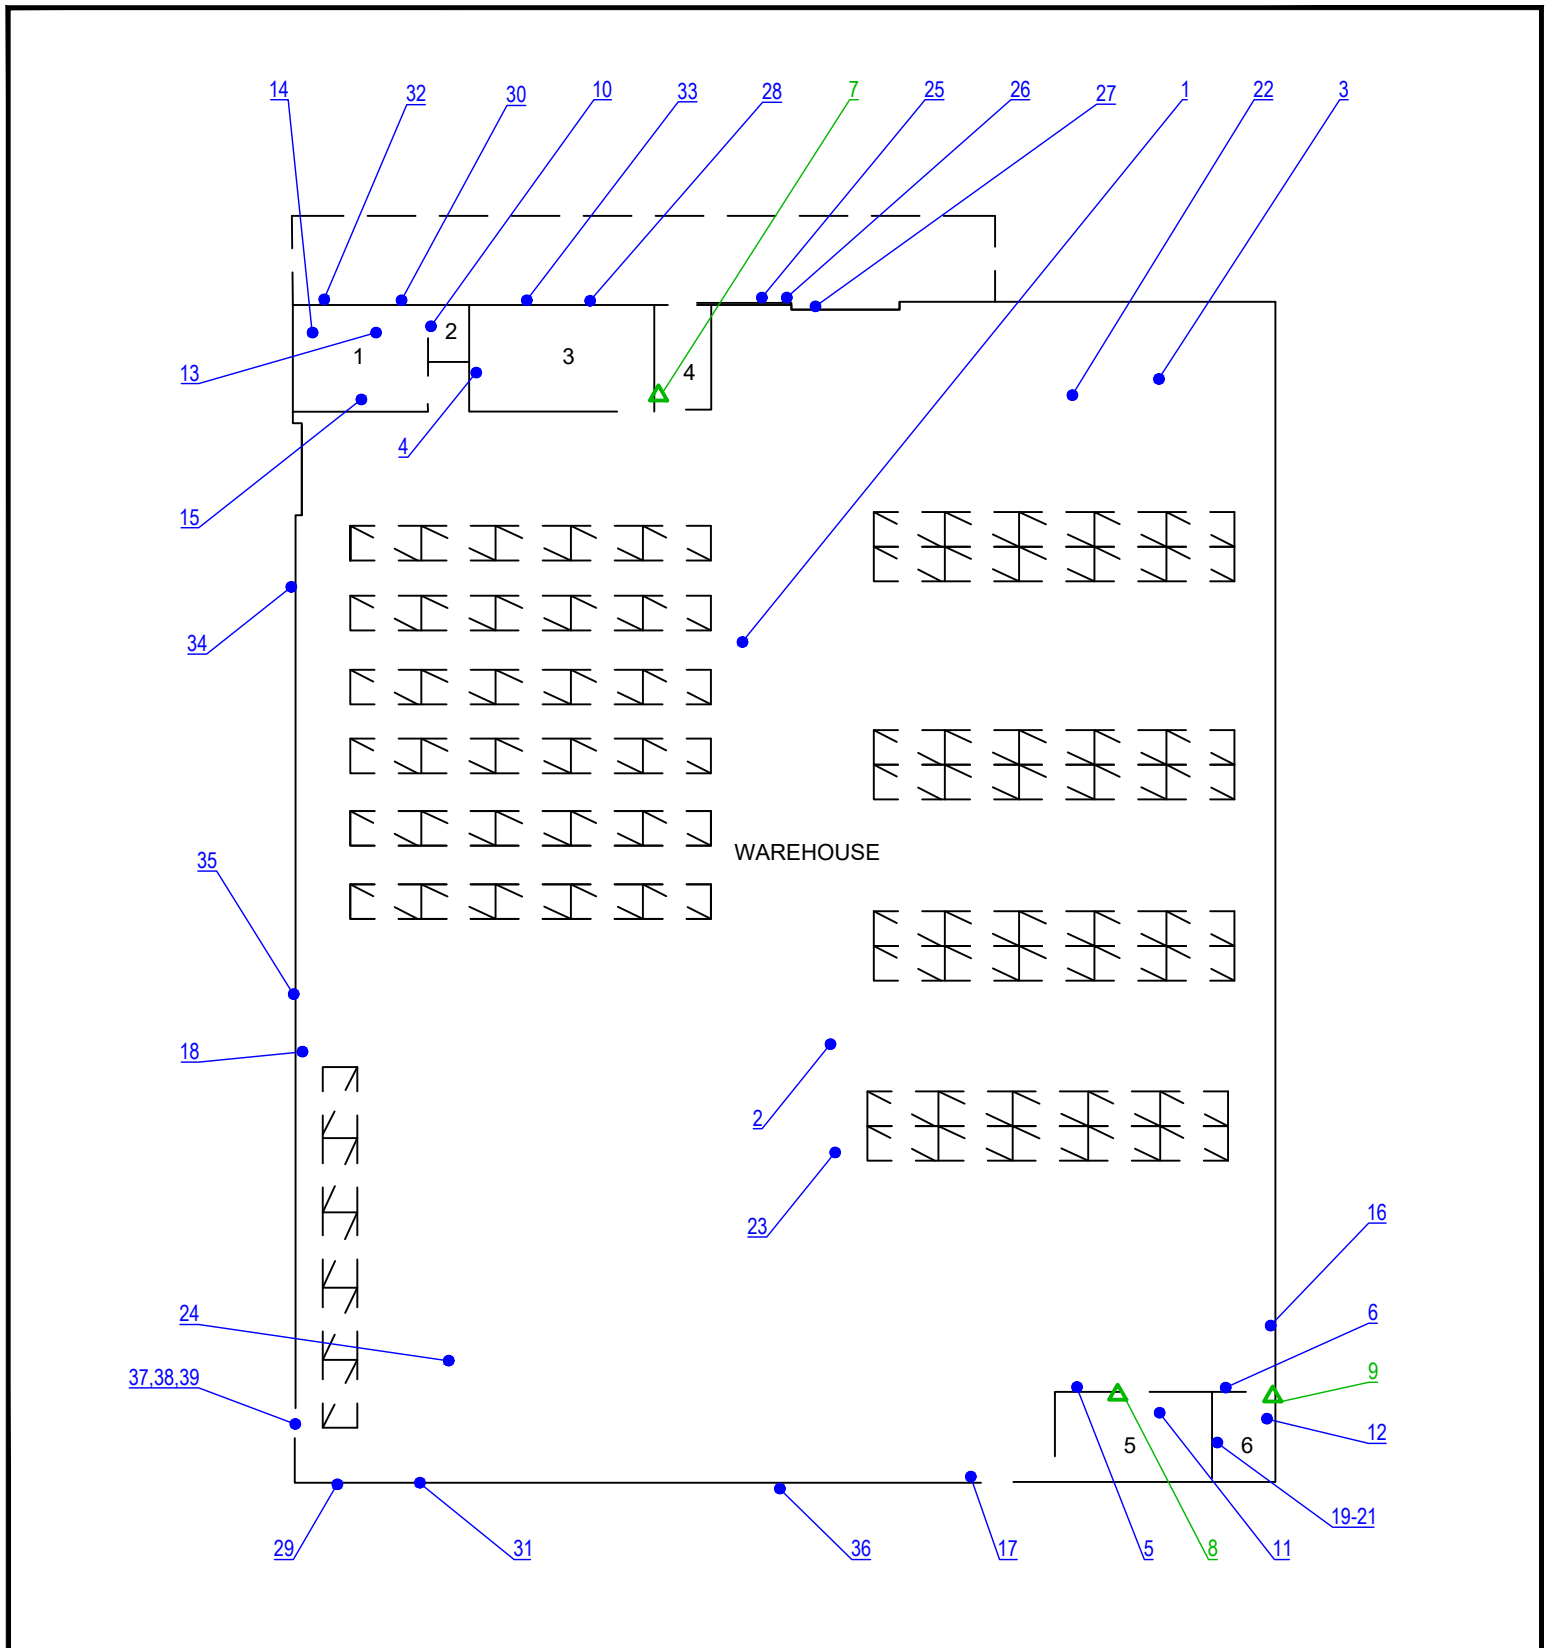
ASBESTOS SAMPLING DIAGRAMS

Summary of Identified Materials with <1% asbestos			
HA No.	Material Description	Material Location	Estimated Quantity
3	Skim Coat Texture Drywall System	Rooms 1 - 6	3,000 Sq. Ft.

HA No.	Material Description	Material Location	% and Type Asbestos# ^	Condition	Estimated Quantity*
3	Skim Coat Texture Drywall System	Rooms 1 - 6	1.00% Chrysotile by PC – Paint Texture 2	Good	3,000 Sq. Ft.

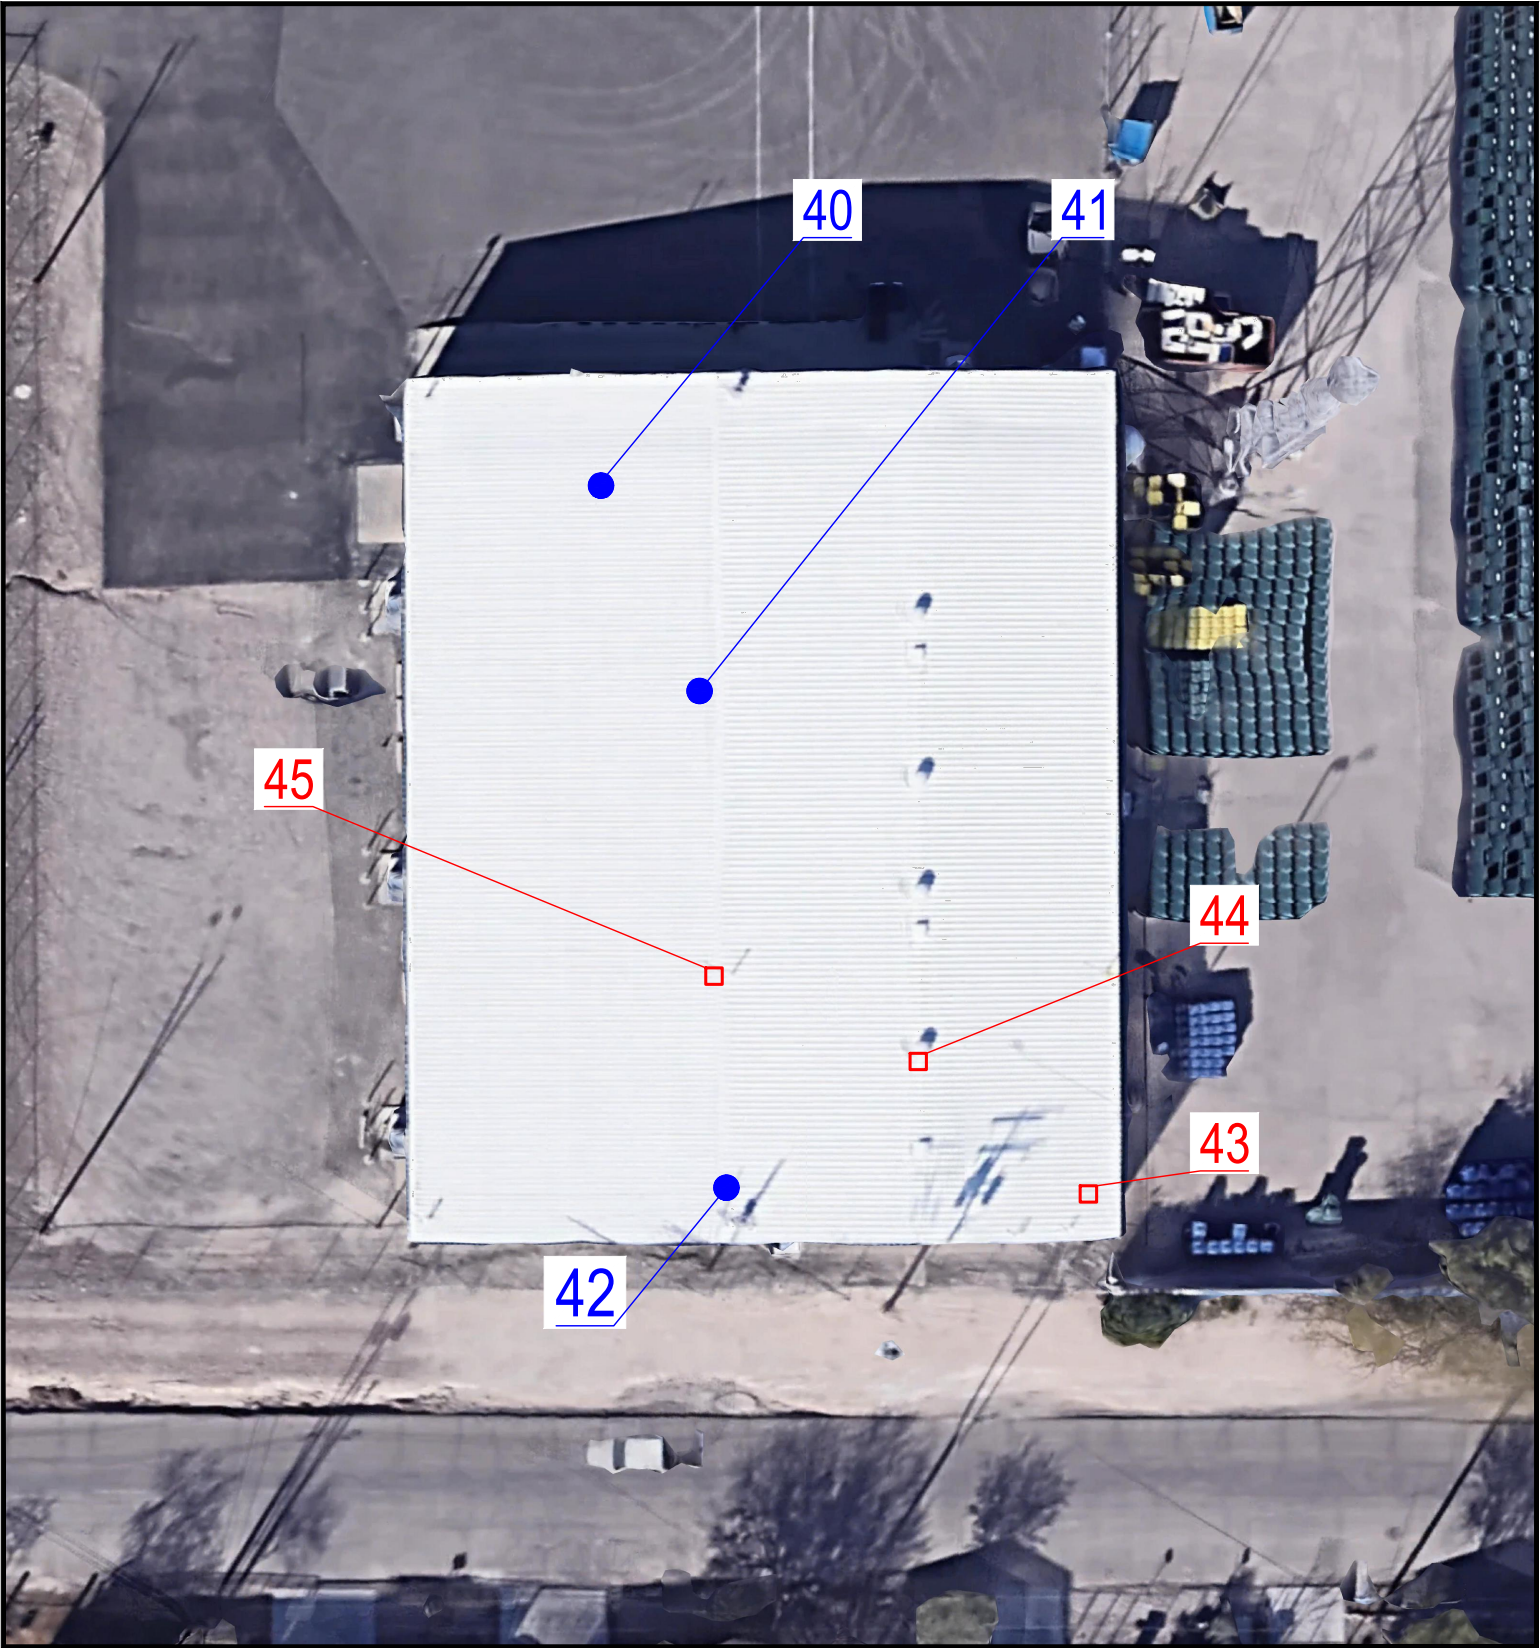
Summary of Identified ACM				
HA No.	Material Description	Material Location	NESHAP Classification ¹	Estimated Quantity
15	Black Penetration Tar	Roof	CAT I – Non-friable	150 Sq. Ft.

HA No.	Material Description	Material Location	% and Type Asbestos [^]	NESHAP Classification	Condition	Estimated Quantity*
15	Black Penetration Tar	Roof	5% Chrysotile	CAT I – Non-friable	Good	150 Sq. Ft.

- APPROXIMATE SAMPLE LOCATION (NON-ACM)
 - APPROXIMATE SAMPLE LOCATION (ACM)
- ACMs
HA 15: Samples 43-45: BLACK PENETRATION TAR

The listed Category I non-friable ACM that is damaged or could be damaged to the extent that it could be crumbled, pulverized or reduced to powder when dry, making it friable, must be removed prior to activities (renovation and/or demolition) that may disturb this material in accordance with applicable federal, state and local regulations.
