CAPITAL NEEDS ASSESSMENT

Downtown Motor Hotel
383 South Stone Avenue
Tucson, Arizona 85701

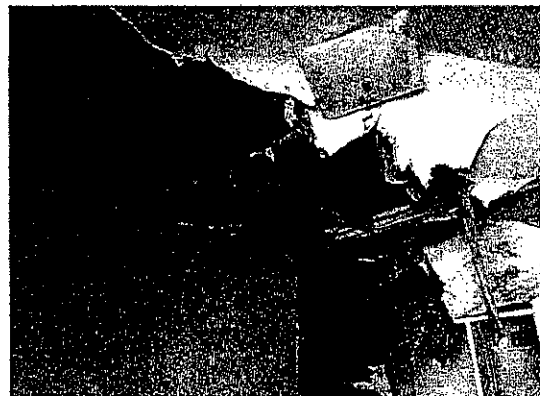
Severe damage to the ceiling

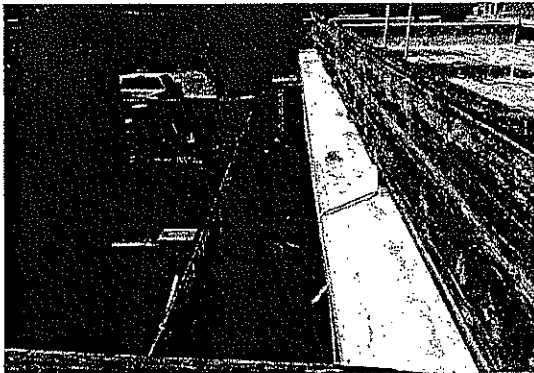
Yard filled with trash.

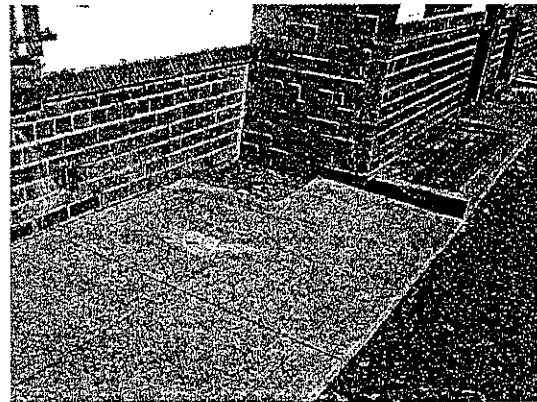
Planter is filled with brick. Cracks are visible on exterior wall.

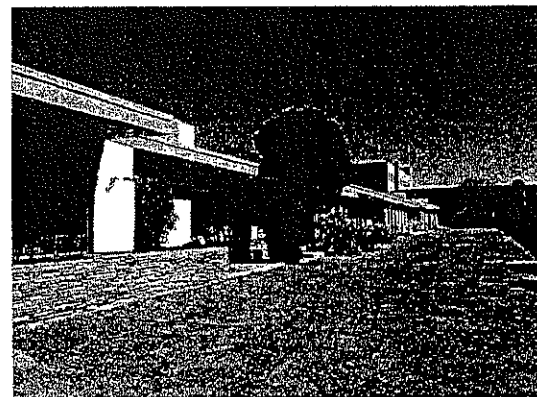
Asphalt is worn. Plants are too close to building.

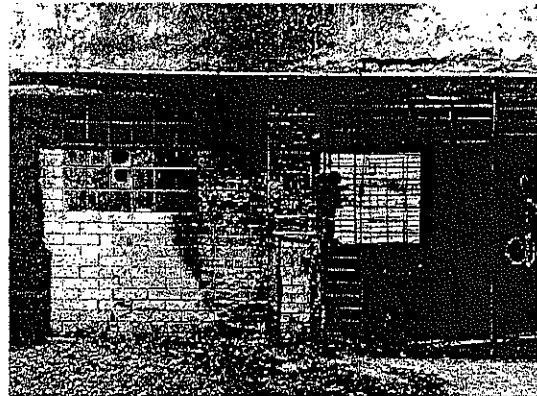
Fire damage on the alley side.

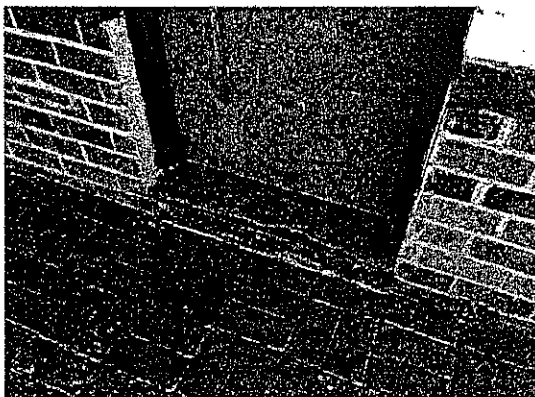
Step at 1st floor entry door.

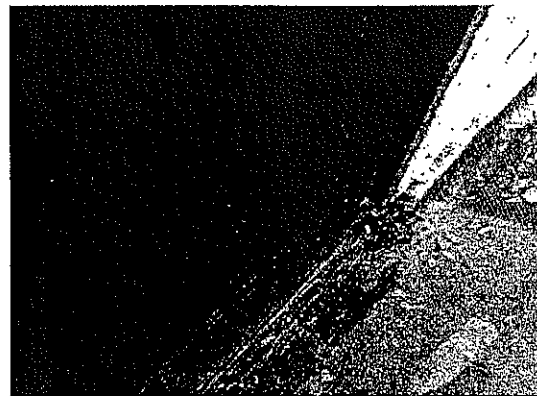
Damages at 2nd floor entry door.

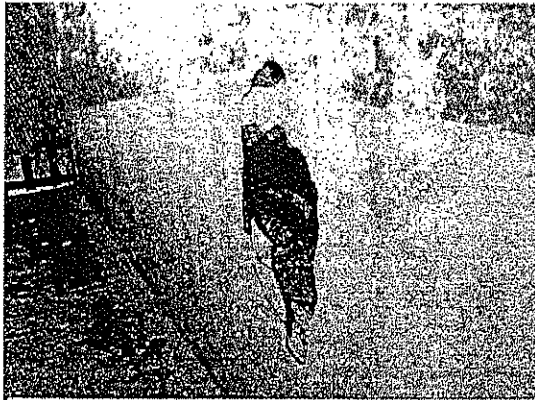
Hole in stucco wall.

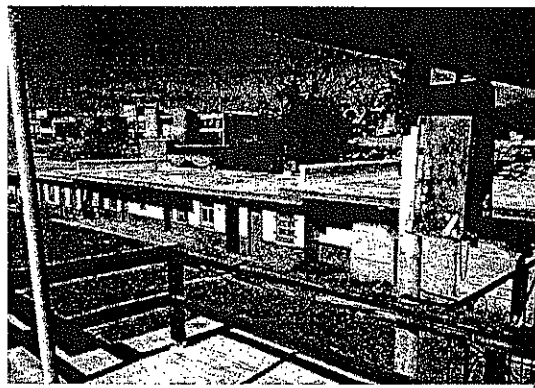
Precarious balcony rail.

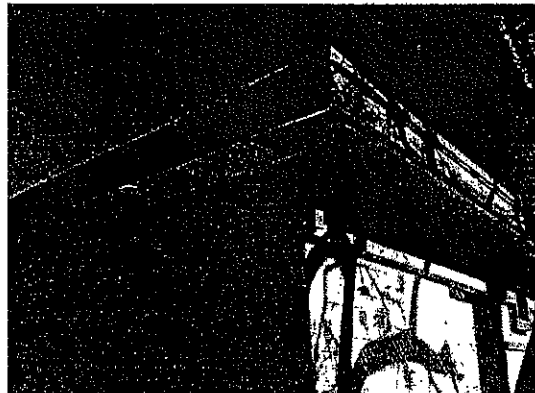
Damage to eaves and soffits.

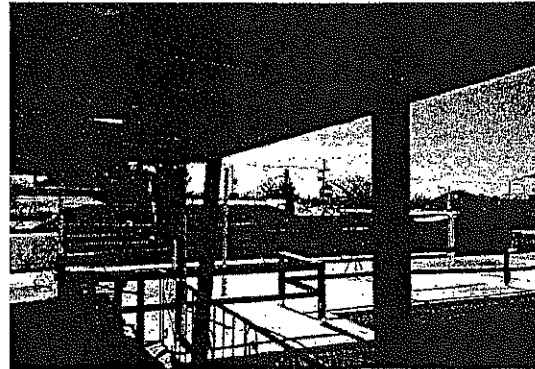
Balcony roof support is leaning.

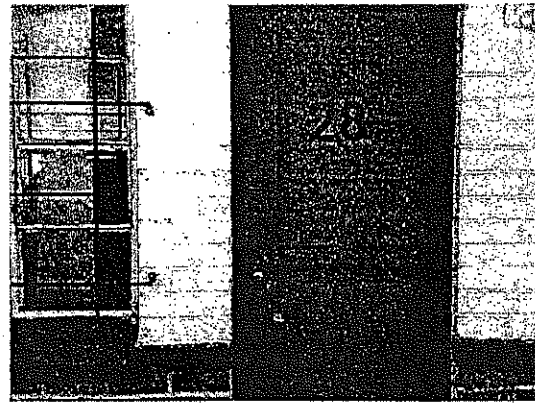
Typical fixed window next to typical entry door.

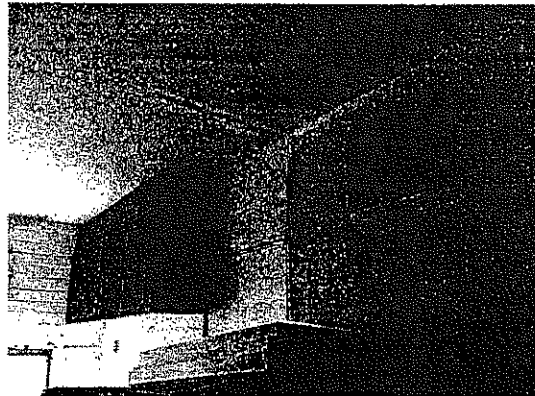
Hole in wall from removed ductwork.

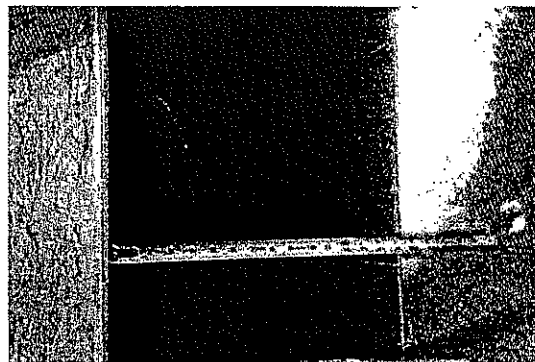
Opening to the shower stall is too narrow.

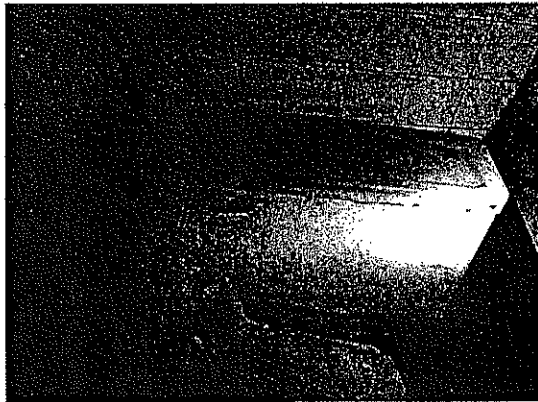
Toilet is too close to the heater.

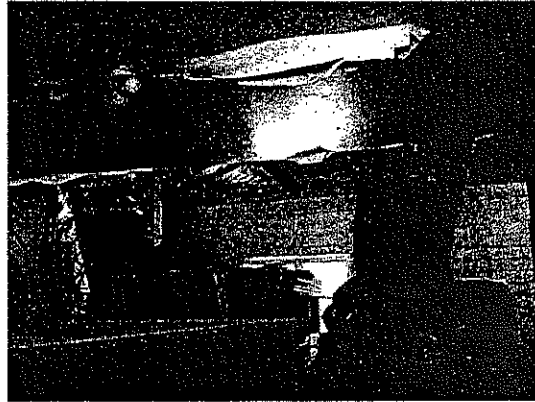
Extensive damage to the ceiling.

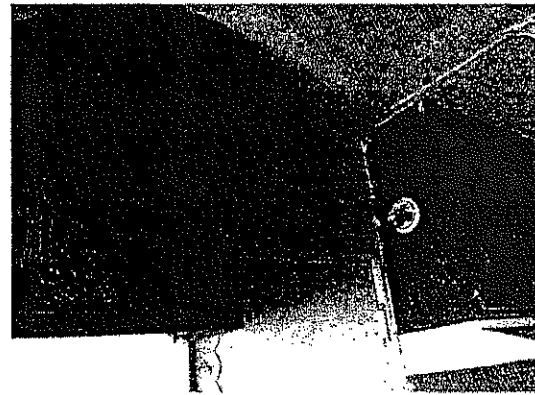
Cabinets and a broken fire alarm..

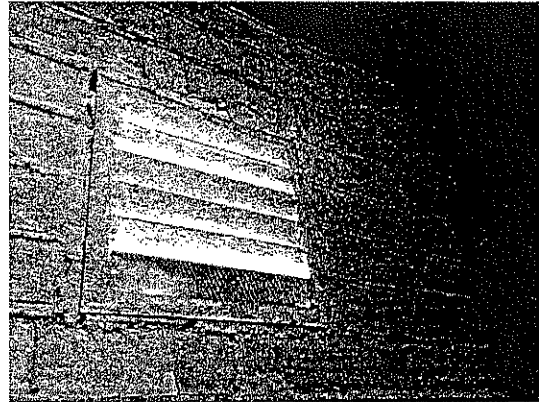
Vent opening in exterior wall.

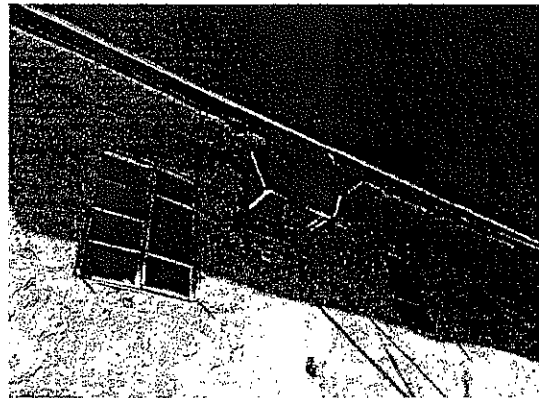
Rusted cage where AC equipment used to hang.

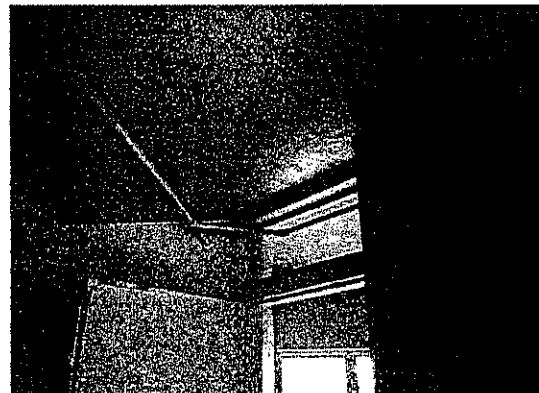
Exposed piping indoors.
