# HISTORIC HOUSES DOCUMENTATION AND RELOCATION PLAN

WEST UNIVERSITY NEIGHBORHOOD  
SPEEDWAY BLVD. AND EUCLID AVE.  
TUCSON, AZ

MARCH 2022

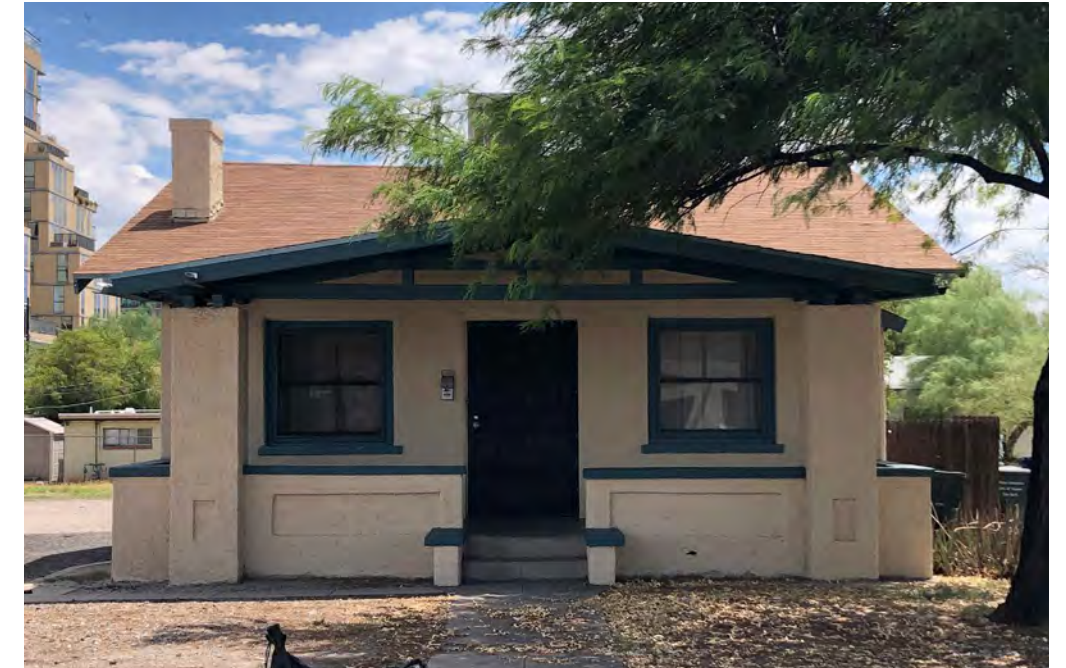
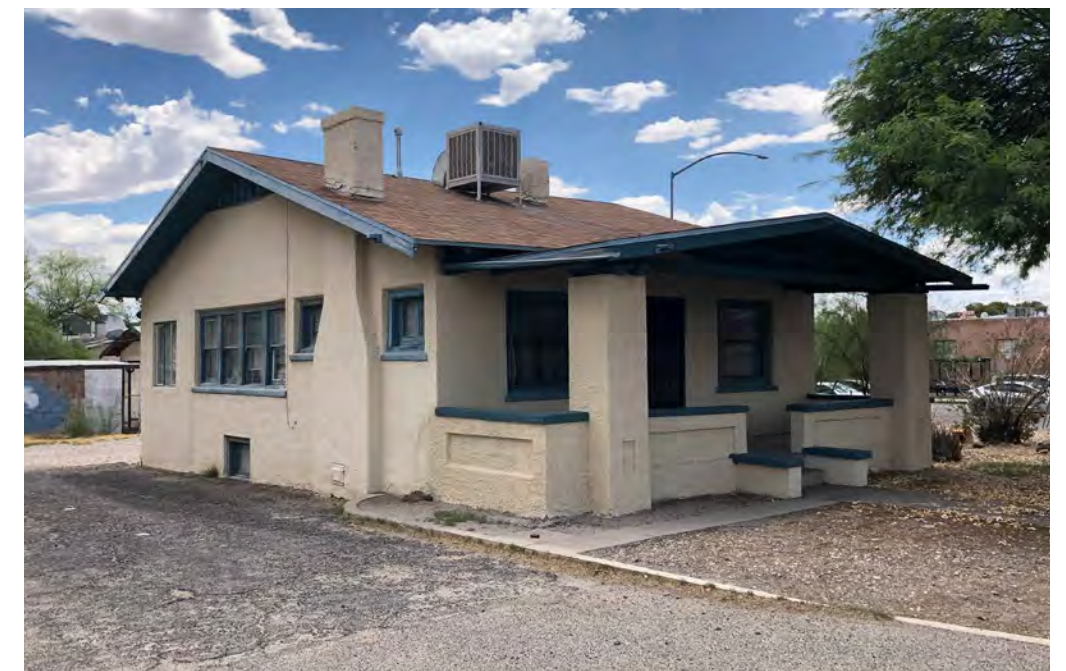
## HOUSE INVENTORY - 812 E. SPEEDWAY BLVD.

**CONDITION:** Good, needs window repair, trim and rafters need filling/painting.

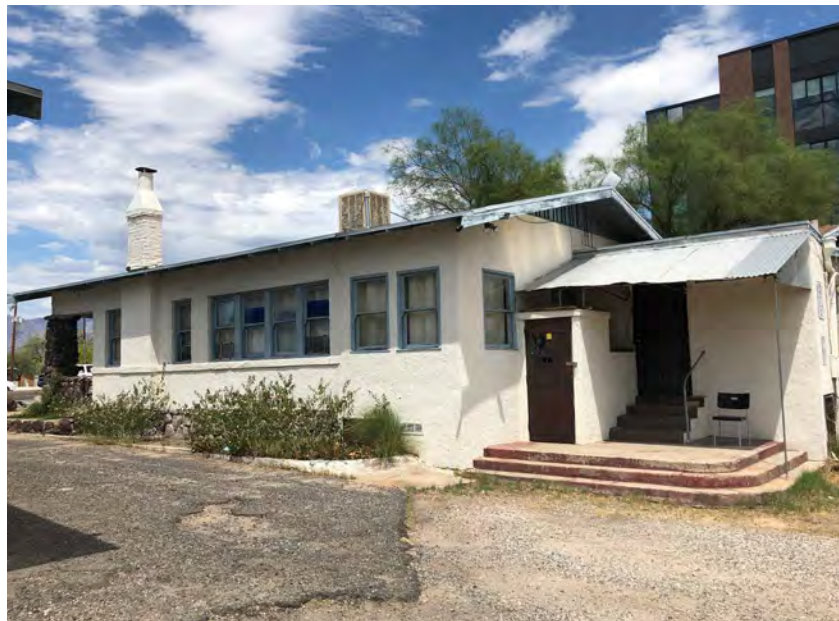
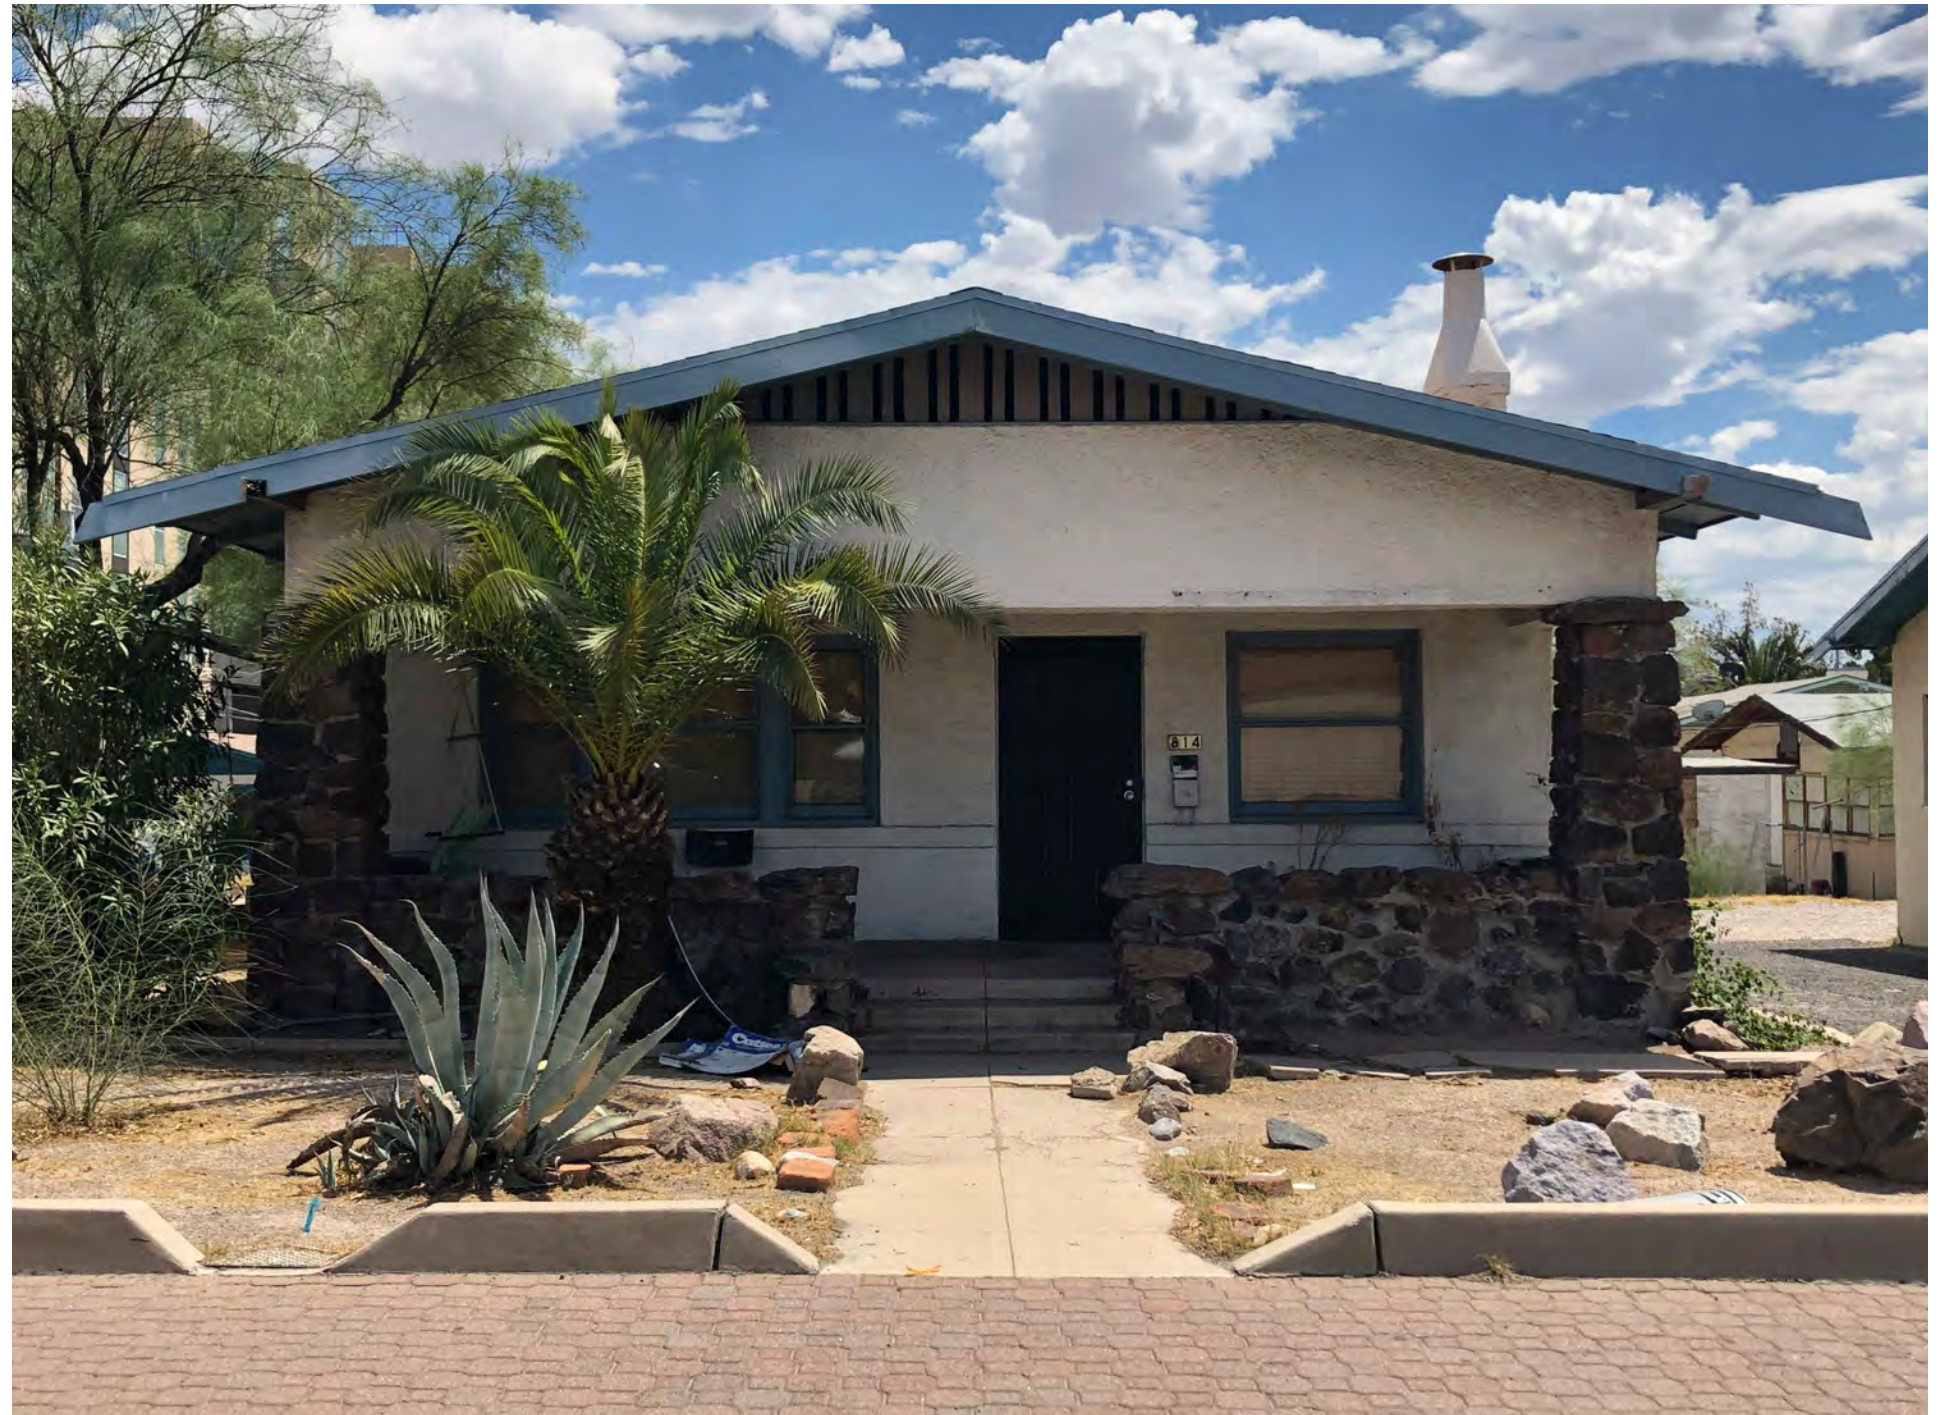
## HOUSE INVENTORY - 814 E. SPEEDWAY BLVD.

**CONDITION:** Fair, needs minor stucco repair, trim and windows need fill and paint.

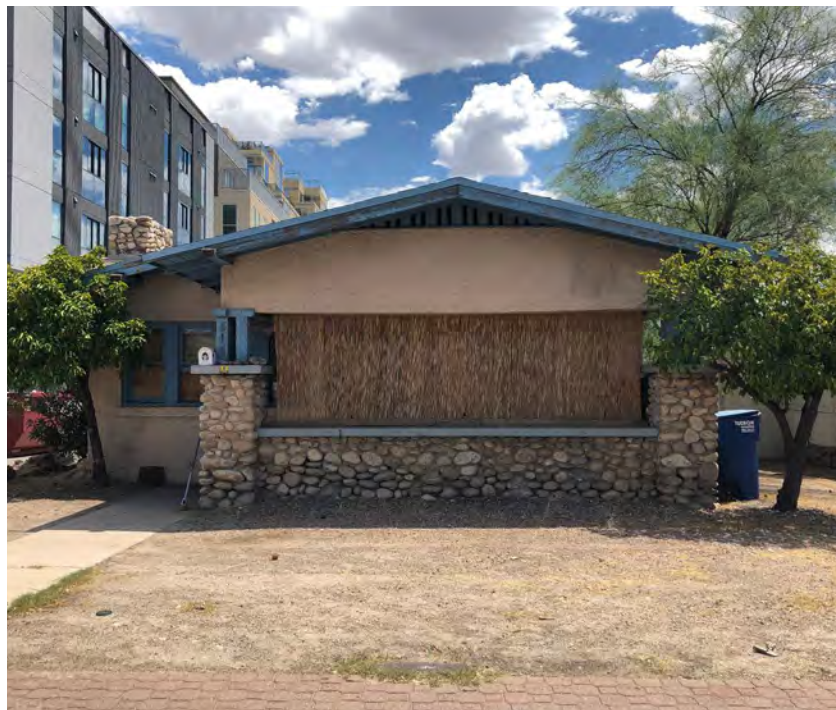
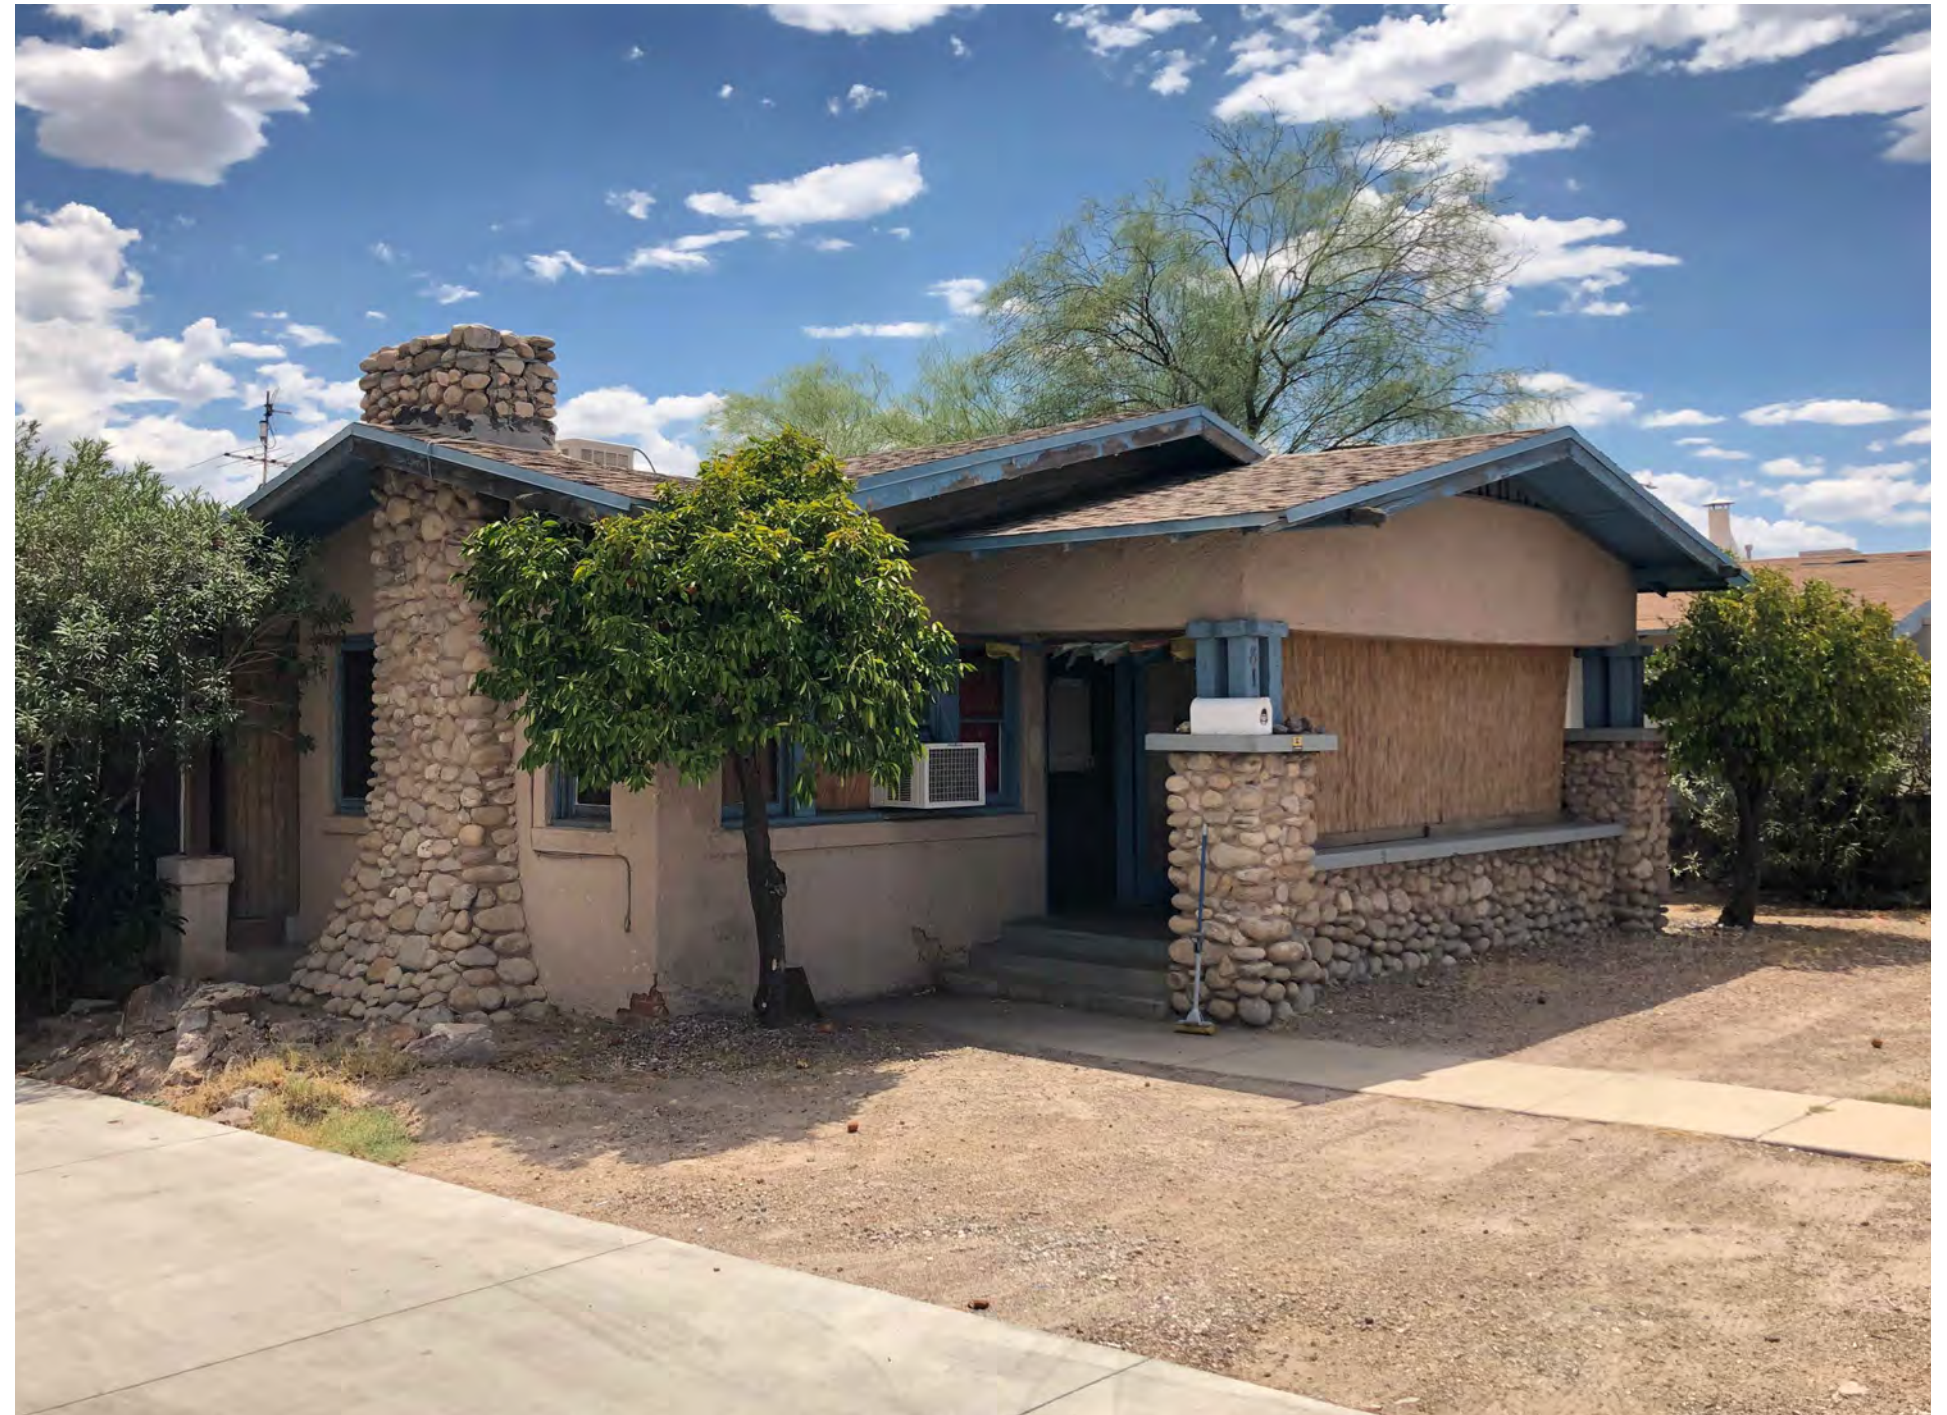
## HOUSE INVENTORY - 818 E. SPEEDWAY BLVD.

**CONDITION:** Good. Rafters, fascia need paint, rear additions need new siding.

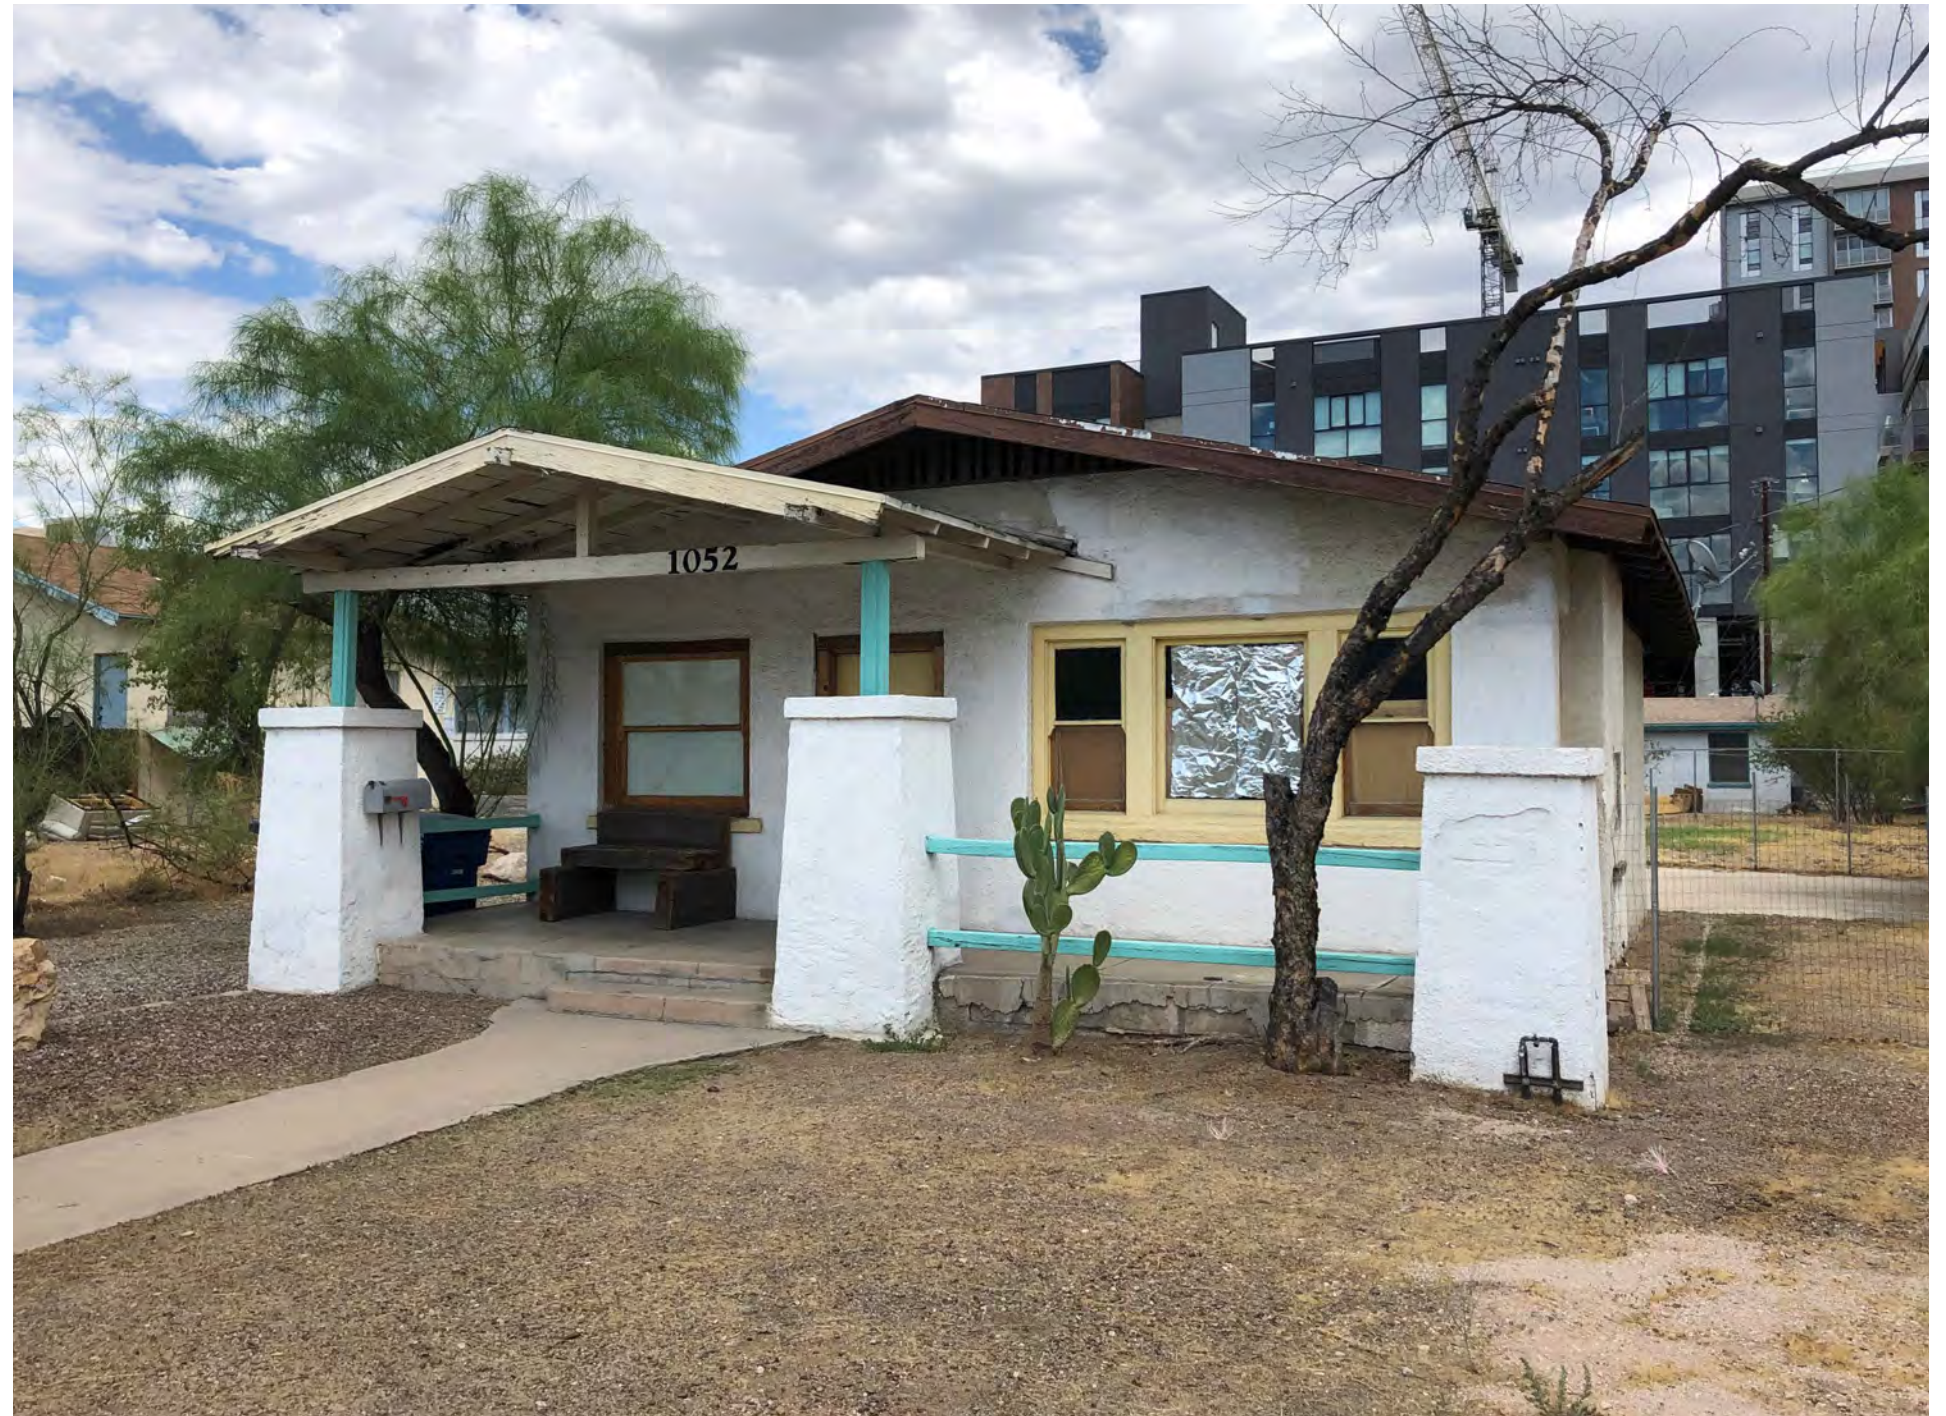
## HOUSE INVENTORY - 1052 N. EUCLID AVE.

**CONDITION:** Poor Wood trim and windows need paint.

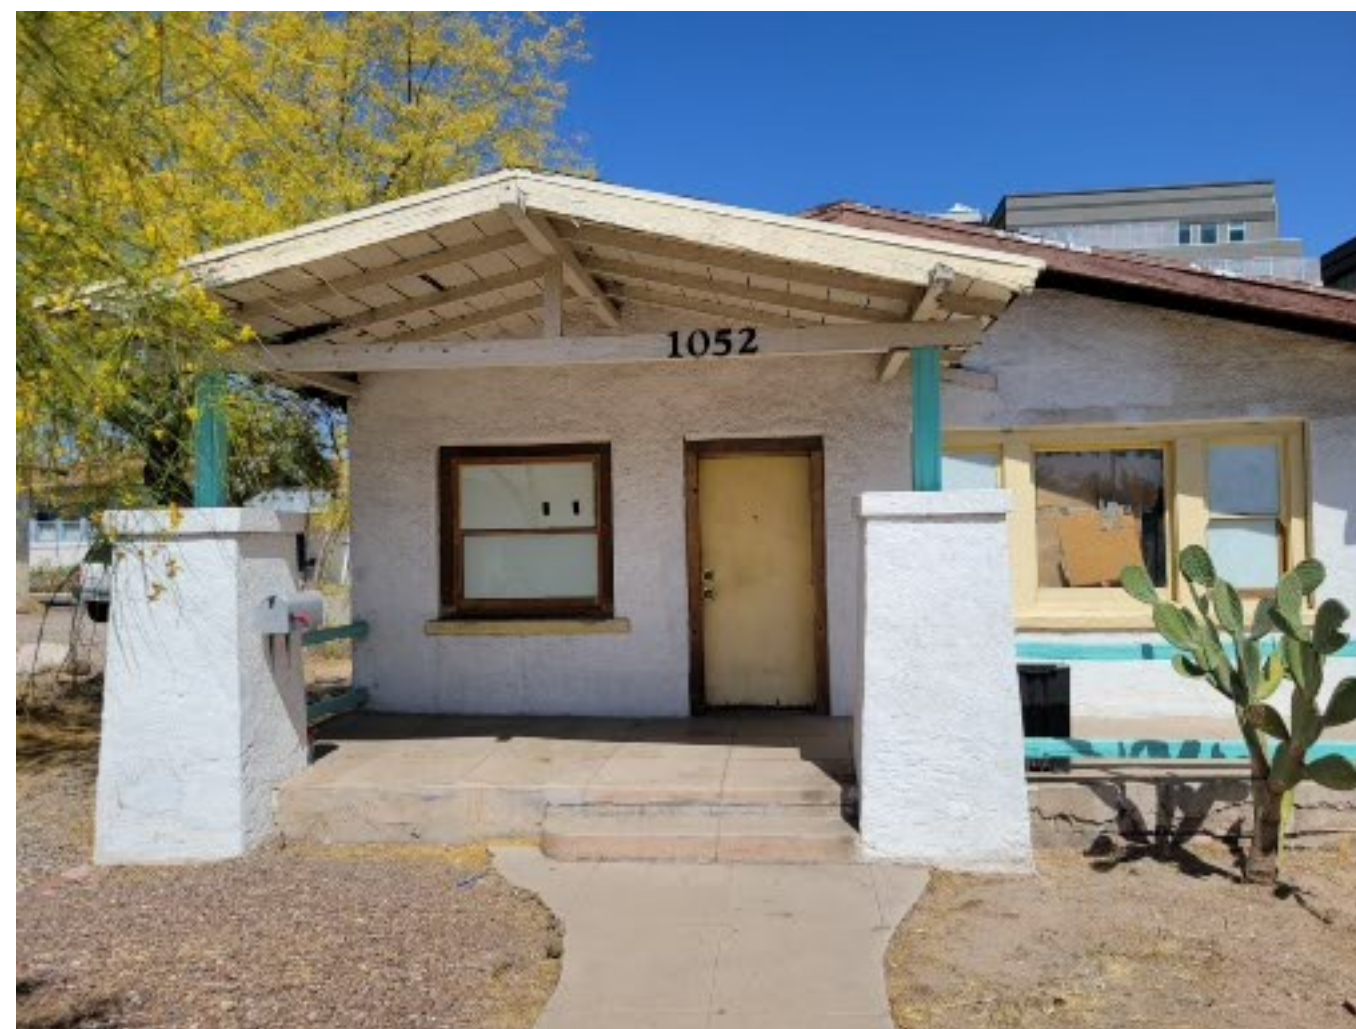
Schneider Engineers visually reviewed the property on 06/17/2022. Ron Schneider, PE, the representative for Schneider Structural Engineers (SSE), performed the site visit and gathered the information necessary for this structural assessment. The existing structure is a single-story structure with a wood framed roof supported on double Wythe unreinforced brick masonry and a wood framed floor supported on the foundation. The foundation stem walls below the floor joists appeared to be either masonry or cast in place concrete. There is stucco over the brick walls on the exterior and plaster on the interior.

The interior walls are wood framed with wood lath and plaster or stucco. This house has some large openings in the masonry, like the south wall on the west side. We noted evidence of a previous fire in the attic. Some of the wood roof planks are burnt and need to be replaced and some of the roof rafters were burnt and need to be replaced. It is estimated that about 30% of the roof is fire damaged.

This house is well-worn and many items need to be repaired. Because of the large window openings and/or wood-framed openings in the masonry walls, there are weak areas that a house mover would need to reinforce. A crack above the head of the window (north wall) and two (2) windows on either side create weak sections of these walls.

Due to the fire, all of the fire damaged lumber of the roof needs to be replaced to maintain the integrity of the structure during a move. We recommend to tie the ceiling rafters to the exterior walls with metal straps/ clips which will help support the integrity of the walls. We also recommend removing the front porch and the rear porch. We recommend that the house mover review our finding and determine if the structure is feasible to move considering the weaknesses identified.

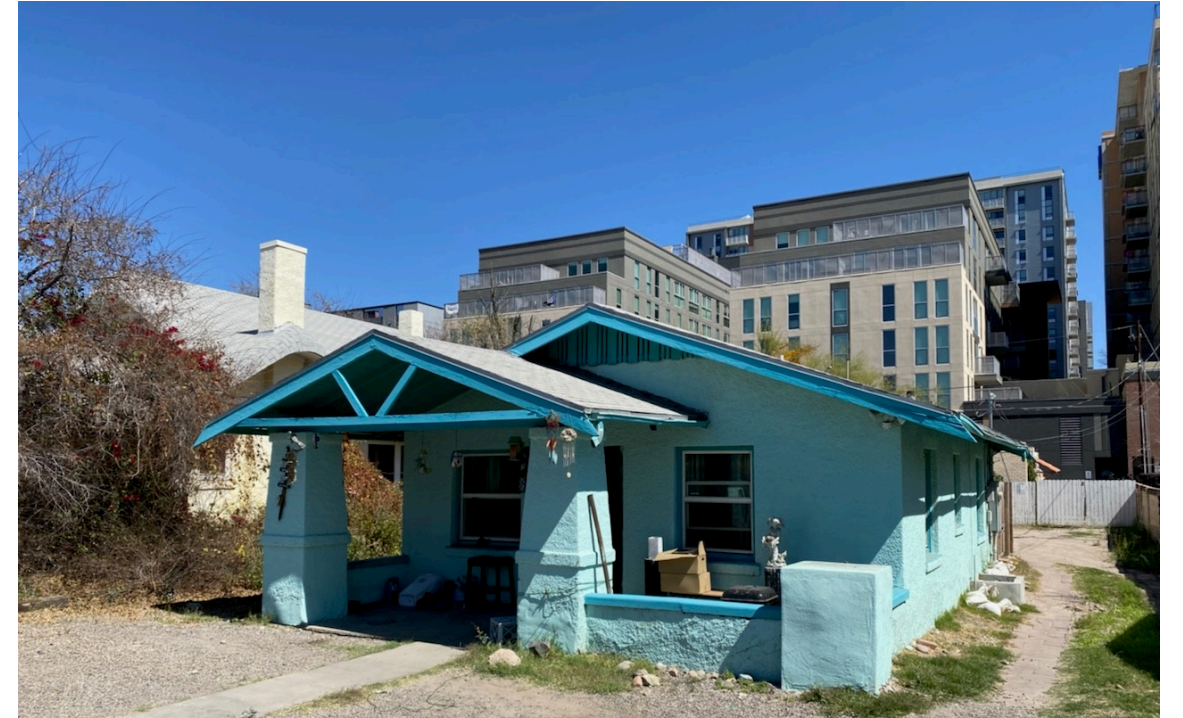
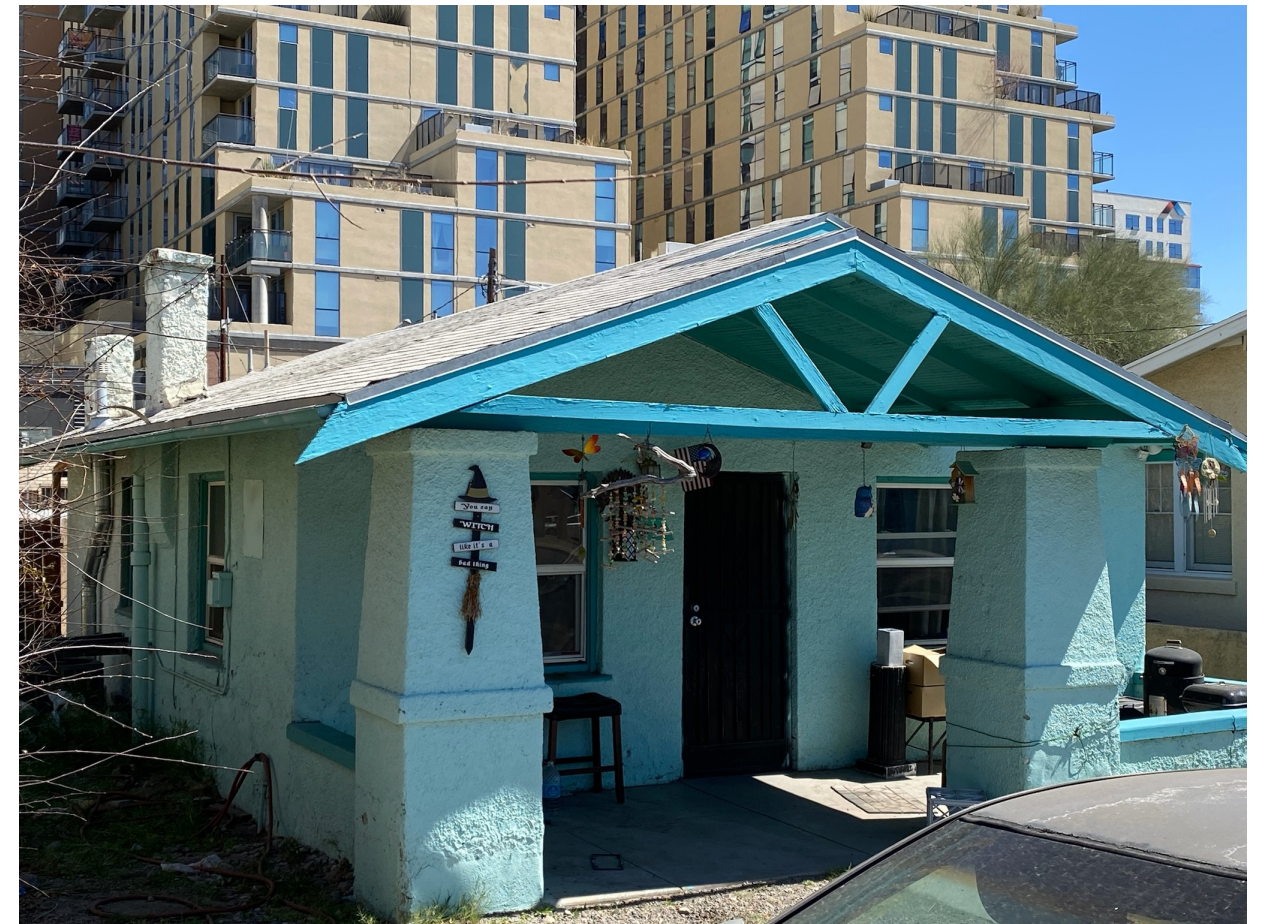
## REHABILITATION SCOPE - 1024 EUCLID AVE.

**CONDITION:** Fair. Rafters, windows and eaves need to be painted. There are minor stucco cracks.

Windows may be replaced with similar wood sash pending condition and approval by City HP office.

Roof to be stripped, all wood decking repaired, and new dimensional asphalt shingles installed.

All stucco cracks to be repaired or holes patched with similar material and texture and painted.

Chimneys to be stabilized and restuccoed.
