Citizens Warehouse

Building Condition Assessment Report

Draft Report
April 2007

Re: **Building Assessment for Citizens Warehouse**
TLCP Job No. T07028

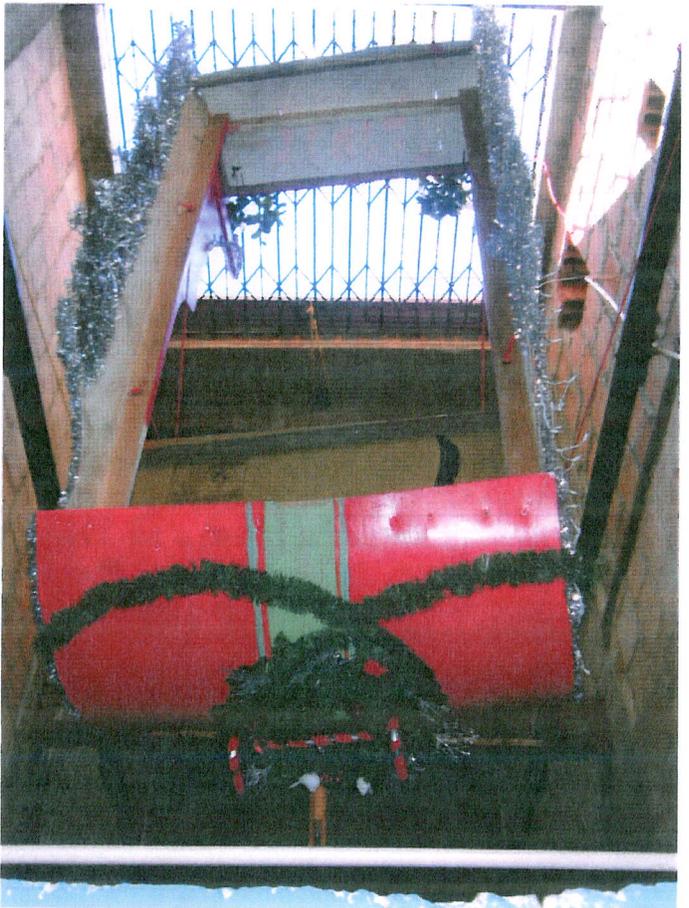
Former elevator shaft provides light to the basement

The original elevator shaft remains, but a new elevator car and hydraulic lift is needed.

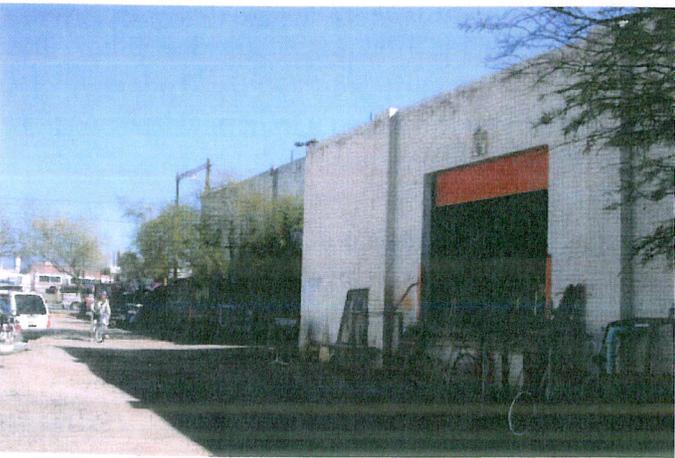
Roll up door at north side of the one story brick addition

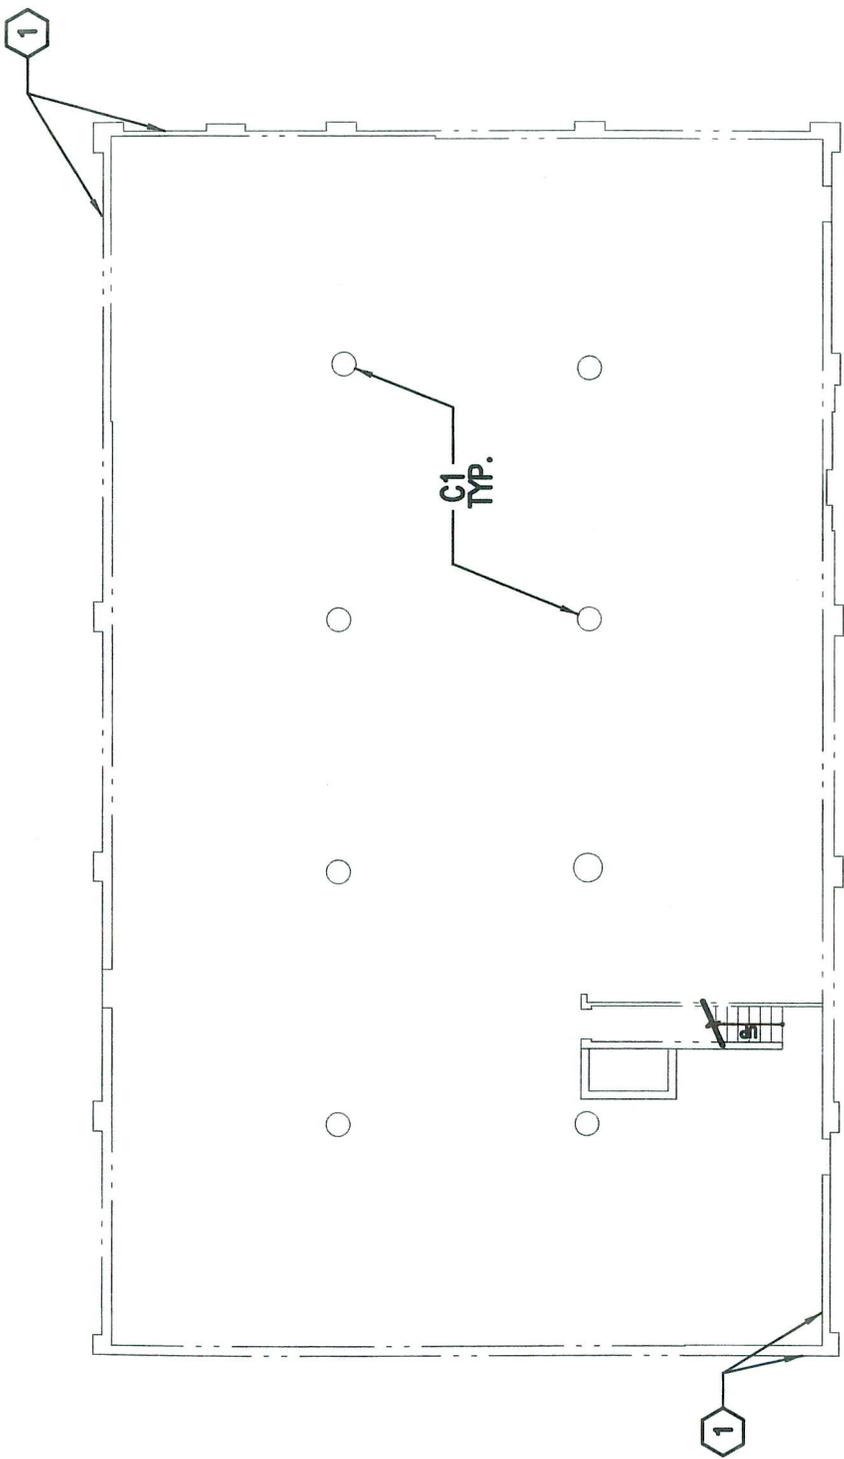
FIG. S2.1

FOUNDATION: TWO-STORY BUILDING AND ONE-STORY ADDITION (see Figures S2.1 and S3.1)

Since the foundation system is not exposed at any portion of the building, it is not certain what the system is. It is very likely however, that all columns and walls bear on cast-in-place concrete footings.

1. Since footing sizes and soil characteristics are not known, calculations for the foundation were not performed. However, there were no signs of settlement or distress.

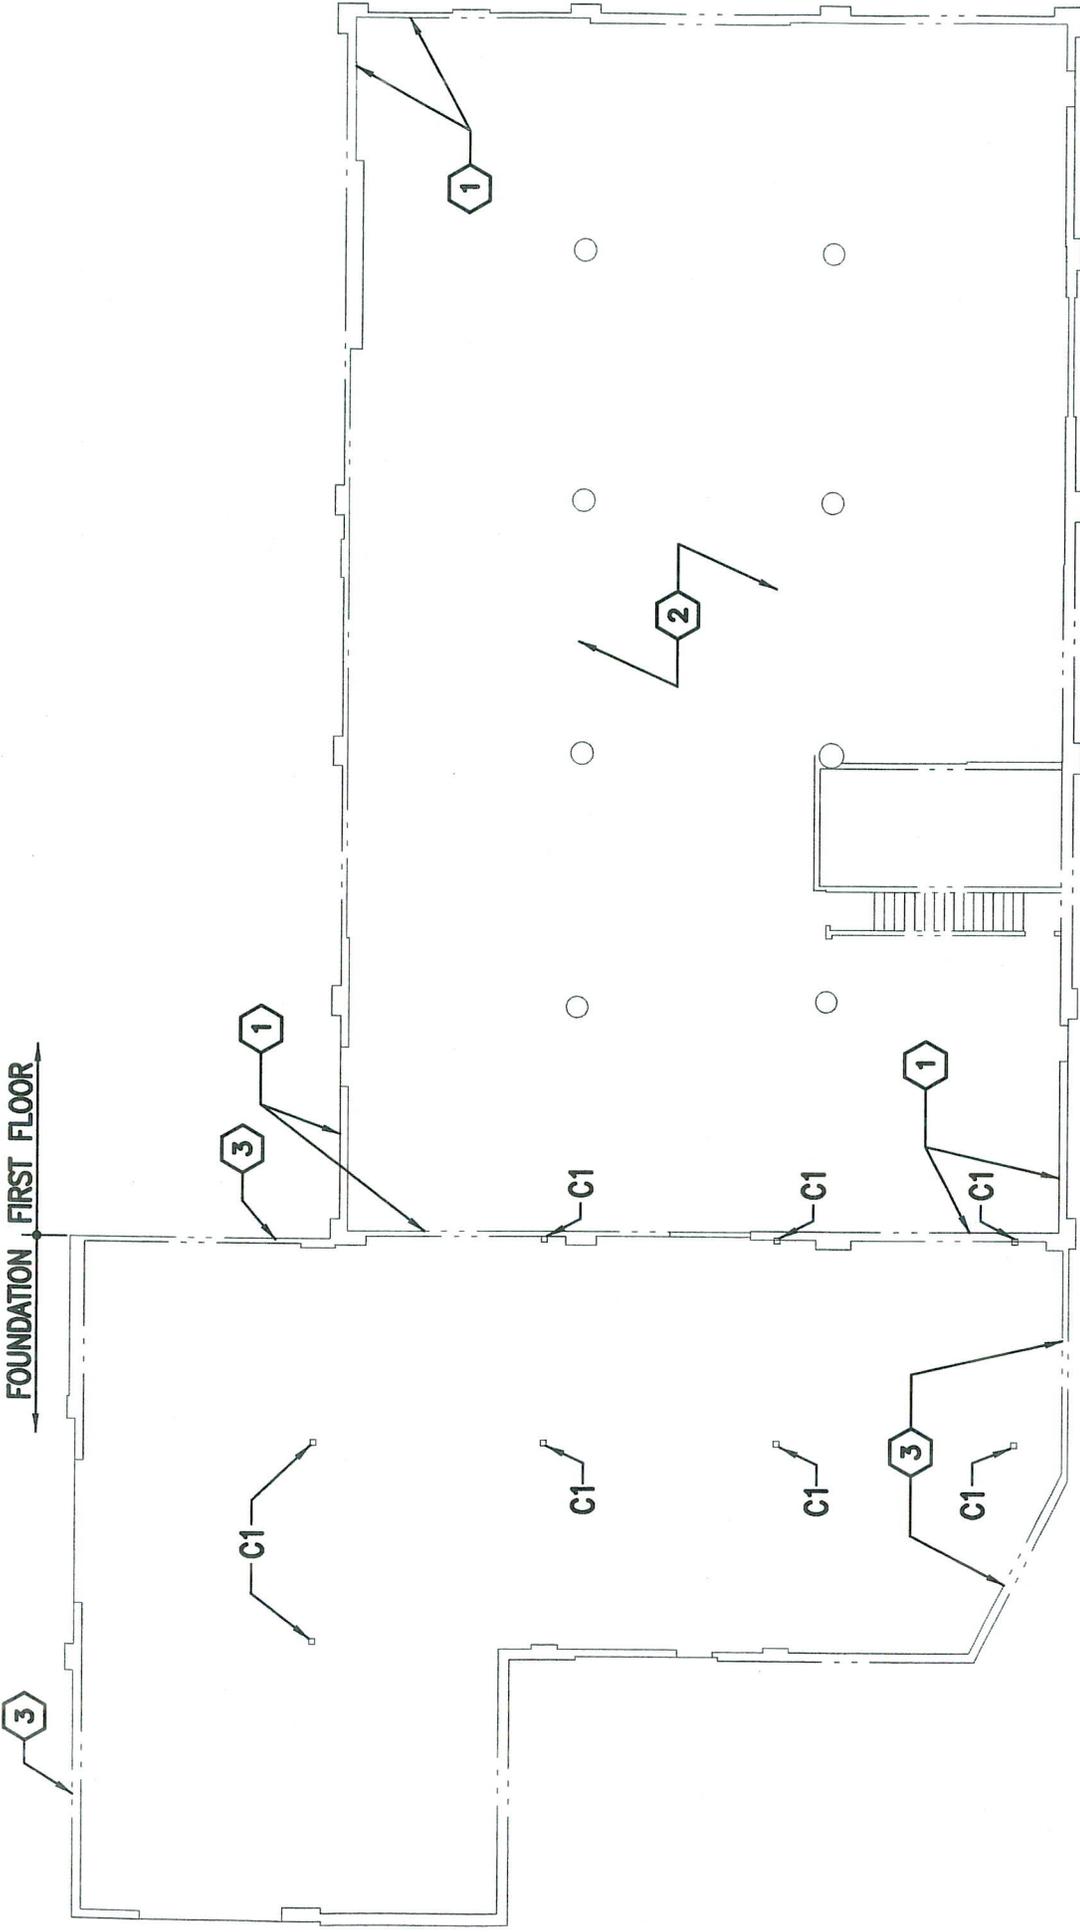
FIG. S3.1

FIRST AND SECOND FLOOR FRAMING: TWO-STORY BUILDING (see Figures S3.1 and S4.1)

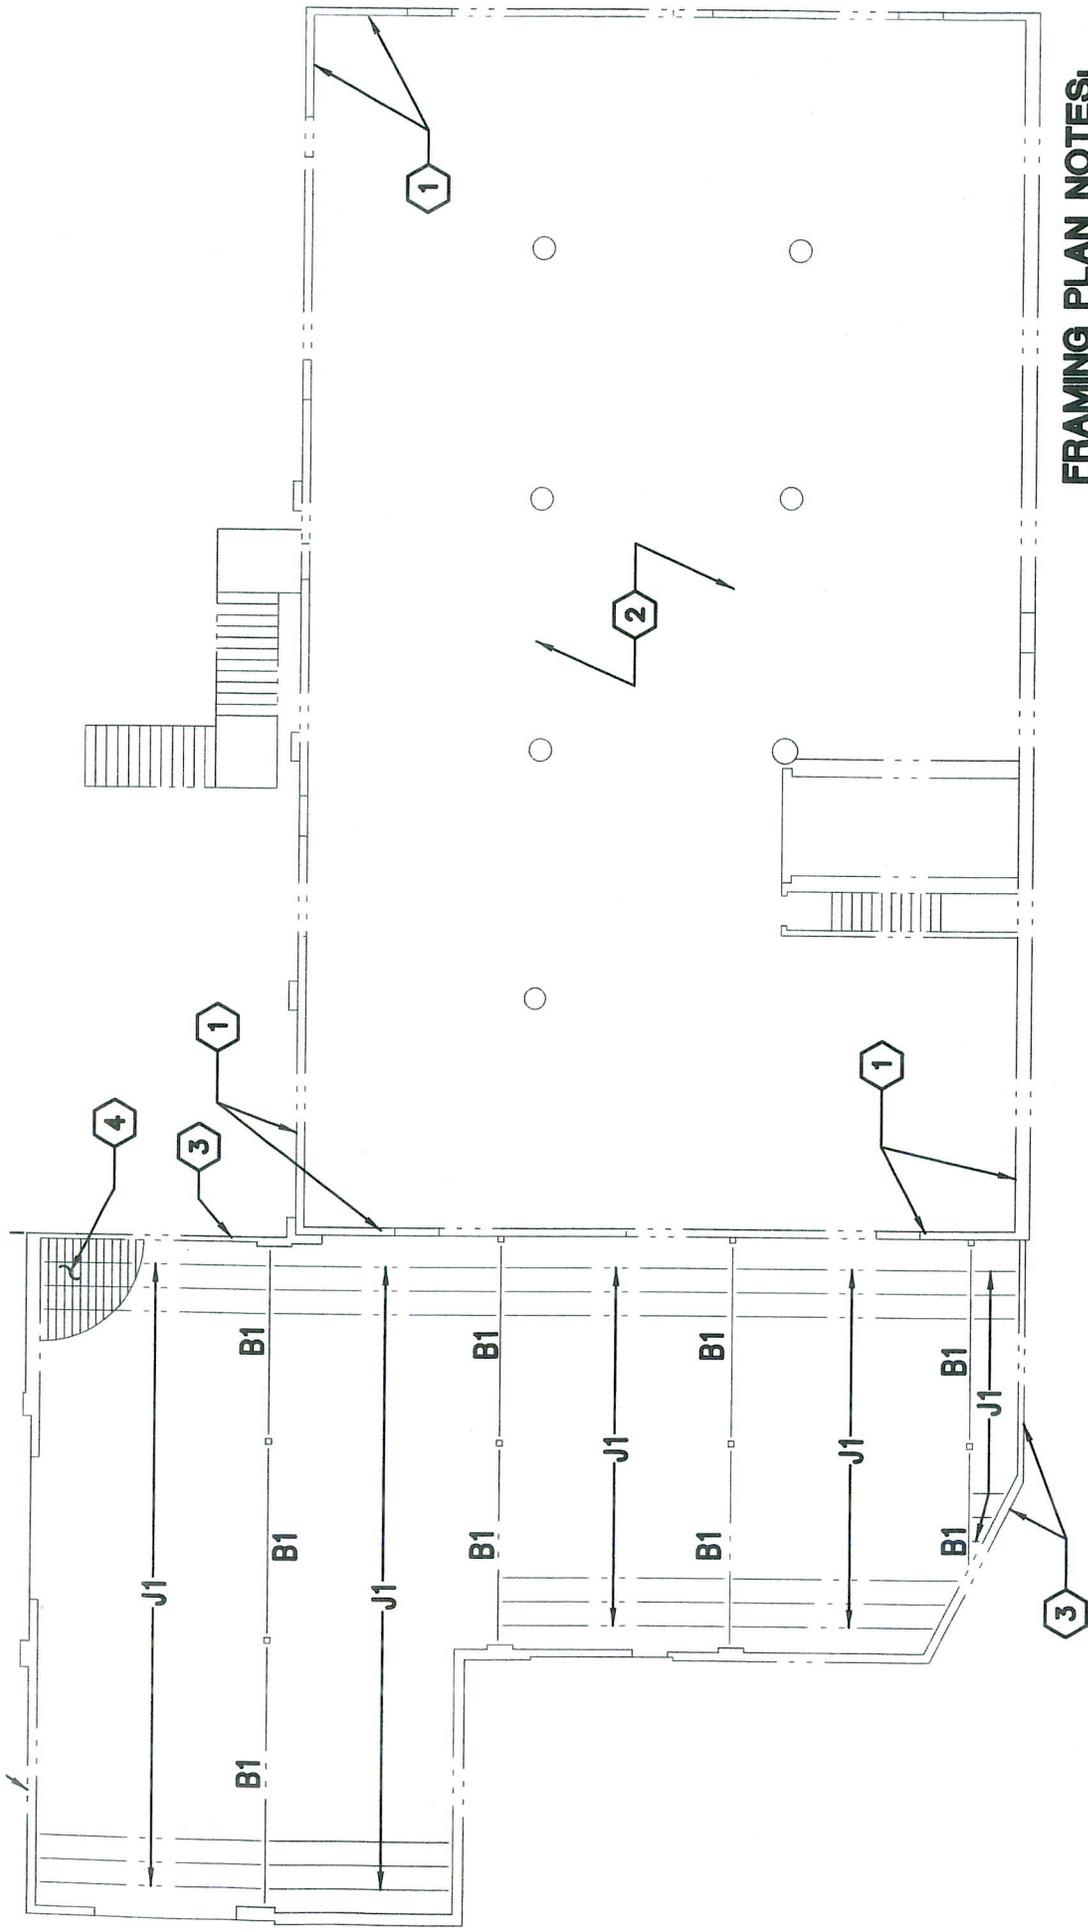
FIG. S4.1

ROOF FRAMING: ONE-STORY ADDITION (see Figure S4.1)

Framing consists of 1 x tongue and groove lumber decking that spans horizontally over 2 x 12 wood joists spaced at 24 inches on-center. The joists are supported by a series of 6 x 14 wood beams. The entire roof system is supported by 6 x 6 wood columns and two-wythe (8"), unreinforced brick walls.

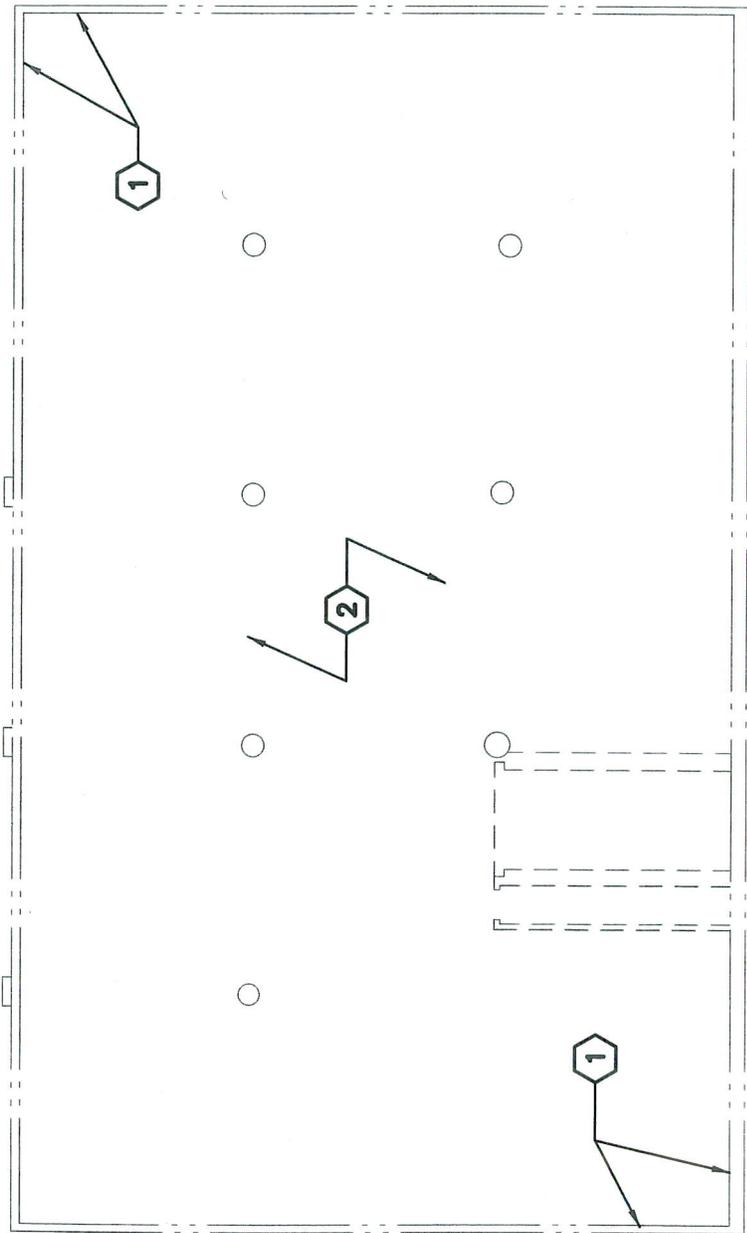
ROOF FRAMING: TWO-STORY BUILDING (see Figure S5.1)

Framing consists of a mildly reinforced cast-in-place concrete slab supported by cast-in-place concrete columns and walls. Since the original construction documents are not available, it is not known how the slab was designed or what the reinforcing is. Because there is an absence of beams spanning between the columns, it is very likely that the slab was designed as a two-way slab. This means that the structural reinforcing was placed in both the longitudinal and transverse directions.

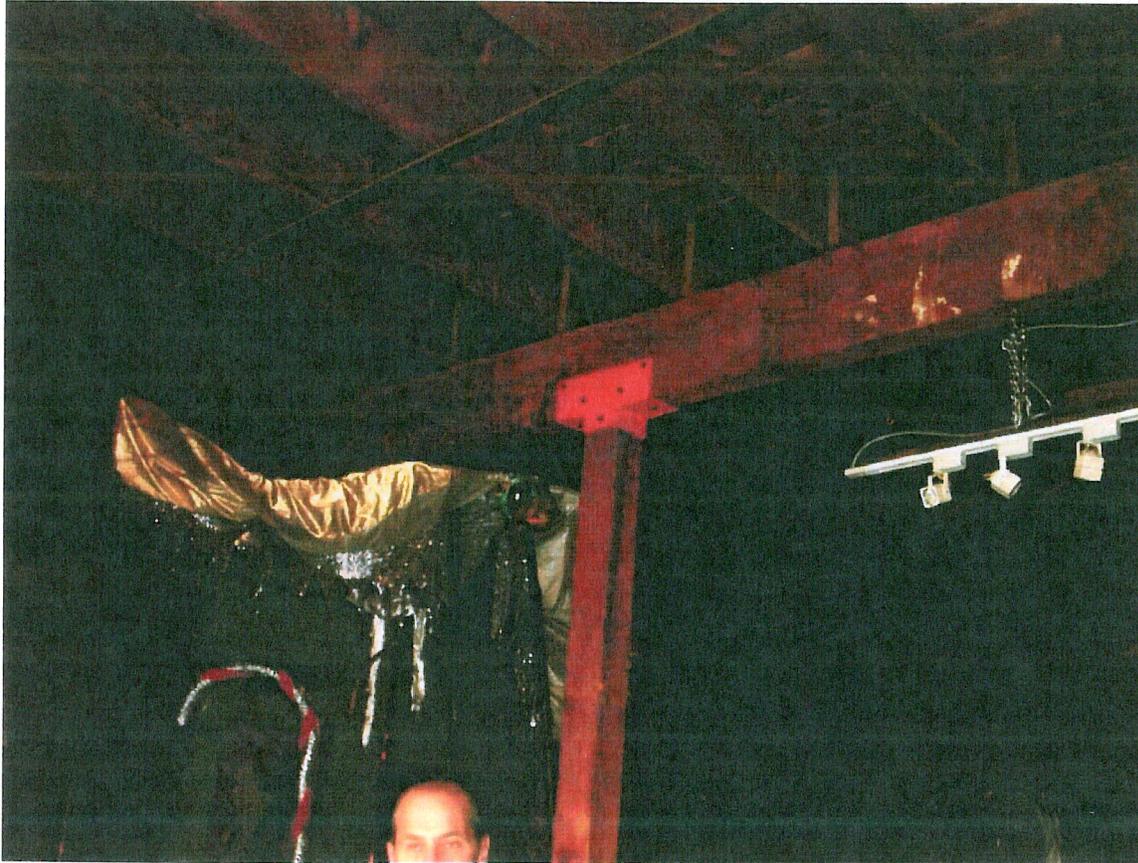
Citizens' Warehouse - Photo 1
2/27/07

1. Stress levels in the roof joists, beams and wood deck are within allowable design values for dead load and live load and all members appeared to be in excellent condition.
2. The age of the roof membrane is not known, but as shown in Photos 1 through 3, minor leakage has occurred. Observation of the roof membrane showed that it should be replaced in the near future.
3. As shown in Photo 1, the wood deck diaphragm is not connected to the brick shear walls.

1. Remove the existing roof membrane(s) to the decking and replace with a new roof to prevent leaking and subsequent structural damage to the roof framing.
Approx. 3,900 sf at \$10/sf = \$39,000.
2. As noted above, the roof diaphragm consists of 1 x tongue and groove lumber decking. The ability of this material to transfer wind and seismic forces to the shear walls is limited. Therefore, we recommend overlaying the existing deck with new plywood panels.
Approx. 3,900 sf at \$2/sf = \$7,800.
3. Connect perimeter brick walls to roof diaphragm with tension-ties.
Approx. 200 lineal feet at \$50/ft = \$10,000.
4. Install ledgers to connect roof diaphragm to shear walls at all brick walls.
Approx. 260 lineal feet at \$50/ft = \$13,000.
