# Steinfeld Warehouse

## Building Condition Assessment Report

Draft Report  
April 2007

Poster Frost Associates, Inc.

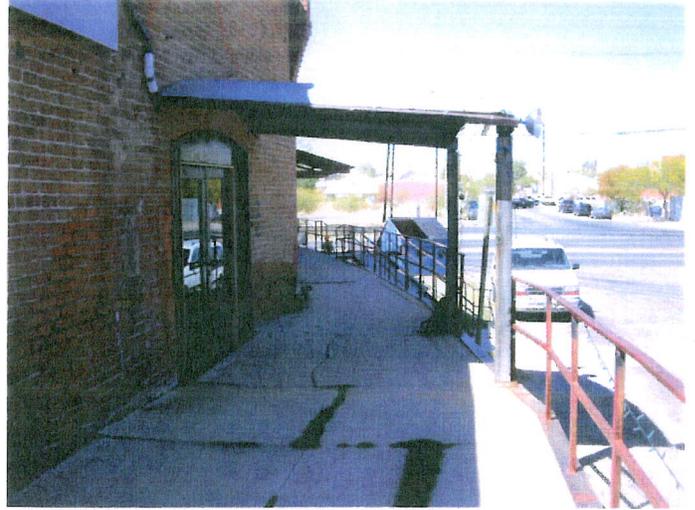
*Non-historic canopy at entrance to gallery*

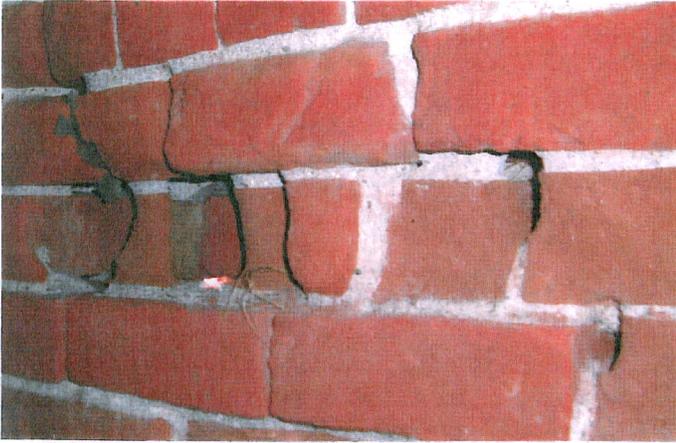
*Water damaged bricks at interior of east wall of south bay*

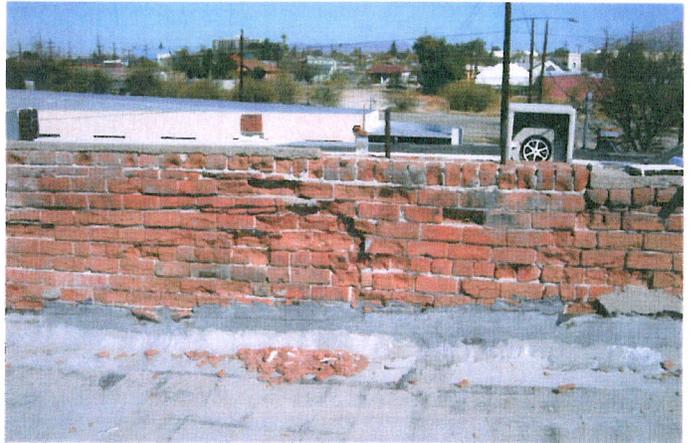
*Parapet walls are severely deteriorated*

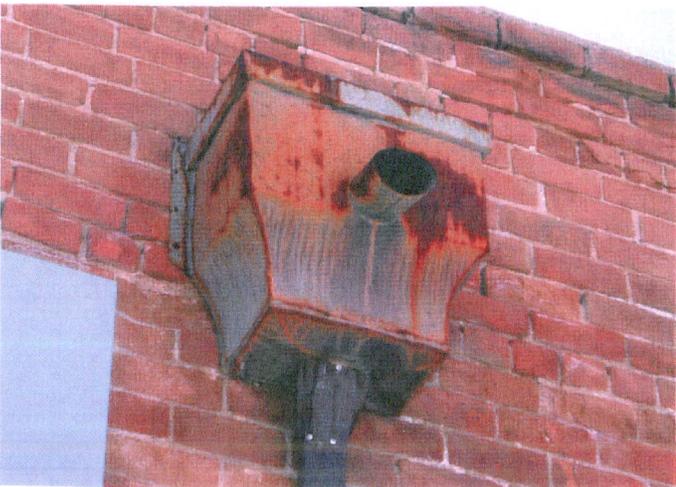
*Original conductor head with non-historic downspout*

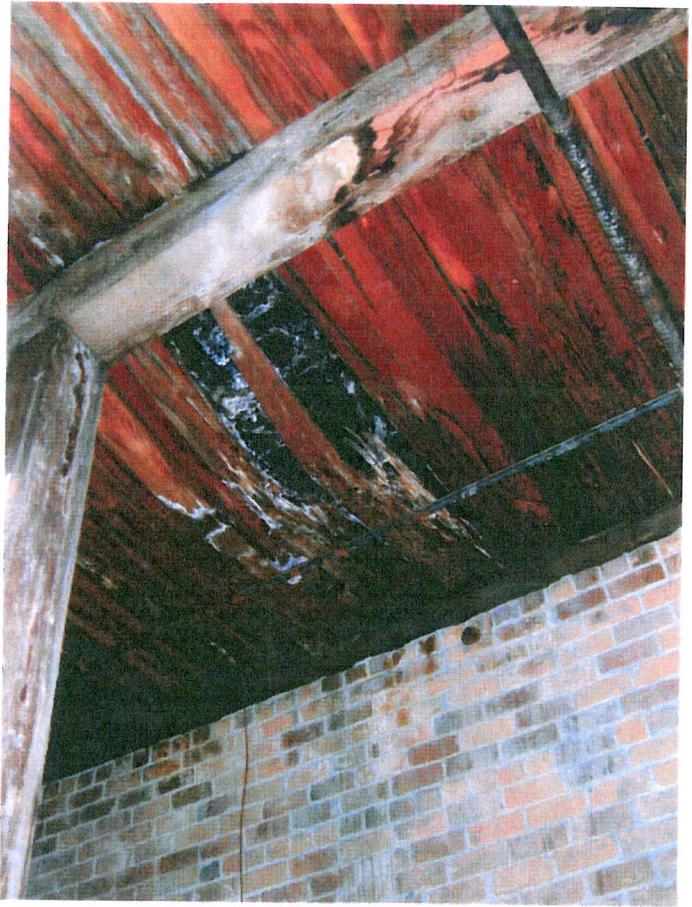
*Serious water damage to wood sheathing at south bay*

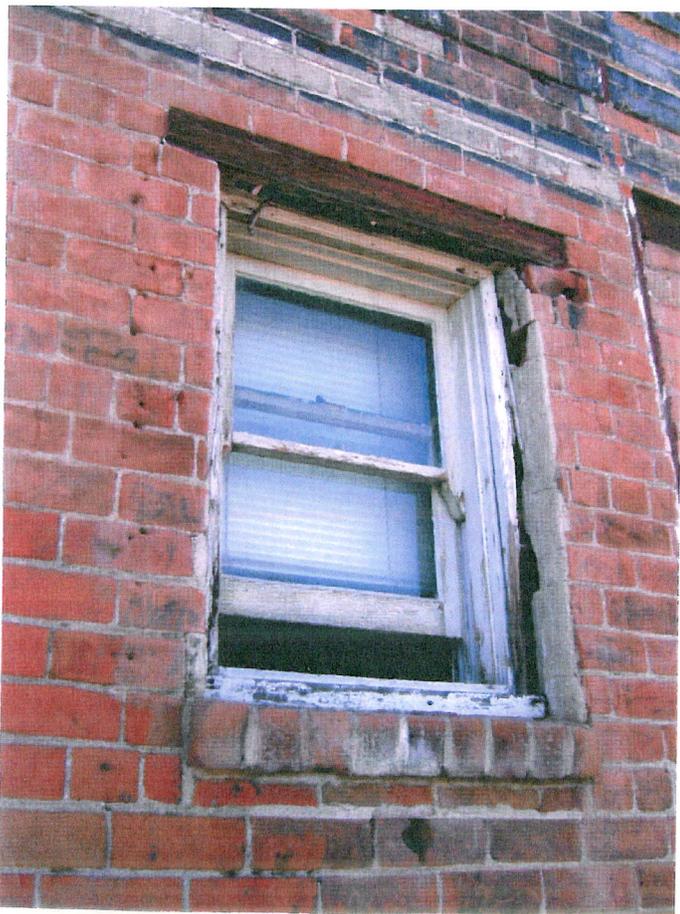
*Damaged wood, double hung window at north elevation*

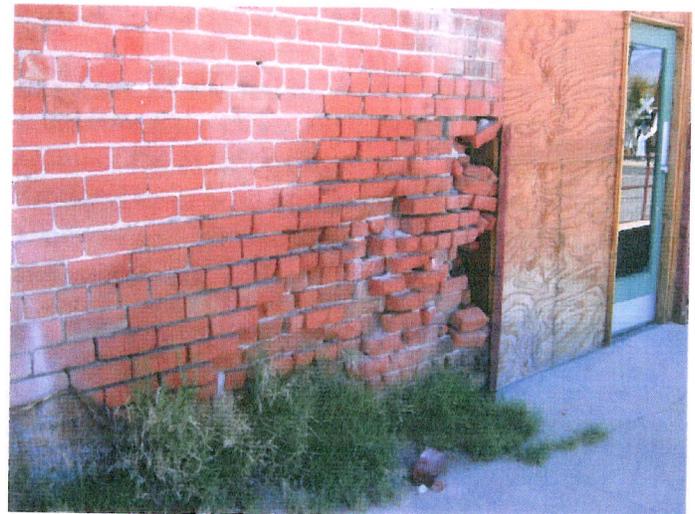
*Damaged brick at east elevation*

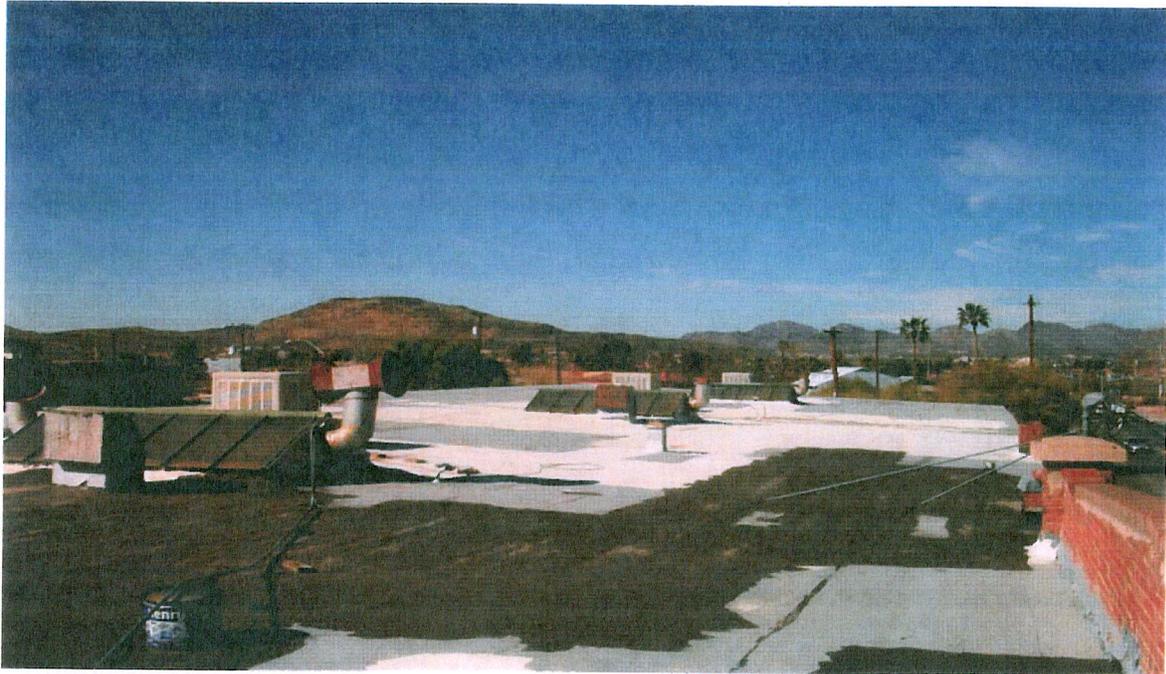
**Steinfeld Warehouse - Photo 1**  
*2/27/07*

2. The age of the roof membrane is not known, but as shown in Photo 1 it has been patched several times to stop leaking. Photo 2 indicates that leakage is an on-going concern. The roof membrane is in extremely poor condition.

1. Remove the existing roof membrane(s) to the decking and replace with a new roof to prevent leaking and subsequent structural damage to the roof framing.

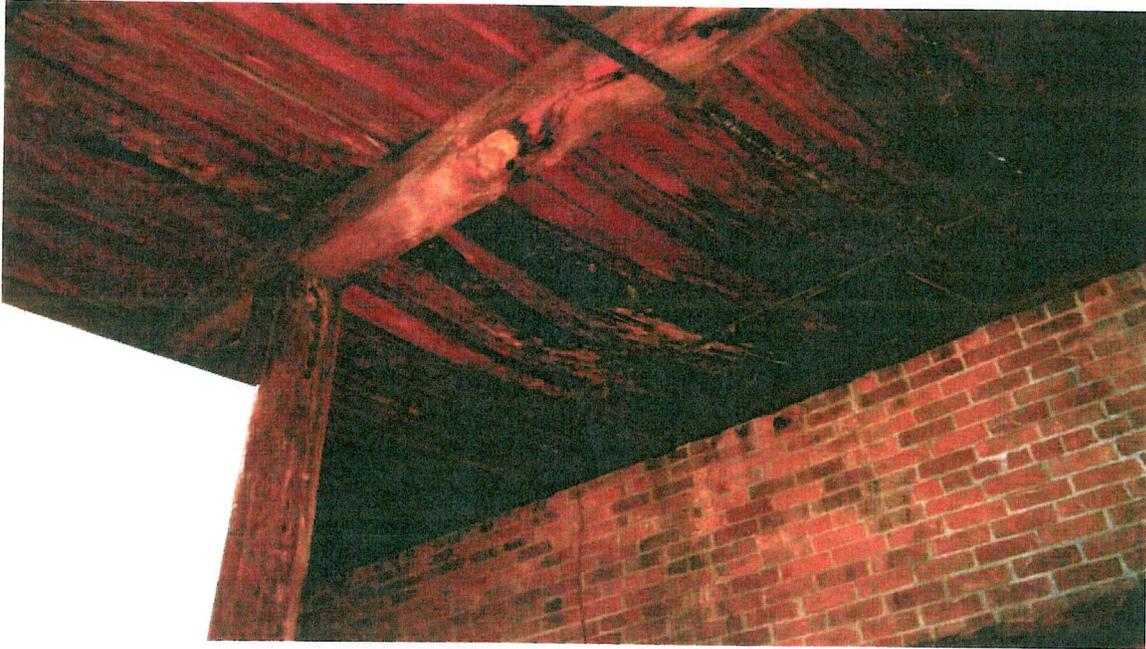
Steinfeld Warehouse - Photo 3  
2/27/07

3. As a result of water infiltration through the roof, the wood deck has failed in several locations (see Photos 3 and 4). However, the beams do not appear to have been affected.

2. After removing the existing roof membrane, but prior to installing the new roof membrane as described above, replace damaged and failed 2 x wood decking with new members of the same size.

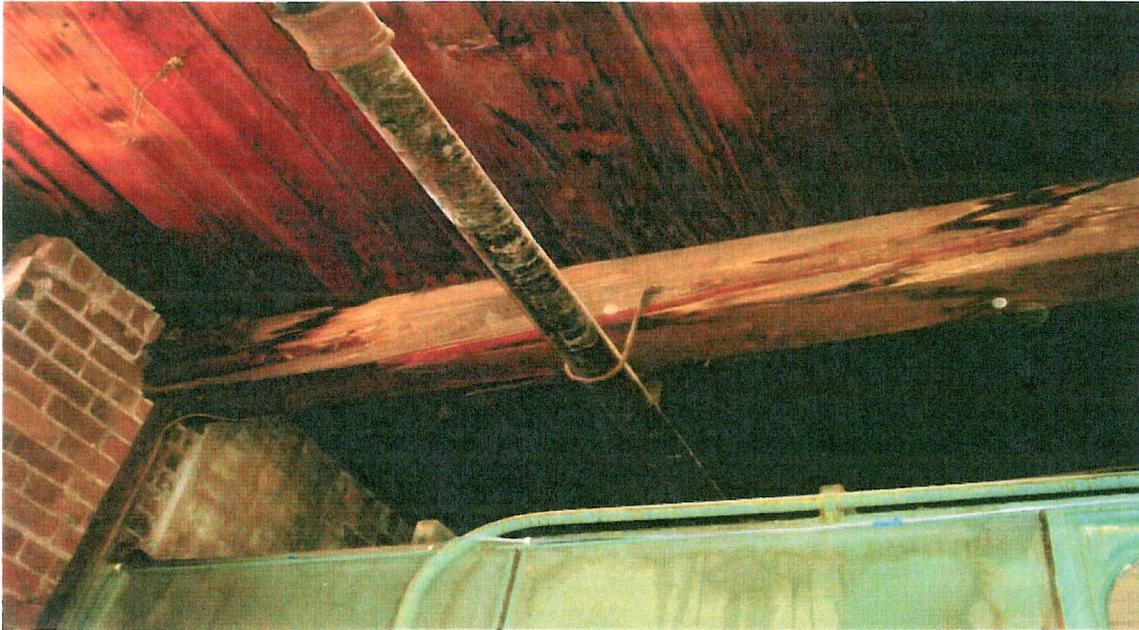
**Steinfeld Warehouse - Photo 5**  
2/27/07

4. The wood deck diaphragm is not connected to the brick shear walls.
5. Minor checking was observed in some beams, but not enough to affect their integrity. However, one beam has a severe split in it apparently from pipe loading (see Photo 5).

4. Connect perimeter brick walls to roof diaphragm with tension-ties.  
Approx. 800 lineal feet at \$50/ft = \$40,000.
5. Install ledgers to connect roof diaphragm to shear walls at all brick walls.  
Approx. 1,150 lineal feet at \$50/ft = \$57,500.
6. Replace one split beam.  
Approx. 30 lineal feet at \$100/ft = \$3,000.

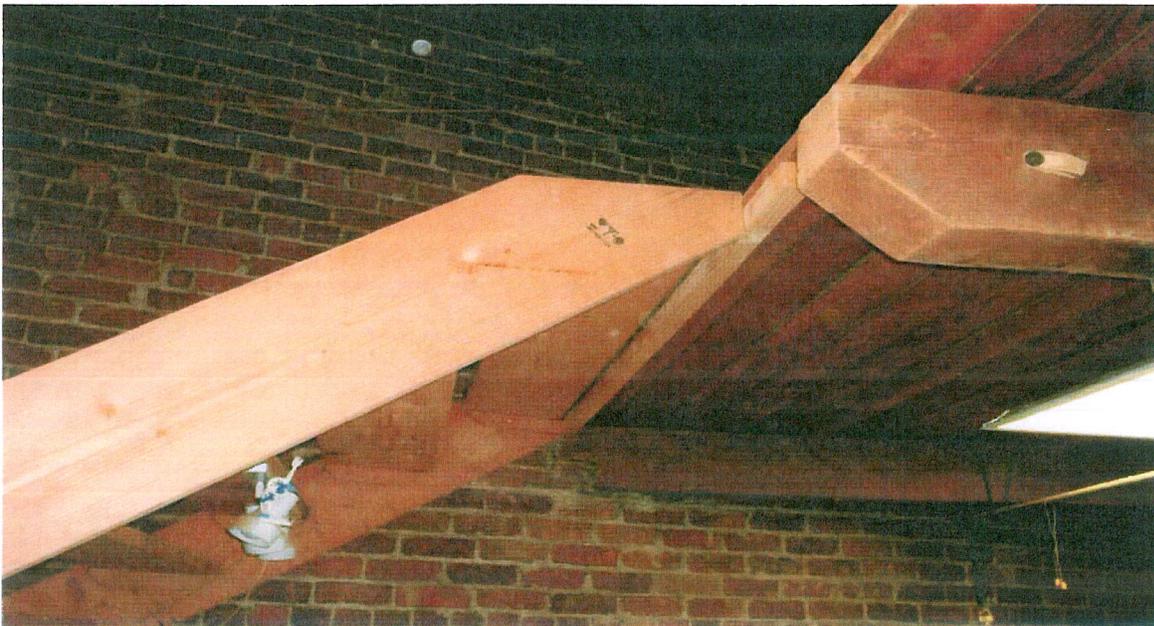
**Steinfeld Warehouse - Photo 6**  
2/27/07

1. Stress levels in the mezzanine beams, 1" diameter beam hanger rods and wood deck are within allowable design values for dead load and live load. However, deflection calculations of the deck do not meet minimum code requirements. The deck has shrunk over the years so that the tongues and grooves have separated. Noticeable movement of the decking was observed while walking on it.
2. The wood mezzanine stairs, and their connections to the mezzanine, are inadequate (see Photo 6).
3. The wood deck diaphragm is not connected to the brick shear walls.

1. Replace all stairs that access the mezzanines from the first floor.  
Five stairs at \$2000/stair = \$10,000.
2. Replace 2 x decking with 3 x T & G wood decking.  
Approx. 3,600 sf at \$5/sf = \$18,000.
3. Connect all brick walls to floor diaphragm with tension-ties.  
Approx. 450 lineal feet at \$50/ft = \$22,500.
4. Install ledgers to connect floor diaphragm to all brick walls.  
Approx. 450 lineal feet at \$50/ft = \$22,500.

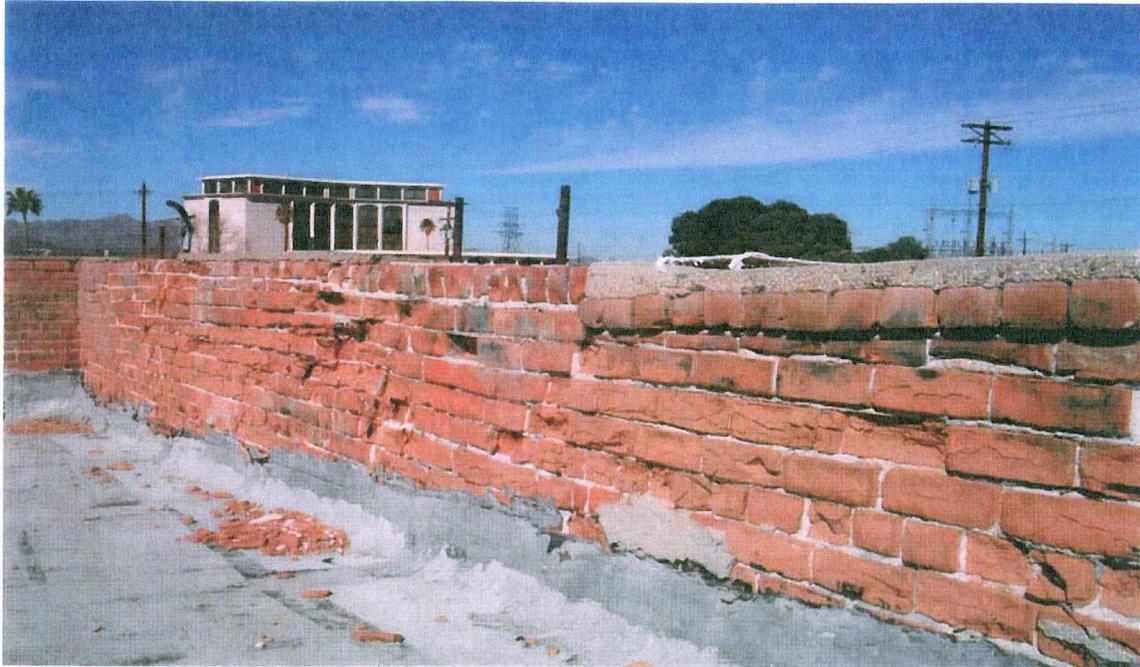
**Steinfeld Warehouse - Photo 13**  
*2/27/07*

1. Stress levels in the first floor unreinforced brick walls (i.e.: walls from the first floor to the roof) are within the allowable design values for dead load, live load, seismic and wind loads. These include only the walls that are still intact.
2. The condition of several of the walls is extremely poor - particularly the north wall along 6<sup>th</sup> Street. There are several large cracks, spalled brick units, missing brick units and deteriorated mortar joints (see Photos 8 through 12).
3. As shown in Photos 13 and 14, deterioration of the brick parapet walls on the roof is extensive.

1. Replace all spalled and missing brick units in the walls from the top of the foundation up to the roof diaphragm.  
Approx. 5,000 square feet at \$25/sf = \$125,000.
2. Replace all parapet walls with new and reinforced walls and anchor them to the existing walls below.  
Approx. 3,500 square feet at \$30/sf = \$105,000.

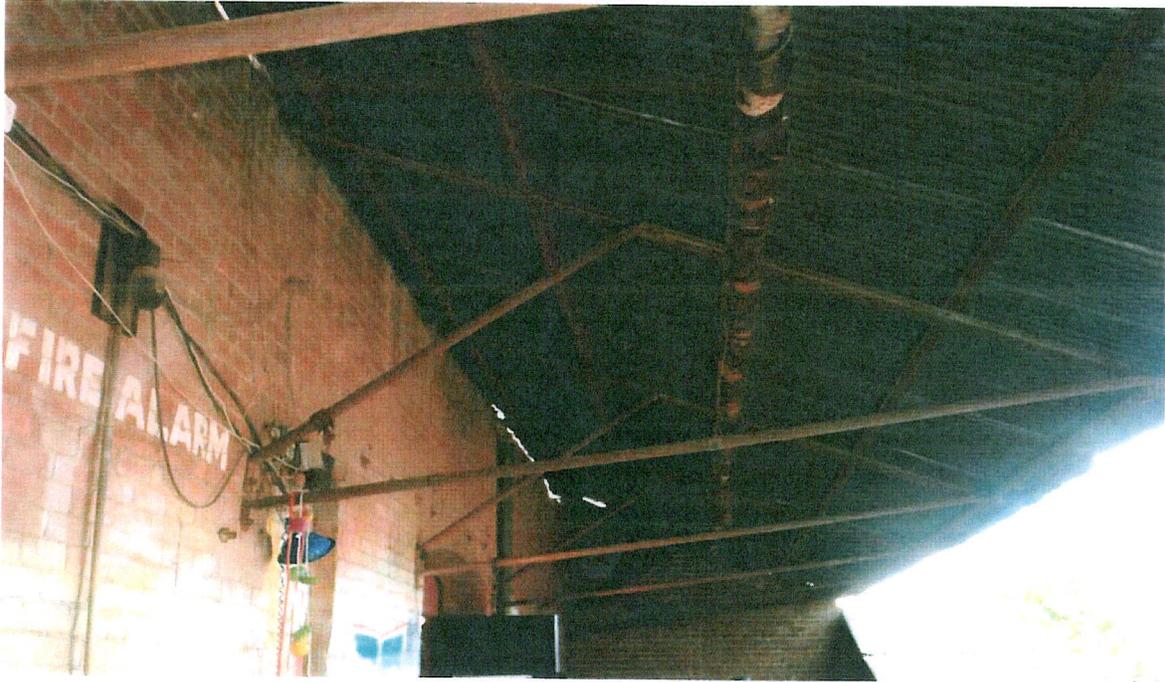
**Steinfeld Warehouse - Photo 15**  
2/27/07

1. Due to the extremely poor condition of the canopy framing and shed framing (see Photos 15, 16 and 17), calculations were not performed for these areas.
2. As shown in Photo 18, both ramp walls that support the elevated slab over the basement entrance have failed.
3. The wood and metal roof of the shed provides no lateral support for the approximately 10-foot tall, unreinforced brick wall along the south side.

1. Replace the entire cantilevered steel canopy and wood/metal roof at the shed with new framing.  
 Approx. 4,000 square feet at \$15/sf = \$60,000.
2. Replace the concrete ramp walls and the elevated slab over the basement entrance.  
 Approx. 30 cu. yds. conc. at \$400/cy = \$12,000.
3. Stabilize the south and west cantilevered walls of the shed with pilasters and steel framing.  
 Approx. 150 lineal feet at \$250/ft = \$37,500.
