ARIZONA STATE HISTORIC PROPERTY INVENTORY

Brief Statement of Proposal

PROJECT: PONGRATZ RENOVATON / ADDITION

ADDRESS:
A&A PONGRATZ RESIDENCE
903 NORTH 5th AVE
TUCSON, AZ. 85705

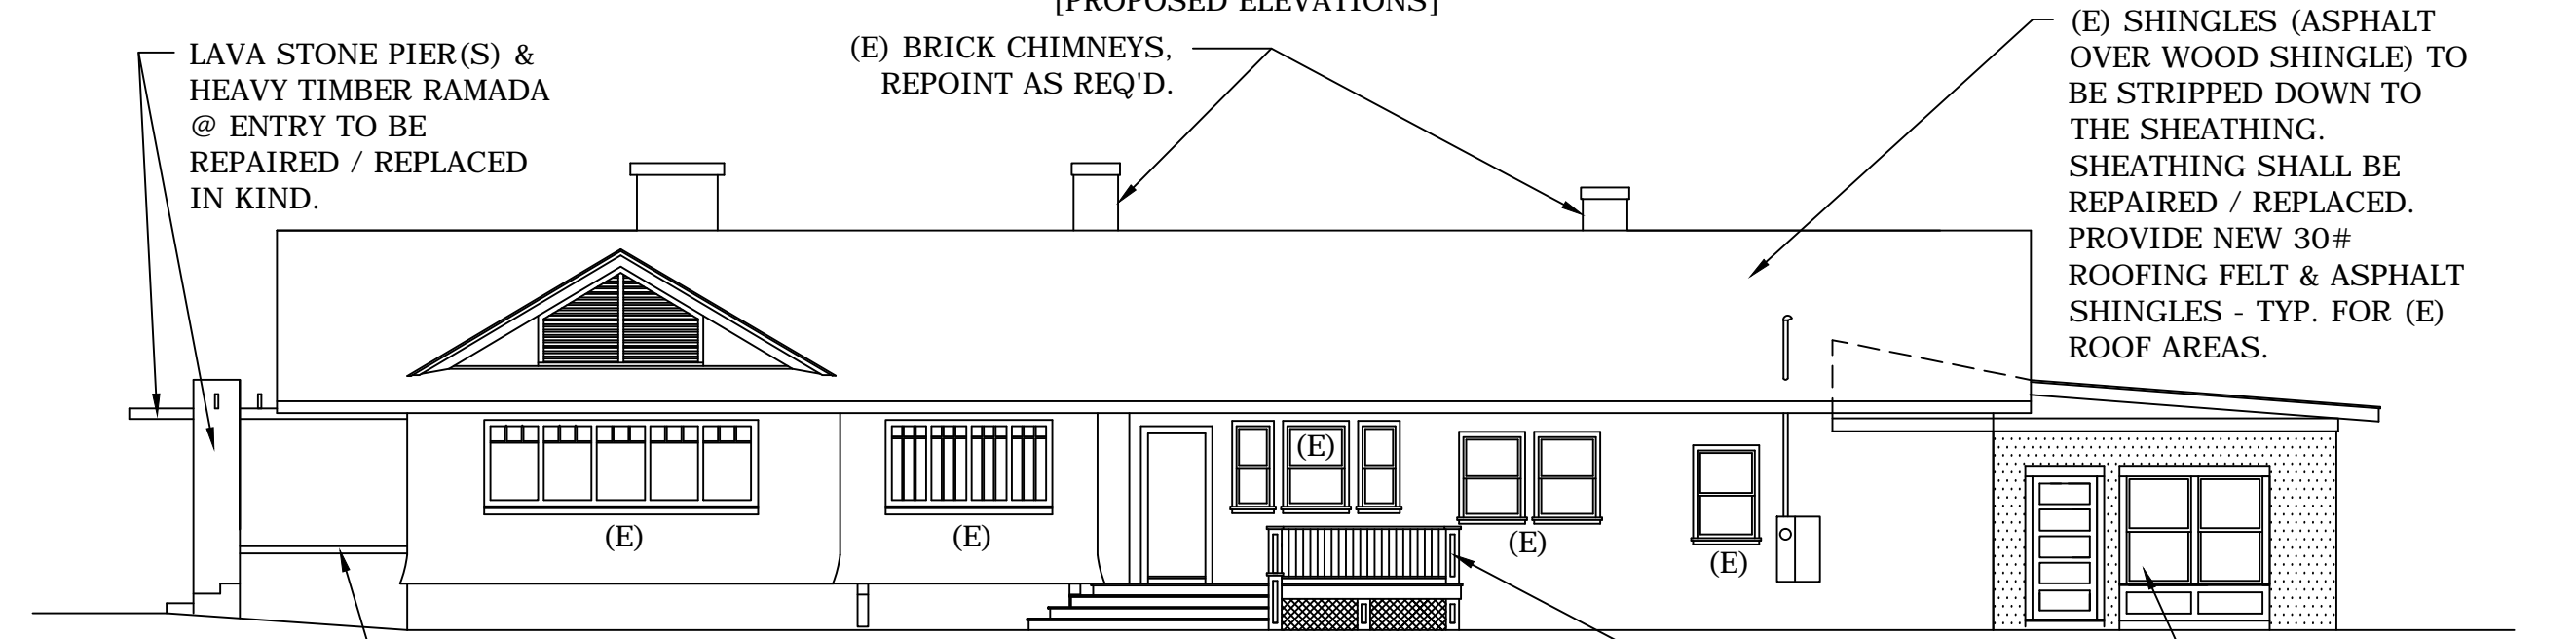
NORTH ELEVATION

REPAIRED / REPLACE
(E) HEAVY TIMBER
RAIL @ NORTH,
SOUTH & EAST SIDES
OF FRONT PORCH.

(E) WOOD VENT AND
BRACKET DETAILING.

NEW BUILT UP
ROOFING, AT
ADDITION.
REPAIR or REPLACE
SAME @ (E) SHED
ROOF.

NEW WOOD DECK
OFF KITCHEN

NEW SINGLE HUNG
WINDOWS 36"Wx60"H,
SEE DETAILS FOR
CASING TRIM DETAIL &
PANEL BELOW WNDWS.

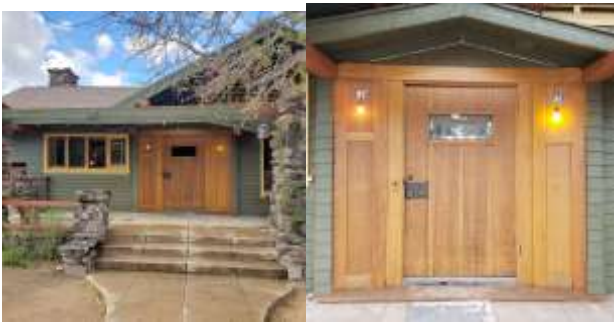
Front entry door after picture: clear polyurethane finish by Behr

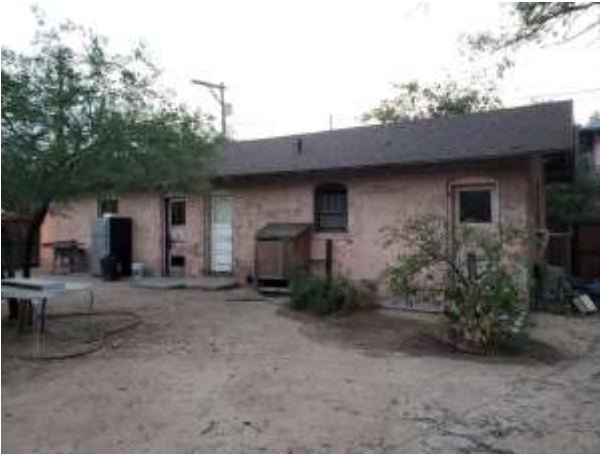
East face north end of guest house

The exposure to the elements started deteriorating the existing clay brick walls and stucco.

J& M Stucco contractor was called in to repair and re-stucco the whole guest house. A one inch foam board was added to smooth out failing walls and add an insulation value of R7.

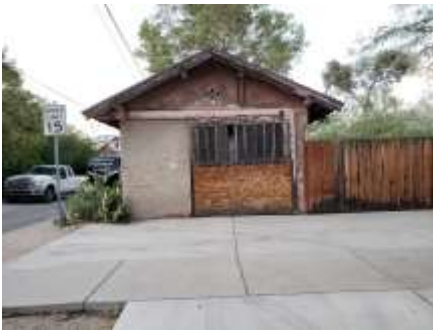
The original garage door on the south face of guest house

The garage door was continuously broken into for decades and is damaged beyond repair.

Example of proposed replacement garage door

The garage door manufacturer is Clopay, Coachman Collection 8ft x 7ft, model# CXU13_SW_SQ24 – Timeless Carriage House Design.

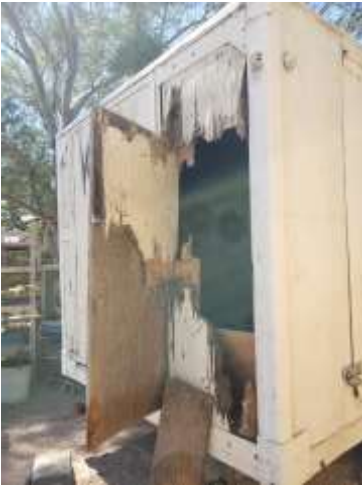
Example of a trailer door being vandalized located behind locked gates in our private court yard.

The building is located in a high crime area therefore safeguards need to be placed on the property. We are proposing security doors to be installed on the Master Bedroom and Hallway doors located on the south Ramada and also the pocket door off the kitchen on the north side.

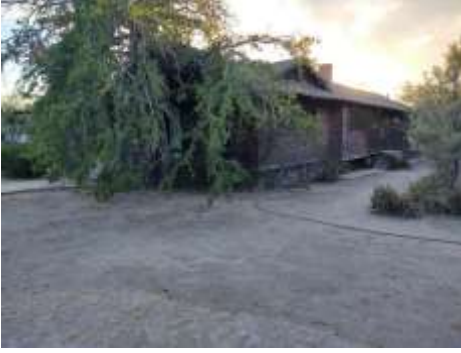
Before picture

North face east side of building

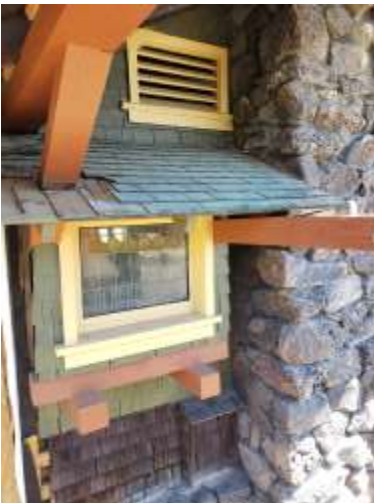
Example of roof above the stained glass windows – south face of building, left and right of chimney.

Shingles were removed, repaired and repainted above the stained glass windows.
