**PHASE I ENVIRONMENTAL SITE ASSESSMENT
FLINT OIL PROPERTY
500 (511 AND 527) WEST SIMPSON STREET
TUCSON, ARIZONA**

October 17, 2006
AAI Date: February 6, 2006
File No. 10.204058.08

Subject: Phase I Environmental Site Assessment
Flint Oil Property
500 (511 and 527) West Simpson Street
Tucson, Arizona

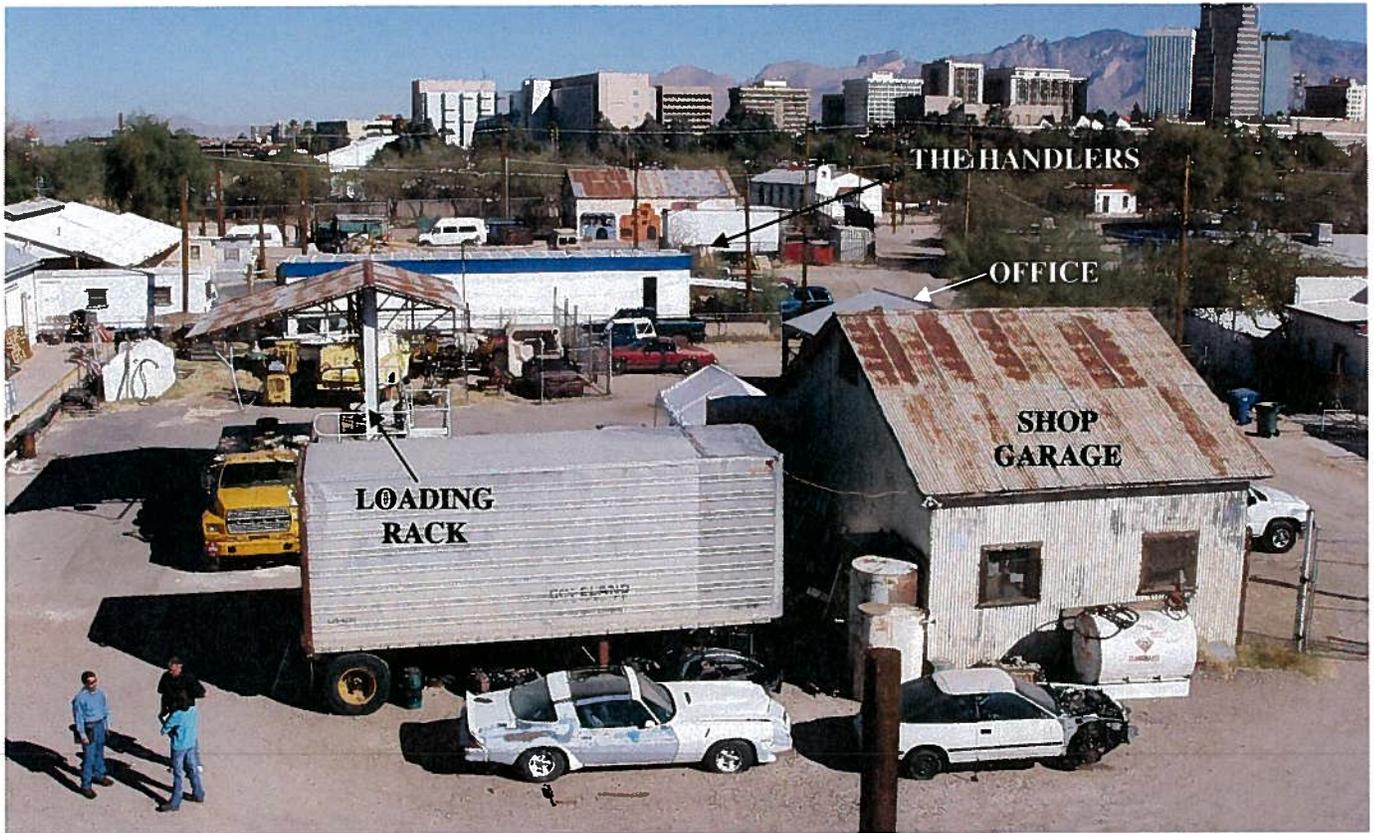
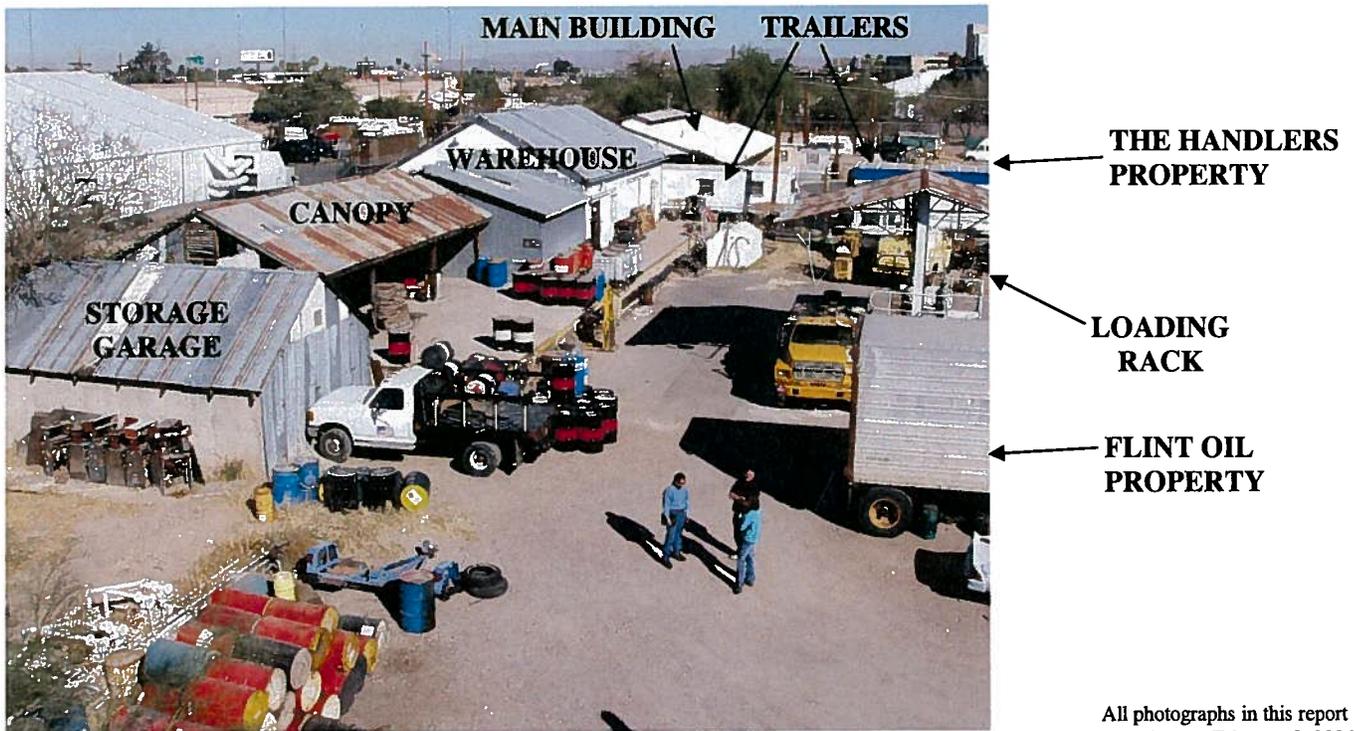
1 and 2. Views of the site showing the northern portion of the Flint Oil property and The Handlers property to the north; views to the north and northwest.

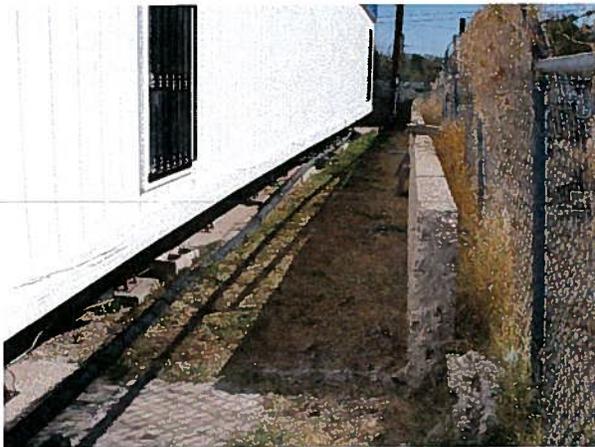
5. Former concrete AST pads under the trailer and the containment wall in the southern portion of The Handlers property; view to the east.

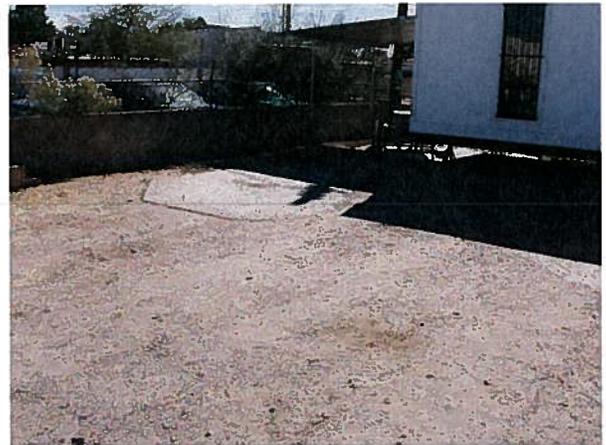
6. Former concrete AST pads and containment wall in the southeast portion of The Handlers property; view to the southeast.

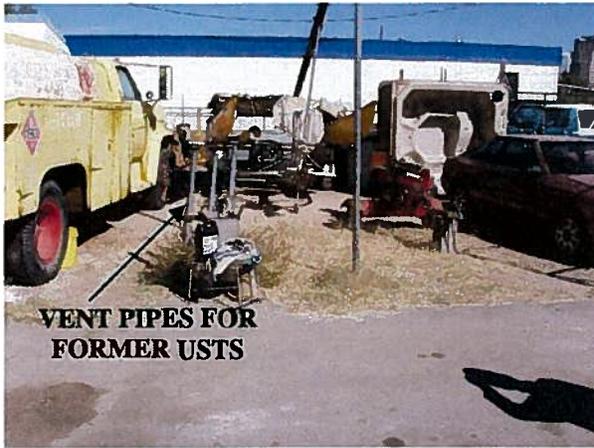
**VENT PIPES FOR
FORMER USTs**

9. Vehicle and equipment storage area on the north portion of the Flint Oil property; view to the north.

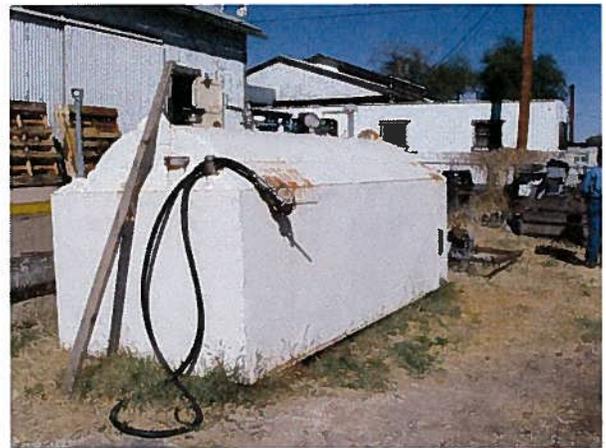
10. Empty new oil AST east of the warehouse on the north portion of the Flint Oil property; view to the northwest.

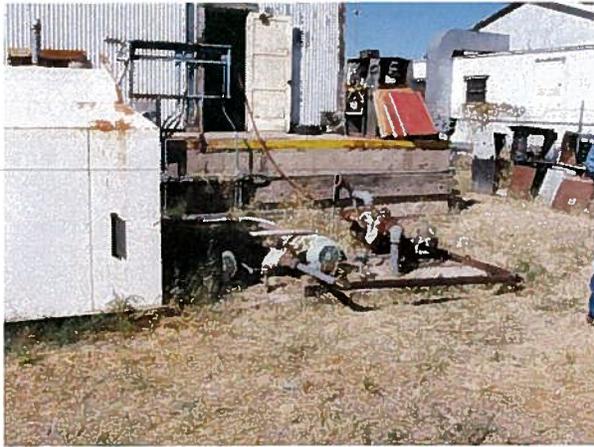
11. Pump equipment for the former new oil USTs east of the warehouse; view to the northwest.

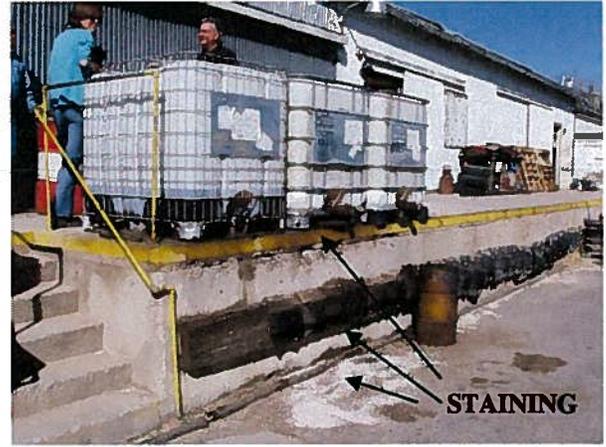
12. Three new oil ASTs east of the warehouse; view to the northwest.

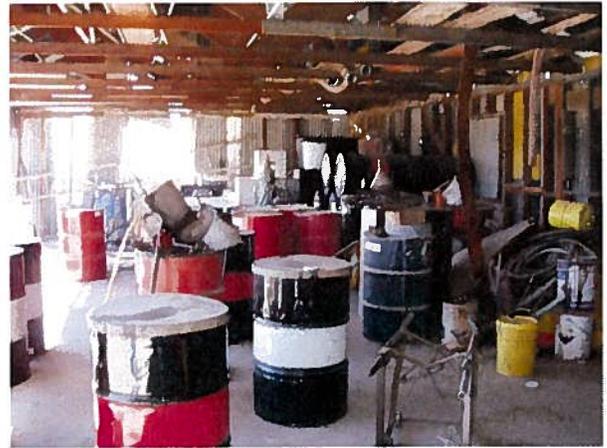
16. Drums and other materials stored under the warehouse canopy on the west side of the Flint Oil property; view to the south.

- **Physical Obstructions to Observations** – The ground surface beneath storage areas for drums and other materials could not be observed. Such areas should be addressed by Phase II ESA investigation.

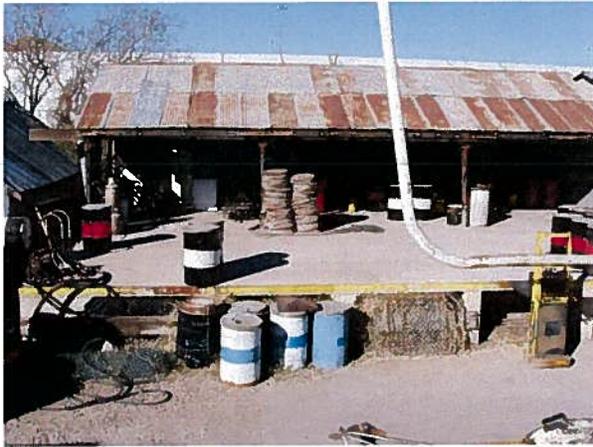
17. Drums stored east of the elevated platform and warehouse canopy; view to the west.

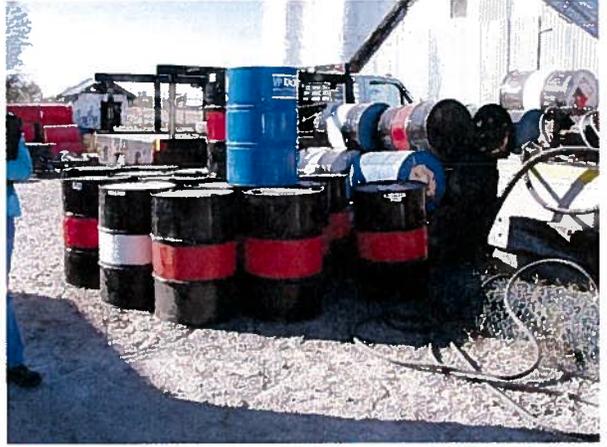
18. Drums stored at the southeast corner of the elevated platform; view to the south.

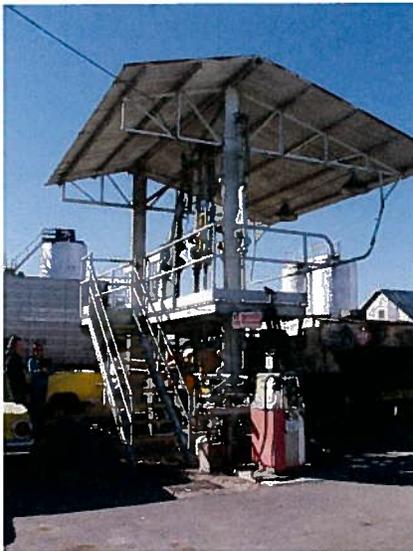
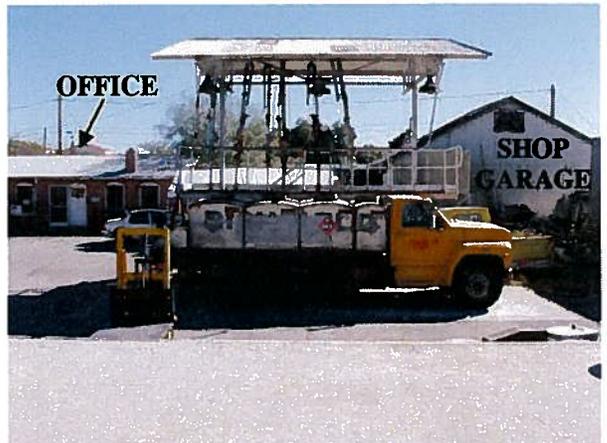
19 and 20. Loading rack in the central portion of the Flint Oil property; used to dispensing product using hose dispensers and two fuel dispensers located at each end of the rack.

- Drill soil borings or perform excavations at the Flint Oil and The Handlers properties adjacent to and beneath the current and former ASTs and the AST pumps, fill ports, underground and aboveground piping, dispensers, and loading racks. In addition, soil borings or excavations should be placed adjacent to and beneath the drum storage areas, garages, warehouse platform, areas of stained soil, and areas where runoff occurs on site or leaves the site onto adjoining or nearby properties. At a minimum, soil samples should be collected and analyzed for petroleum hydrocarbons, volatile organic compounds (VOCs), semi-VOCs (SVOCs), and RCRA metals.

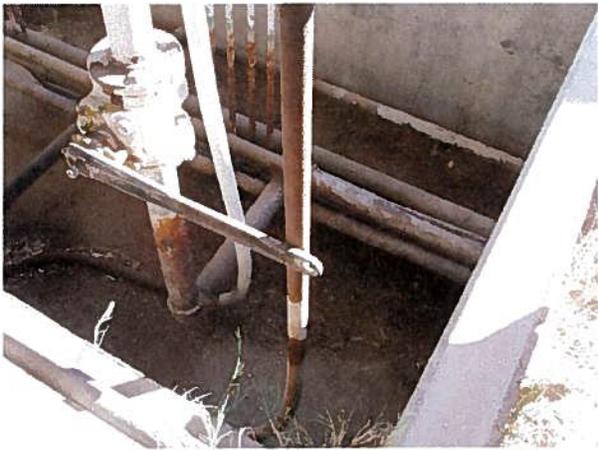
21. Concrete vault at the base of the loading rack showing below grade piping from the ASTs.

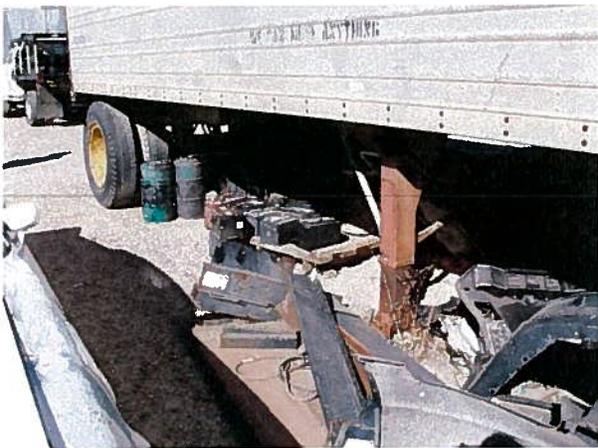
23. Batteries, drums, and other materials stored under the truck trailer, southwest of the shop garage; view to the northwest.

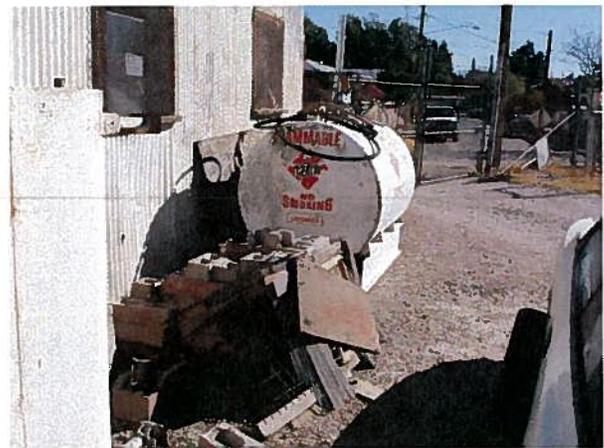
24. Gasoline AST south of the shop garage; view to the east.

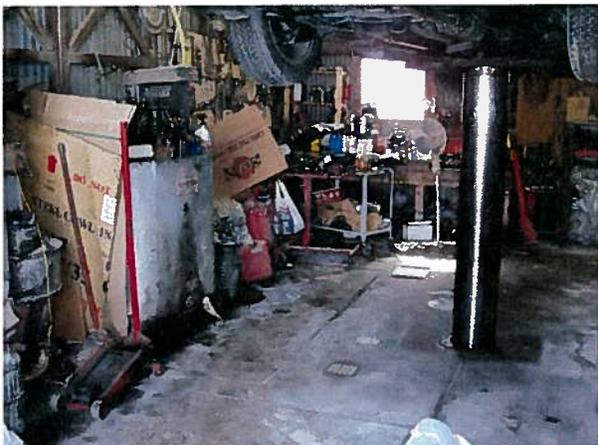
25. Hydraulic lift, parts washer, parts, tools, and equipment inside the shop garage; view to the south.

A hydraulic lift was located in the center of the shop garage. A variety of vehicle maintenance materials were observed in the garage, such as vehicle batteries, thinner, urethane reducer, paint, refrigerants, oils, aerosols, antifreeze, cleansers, glass cleaner, and used oil.

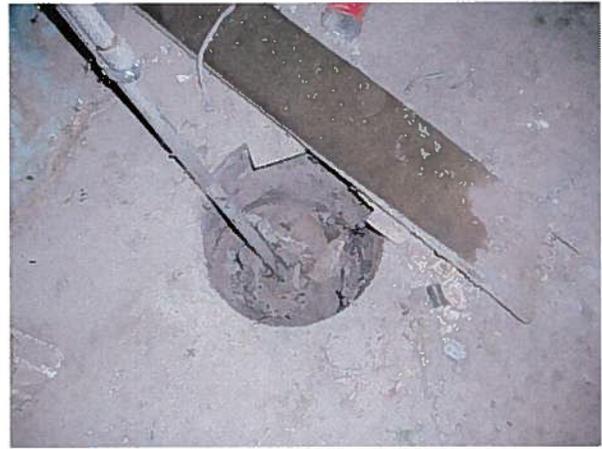
28. Hole in the floor of the storage garage, possibly a former hydraulic lift location.

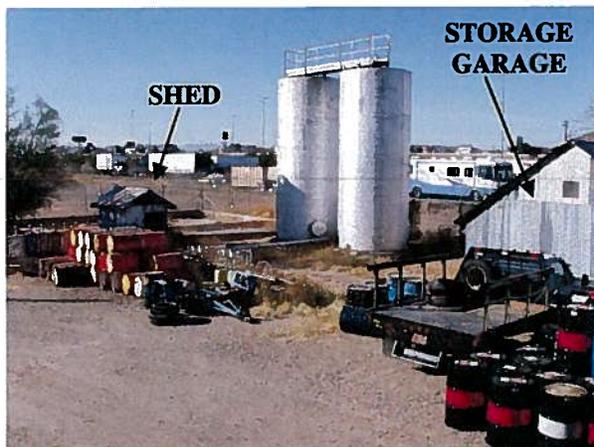
29. Two former solvent ASTs and drum storage areas in the southwest portion of the Flint Oil property; view to the southwest.

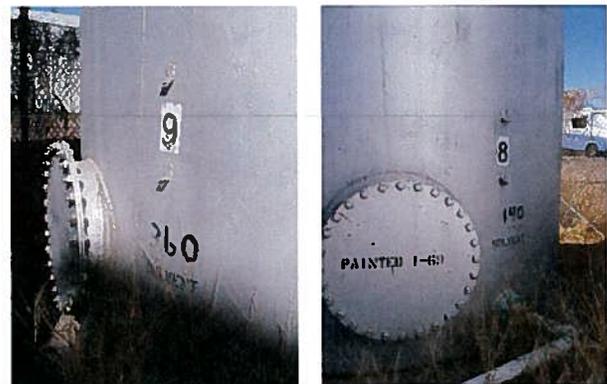
30 and 31. The two former solvent ASTs in the southwest portion of the Flint Oil property.

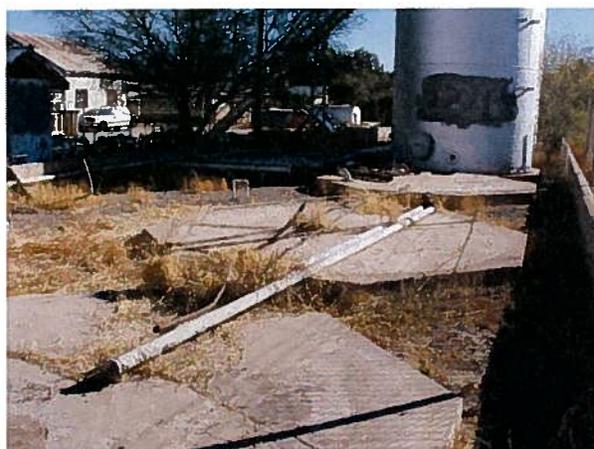
32. Concrete pads for three former ASTs in the southwest portion of the Flint Oil property; view to the east.

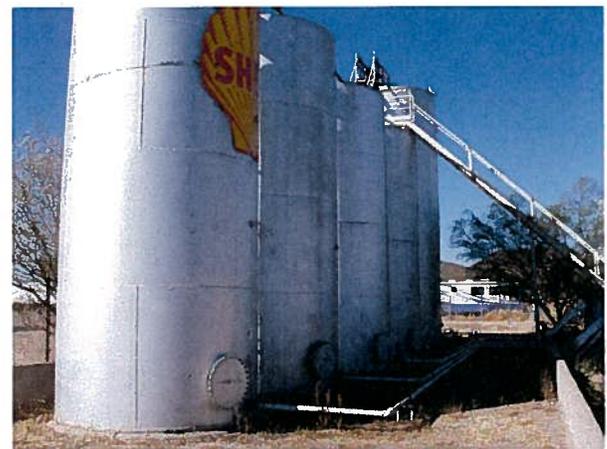
33. Five ASTs on the southern portion of the Flint Oil property; view to the west.

Seven vertical aboveground storage tanks (ASTs) on concrete pads and three former AST concrete foundations were located along the southern and western boundaries of the property. Pumps, aboveground piping, electrical panels, and a small storage building containing hoses and pipes were located north of the ASTs. Underground piping from the ASTs led to a loading rack in the central portion of the site. Six smaller ASTs were located in various locations on the property. Five empty ASTs were stored south of the shop garage. Numerous 55-gallon drums were located on the elevated concrete pad south of the warehouse, east and southeast of the elevated concrete pad, and on the southern portion of the property.

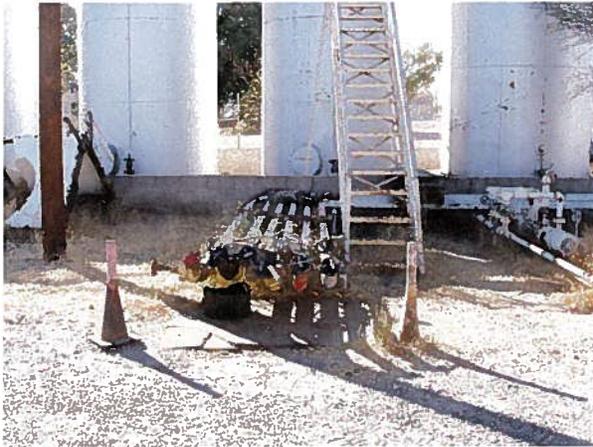
34. Fill pipes for the five ASTs on the southern portion of the Flint Oil property; view to the south.

Stained soil or pavement was observed at the fill ports for the five vertical fuel ASTs, and at one of the pumps, at three new oil ASTs on the elevated platform, on the shop garage concrete floor, around the stack of empty drums on the southern portion of the property, on the elevated platform in the area of the canopy, on the concrete floor inside the warehouse, and on the asphalt pavement in the northern portion of the property

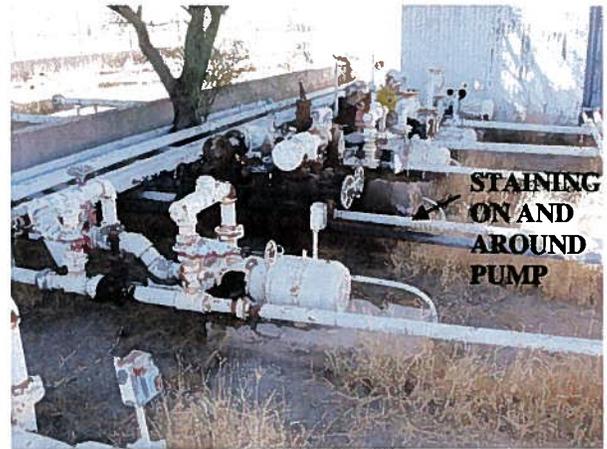
35. Pumps for ASTs in the southern portion of the Flint Oil property; view to the southwest.

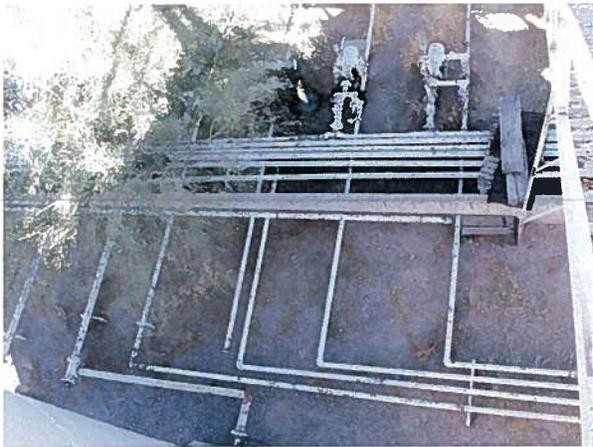
36. Piping north of the ASTs on the southern portion of the Flint Oil property.

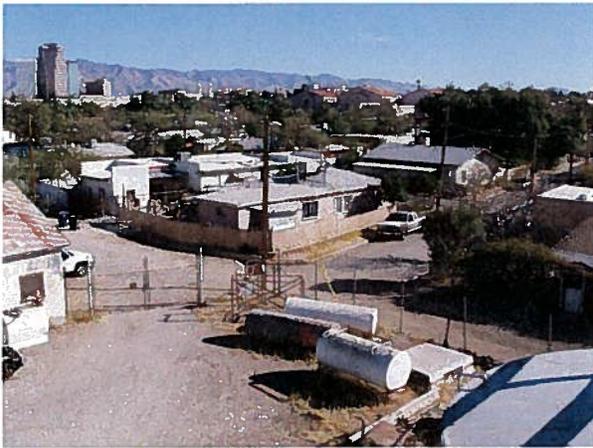
40. Empty ASTs on the eastern portion of the site, the site driveway, and the residential neighborhood east of the site; view to the northeast.
