**Phase I Environmental Site Assessment
Los Reales Landfill Expansion Project
73.6 Acres of Undeveloped Land
Pima County Parcel Nos.: 140-39-052E & -052F
Tucson, Arizona**

February 6, 2014

CTEC Job No. 13-1319

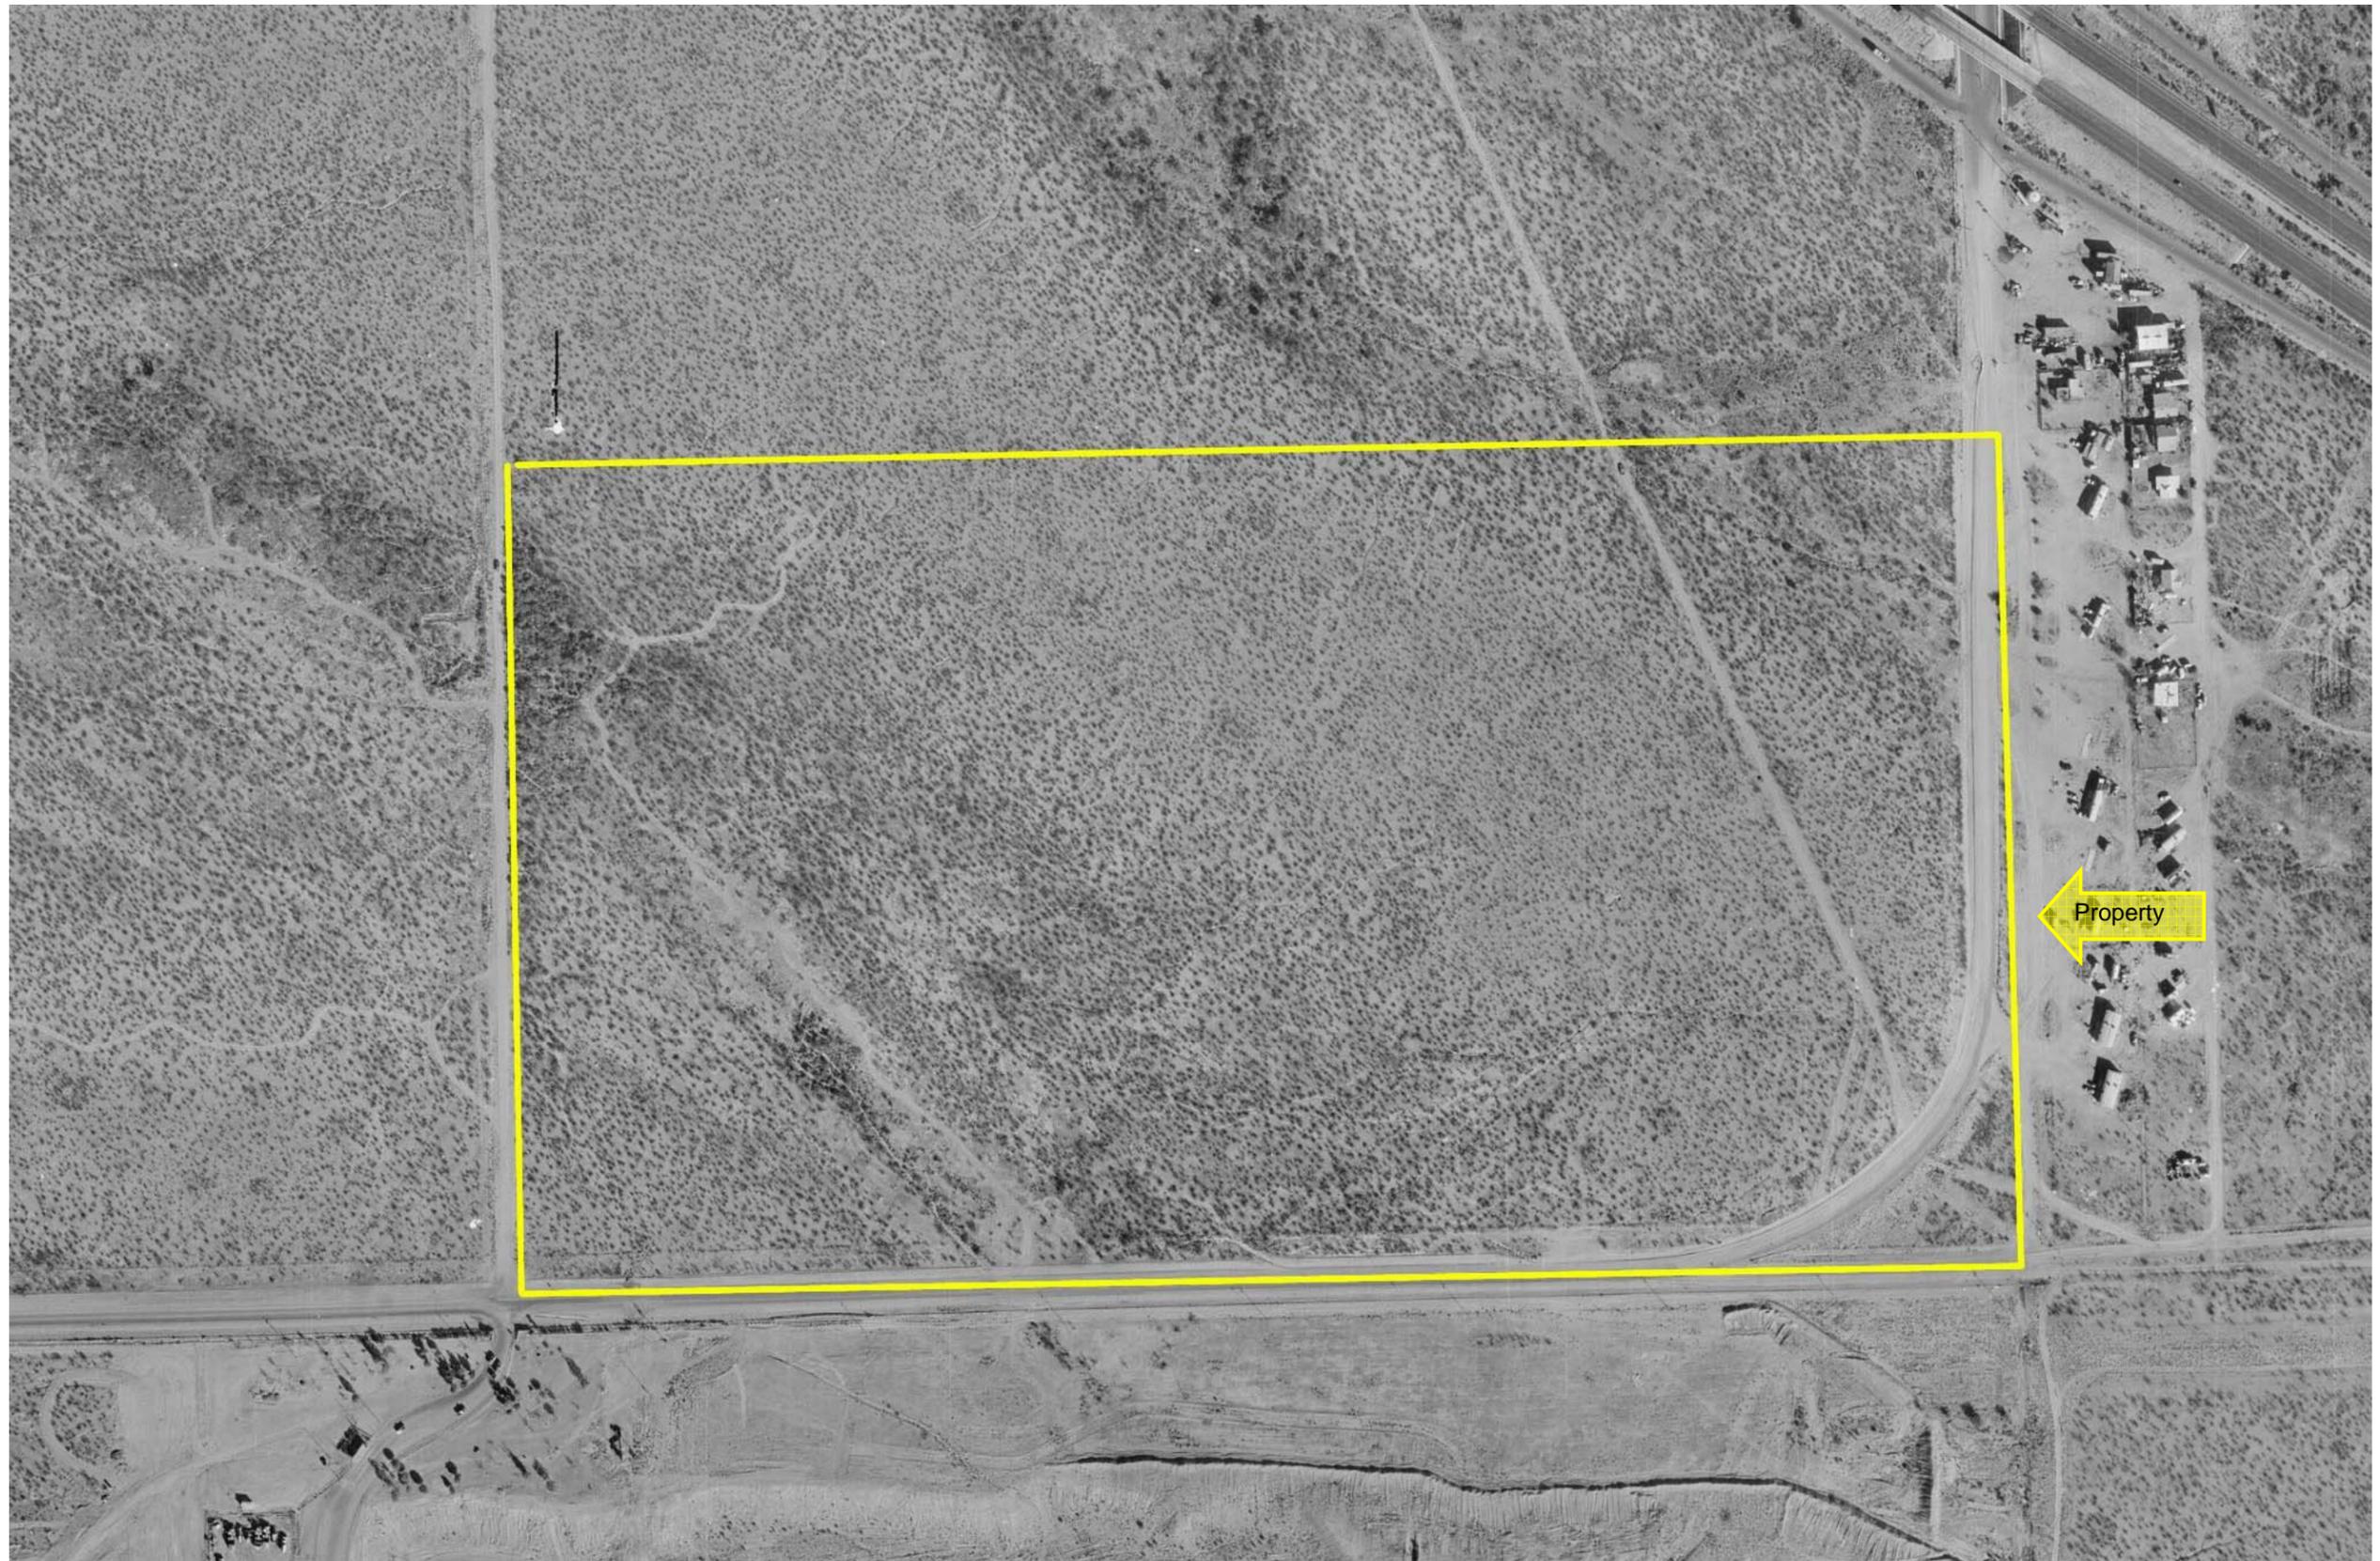
FIGURE 2
 Property Detail Map
 Los Reales Landfill Expansion Project
 Tucson, Arizona

- Two areas of potentially buried waste material were observed near the west property line. These two areas are indicated on Figure 2. The northern disturbed area is located from 32.12171/110.88357 to 32.12142 and has dimensions of approximately 100 feet north-south and 20 feet east-west (Photo 5). At the southwest corner of parcel 140-39-052E, partially buried debris was observed at 32.11975/110.88357 (Photos 6 & 7). CTEC recommends the physical investigation of these areas to assess the extend and type of potentially buried waste.

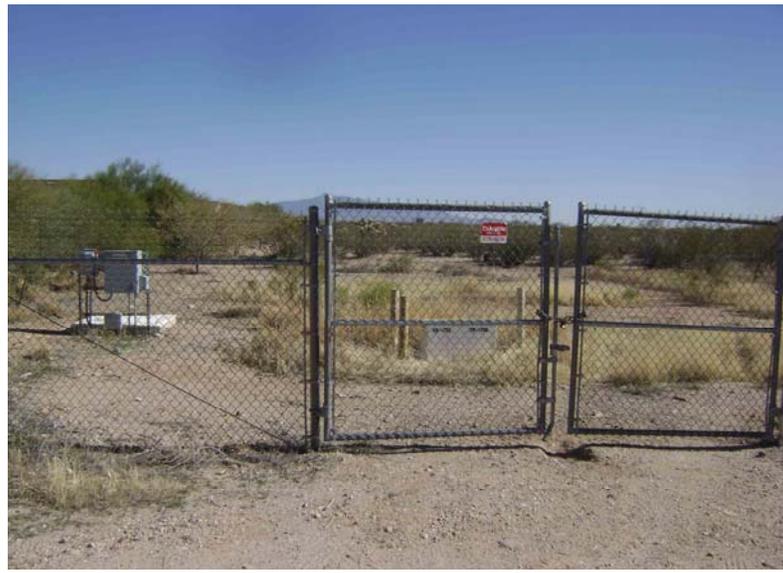
Photo 1: Looking east, northwest corner of Property. Monitoring well WR-471A (box) near center of photo and WR-470 (flush mounted) on left side of photo.

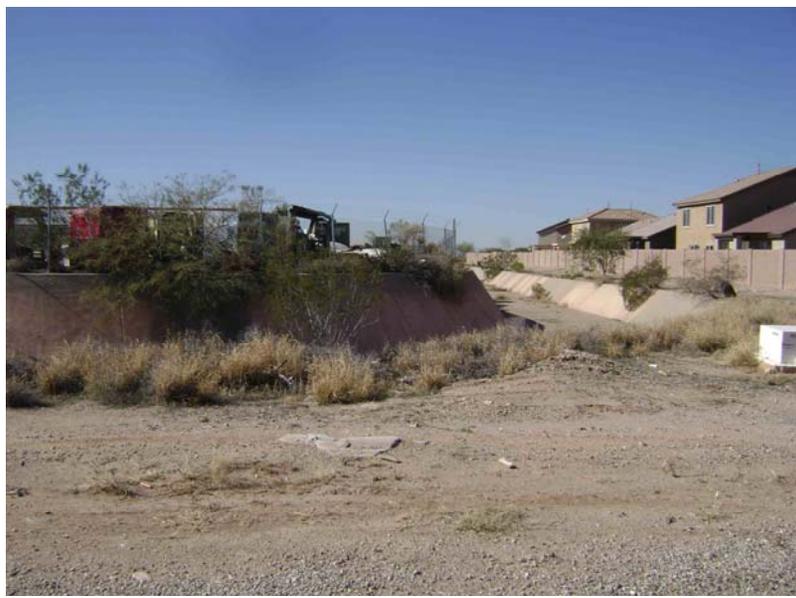
Photo 3: Looking west from northwest corner of the Property. Note concrete-line storm water drainage. White box on right side of photo is monitoring well WR-184A.

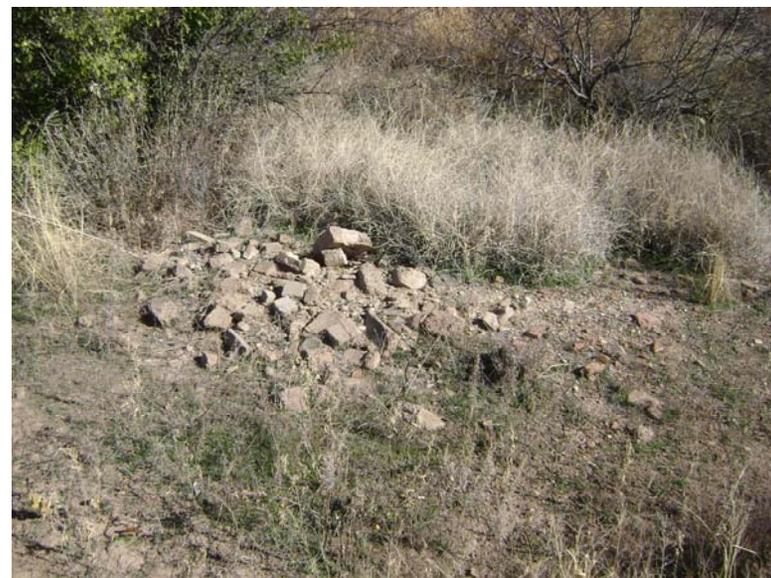
Photo 4: Looking east, typical debris pile located on northwest portion of the Property (32.12194/110.88328).

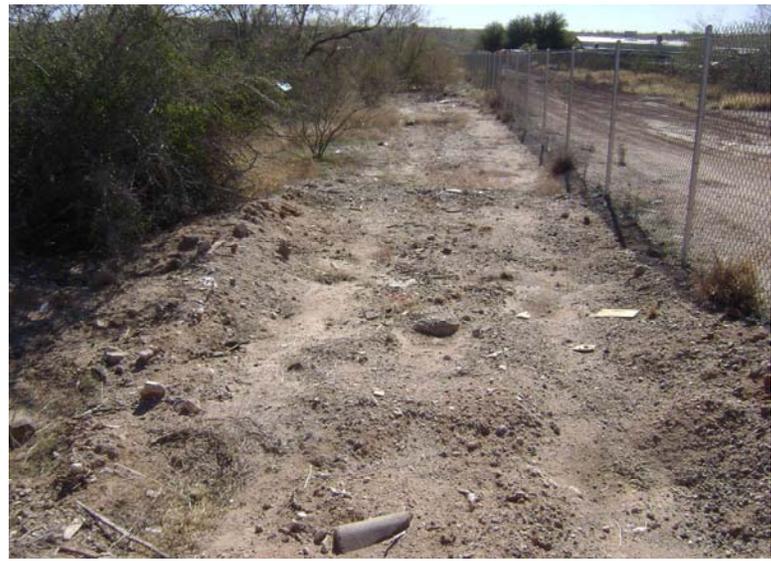
Photo 5: Looking south along west fence line on northwest portion of Property. Partially buried debris observed (32.12171/110.88357 – 32.12142) approximately 100 feet north-south and 20 feet wide.

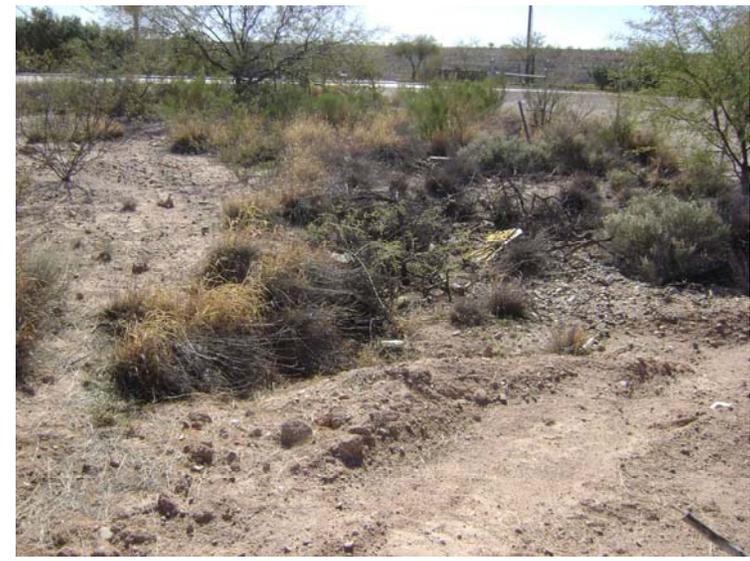
Photo 6: Looking southwest, southwest portion of the Property. Partially buried debris observed at 32.11975/110.88357).

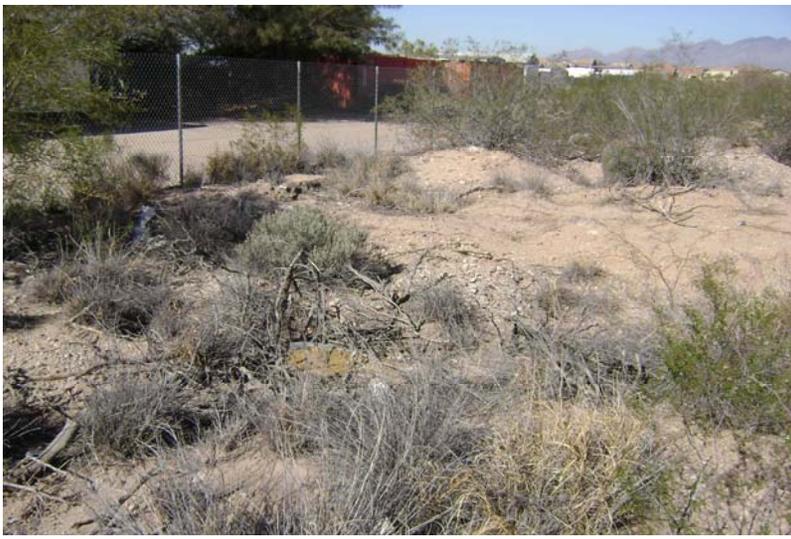
Photo 7: Looking northwest, southwest corner of Property. Partially buried debris observed here (near Photo 6).

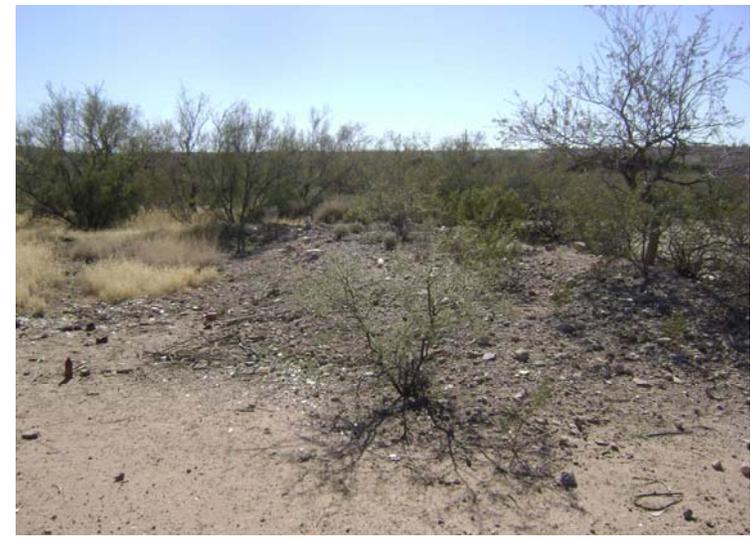
Photo 8: Looking south, pile of soil and concrete north of southern storm water culvert under Los Reales Road (32.12064/110.88199).

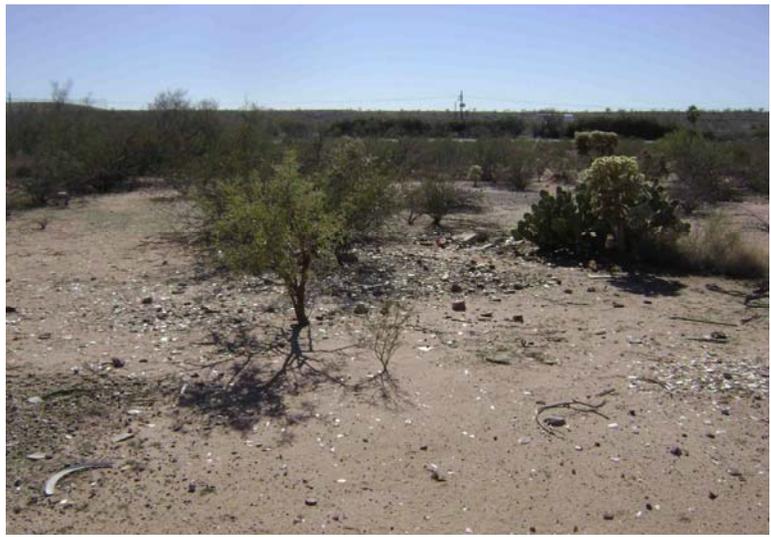
Photo 9: Looking south, scattered debris area north of north storm water culvert under Los Reales Road (32.12092/110.88208).

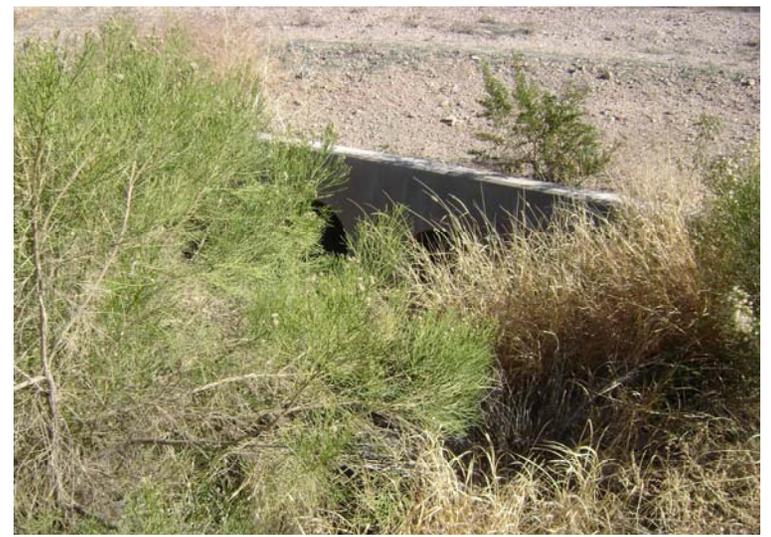
Photo 10: Looking southeast, western storm water culvert under current Los Reales Road.

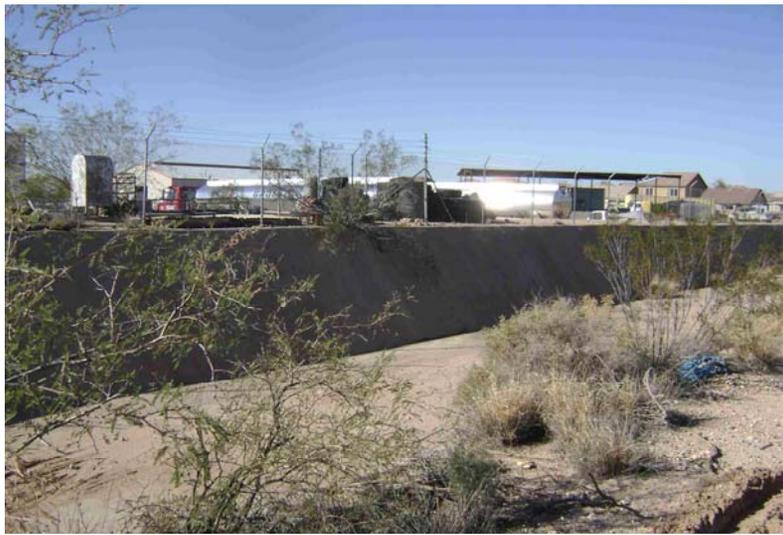
Photo 17: Looking northwest, tanker truck parking on adjoining property to the west of the northwest corner of the Property. Note concrete storm water drainage between Property and adjoining property.

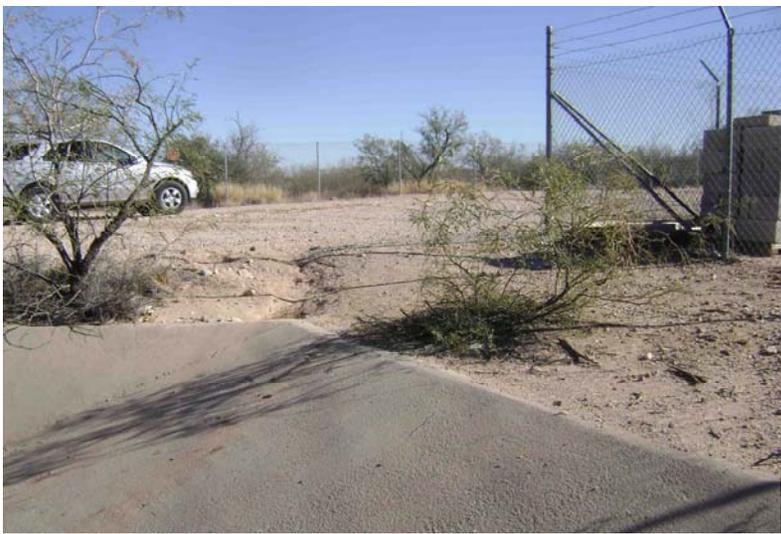
Photo 19: Looking southeast, storm water on Property enters drainage on adjoining property to the west (foreground).

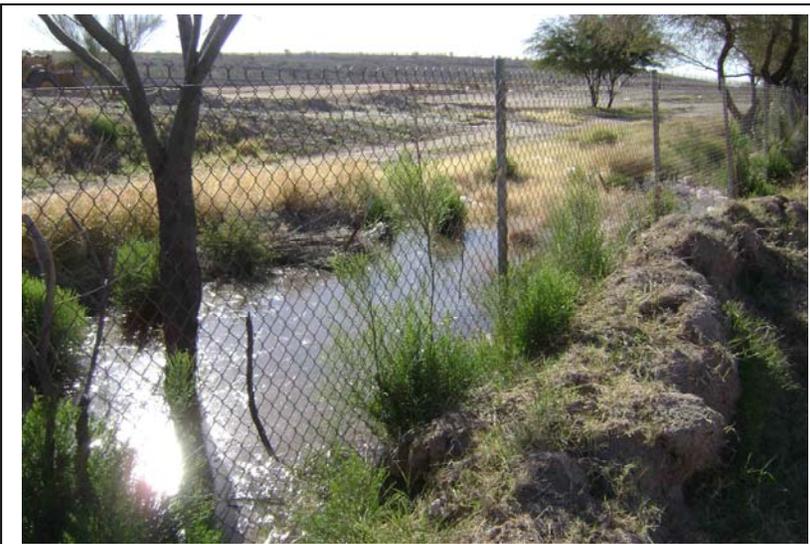
Photo 25: Looking southwest from a point approximately 850 feet east of the southwest corner of the Property. Standing water behind earthen berm on Los Reales Landfill on adjoining property to the south.

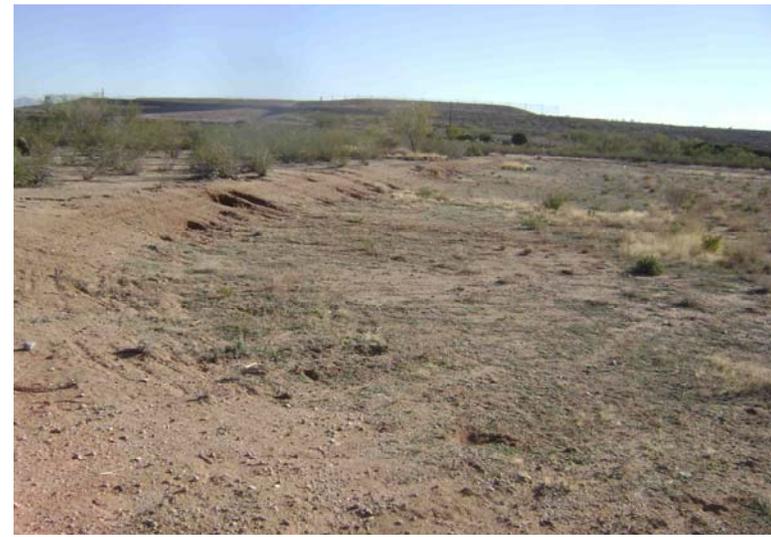
Photo 30: Looking southwest, storm water detention basin on southwest portion of parcel 140-39-052F.

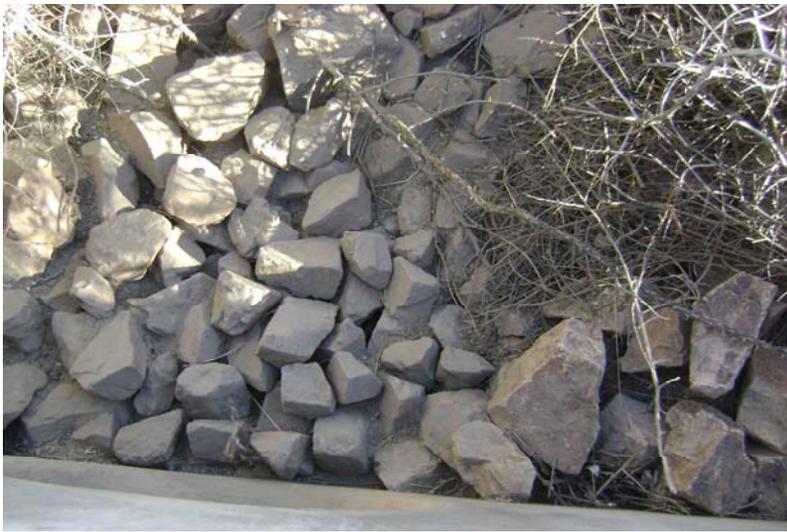
Photo 31: Looking down, storm water culvert on northwest portion of basin. Culvert goes under Los Reales Road.

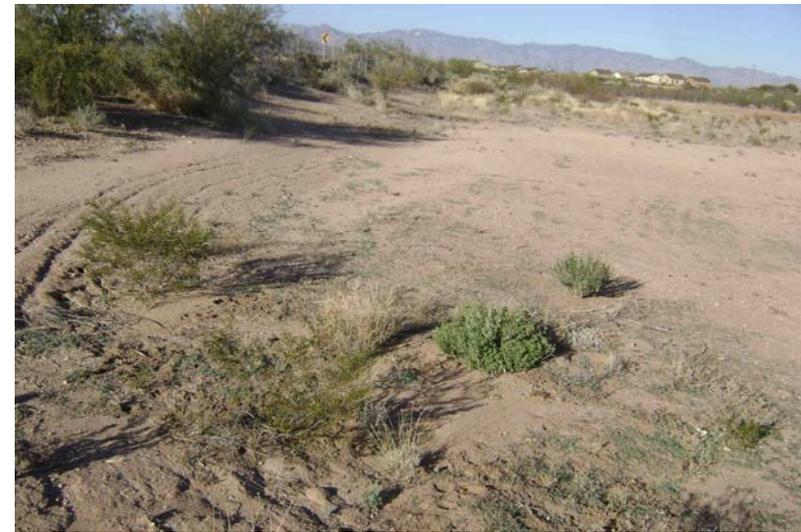
Photo 32: Looking northwest, west side of storm water detention basin.
