SITE ASSESSMENT and CLOSURE REPORT

CITY OF TUCSON CENTRAL ENERGY PLANT

**ARIZONA DEPARTMENT OF ENVIRONMENTAL QUALITY
VOLUNTARY REMEDIATION PROGRAM SITE 508392-00**

Prepared by
City of Tucson – Environmental Services
August 26, 2008

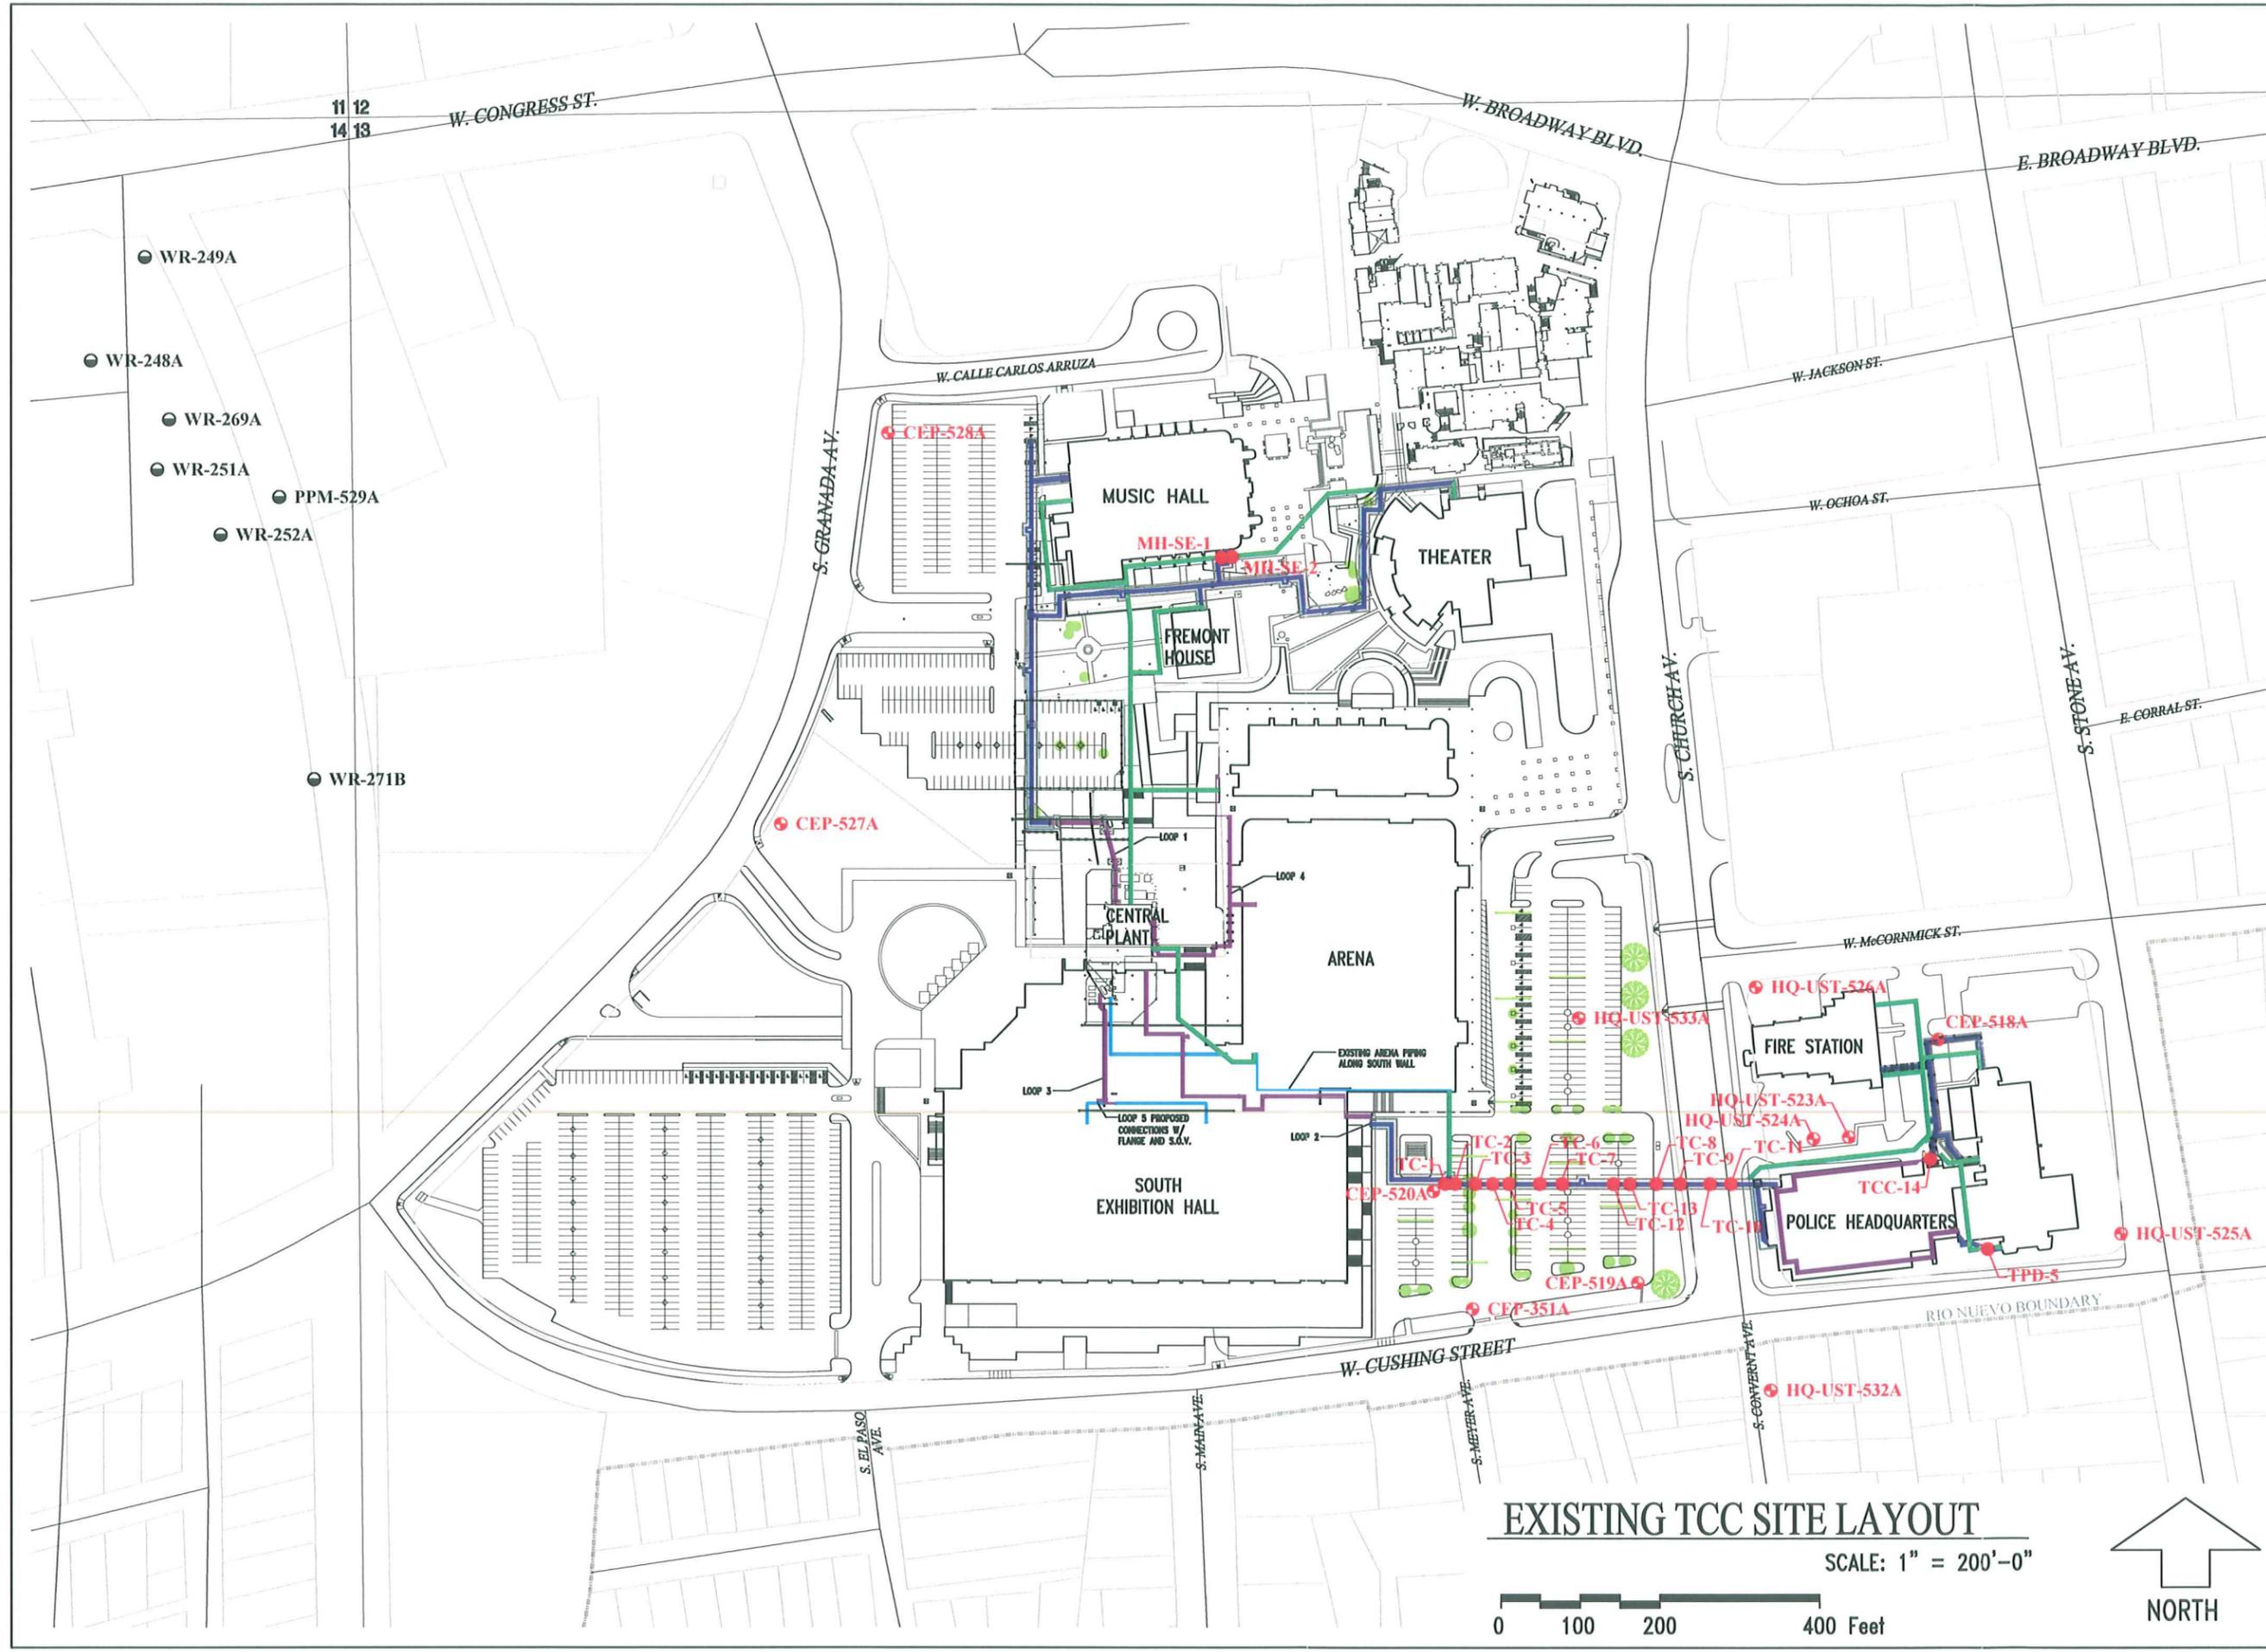
General Notes		
LEGEND		
	ABANDONED UNDERGROUND PIPING	
	UNDERGROUND PIPING NEW	
	ABOVE GROUND PIPING (NEW)	
	ABOVE GROUND PIPING	
	HQ-UST-526A	
	MONITORING WELLS	
	TCC-1	
	SOIL SAMPLE LOCATIONS (BENEATH FORMER PIPELINE)	
	MW-248A	
	PIONEER PAINT WELLS	
No.	Revision/Issue	Date

The City of Tucson (COT) CEP is located on the lower level (western side) of the Tucson Convention Center (TCC) at 265 S. Granada Ave. (Figure 1). The CEP and TCC were built in 1969. The plant provides heated and cooled water to the heating, ventilating and air-conditioning (HVAC) systems in surrounding buildings. At the time of the suspected releases, the HVAC distribution system was constructed with a combination of direct burial and interior mounted steel and Transite® piping. The distribution system had three loops: Loop 1 serves the Music Hall, Leo Rich Theater and the Fremont House; Loop 2 serves TCC, Police and Fire Headquarters buildings; and Loop 3 serves the TCC Arena (Figure 2). Each loop included four (4) separate pipelines to make up separate heating and cooling distribution and return lines. The cooling and heating system used process solution that was potable water mixed with small quantities of sodium nitrite (as a corrosion inhibitor) at a concentration of 700 to 800 parts per million (ppm). Optimal concentration for the sodium nitrite in the system was approximately 1,000 ppm. The HVAC Loop locations are illustrated in Figure 2.

Starting in December 2006 and running through the end of 2007, the COT implemented a phased replacement process for the heating and cooling loop lines connected to the CEP. Due to the potential environmental concerns, the pipelines with the largest loss rates were taken out of service first. Loop 2 was addressed first, then Loop 1, and lastly Loop 3. See Figure 2 for Loop pipeline locations.

Loop 3 was abandoned in place and replaced with new above grade piping. Figure 2 identifies the old and new pipeline locations, and respective soil sample collection points.

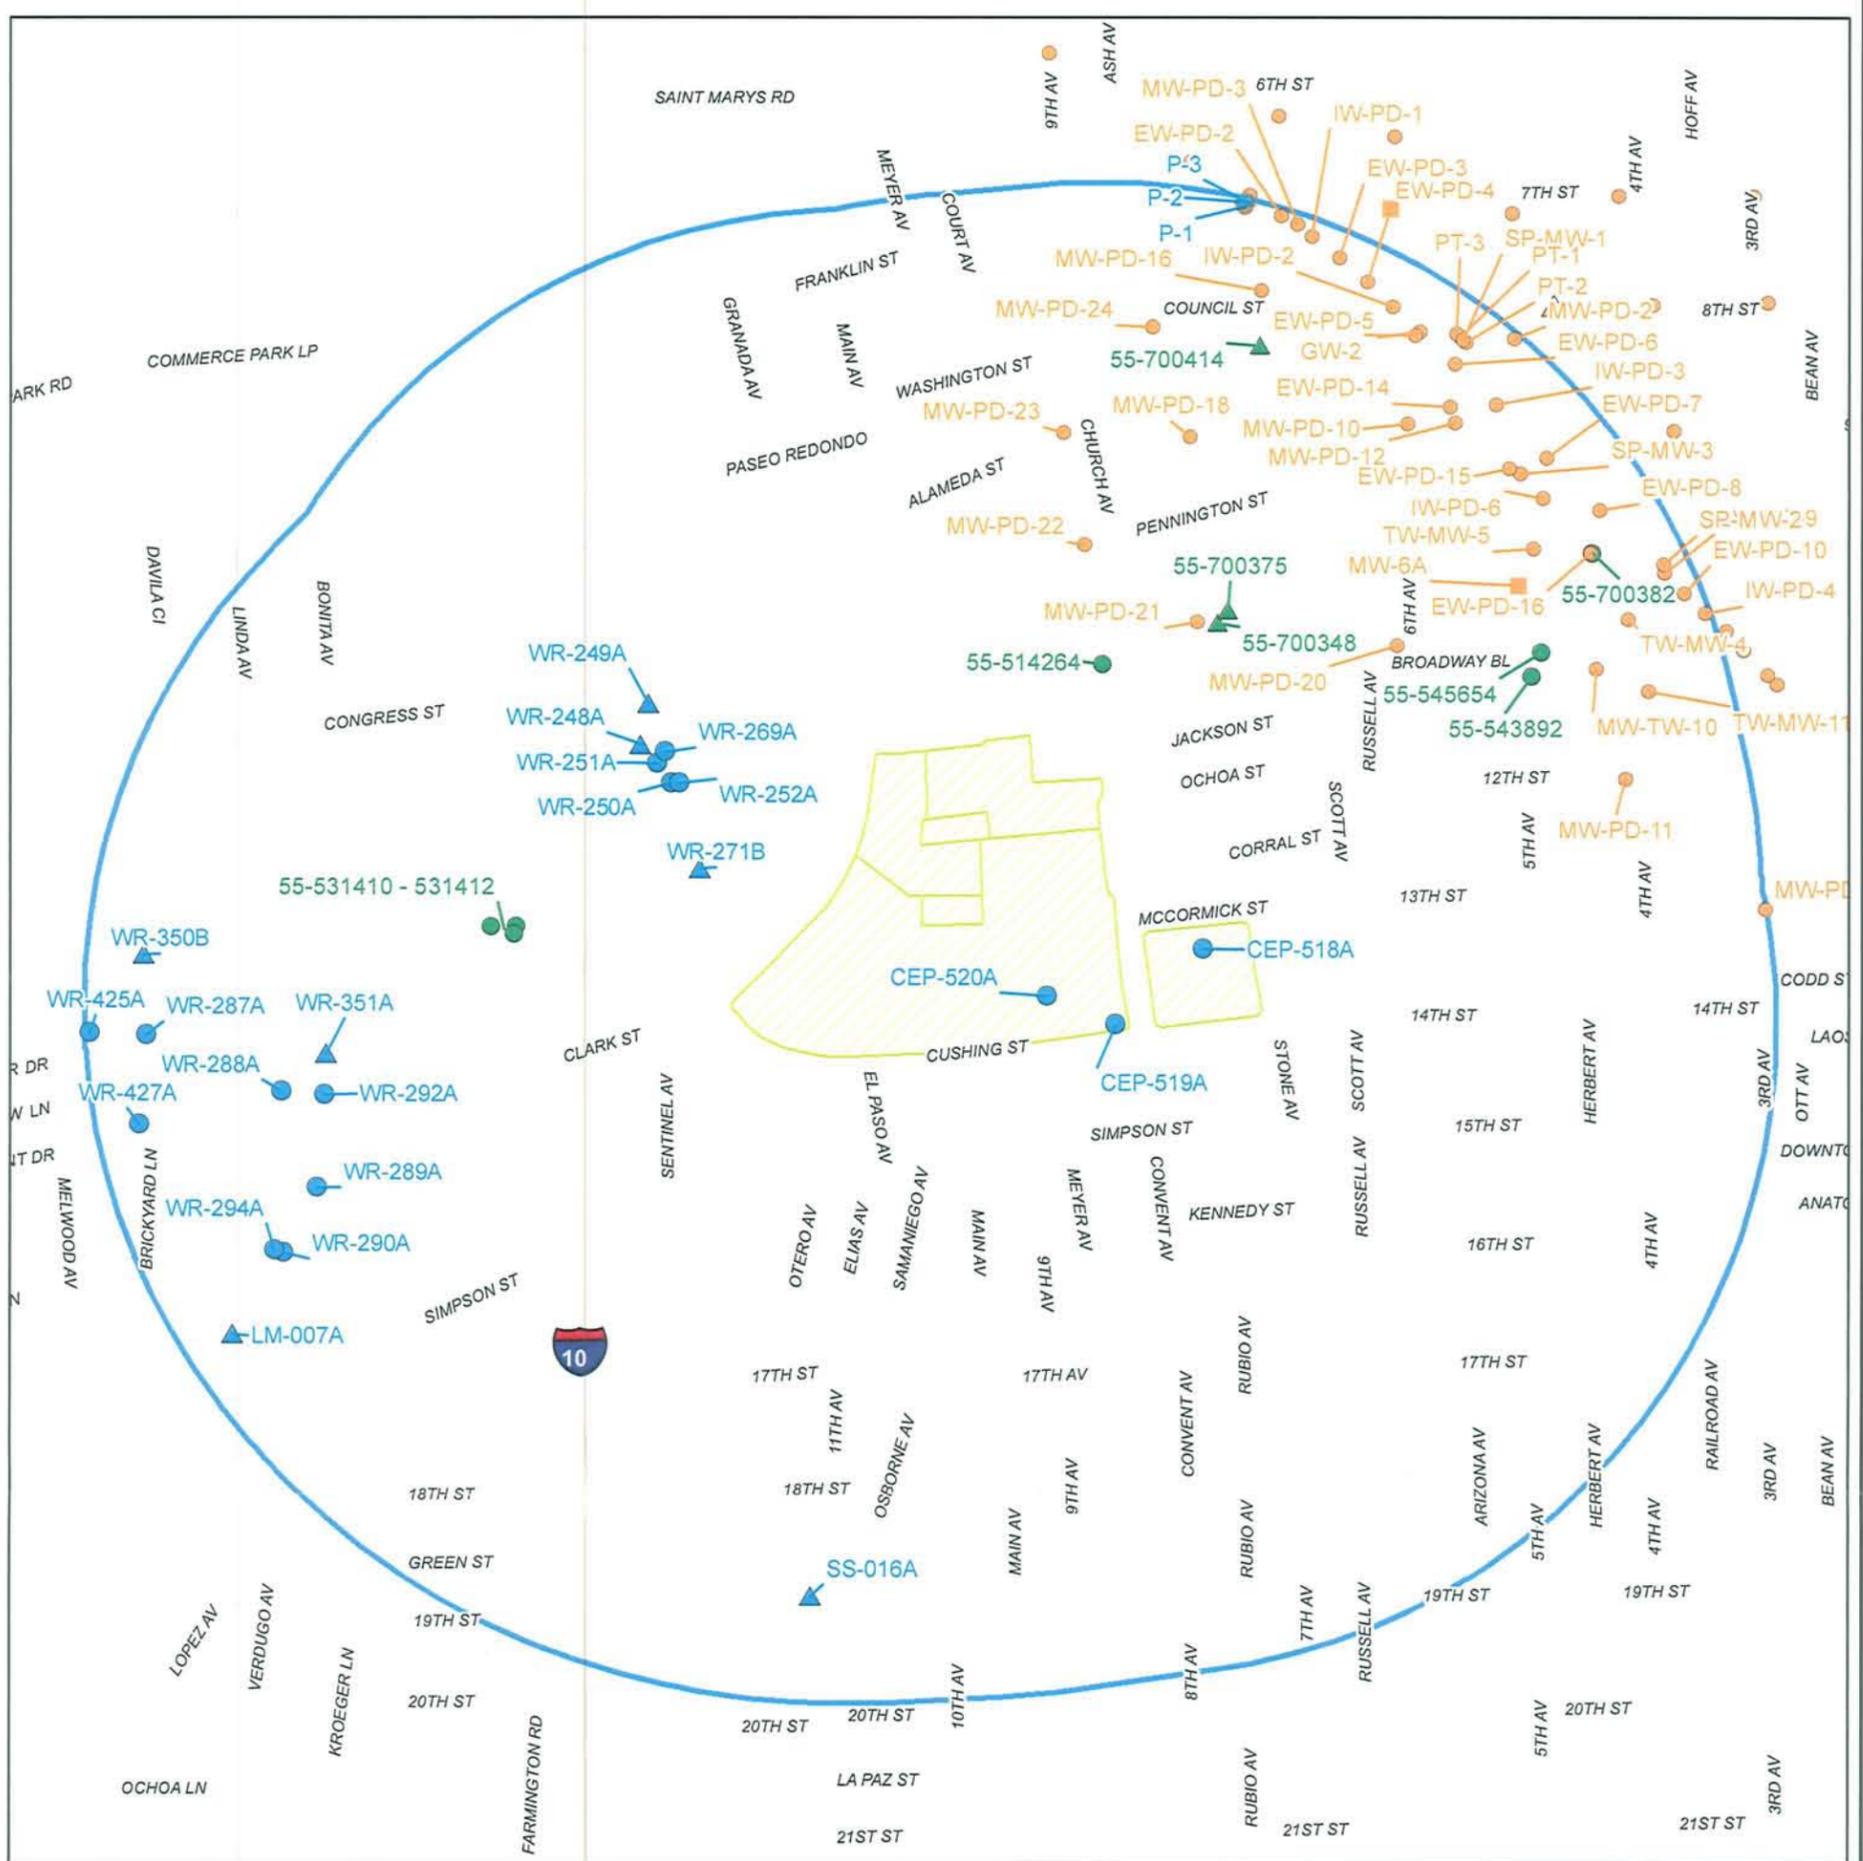
Figure 3
Well Inventory Map
Central Energy Plant

Arizona Department of Water Resources (ADWR) well locations provided by Wells 55 Database (September 2006). Data supplemented by the Park-Euclid and 7th Street & Arizona Avenue Water Quality Assurance Revolving Fund (WQARF) Sites April 2004 Well Inventory.

City of Tucson (COT) well locations provided by the City of Tucson - Tucson Water and Environmental Services.

In January 2007 ES staff conducted a well inventory search for possible receptor wells within a half mile radius of the CEP pipelines. ES reviewed the April 2004 Arizona Department of Water Resources (ADWR) well inventory report for the Park Euclid WQARF site. The search radius for that report includes the subject area. ES then reviewed all ADWR databases to identify any new wells that may have been installed since 2004. Tucson Water was contacted to acquire any updated information, as well as the Union Pacific Railroad. All known registered wells as of December 2006 within the one-half mile search radius were identified; none were drinking water supply wells. See attached Figure 3.

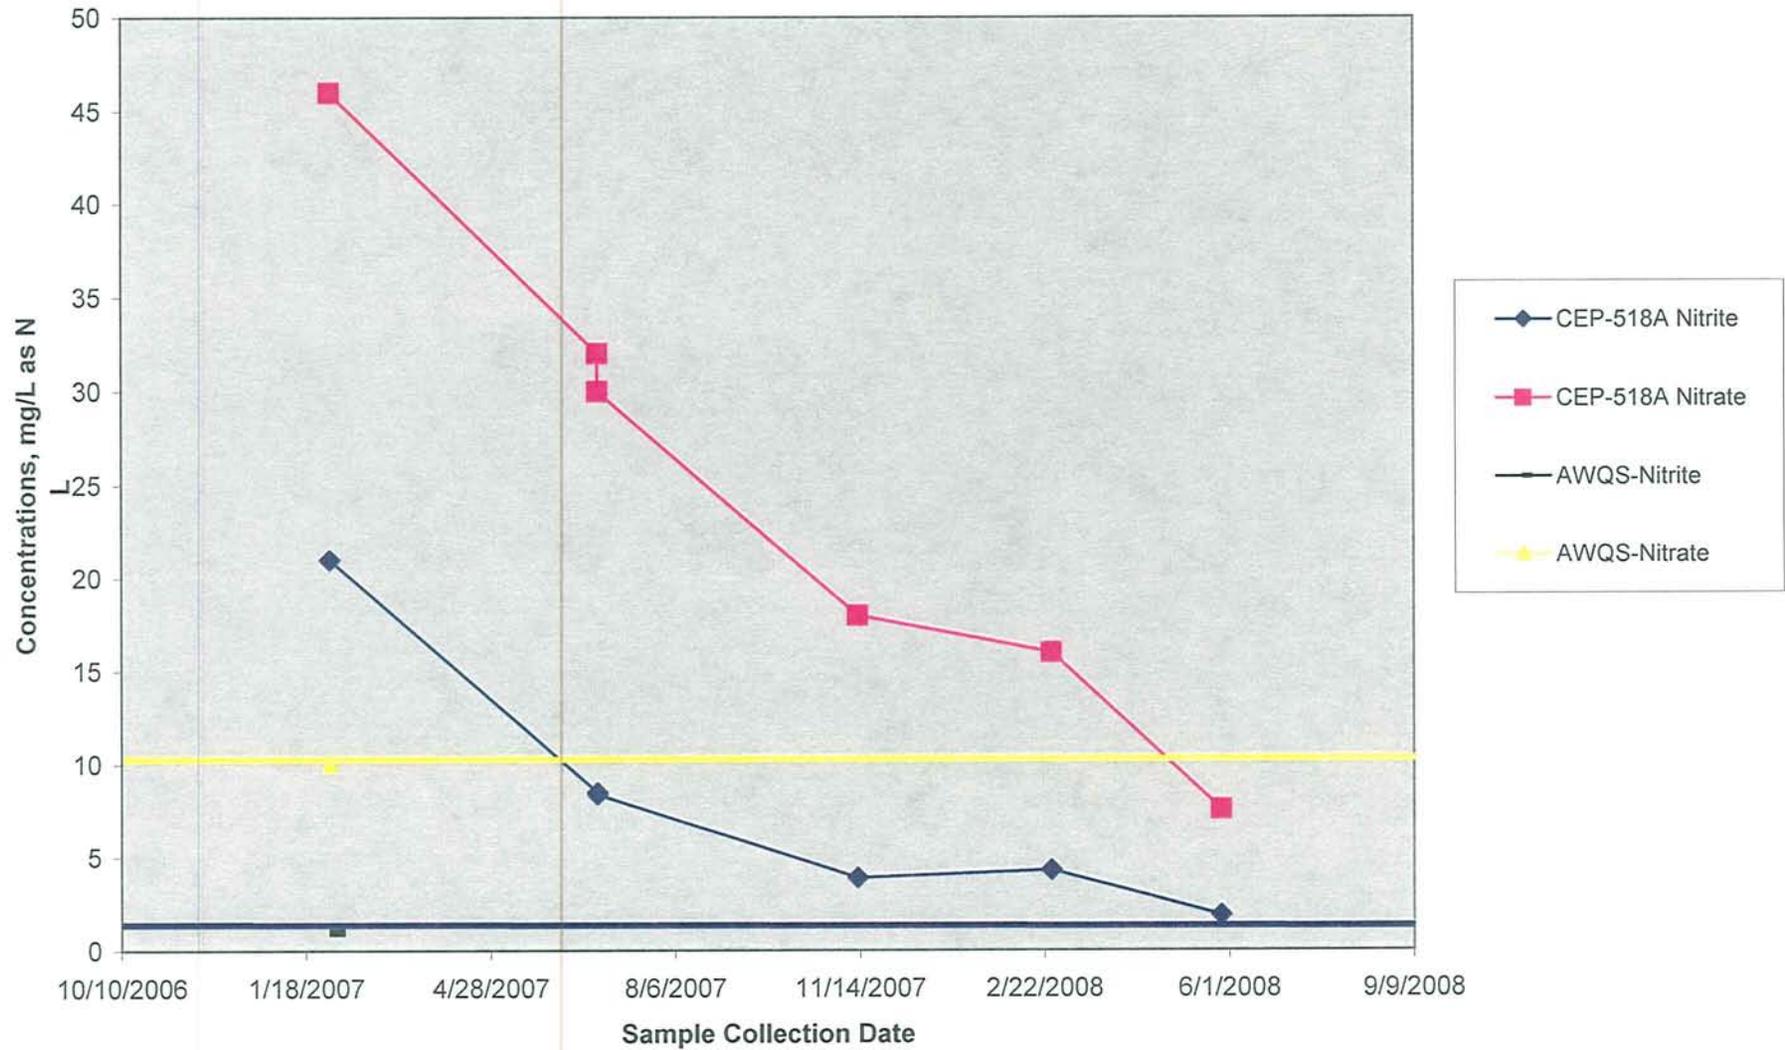
Figure 8

Nitrite & Nitrate Concentrations in CEP-518A
