PHASE I ENVIRONMENTAL SITE ASSESSMENT (ESA) REVIEW SUMMARY

PROPERTY NAME: Former Arizona State Elk's Association Hospital, unimproved 21.4 Acre Parcel

LOCATION: North side of Speedway Blvd. between Greasewood and Silverbell roads. Tucson, Pima County, Arizona.

ESA CONSULTANT: EnviroMD, Inc. 4400 East Broadway Blvd. Suite 300, Tucson, AZ. 85711,

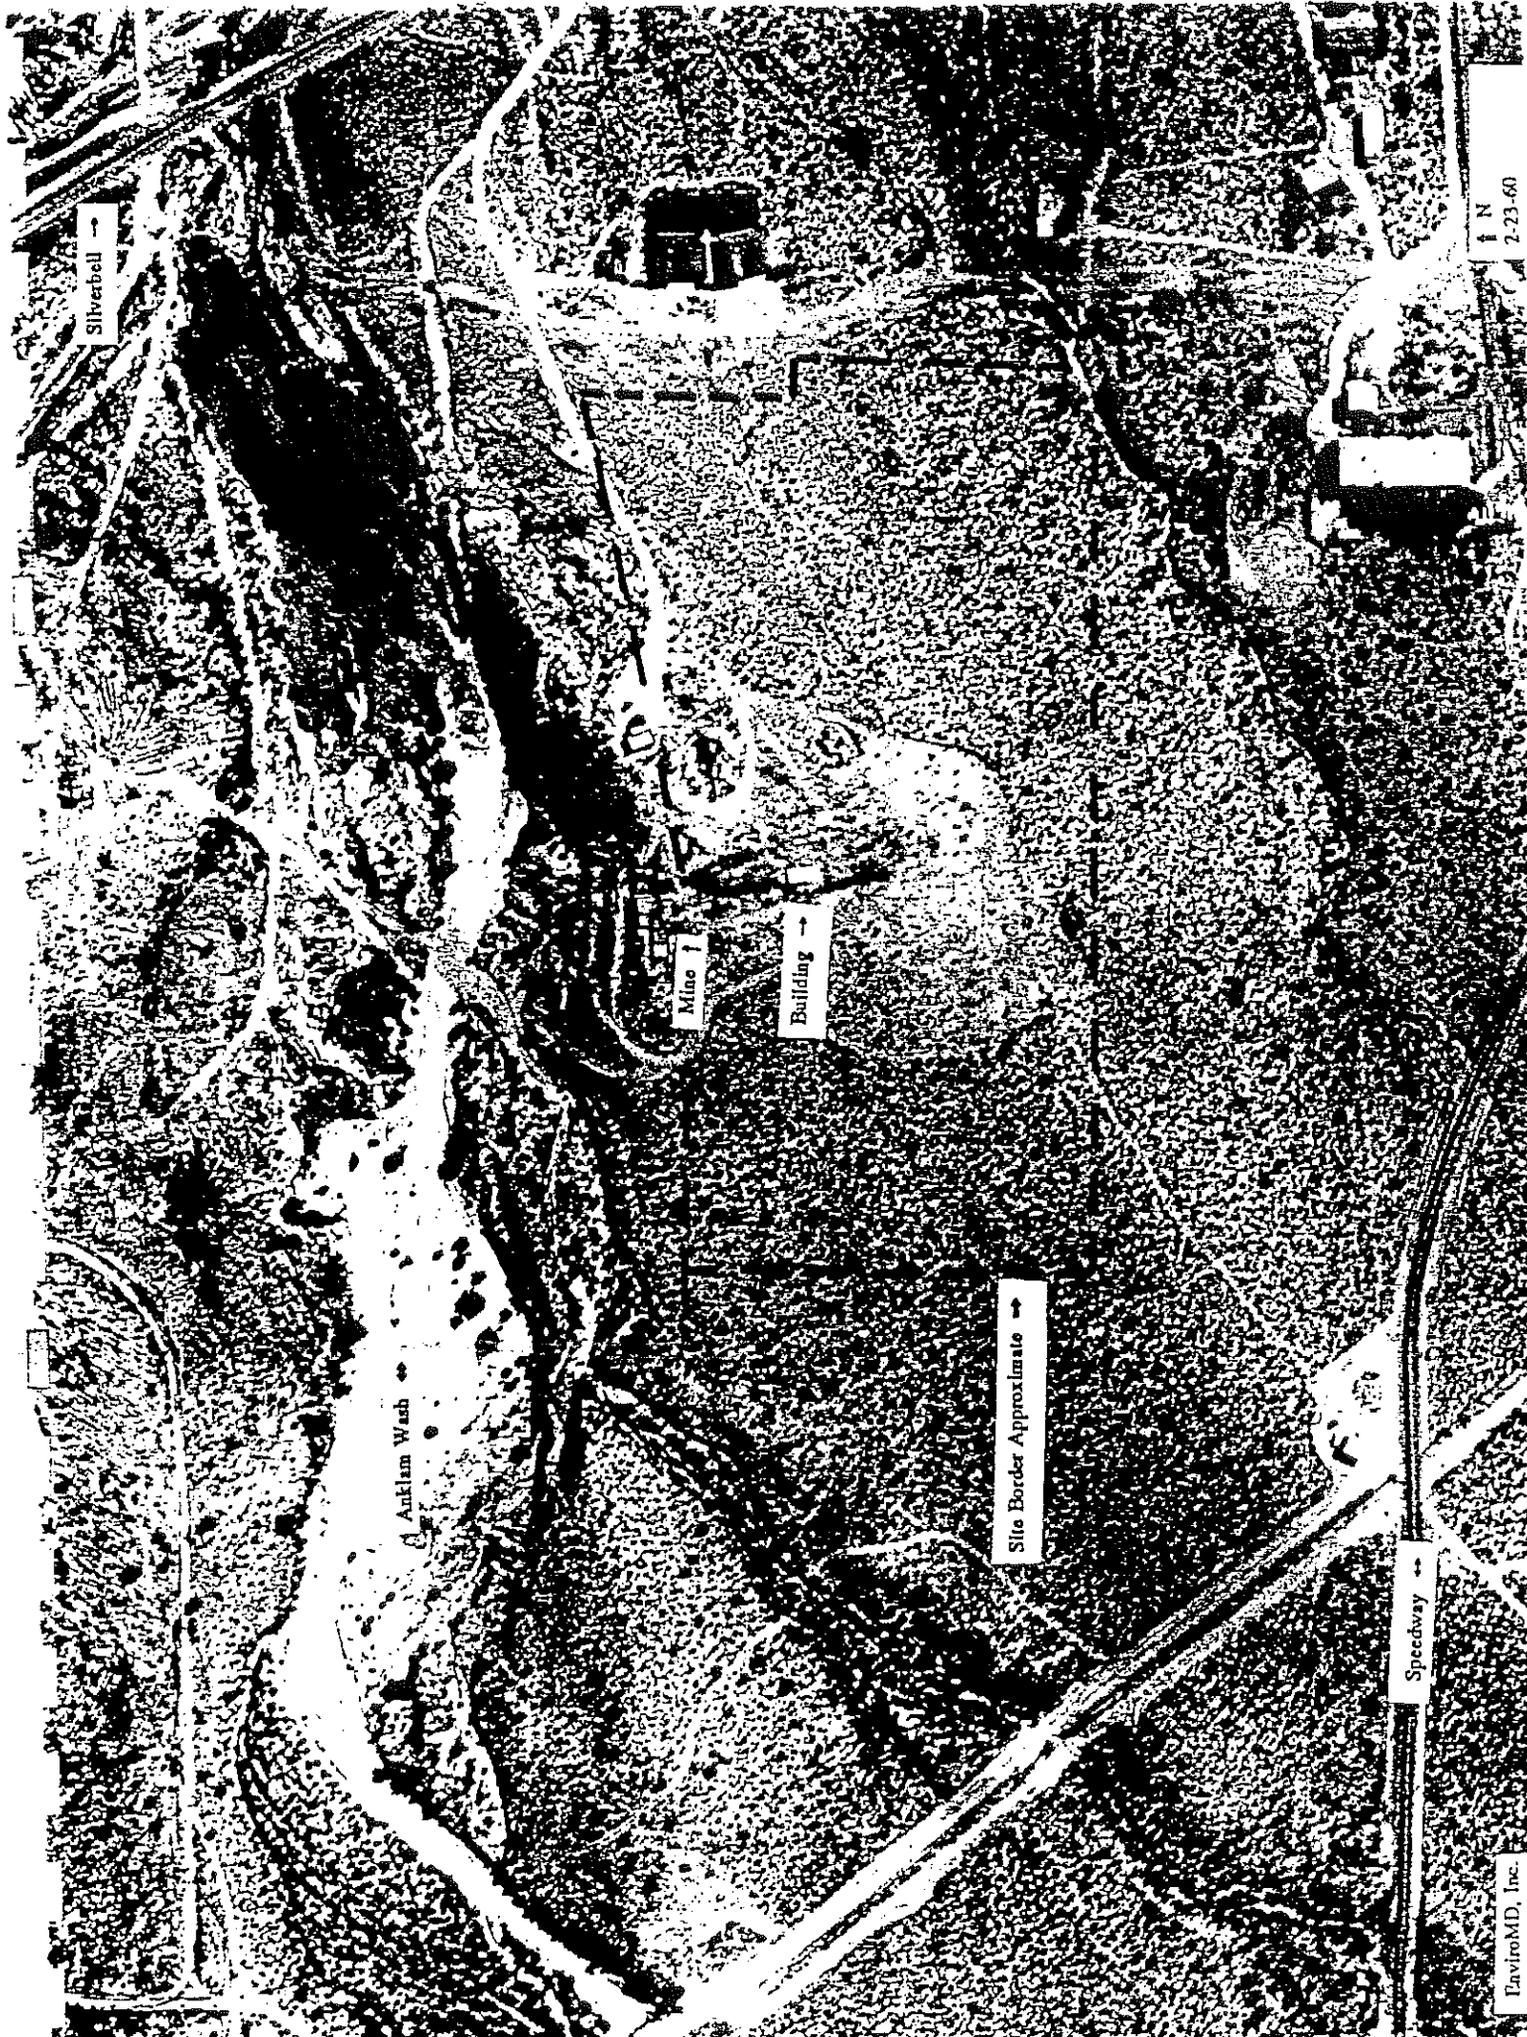
N
2-23-60

A review of aerial photographs provided limited evidence that the subject property was ever used for handling large quantities of hazardous materials and that there was the appearance of contamination due to activities on the property or on surrounding properties.

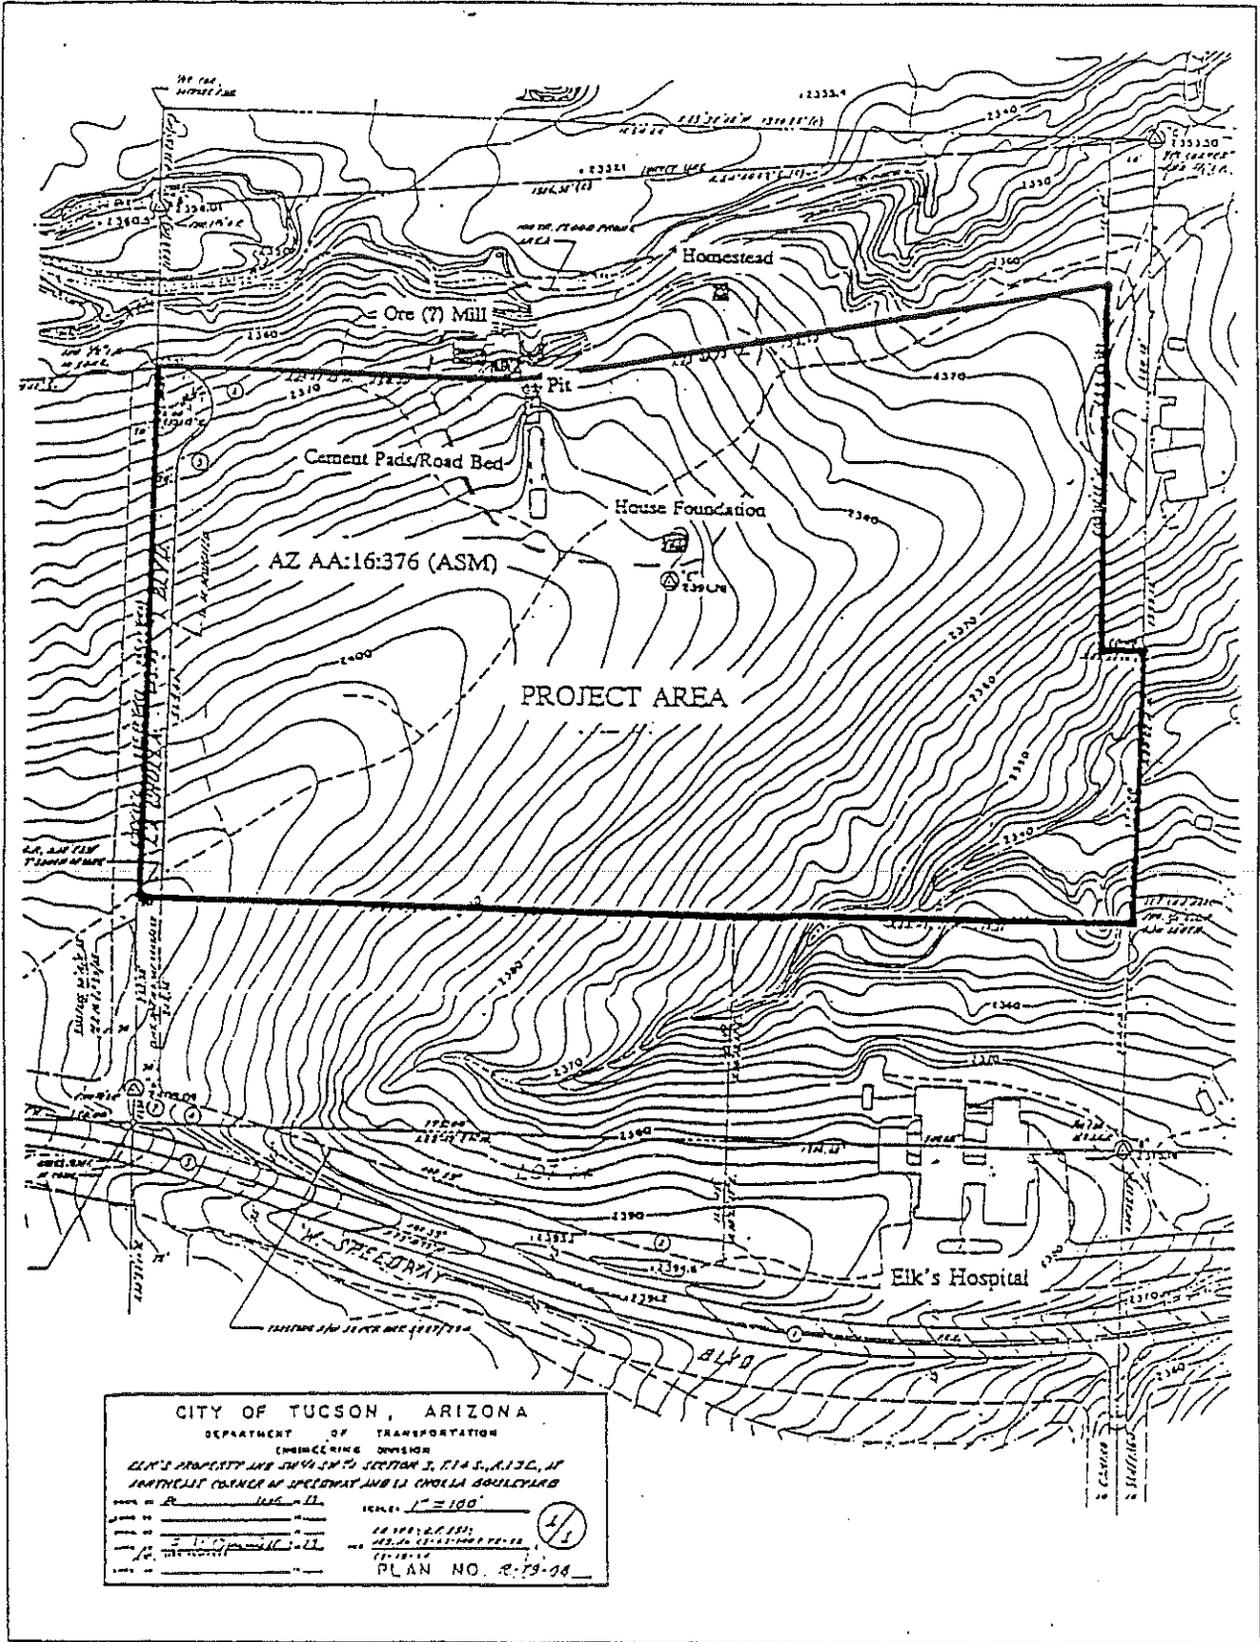
Figure 2. Photocopied portion of City of Tucson topographic map of the project area, showing location of site AZ AA:16:376 and associated historic features discussed in the text.

In an archaeological survey conducted by Desert Archaeology, Inc. in 1993, recommendations for archival research and significance assessments prior to sale of the subject property were made (Appendix E). This was based on the unknown significance of a pit, cement pads and an isolated foundation found within the subject area. Of concern was a site, AZ AA:16:376, located outside the northern boundary of the property. This site includes an ore mill and homestead which predate 1906 and may be eligible for inclusion in the National Register of Historic Places under Criterion D (36 CFR 1202). Since this site is not located on the subject property and artifacts found during the survey are not believed to be significant, archaeological clearance for the area outside AZ AA:16:376 site boundaries was recommended by Desert Archaeology, Inc..
