Downtown Motor Apartments

Phase I Environmental Site Assessment

**Centralized address 383 South Stone Avenue  
Stone Motor Hotel - Fully Developed Land  
City of Tucson, Pima County, Arizona**

**Project ID: MCT\_1411**

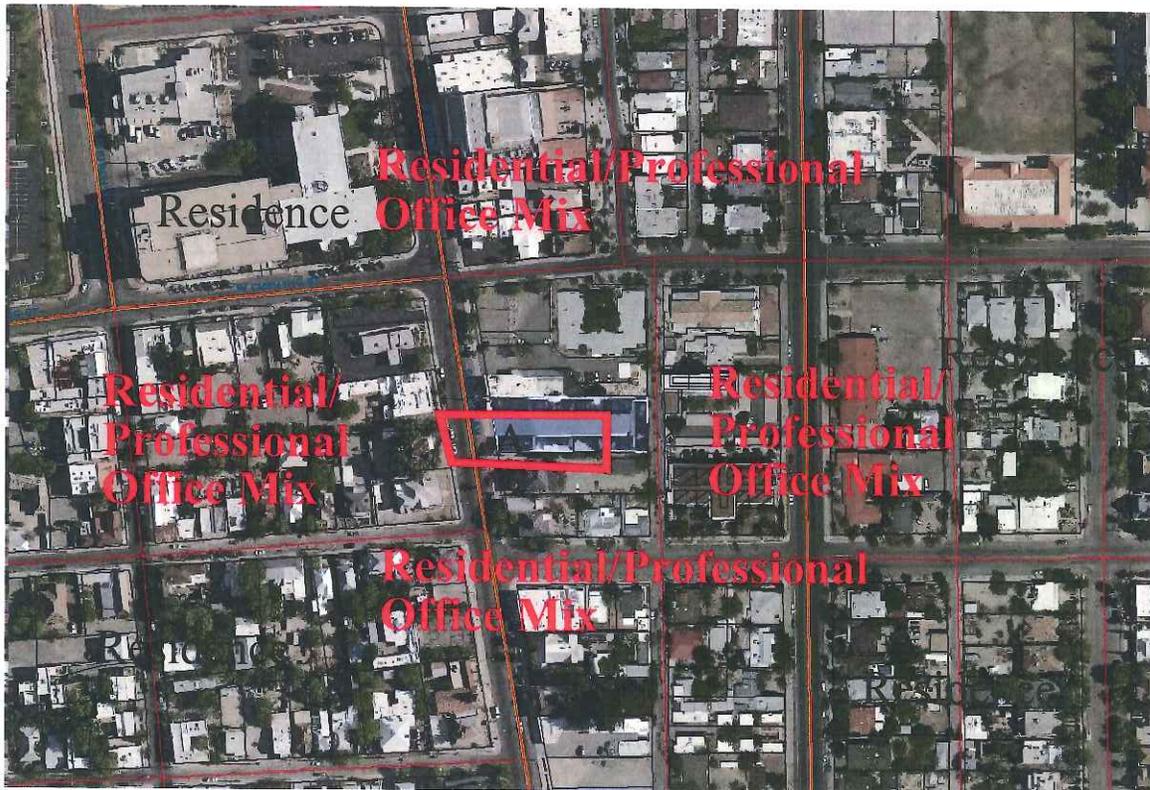
The overview aerial above taken in 2013 by the Pima County Assessors office provides the property location under study outlined by the broad red line and letter "A". This view also shows the adjacent development surrounding the subject. The total parcel is approximately .51 acres (point 51) surrounded by developed commercial residential service businesses and residentially occupied housing on all sides. All of these are visible and generalized in the aerial view.

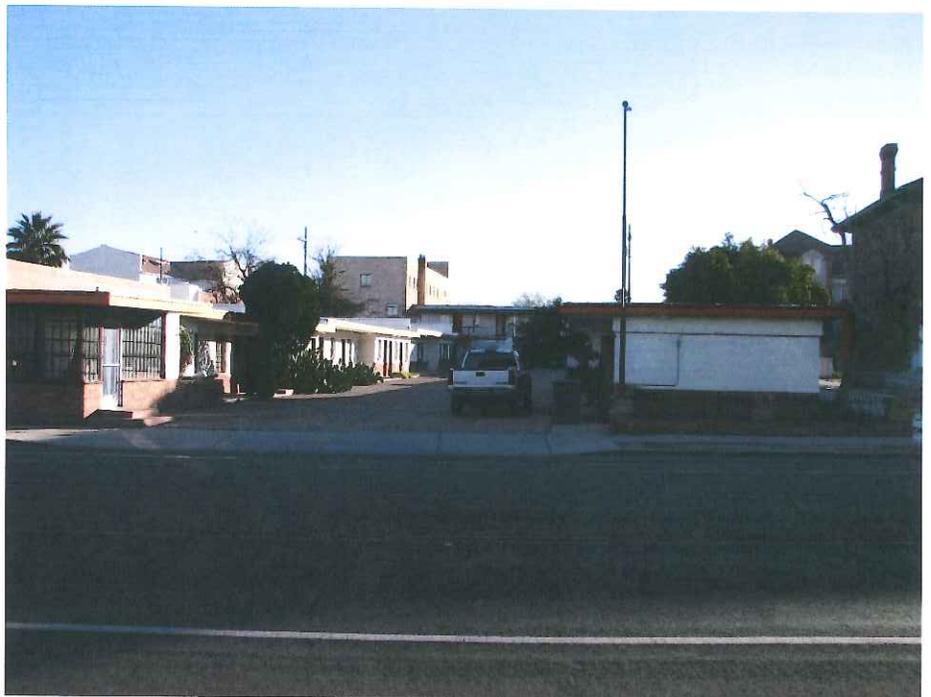
Residential buildings have public sidewalk access both from parking lots situated in the centralized area and depicted at right with direct access from Stone Avenue a 3 lane street (center turn lane) in the foreground.

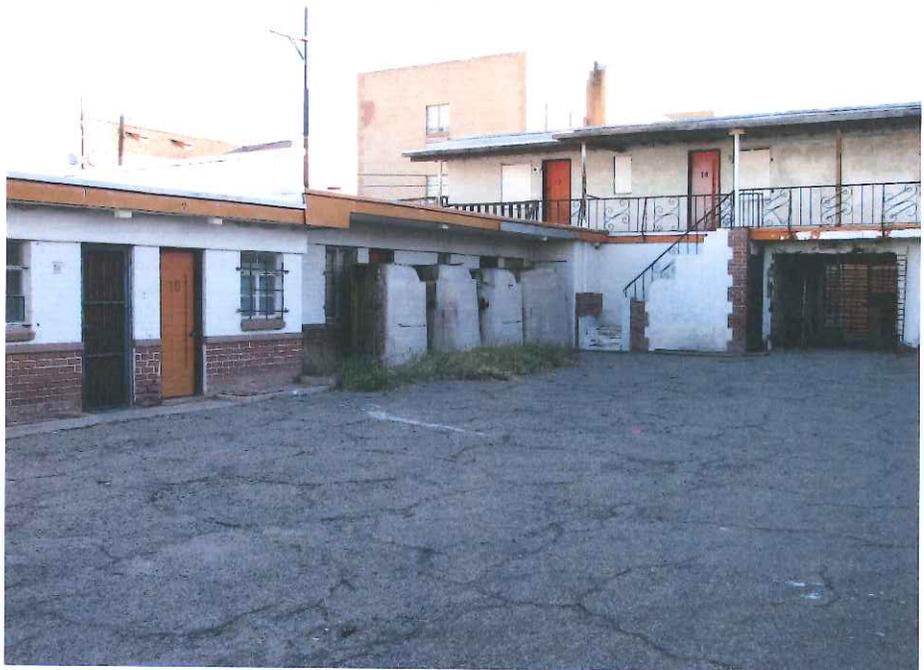
The developed site is secure but is not had structural maintenance in at least the last 5 years.

The picture at right is typical of the site and building condition. All doors to all units were tested as well as windows and found secure.

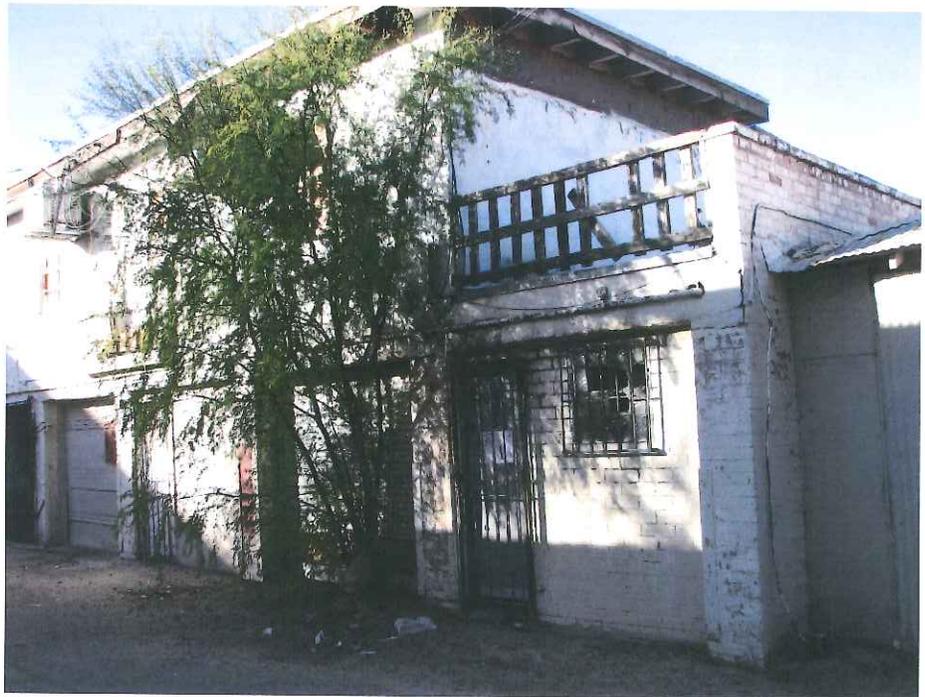
The structure currently in a dilapidated condition does serve as storage for dry goods and remaining artifacts from years of past usage. This view from the back alley shows some vandalism but careful assessment at the site indicates all units are resistive of any unauthorized entry attempt.

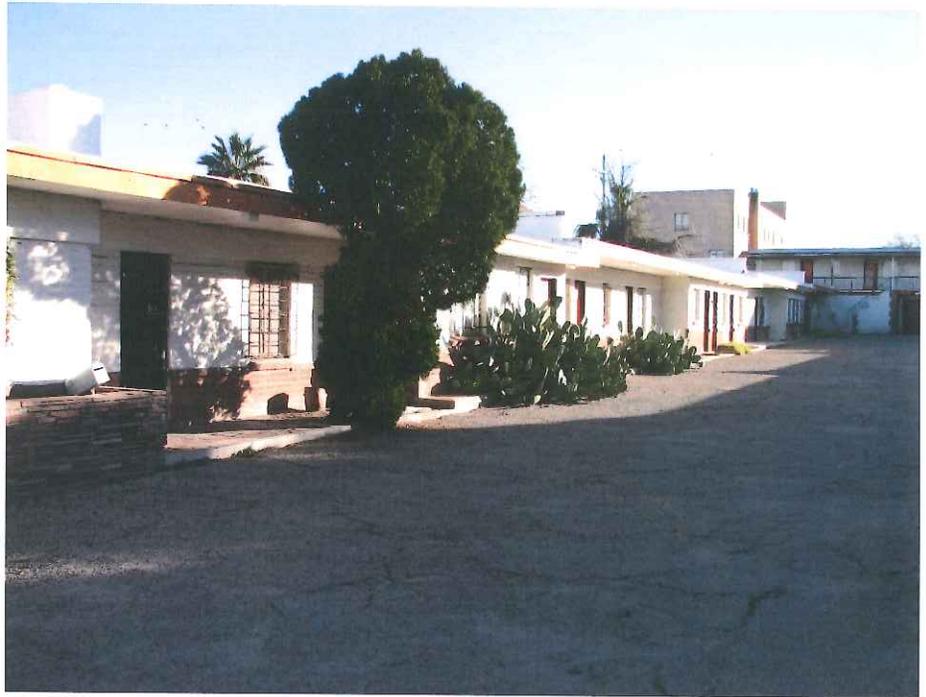
There are virtually no sensitive environmentally important site improvements on the fully developed site. Notably the site is about .51 acres (point 51) (all areas collectively) and 32 apartments, single floor and one two story commercial residential sitting at the east end of the lot. This development includes fully improved parking, curb, gutter and sidewalks on the site.

Vegetation at the subject is primarily native ornamental bushes and cactus which is typical of surrounding developments. All plantings are cultivated and there is no evidence of chemically treated landscaping. None of the trash viewed on site was commercial or industrial in nature. All would be considered household rubbish and non-impacting to any environmental condition for this report.

There are signs of mechanical maintenance from trash pickup and loose debris removal, but very little else has been seen at the site to indicate updates to parking areas, public access walkway or any recreational areas.

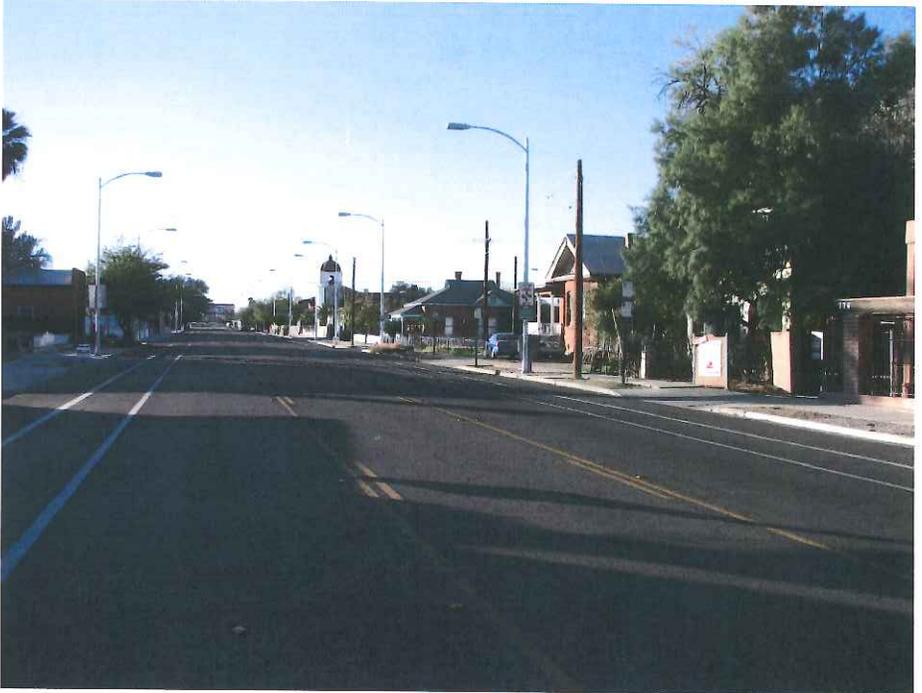
The subject is generally surrounded by professional offices, residential services and residential rental and owner occupied housing.. In the picture at right is a view from the street in front of the subject.

It was noted in reviews this area has diverse uses permitted, however; manufacturing and industrial uses would be considered nonconforming. The highest and best use according to City of Tucson Planning would be residential development. All of the current uses and developments are in conformance with city code.

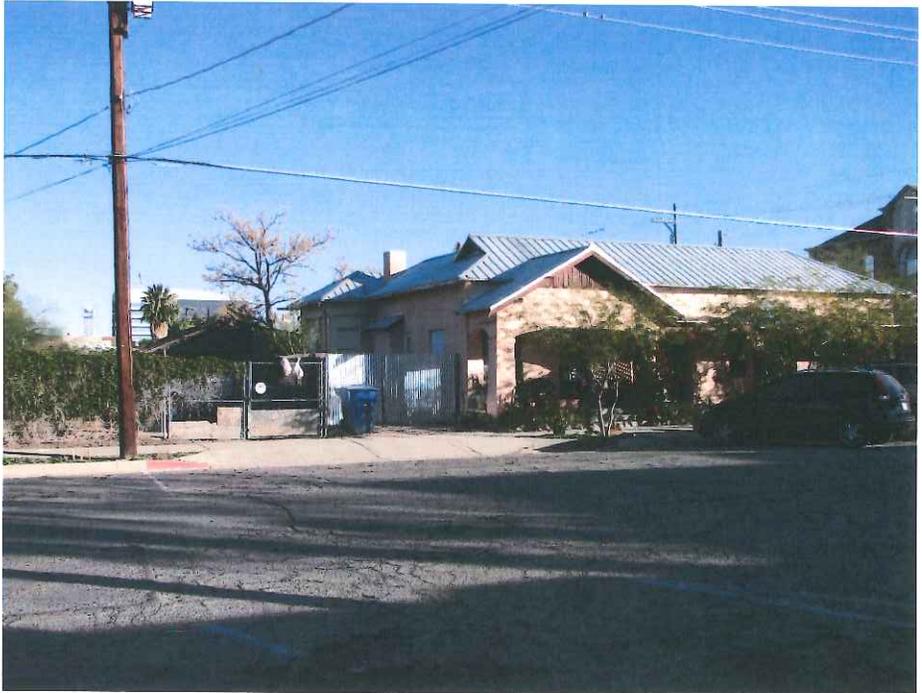
Typical of the area and adjoining the subject is single family residential housing and multifamily rental housing. Generally the streets in this area are residential access locations and prohibit through traffic heavy trucks.

The view at right is a view to the North on Stone Avenue standing in front of the Motor Lodge. This is representative of both the development in the area and the condition/style of the common development. This view would be considered looking to City of Tucson town center. As might be expected more business and more high-rise development can be noted moving further north.

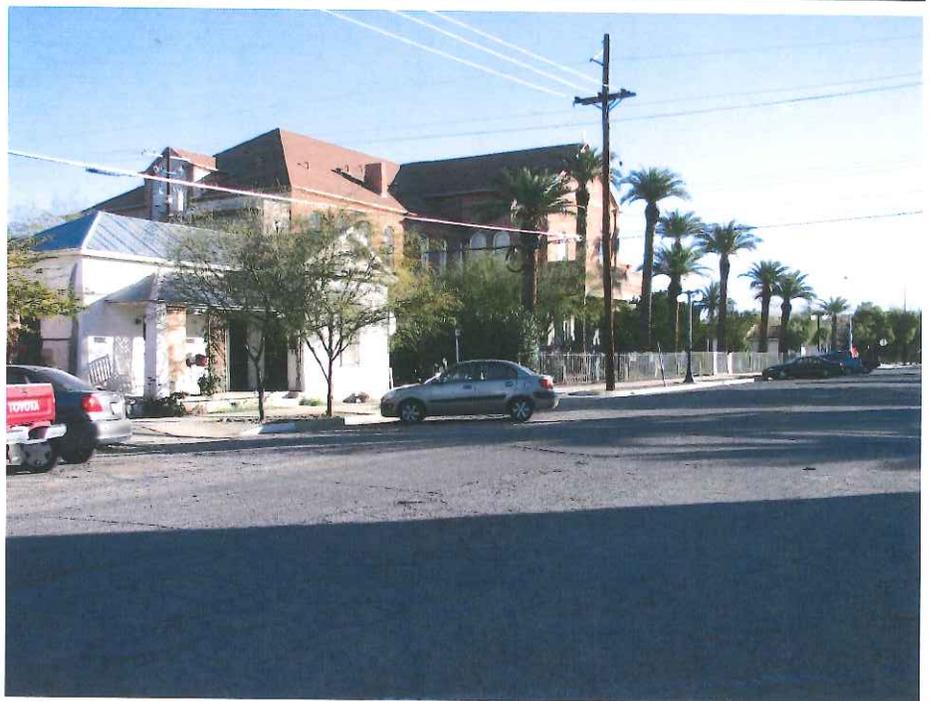
All adjoining uses are well defined lots and within many cases a zero lot line setback. Adjoining and on site reviews for any evidence of adverse environmental effects did not reveal any hazardous effect. Records searches for all of the adjoining properties were conducted for storage of volatile chemicals or medical waste disposal and none of the adjacent developments have any known adverse environmental effects (currently or historically).

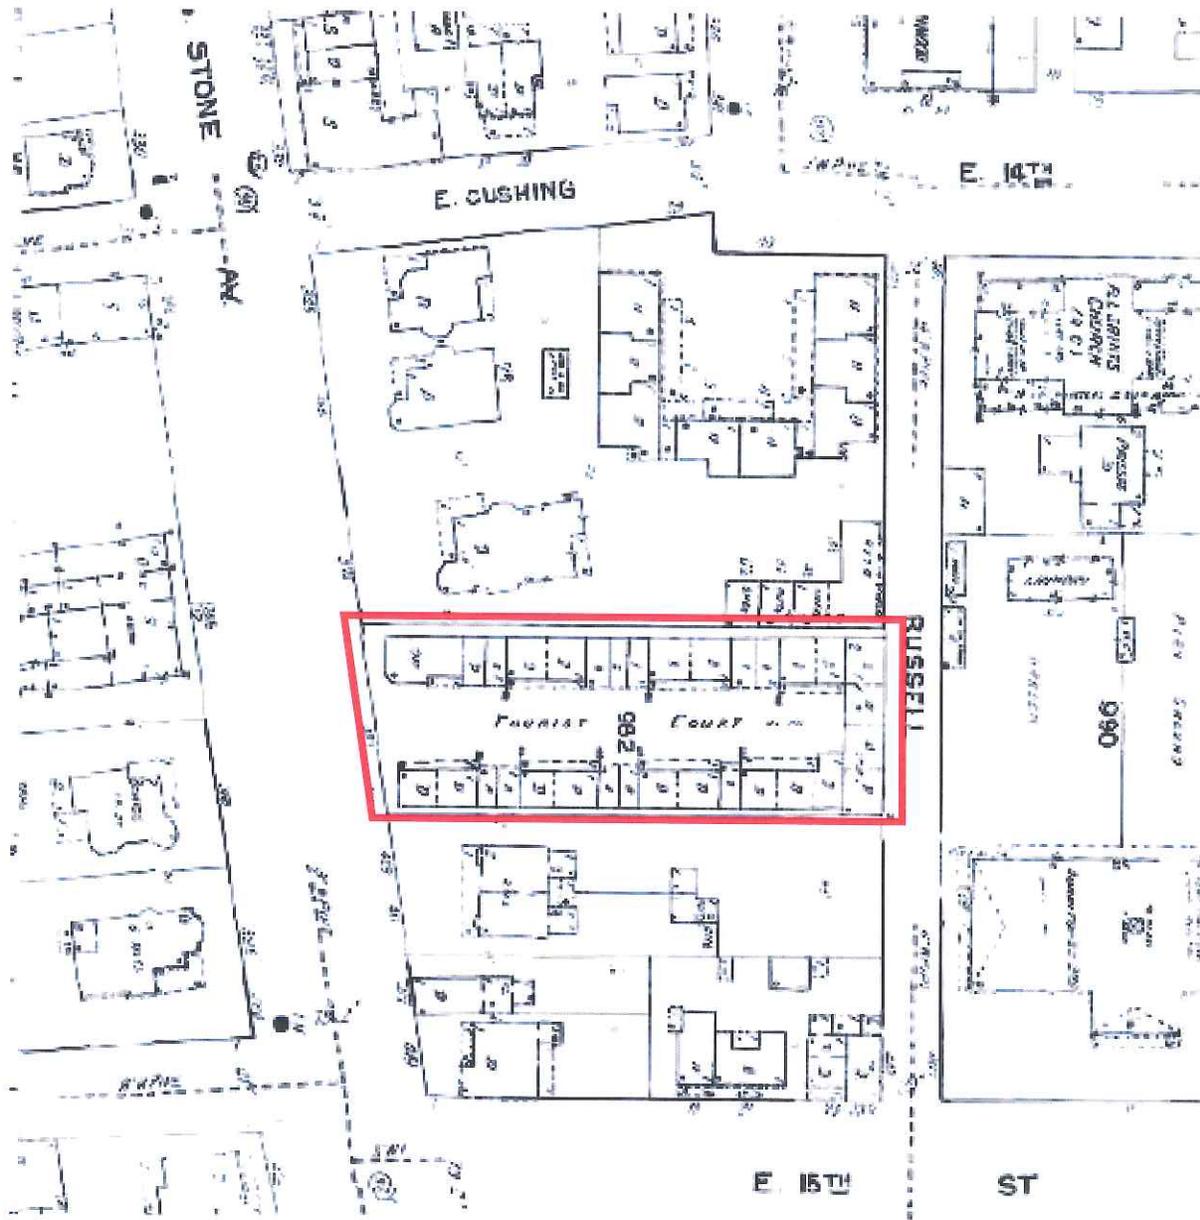
Site Name: Stone Motor Hotel  
 Address: 383 South Stone Avenue  
 City, ST, ZIP: Tucson AZ 85701  
 Client: Cam Sensa  
 EDR Inquiry: 3926630.3  
 Order Date: 1/14/2014 8:33:00 AM  
 Certification #: 655E-45B1-8301  
 Copyright: 1947

Our subject consisted of large vacant lot fronting on Stone Avenue with 2 single family residential units set at the back of the lot. This was the use in 1901.

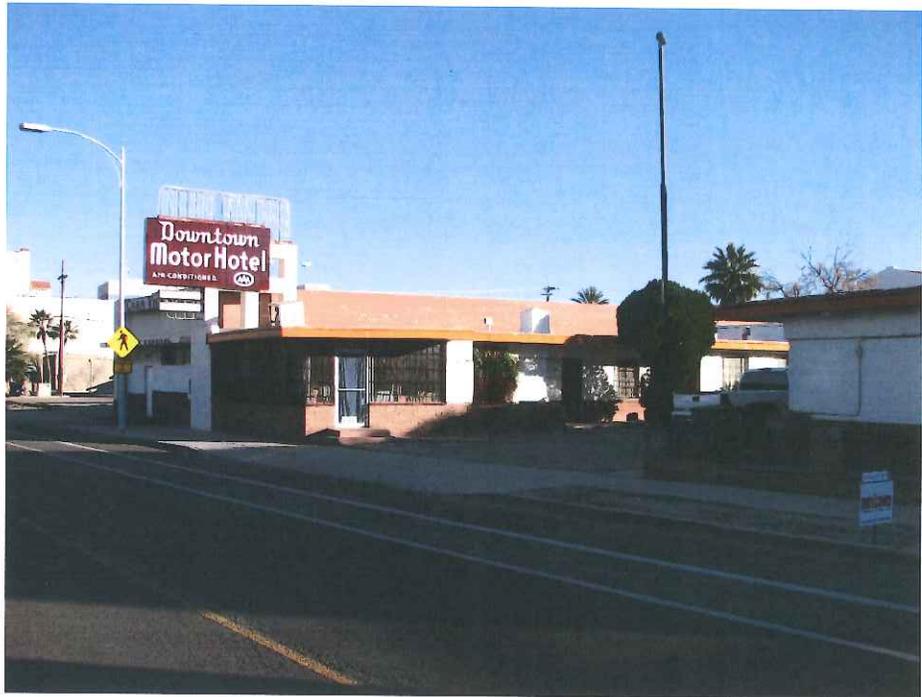
On November 11, 13 and 20, 2014 and follow up reviews for environmental assessment December 29, 2014, January 21, 2015 and most recently on April 24, 2015 by CSI personnel who conducted site specific inspections of the subject property and surrounding sites to assess the presence of visible, potentially adverse environmental conditions as part of this Phase I ESA. In the picture at right is a typical view of the entry access to the residentially developed area of the subject and typical of the fully developed grounds at the subject.

During the survey, observations were recorded and photographs obtained to clearly demonstrate the existing condition of the subject property as well as surrounding and adjacent areas. Soil was inspected for areas which were found to be loose, mounded or soils stained with any hidden problems or chemical contaminants. The soil was probed to 3 feet where loose or mounded soil was discovered or soft depressions were found such as the depression in the photo at right.

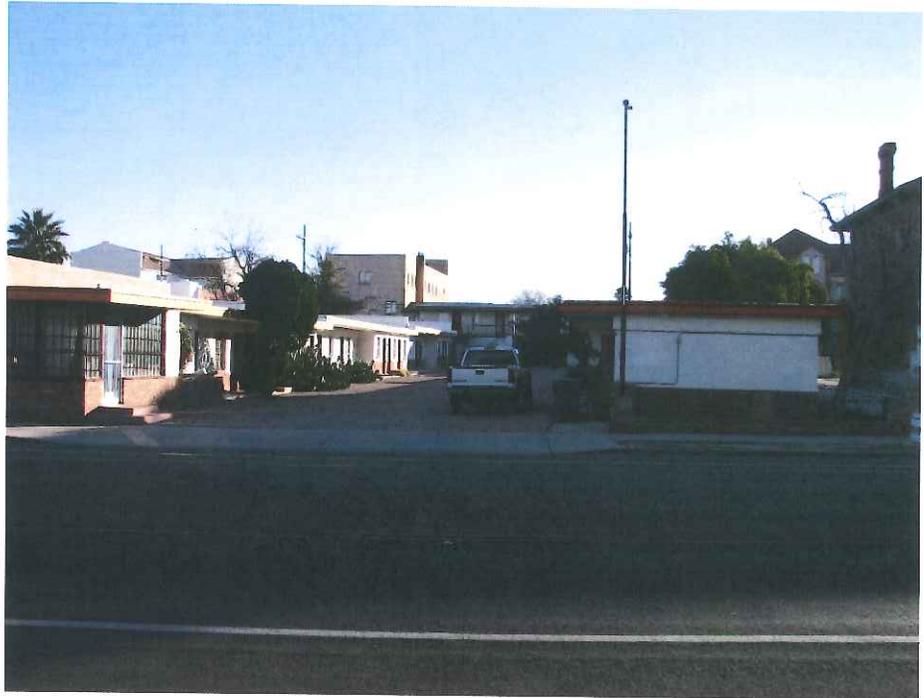
During the survey, observations were recorded and photographs obtained to clearly demonstrate the existing condition of the subject property as well as surrounding and adjacent areas. Soil was inspected for areas which were found to be loose, mounded or soils stained with any hidden problems or chemical contaminants. There were virtually no areas that were not paved other than designed beds for plants adjacent to existing structures. The soil was probed where loose or mounded soil was discovered or soft depressions were found, but none of the suspect areas were of any consequence and completely solid (no hidden trash or debris). No significant rubbish was found on the site and no chemically induced vegetation controls were seen on the site.

The developed commercial residential site has only basic amenities with rock walls, side walks and curb and gutter. The intended commercial residential use of the building has been abandoned for more than a few years.

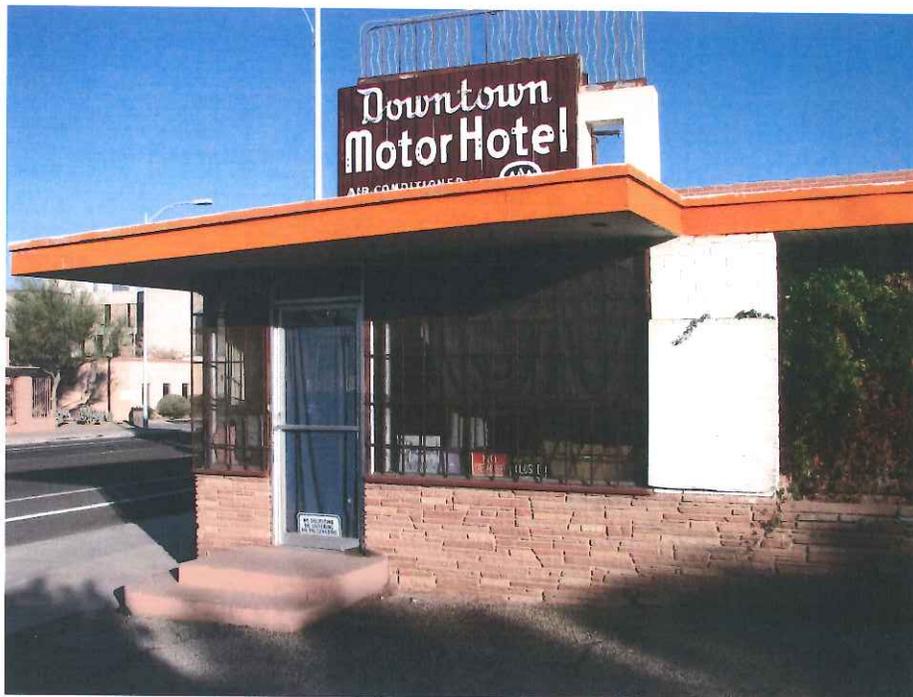
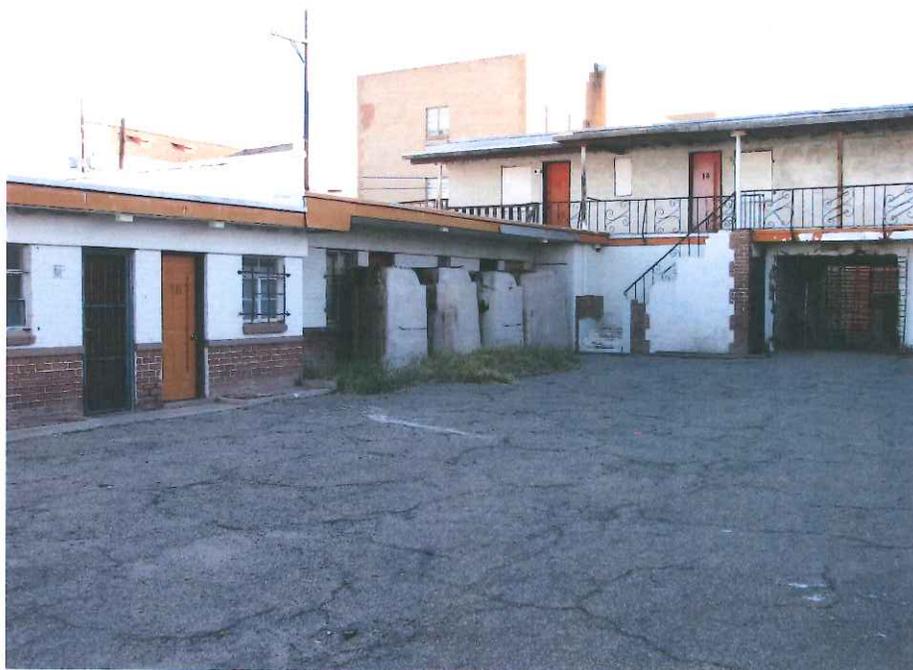
The designated parking areas at the site were studied for excess petroleum products and abandoned vehicles. No abandoned vehicles were noted and traffic areas showed no petroleum product run-off of any kind. Site research confirmed no citations or registrations of an environmental concern were associated with this property. Police records from 2009 to date indicate there have been 3 abandoned vehicle removals from the site in that time to date and none were registered as an environmental

nuisance or fire hazards. All aspects of the subject were considered secured, orderly and modestly maintained around the developed commercial residential buildings. There was no evidence of any potential of adverse environmental impact.

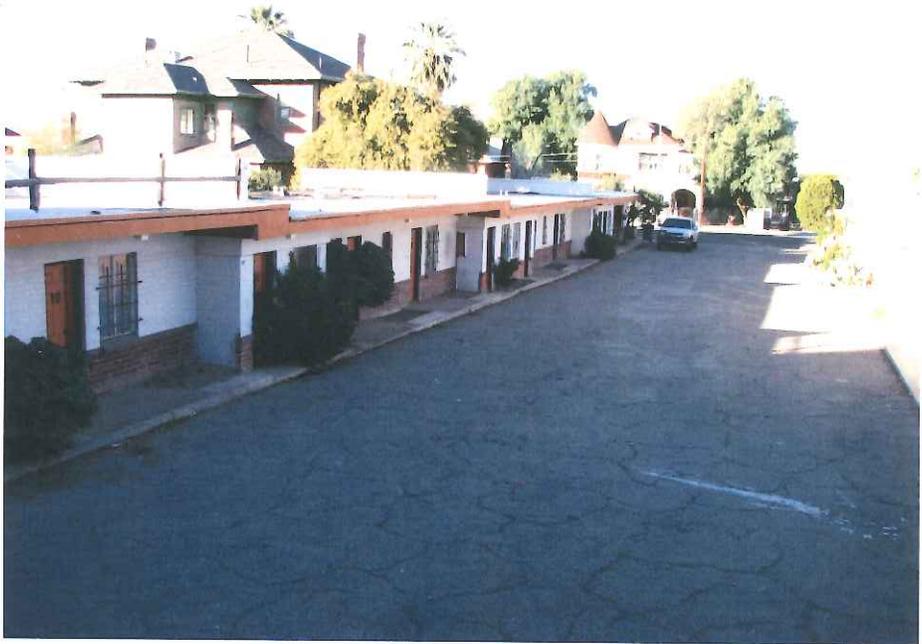
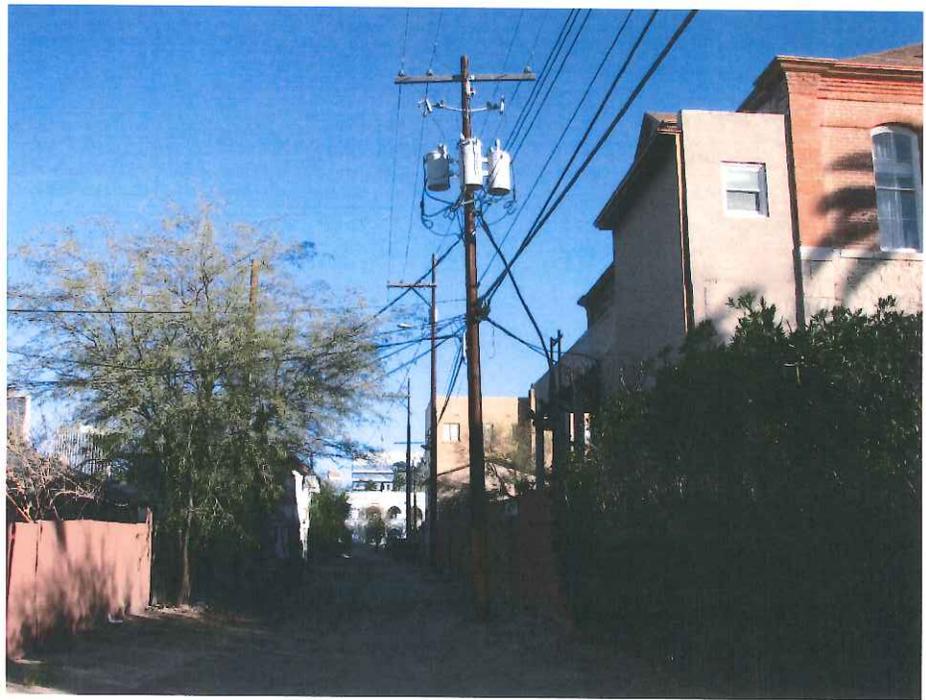
Arizona Department of Environmental Protection (ADEQ) has no records of operational transformers that are known to remain in the this area of Tucson that contain polychlorinated biphenyl compounds (PCB). Transformers were examined for any staining in units including nearby neighborhoods and all transformer units seen within 1 mile of the subject appear new or are stamped

with a date of 2008 or later. The picture at right is a view down the alleyway adjoining the subject and forming the Eastern boundary to the property . Utility right-of-way does no does not adjoin the subject but is about 30 feet further east.

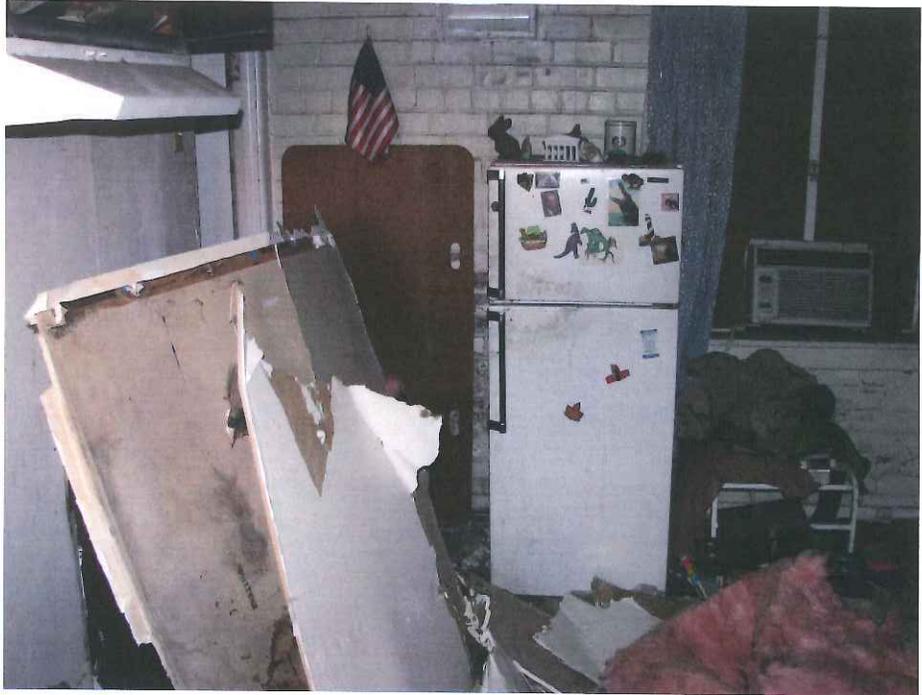
the entire complex could be considered as storage. In this regard our review was specific to any potentially hazardous material storage. Focus was made for all bulk storage materials. The room storage at right was typical of all units. Although in disuse we found typical residential storage of standard paper products and dry goods. Storage in all areas was examined. And no areas were off-limits to our interior conditions assessment on November 11, 2014.

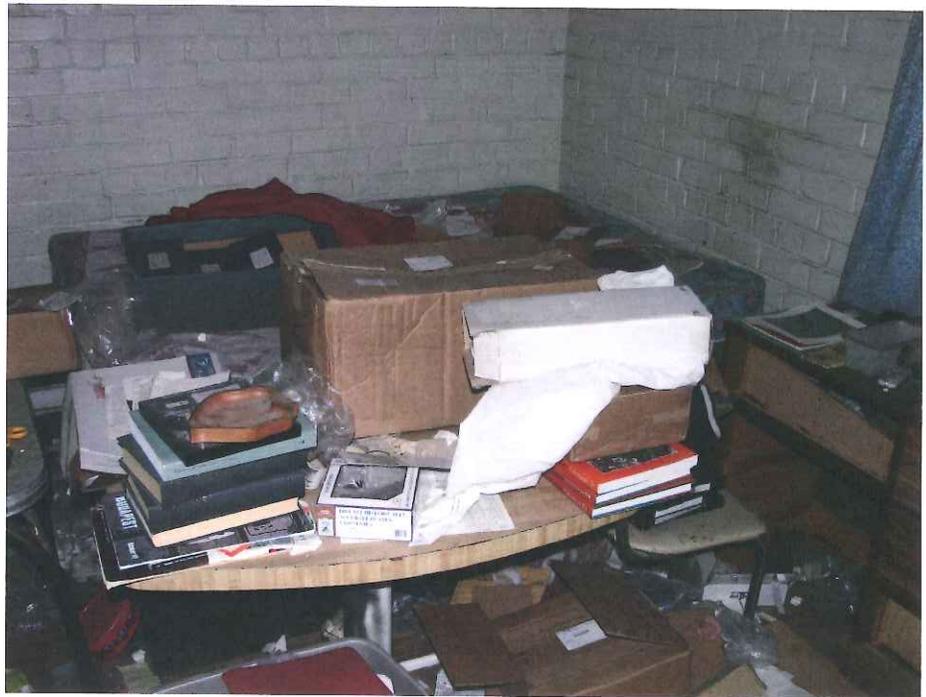
On-site storage discoveries can all be characterized as dry goods, abandoned mechanical and some electronic items.

A theme noted as repeating in all of the units was a mix of boxed storage and scattered material from prior use.

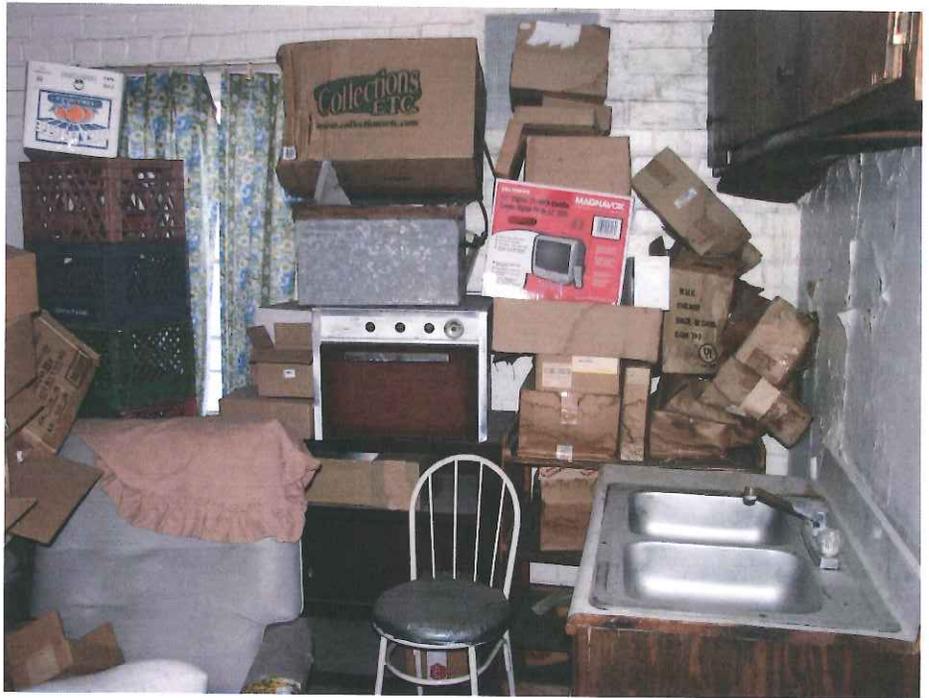
Even the on site manager/security apartment had marginal facilities for habitation.

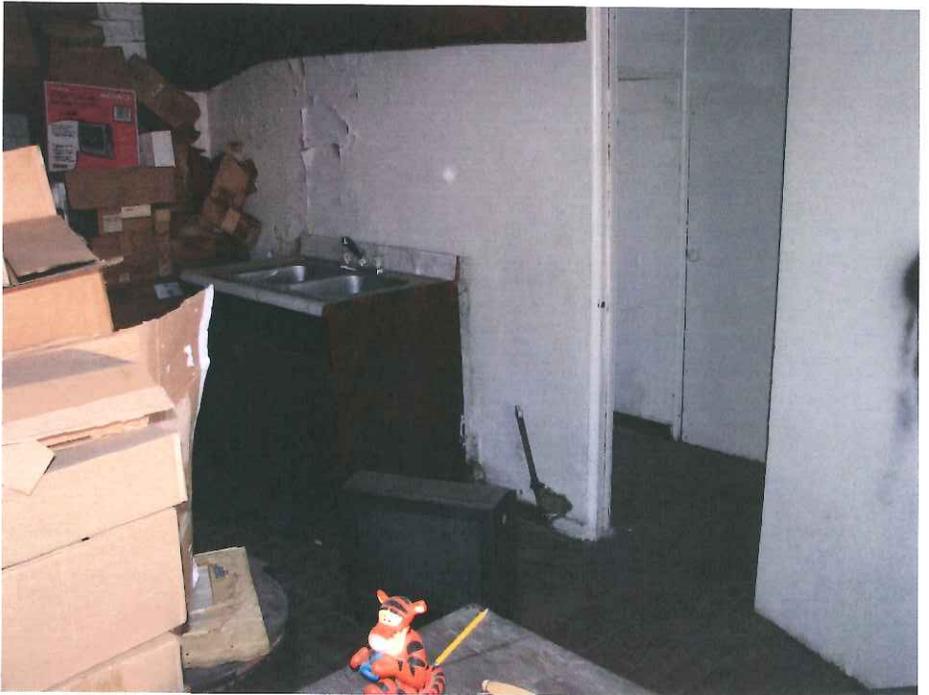
General chemical storage needs were seen in apartments for small 1 gallon latex paint products, and some smaller containers a powerful cleaning agents such as turpentine and rubbing alcohol. There was no bulk storage of any kind found at the site.

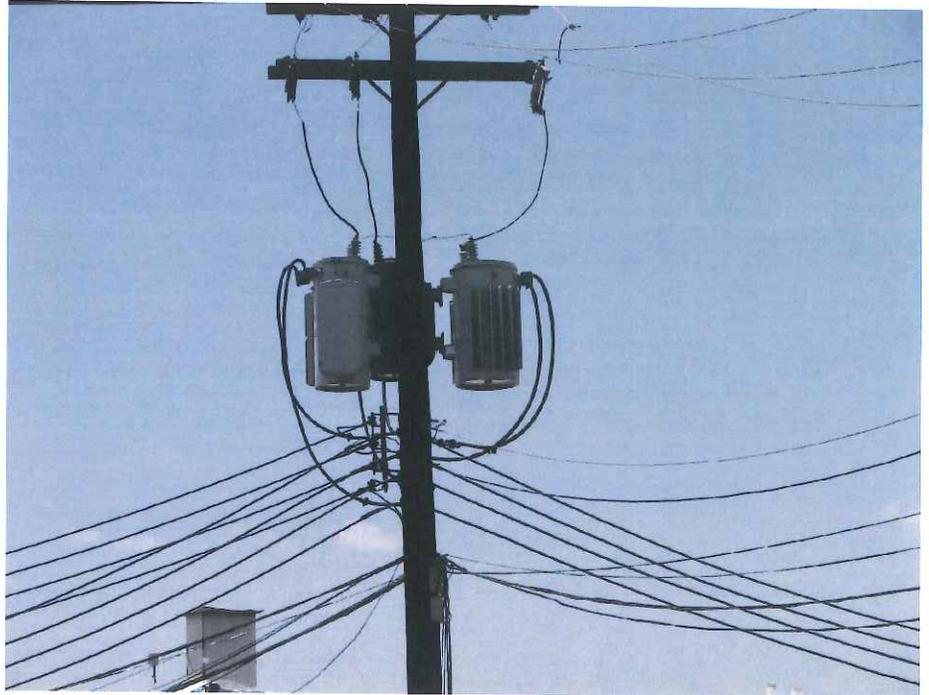
The area transmission is residential voltages (approximately less than 240 KV) and not high voltage regulators. Regulators like the one servicing the site and pictured in the photo above contain no PCB's.

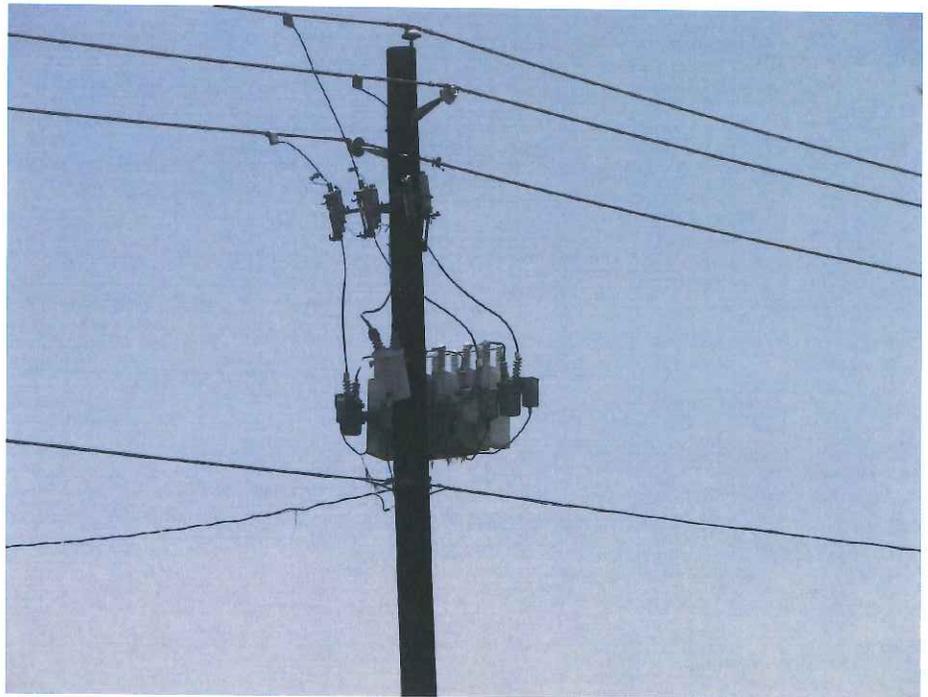
More typical of area transmission units are the transistorized updates seen in the area as pictured at right. Again these units do not contain any PCB's which is our environmental concern.
