## Phase I Environmental Site Assessment

**Pennington Triangle Property  
APN 117-06-083A  
126 North 6th Avenue  
Tucson, Arizona**

December 3, 2008  
AAI Date: November 5, 2008  
File No. 10207028.05

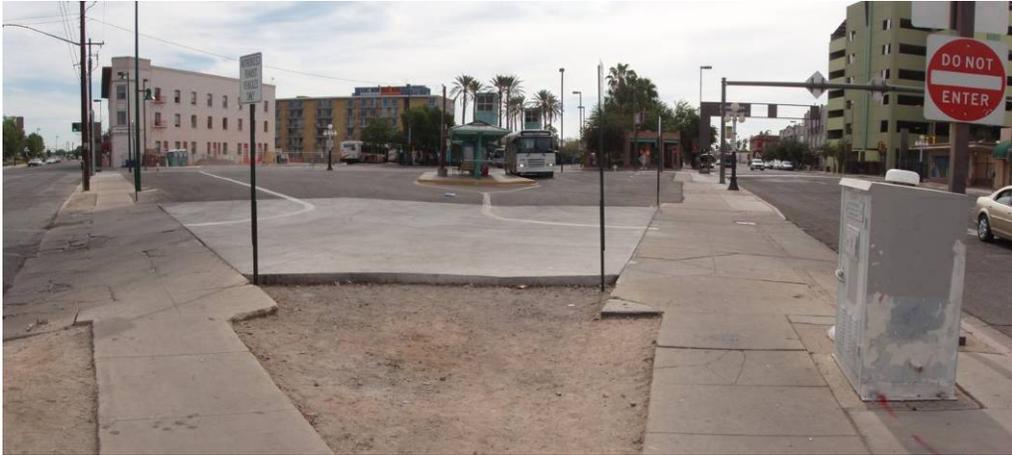
North portion of the site; view to the southeast.

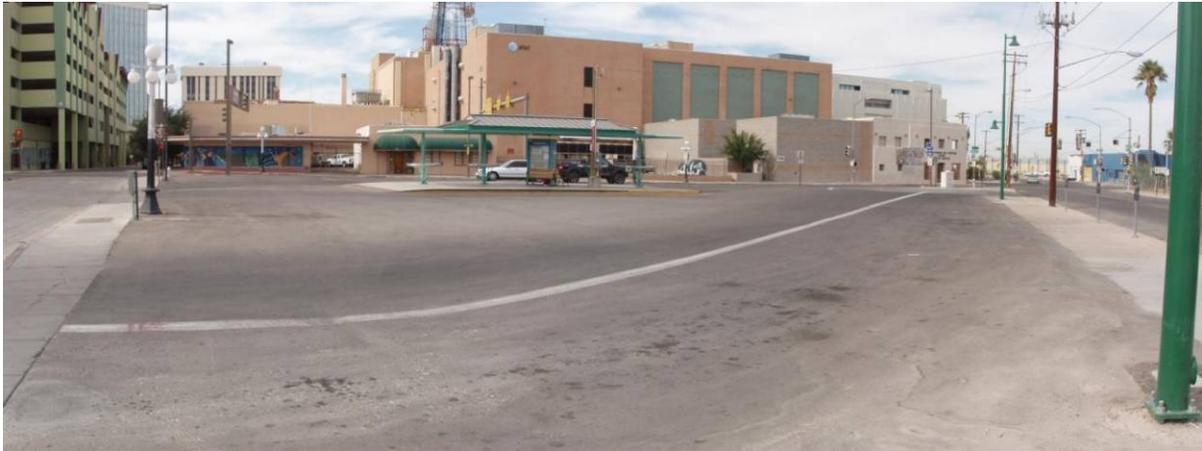
Southeast portion of the site; view to the northwest.

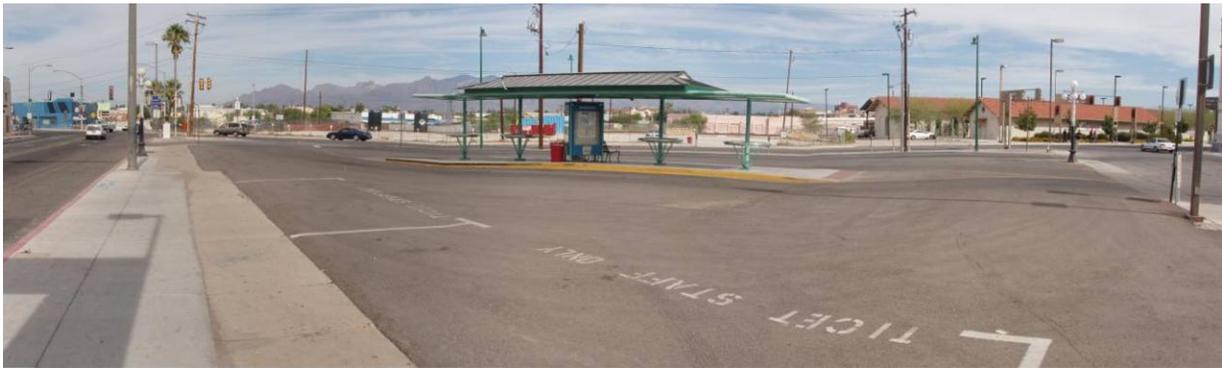
Southwest portion of the site; view to the northeast.

- An exploratory excavation should be performed in the vicinity of the geophysical anomaly in the southwest portion of the site in the area of the former service station in order to identify the source of the anomaly. If USTs are found, they should be removed and a closure investigation should be performed in accordance with ADEQ requirements. Anomalies were not identified in the north portion of the site where the other service station was located; therefore, no exploratory excavations are recommended for this area.

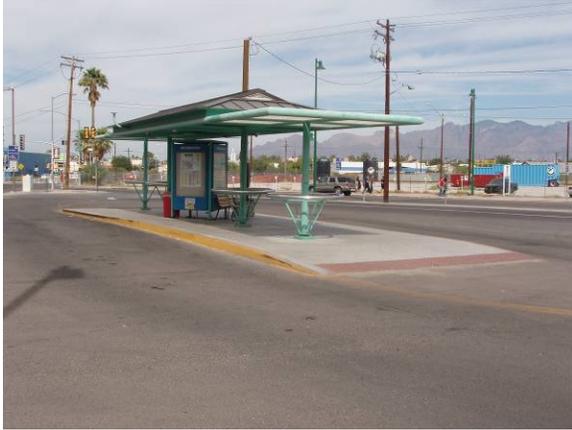
No stains or corrosion were observed under the bus shelter canopy in the central portion of the site.

Canopy bus shelter in the central portion of the site; view to the north.

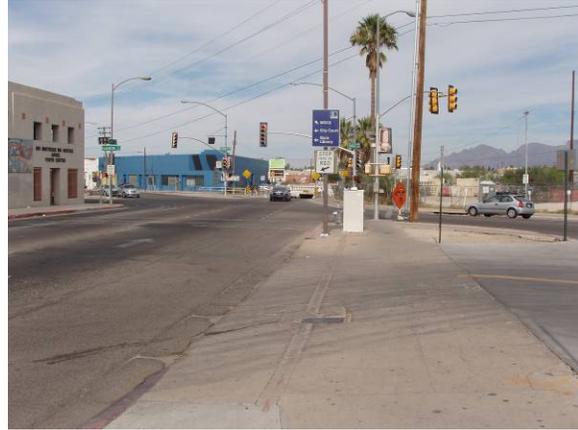
Intersection of 6<sup>th</sup> Avenue, Alameda Street, and Toole Avenue northwest of the site; view to the north.

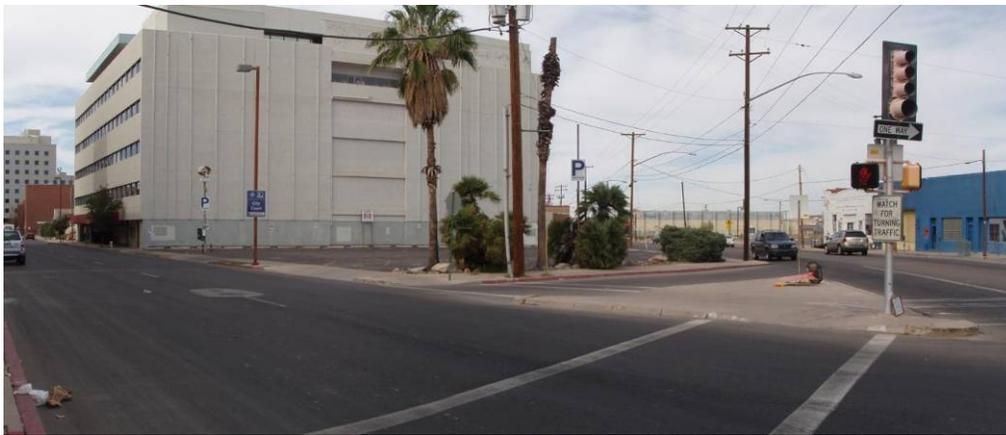
Traffic island and City Hall parking lot northwest of the site; view to the northwest.

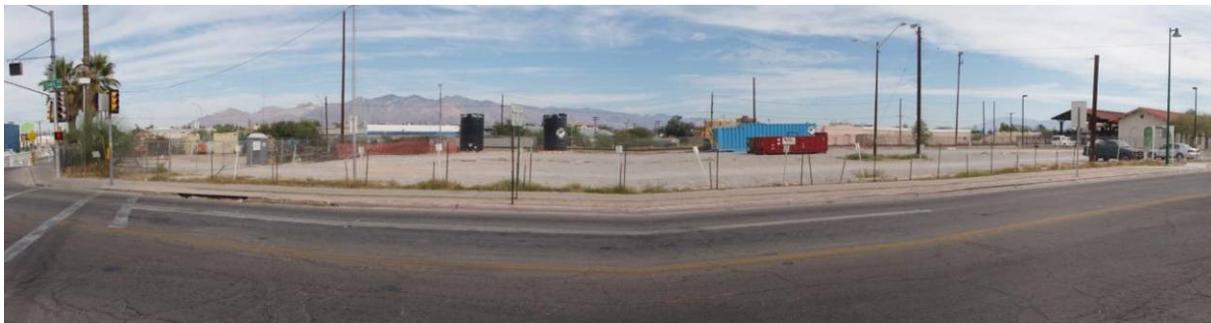
A storage area and a parking lot adjoining the site to the north, northeast, and east, east of Toole Avenue; view to the northeast. Rain For Rent storage containers are visible on the east side of the parking lot in the central portion of the photograph.

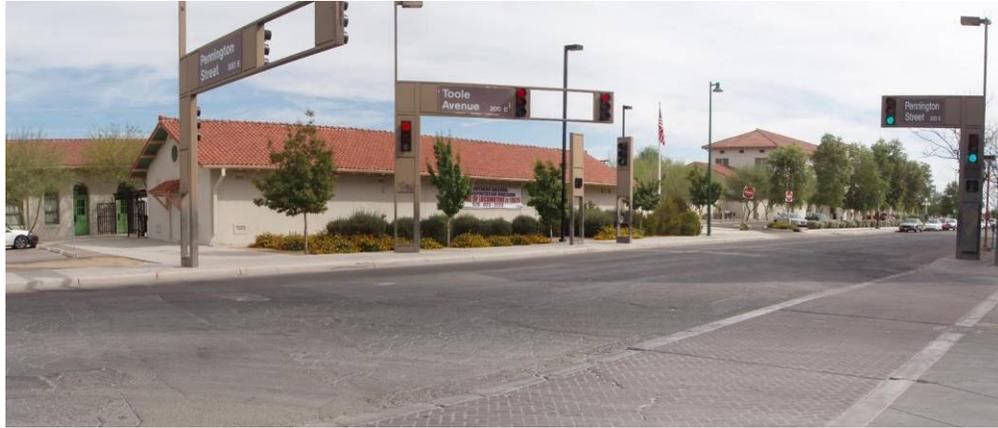
The Southwest Train Museum, shops, and historic Depot southeast of the site, southeast of the intersection of Pennington Street and Toole Avenue; view to the southeast.

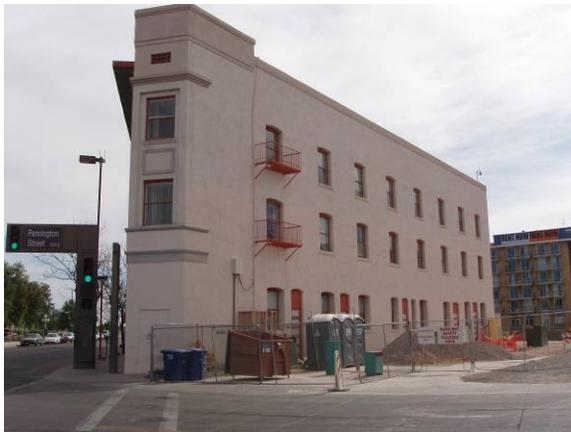
MacArthur Building (offices) south of the site, south of Pennington Street; view to the south.

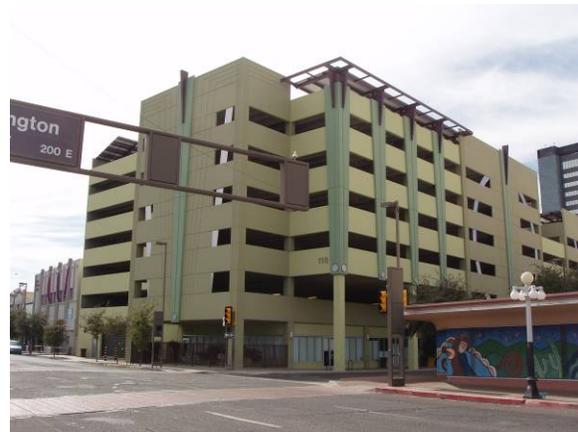
Parking garage, offices, and restaurant southwest of the site, southwest of the intersection of Pennington Street and 6<sup>th</sup> Avenue; view to the southwest.

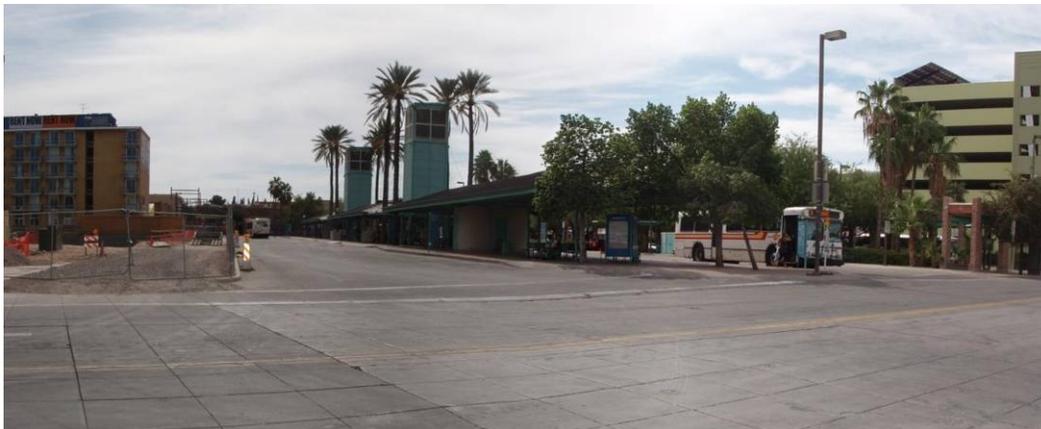
Ronstadt Transit Center (municipal bus terminal) south of the site, south of Pennington Street; view to the southwest. The entrance for a construction project south of the MacArthur Building and east of the Ronstadt Transit Center is on the left side of the photograph.

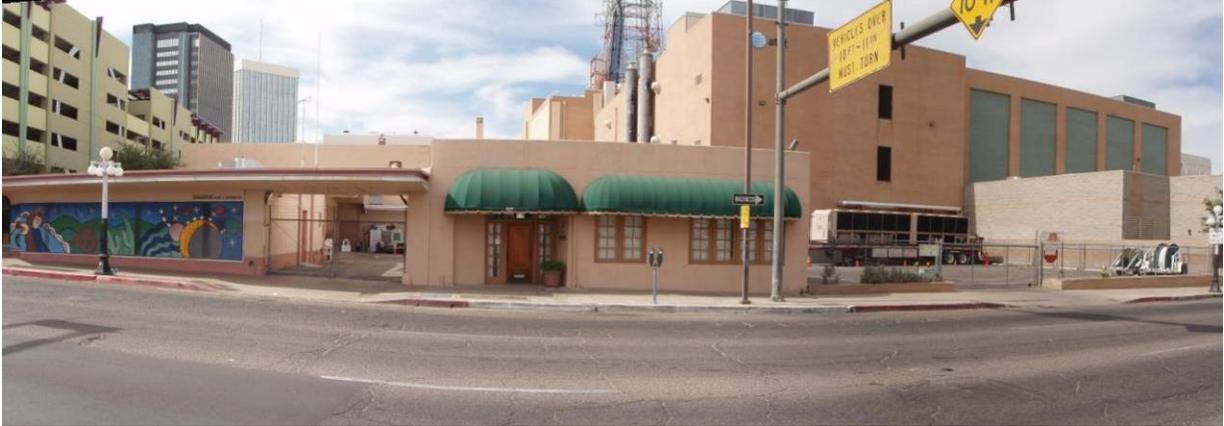
Adjoining the site to the west, west of 6<sup>th</sup> Avenue, was an unmarked building on the left (Qwest vehicles in the parking lot to the right of the building), Alpha Engineering in center, and a parking lot to the right (signs for telephone company vehicles only, AT&T, and US West); view to the west.

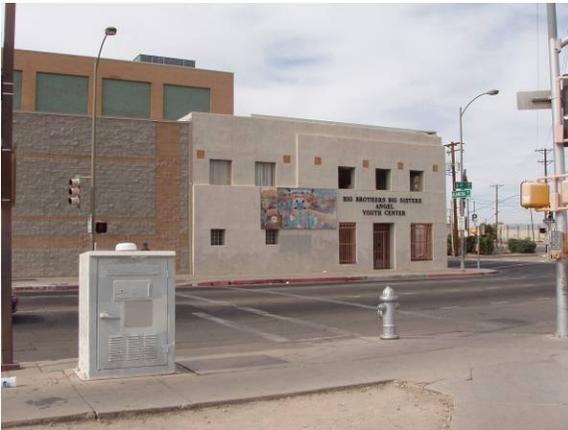
Big Brothers Big Sisters Angel Youth Center west of 6<sup>th</sup> Avenue, west and northwest of the site; view to the west.

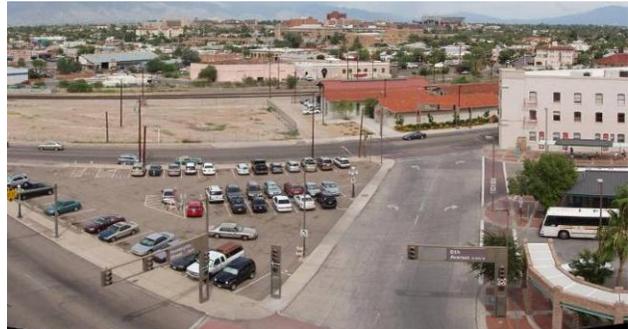
The site on August 20, 2006 (photograph was taken during a previous site assessment project for an adjoining property); view to the east.

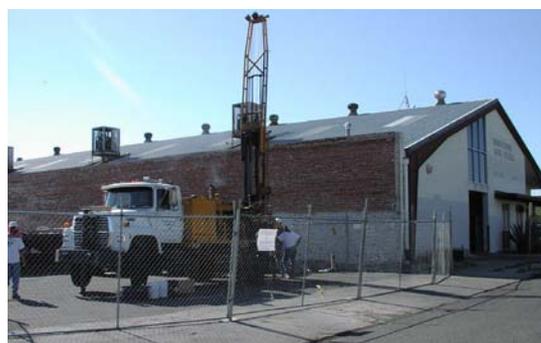
**Groundwater Monitor Well Being Installed  
near Historic Dry Cleaners**

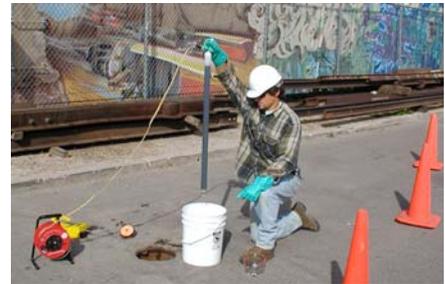
**Sampling at the Site from a Monitor Well**

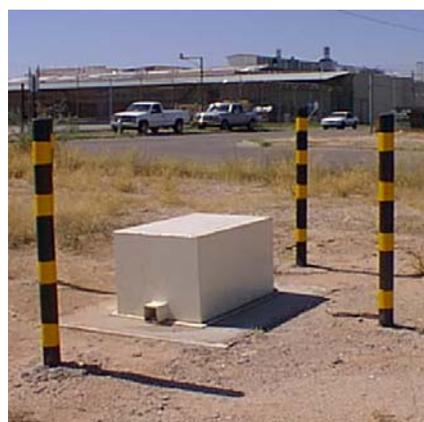
**Monitor Well at the Site near  
Historic Dry Cleaning Operations**

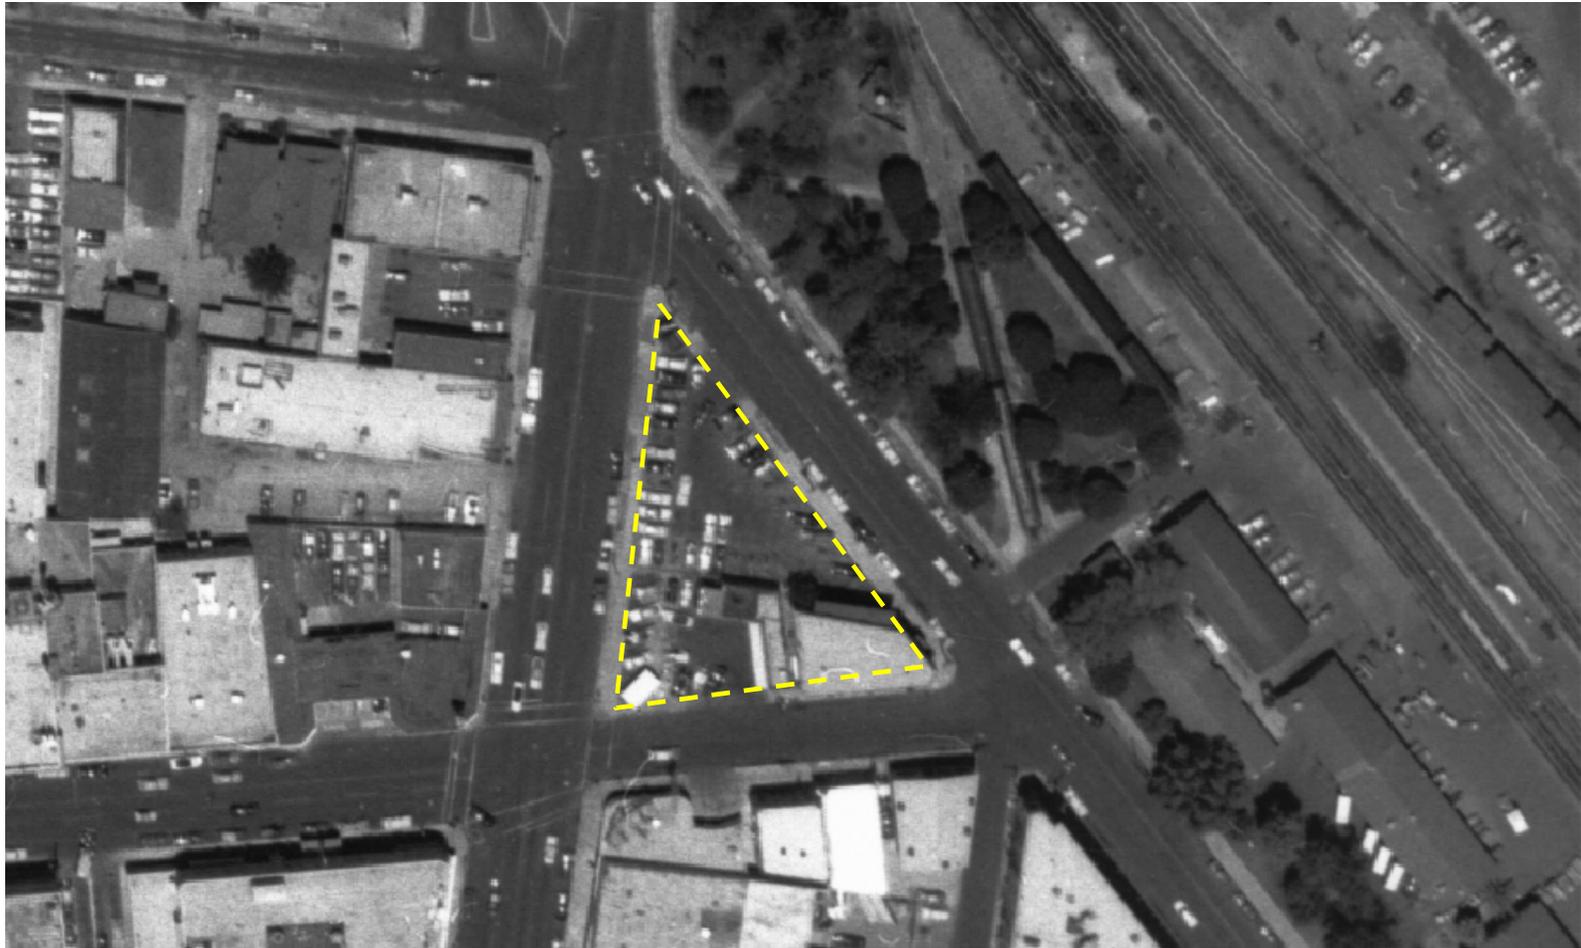
Source: Cooper Aerial Survey, 1953

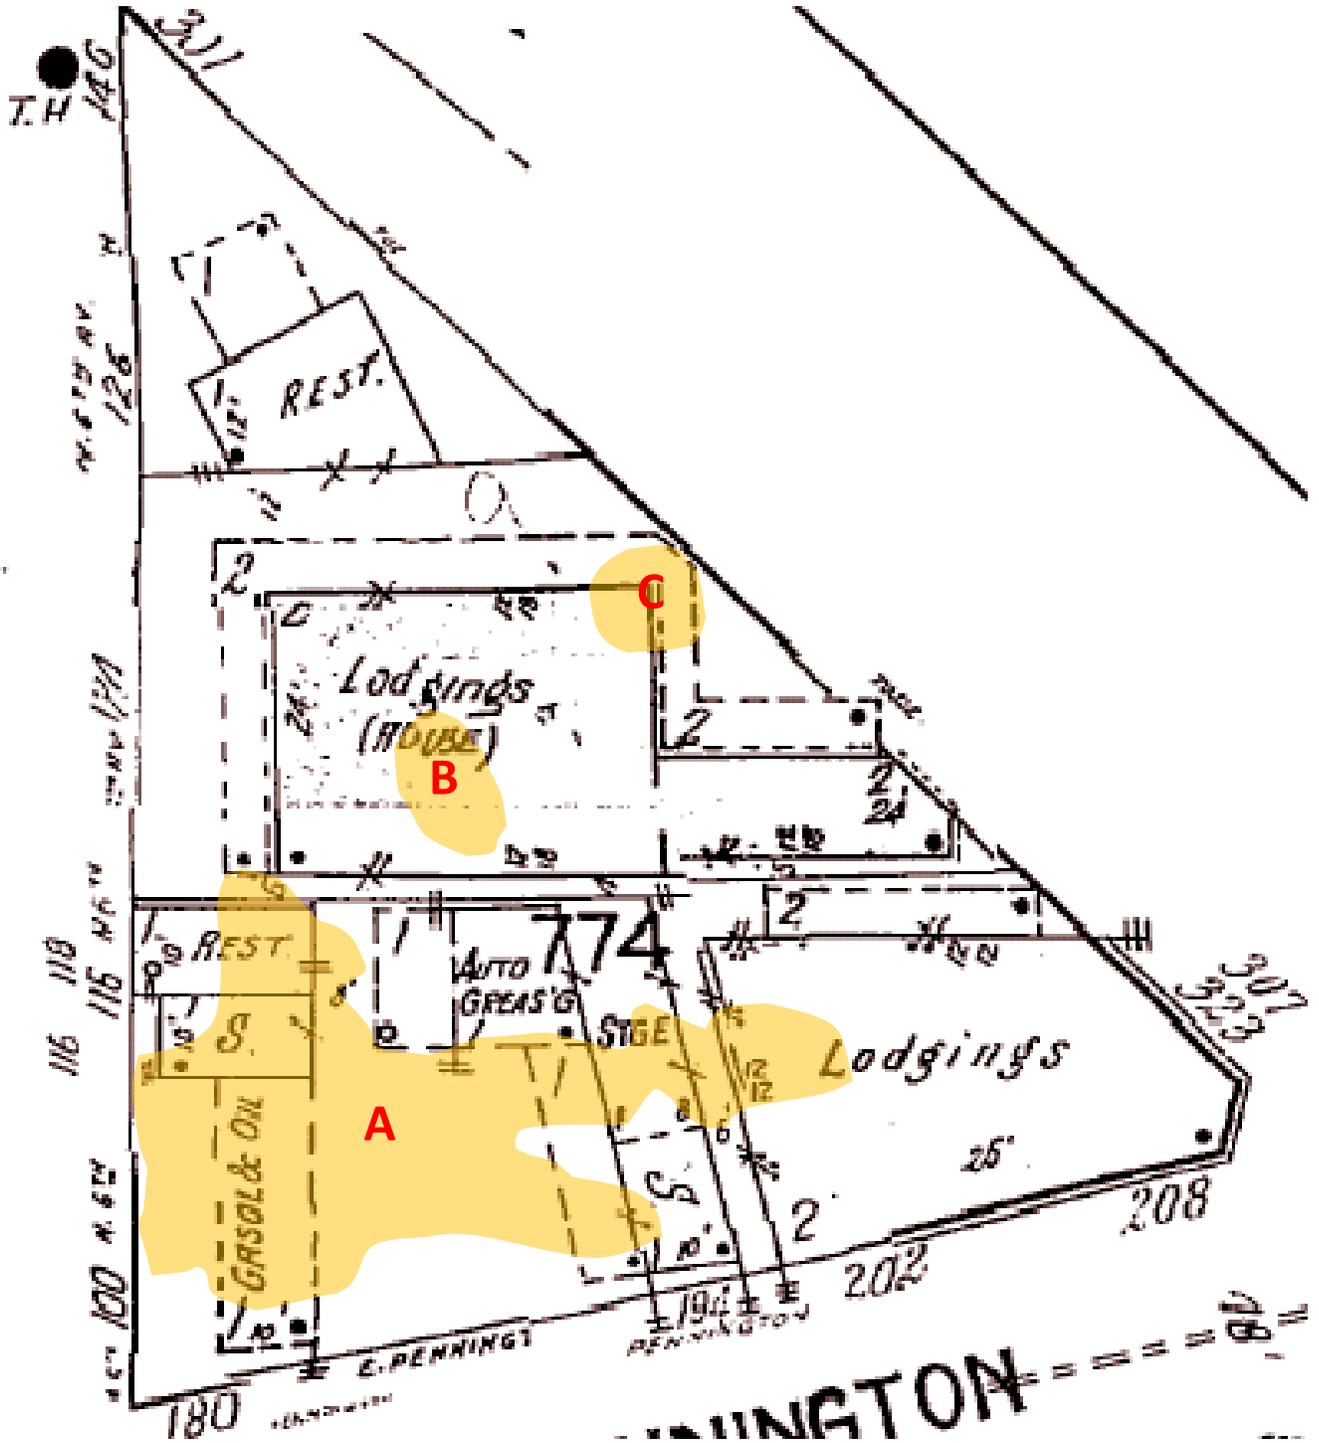
Overlay of anomalies identified in report by Zonge Engineering & Research Organization, Inc. (Zonge; included in *Final Report, Electromagnetic Surveys, Broadway Projects, Tucson, Arizona, May 5, 1997*) on the 1949 Sanborn map for the site area.

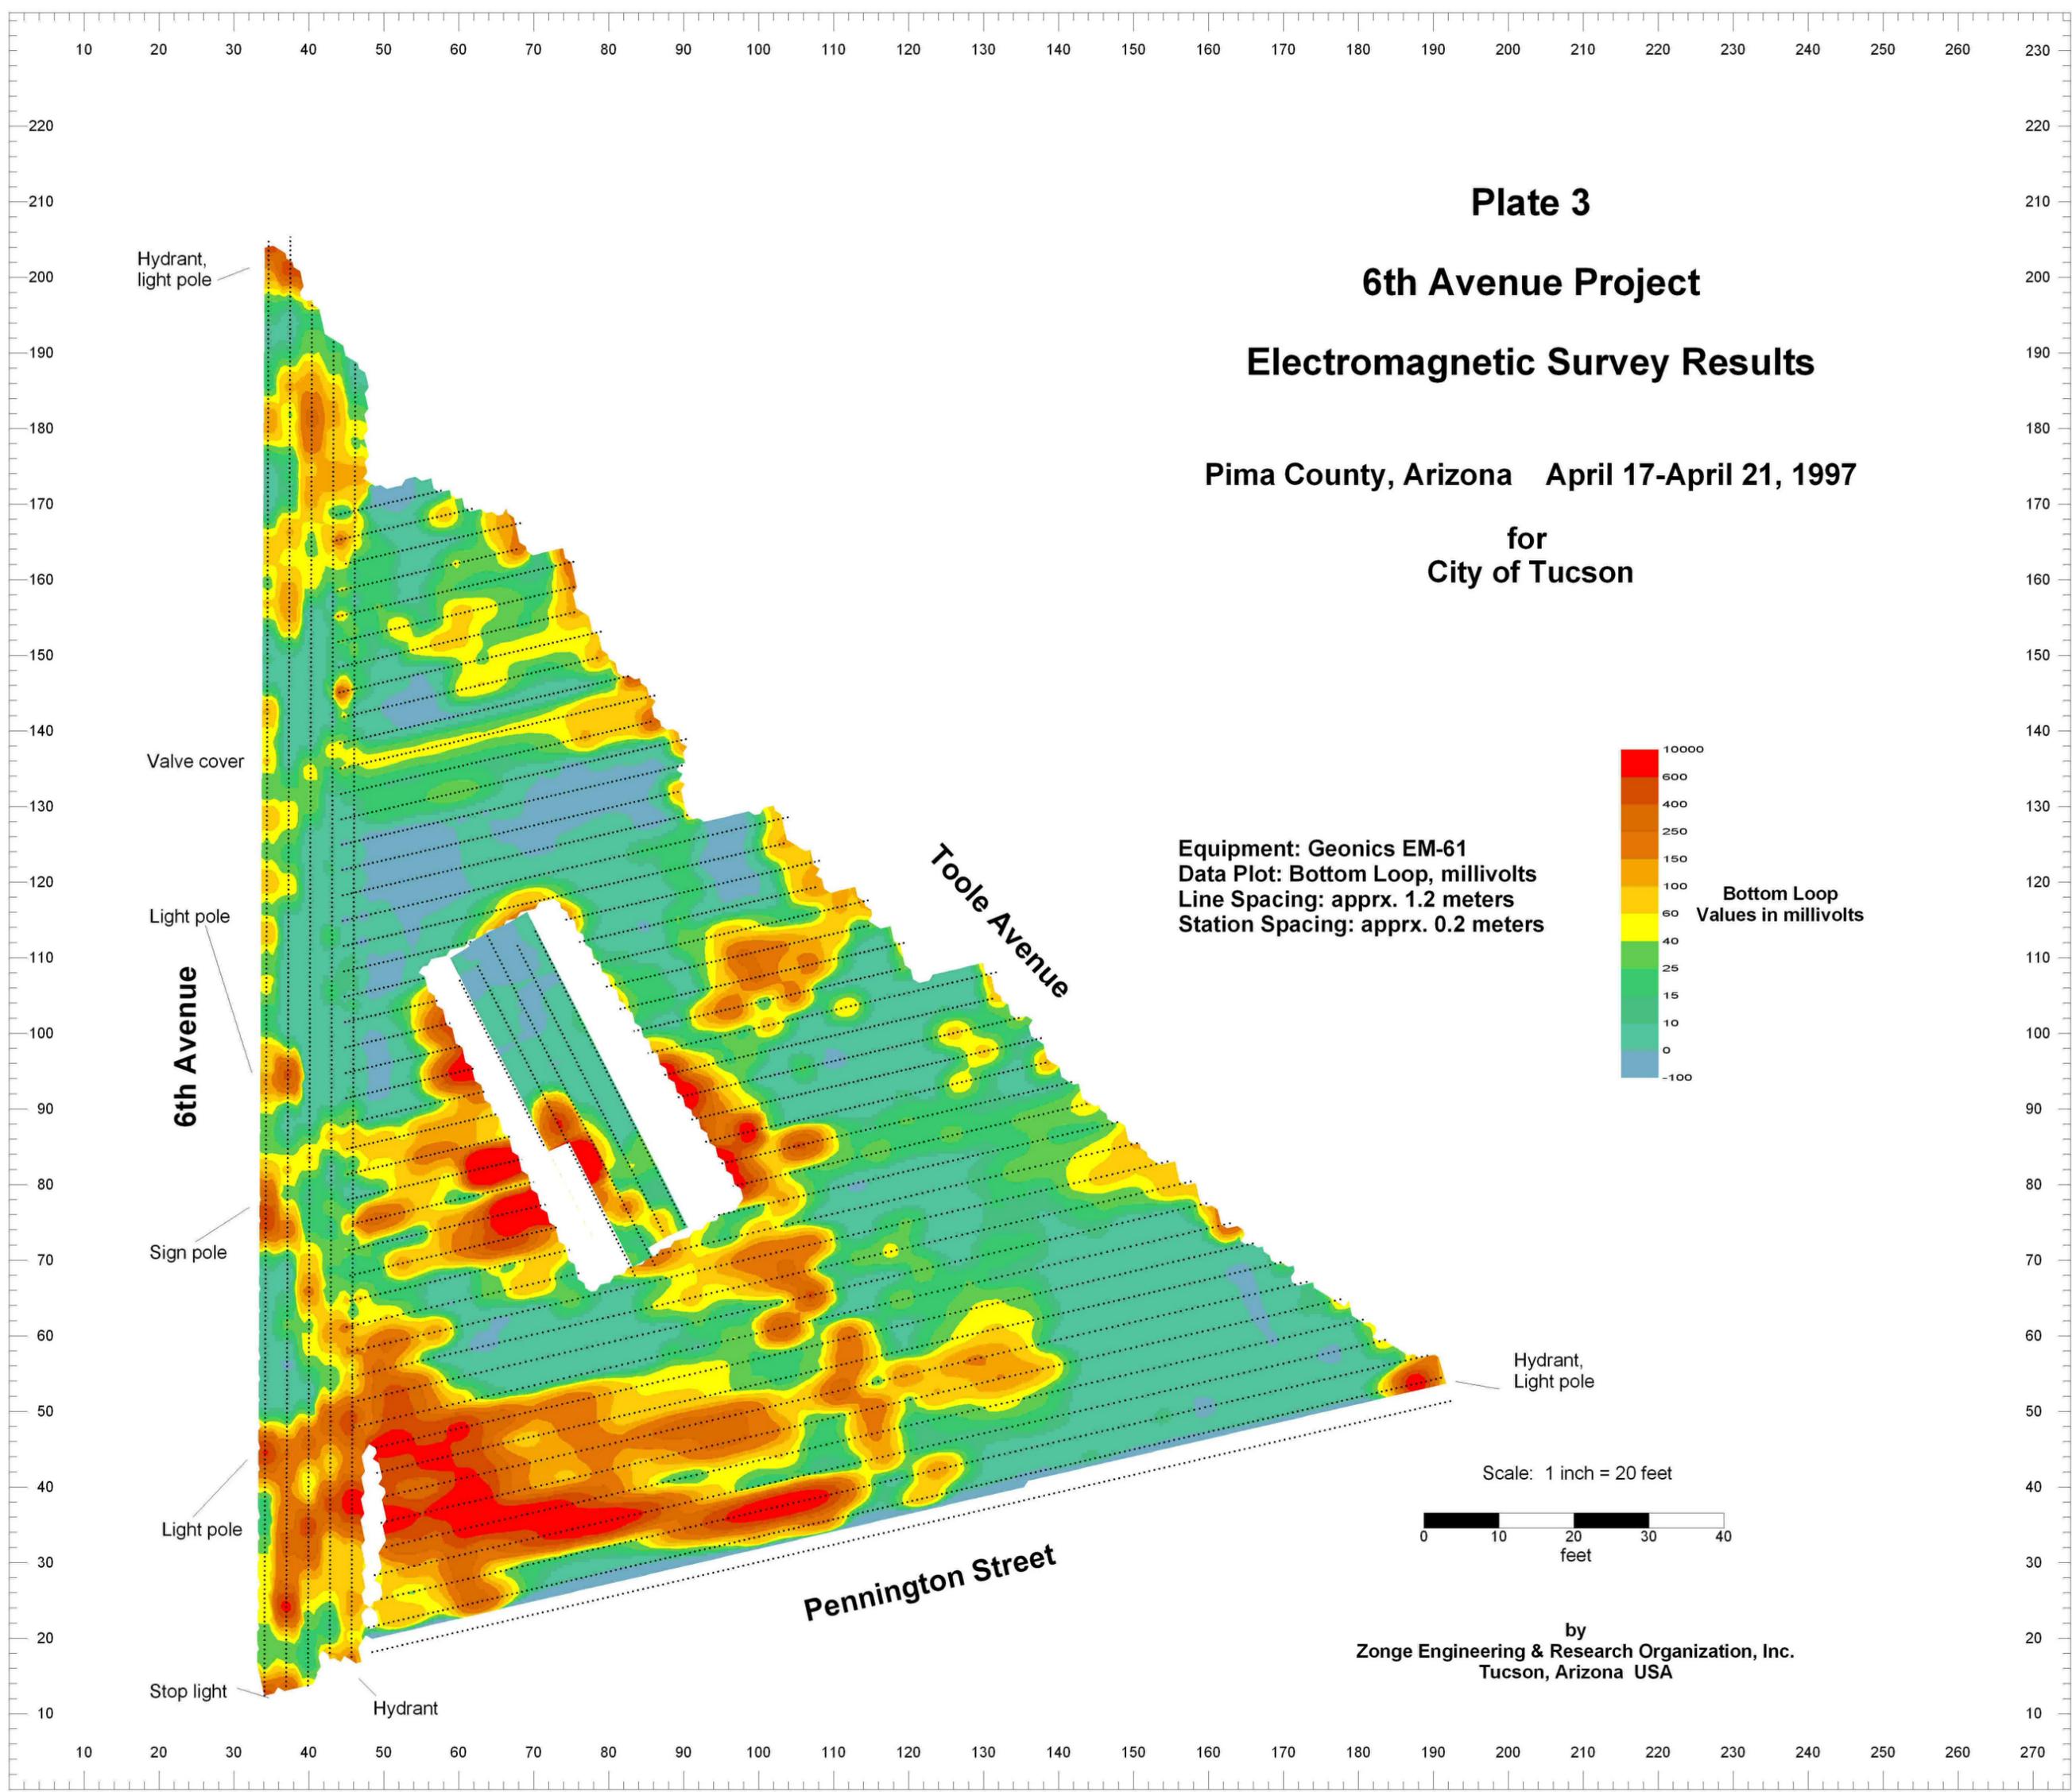
# Plate 3

Equipment: Geonics EM-61  
Data Plot: Bottom Loop, millivolts  
Line Spacing: appr. 1.2 meters  
Station Spacing: appr. 0.2 meters
