# ASLD Property

## Houghton Road and Valencia Road

# Environmental Resource Report

WLB No. 119019-A-001

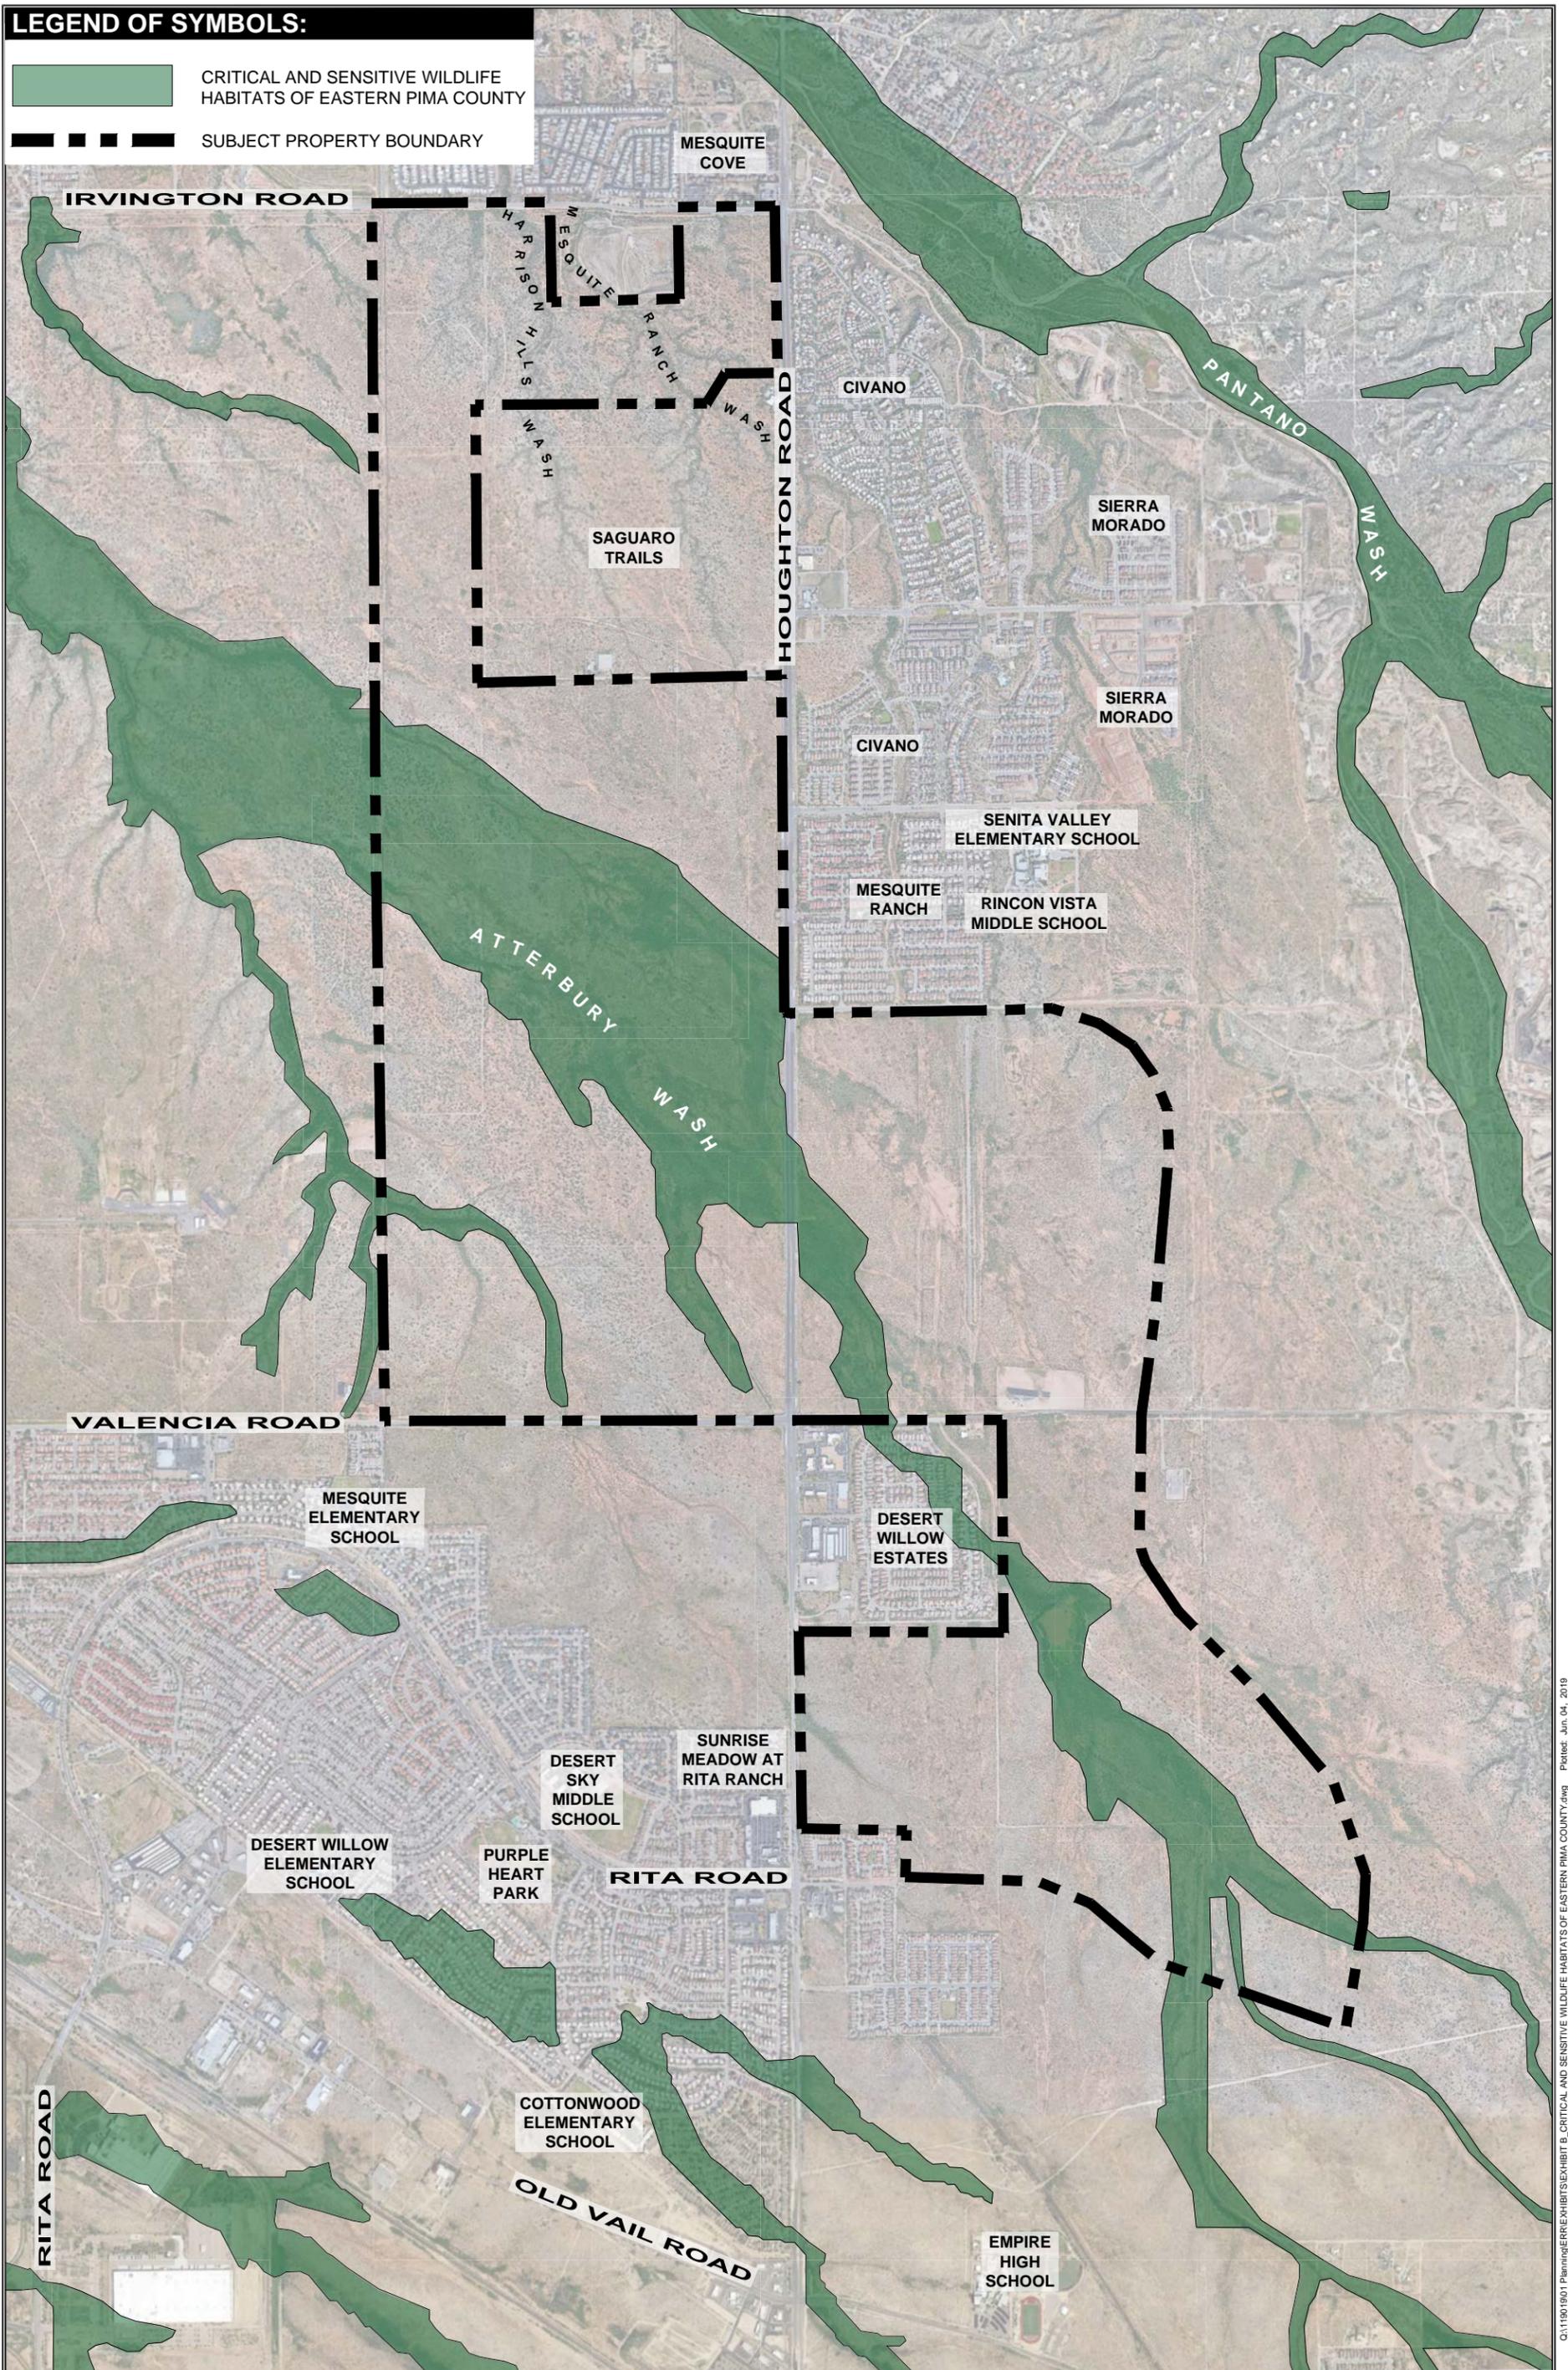
**Exhibit B: CRITICAL AND SENSITIVE WILDLIFE HABITATS OF EASTERN PIMA COUNTY**

Please refer to *Exhibit B: Critical and Sensitive Wildlife Habitats of Eastern Pima County* (Dr. William Shaw 1986) for the location of this environmental designation on the property.

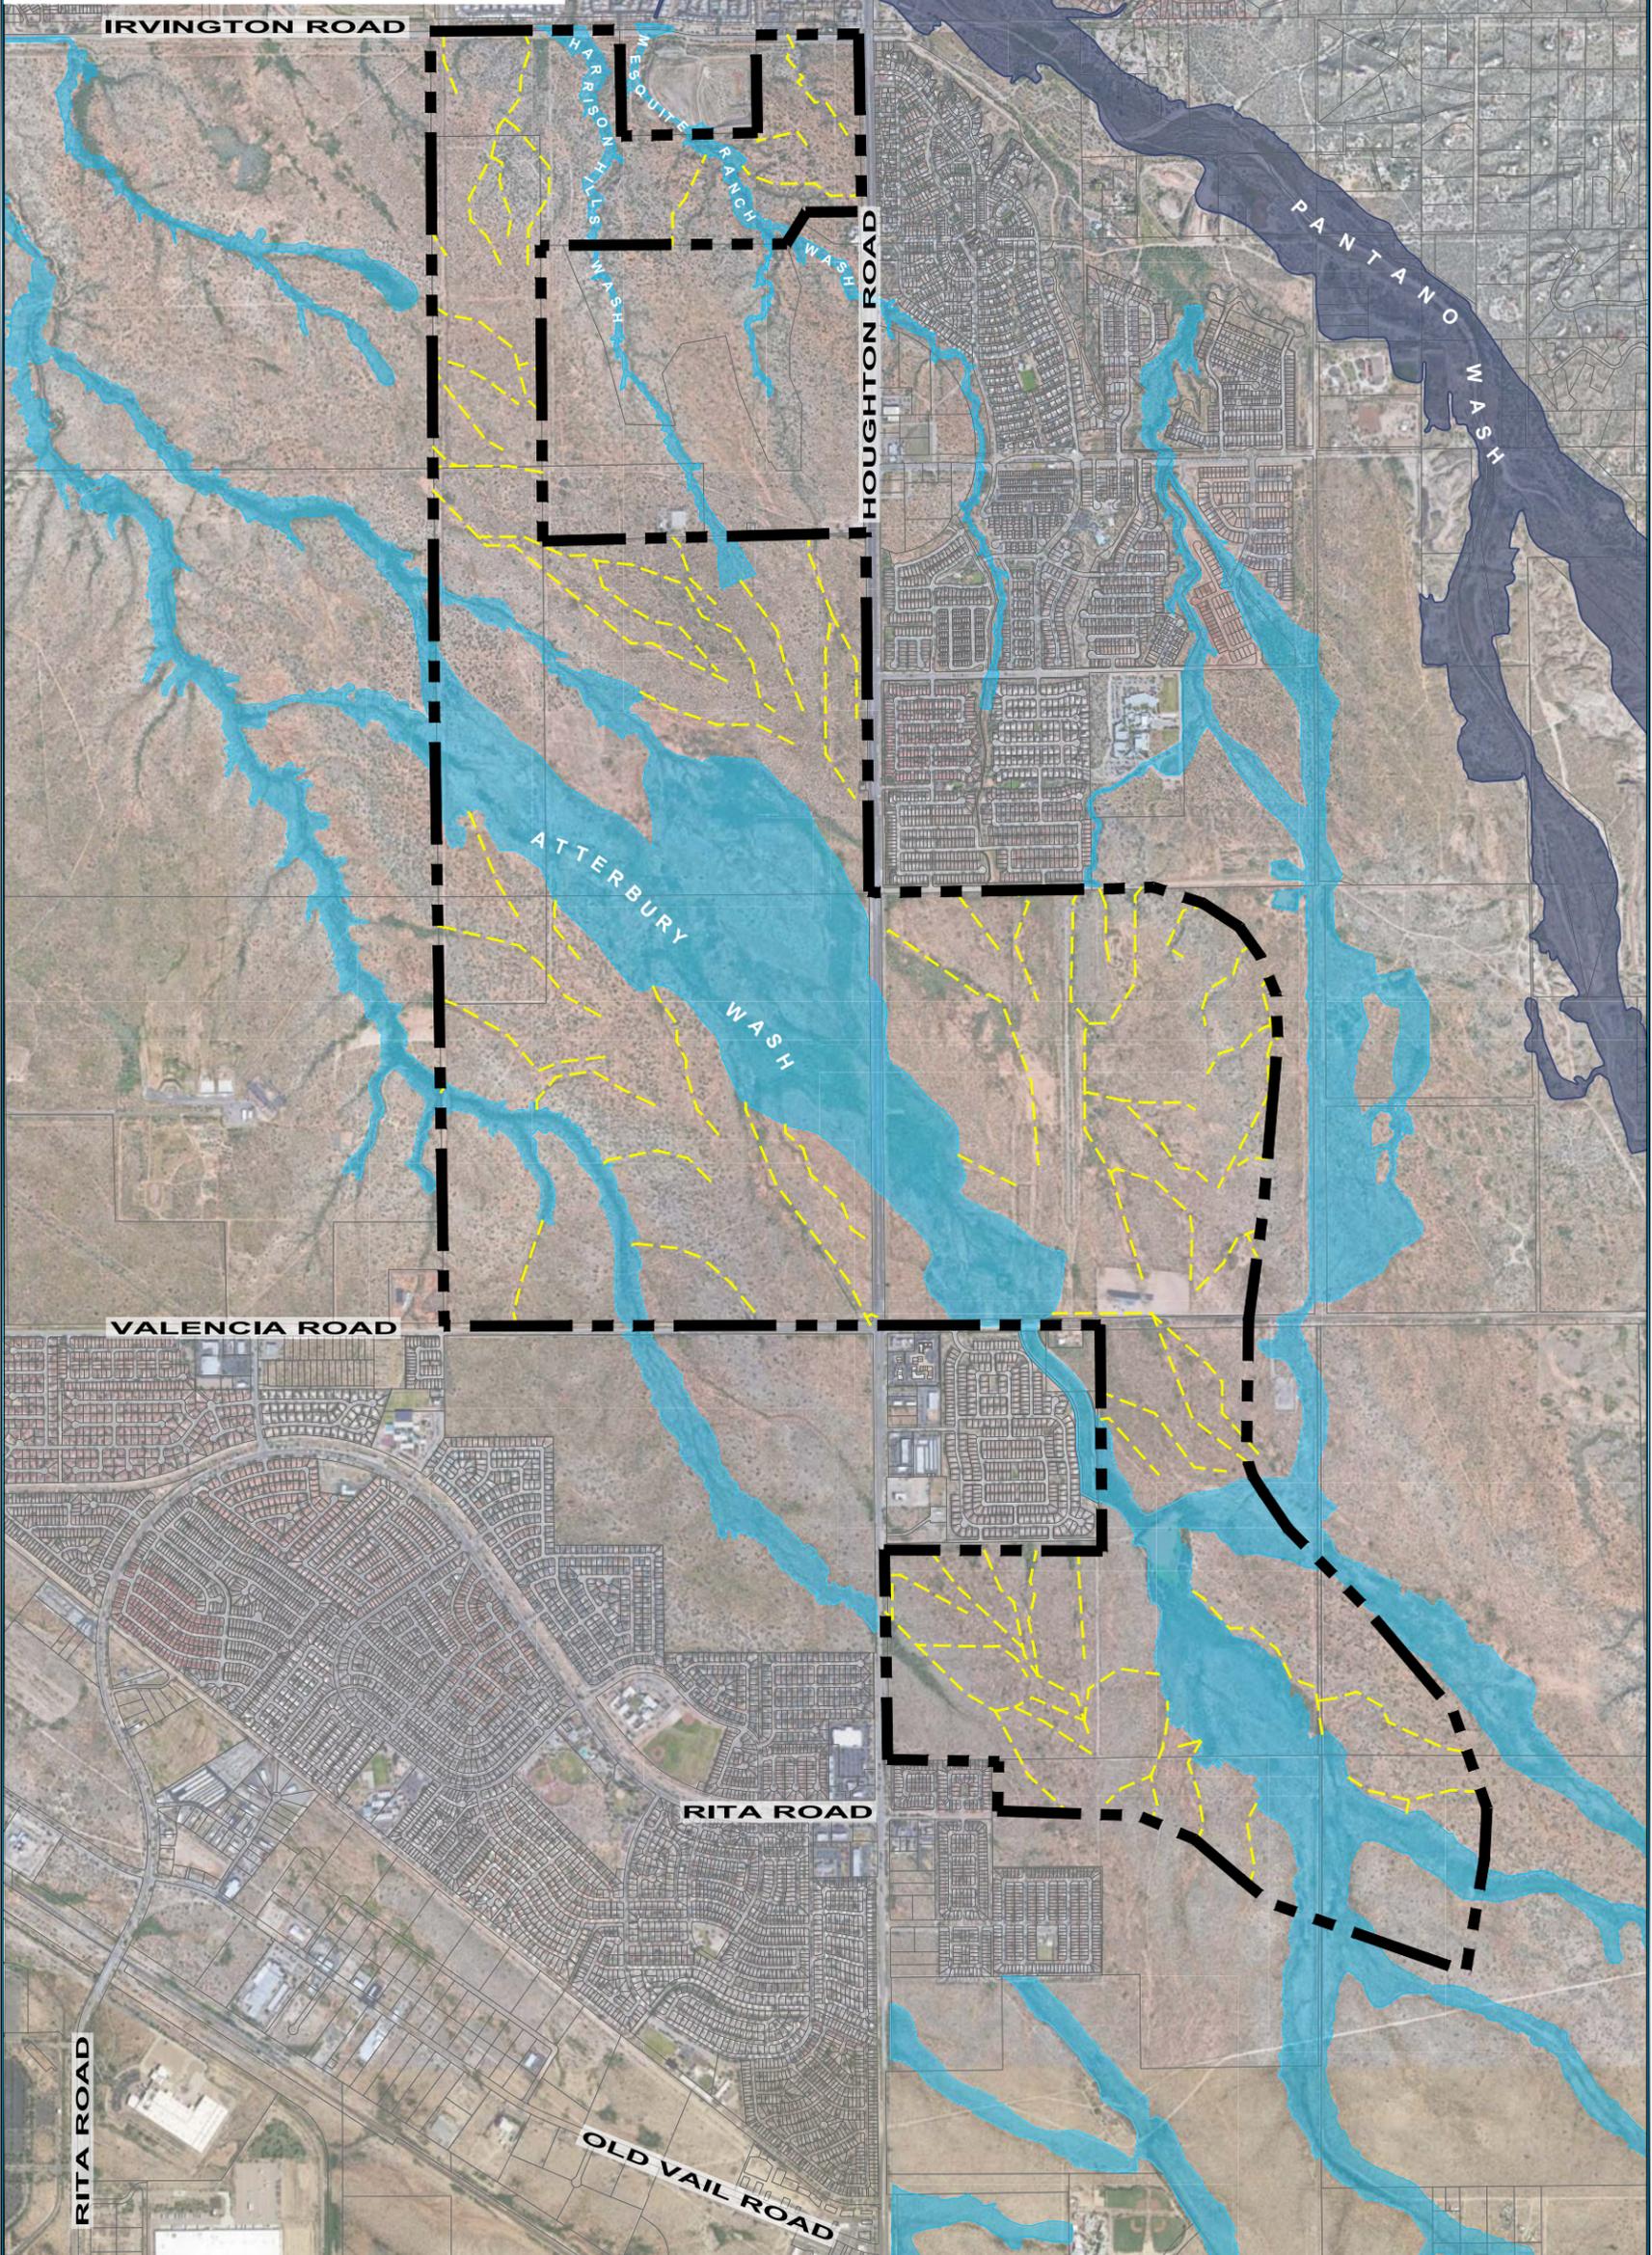
**Exhibit D: 100-YEAR FLOODPLAINS**

As per Section 4-02.2.3 Protected Riparian Area (PRA) of the UDC, the focus of this ERR was on the areas of the site located within 100-year floodplains, both FEMA and local. *Exhibit D: 100-Year Floodplains* identifies the areas on the site that are included within 100-year floodplains. These floodplains are inclusive of both designated and proposed W.A.S.H and ERZ watercourses and a FEMA floodplain and are described as follows:

- A FEMA Zone A floodplain associated with the Atterbury Wash is located in the subject property running the extent of the site from the southeast corner to the northwest corner. This floodplain is shown on FIRM (Flood Insurance Rate Map) panels #04019C2320L, 04019C2925L and #04019C2930L
- The Atterbury Wash is a designated ERZ regulatory watercourse throughout the extent of the project site.
- There are three tributary washes to the Atterbury Wash that are proposed ERZ watercourses within the subject property.
- There are portions of four tributary washes to the Atterbury Wash that are designated as proposed W.A.S.H. watercourses based on the Tucson Storm Water Management Study (TSMS) located in the subject property.
- Per City of Tucson data, local washes containing flows of 100 cfs or greater.

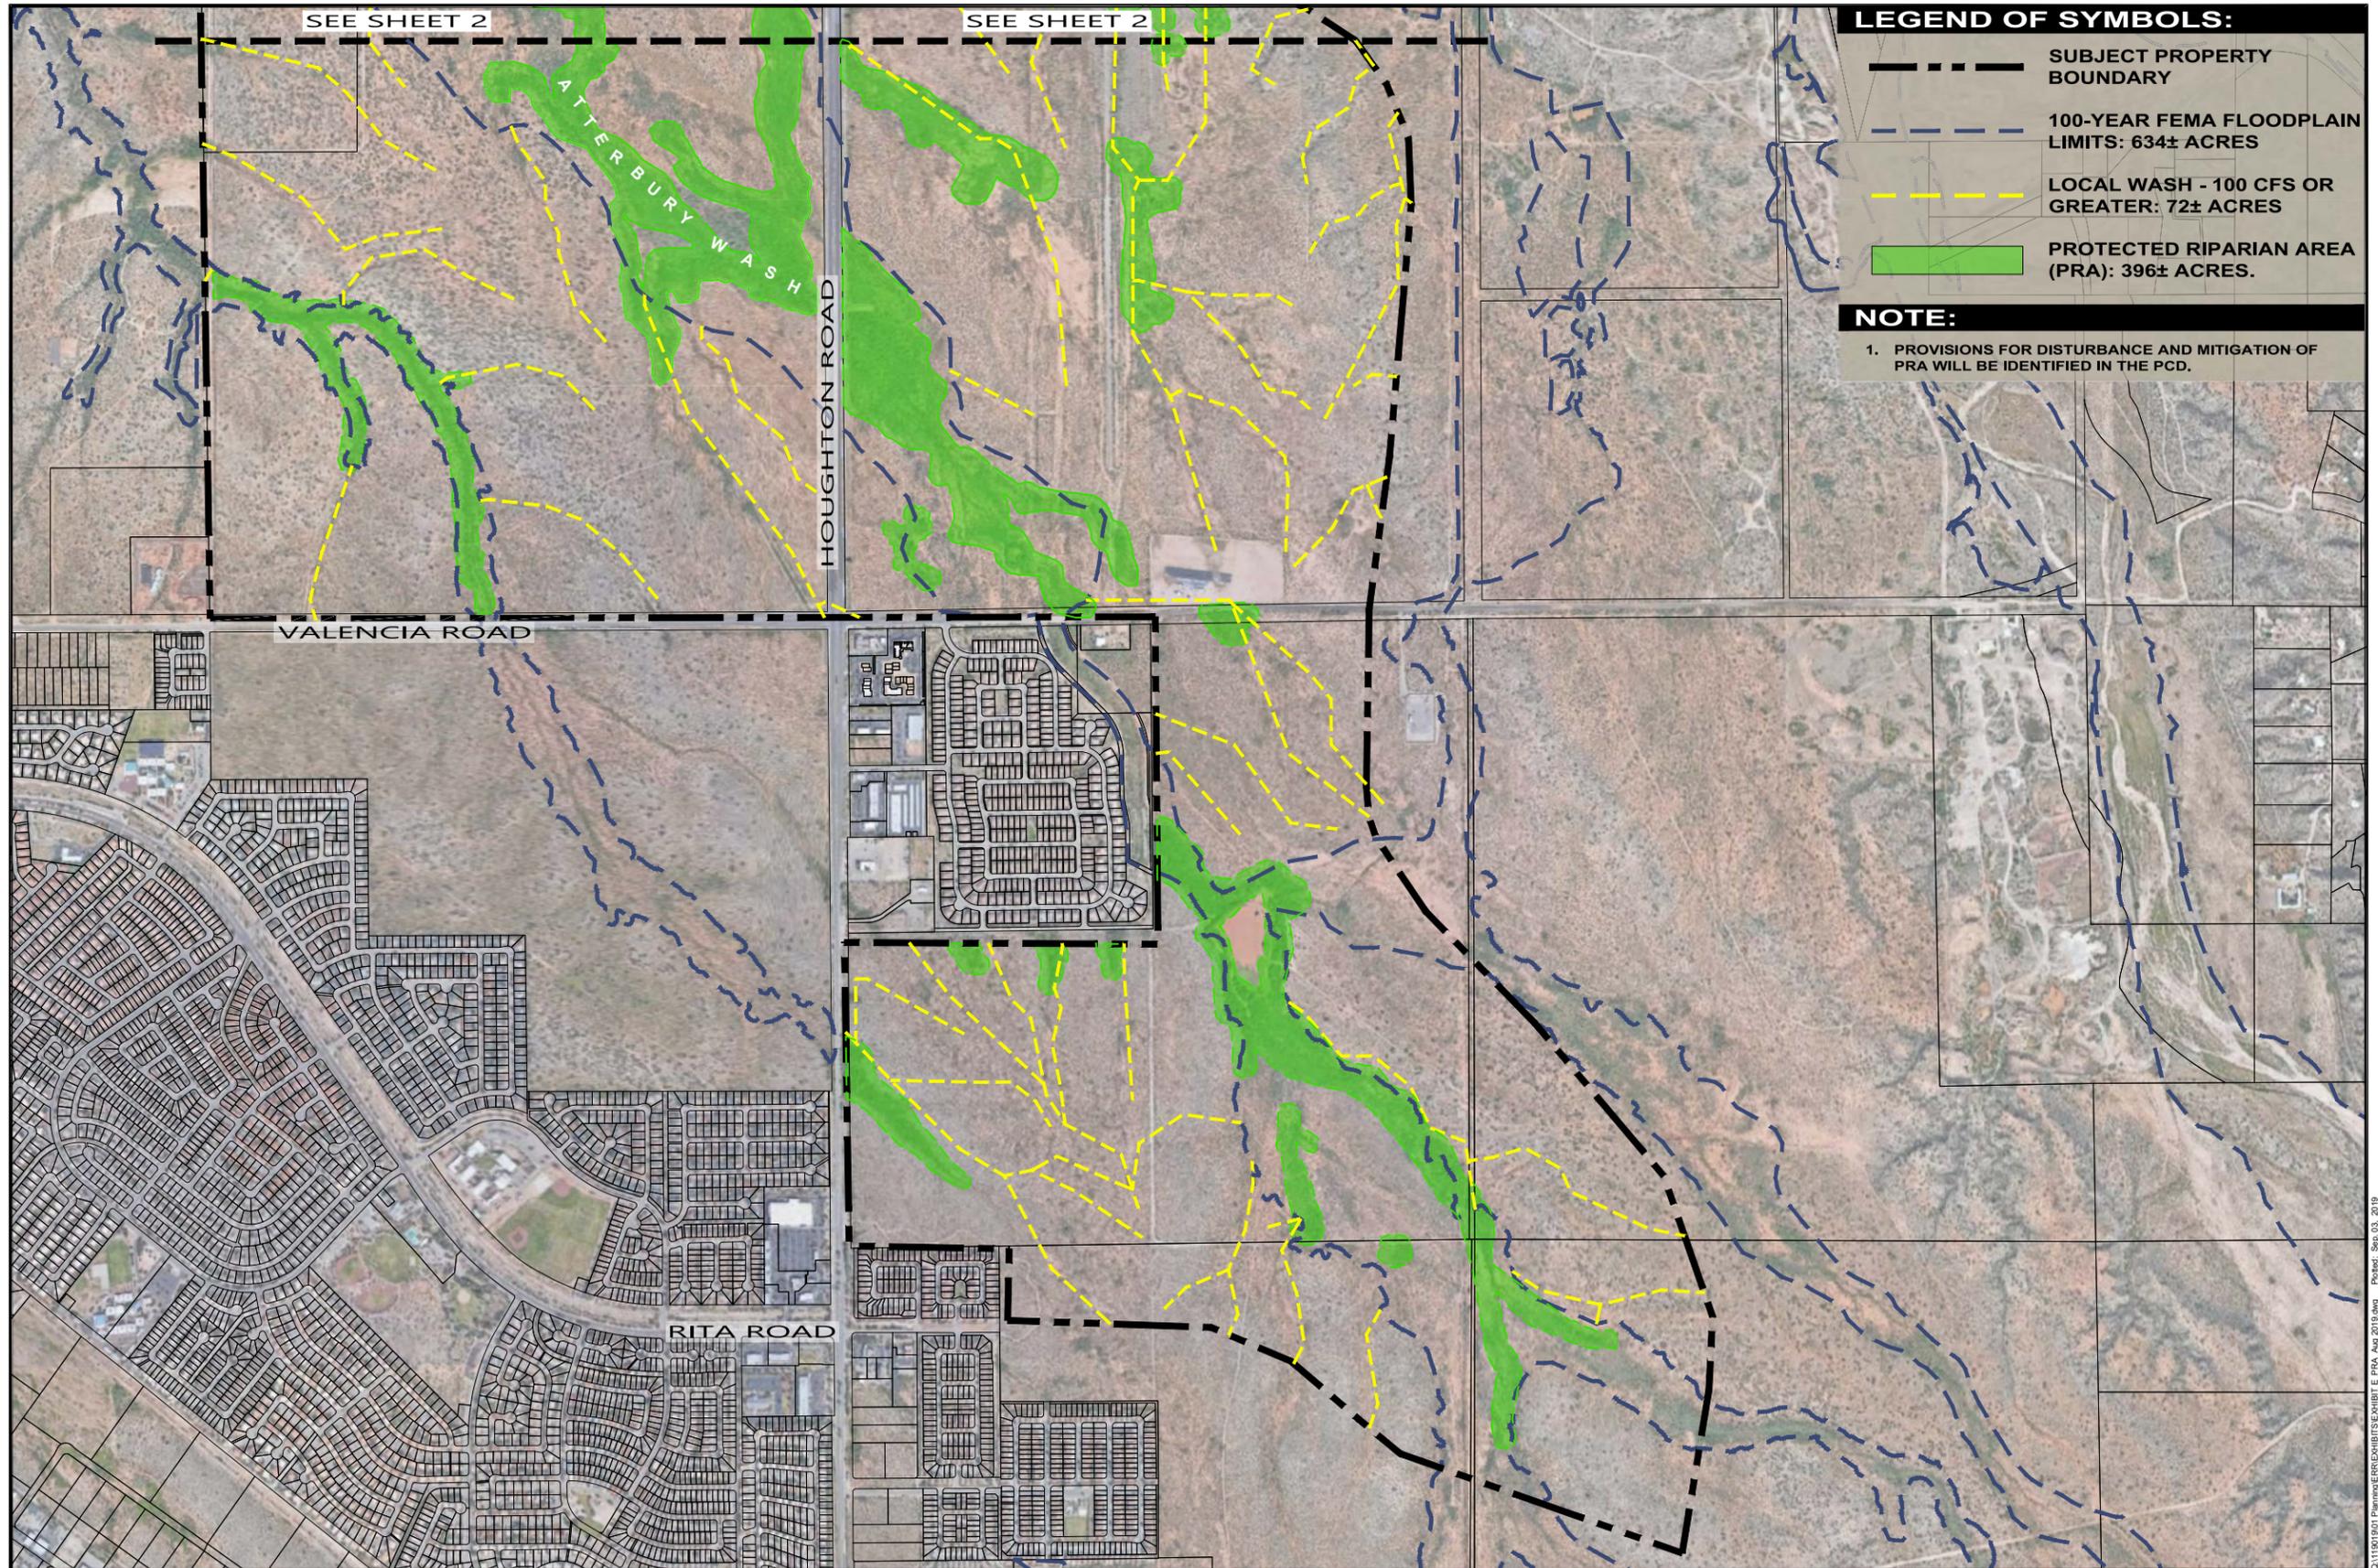
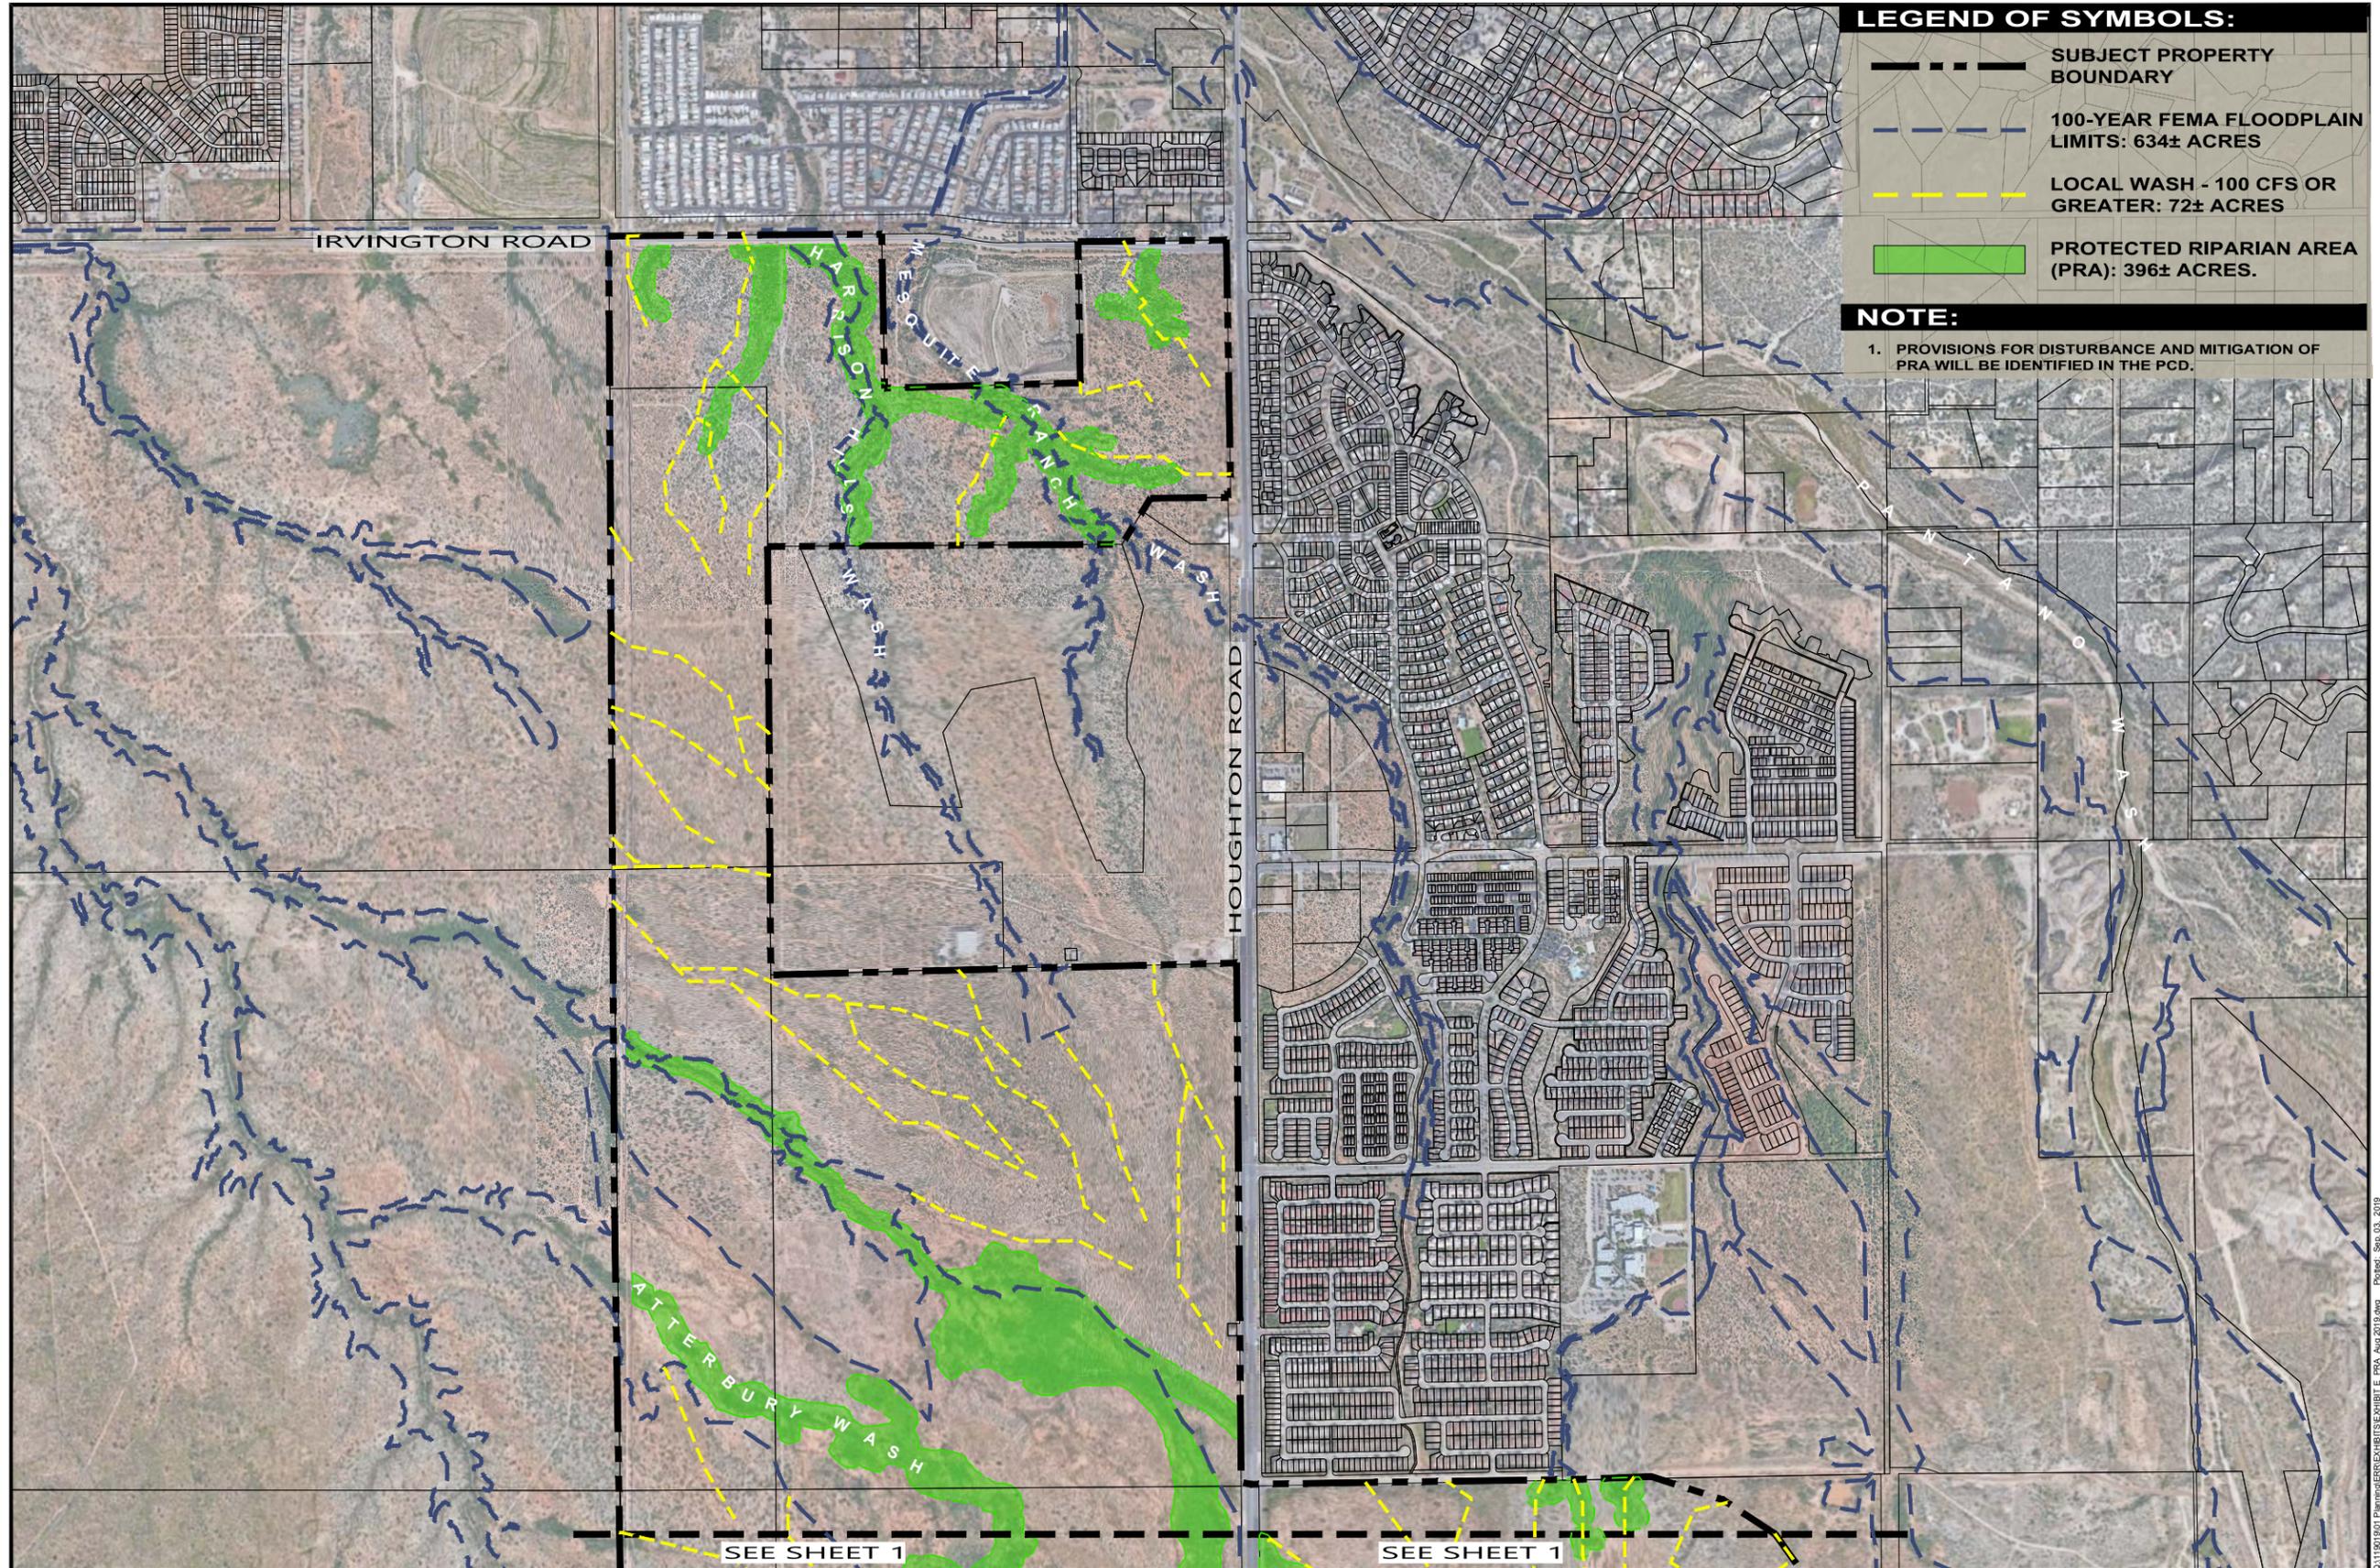
**Exhibit E: PROTECTED RIPARIAN AREA**

these criteria were used during our field analysis. Please refer to *Exhibit E: Protected Riparian Area (PRA)*. This exhibit identifies the location of PRA meeting the criteria on the subject property.

*Results of Analysis: Please refer to Exhibit E: Protected Riparian Area which identifies area on the site which meets the City of Tucson criteria for PRA designation.*

*Results of Analysis: Please refer to Exhibit E: Protected Riparian Area which identifies area on the site which meets the City of Tucson criteria for PRA designation.*

*Results of Analysis: There are areas on the site containing more dense clusters of Mesquite trees. These areas are included in the PRA designated area.*

*Results of Analysis: There is an area in the northeast quadrant of Section 24 that contains a cattle drinking area (aka drinker) and it contained water during the May 10th site visit. It was not visited during the other site visits. A current Special Land Use Permit from the Arizona State Land Department is in place on this portion of the State Land property which allows for grazing, which includes a corral and cattle drinker. The area of the cattle drinker is surrounded by the PRA designated area.*

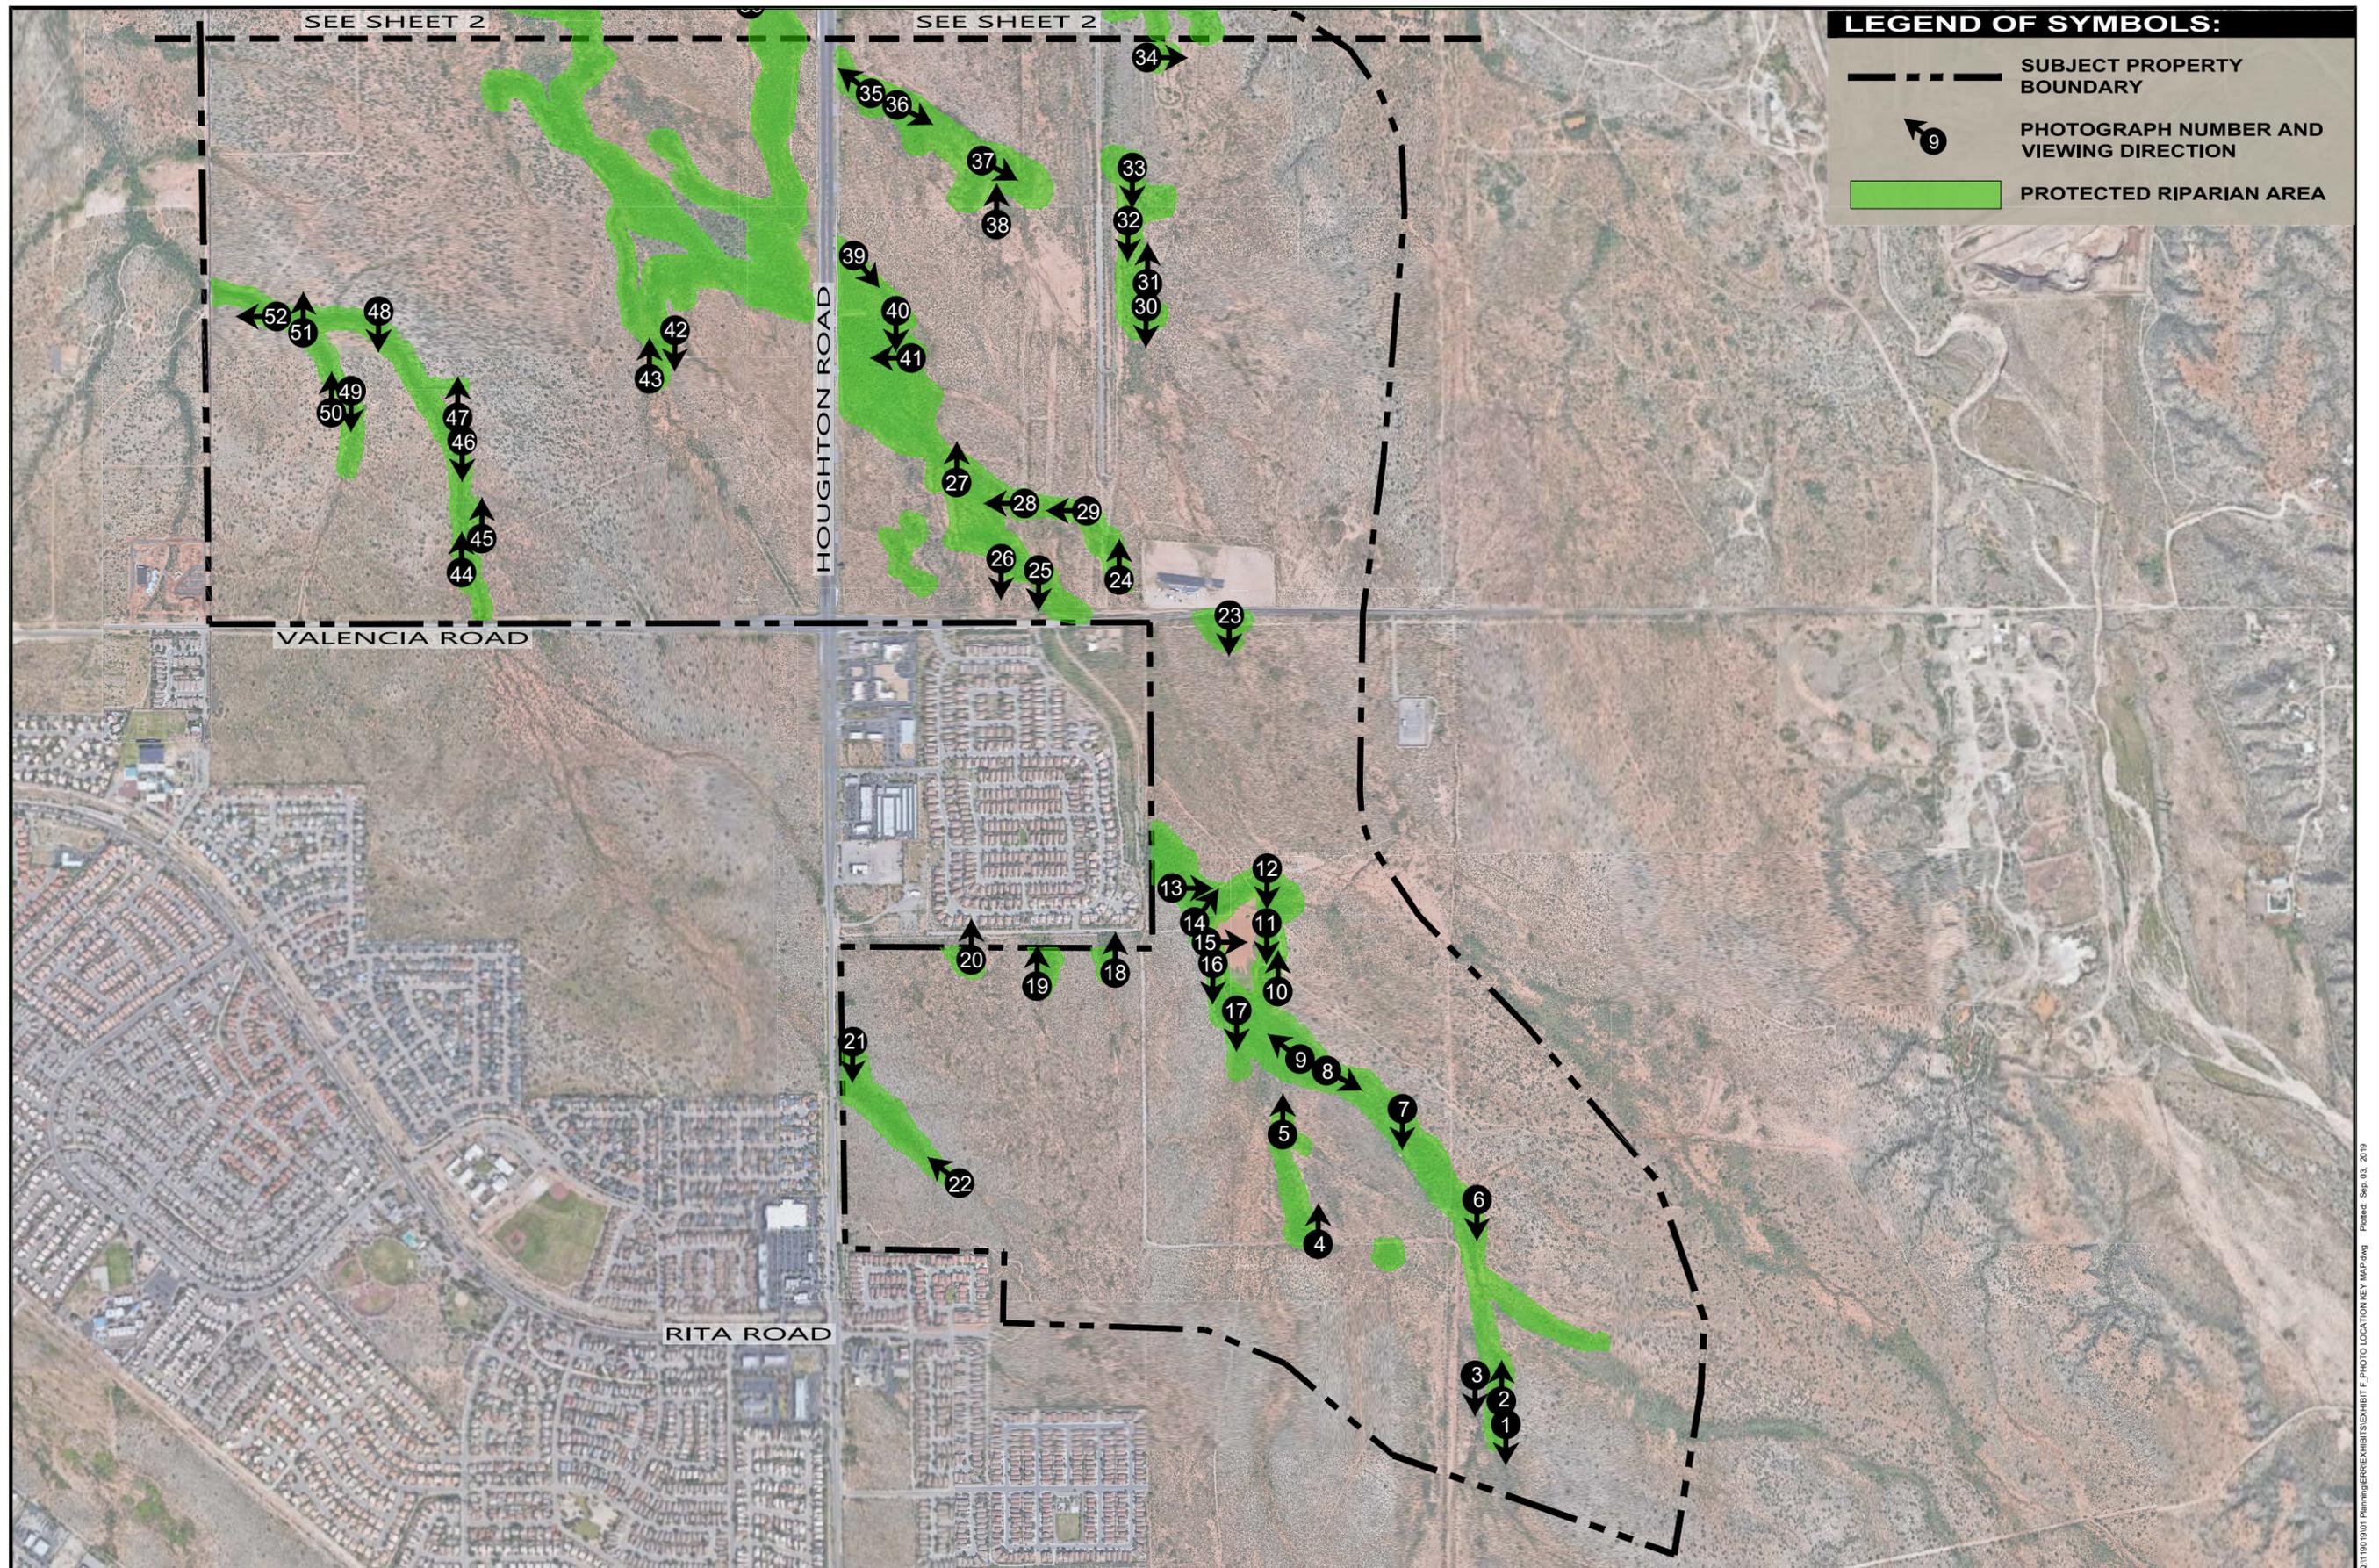
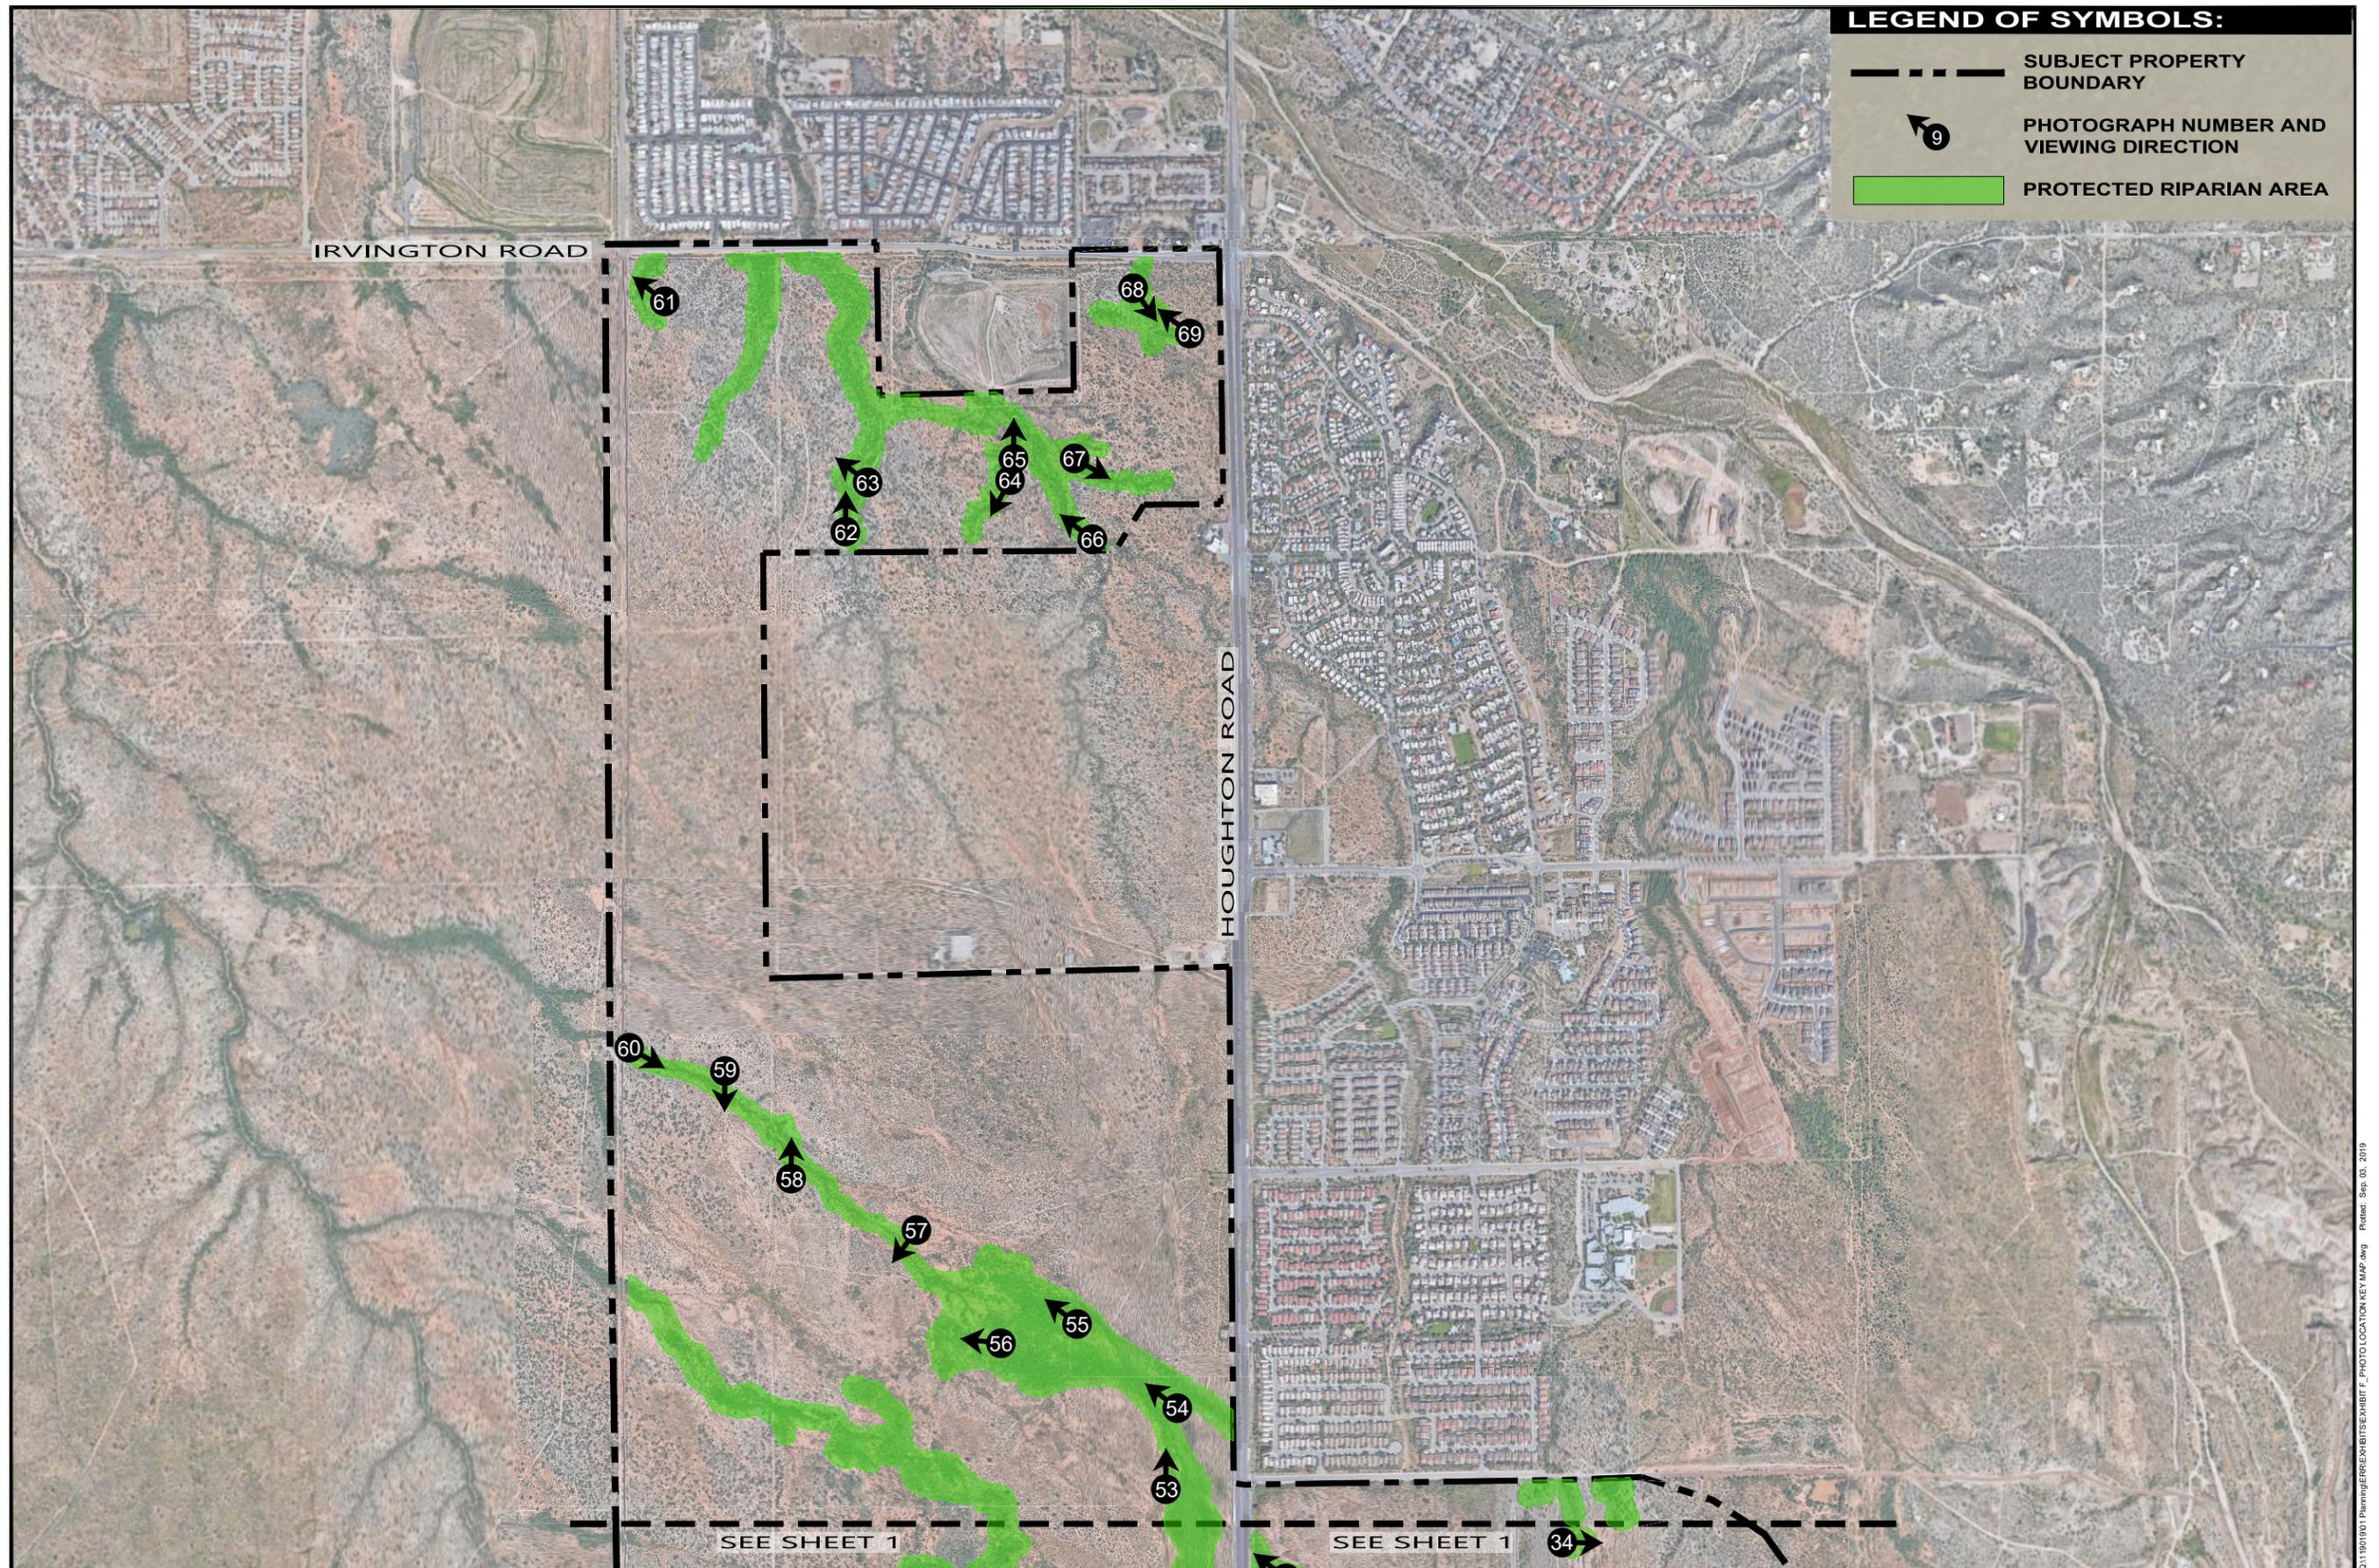
**Exhibit F: PHOTOGRAPH LOCATION KEY MAP**

Please also refer to *Exhibit F: Photograph Location Key Map and Exhibit G: Ground Level Photographs* for photographs of the areas on site identified as PRA.
