# ASLD Property

## Houghton Road and Valencia Road

# Environmental Resource Report

WLB No. 119019-A-001

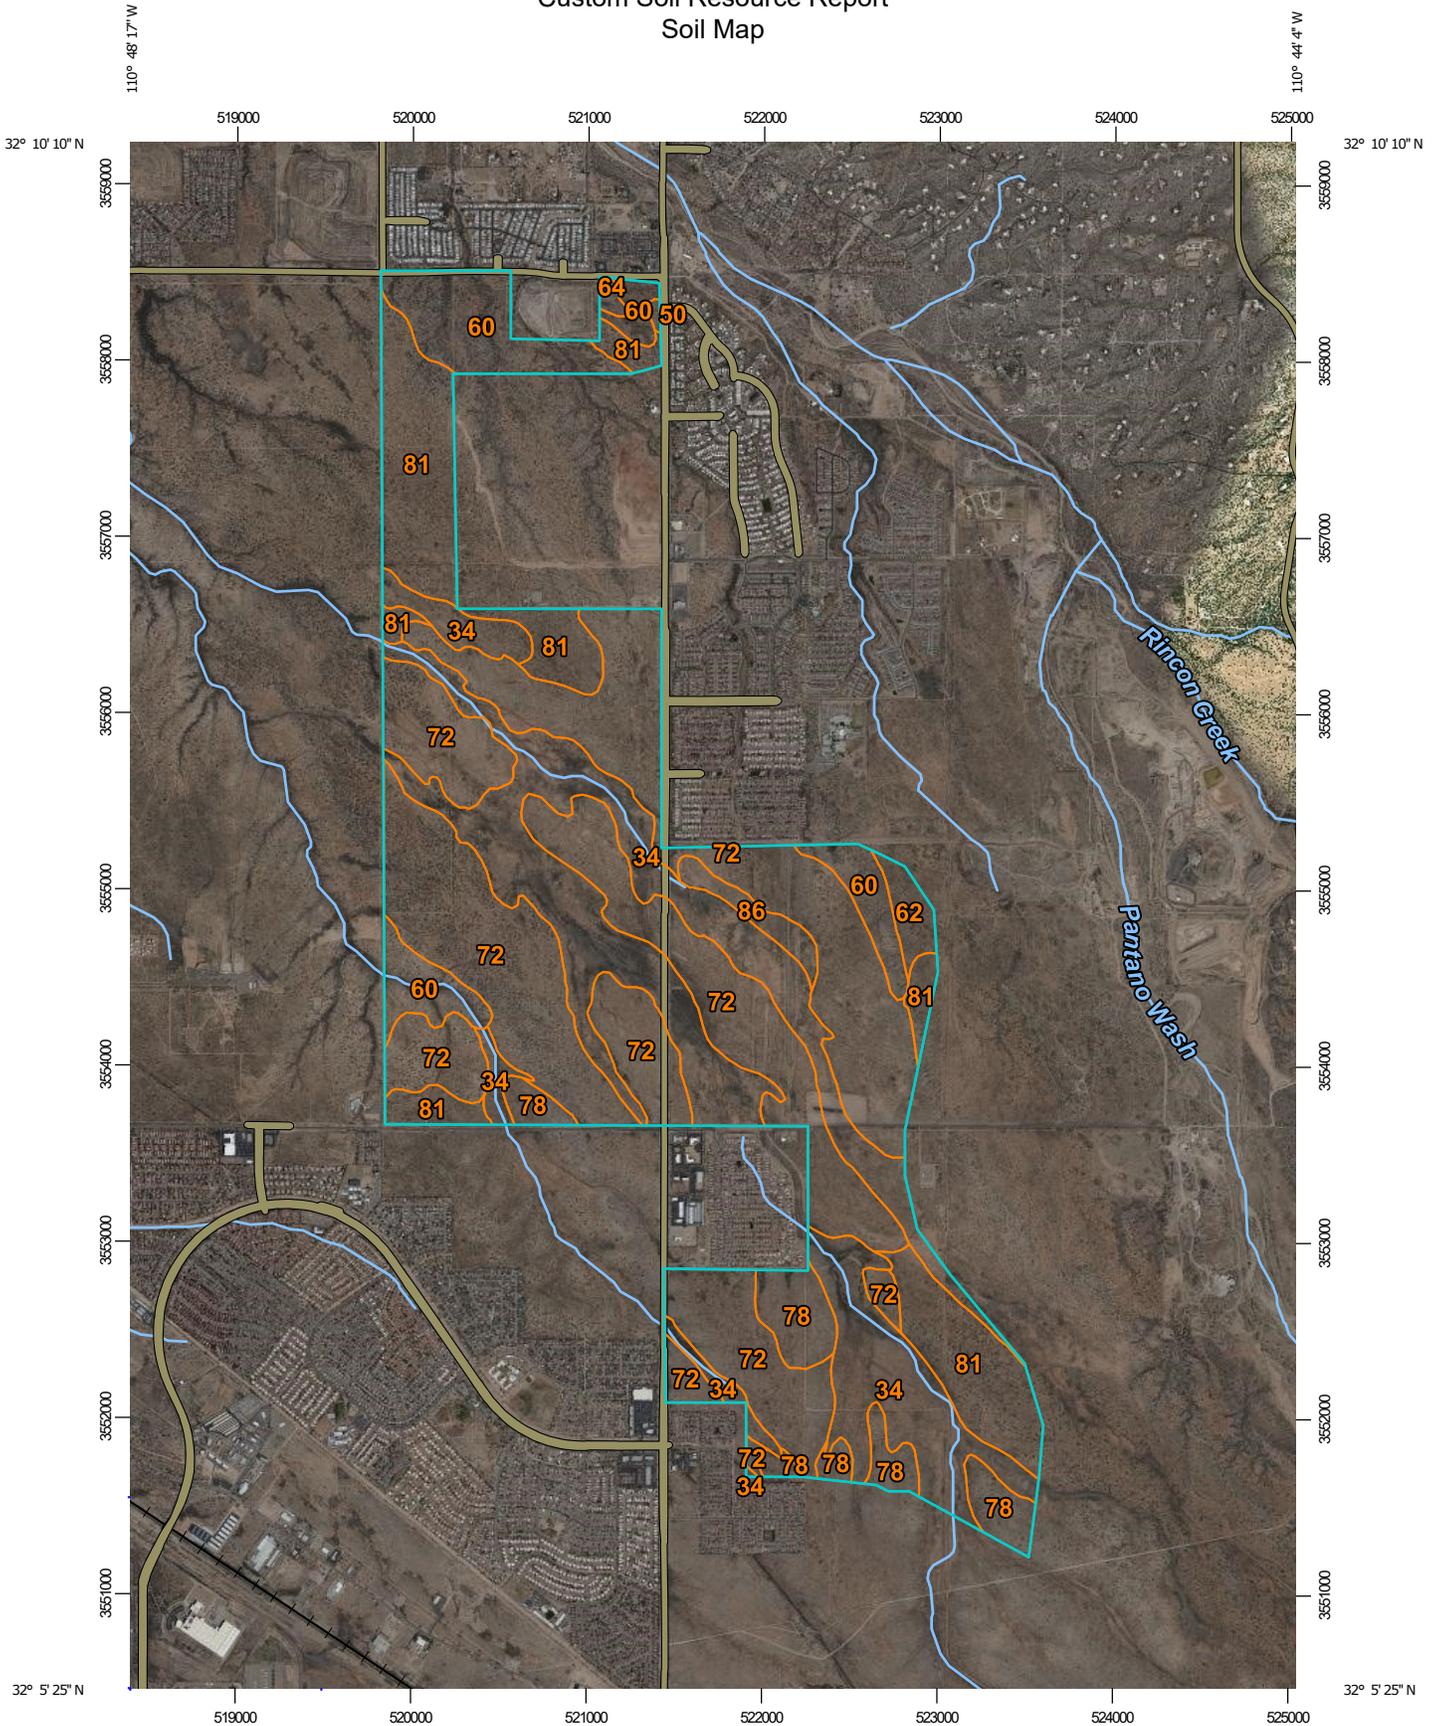
# Custom Soil Resource Report Soil Map

The soil map section includes the soil map for the defined area of interest, a list of soil map units on the map and extent of each map unit, and cartographic symbols displayed on the map. Also presented are various metadata about data used to produce the map, and a description of each soil map unit.
