HISTORIC LANDMARK SIGN (HLS) TREATMENT PLAN

Address: 311 East Congress Street | Tucson, AZ | 85701 GPS Lat: 32°13'19.91"N Long: 110°58'0.07"W

Original business/copy: HOTEL CONGRESS
(attach additional sheet if necessary)

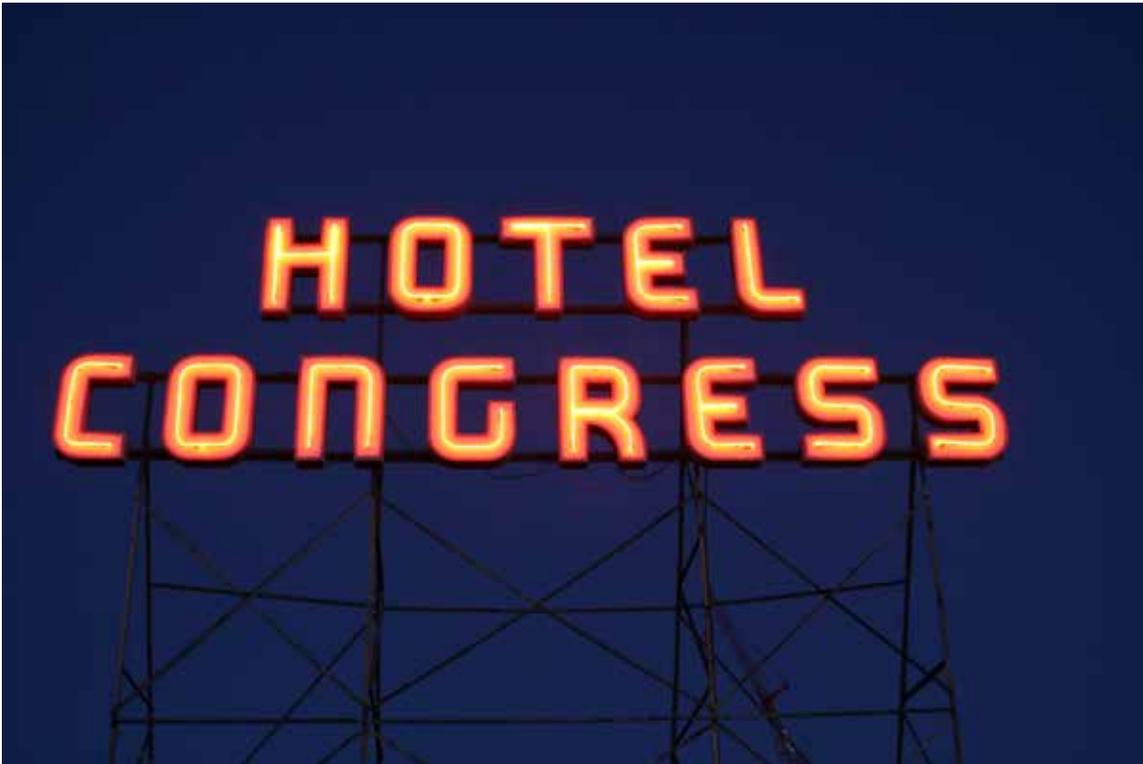
Hotel Congress Sign | Night View | 22 January 2011

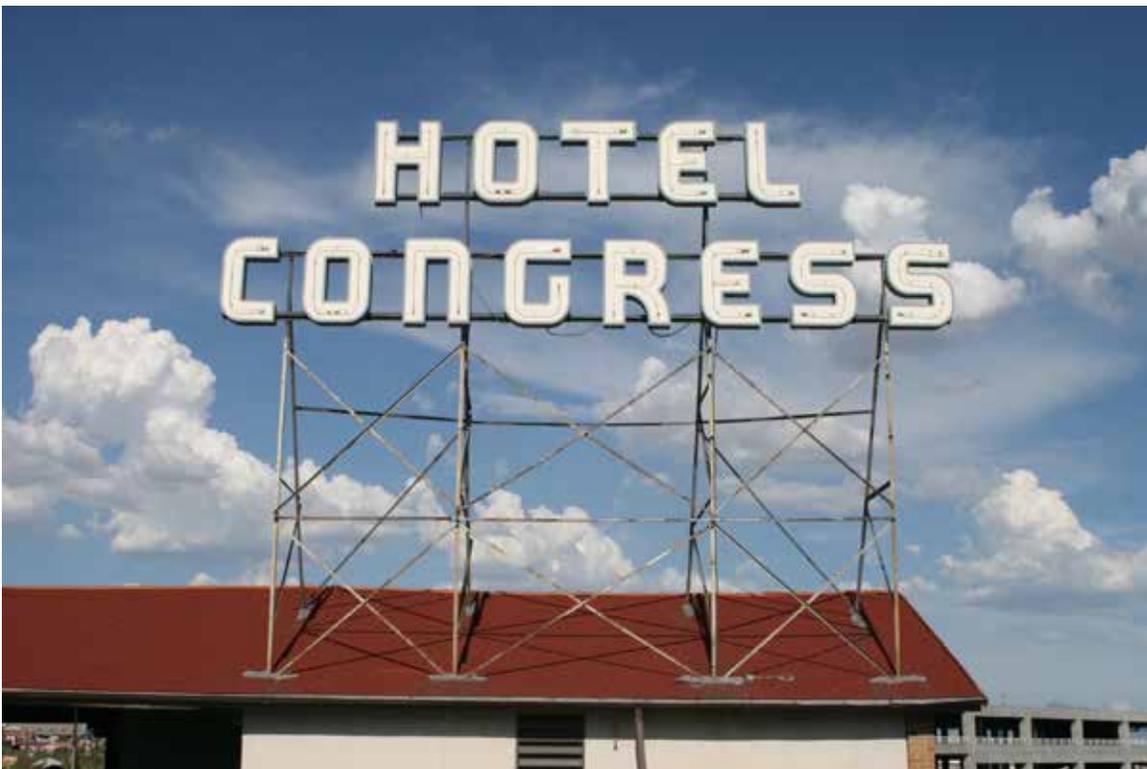
Hotel Congress Sign | Day View | 1 August 2011

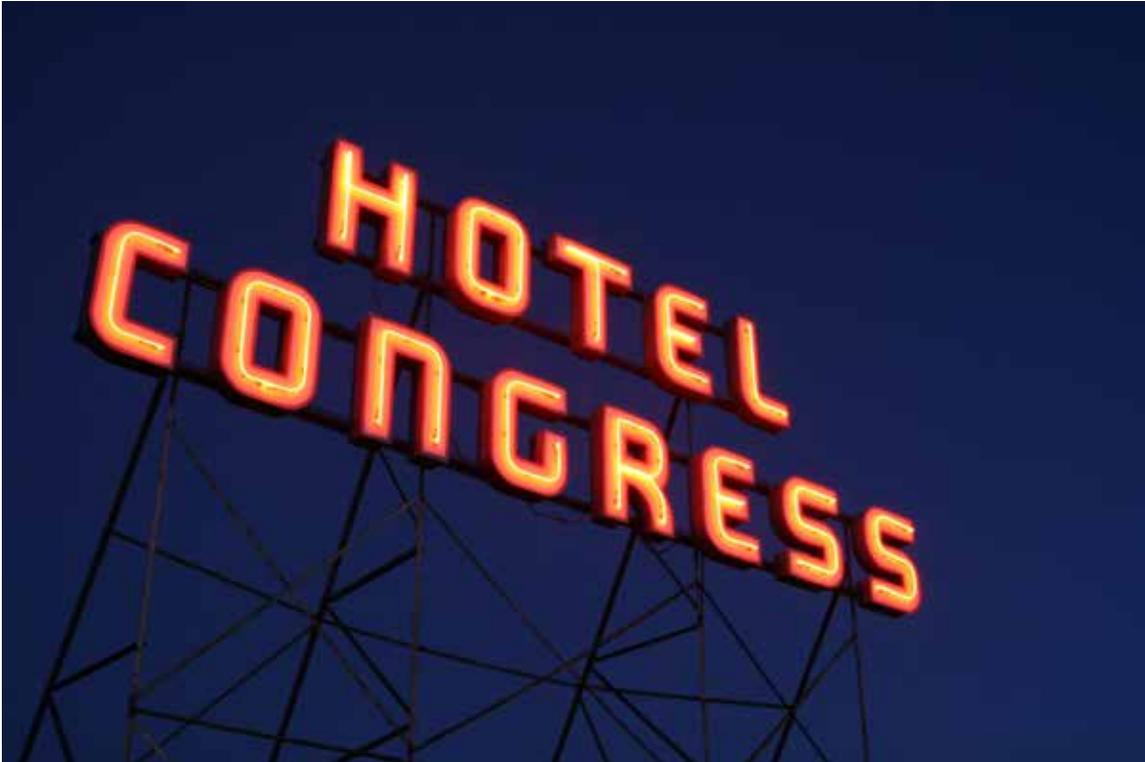
Hotel Congress Sign | Night View | 22 January 2011

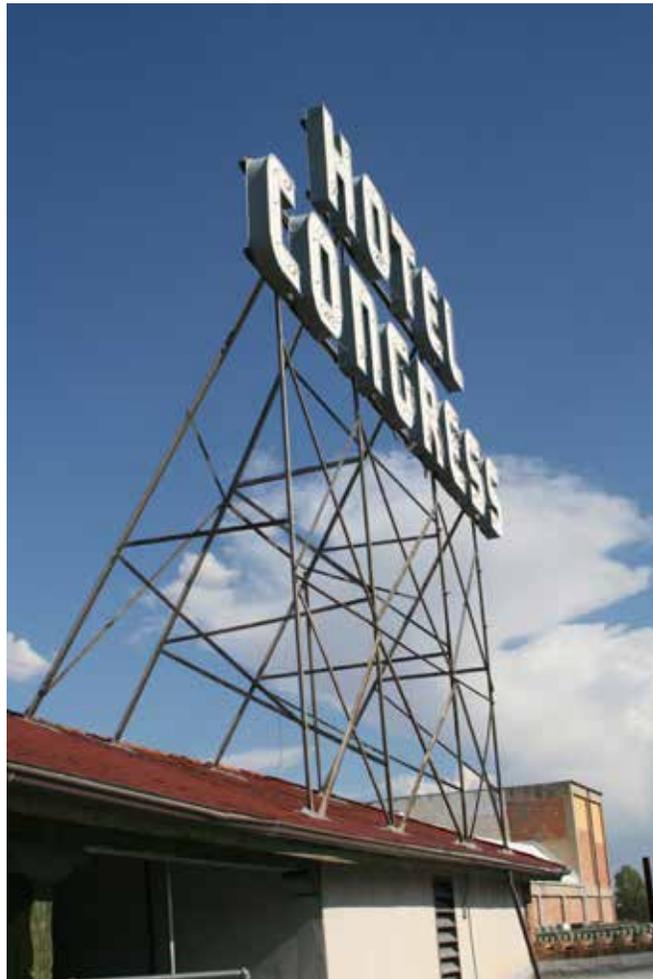
Hotel Congress Sign | Day View | North Elevation | 1 August 2011

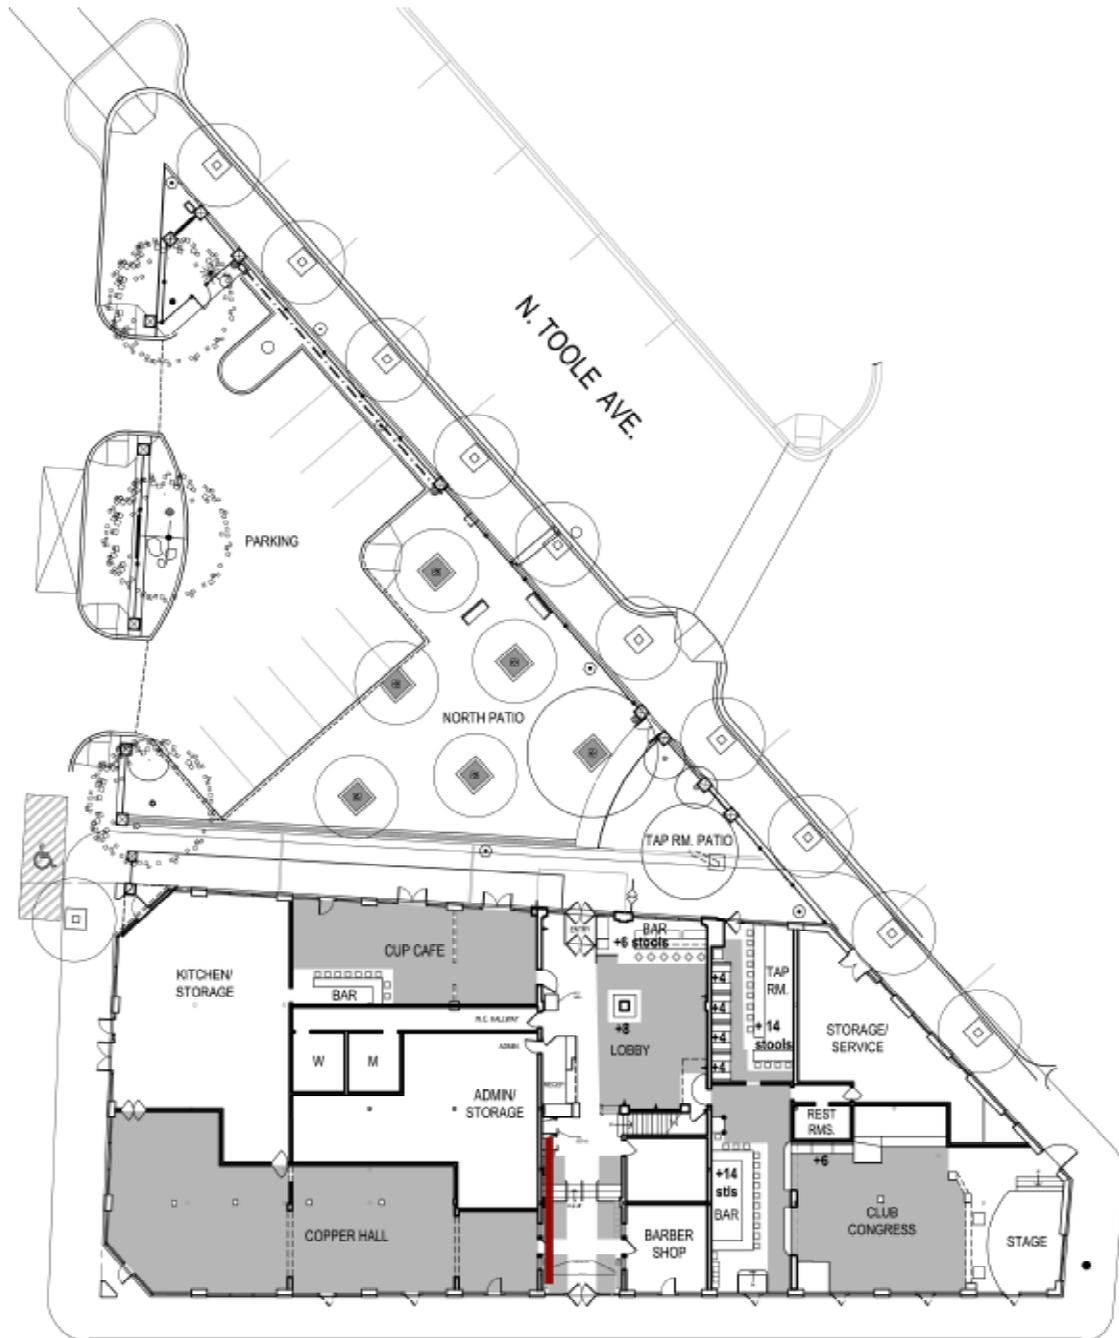
C. Site Plan

Plan - Hotel Congress

Hotel Congress Roof Sign

Site Plan Courtesy Vint & Associates Architects, Inc.

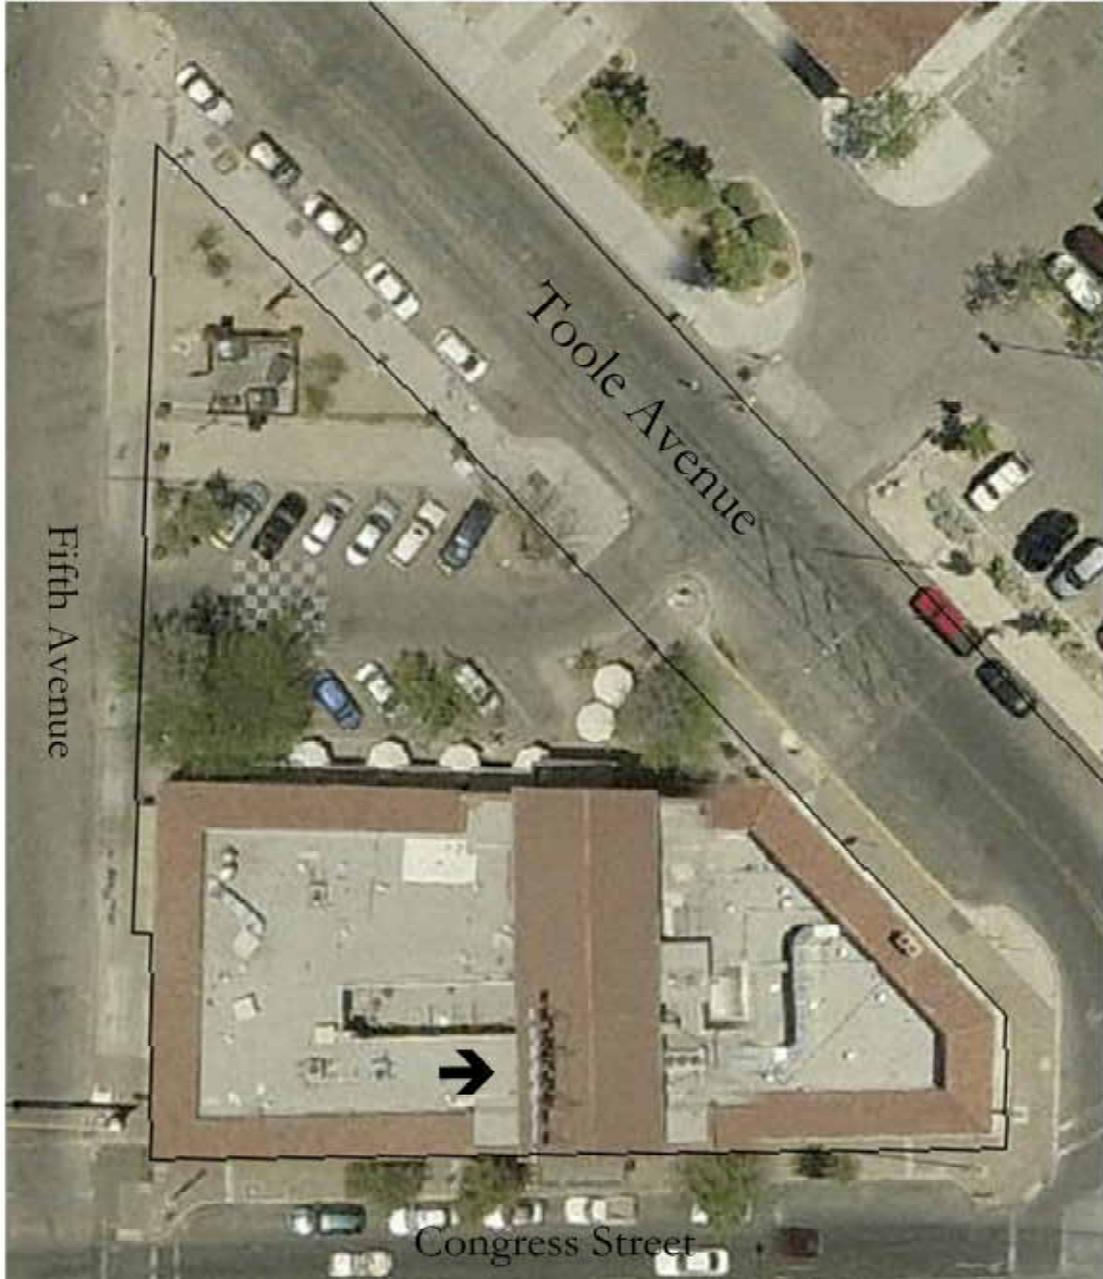
Hotel Congress | Historic Landmark Sign | Aerial View Plan

74 ft

Hotel Congress Sign →

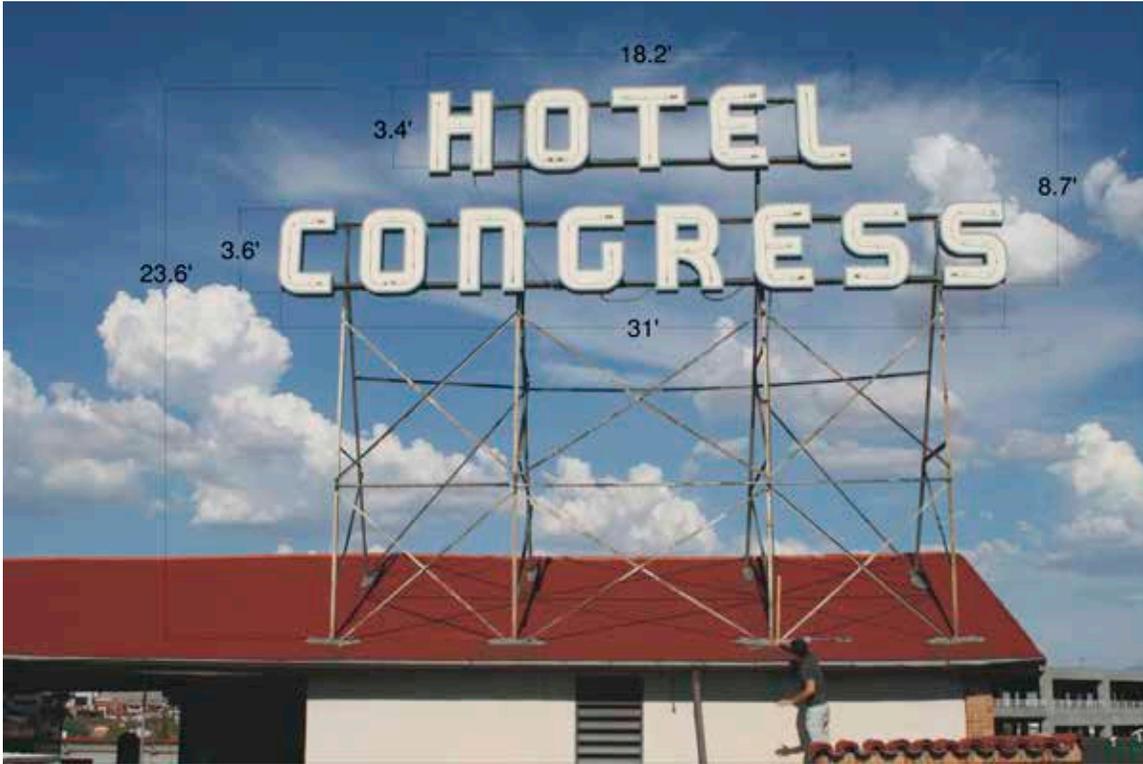
Hotel Congress Sign | Measured West Elevation

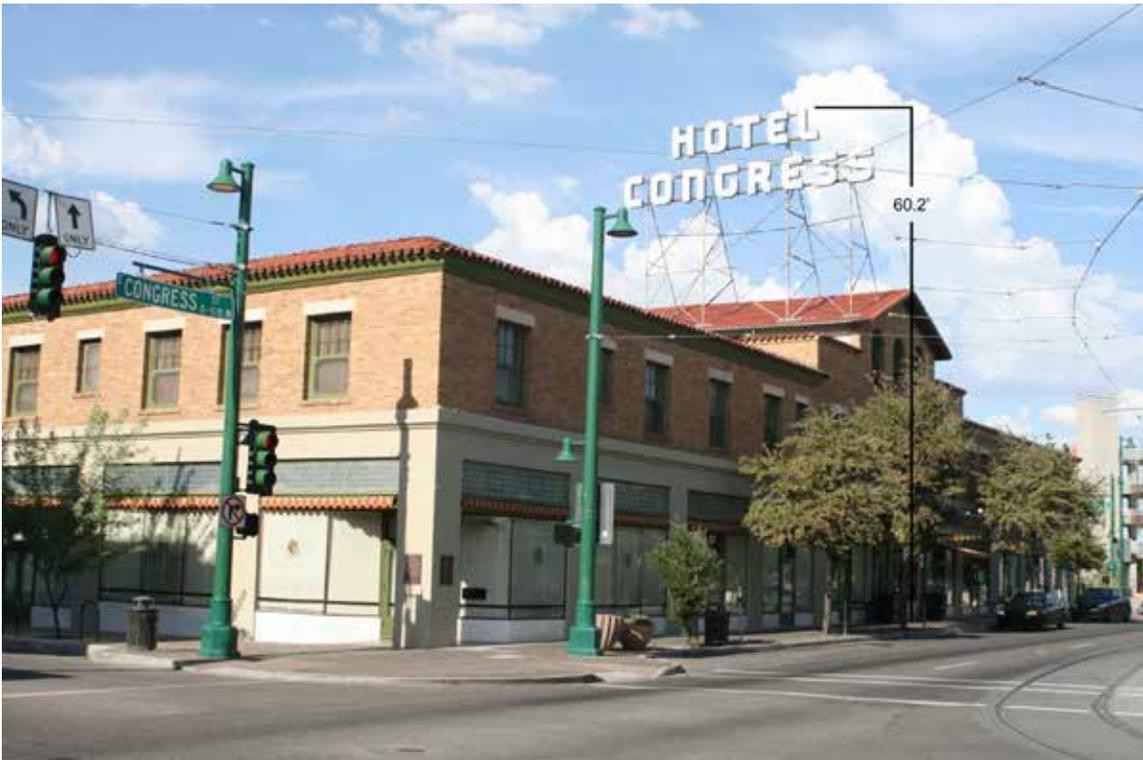
Hotel Congress and Sign | Measured South Elevation

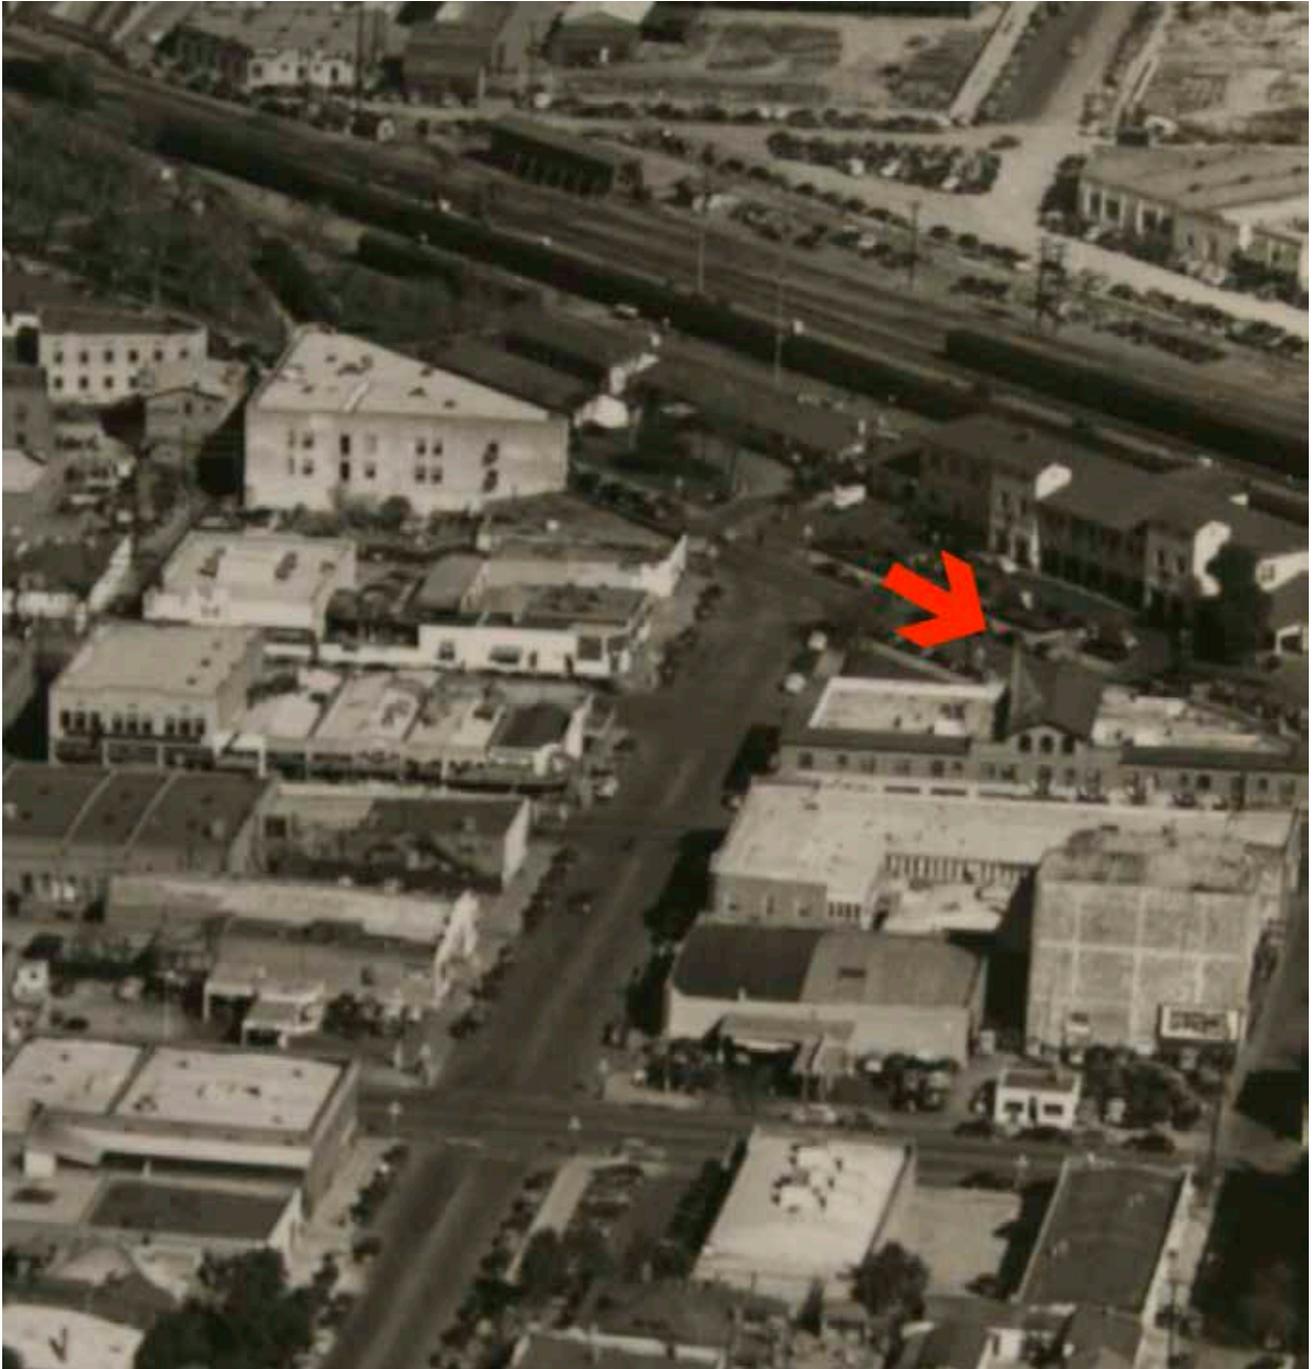
Magee Photo Collection | 1946 | AHS PC 177 F. 17

Neither drawings, permits, nor records have surfaced to pinpoint the exact construction date, neon sign company, or craftsman responsible for the Hotel Congress sign. Photo documentation at the Arizona Historical Society confirms that the sign had been installed by 1946. (AHS PC 177 F. 17) The sign was installed sometime after the 1934 fire; photos reveal that shortly after the post-fire reconstruction had been completed, no sign had been installed.

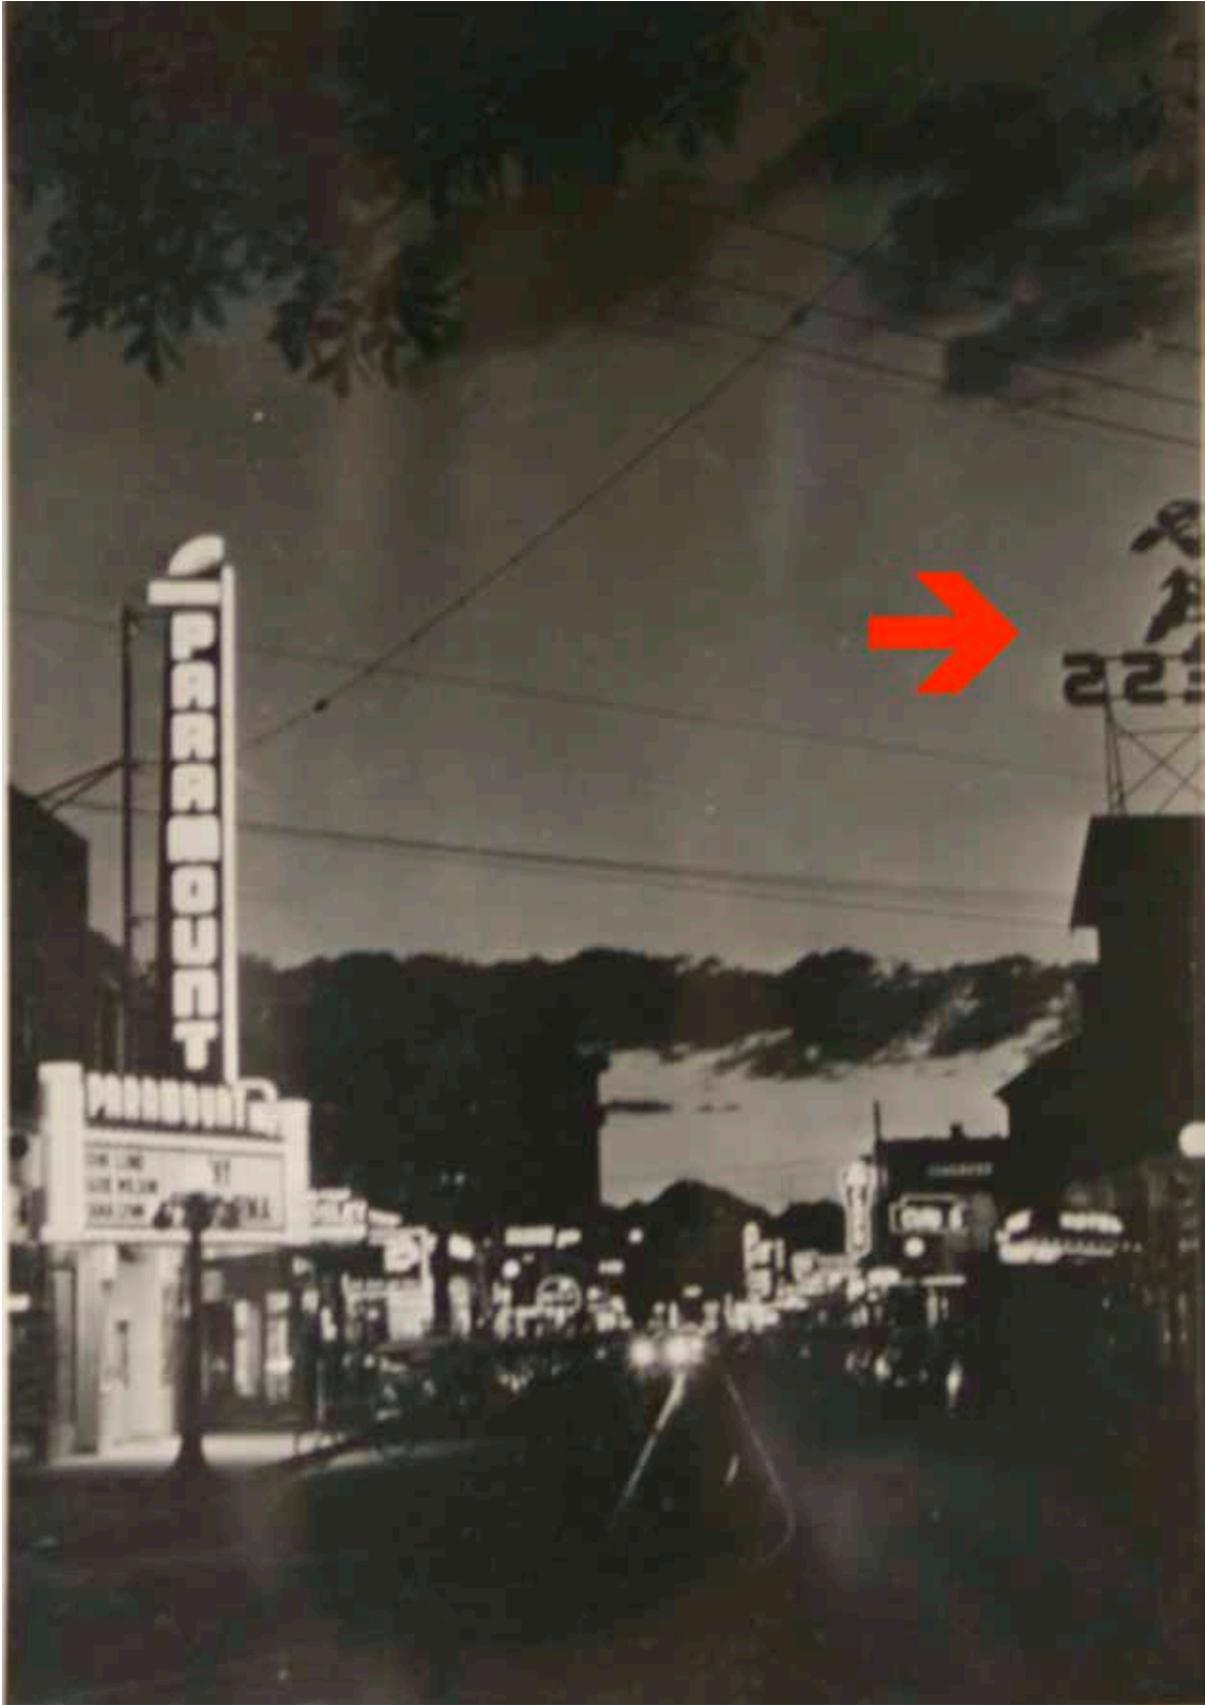
AHS Places-Tucson –Streets Congress post 1924 | photo ca. 1950
