Archaeological Excavations of the Hooper Warehouse, the Tucson Sampling Works, and the Southern Pacific Railroad Clubhouse, Historic Block 95, Tucson, Pima County, Arizona

Technical Report No. 2009-08
Desert Archaeology, Inc.

3975 North Tucson Boulevard, Tucson, Arizona 85716 • June 2010

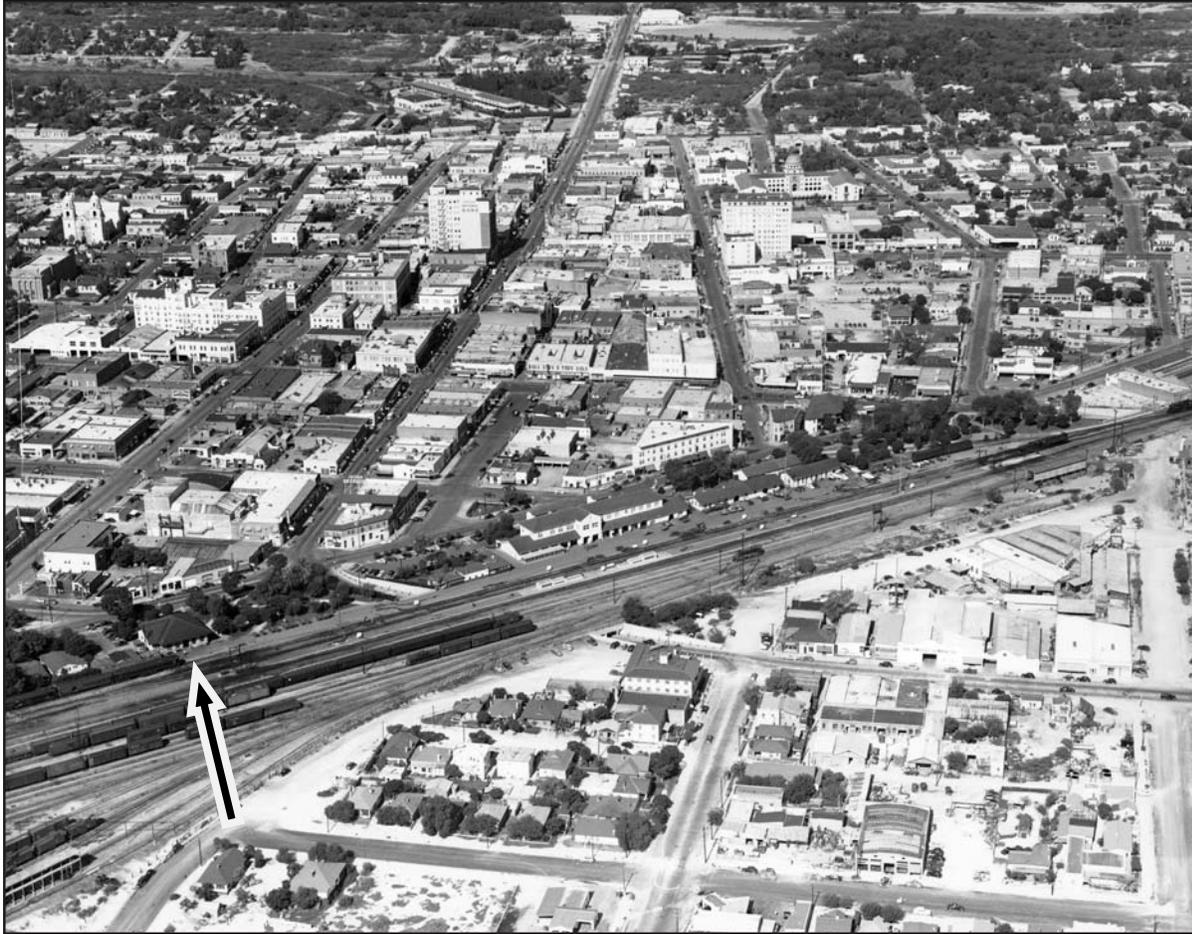
By 1927, the clubhouse building was labeled in city plans as a "Yard Office," although Sanborn maps through 1960 and various undated city railroad maps continued to label the building as a clubhouse. It is visible in aerial photographs of the downtown (Figure 2.8).

Figure 2.8. An aerial photograph of Block 95, Tucson, taken in 1924 (courtesy of the Arizona Historical Society; PC 136, B6). (Arrow points to the location of the former Southern Pacific Clubhouse.)

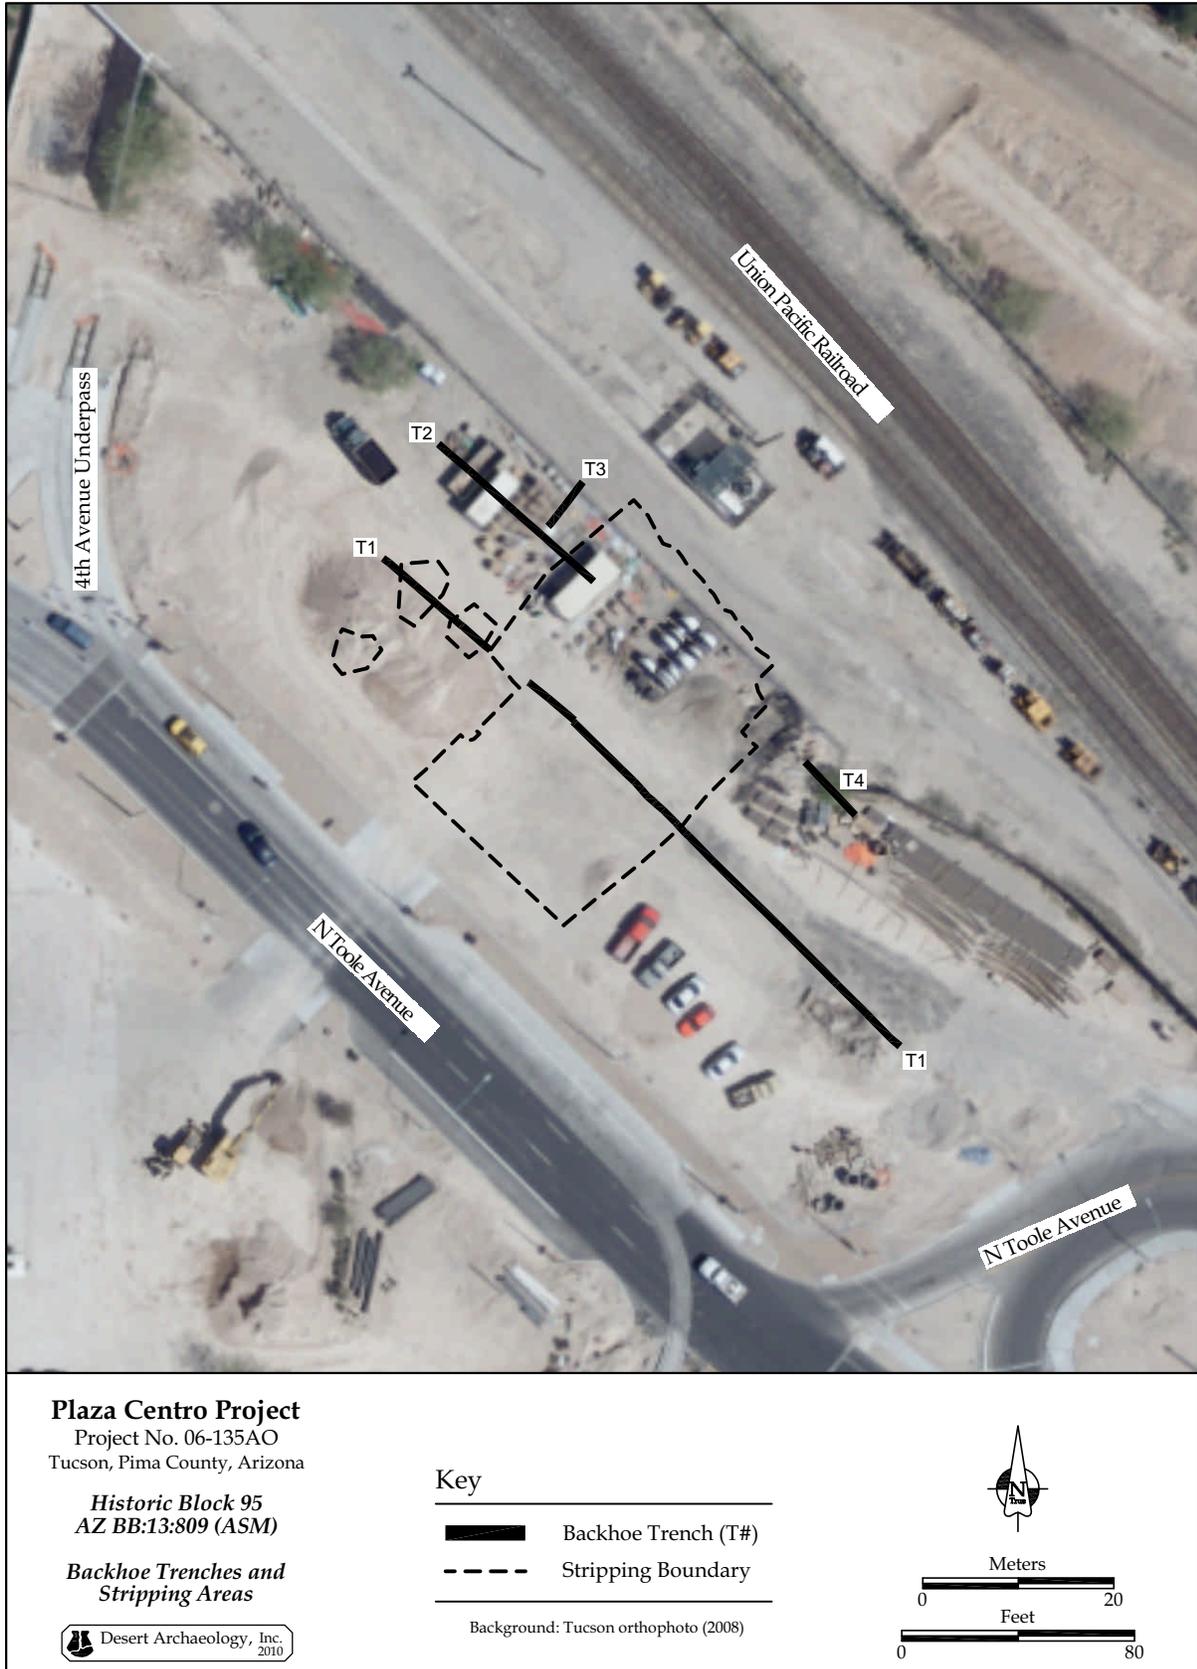
Figure 3.1. Location of backhoe trenches and extent of backhoe stripping, Historic Block 95, AZ BB:13:809 (ASM).

A backhoe equipped with a 70-cm-wide bucket was used to excavate four trenches to locate archaeological features and to determine the location of disturbances (Figure 3.1). Unexpectedly, numerous intact subsurface features were located in the first trench; Trench 1 was 75.0 m long, and was positioned across the center of the project area. The trench was excavated down to caliche, a hard layer of calcium carbonate that develops in portions of the desert Southwest. Five features were identified in the trench, including an outhouse pit, a large planting hole, the foundation of the Southern Pacific Clubhouse, and an ore waste pit. Trench 2, 21.5 m long, was excavated north of Trench 1. The basement of the Hooper warehouse was identified within this trench. Trench 3 was then excavated within the basement in an attempt to locate its northern edge. The trench was terminated, however, before the basement edge was found due to the proximity of a buried fiber optic cable. Trench 4 extended eastward from a concrete foundation, north of Trench 1, to determine if the area was completely disturbed; this proved to be the case.

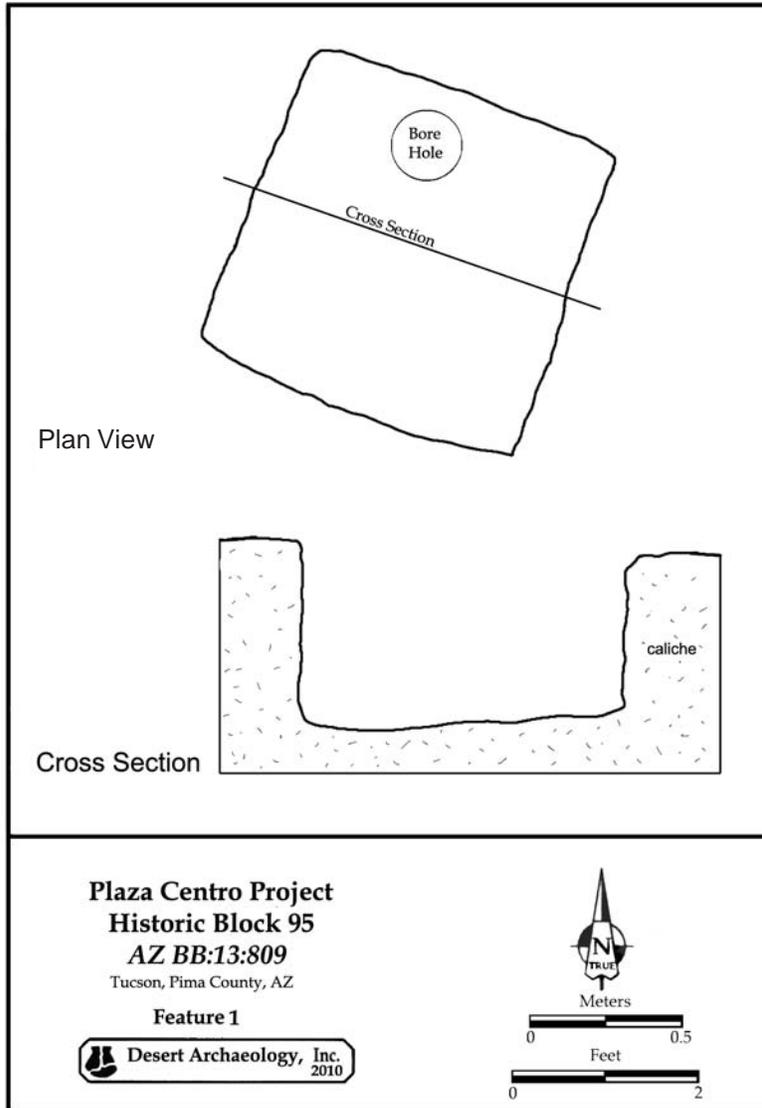
Figure 3.3. Plan view and profile drawing of Feature 1, an outhouse pit dating between 1887 and 1901, Historic Block 95.

Feature 1 was an outhouse pit located in Trench 1 (Figure 3.3). The pit was 1.10 m long by 1.05 m wide; it was at least 1.75 m deep. The upper fill was light tan brown silty sand with many pieces of gravel; the upper fill measured 1.23 m in depth. This fill appears to have been dumped into the pit as a closing or filling episode, with only a few artifacts present. The remaining 52 cm of fill was a mixture of light green clayey silt, white ash, and charcoal. Among the large number of artifacts recovered from this layer were a decorated O'odham water *olla*, a Mexican ceramic vessel shaped like a duck, tin cans, and assaying cupels. A modern borehole had intruded into the pit and was filled with concrete. The borehole almost certainly removed some artifacts from the feature. The outhouse pit dates to the operation of the Tucson Sampling Works, from 1887 to 1901.

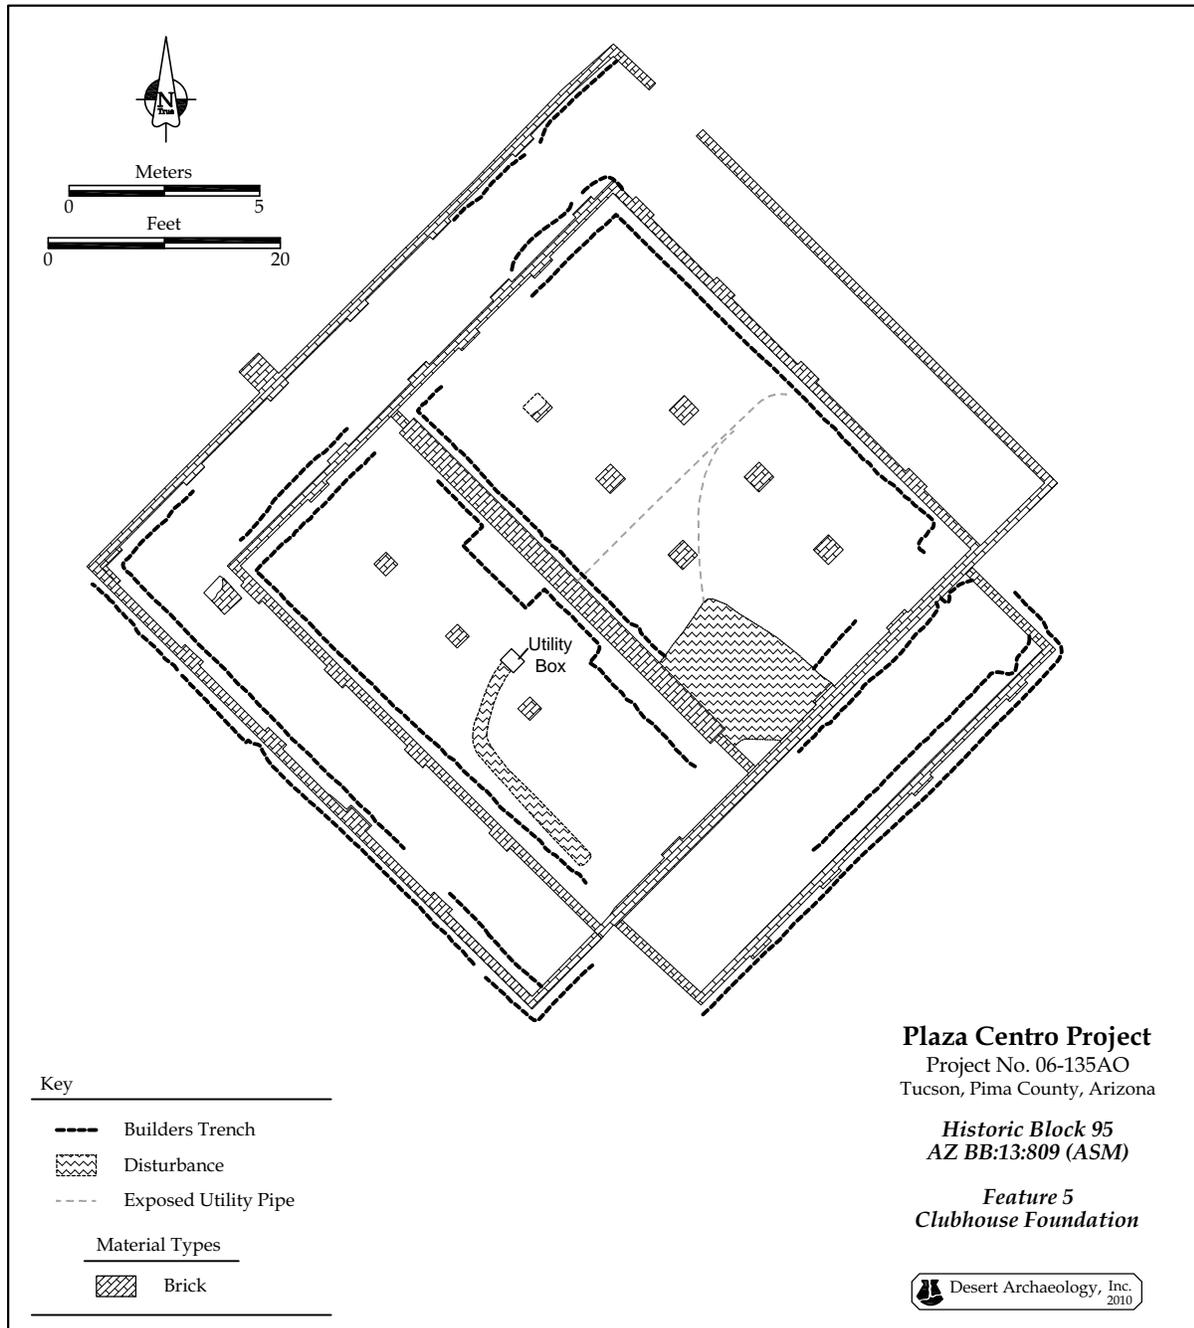
Figure 3.4. Plan view map of Feature 5, the Southern Pacific Clubhouse foundations, Historic Block 95.

The individual bricks used in construction of the building measured 8¾ inches long by 4 inches wide and 3 inches tall. They were extruded, unmarked

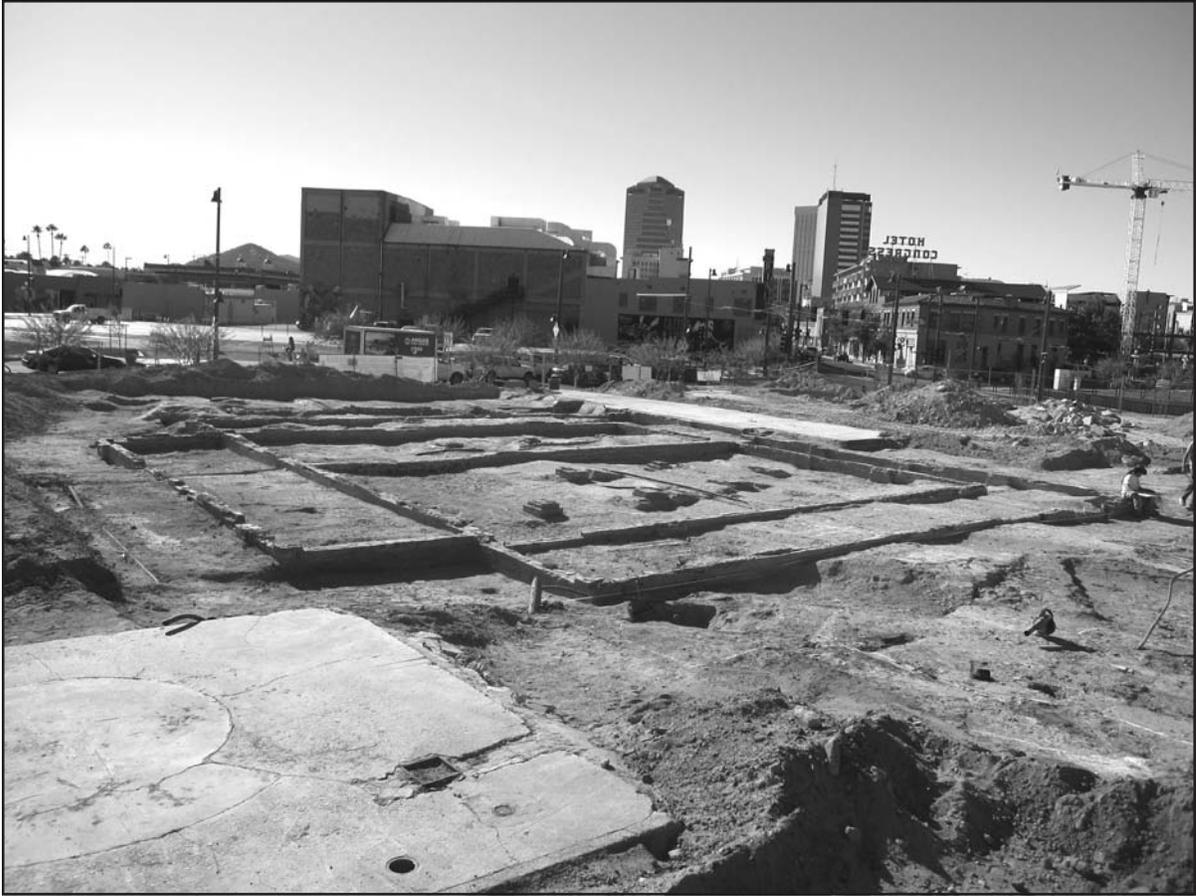
Figure 3.5. Photograph of the Southern Pacific Clubhouse foundations, Feature 5, looking southwest, Historic Block 95.

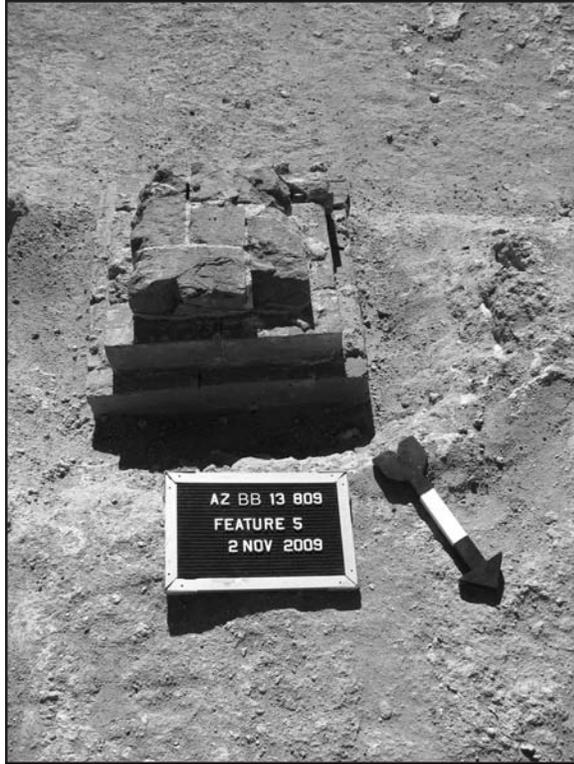
Figure 3.6. A floor support pier inside Feature 5, the Southern Pacific Clubhouse, Historic Block 95.

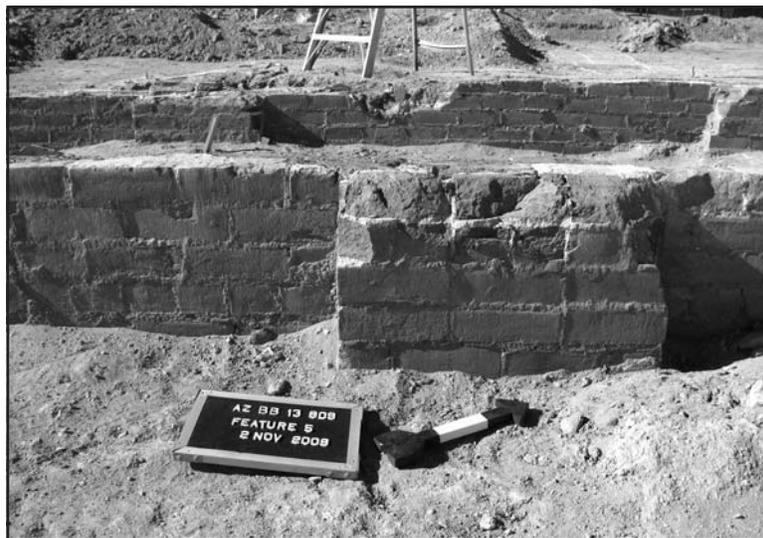
Figure 3.7. Detail of the foundation brickwork and a built-in floor support pier for Feature 5, the Southern Pacific Clubhouse, Historic Block 95.

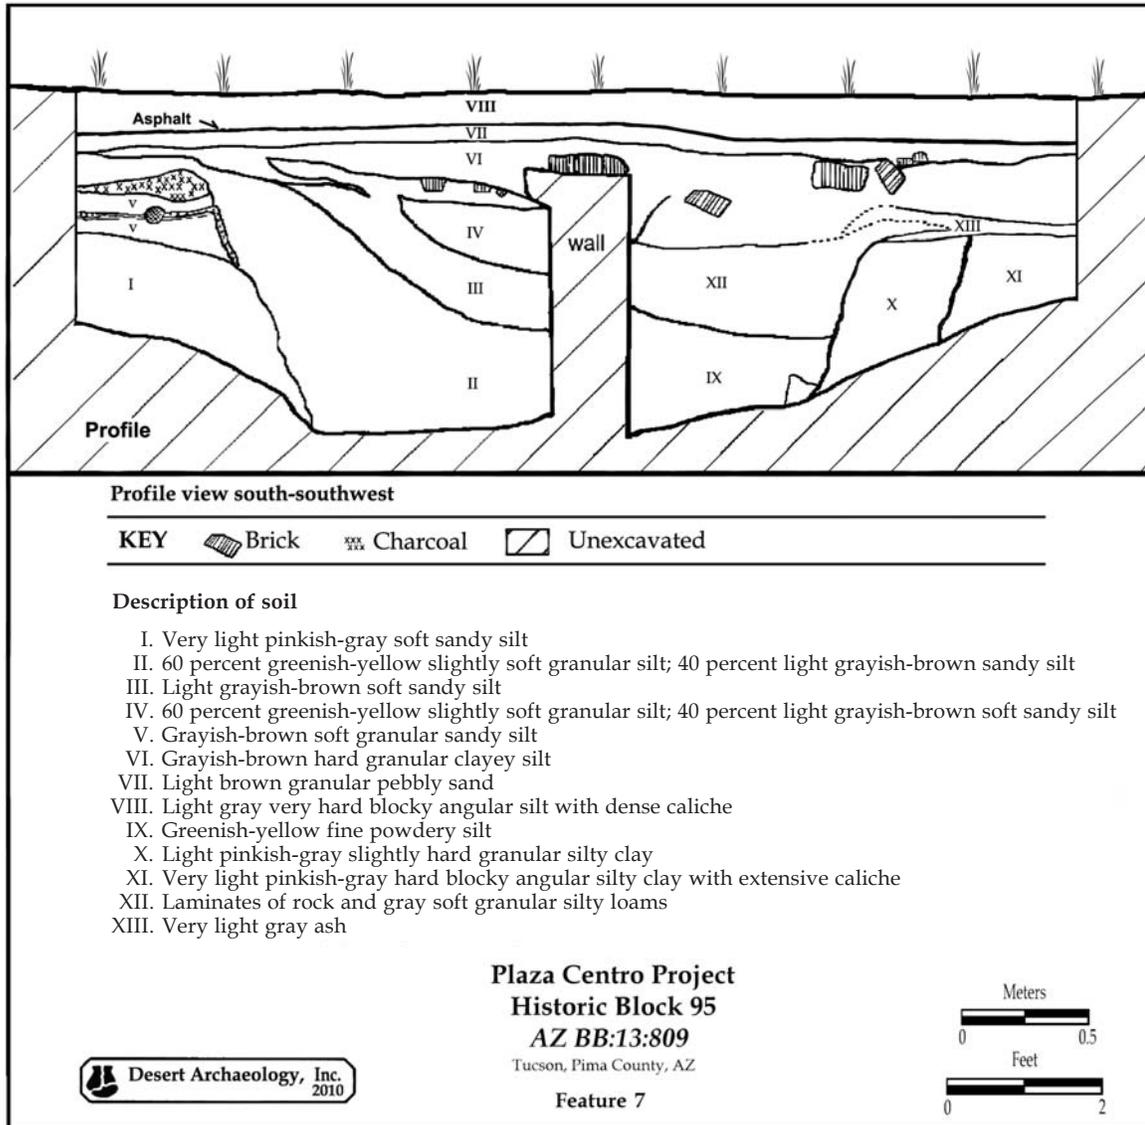
Figure 3.8. Profile drawing of Feature 7, an ore waste pit, Historic Block 95.

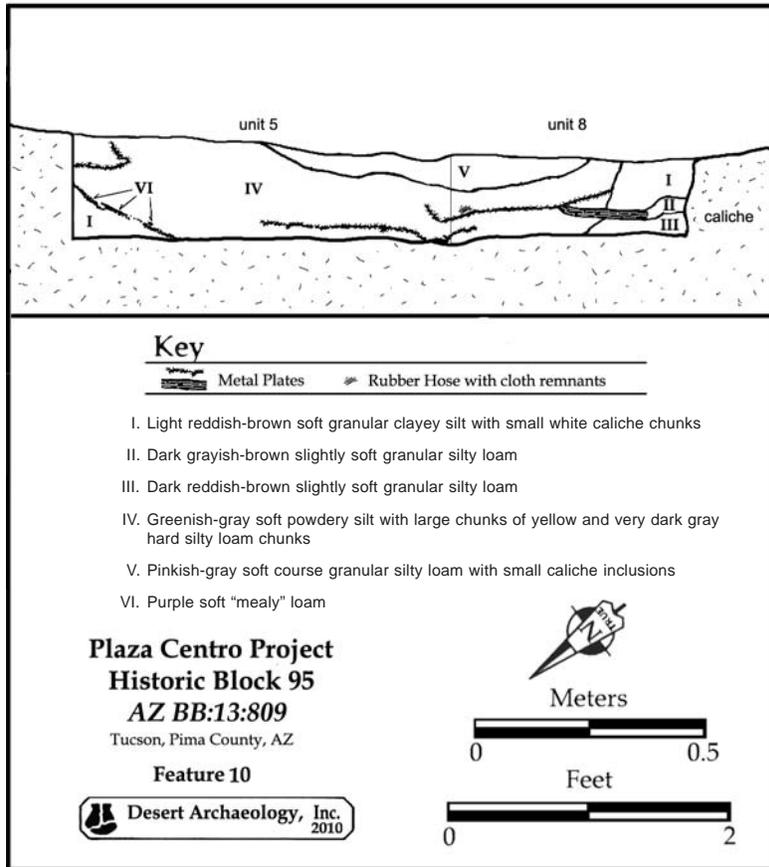
Figure 3.9. Profile drawing of Feature 10, an ore waste pit, Historic Block 95.

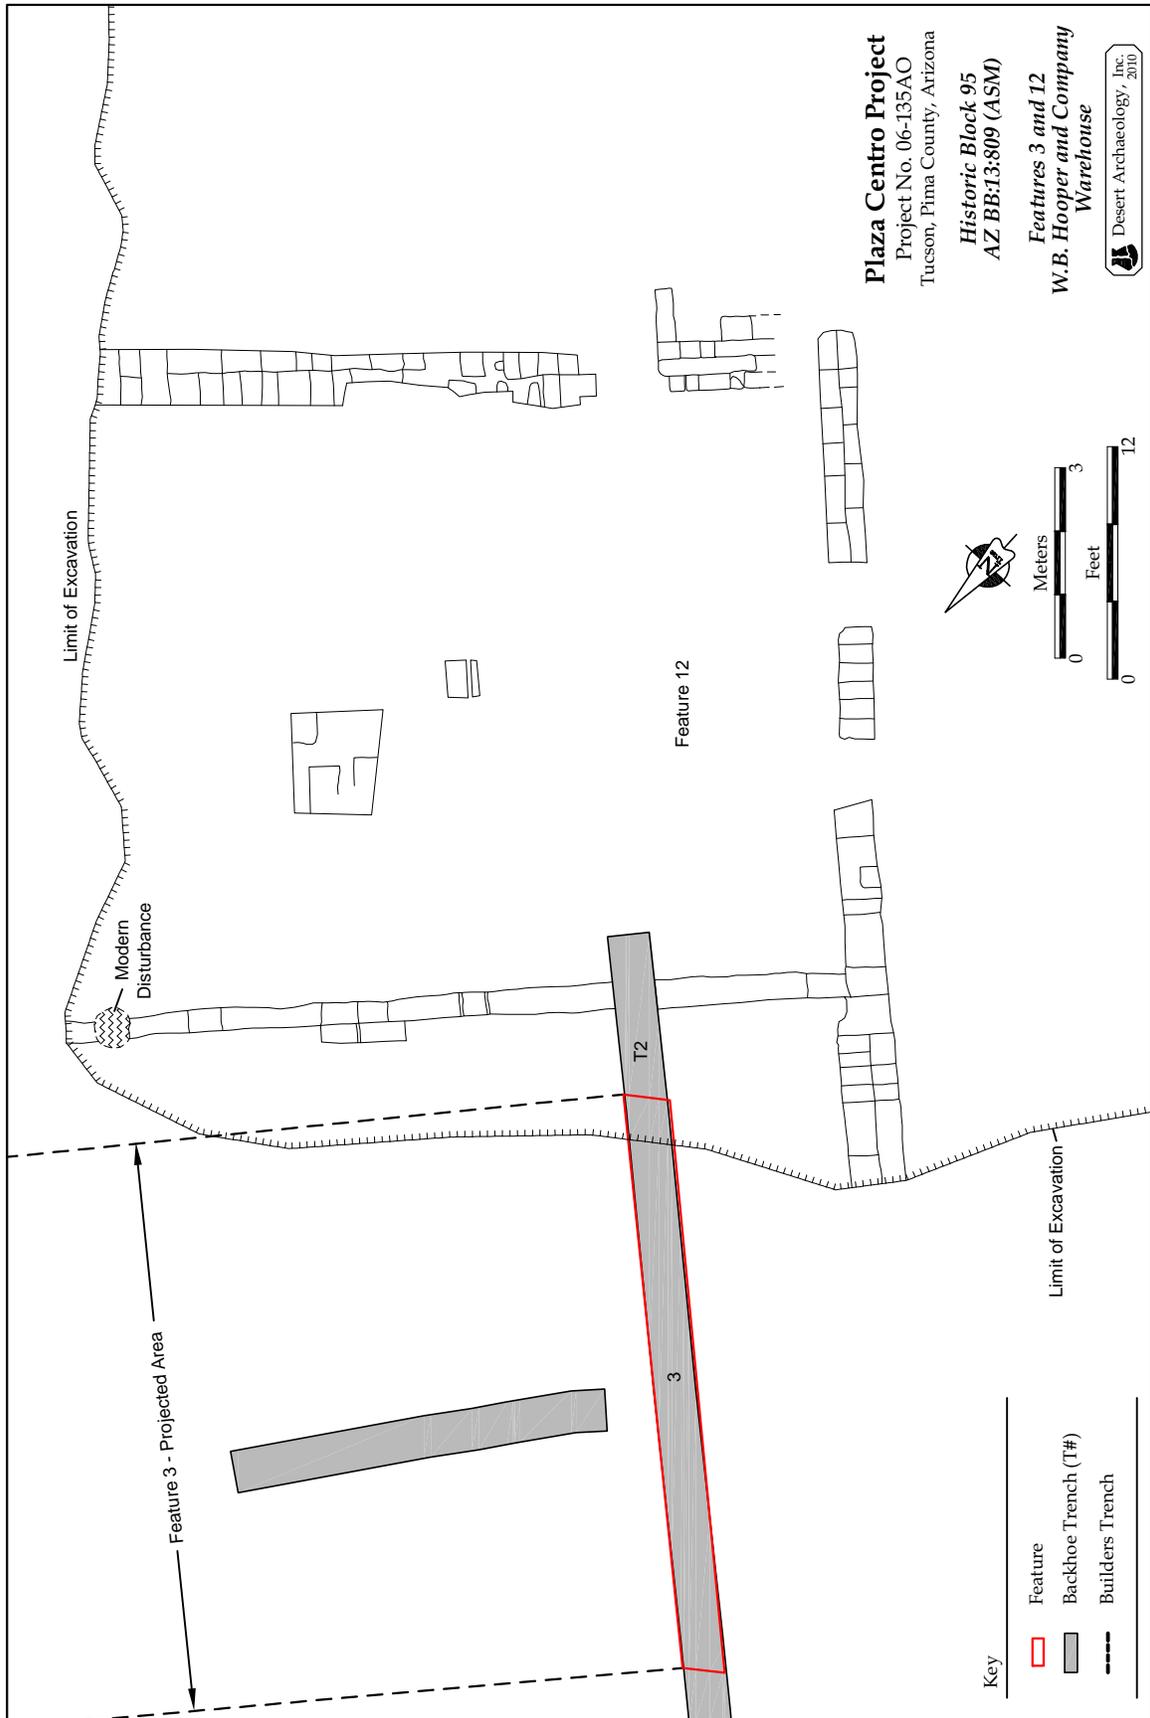
Figure 3.10. Plan view of Features 12 and 3, the William B. Hooper & Co. warehouse, Historic Block 95.

Feature 12 was the adobe brick foundation of the William B. Hooper & Co. liquor warehouse (1880-

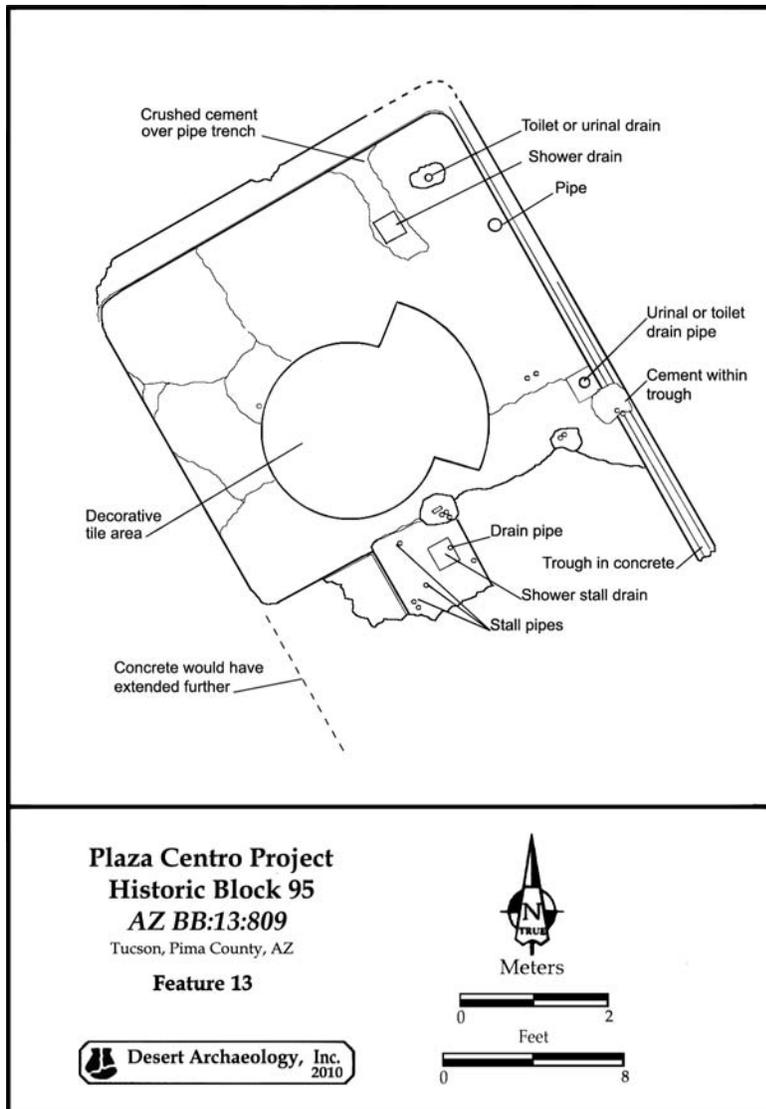
Figure 3.11. Plan view of the Southern Pacific Washroom, Feature 13, Historic Block 95.

The concrete foundation measured 7.55 m in length and 5.78 m in width (Figures 3.11 and 3.12). It was constructed from concrete poured-in-place. The center of the floor had a "keyhole" design, which was apparently the location of decorative tiles, probably in the form of the front of either a Southern Pacific insignia, or possibly a train engine with a cattle-catcher. The tiles were missing, but the con-

Adjacent to the western shower area was another pipe opening in the floor, probably for a sink or a urinal. Another, larger pipe was present in the floor nearby, for either a toilet or a urinal. No pipes for enclosing this area were noted, further suggesting this was a urinal location. To the east, along the northern wall, was a toilet location marked by a large drain pipe and smaller pipes for the toilet stanchion stall walls and floor.

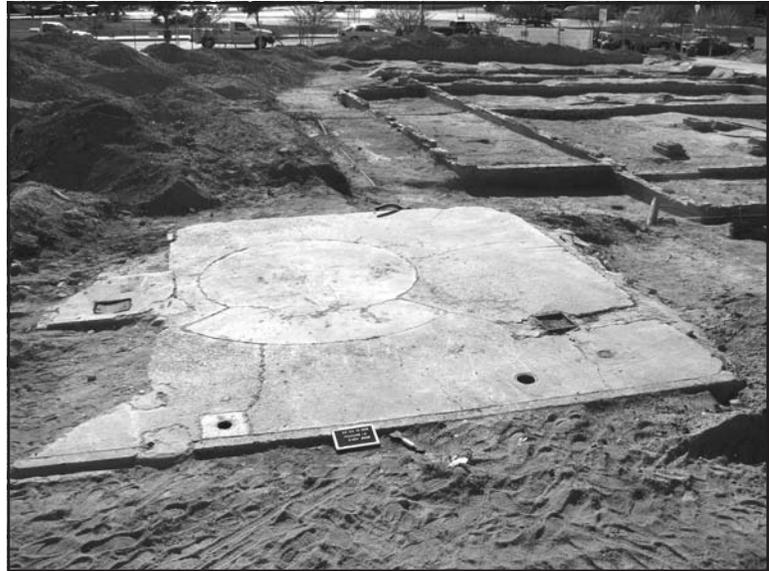
Figure 3.12. Photograph of the Southern Pacific washroom foundation, Feature 13, looking south, Historic Block 95.

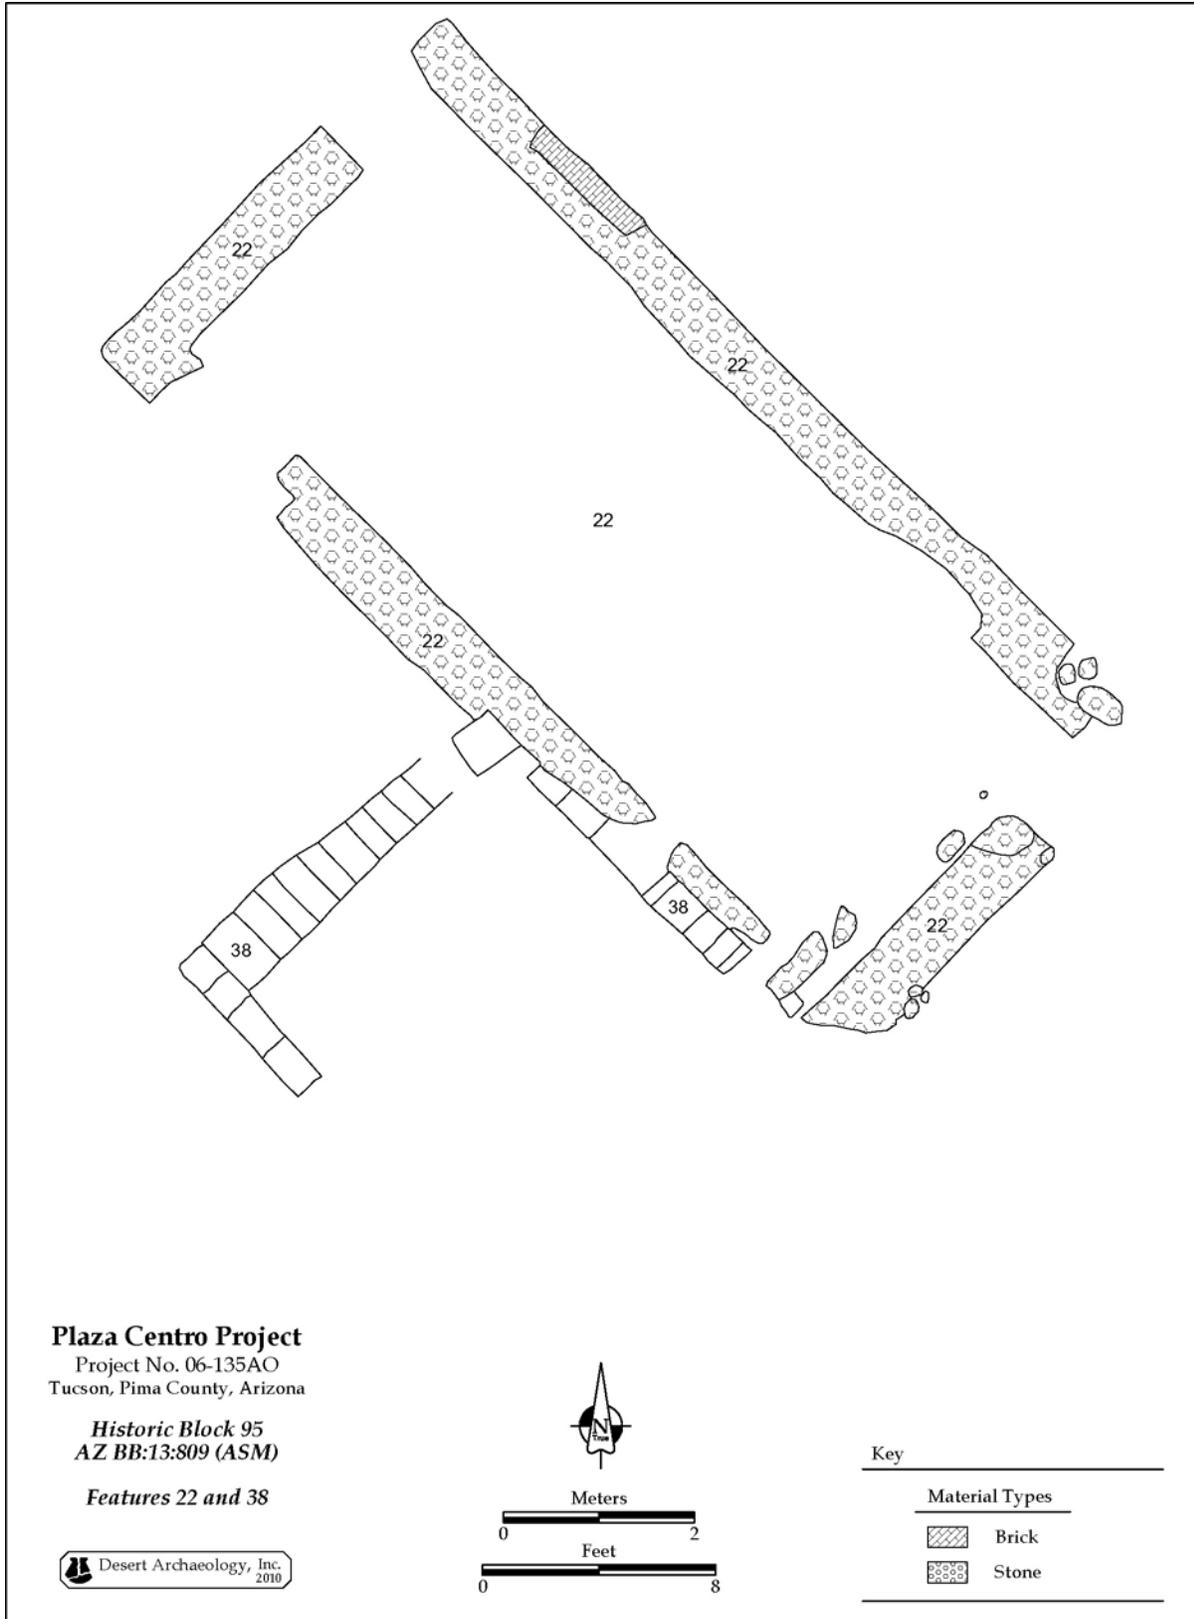
Figure 3.13. Plan view of Features 22 and 38, a house foundation, Historic Block 95.

Feature 22 was the rock foundation for a room attached to the back of an adobe brick dwelling (Figures 3.13 and 3.14). The foundations were made from basalt rocks quarried from Sentinel Peak (A-Mountain). The foundation was rectangular, measuring 10.8 m in length and 4.9 m in width. It ranged in width from 35 cm to 62 cm, averaging about 60 cm. A lime mortar was used to hold the rocks together. Remnants of brown adobe bricks were present on

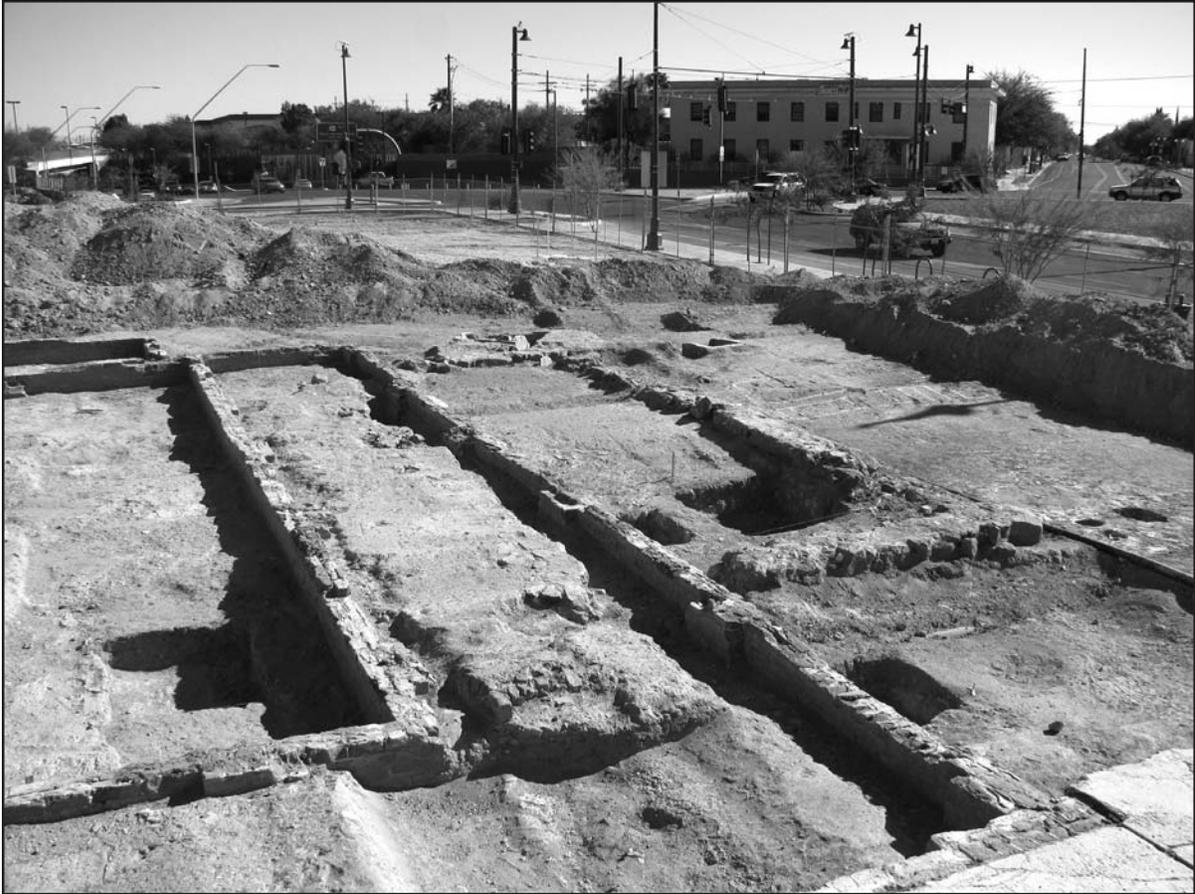
Figure 3.14. Photograph of the rock foundation of Feature 22, cut into by the later Southern Pacific Clubhouse foundation, Feature 5, looking to the southeast, Historic Block 95.

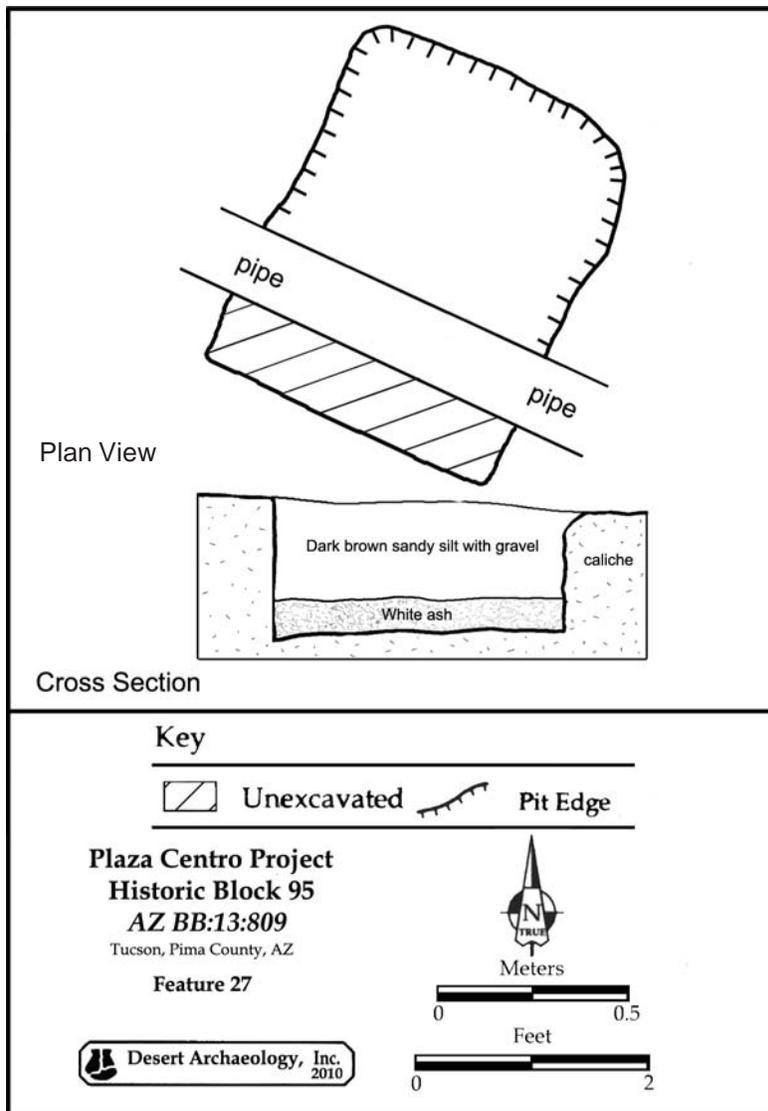
Figure 3.15. Plan view and cross section of Feature 27, a planting pit, Historic Block 95.

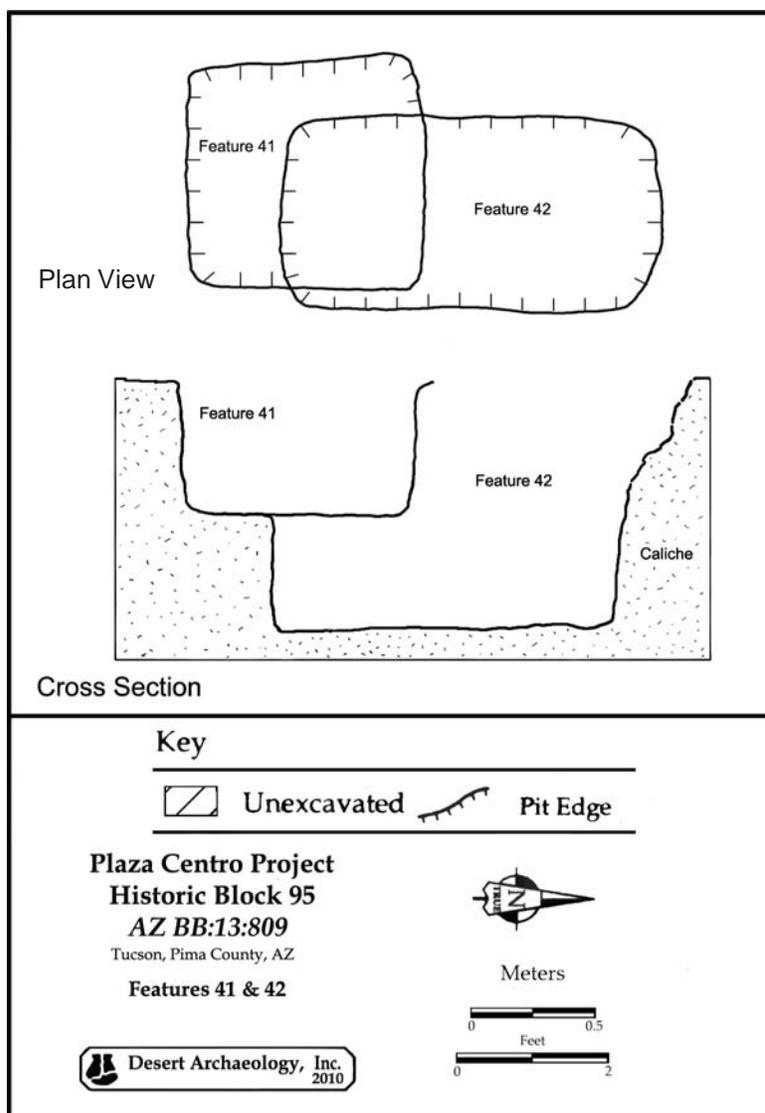
Figure 3.16. Plan view and cross section of Features 41 and 42, two out-house pits, Historic Block 95.

Feature 42 was an outhouse pit located west of the adobe dwelling (see Figure 3.16). It is depicted on the 1883 Sanborn Fire Insurance map as a small building marked "W.C.," for either Waste Closet or Water Closet. The rectangular pit was 1.58 m long by 81 cm wide. It was cut into the caliche layer, and was at least 1.02 m deep. Measuring from the historic ground surface, the pit would have been 1.3 m deep. The upper portion of Feature 42 contained

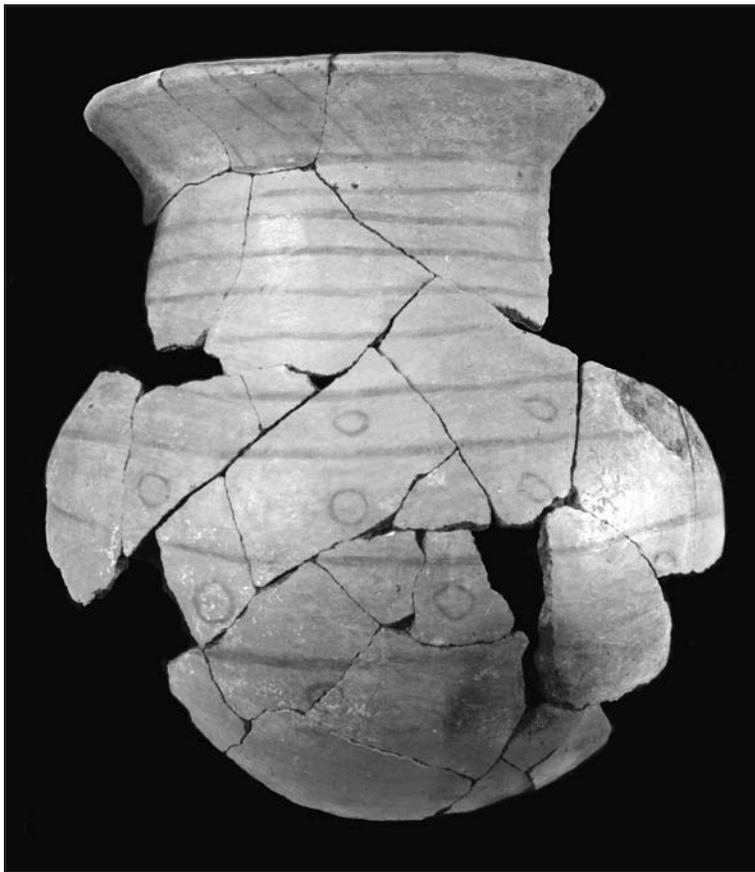
The vessel form of American Territorial period O'odham pottery recovered from Block 95 contexts is reported in Table 4.6. The only distinct vessel form identified was the tall flare-rim jar. Classification of that vessel using the Shepard-Braun approach indicates this Papago Black-on-red jar would have been a temporary storage container well-suited to water cooling (Figure 4.2; Table 4.7). Based on its partial reconstruction, this jar had a diameter of 32 cm and a height of 30 cm. Assuming it had a roughly spherical shape, it would have held approximately 3.75 gallons (14.1 liters) of liquid.

Figure 4.2. Papago Black-on-red jar recovered from Historic Block 95 Feature 1 (2009-699-2).

1 (see Figure 4.2) was partially reconstructible and once held about 3.75 gallons of water. These pots quickly fell out of favor with Euro-American residents after indoor plumbing was installed. They continued to be used by local Mexican-American families into the 1930s or 1940s, with some people

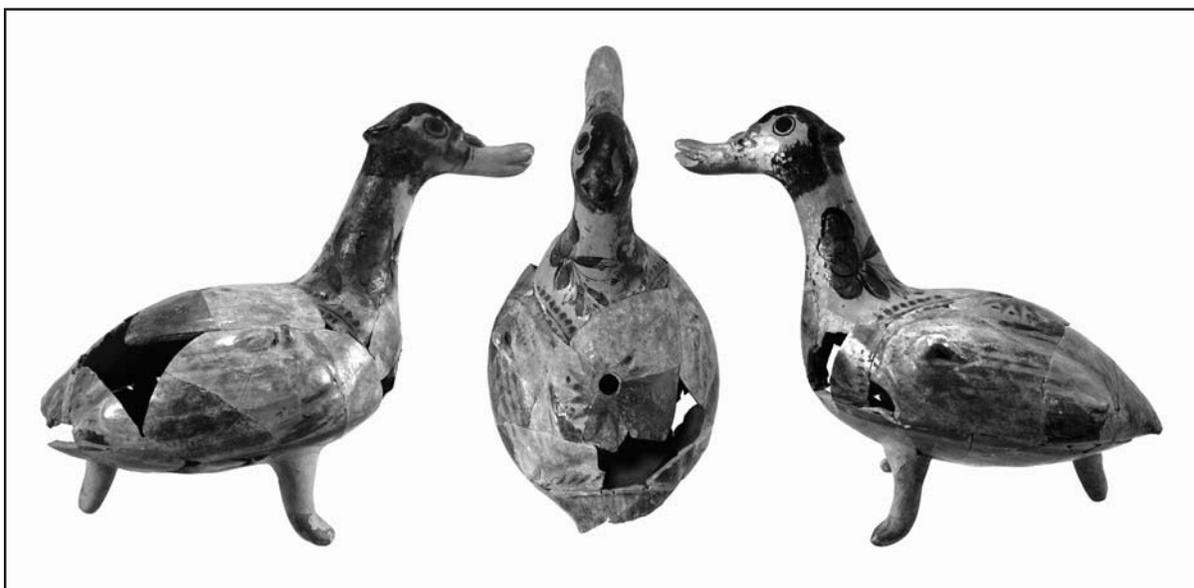
Perhaps most interesting was a charming ceramic duck effigy pot made in Mexico (Figure 4.4). The duck was 8.75 inches tall and 11.00 inches long. It was hand-made, with the bottom and top halves made separately and then joined; the two legs and a third peg leg were attached on the bottom. The duck was then painted light brown with black, red, and blue designs, including flowers on the neck and a star or flower around a vent hole in the back. Two small loop handles are present, although it is unclear if the duck was designed to hang in the air.

Figure 4.4. A Mexican duck effigy vessel from Feature 1, Historic Block 95 (2009-699-3).

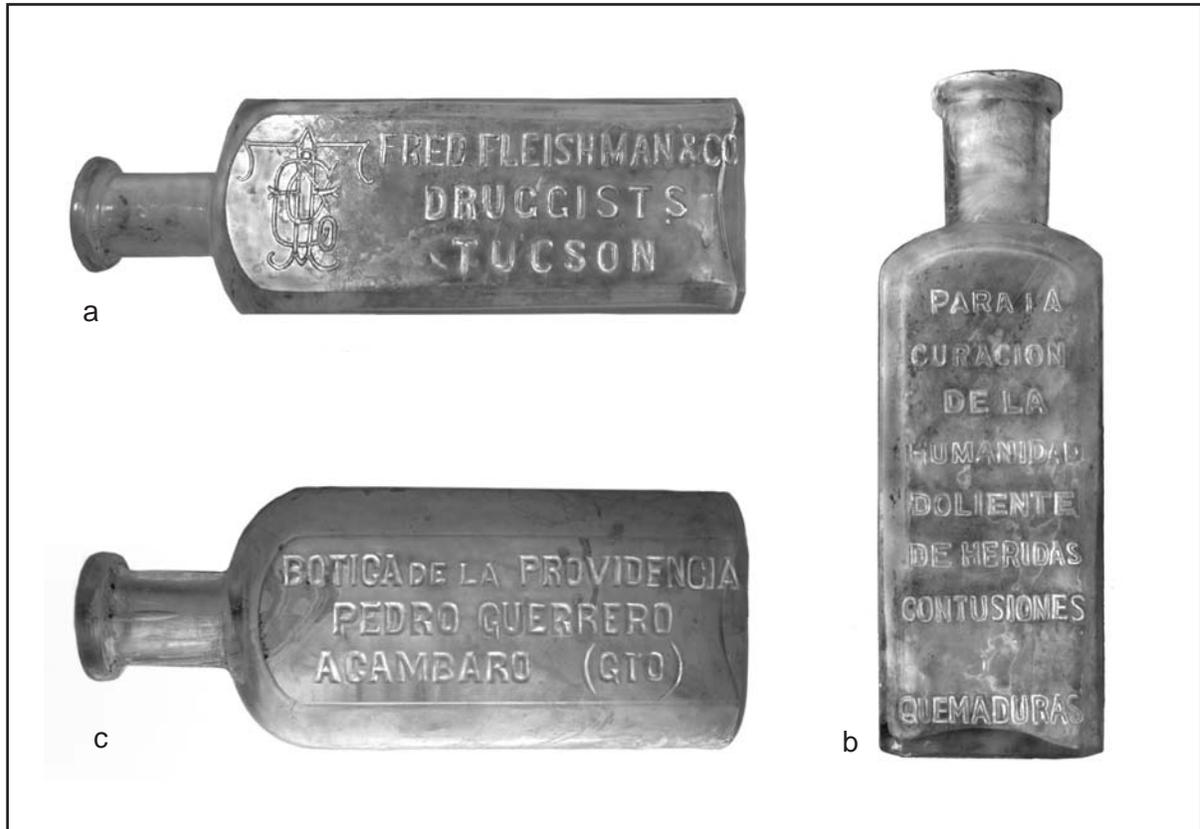
Medical artifacts consisted of 76 fragments of medicine bottles and a pipette. Five of the bottles were marked with either product or pharmacy names (Figure 4.7a-c). These were: (1) BOTICA DE LA PROVIDENCIA PEDRO GUERRERO; (2) TA SLOCUM CO. MANFG CHEMISTS NEW YORK

LONDON FOR CONSUMPTION AND LUNG PROBLEMS; (3) FELLOWS AND CHEMISTS ST. JOHN NB; (4) FRED FLEISCHMAN & CO. DRUGGISTS TUCSON; and (5). BALSAMO EL PRODIJIOSO AMERICA DE OCCIDENTE POR FRANCO FERNANDEZ DE CORDOVA. The lung medicine bottle indicates someone discarding trash

into the Feature 42 outhouse may have had tuberculosis, a common disease in Tucson in the late nineteenth and early twentieth centuries. The two bottles embossed with Spanish are unusual, and suggest a Mexican-American discarded the bottles into the outhouse. It is unlikely that Charles Wores would have visited a Mexican pharmacy in Tucson, and this is supported by the presence of the Fred Fleischman bottle, which once held prescription medicine.

Figure 4.7. Three medicine bottles, Historic Block 95: (1) a clear bottle from Feature 42 is marked “FRED FLEISCHMAN & CO. DRUGGISTS TUCSON” (2009-699-6); (b) a clear bottle from Feature 42 is marked “BALSAMO EL PRODIJIOSO AMERICA DE OCCIDENTE POR FRANCO FERNANDEZ DE CORDOVA” on its reverse side (2009-699-7); (c) a light green bottle from Feature 41 is marked “BOTICA LA PROVIDENCIA PEDRO GUERRERO” (2009-699-8).

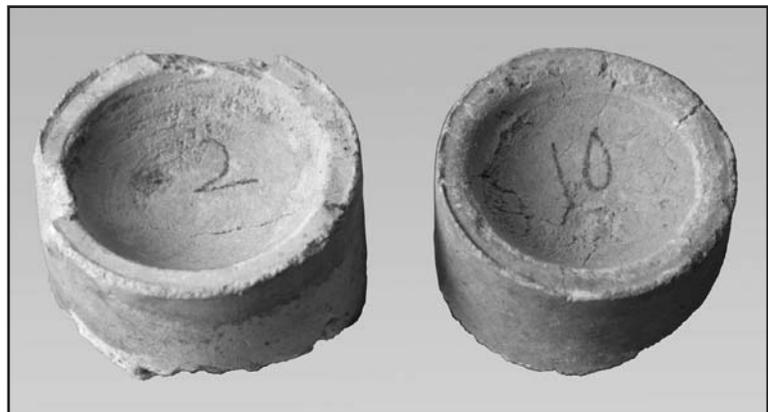
Figure 4.8. A pair of cupels from Feature 45, Historic Block 95, one with the number 2 written in its interior in pencil and the other with the number 10 (2009-699-9 and 10).

Cupels are small, shallow dishes made from fine bone ash that has been compressed in a form; the best cupels were made using a machine (Figure 4.8).

Cupels were used to extract silver or gold from base metals, such as lead, copper, zinc, or arsenic. In small-scale cupellation, the purpose was to determine the silver or gold content of a sample. Lead was often added to the sample, sometimes in the form of lead foil. The weight of the sample was recorded, and it was then placed in a furnace and heated until the sample had melted. Some of the lead was absorbed into the cupel, and a button of silver and/or gold formed in the center of
