Archaeological Excavations of the Hooper Warehouse, the Tucson Sampling Works, and the Southern Pacific Railroad Clubhouse, Historic Block 95, Tucson, Pima County, Arizona

Technical Report No. 2009-08
Desert Archaeology, Inc.

3975 North Tucson Boulevard, Tucson, Arizona 85716 • June 2010

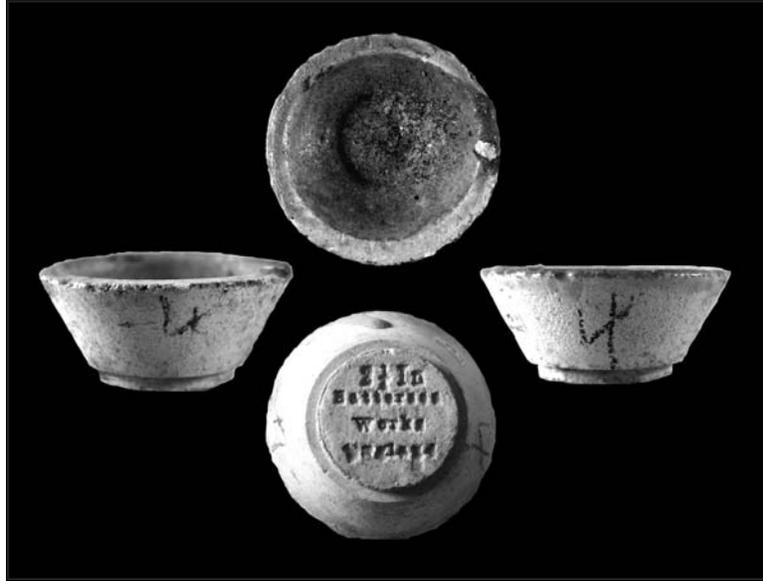
Figure 4.9. A scorifier found near the Feature 12, Historic Block 95, foundation (2009-699-11).

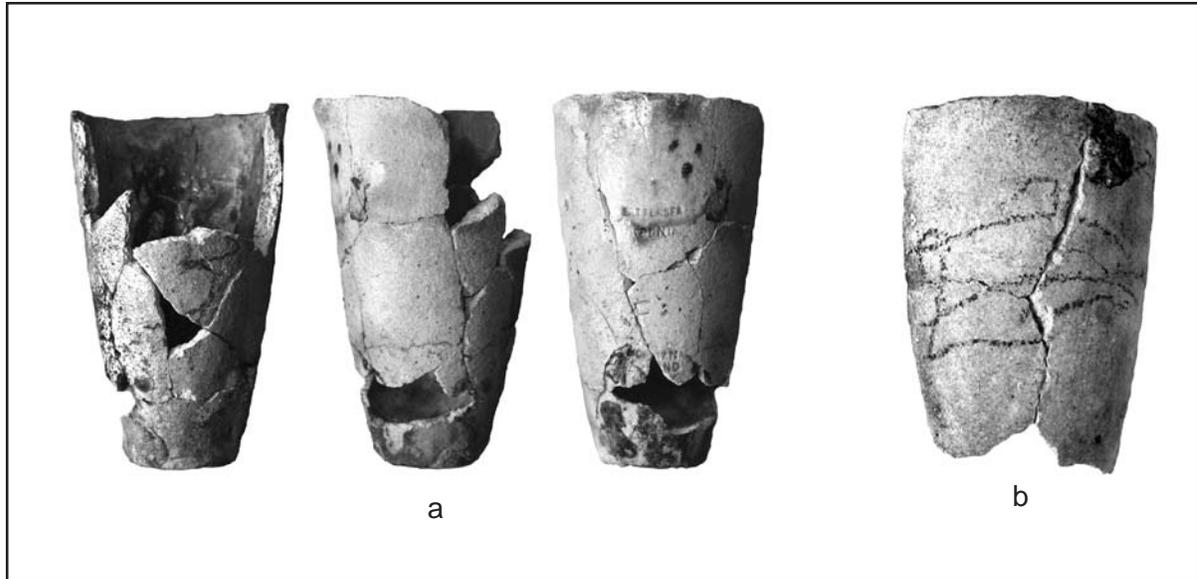
Figure 4.10. Two crucibles recovered from Historic Block 95: (a) from Feature 45, with an illegible mark scrawled on its exterior (2009-699-12); (b) marked BATTERSEA WORKS ENGLAND (2009-699-13).
