# Appendix F

**Historic Property Inventory Forms: Ineligible Properties**

**North Side of Broadway from Euclid to Country Club**

HISTORIC PROPERTY INVENTORY FORM

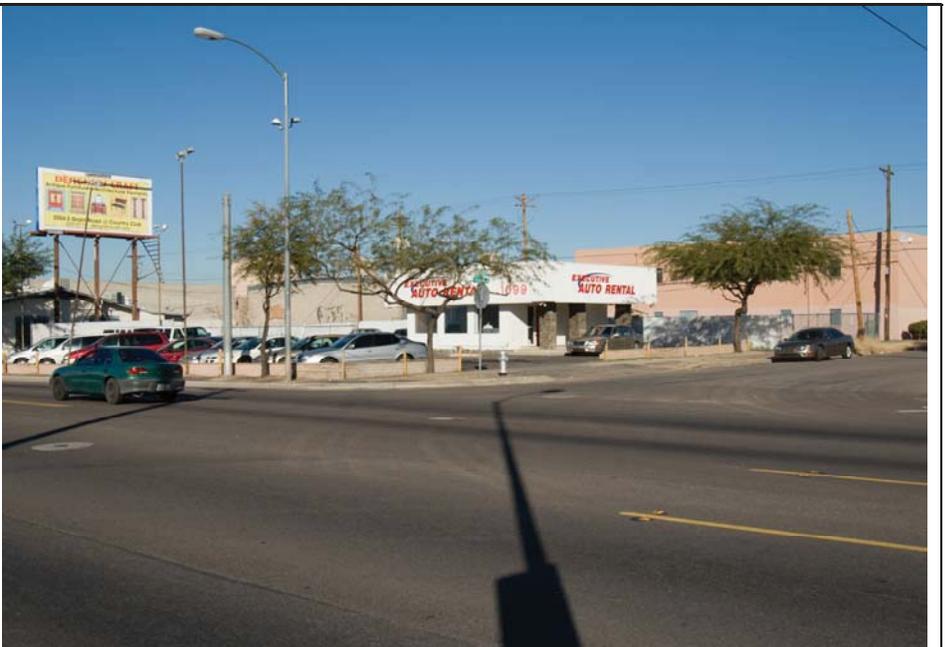
Negative No. 124062430

Roof Built up with polymer coating Foundation Stone

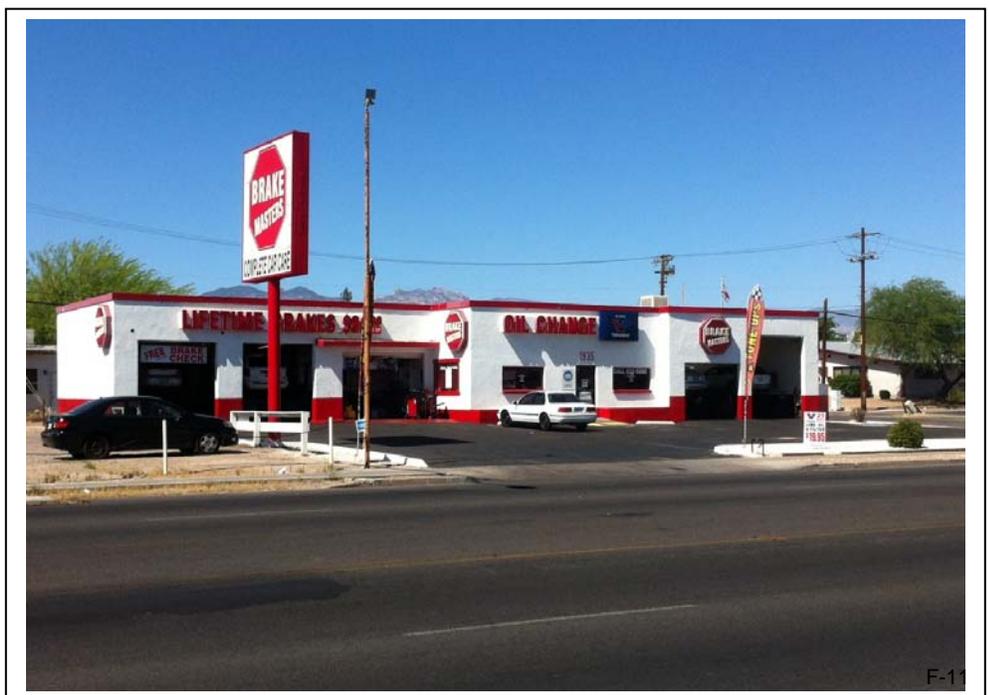
Negative No.: 45

- 1. LOCATION  Original Site  Moved (date \_\_\_\_\_) Original Site: \_\_\_\_\_
- 2. DESIGN (Describe alterations from the original design, including dates—known or estimated—when alterations were made) Single-story commercial building with rectangular massing, moderate setback, flat roof, small picture windows, and five garage bays with roll up doors. At an unknown date, the windows were replaced and a three-car garage was added to the west elevation.

- 4. MATERIALS (Describe the materials used in the following elements of the property)  
Walls (structure): Unknown Foundation: Concrete Roof: Built up  
Windows: Steel  
If the windows have been altered, what were they originally? \_\_\_\_\_  
Wall Sheathing: Stucco  
If the sheathing has been altered, what was it originally? \_\_\_\_\_

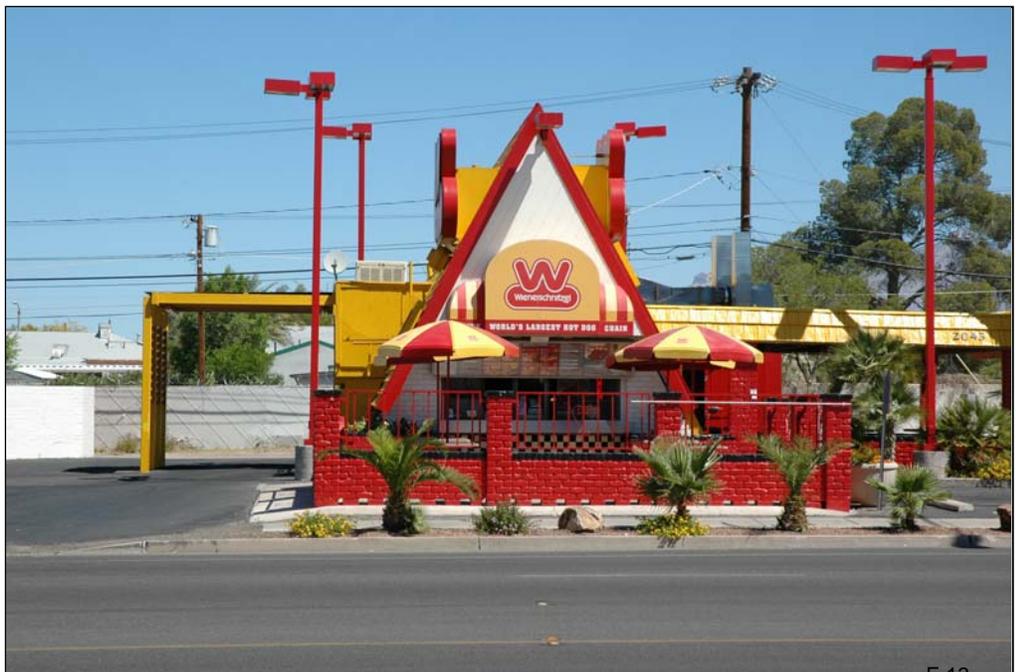
Negative No.: BC-2043

4. MATERIALS (Describe the materials used in the following elements of the property)  
Walls (structure): Masonry and wood Foundation: concrete Roof: Aluminum shingle  
Windows: Fixed glass  
If the windows have been altered, what were they originally? Appear unaltered  
Wall Sheathing: Painted concrete masonry  
If the sheathing has been altered, what was it originally? Appears unaltered

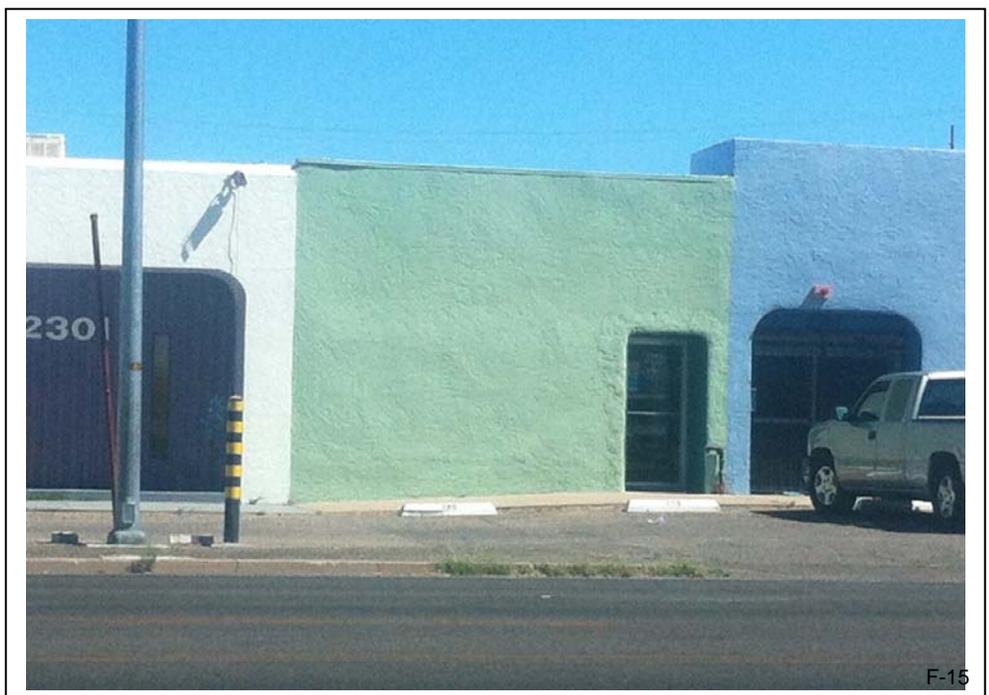
Negative No.: 31

- 4. MATERIALS (Describe the materials used in the following elements of the property)
  - Walls (structure): Concrete block/ wood frame Foundation: Concrete block Roof: Built up

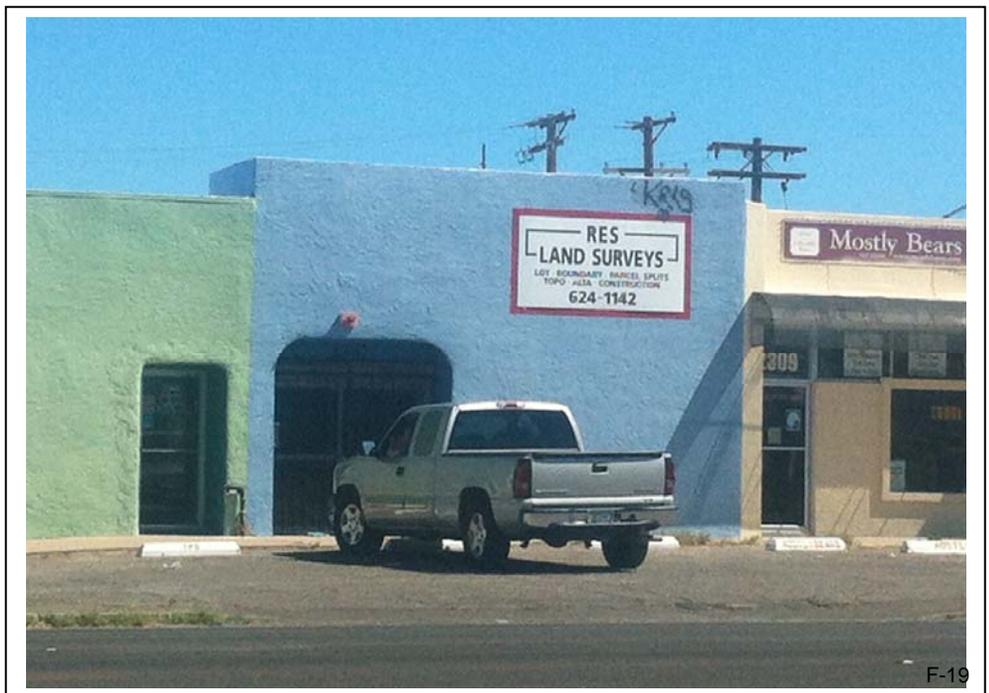
Negative No.: 32

- 4. MATERIALS (Describe the materials used in the following elements of the property)  
Walls (structure): Concrete block Foundation: Concrete block Roof: Built up  
Windows: Aluminum  
If the windows have been altered, what were they originally? \_\_\_\_\_  
Wall Sheathing: Stucco  
If the sheathing has been altered, what was it originally? \_\_\_\_\_

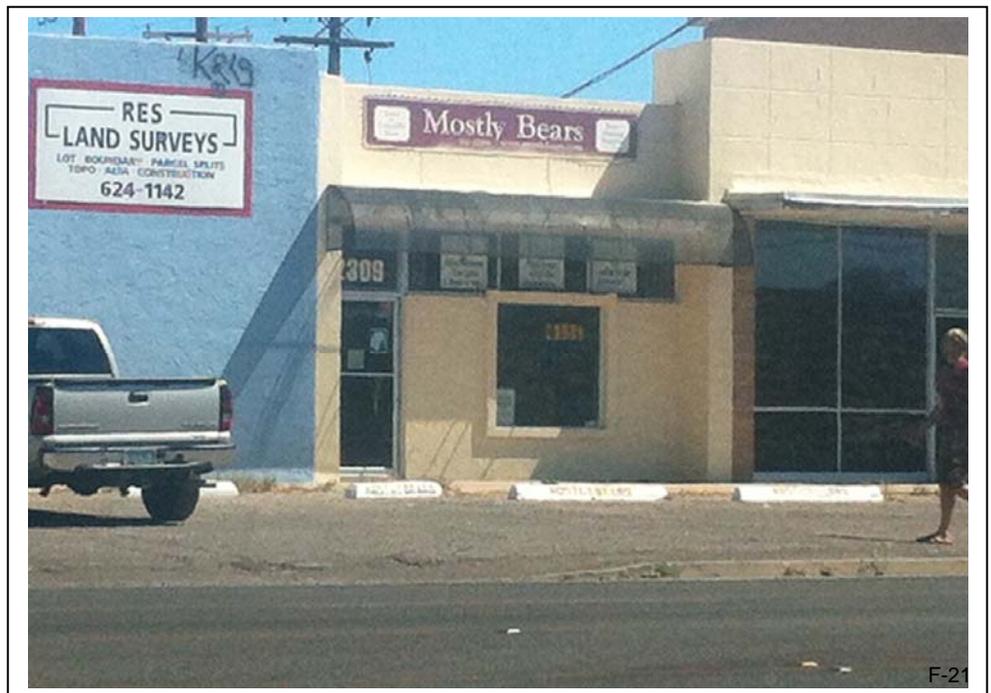
Negative No.: 33

- 1. LOCATION  Original Site  Moved (date \_\_\_\_\_) Original Site: \_\_\_\_\_
- 2. DESIGN (Describe alterations from the original design, including dates—known or estimated—when alterations were made) Single-story commercial building with boxy massing, flat roof and shallow parapet, shallow setback, central picture window capped by transom windows, and perforated metal awning over storefront. At an unknown time, the windows were replaced and it is unclear if the transom windows are original.

- 4. MATERIALS (Describe the materials used in the following elements of the property)  
Walls (structure): Concrete block Foundation: Concrete block Roof: Built up  
Windows: Steel/Aluminum  
If the windows have been altered, what were they originally? \_\_\_\_\_  
Wall Sheathing: \_\_\_\_\_  
If the sheathing has been altered, what was it originally? \_\_\_\_\_

- Property  is  is not eligible individually.
- Property  is  is not eligible as a contributor to a potential historic district.
- More information needed to evaluate.
- If not considered eligible, state reason: Windows replaced and additional windows added.

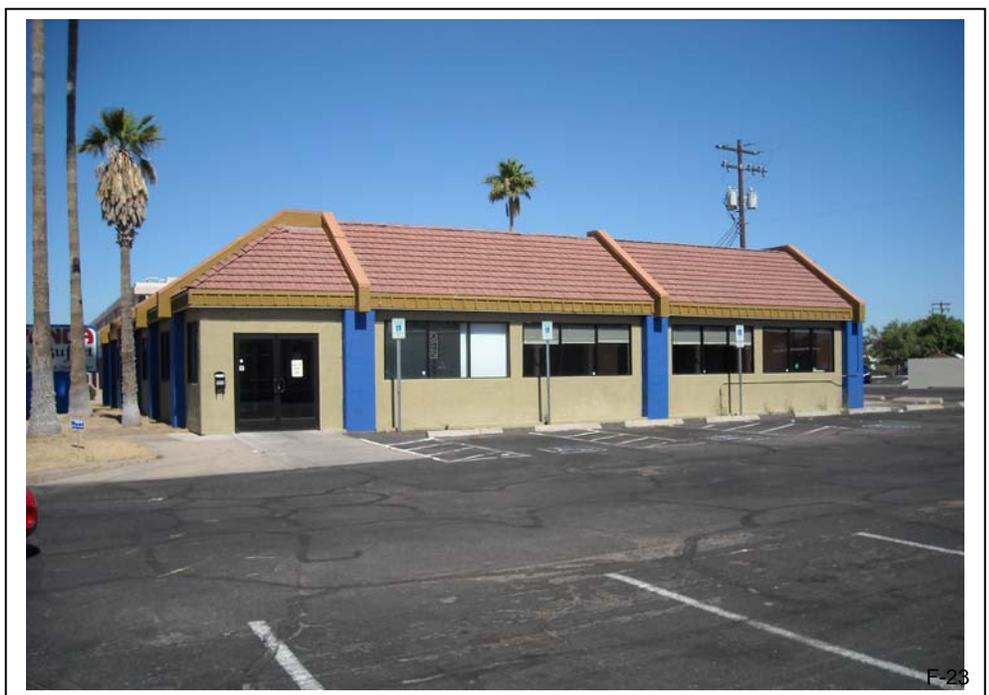
Negative No.: 45

- 4. MATERIALS (Describe the materials used in the following elements of the property)
  - Walls (structure): Concrete Block Foundation: Concrete Roof: Prepared roll and engineered tile

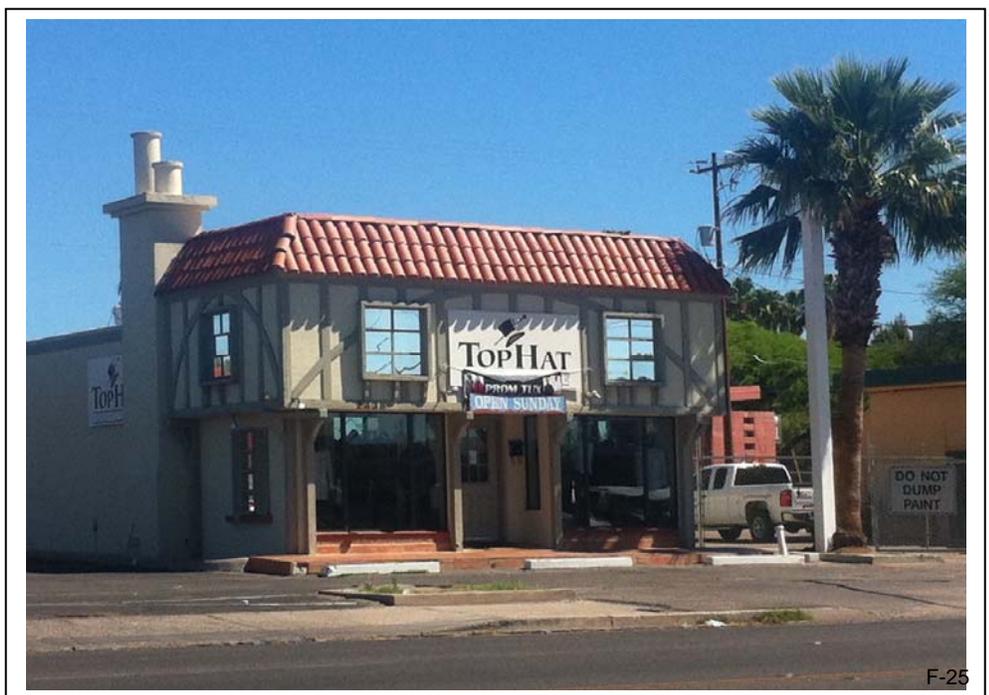
Negative No.: 34

- 4. MATERIALS (Describe the materials used in the following elements of the property)  
Walls (structure): Concrete block Foundation: Concrete Roof: Mission tile/built up  
Windows: Wood  
If the windows have been altered, what were they originally? \_\_\_\_\_  
Wall Sheathing: Stucco  
If the sheathing has been altered, what was it originally? \_\_\_\_\_

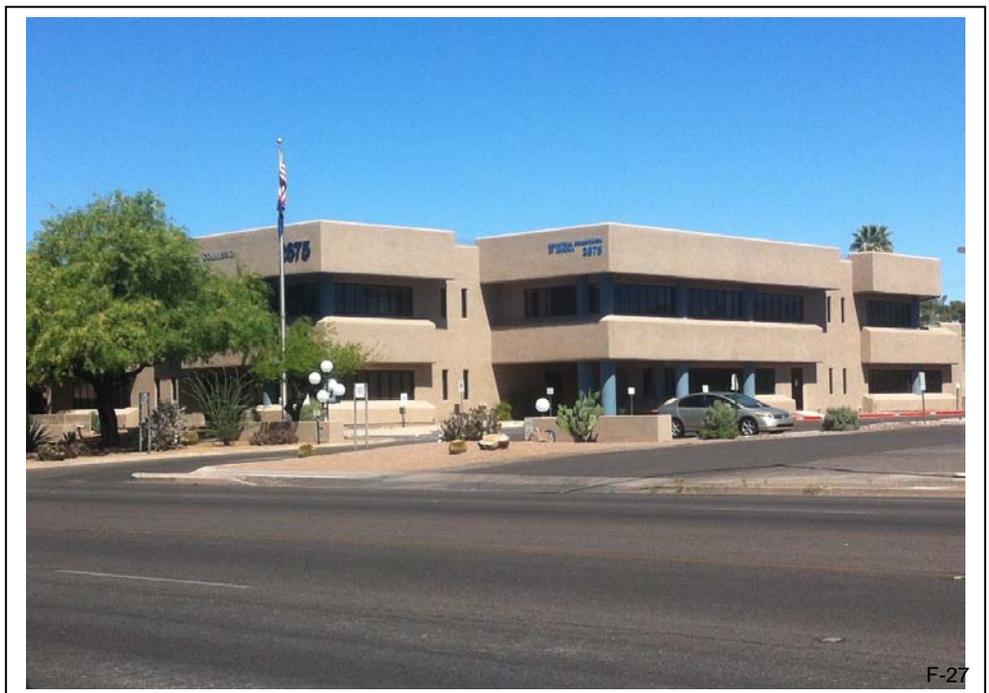
Negative No.: 37

4. MATERIALS (Describe the materials used in the following elements of the property)  
Walls (structure): Wood Frame Foundation: Concrete Roof: Composite roll  
Windows: Metal  
If the windows have been altered, what were they originally? Wood  
Wall Sheathing: Stucco  
If the sheathing has been altered, what was it originally? \_\_\_\_\_

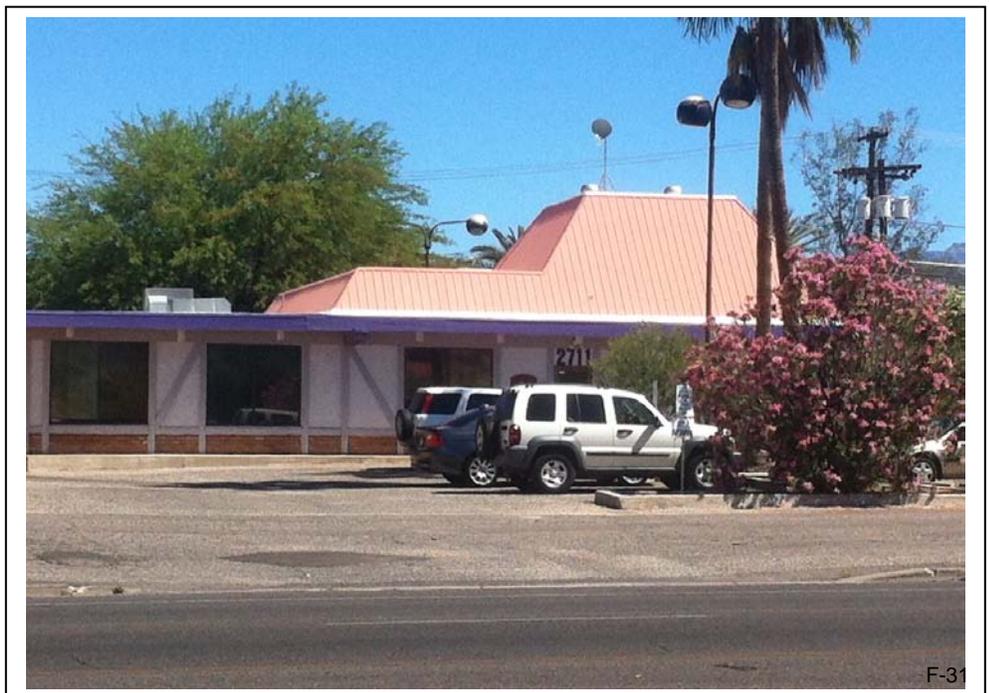
Negative No.: 39

- 1. LOCATION  Original Site  Moved (date \_\_\_\_\_) Original Site: \_\_\_\_\_
- 2. DESIGN (Describe alterations from the original design, including dates—known or estimated—when alterations were made) Single-story commercial building with rectangular massing, moderate setback, multiple roof forms with metal sheeting and exposed rafter ends, picture windows, wood trim, and stone facing along foundation. The building does not appear to have been significantly altered since its original construction.

- 4. MATERIALS (Describe the materials used in the following elements of the property)
  - Walls (structure): Wood Foundation: Concrete Roof: Metal
  - Windows: Metal

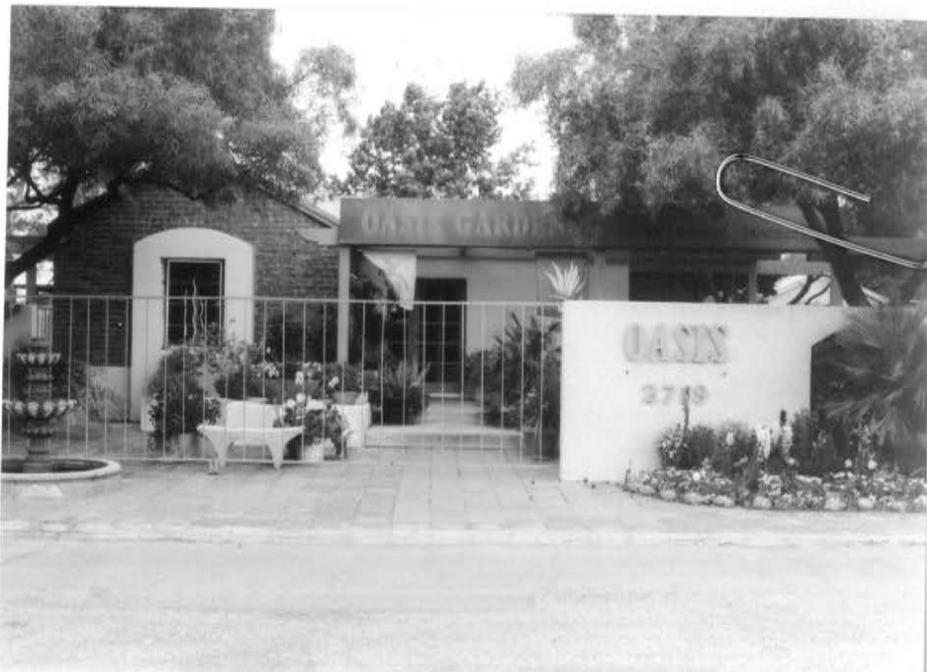
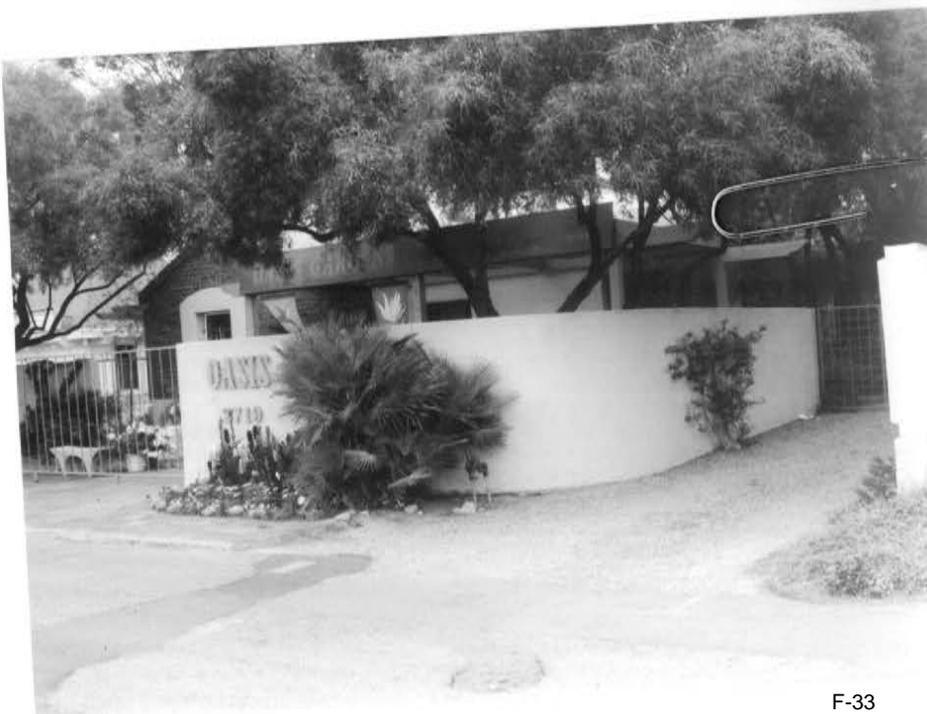
STORIES: 1  
FOUNDATION: concrete  
STRUCTURAL MATERIALS: brick

WALL CLADDING: brick, stucco

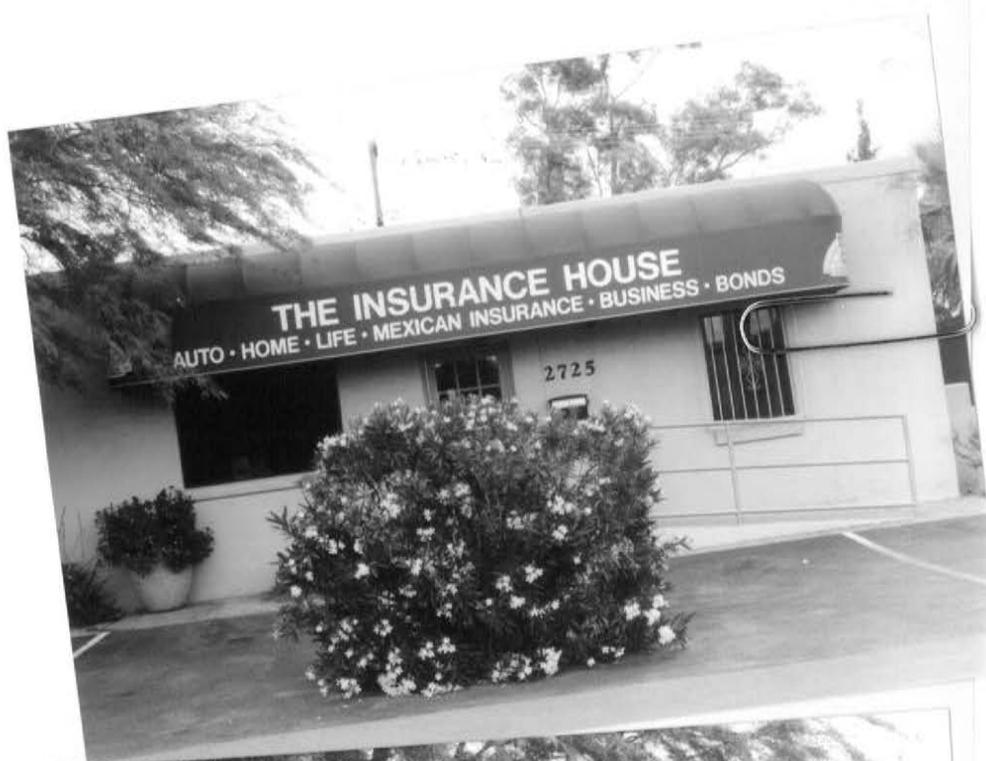
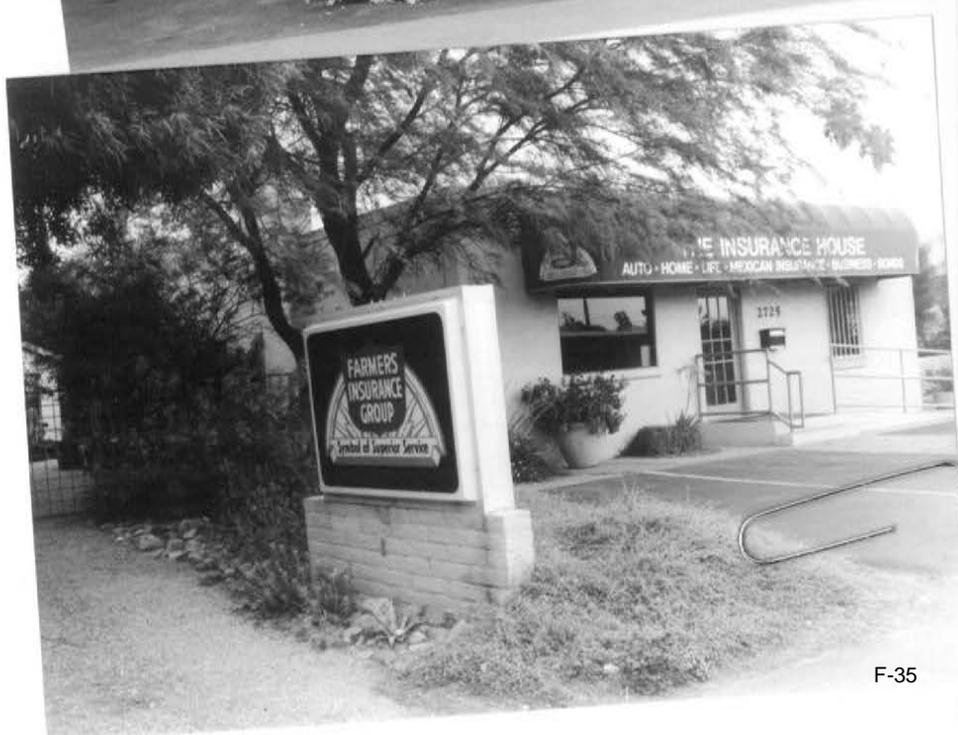
STORIES: 1  
FOUNDATION: concrete  
STRUCTURAL MATERIALS: brick

ALTERATIONS/DATES: originally Sonoran Ranch style--W front bay demolished, steel casement windows partially replaced with aluminum (1980s)--part of commercial strip

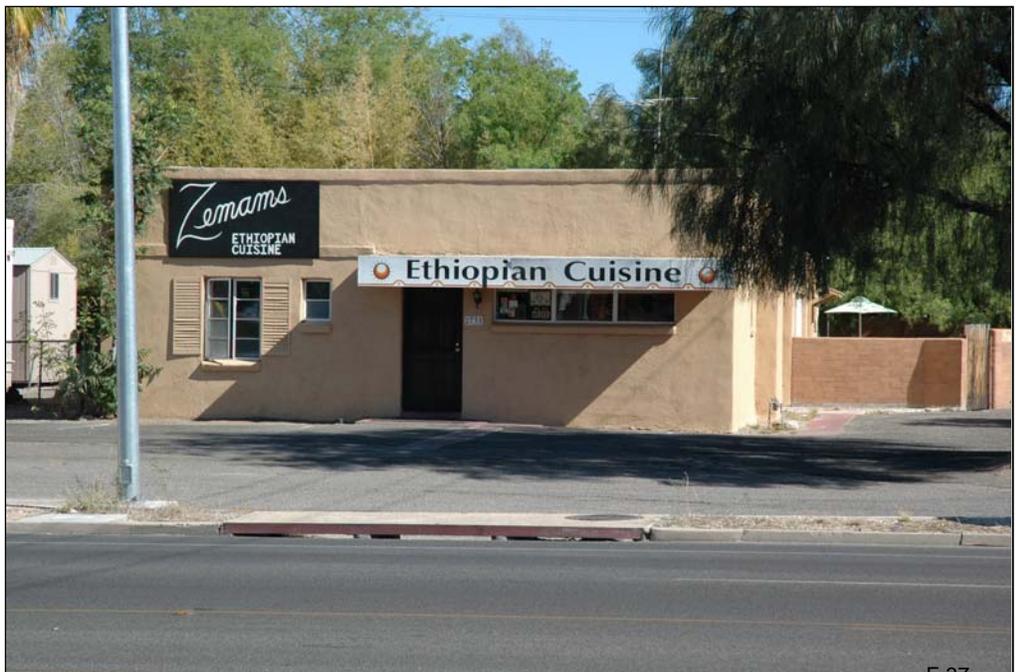
Date of photo: 4/18/09
View Direction (looking towards) N
Negative No.: BC-2731

4. MATERIALS (Describe the materials used in the following elements of the property)  
Walls (structure): Masonry Foundation: Concrete Roof: Asphalt  
Windows: Steel casement, aluminum slider  
If the windows have been altered, what were they originally? Likely more steel casement  
Wall Sheathing: Stucco  
If the sheathing has been altered, what was it originally? Brick

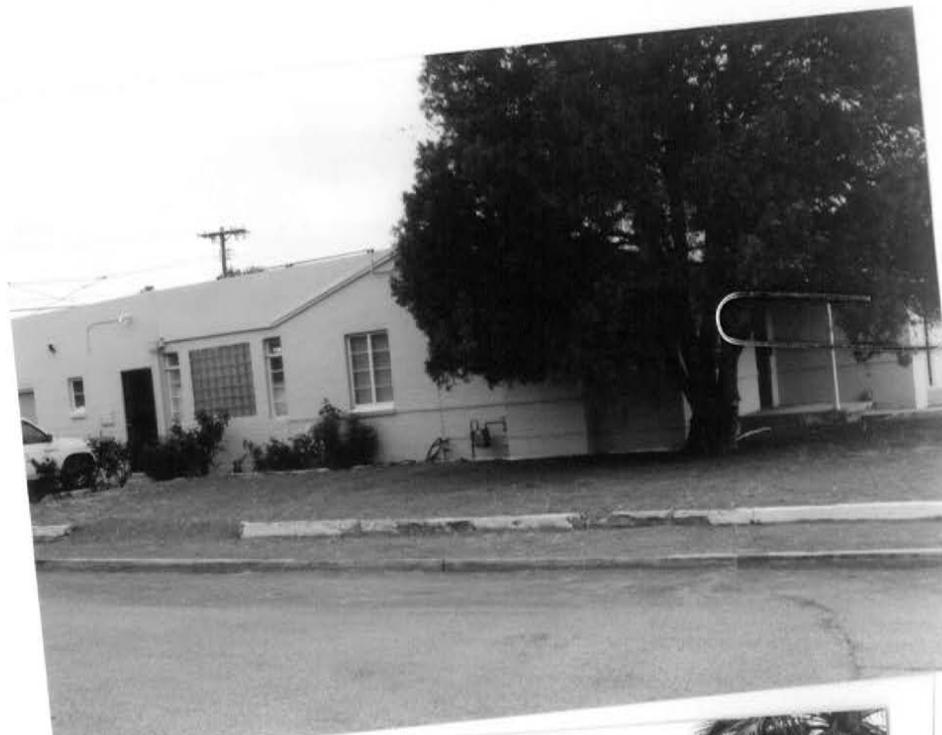
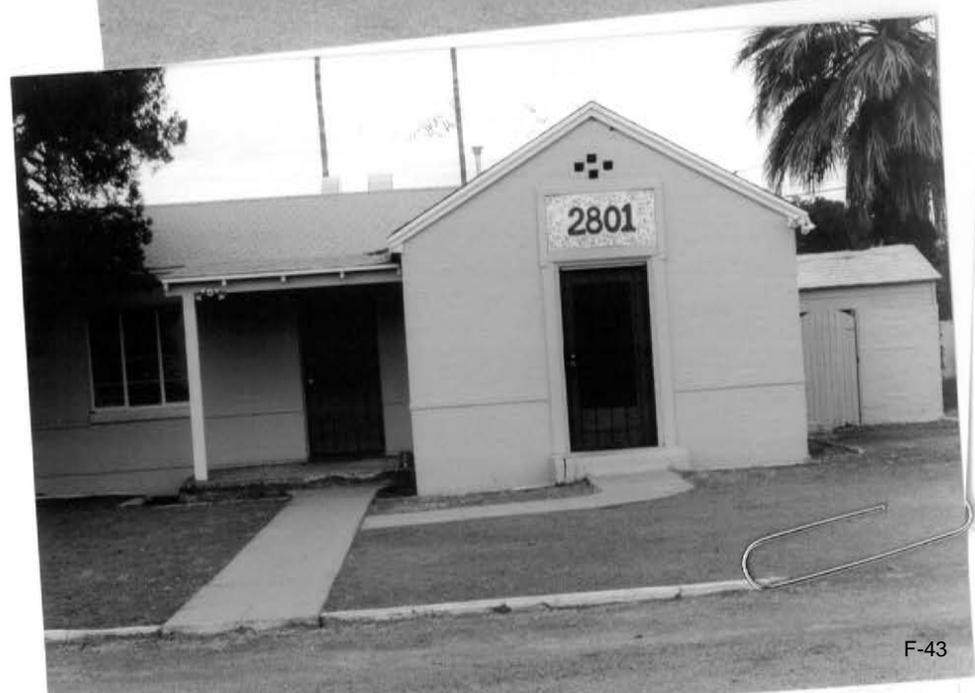
STORIES: 1  
FOUNDATION: concrete  
STRUCTURAL MATERIALS: brick

ALTERATIONS/DATES: window in E front bay replaced with doorway, rooms added on rear (1950s)--part of commercial strip

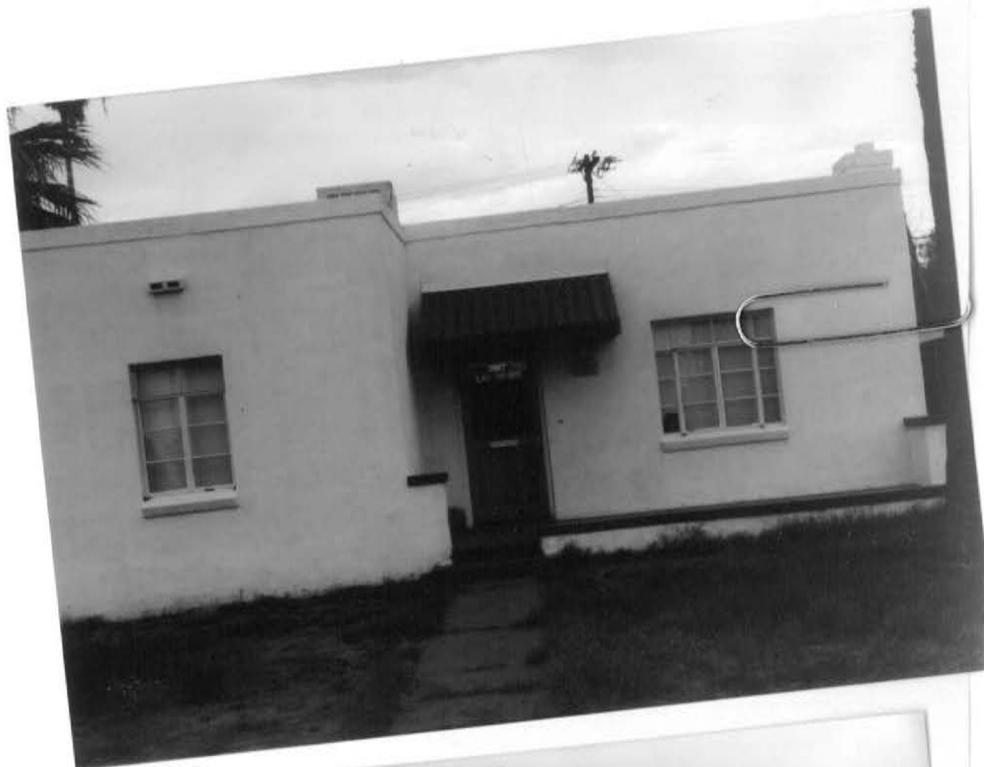
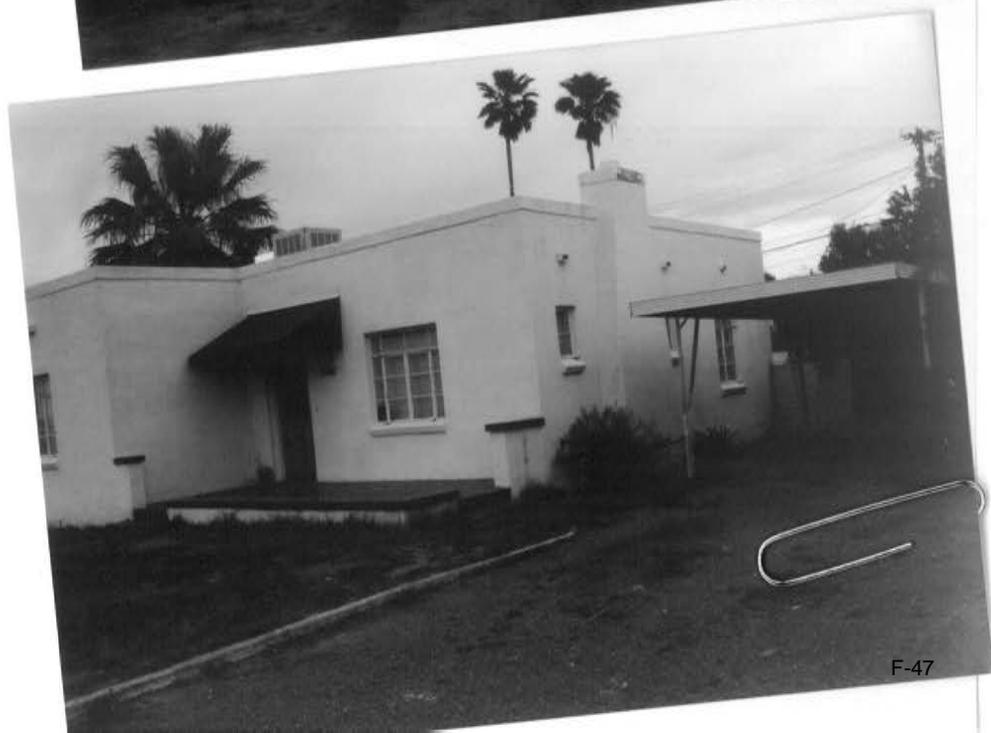
STORIES: 1  
FOUNDATION: concrete  
STRUCTURAL MATERIALS: brick

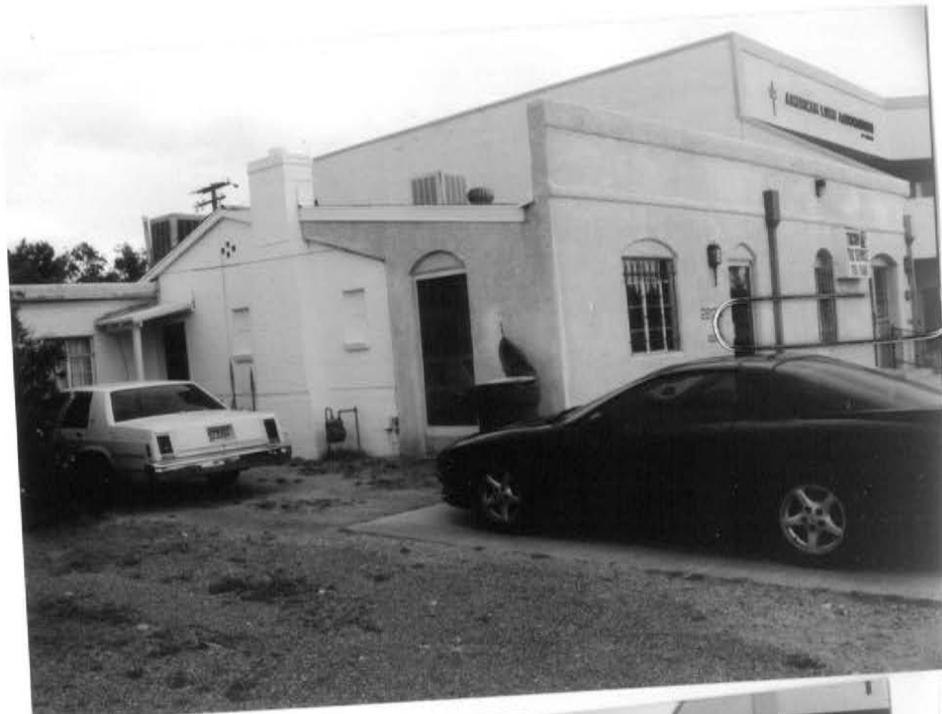
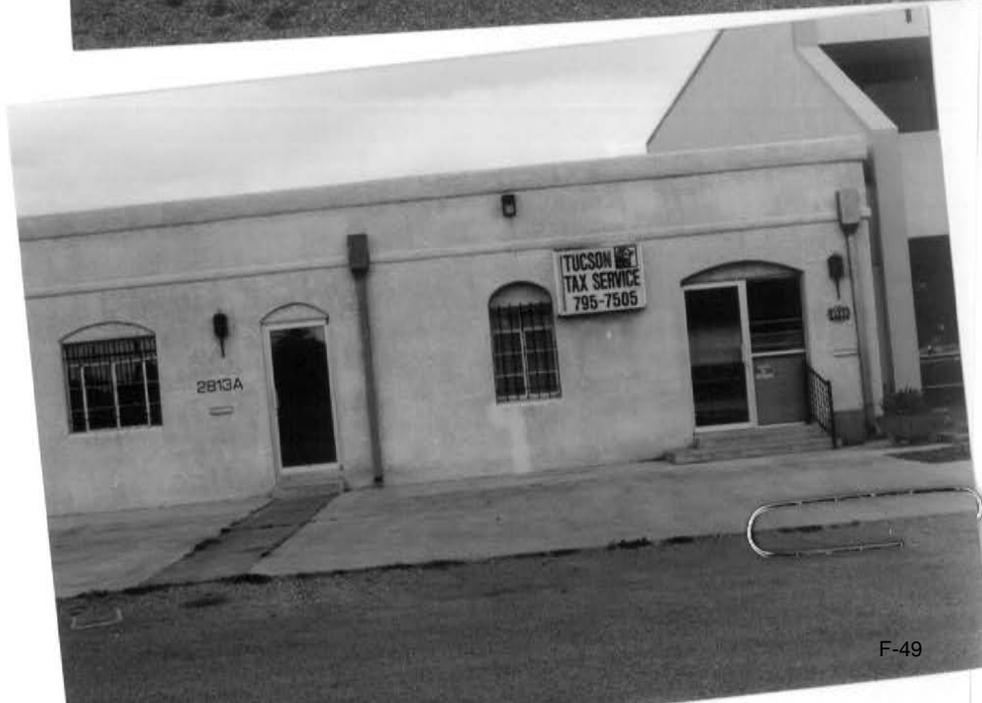
STORIES: 1  
FOUNDATION: concrete  
STRUCTURAL MATERIALS: brick, concrete block,  
wood frame  
WALL CLADDING: painted brick, stucco

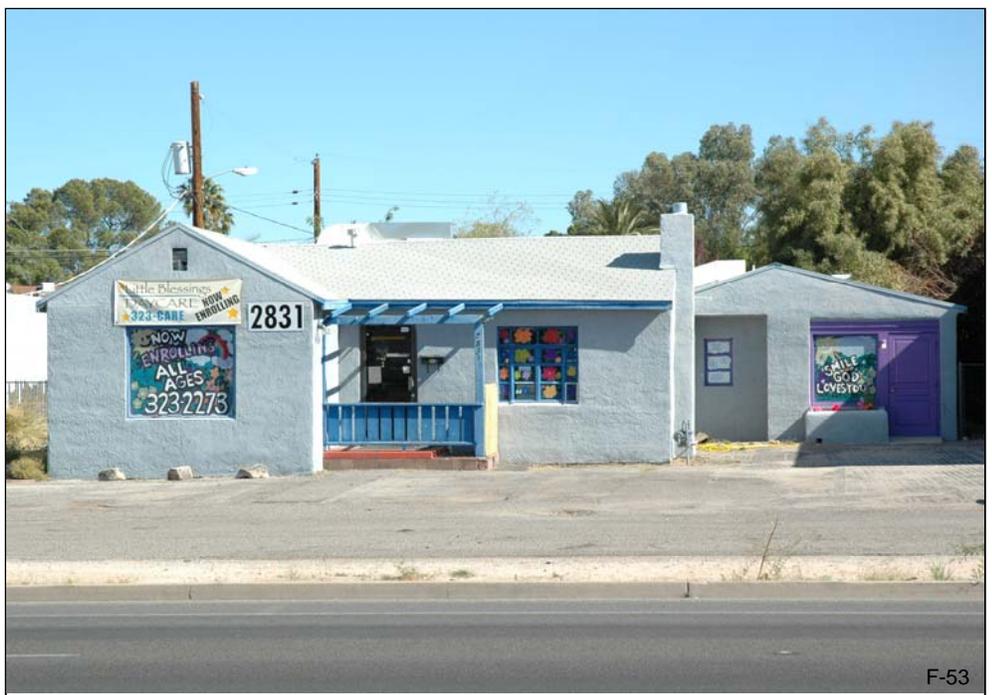
Negative No.: BC-2831

4. MATERIALS (Describe the materials used in the following elements of the property)  
Walls (structure): Masonry Foundation: Concrete Roof: Asphalt shingle  
Windows: Steel casement, fixed glass  
If the windows have been altered, what were they originally? N/A  
Wall Sheathing: Stucco  
If the sheathing has been altered, what was it originally? Brick

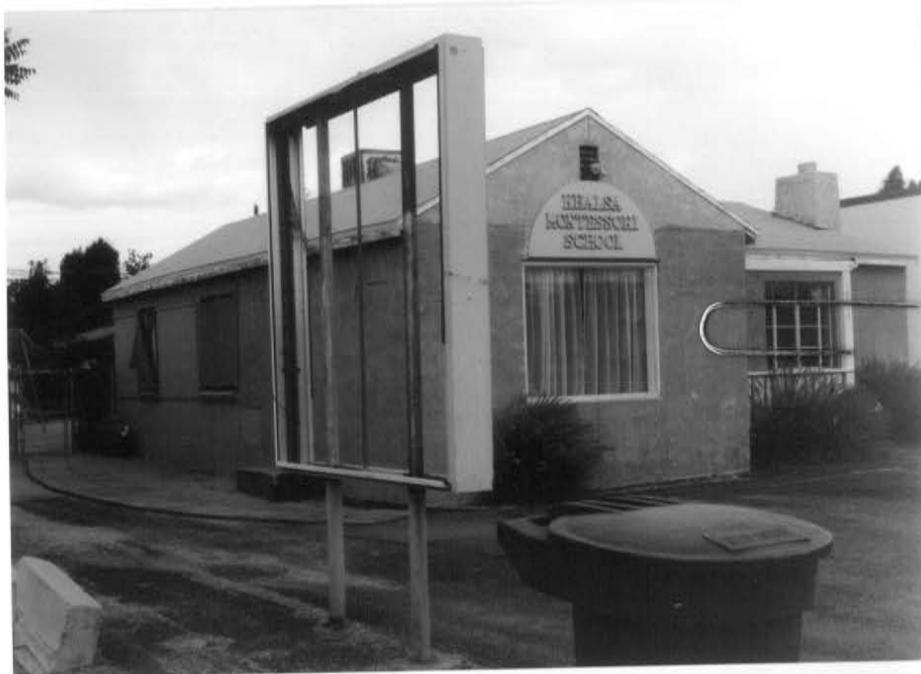
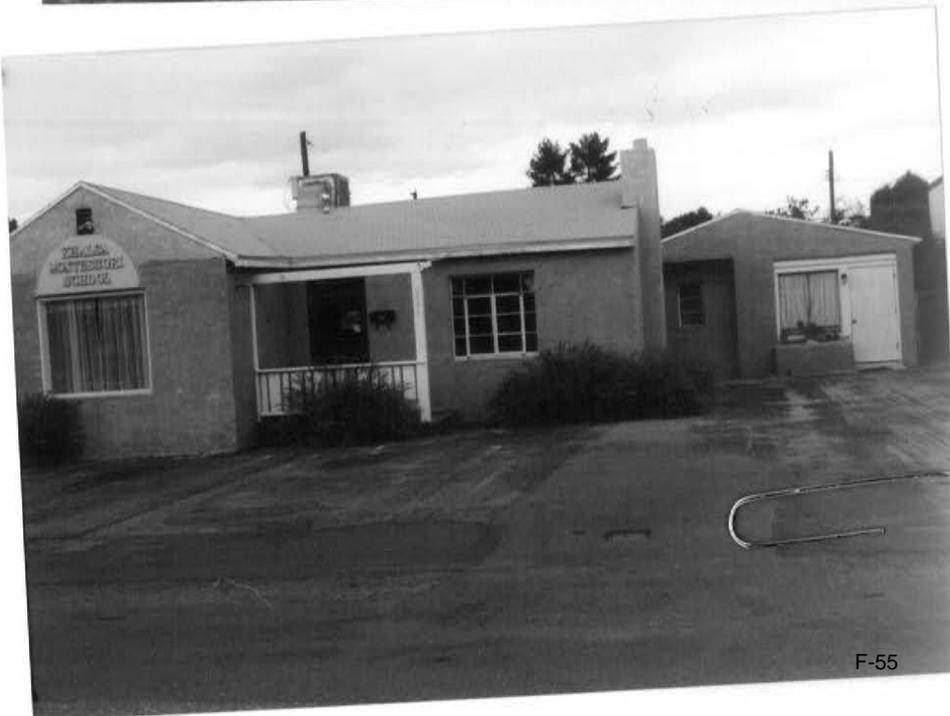
STORIES: 1  
FOUNDATION: concrete  
STRUCTURAL MATERIALS: brick

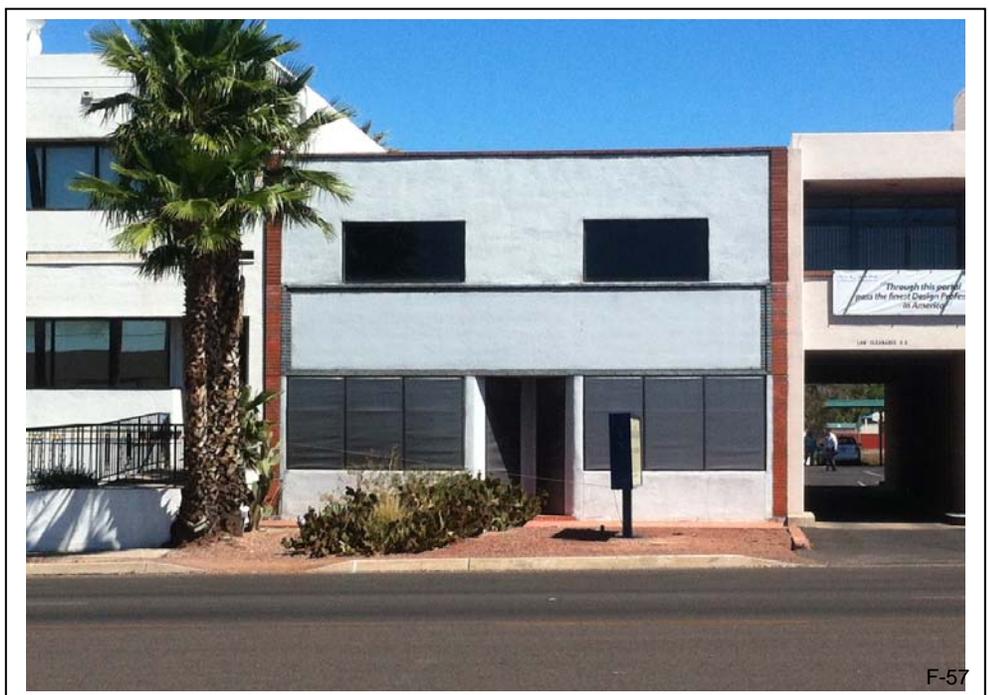
Negative No.: 42

2. DESIGN (Describe alterations from the original design, including dates—known or estimated—when alterations were made) Two-story commercial building with boxy massing, narrow setback, flat roof, picture windows, brick coping along walls and between windows, and recessed entry. At an unknown date, the entry windows and doors were obscured by shade screens and the upper story windows were replaced.

4. MATERIALS (Describe the materials used in the following elements of the property)  
Walls (structure): Composite brick Foundation: Concrete Roof: Tar and gravel built up  
Windows: Unknown  
If the windows have been altered, what were they originally? \_\_\_\_\_  
Wall Sheathing: Stucco  
If the sheathing has been altered, what was it originally? \_\_\_\_\_

Property  is  is not eligible individually.  
Property  is  is not eligible as a contributor to a potential historic district.  
 More information needed to evaluate.  
If not considered eligible, state reason: Replaced windows, and windows and entry obscured by screens.
