RE: **IID 15-07**
238 North 4th Avenue, Tucson AZ, (4th Avenue Sub-Area (FAS) of 4th Avenue Area (FAS) of Downtown Links Sub-District).

HISTORIC PROPERTY INVENTORY FORM

Historic Name(s): Belton Feed and Fuel

Address: 238 N. 4th Avenue

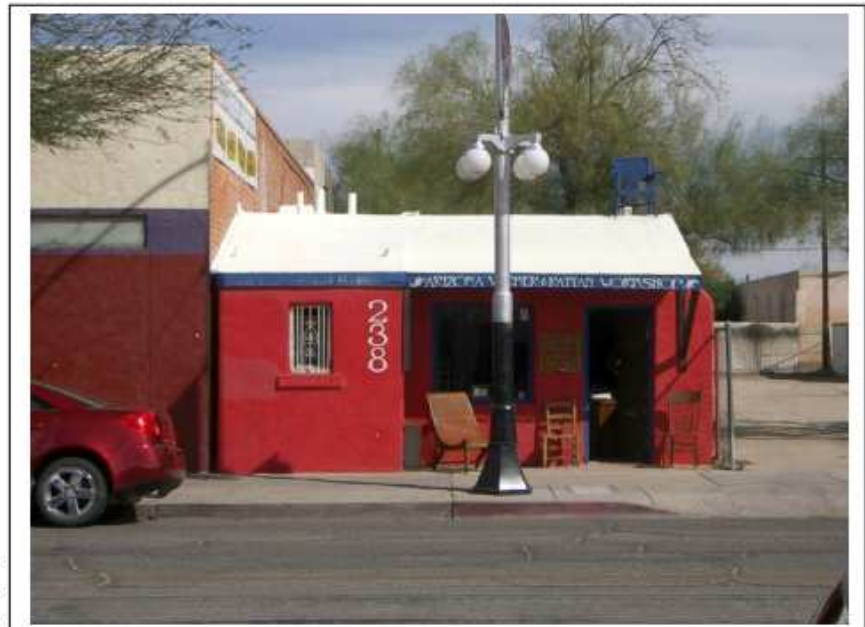
Date of photo: February 2009
View Direction: East
Negative No.:

[X] Good (well maintained, no serious problems apparent)

[] Fair (some problems apparent) Describe: Broken window pane on west elevation; moisture damage between this and adjacent building to the north

2. DESIGN: Small, single-story building with square massing, integrated porch at entry, and gable roof. Originally this building had a companion building to the south that has since been demolished (unknown date). In addition, iron security bars are present over the west-facing windows (unknown date).

5. WORKMANSHIP: Rounded projection on southwest corner of building (likely related to a companion building that is no longer standing at this location)
