# Master Plan for the Improvement of John F. Kennedy Park

June 2016

Prepared for:  
City of Tucson Parks and Recreation Department

Prepared by:  
McGann & Associates, Landscape Architects

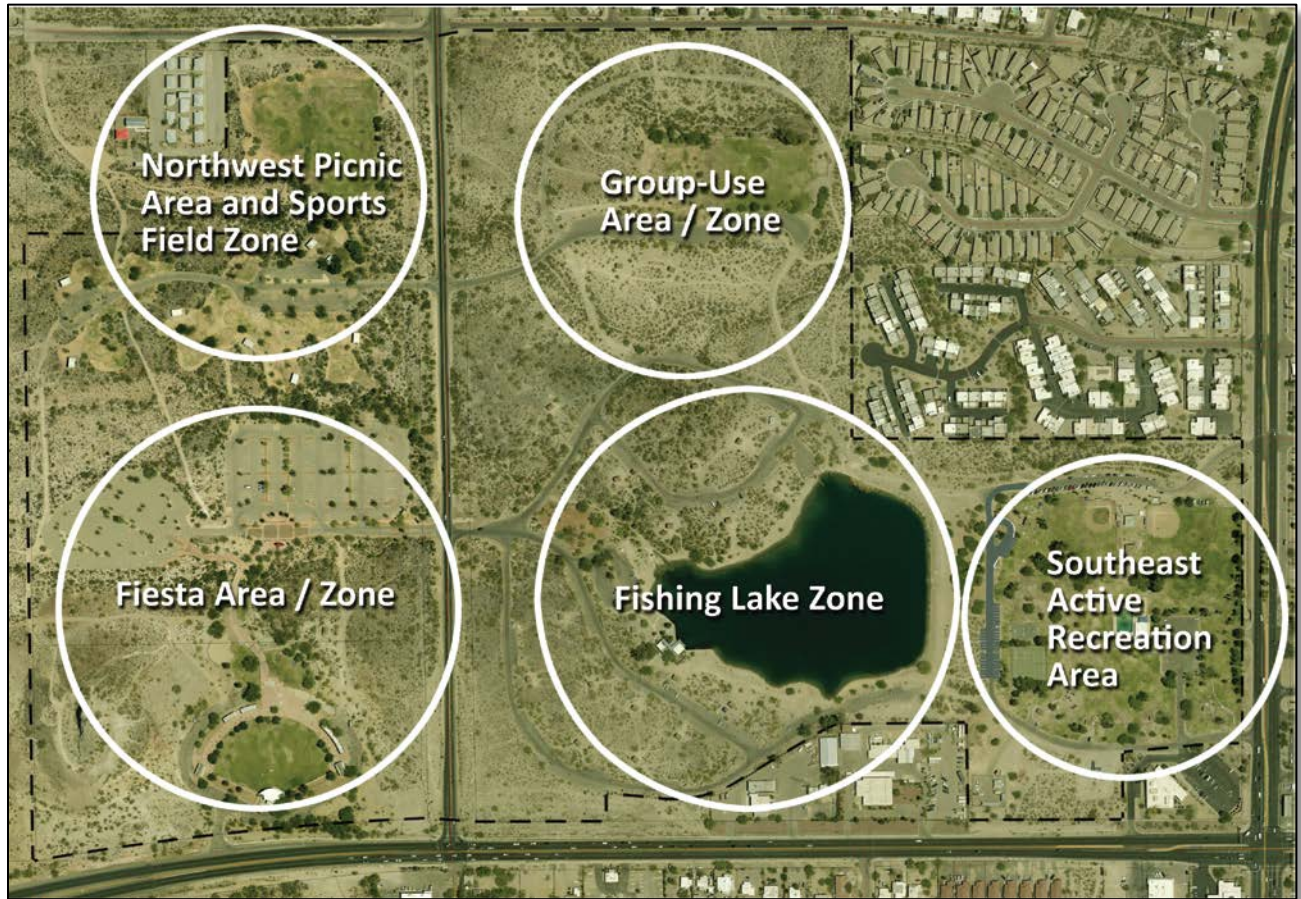
Figure 1-B: Developed Areas / Zones within Kennedy Park (NTS)

Combined, these park areas or zones offer a wide range of recreational opportunities making Kennedy Park an interesting and desirable park to visit.

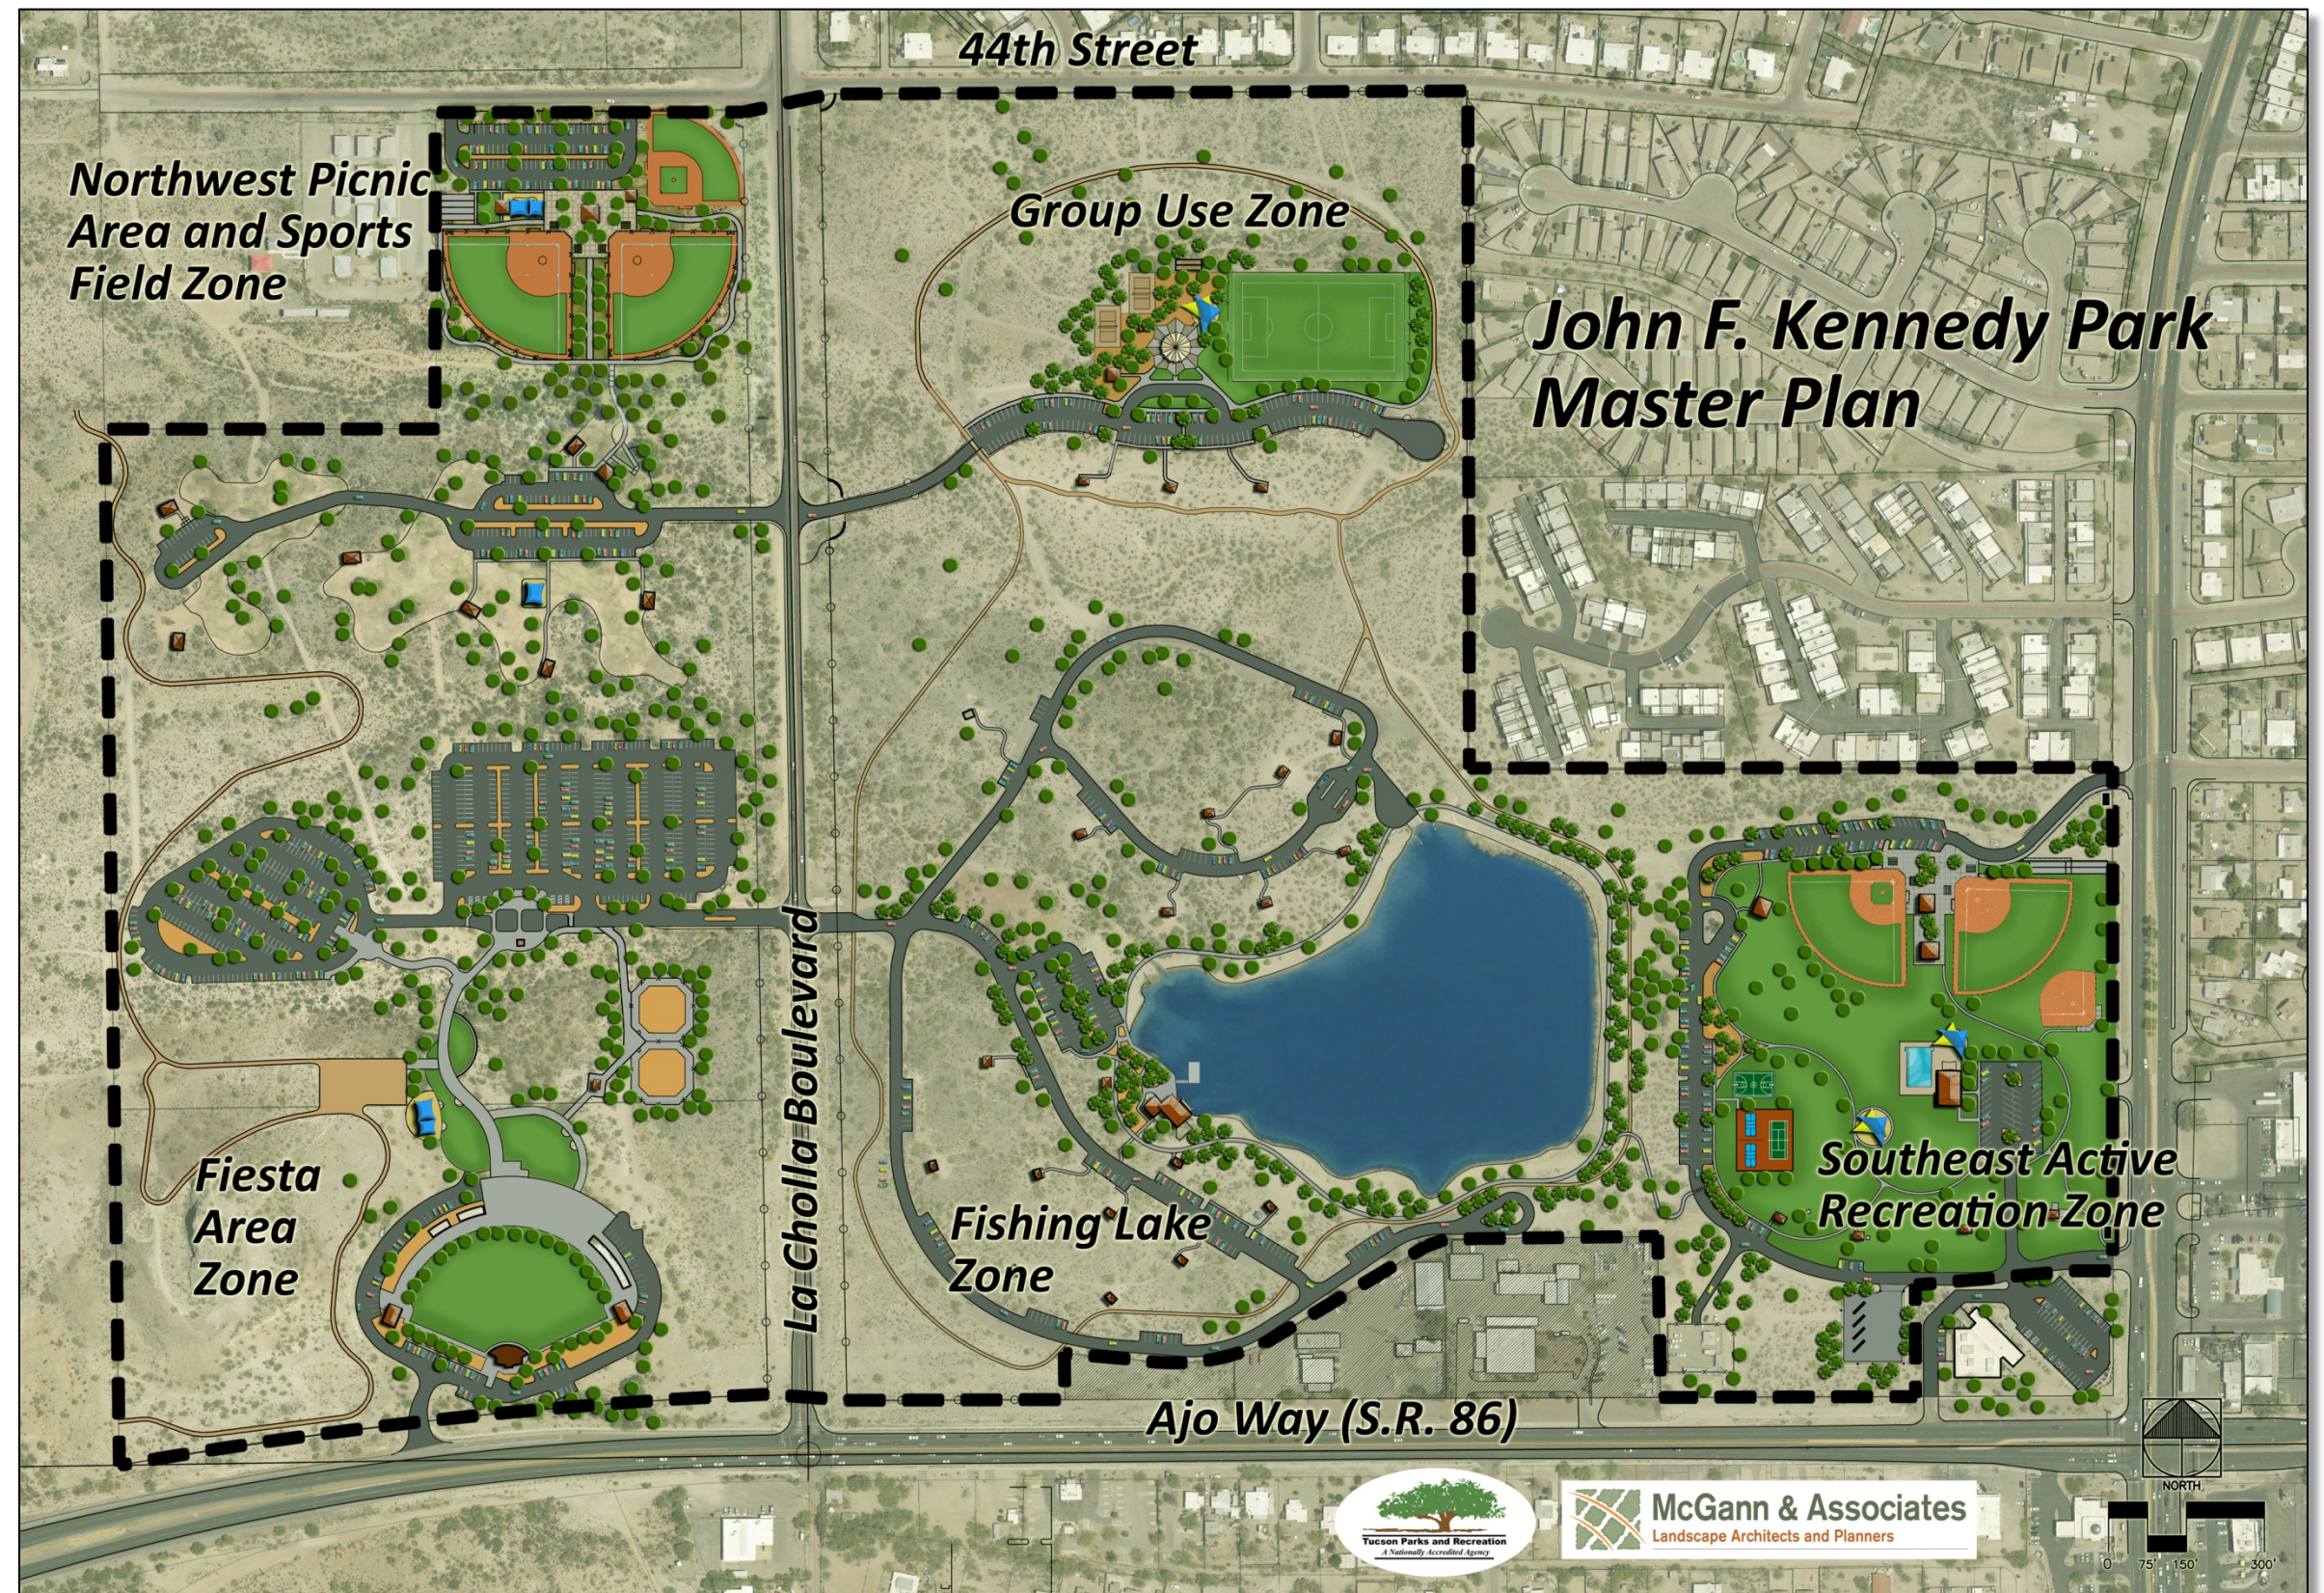
Figure 5-A – John F. Kennedy Park Master Plan

The master plan is organized with recommendations for the renovation and enhancement of facilities within each of five development zones within the park. These zones or areas are:

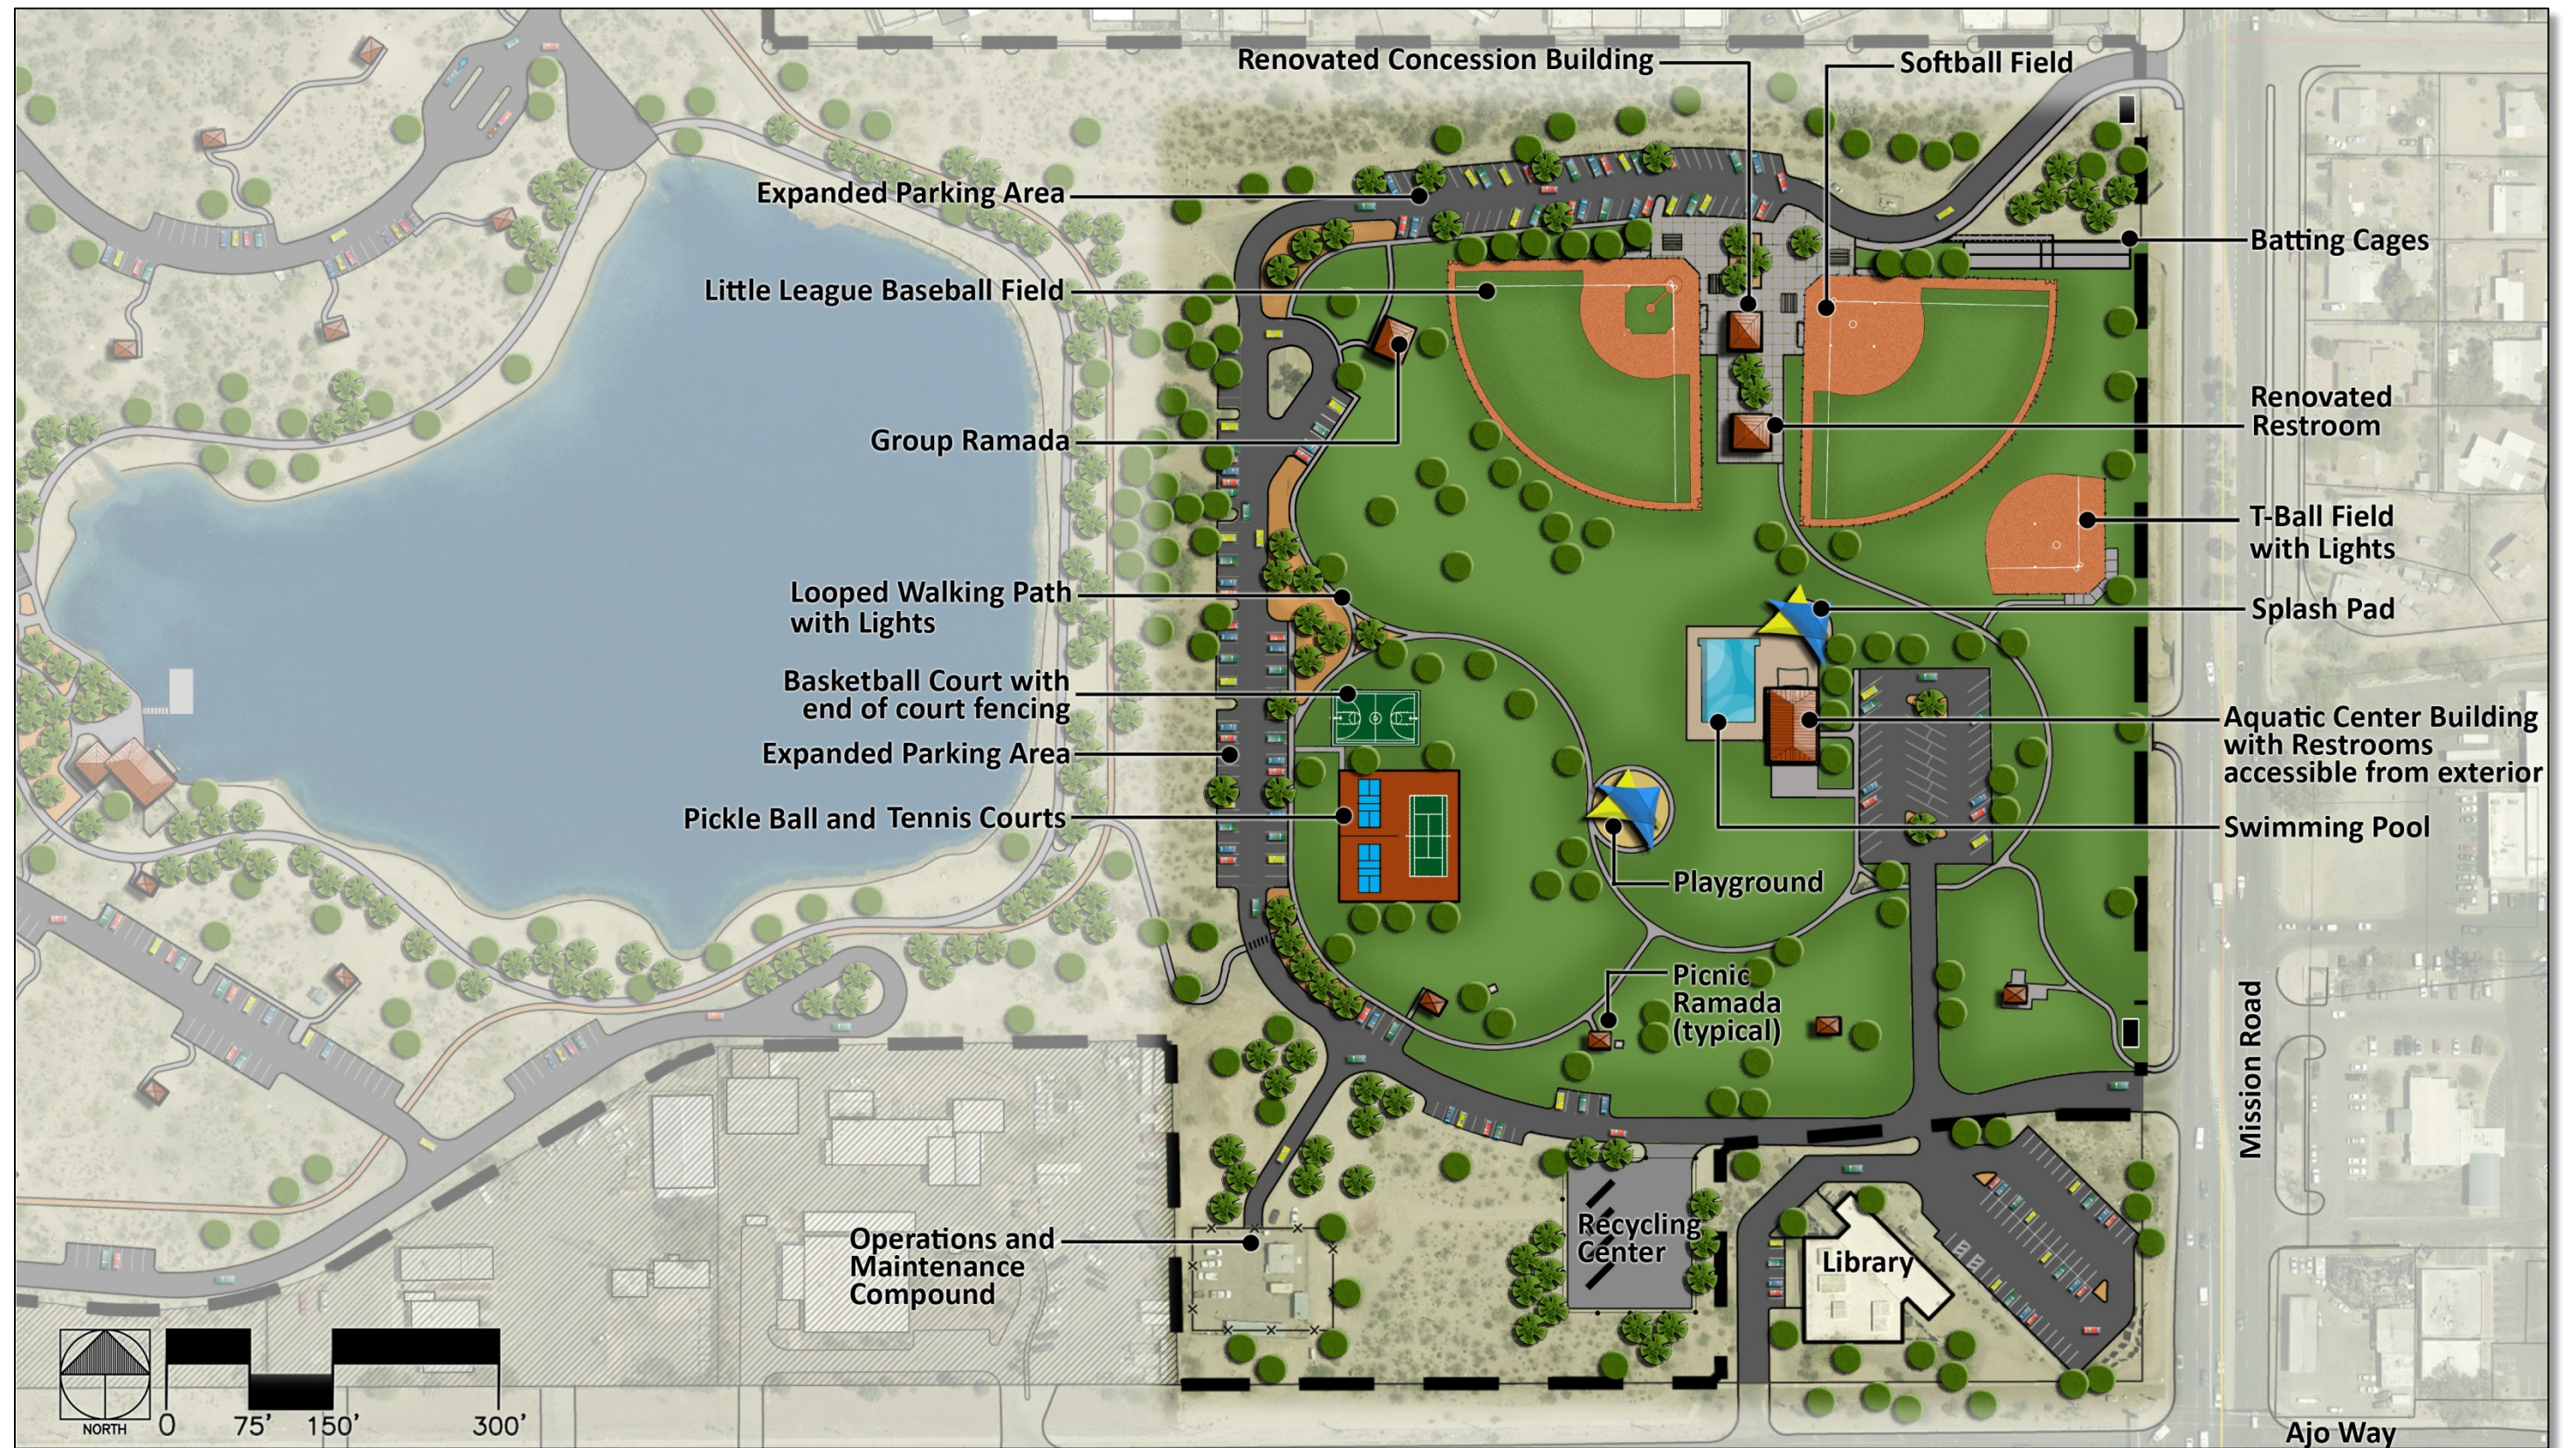
Figure 5-B – Southeast Active Recreation Zone

- Installation of new entry sign / monument at north entrance from Mission Road
- Installation of additional landscape plantings at north entrance from Mission Road
- Installation of new entry sign / monument at south entrance from Mission Road
- Removal and replacement of existing / deteriorated park drive pavement
- Installation of a HAWK Traffic signal at north entrance from Mission Road

- Removal and replacement of existing parking lot pavement
- Expansion of parking lot near baseball / softball fields to provide for (+/-) 70 nearby spaces
- Installation of concrete curbs to control motor vehicle traffic and stormwater runoff
- Construction, marking, and signing of accessible parking spaces

- Renovation of turf grass infield and outfield
- Replacement of damaged fencing, dugouts, and gates
- Construction of accessible walkways to spectator areas
- Construction of batting cages with lights (shared with softball field)

- Replacement of the field lighting and lighting control system
- Renovation of turf grass outfield and skinned infield
- Replacement of damaged fencing, dugouts, and gates
- Construction of accessible walkways to spectator areas
- Construction of batting cages with lights (shared with baseball field)

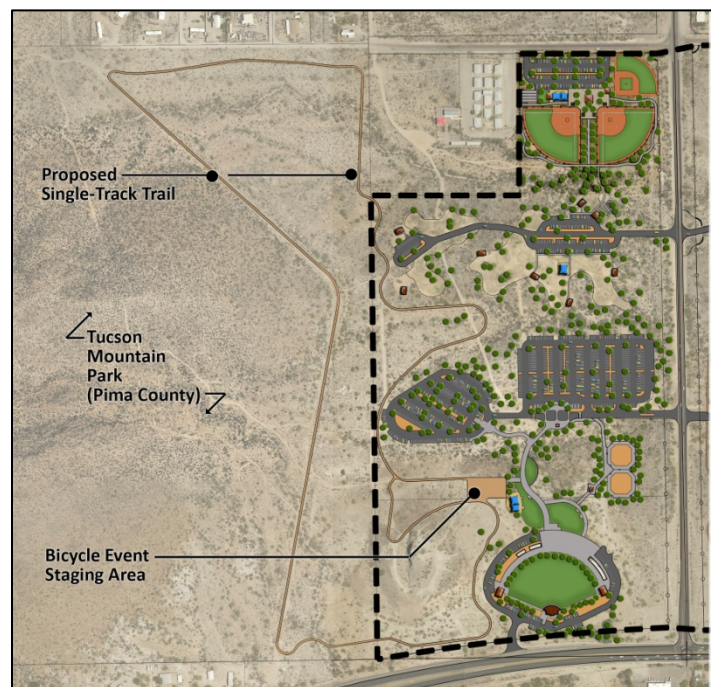
Concept for Single Track Trail extending into Tucson Mountain Park

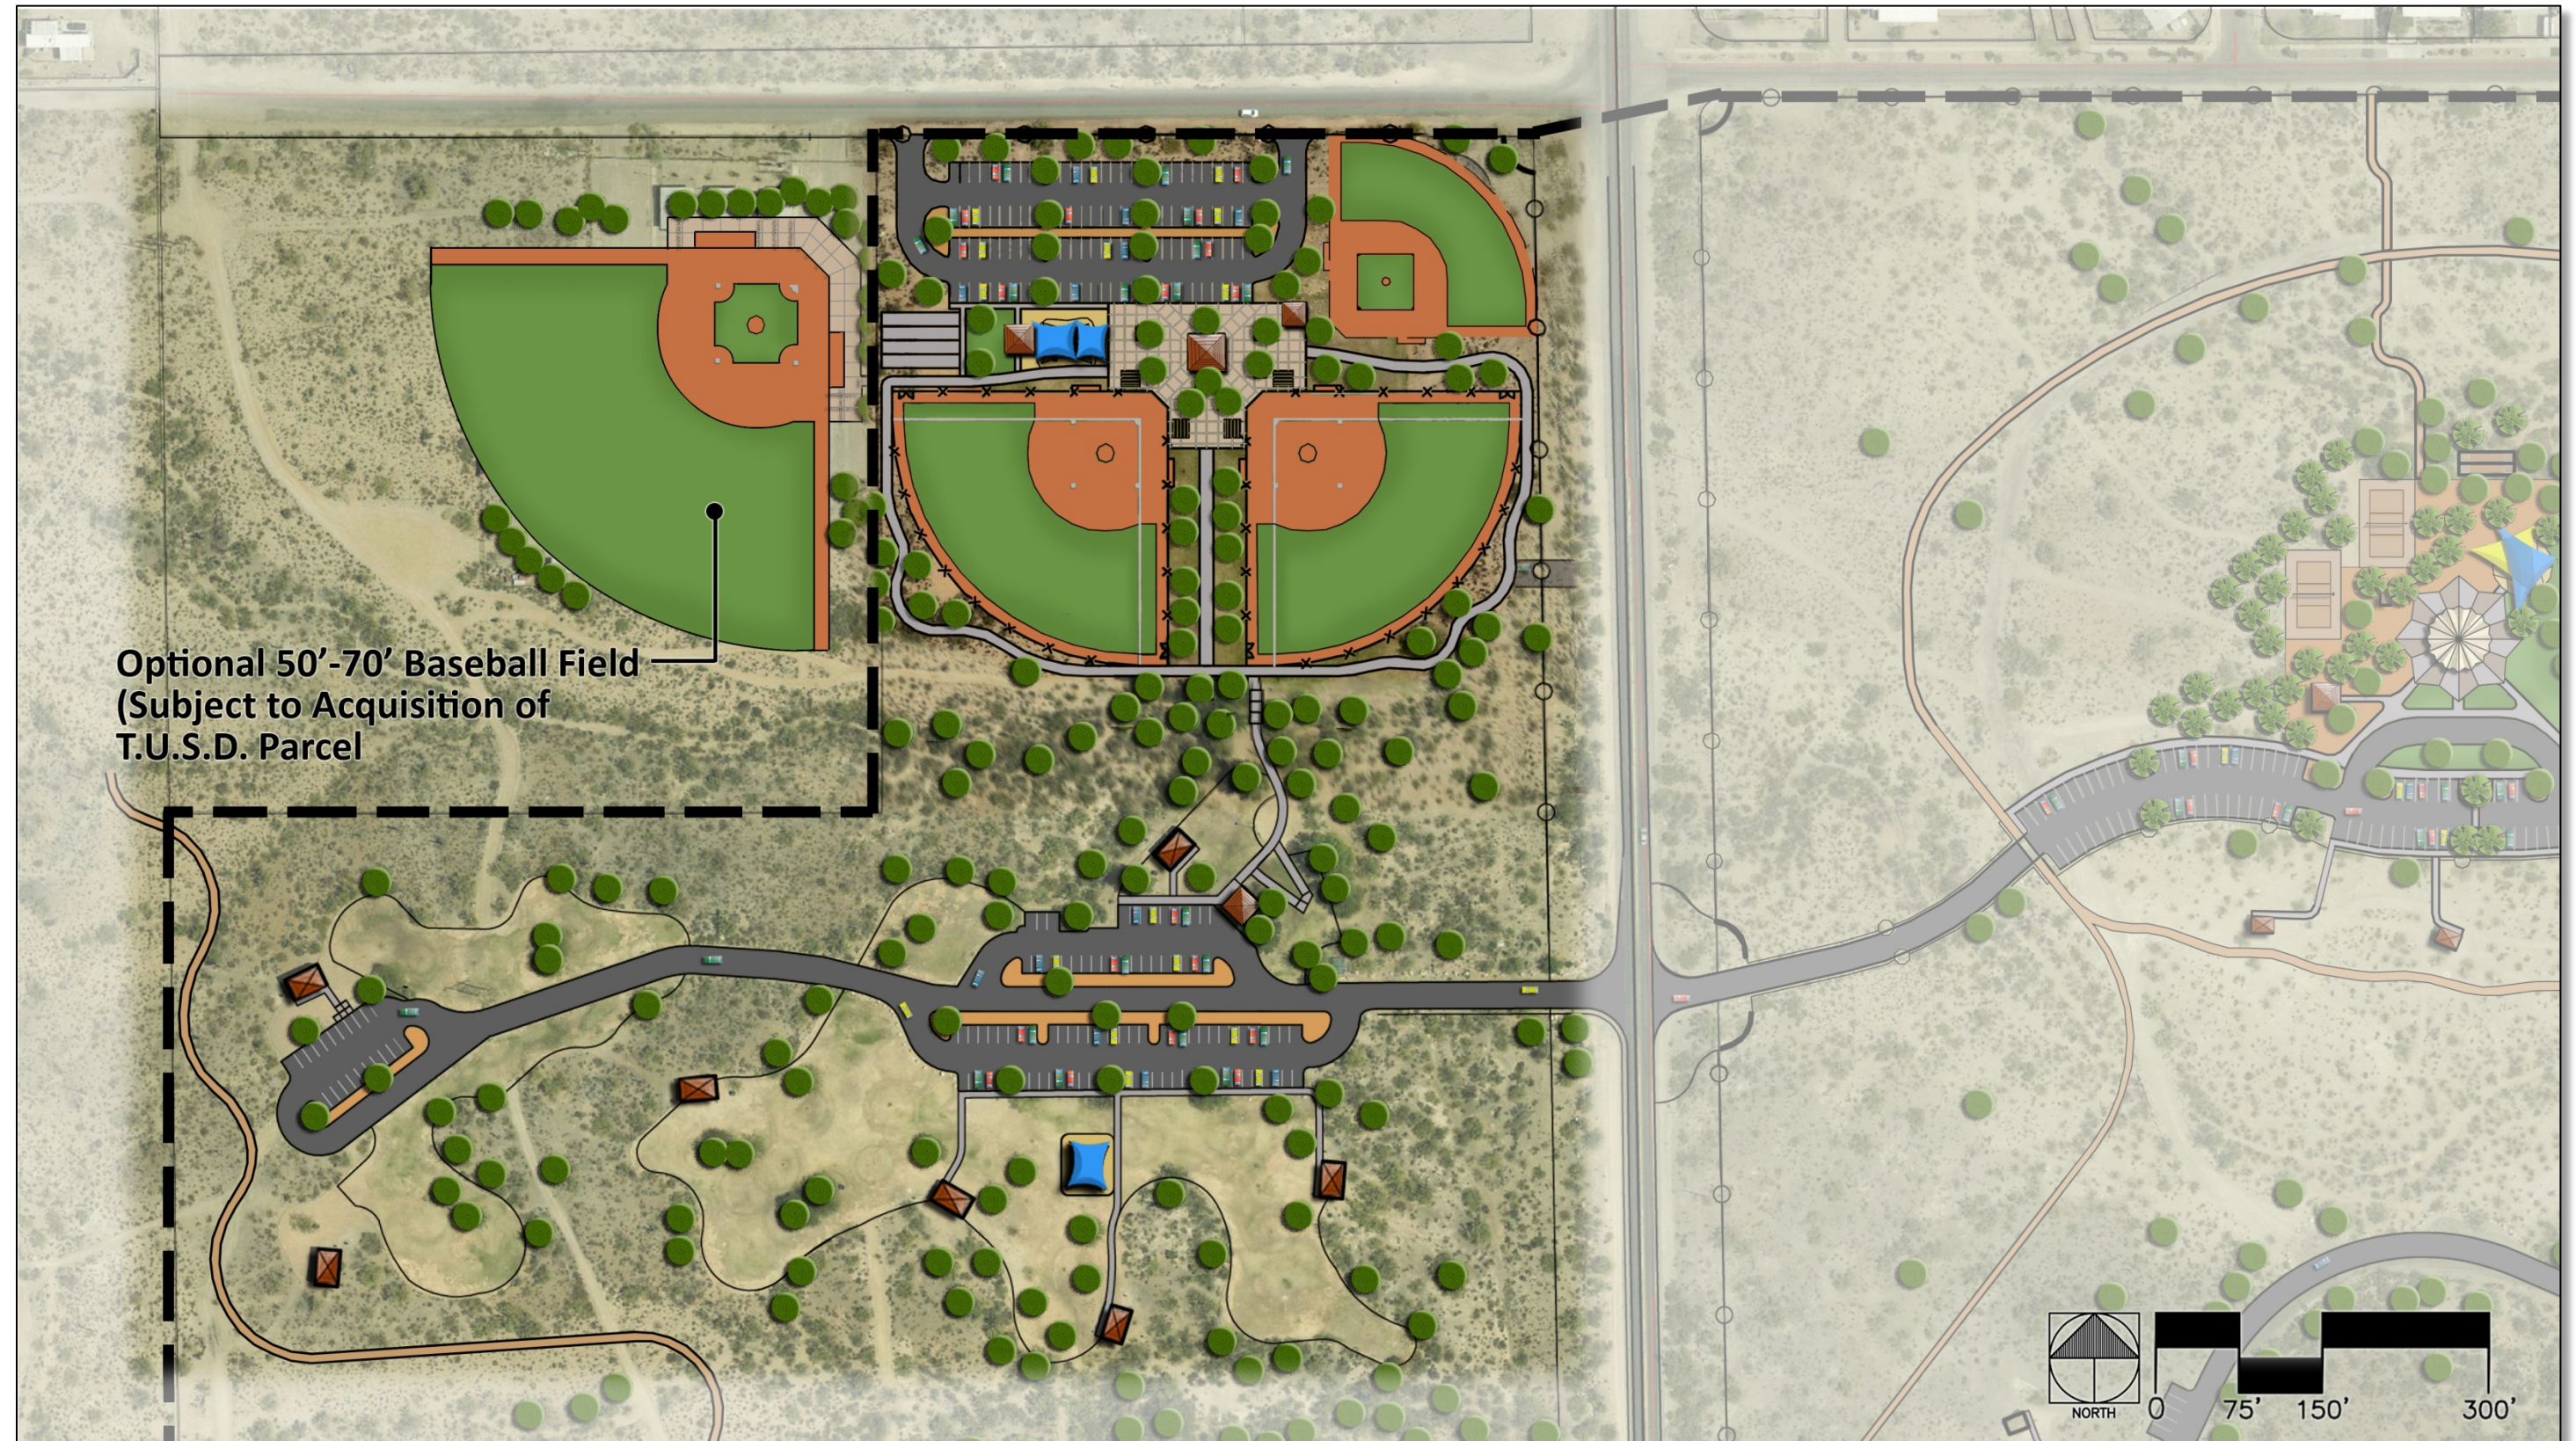
Figure 5-G: Northwest Picnic Area and Sports Field Zone – Potential Expansion

Figure 5-G illustrates how this parcel might be developed to include an additional 50-70 baseball field as requested by stakeholders.

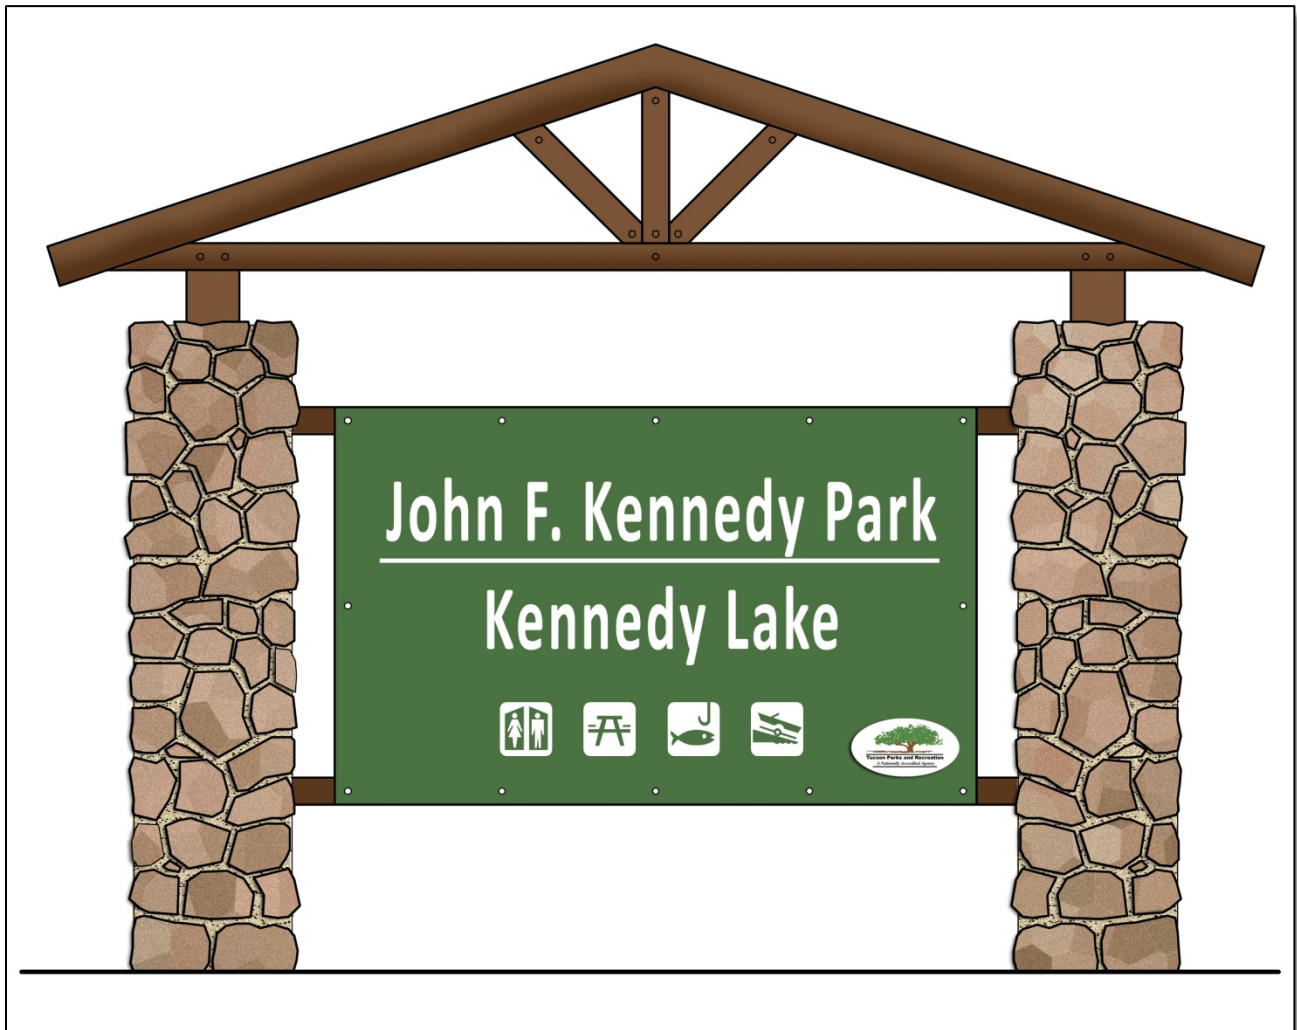
Figure 5-H: Park Entry Sign / Monument Concept Sketch

Provided below is a concept sketch for a monument sign to be installed at each park entry. The design of this sign draws from the unique architecture of the older ramadas within the park. Installed at each entry, it will make the public aware that there are several different zones within Kennedy Park and let them know which facilities are accessible from each entry.

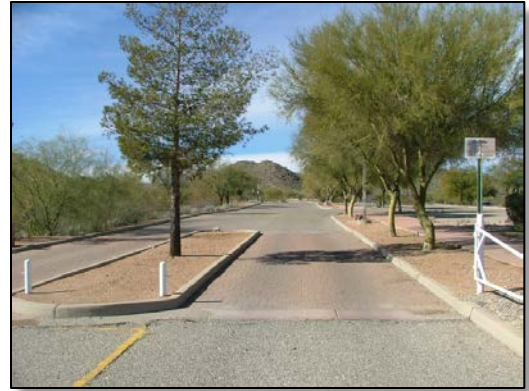
**Fiesta Area Entry Drive**

Facility	Condition	Notes
Drive around ball field swimming pool area	Poor	Significant cracking of asphalt pavement. Pavement patched in many locations.
		Extruded concrete curbs in most locations. Curb condition fair.
		Grading, curb openings allow for runoff into playground area.
Drives north, west, and south of Fishing Lake	Poor	Significant cracking of asphalt pavement. Pavement patched in many locations.
		Drives typically not curbed. Boulders used to prevent vehicles from driving off roadway.
		Stormwater runoff from roadways causing erosion of shoulder and roadside areas in some locations.
Drive to Group Ramada (No. 33)	Fair	Some cracking of asphalt pavement. Pavement patched in several locations.
		Curbs installed in limited areas. Boulders used to prevent vehicles from driving off roadway.
		Poor definition of what is roadway and what is adjacent parking area.
Drive to Fiesta Area	Fair	Significant cracking of asphalt pavement.

Curbed. Curbs generally in good condition.
		Colored concrete pavers at entrance.

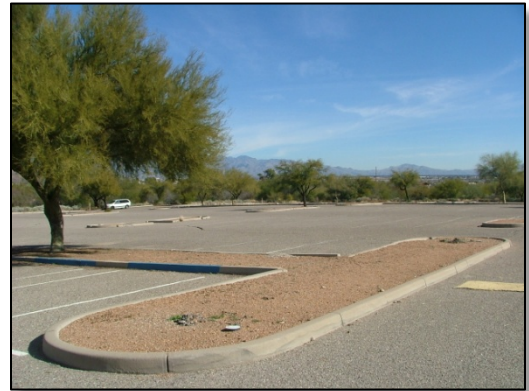
**Fiesta Area Parking Lot**

On the west side of the park in the vicinity of the Fiesta Area, there are several large parking areas, but these parking areas are remote from other park facilities and service the Fiesta Area only. The location, capacity, and condition of the existing parking lots is noted below and shown in Figure A-C and A-D).

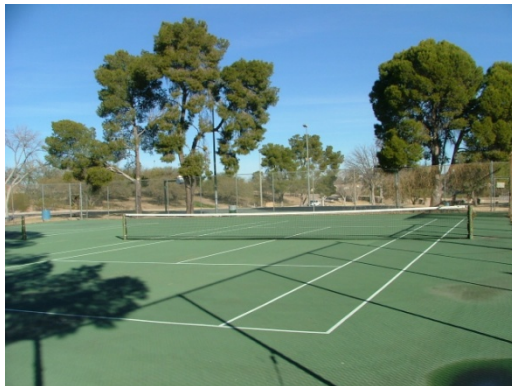
**Tennis Courts**

There are no lights at the tennis courts.
		There are no accessible walkways from nearby parking lots to the tennis courts.
Basketball Court	Good	Basketball court surface consists of a color coated concrete. The concrete is in good condition but the color-coat surfacing needs to be recoated. There is no fencing at the perimeter of the court.
		The basketball court has lights that allow for evening play. The lighting system is not user-activated.
		There are no accessible walkways from nearby parking lots to the basketball court.

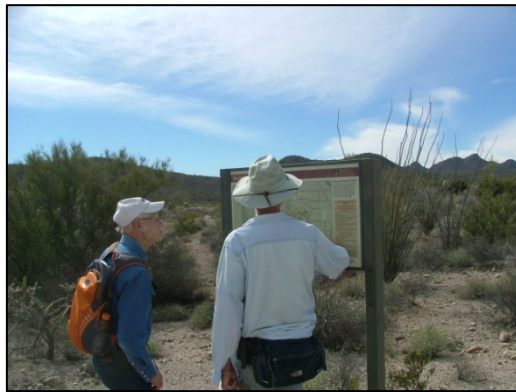
**Explorer Trailhead – Access to Tucson Mountain Park**

On the far west edge of the park, there is a trailhead that provided for public access to the Explorer Trail in the adjacent Tucson Mountain Park. Trailhead users are able to park a vehicle within Kennedy Park when using this facility.

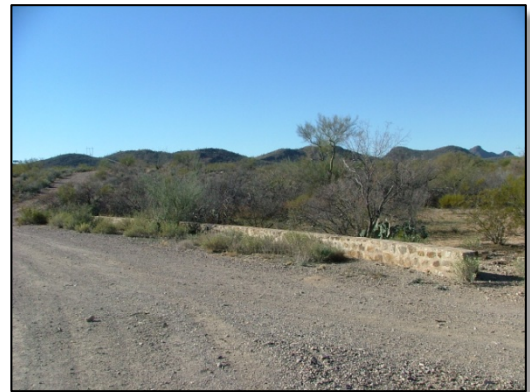
**Old Road Bed / Potential Trail Corridor**

While there are few accessible walkways on site there are several miles of cleared “trails.” Some of these follow old park roads that have been taken out of service and the pavement removed. Others are single-track trails that were developed over time. These trails are not improved, they are not marked or signed, and they have not been integrated into an overall trail system. With the currently popularity of walking as a recreational and fitness activity, there is great potential to develop a pathway / trail system within the park using the existing cleared corridors.

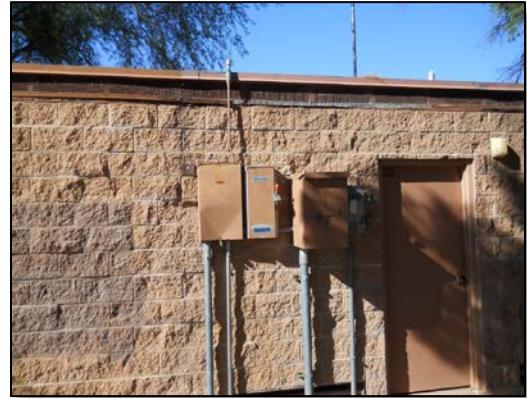
**Upper Kennedy First Service Distribution**

Findings: This area of the park has two (2) utility services. The first service is a 100A, 480V/1PH, 3W main disconnect located on the side of the comfort station and serves a small step-down transformer located within a separate enclosure adjacent the disconnect. The 480V side of the transformer provides power for Ramada’s 1 thru 4. The step-down 208/120V, 1PH, 3W side provides power for a branch circuit panelboard located within the comfort station’s utility chase via a heavy duty safety disconnect switch rated at 100A, 240/120V, 1PH, 3W. This switch is located adjacent to the transformer cabinet. The Ramada nearest the comfort station is fed from the comfort

station’s 120V power source. Ramada’s 1 thru 4 are provided with a step-down transformer located at each Ramada for 120V lighting and receptacle power. This distribution also provides electrical power for pole mounted full cutoff ‘puck” style and post top “acorn” style area lights. All the pole mounted area lights are provided with high pressure sodium (HPS) lamps. Ramada and comfort station lights are not considered full cutoff and are a mixture of high pressure sodium (HPS) and compact fluorescent (CFL) lamps. General use receptacles are provided for the Ramada’s.

Conclusions: The first service is in less than average condition for usage with faded labels and rusted cabinets. The 240V disconnect is labeled as “Main Disconnect for Ramada’s 1 through 4 even though the Ramada’s are powered from the 480v source. The cabinet cover for the step-down transformer is bent and does not close properly. The “acorn” style lights are on all night and are therefore non-compliant with the COT Outdoor Lighting Code.

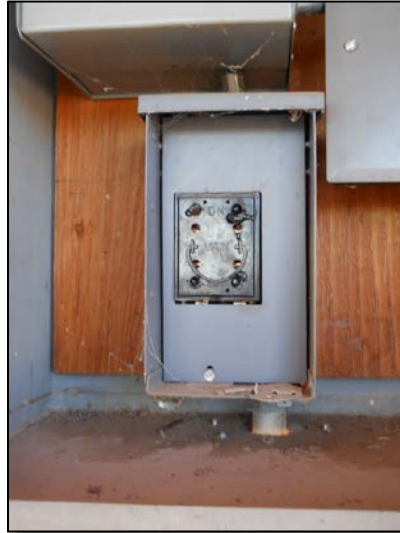
Melted "Pull-Out: Fuse Holder

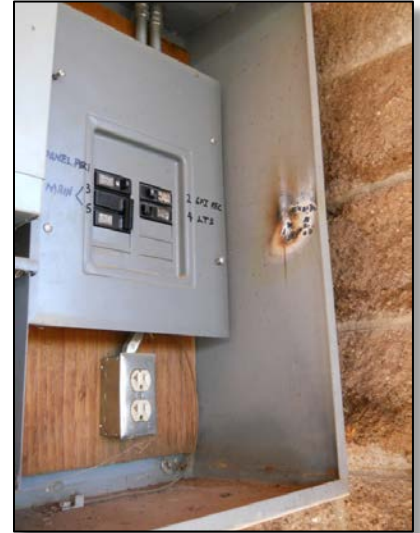
Arc Flash Burn within Cabinet

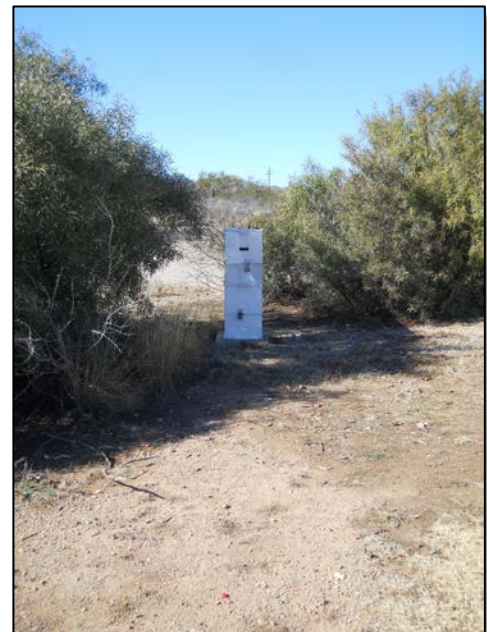
Ramada 33 Service Pedestal

Conclusions: The service pedestal is in average condition for usage and looks to have been painted multiple times. The lighting in the Ramada was on in the middle of the day.

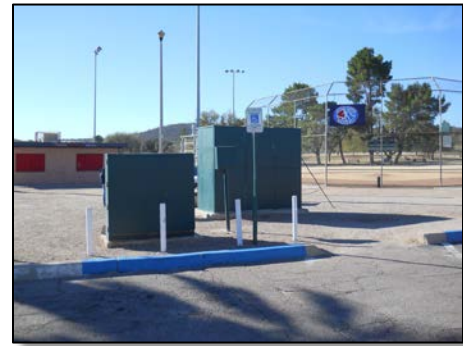
**Little League Fields Service Distribution**

Conclusions: The distribution is in average condition for usage. However, there is a lot of dirt accumulation within the interior base of the cabinet and also behind the ventilation covers of the cabinet itself. Field #1 is not considered energy efficient illuminated with HPS lamps.

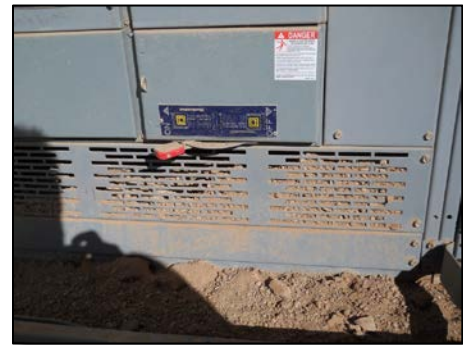
**Dirt Accumulation within Cabinet**

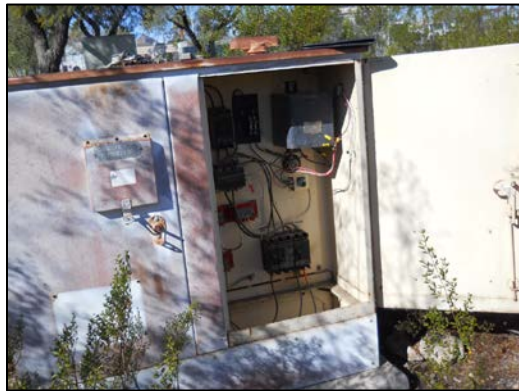
**Lower Kennedy Park Service Distribution**

Findings: This area of the park is served from a pad mounted low profile distribution enclosure rated at 70A, 480/277V, 1PH, 3W. This serves the basketball court lights and the Ramada’s. There is a 480V panelboard located on the column of Ramada #3 which provides the overcurrent circuit breakers to the step-down transformers; one (1) transformer each for Ramada’s #1 thru #4. Ramada #5 is provided with a “power pack”. This service also provides electrical power for the pole mounted post top “acorn” style area lights to include the three (3) pole mounted “acorn” area lights along the damn. All the pole mounted area lights are provided with high pressure sodium (HPS) lamps. The basketball court lighting is exempt from the COT Outdoor Lighting Code.

Conclusions: The distribution is in fair condition for usage with the cabinet having rust. The internal breakers and step-down transformer are showing ware. The “acorn” style lights are on all night making them non-compliant with the COT Outdoor Lighting Code.

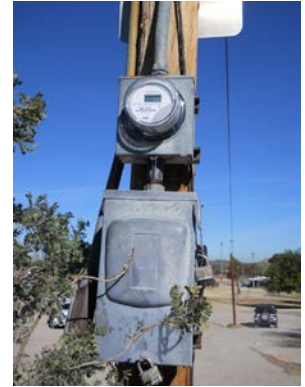
**Electrical Compound Service Disconnect**

Conclusions: The distribution is in fair condition for usage with the equipment showing wear and no labels.

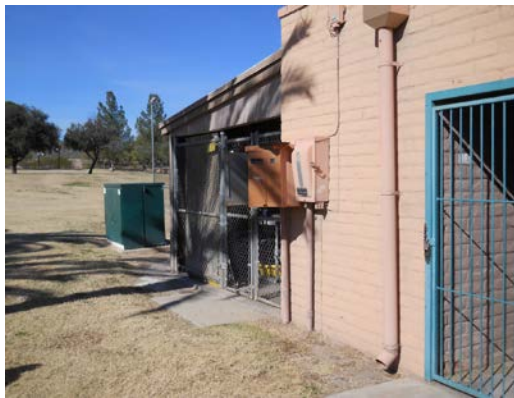
**Kennedy Park Pool Service Distribution**

Conclusions: The service disconnect is in fair condition for usage with the cabinets rusting and fading of labels.

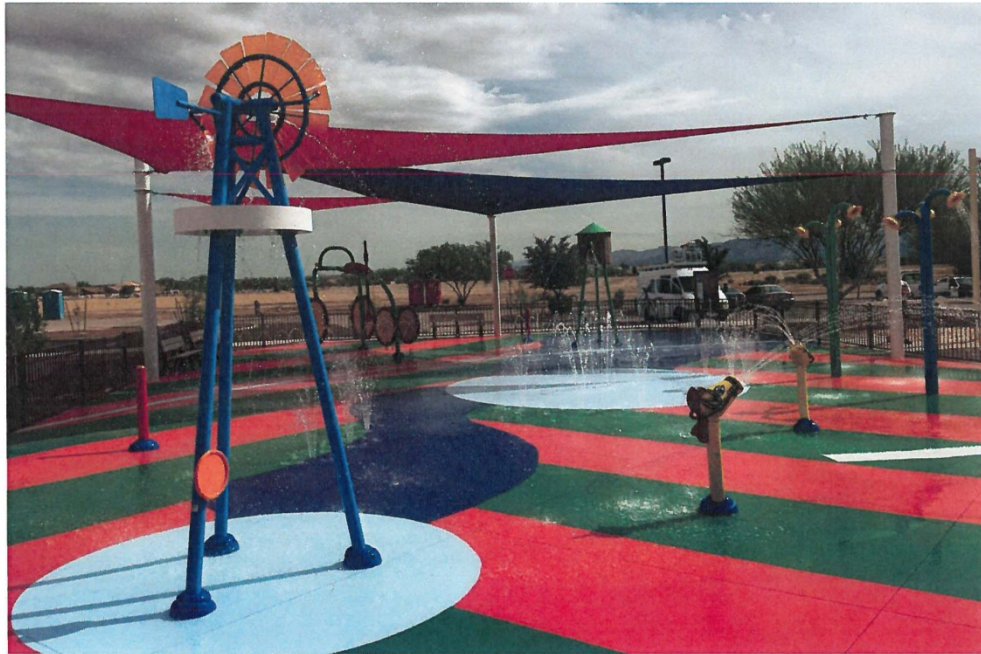
We are going to offer the splash pad cost in a wide range. The reasons is the pad cost will escalate rapidly with the selection of more toys and more elaborate toys. The project image below is the Town of Marana. This project featured several vertical splash toys with a farming, or agricultural theme. The pad was also quite large as it is a standalone feature in a regional park (no pool in the park).

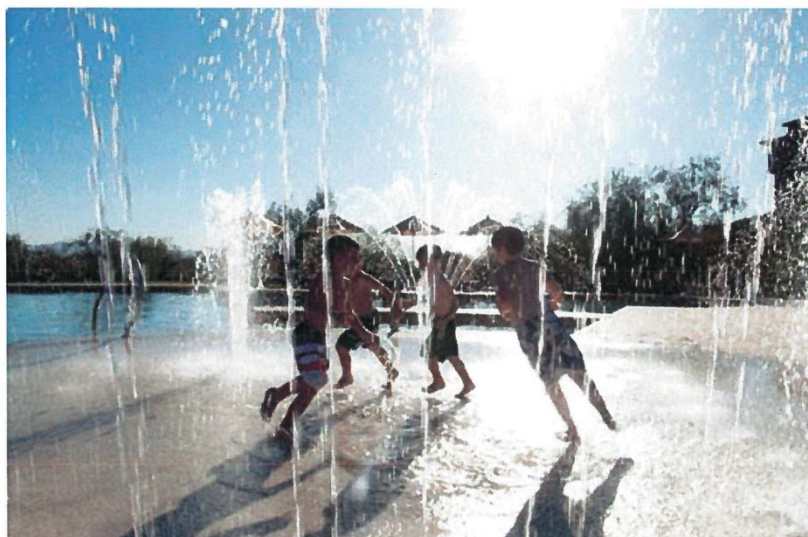
The splash pad image below is from the Ritz Carlton Dove Mountain. This splash pad makes use of ground sprays exclusively and would cost; of course, much less than a pad using the vertical splash pad toys. Since no design and program has been determined we can offer a range in prices. It is possible to economize on the splash pad by placing a concrete deck over the existing wading pool and simply using the wading pool as the surge tank instead of purchasing a new surge tank. We would suggest adding a seat wall at the perimeter of the splash pad deck, possible under the existing shade structure in order for the parents to have a place to hang out close to the toddlers and young kids using the splash pad.

The cost range for the addition of a splash pad is between \$100,000 and \$250,000. The addition of a splash pad could boost attendance to the pool substantially.
