National Register of Historic Places Registration Form

Historic name: Barrio San Antonio

Street & number: Manlove Street, Arroyo Chico, Park Avenue, Aviation Highway, and Santa Rita Ave

City or town: Tucson State: AZ County: Pima

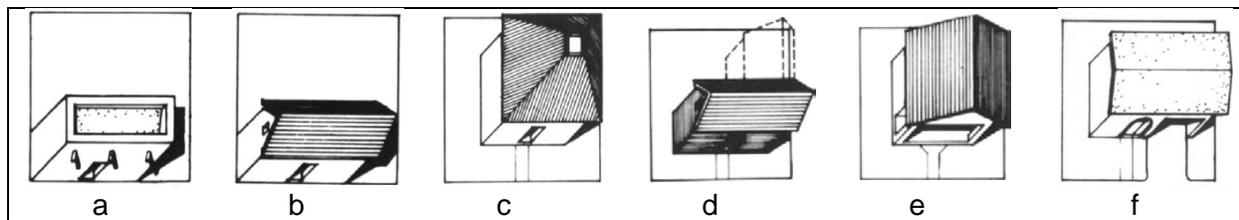
Figure 4. Conventional narrative showing transformation of Sonoran style into Anglo-American architectural styles: a) Sonoran style (1850–1890); b) Transitional Sonoran style (c. 1880–1900); c) American Territorial style (c. 1880–1910); d) American-Victorian (Queen Anne) style (1890–1910); e) Bungalow (1900–1940); f) Ranch/Contemporary (1935–c. 1970). Drawings by Harris J. Sobin, 1975. *The Journal of Arizona History* 61(4):357–382.

The late nineteenth and early twentieth century evolution of the Sonoran style into more socially current Anglo-American styles is well documented (Nequette and Jeffery 2002; Sobin 1975). The austere, street-edged style was adapted into the Transitional Sonoran style with its pitched roof and street-edged buildings that later became the Territorial style with its fully detached dwellings and imported construction materials (**Figure 4**) (Nequette and Jeffery 2002; Sobin 1975).

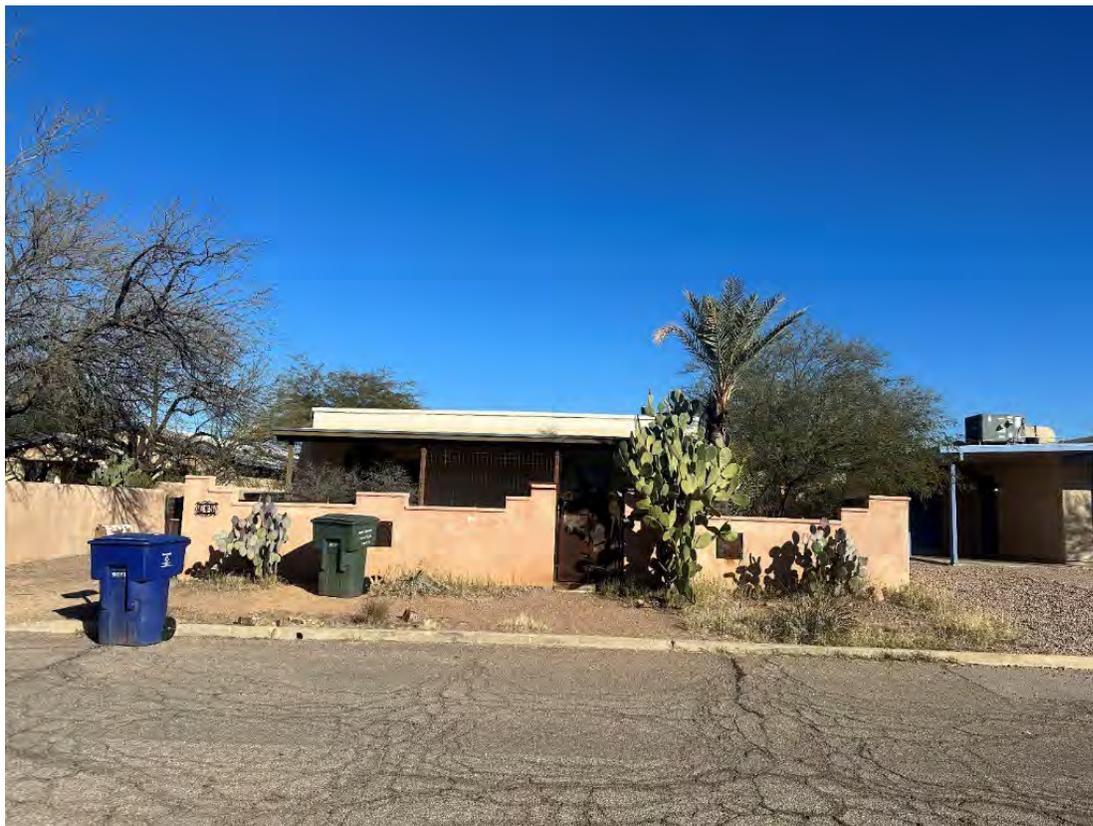
Photo 1. 615 South Star Avenue, view facing east (WestLand Engineering & Environmental Services [WestLand], January 2023 [AZ_PimaCounty_BarrioSanAntonio_0001])

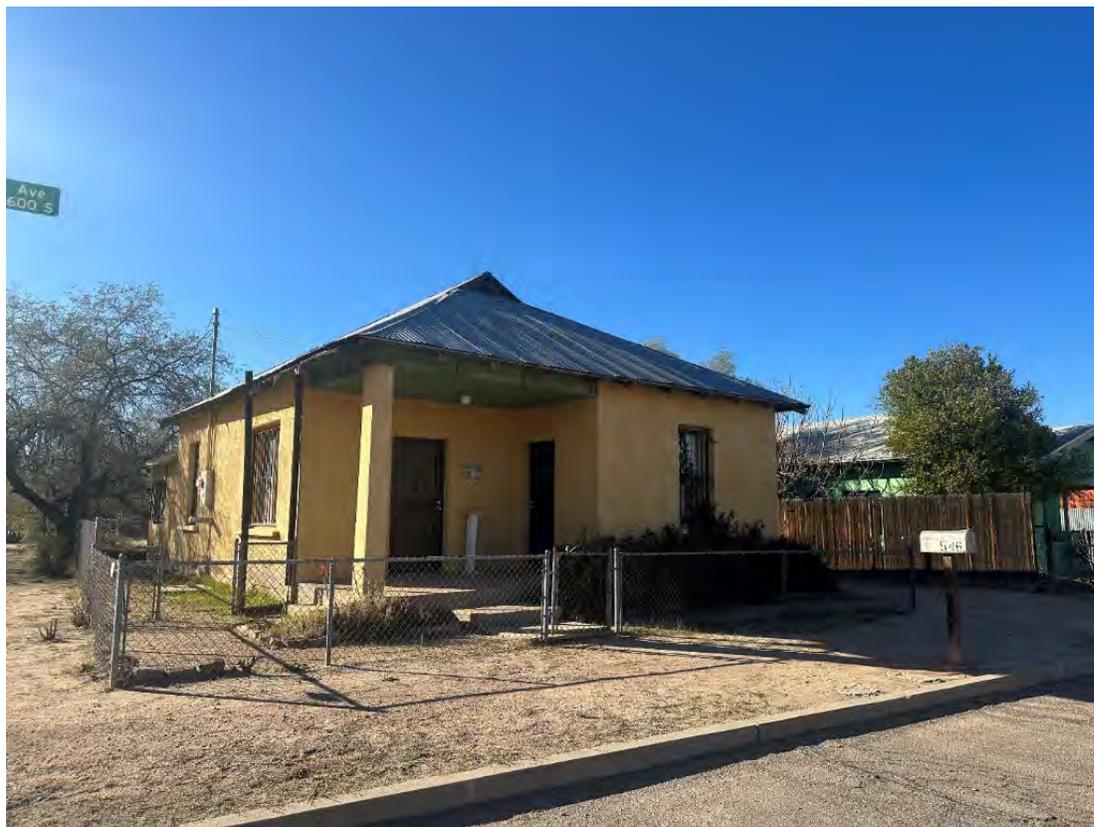
Photo 2. 546 South Star Avenue, view facing northwest (WestLand, January 2023 [AZ_PimaCounty_BarrioSanAntonio_0002])

With the construction of the Southern Pacific Railroad through Tucson in 1880, imported construction materials became substantially cheaper and more accessible for residents and builders. Suggestive of their increasing political power, Tucson’s Anglo-American residents began a concerted effort to restyle the city in the image of Eastern America. These efforts raised brick and stone construction to the peak of the “modern style,” while denigrating adobe buildings as “mud and straw.” Because of this changing attitude, numerous buildings in the American Territorial style were constructed throughout the city, despite their apparent shortcomings in response to Tucson’s climate. Adobe buildings possessed substantial thermal mass to insulate them from outside temperatures, but brick provided few such benefits. Nonetheless, the style persisted until it was ultimately replaced by the Craftsman Bungalow and other revivalist styles of the early twentieth century. Within Barrio San Antonio, there are six American Territorial residences, and feature a typical side entry and porch with wide pyramidal roofs, many of which are constructed of metal. Further many have fences and walls around their front yards and a rear addition (**Photo 2**).

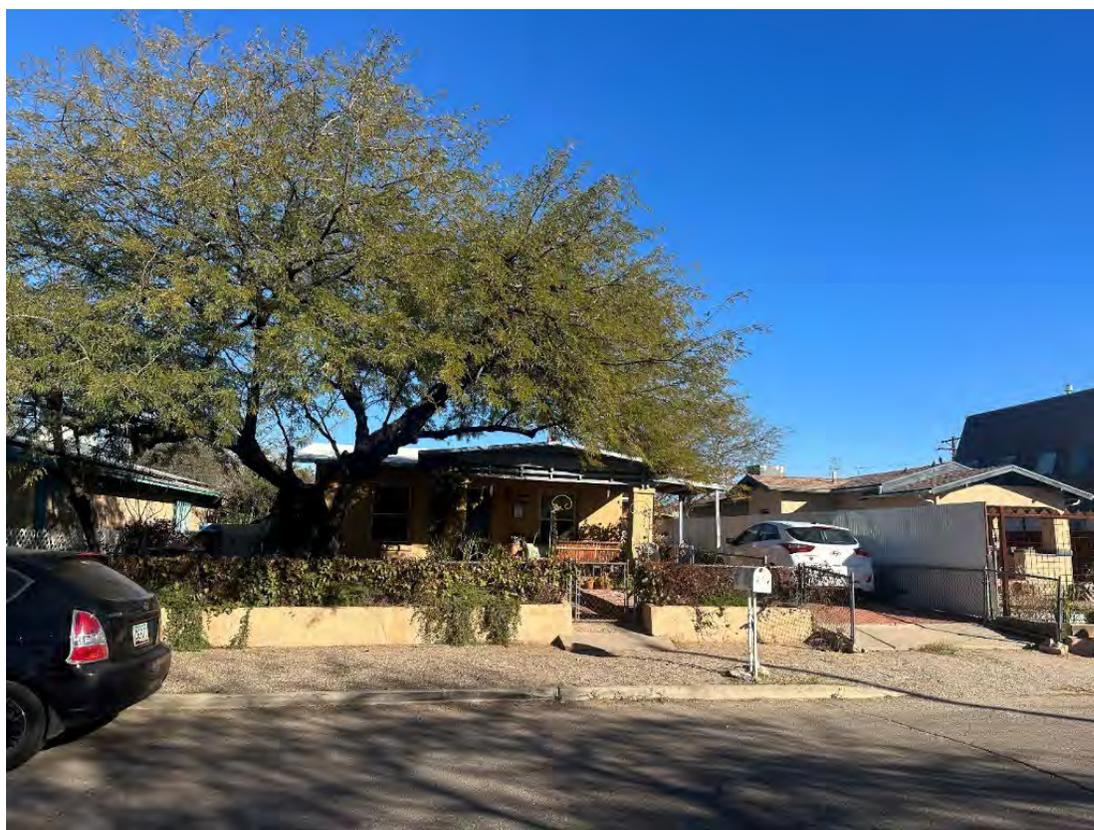
Photo 3. 427 South Star Avenue, view facing east (WestLand, January 2023 [AZ_PimaCounty_BarrioSanAntonio_0003])

Numerous examples of the Bungalow's versatility can be found throughout Tucson. Ready-cut homes are found in some of the city's traditionally Anglo-American neighborhoods, while adobe examples exist in the traditionally Latino barrios (Nequette and Jeffery 2002:284). Within the neighborhood, the Craftsman-style dominates with 16 examples identified. Like many of Barrio San Antonio's residences, its bungalows are modest examples, and most include a single story, have boxy massing, wide front porches, and Spanish Eclectic details (**Photo 3**). The examples of the form are identifiable through their front-facing gables and projecting porches. Many have been reconfigured through additions, but their overall form remains intact, as do elements of their detailing including exposed rafter tails or slated gable vents. Similarly, many feature walls and fencing around their primary façade.

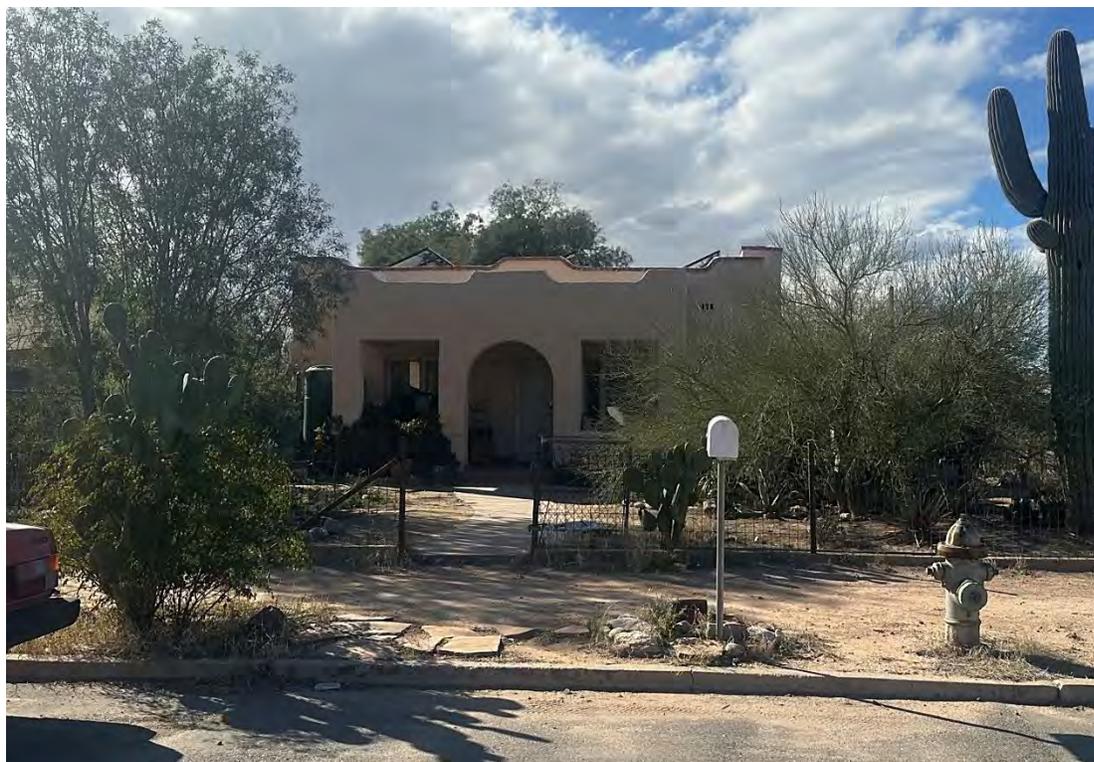
Photo 4. 402 South Star Avenue, view facing west (WestLand, January 2023 [AZ_PimaCounty_BarrioSanAntonio_0004])

With its own ruined *visitá* mission, as well as San Xavier del Bac only eight miles south, Tucson was well positioned to adopt the Mission Revival style. Its first usage in the city occurred around 1895, and the style was successfully employed by local architect Henry C. Trost in his 1899 designs for the Owl’s Club in the El Presidio neighborhood. Within Barrio San Antonio there are six Mission Revival residences (and three Eclectic residences with Mission Revival details), most of which contain the characteristic arched parapet, stucco, and modest brick detailing, while also being enclosed by a fence, wall, or vegetation (**Photo 4**).

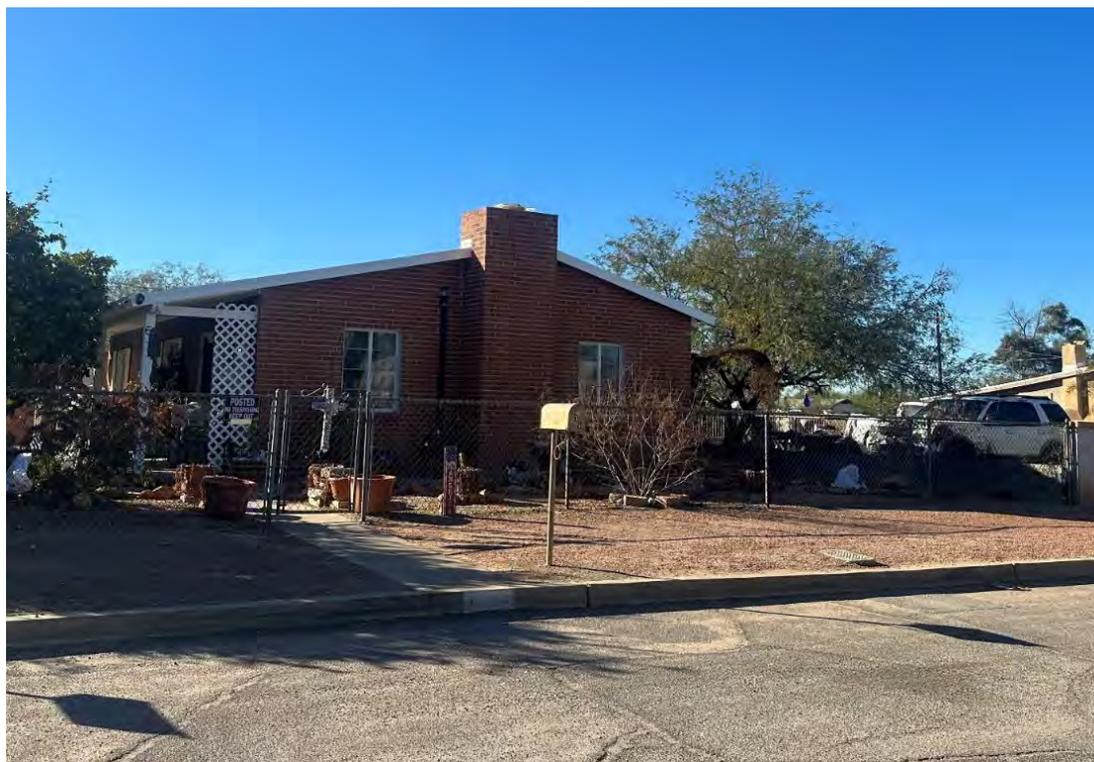
Photo 5. 630 South Santa Rita Avenue, view facing northwest (WestLand, January 2023
[AZ_PimaCounty_BarrioSanAntonio_0005])

The modern Ranch House evolved in Southern California in the first decades of the twentieth century. Among its earliest practitioners were the architectural firm Greene and Greene, who drew inspiration from the architectural form of the hacienda and casa de rancho—both often found in the form of the colonial Spanish courtyard house (i.e., the inner courtyard house). Drawing from these sources, the firm’s 1903 Bandini House was a single-story, U-shaped residence surrounding a central courtyard. The building successfully evoked a heavily romanticized vision of California’s colonial past and inaugurated a low-slung horizontality that would be the style’s most defining feature (Bandini, Arturo, House, Pasadena, CA n.d.) **(Photo 5)**.

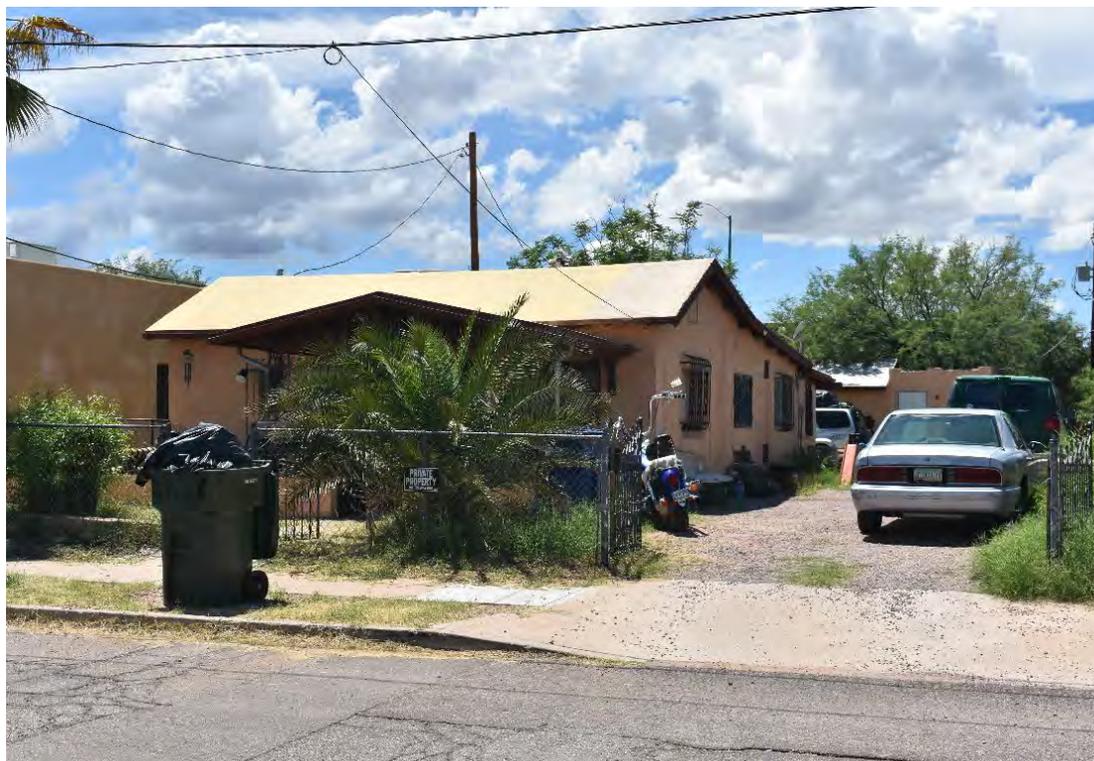
Photo 6. Example of building additions to the rear of 506 S. Fremont Avenue, view facing southwest (WestLand, January 2023 [AZ_PimaCounty_BarrioSanAntonio_0006])

Another fundamental feature of Barrio San Antonio's built environment is the way in which its inhabitants have continually modified and updated their residences through a process of addition. Although this pattern is found in residential neighborhoods throughout the country, the additive growth of the barrio is unique in its historic antecedents and the way these processes have shaped the expansion of individual buildings and housescapes. This growth is defined by the owner occupant's desire to improve domestic circumstances through remodeling and enlargement rather than relocation. Because of this, buildings in Barrio San Antonio are defined by frequent and ongoing expansion, and most show evidence of numerous building projects undertaken at different times. Although such alterations are in part attributable to many residents' financial inability to move elsewhere, they are also indicative of a fundamentally alternative conception of space found throughout the Hispanic/Latino Southwest. Landscape scholar J. B. Jackson explains that historically, "the basic Anglo-American [sic] dwelling unit is the house, which we subdivide into rooms; the basic Spanish-American [Latino] unit is the room which is eventually added to" (Jackson 1959-1960:28).

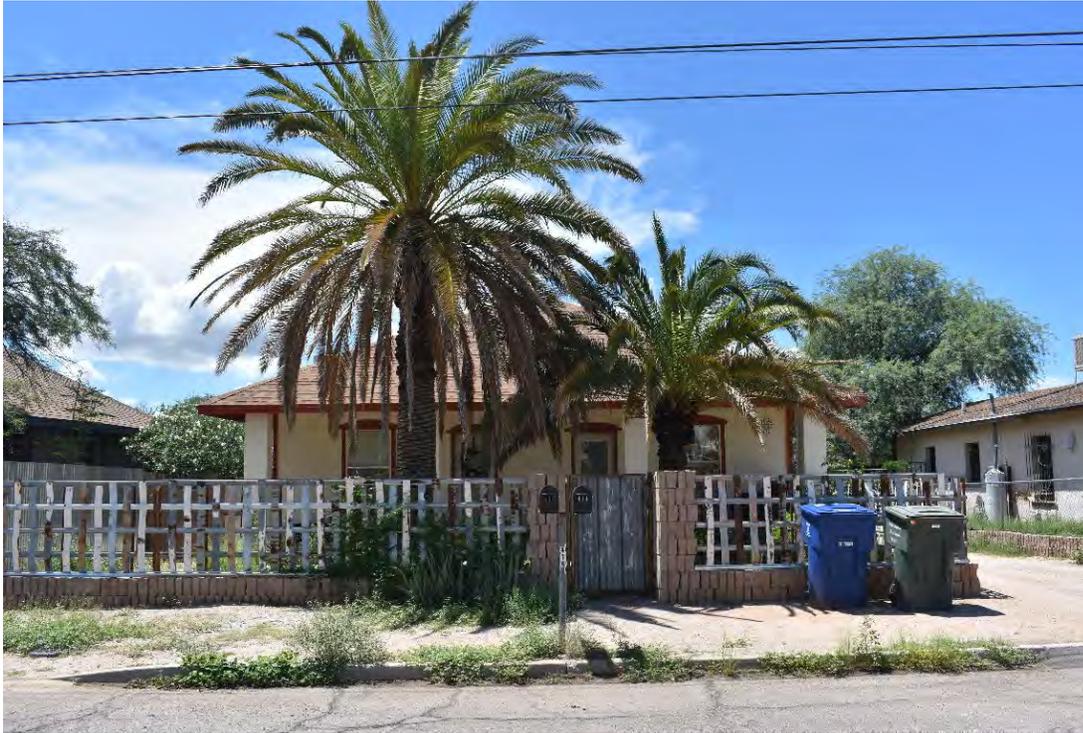
Photo 7. Example of fencing at 416 S. Fremont Avenue, view facing west (WestLand, January 2023 [AZ_PimaCounty_BarrioSanAntonio_0007])

As Latino individuals and families adapted to the Anglo-American built environment throughout the twentieth century, they simultaneously modified it to their needs, in part by creating private plazas through the use of fencing. This trend was widely noted in East Los Angeles where sociologist and urban planner James Rojas defined an "East Los Angeles Vernacular" style which is characterized by the use of fencing placed around a detached residence (Rojas 1991:91) (**Figure 11**). The East Los Angeles Vernacular approximated the *placita* through fenced front yards that were actively utilized as an extension of indoor living space. Meanwhile, the street bordered by the flush façades of the fences became an ersatz public plaza utilized for gatherings, activities, and even small-scale commerce. These traits and the East Los Angeles Vernacular are

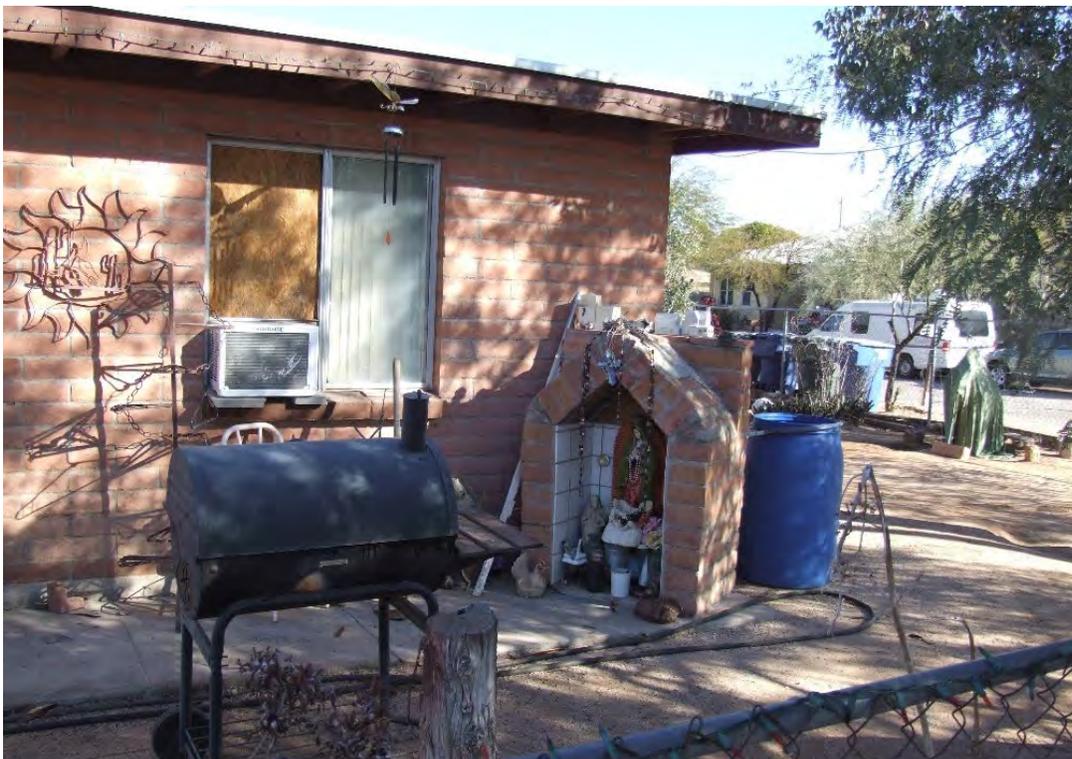
Photo 8. Example of a yard shrine at 546 S. Santa Rita Avenue (WestLand, January 2023 [AZ_PimaCounty_BarrioSanAntonio_0008])

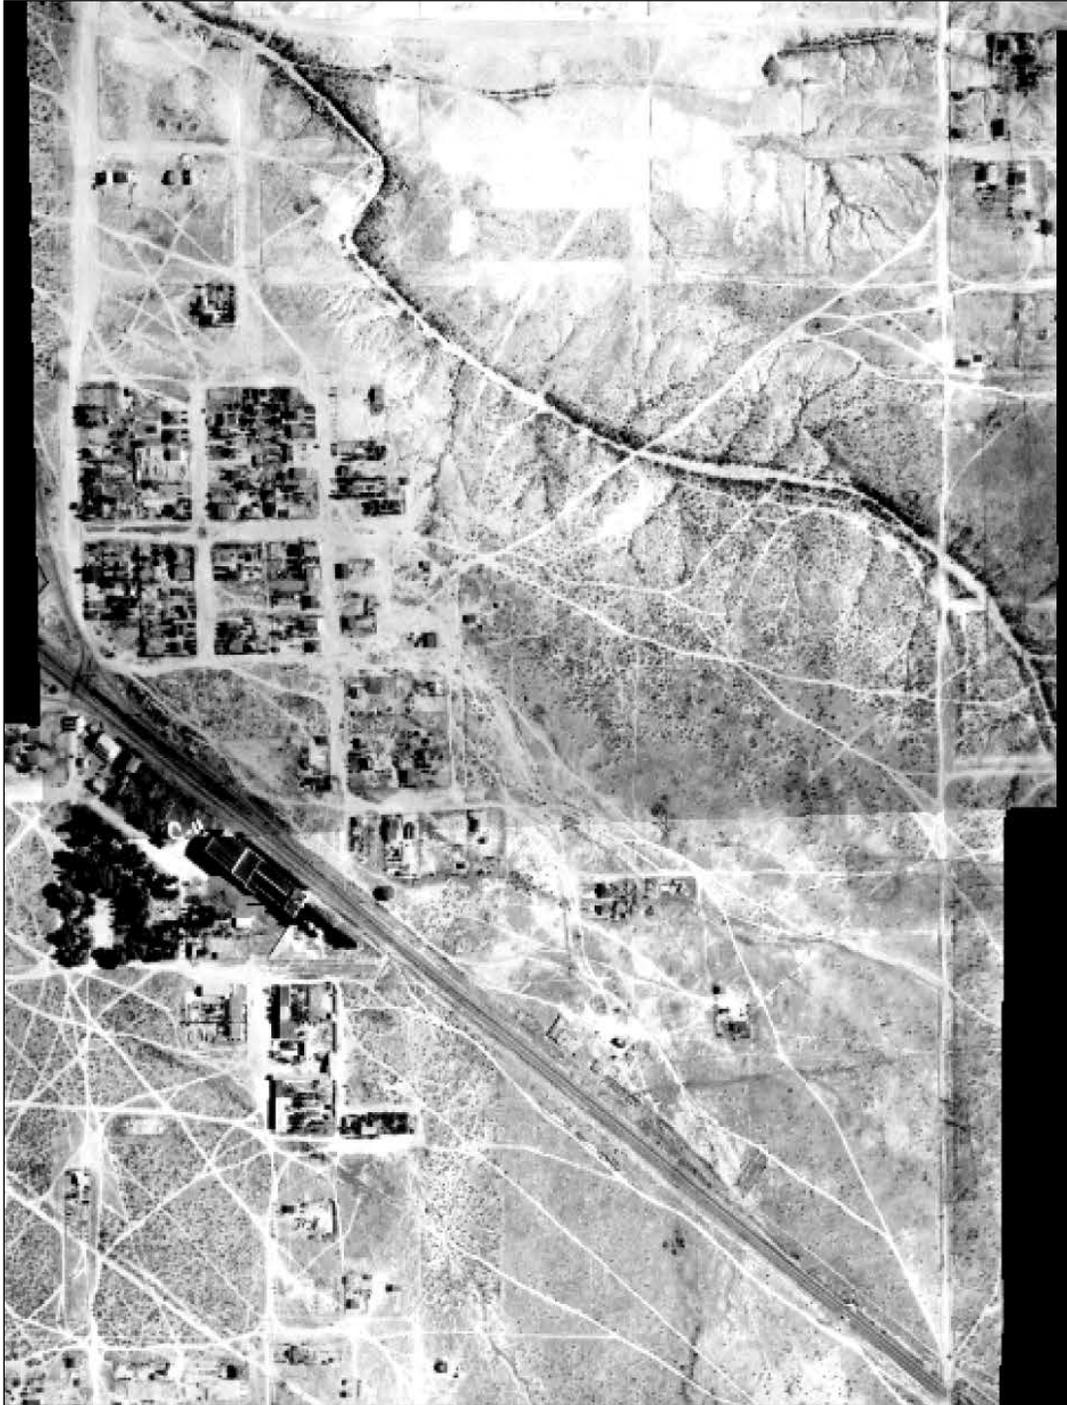
Figure 8. Aerial photograph (1924) (Courtesy City of Tucson GIS).

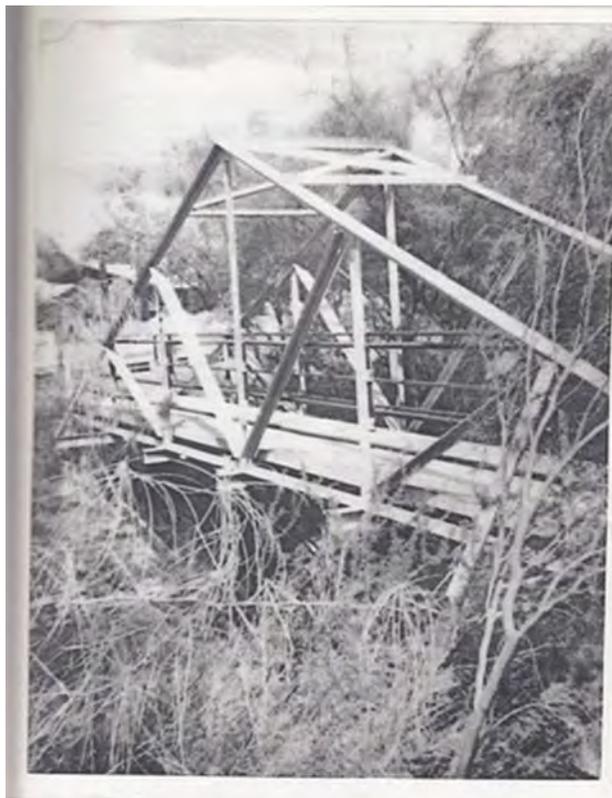
Figure 9. Image of the first steel bridge across Arroyo Chico. Unknown date. Image courtesy of Barrio San Antonio Neighborhood Association.

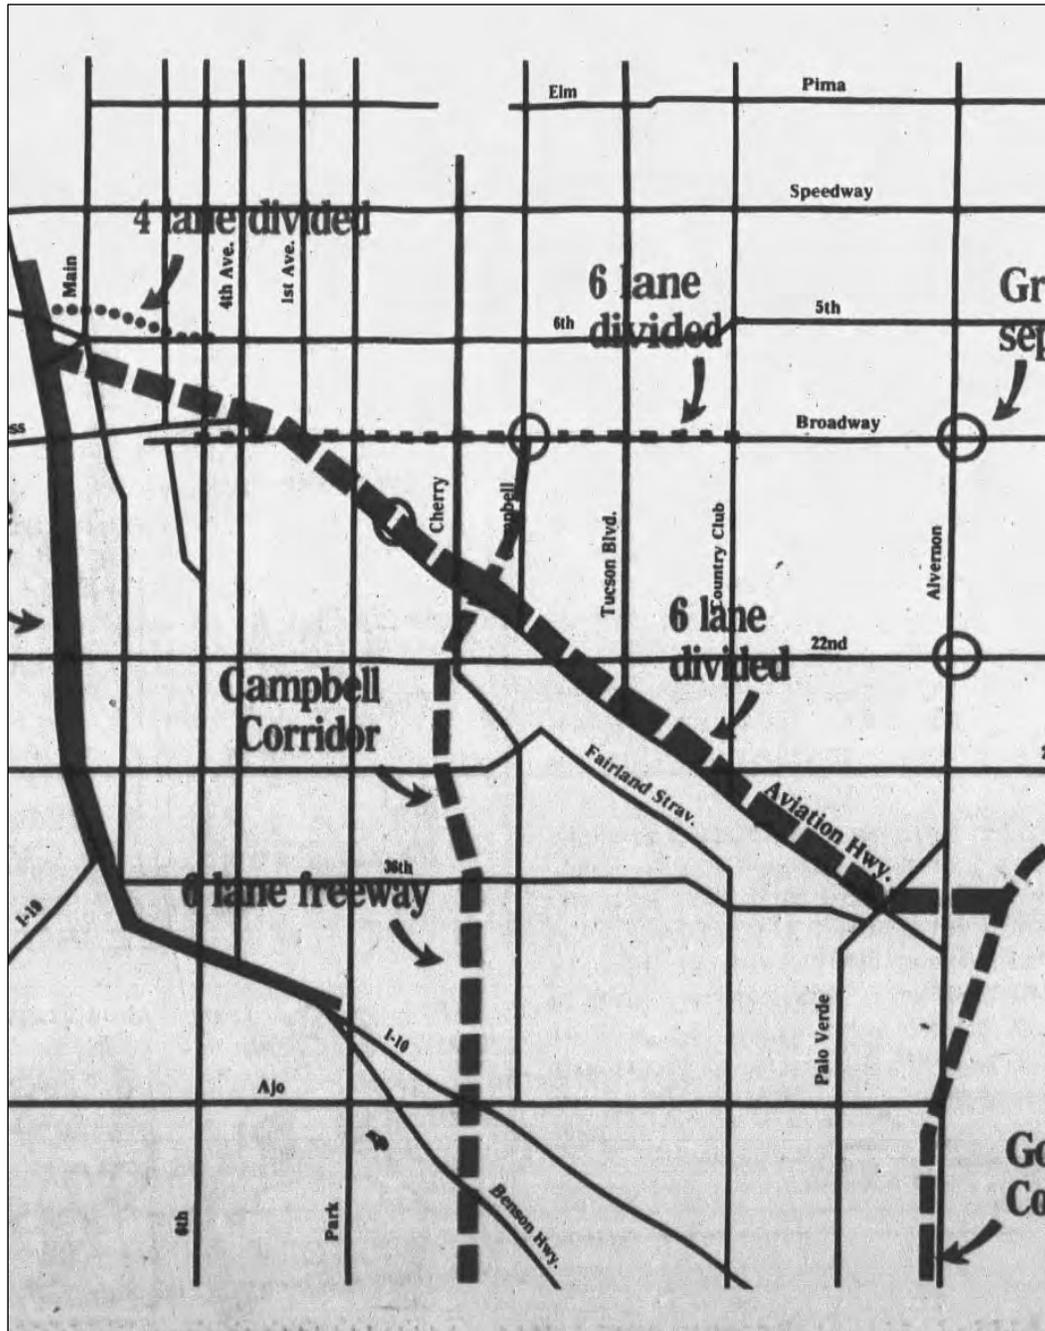
Figure 10. State Route 210 planning map. Barrio San Antonio is in the center of the planned route where Cherry Avenue is depicted (TC 6, August 1983:40).

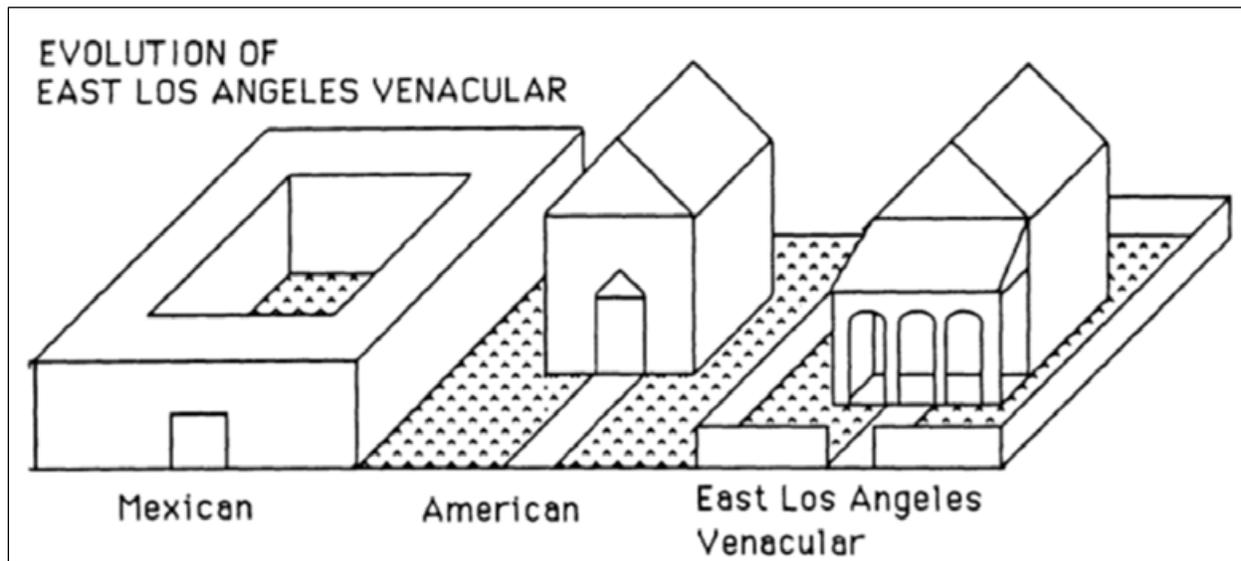
Figure 11. Evolution of East Los Angeles Vernacular. Evolution of East Los Angeles Vernacular. Graphic by James Rojas, 1991.

Rojas asserts that “the vernacular form offers cultural, economic, and regional solutions to the residents’ set criteria ... The vernacular represents peoples’ manipulation and adaptation over their environment” (Rojas 1991:78). Following this definition, the typical “set criteria” in the Southwest is lot size and the spatial relationship between lot, street, and neighboring lots of land. Rojas outlines functional shifts in Latino urban space that transform the suburban Anglo-American streetscape into a Latino vernacular streetscape.

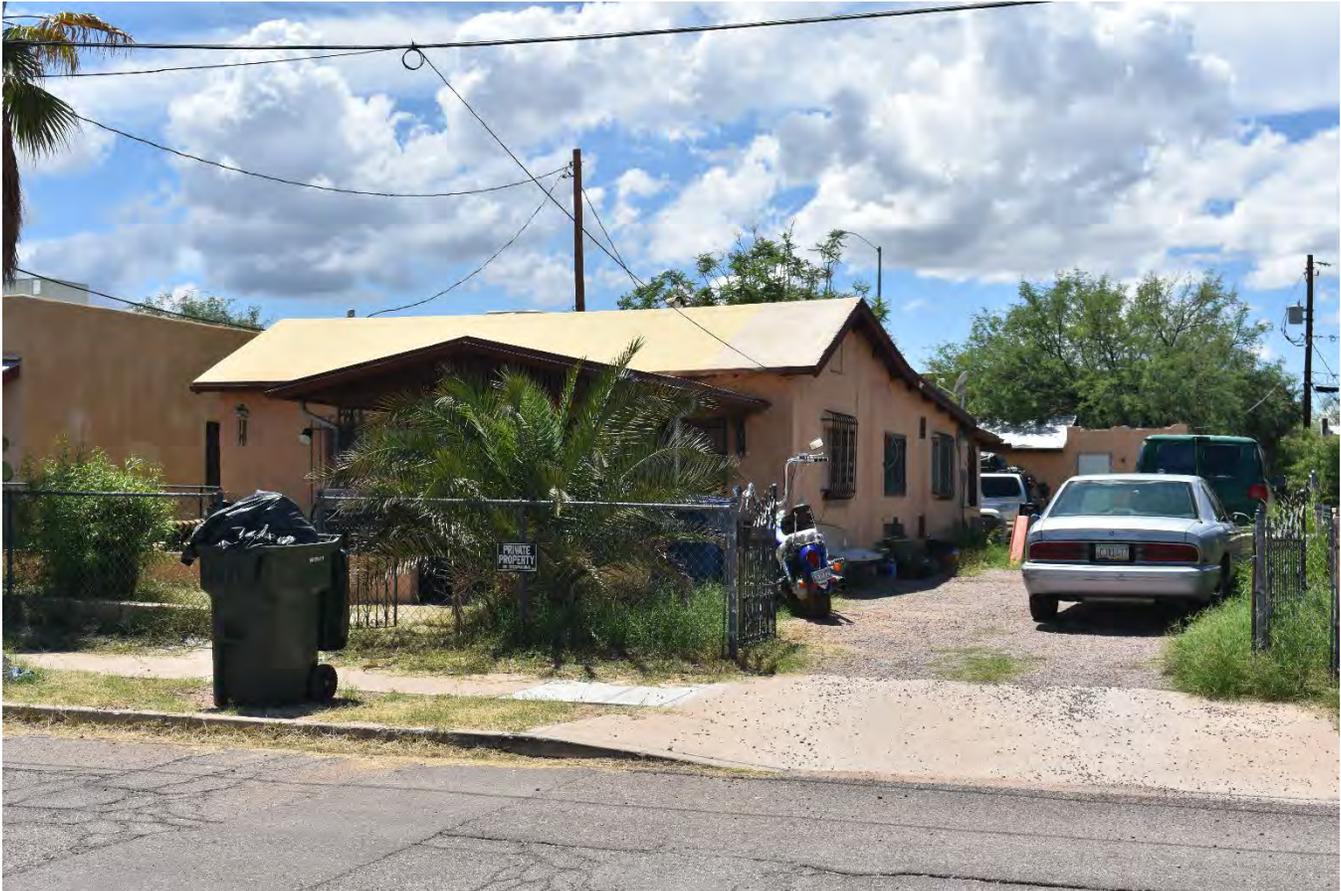
Photograph 6. Example of building additions to the rear of 506 S. Fremont Avenue, view facing southwest. (WestLand Engineering & Environmental Services, January 2023 [AZ_PimaCounty_BarrioSanAntonio_0006] jpeg).

Photo 6. Example of building additions to the rear of 506 S. Fremont Avenue, view facing southwest
(WestLand, January 2023 [AZ_PimaCounty_BarrioSanAntonio_0006])

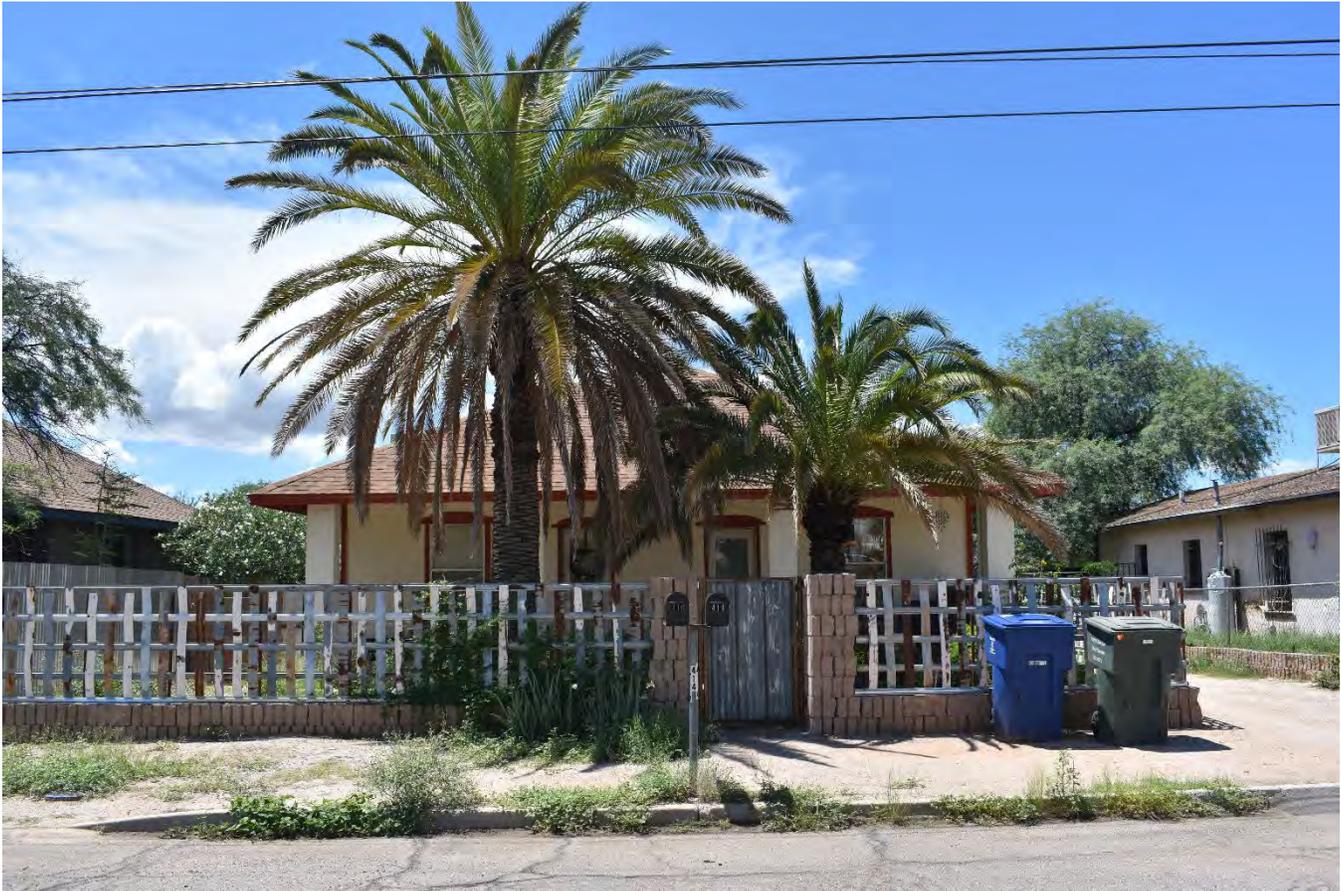
Photograph 7. Example of fencing at 416 S. Fremont Avenue, view facing west. (WestLand Engineering & Environmental Services, January 2023 [AZ_PimaCounty_BarrioSanAntonio_0007] jpeg).

Photo 7. Example of fencing at 416 S. Fremont Avenue, view facing west
(WestLand, January 2023 [AZ_PimaCounty_BarrioSanAntonio_0007])

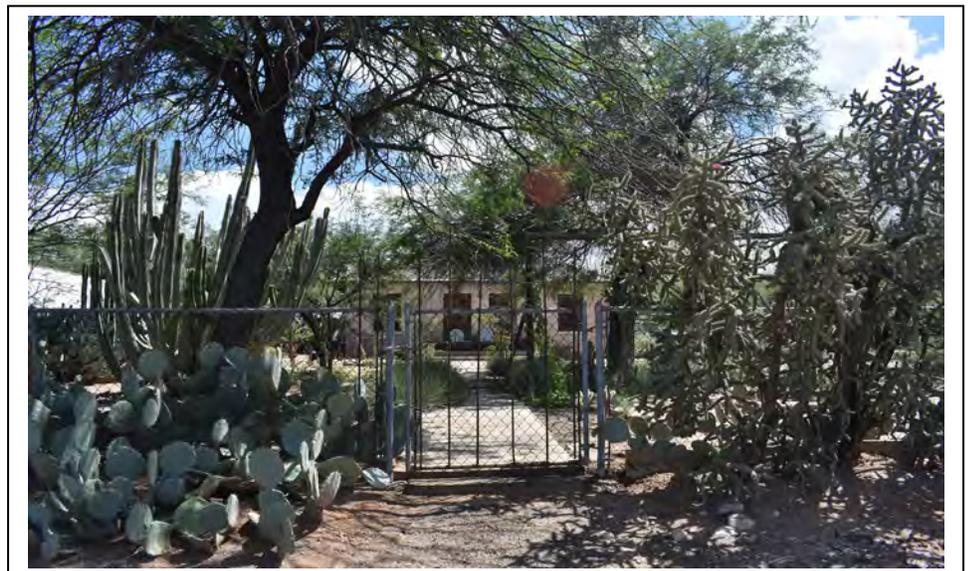
A one-story adobe and stucco Transitional Sonoran single residence with a rectangular floorplan, cement block foundation, hip roof, and wood sash windows. The building is surrounded fencing and cacti. There is a shed-roofed addition added in rear of the original building.

Walls (structure): Adobe Foundation: Cement block Roof: Prepared roll

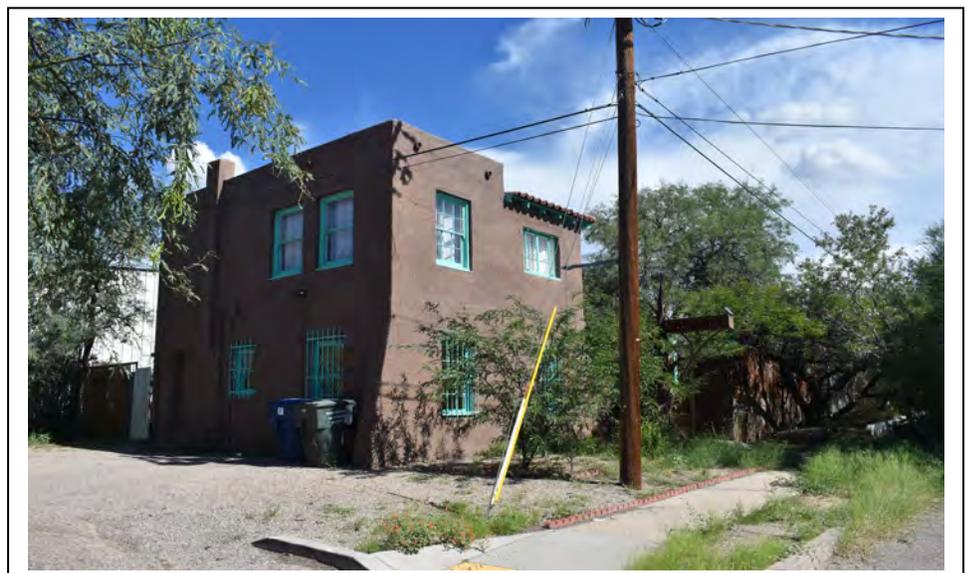
A one-story brick and stucco Mission Revival two-story multi-family residence with a rectangular floorplan, concrete foundation, a flat roof with partial shed roof and clay tiles. There are both steel casement and wood/vinyl sash windows and the lower level has security bars covering the windows. The different windows indicate additions possibly made during the historic period.

Walls (structure): Brick Foundation: Concrete Roof: Tile, Built up T & G

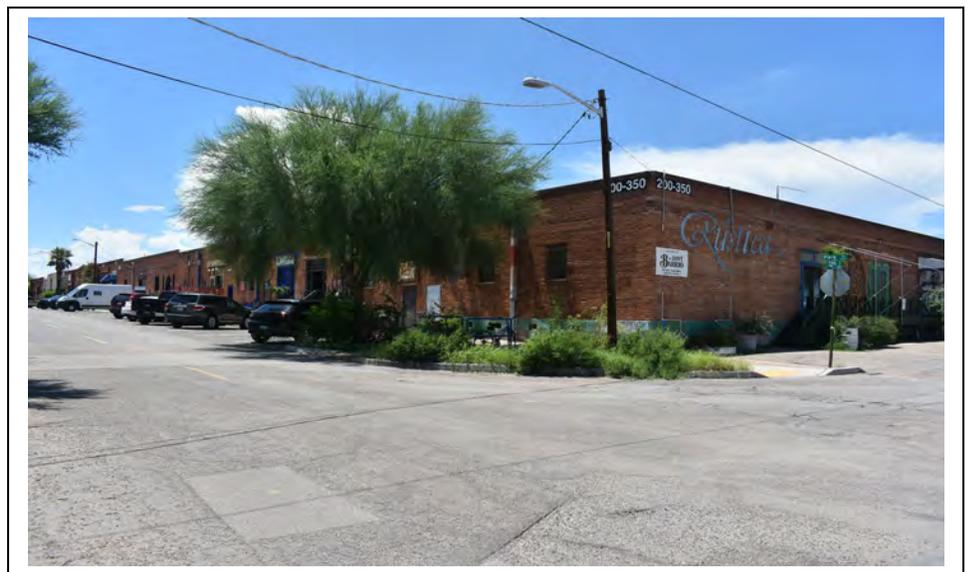
1. LOCATION Original Site Moved (date: _____) Original Site: _____
2. DESIGN (Describe alterations from the original design, including dates—known or estimated—when alterations were made)
A one-story brick warehouses with a flat roof, low parapet, and rectangular floorplans. The foundation is concrete/basement, and the fenestration has been altered on the east elevation.

Walls (structure): Brick Foundation: Concrete/basement Roof: Asphalt

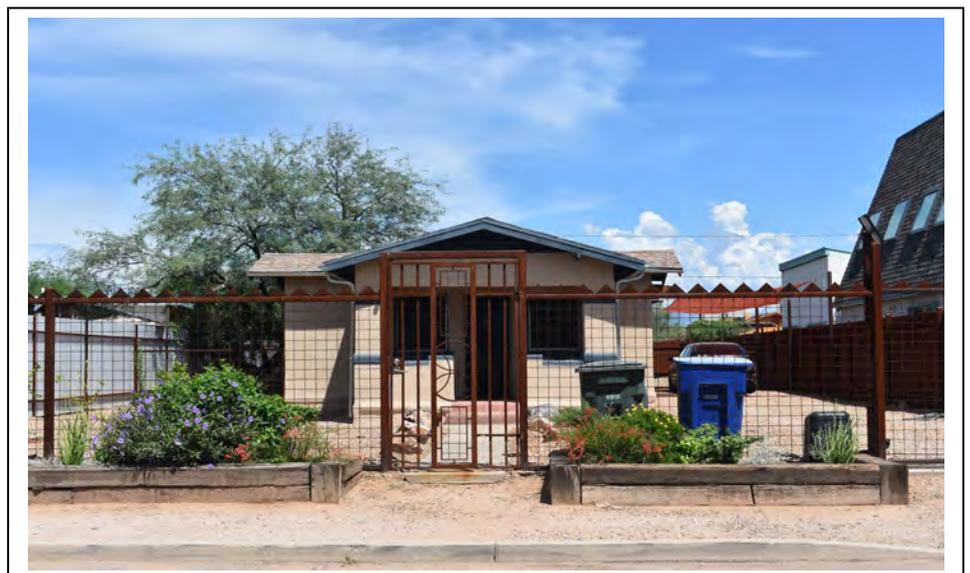
2. DESIGN (Describe alterations from the original design, including dates—known or estimated—when alterations were made)
A one-story adobe and stucco one-story Craftsman Bungalow building with a rectangular/T-shape floorplan, with a concrete block foundation, and a medium pitched gable roof. The front porch has square columns, and the fenestration has possibly been replaced. The stucco has been newly painted, and a new fence surrounds the front of the property.

Walls (structure): Adobe Foundation: Concrete block Roof: Composition

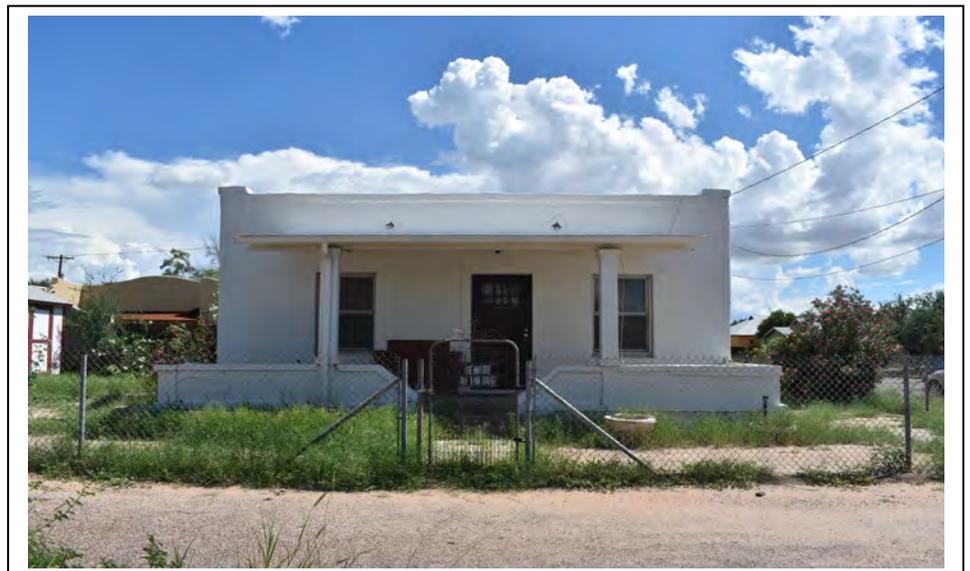
2. DESIGN (Describe alterations from the original design, including dates—known or estimated—when alterations were made)
A one-story adobe and stucco Mission Revival single residence with a rectangular floorplan, cement block foundation, a flat roof, and a front porch supported by square columns and a small stairway leading to the entryway. The original fenestration has been replaced with modern vinyl equivalents.

Walls (structure): Adobe Foundation: Cement block Roof: Prepared roll

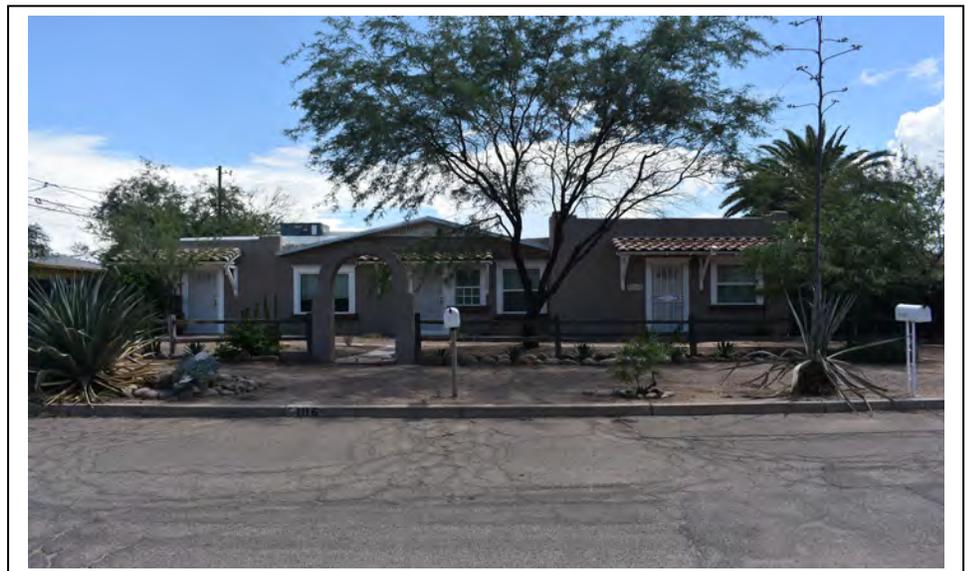
2. DESIGN (Describe alterations from the original design, including dates—known or estimated—when alterations were made)
A one-story adobe, framed wood, and stucco Eclectic building with Craftsman and Mission Revival detailing, a rectangular floorplan, concrete foundation, flat roof with a gable roof over the front of the building. The building is divided into two apartments, both entryways have coverings above them, and the windows have been replaced with vinyl equivalents. The original fenestration has been replaced. The property was enlarged after 1949 according to Sanborn Maps. The additions are still likely within the historic period based upon field observation.

Walls (structure): Adobe, Framed wood Foundation: Concrete Roof: Prepared roll

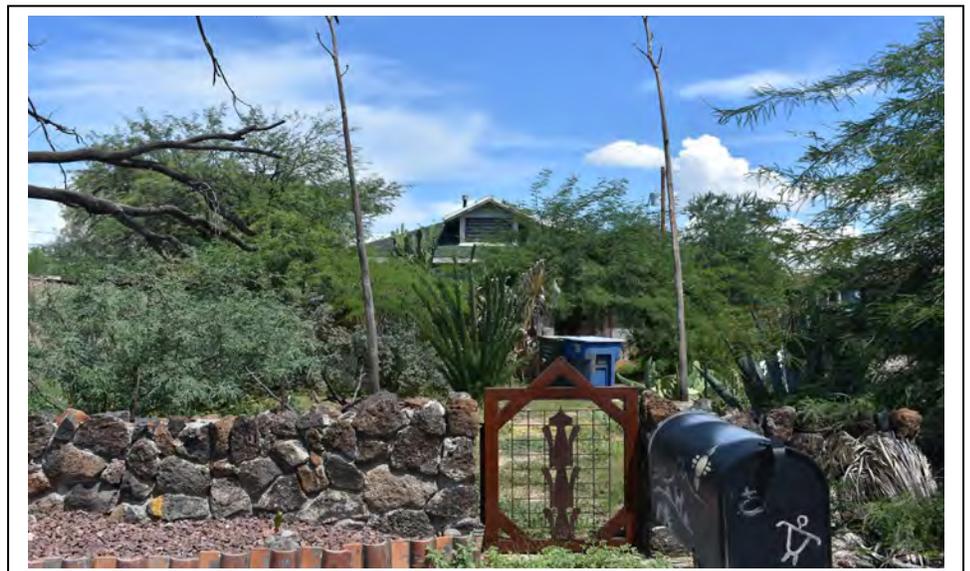
A one-story Craftsman Bungalow single residence building with a rectangular floorplan, stucco exterior, concrete/piers foundation, cross gabled roof, and square columns supporting the front screened porch. There is an addition to the rear.

Walls (structure): Wood frame? _____ Foundation: Concrete/piers? Roof: Prepared roll _____

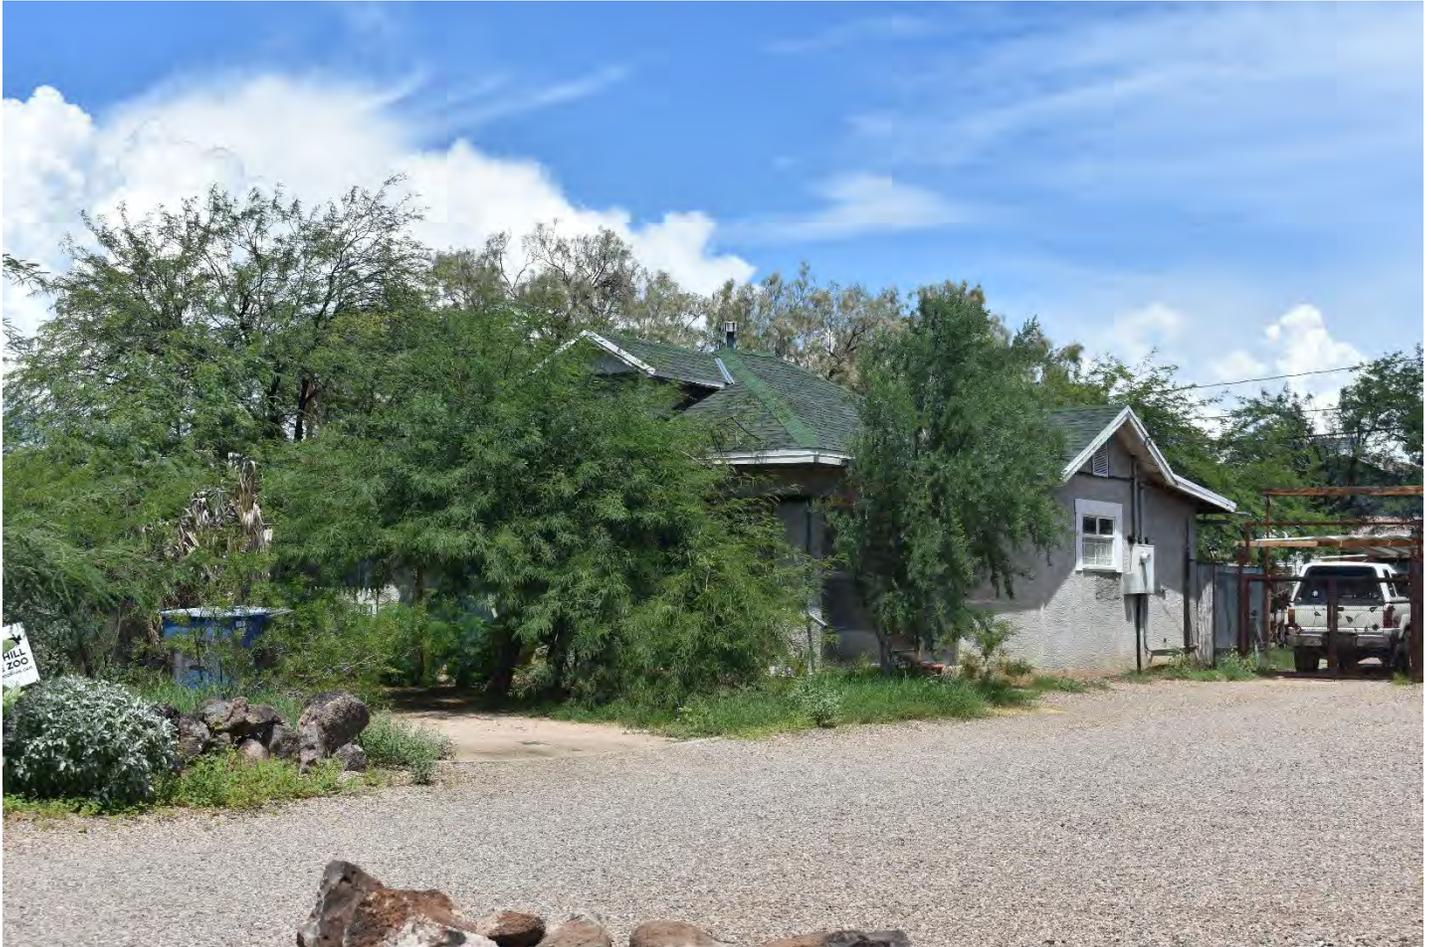
Name of Property: 423 South Fremont Avenue Continuation Sheet No. 1

423 South Fremont Avenue, west and south elevations, view facing northeast, Logan Simpson, 2021.
