National Register of Historic Places Registration Form

Historic name: Barrio San Antonio

Street & number: Manlove Street, Arroyo Chico, Park Avenue, Aviation Highway, and Santa Rita Ave

City or town: Tucson State: AZ County: Pima

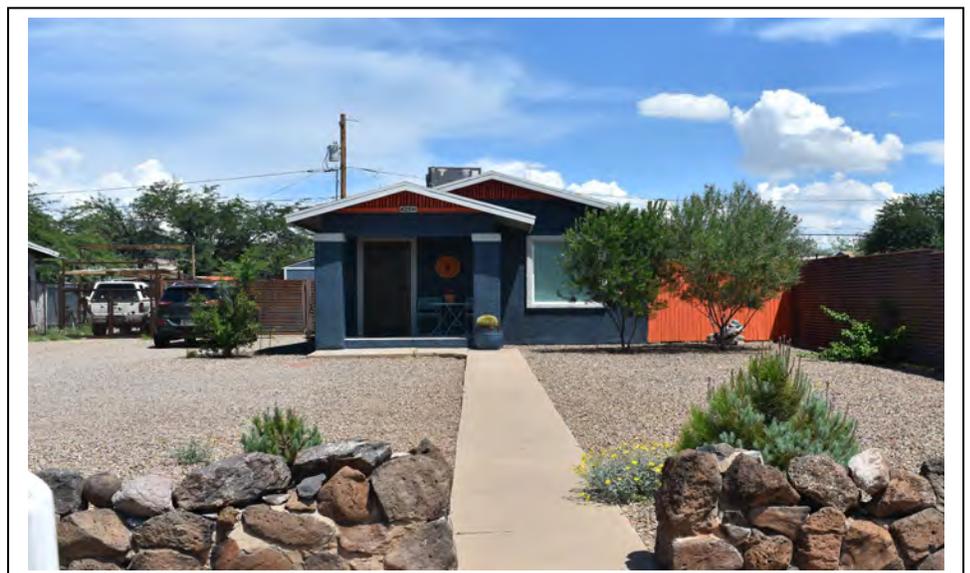
A one-story wood frame Craftsman Bungalow single residence with rectangular floorplan, concrete foundation, fixed/picture window located on the façade, and a side gable roof. The fenestration has been replaced by vinyl plate glass windows and a modern door.

Walls (structure): Framed wood Foundation: Concrete Roof: Asphalt

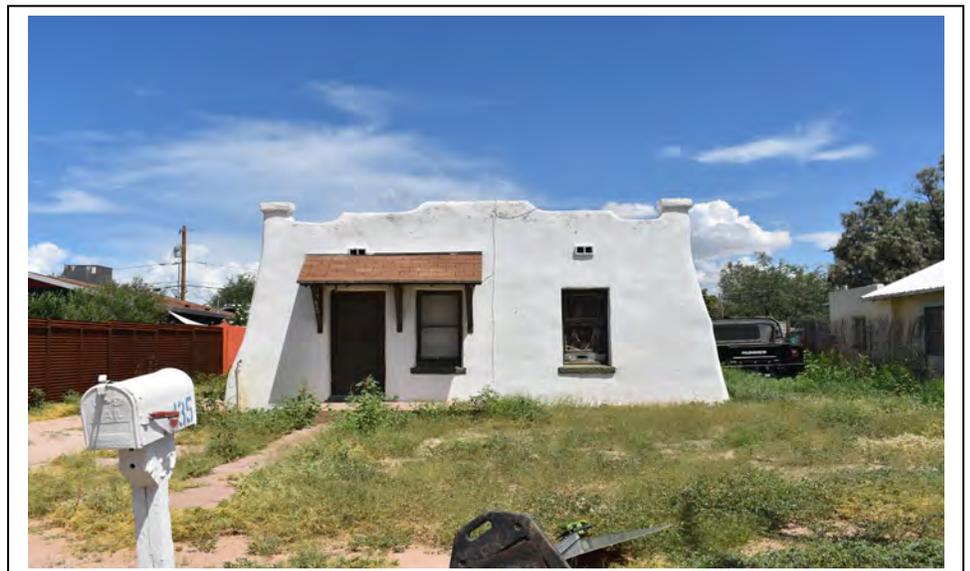
2. DESIGN (Describe alterations from the original design, including dates—known or estimated—when alterations were made)
A one-story adobe and stucco Mission Revival single residence with a square floorplan, concrete foundation, wood sash windows, a flat roof with some curves near the corners, and a small overhang above the main entryway on the west elevation. There are also drains located above each of the windows and doorways on every elevation.

Walls (structure): Adobe Foundation: Concrete Roof: Prepared roll

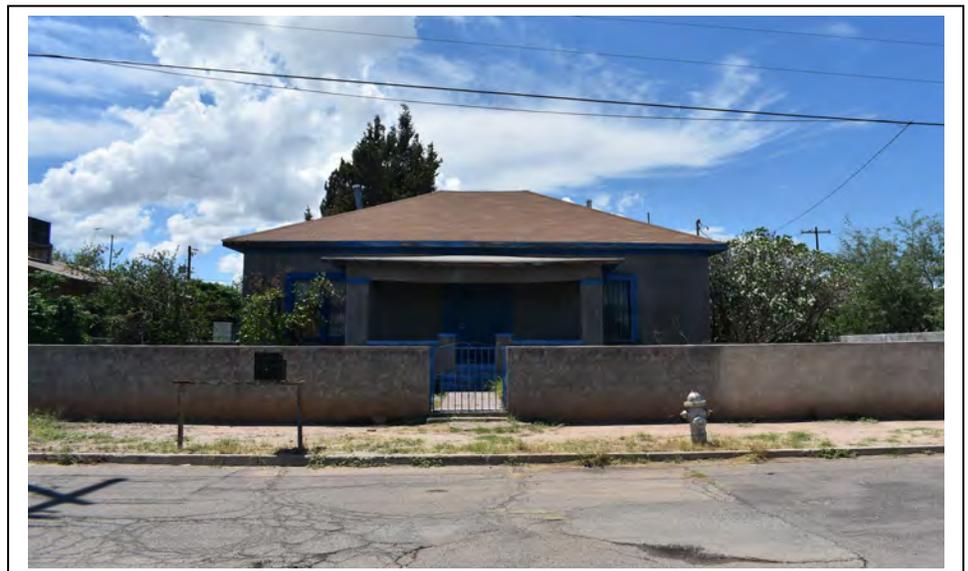
A one-story American Territorial adobe re clad with textured stucco with a square floorplan, concrete foundation, aluminum sash windows, a hipped roof with asphalt shingles, and painted metal security bars covering the windows. There is a concrete half walk surrounding the front of the property with a metal gate located on the east elevation. There is a shed roof addition at the rear that was likely added during the historic period.

Walls (structure): Adobe Foundation: Concrete Roof: Asphalt shingles

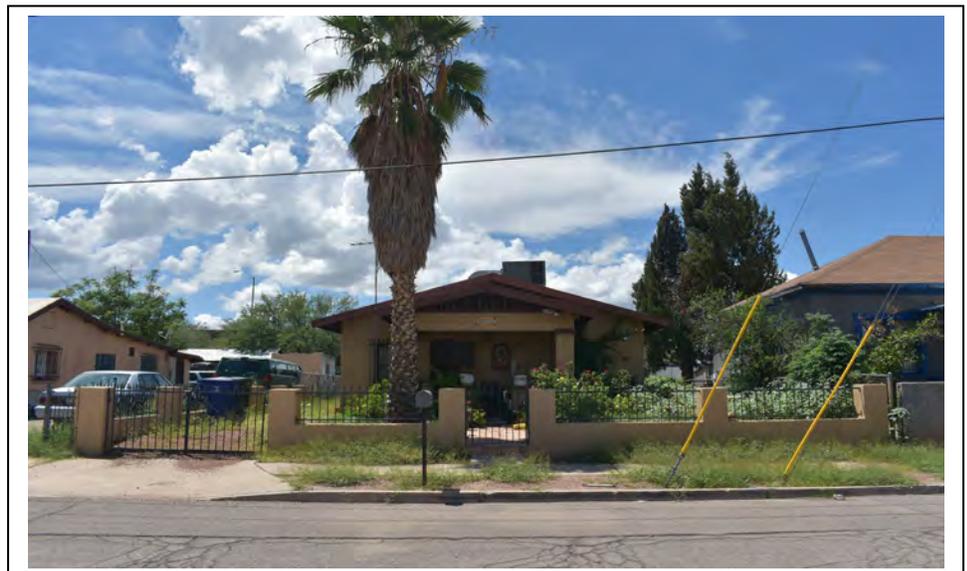
A one-story adobe and stucco Craftsman Bungalow with a rectangular floorplan, concrete foundation, front gable roof, wood/aluminum sash windows with security screens along all windows on all elevations. There is a stucco and metal fence/wall surrounding the front of the building.

Walls (structure): Adobe Foundation: Concrete Roof: Prepared roll

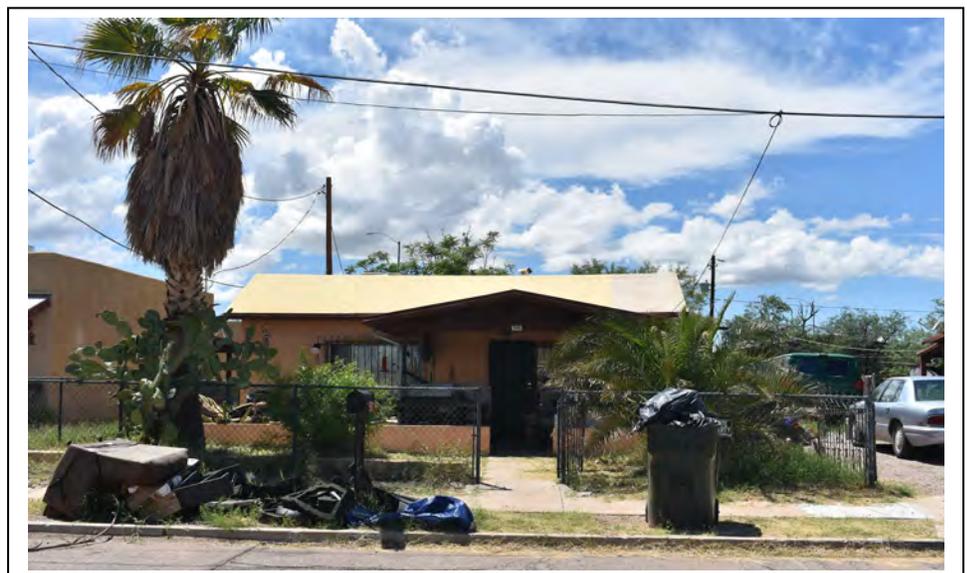
2. DESIGN (Describe alterations from the original design, including dates—known or estimated—when alterations were made)
A one-story adobe and stucco Vernacular single residence with a rectangular floorplan, concrete foundation, a medium pitch gable/shed roof, a porch gable roof, there are security screens covering all windows on all elevations. The shed-roofed addition at rear of building is not visible from the street. The fenestration has been replaced and the porch roof supports have been replaced.

Walls (structure): Adobe, Framed Wood Foundation: Concrete Roof: Prepared roll

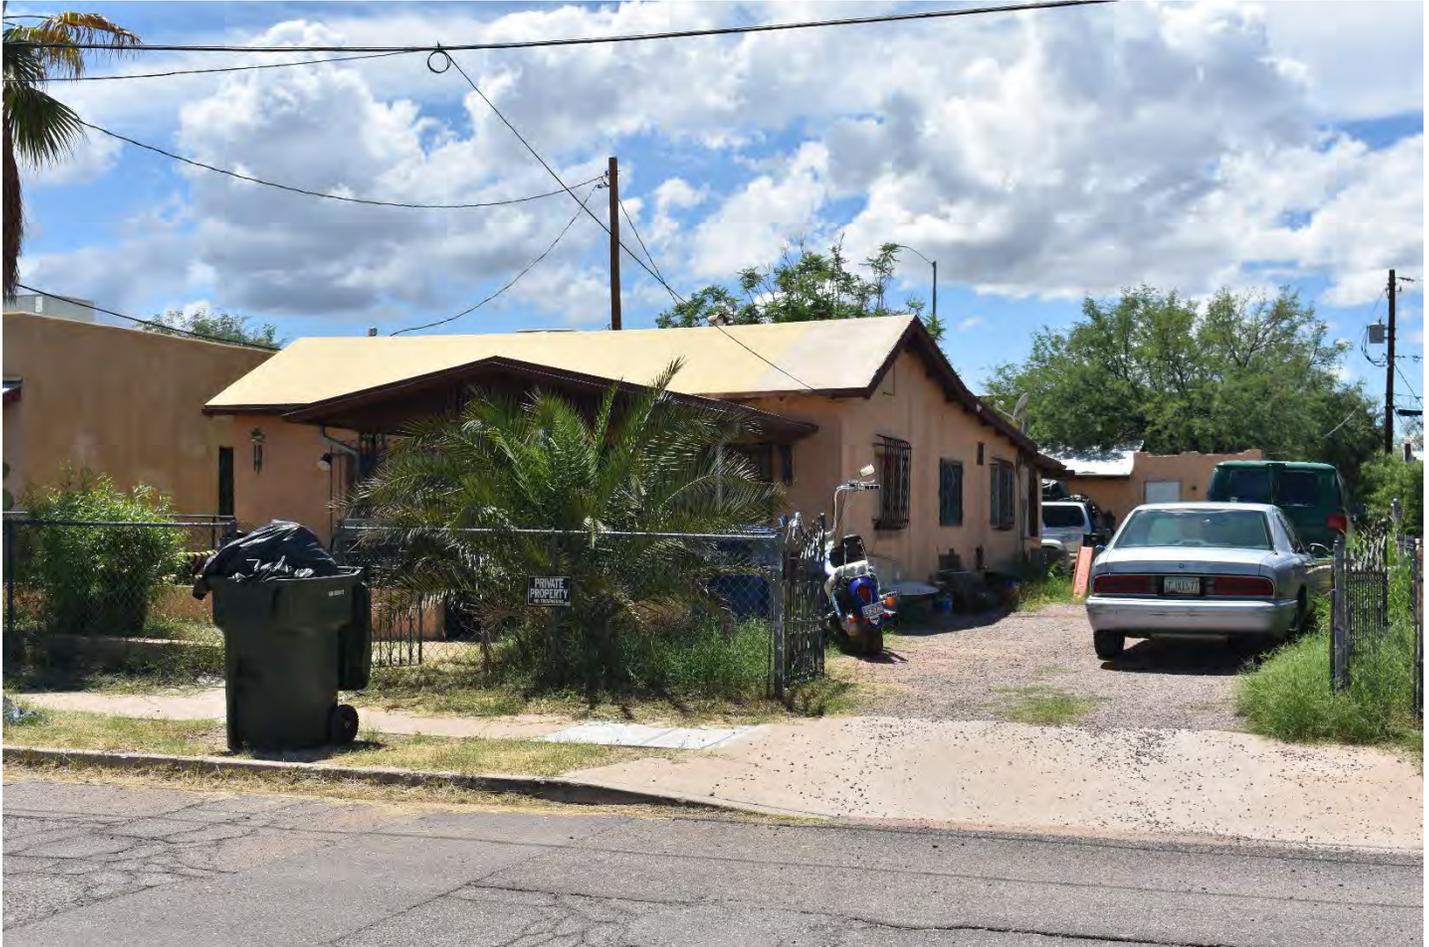
Name of Property: 506 South Fremont Avenue Continuation Sheet No. 1

506 South Fremont Avenue, north and east elevations, view looking southwest, Logan Simpson, 2021.

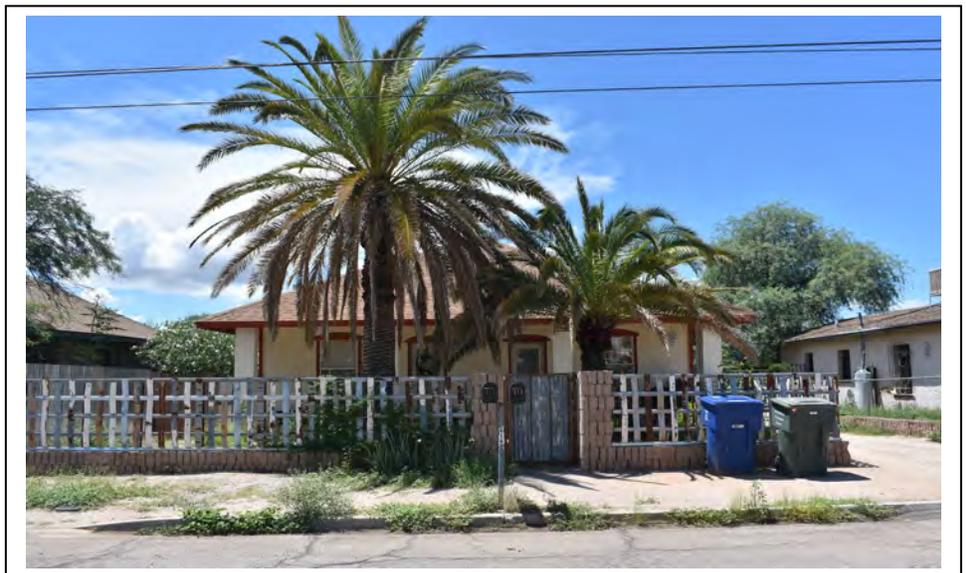
A one-story painted brick American Territorial multiple residence building with square floorplan, a concrete foundation, hip roof, and a front porch supported by square columns. The original fenestration has been replaced. There is a weaved metal/steel fence in front of the residence bordered with small bricks. The driveway is located on the north elevation of the residence.

Walls (structure): Brick Foundation: Concrete Roof: Wood shingles

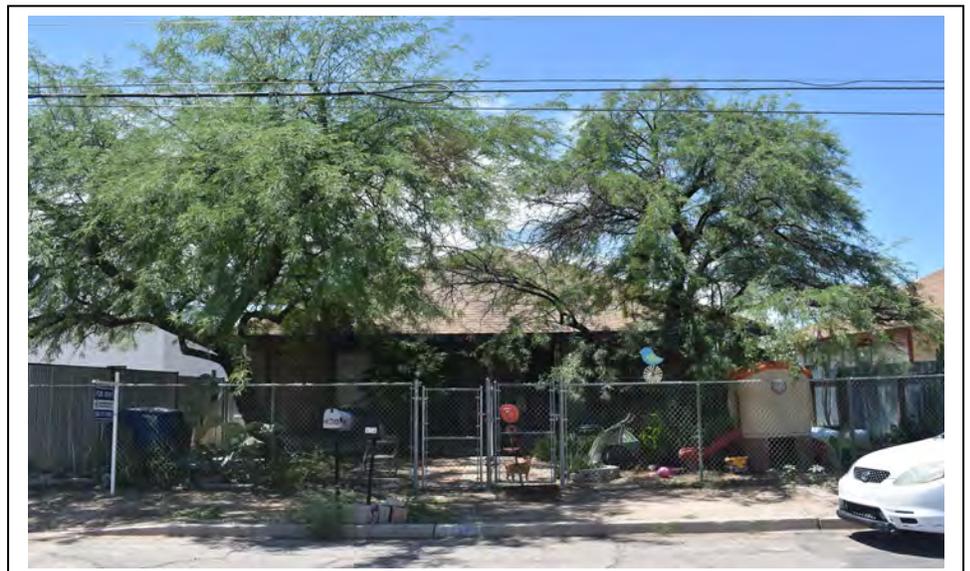
2. DESIGN (Describe alterations from the original design, including dates—known or estimated—when alterations were made)
A one-story painted brick American Territorial multi-family residence with a rectangular footprint, a concrete foundation, and hip roof. There is a shed-roofed addition to the rear, and it is not visible from the street. The original fenestration has been replaced.

Walls (structure): Brick Foundation: Concrete Roof: Asphalt shingles

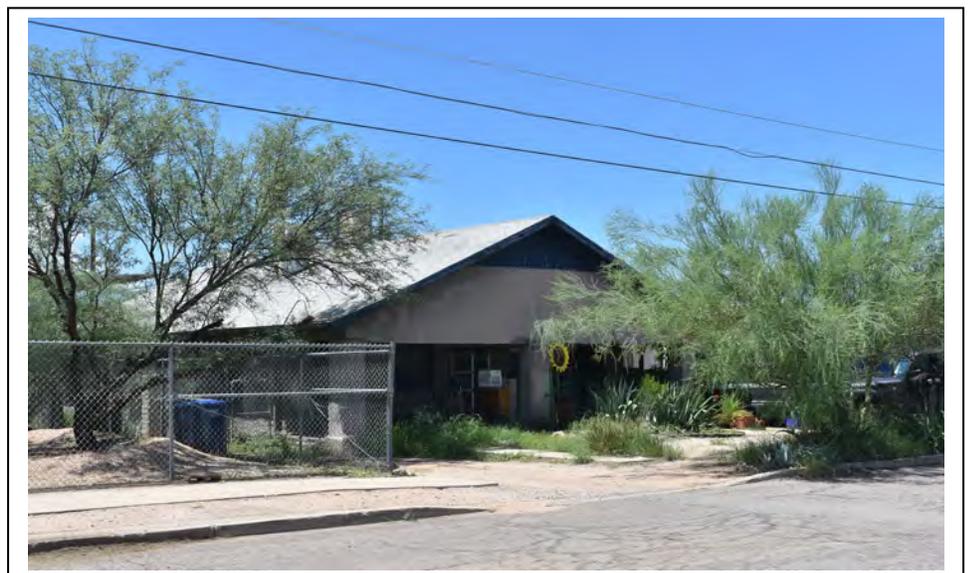
A one-story adobe and stucco Craftsman Bungalow multi-family residence with a rectangular floorplan, stone foundation, a medium-pitch gable roof, and square columns supporting the open front porch. Fenestration possibly replaced and heavily textured stucco applied to exterior.

Walls (structure): Adobe Foundation: Stone Roof: Prepared roll

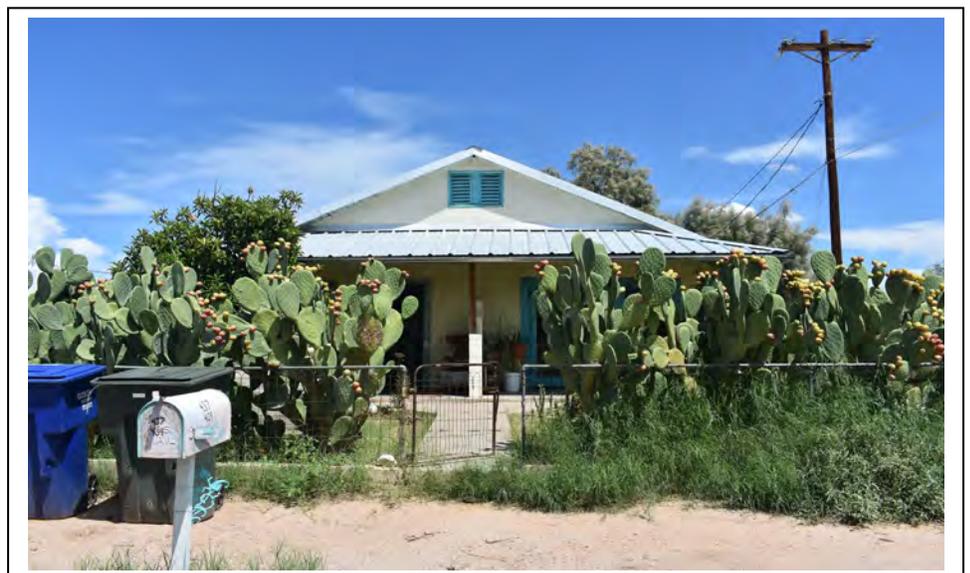
2. DESIGN (Describe alterations from the original design, including dates—known or estimated—when alterations were made)
A one-story framed wood and stucco Craftsman Bungalow with a rectangular floorplan, concrete foundation, front gable roof with ventilation, an overhang above the front porch. The porch roof was likely added and/or original supports were replaced with wrought iron supports within the historic period. An addition added to the rear is likely within the historic period.

Walls (structure): Framed wood Foundation: Concrete Roof: Prepared roll

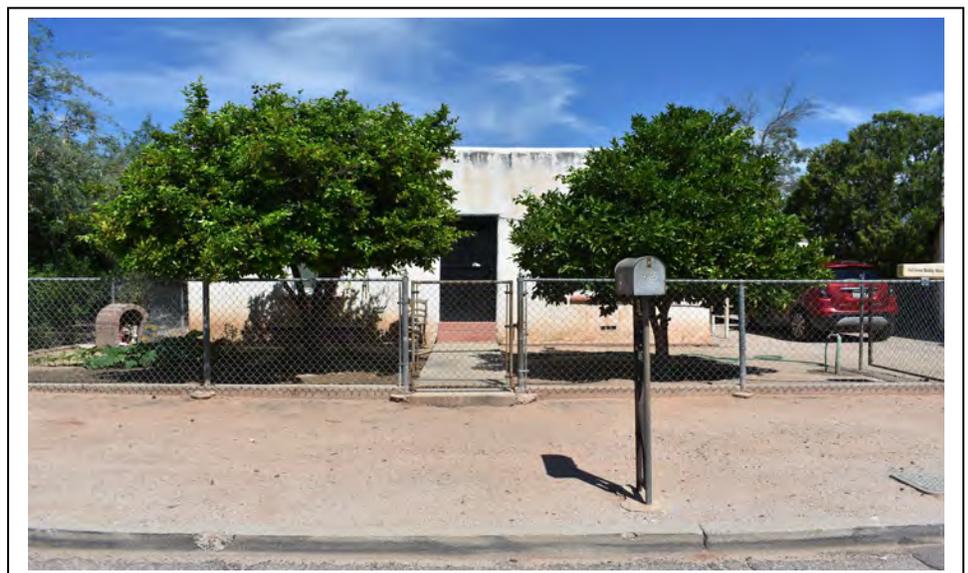
1. LOCATION Original Site Moved (date: _____) Original Site: _____
2. DESIGN (Describe alterations from the original design, including dates—known or estimated—when alterations were made)
A one-story single residence adobe and stucco Sonoran Bungalow with a rectangular floorplan, cement block foundation, and a flat roof. The original fenestration has been altered.

Walls (structure): Adobe Foundation: Cement block Roof: Prepared roll

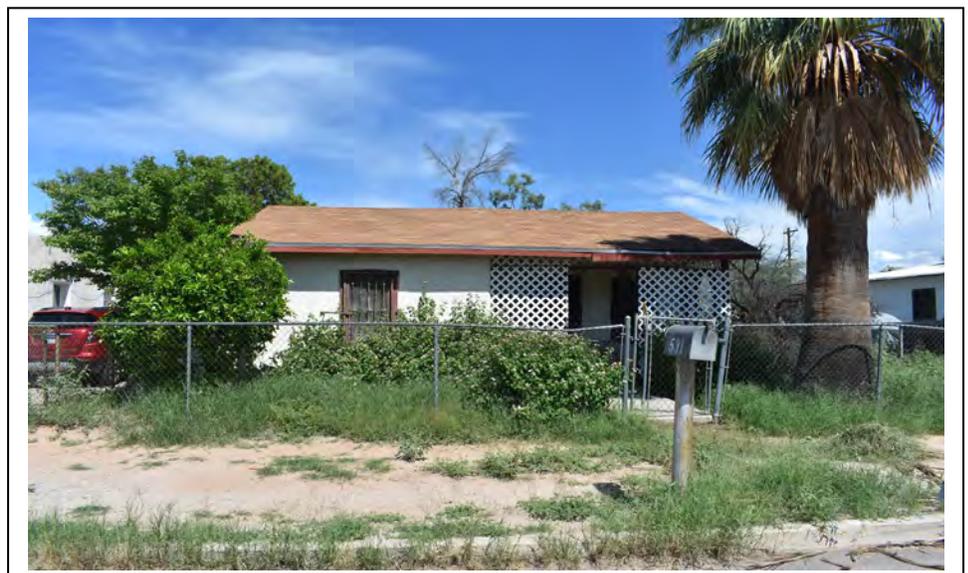
A one-story adobe and stucco Vernacular single residence building with a rectangular floorplan, a low pitch side gable roof, and concrete foundation. The front porch is partially screen by a vinyl lattice, and the windows have security gates covering them. The original wood [?] windows have been replaced with aluminum. There is a shed-roofed addition added onto the rear that was likely constructed within the historic period.

Walls (structure): Adobe Foundation: Concrete Roof: Prepared roll

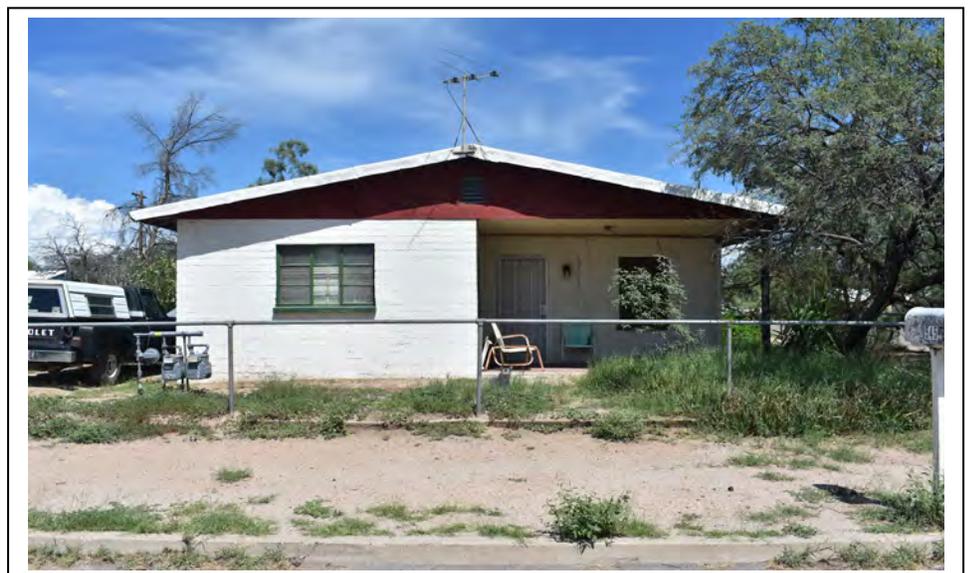
2. DESIGN (Describe alterations from the original design, including dates—known or estimated—when alterations were made)
A one-story brick Early Ranch single residence building with a rectangular floorplan, hipped roof, and concrete foundation with a small front porch. The original door has been replaced with a security screen. The original steel casement windows are still intact and painted.

Walls (structure): Brick Foundation: Concrete/Piers Roof: Prepared roll

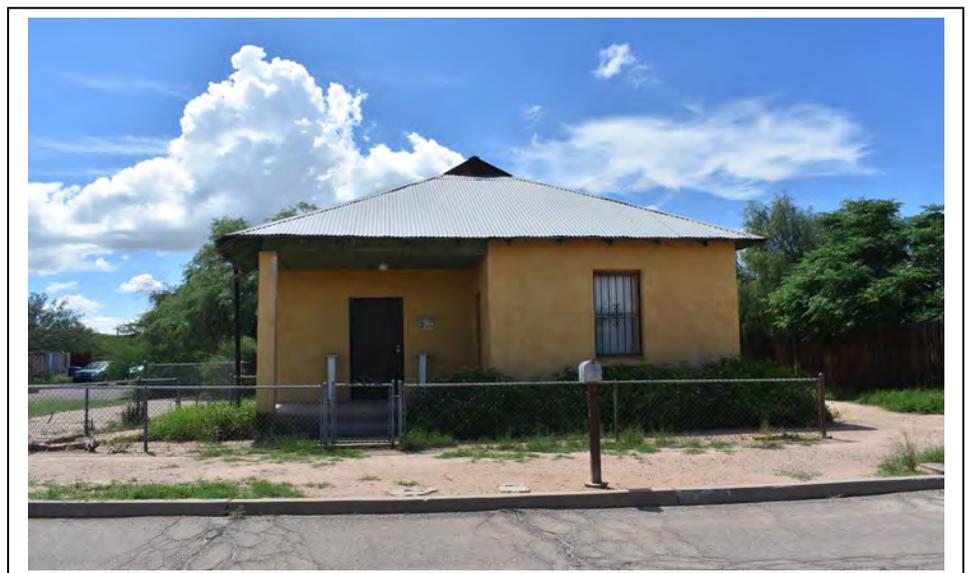
A one-story adobe and stucco American Territorial single residence building with a rectangular floorplan, hip-roof, concrete foundation, aluminum sash windows with decorative security screens. The hip-roofed addition at the rear was added within the historic period. The fenestration has also been replaced.

Walls (structure): Adobe Foundation: Concrete Roof: Metal/Aluminum

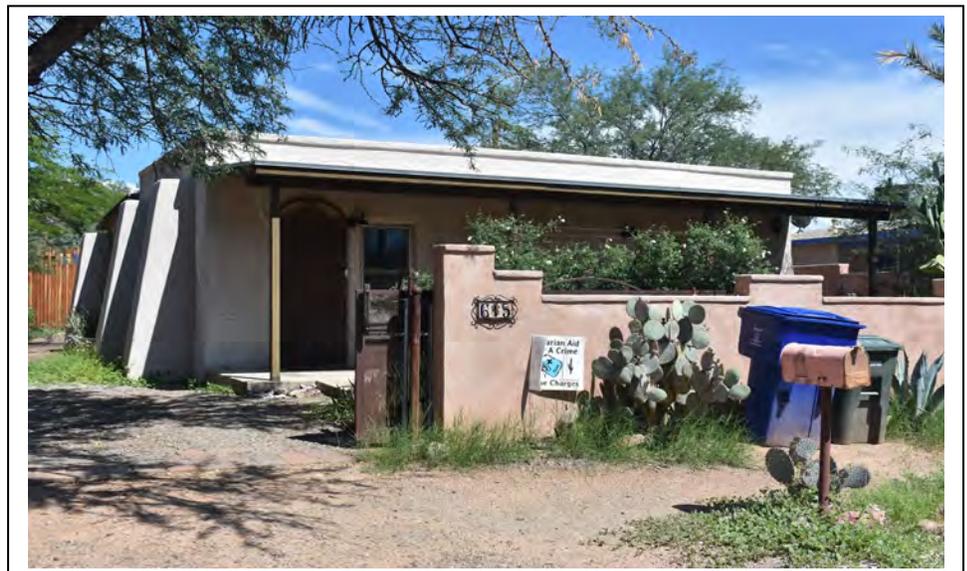
A one-story adobe and stucco Sonoran (Vernacular) single residence building with a rectangular footprint, a flat roof, with small porch overhang supported by wooden posts. There are three slanted square columns that protrude from the sides of the building. There is an adobe and stucco wall that stands at multiple heights in front of the west elevation and wraps around in front of the south elevation. The fenestration has been replaced and the original wood sash windows has been replaced with vinyl sash windows.

Walls (structure): Adobe Foundation: Concrete Roof: Prepared roll

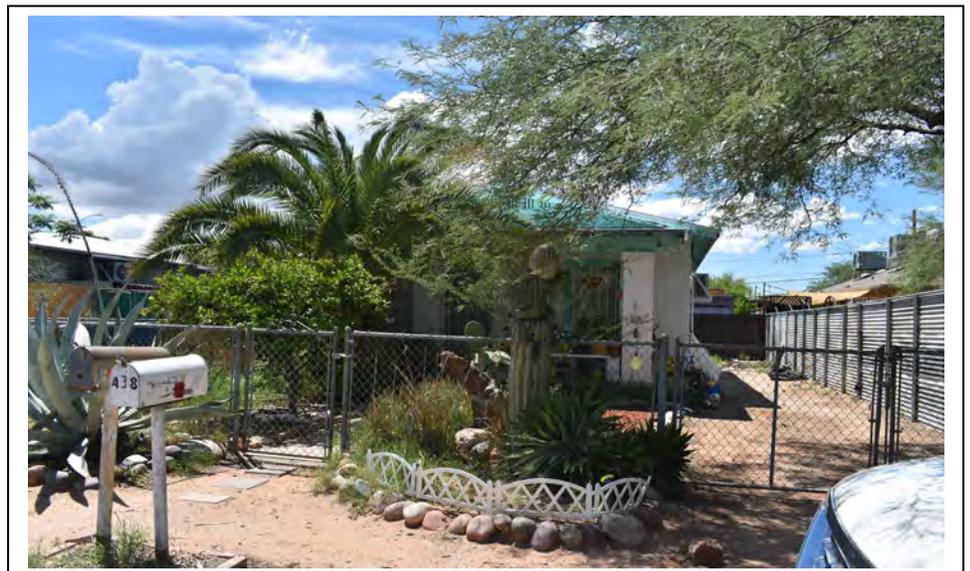
A one-story painted brick Craftsman Bungalow with a rectangular floorplan, concrete foundation, a medium pitch gable roof and a front porch supported by squared columns. The building is used as two single dwelling residences.

Walls (structure): Brick Foundation: Concrete Roof: Prepared roll

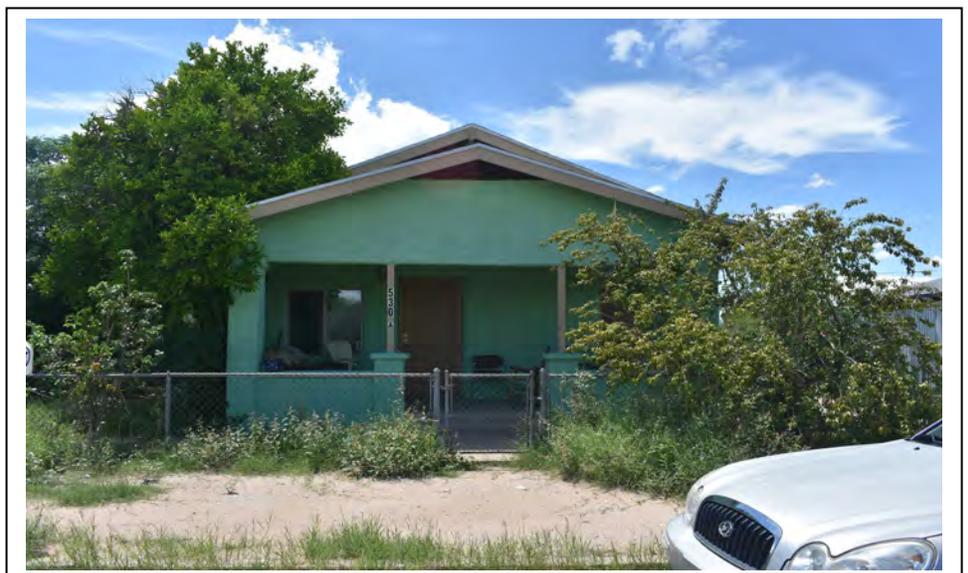
1. LOCATION Original Site Moved (date: _____) Original Site: _____
2. DESIGN (Describe alterations from the original design, including dates—known or estimated—when alterations were made)
A one-story adobe and stucco Craftsman Bungalow multiple residence with rectangular floorplan, a concrete foundation, gable roof, a front porch supported by partial square columns and supports. The supports were added to shore up front porch beam. Mobile home, 530-B is located at rear and was added between 2018 and 2019.

Walls (structure): Adobe Foundation: Concrete Roof: Prepared roll

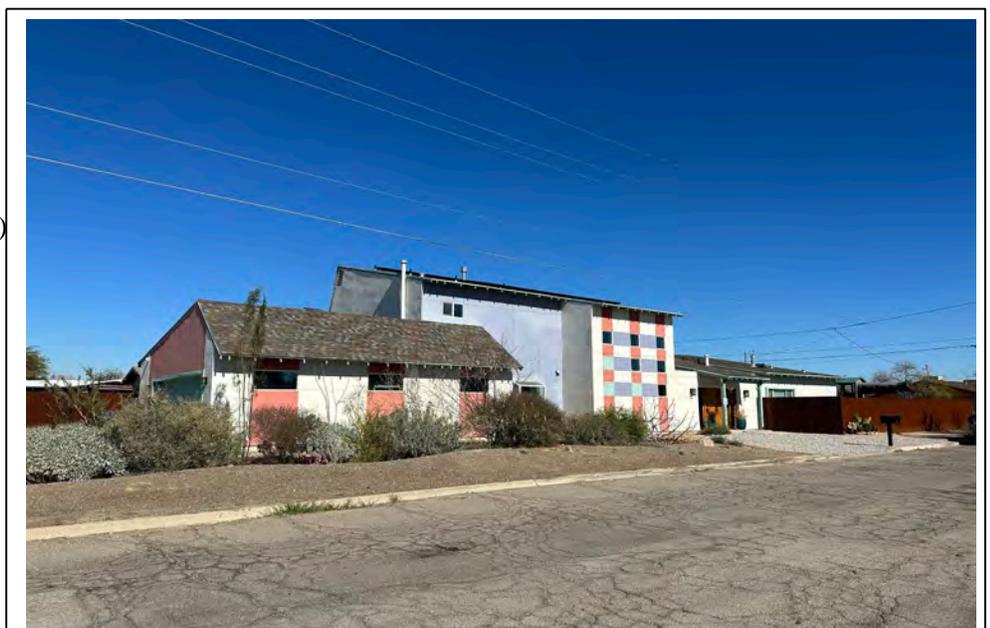
4. MATERIALS (Describe the materials used in the following elements of the property)
Walls (structure): Frame Foundation: Concrete Roof: Asphalt shingles
Windows: Vinyl
If the windows have been altered, what were they originally? N/A
Wall Sheathing: Stucco
If the sheathing has been altered, what was it originally? N/A
5. WORKMANSHIP (Describe the distinctive elements, if any, of craftsmanship or method of construction)
N/A

Fair (some problems apparent) Describe: Cracking exterior walls are peeling paint, fencing.

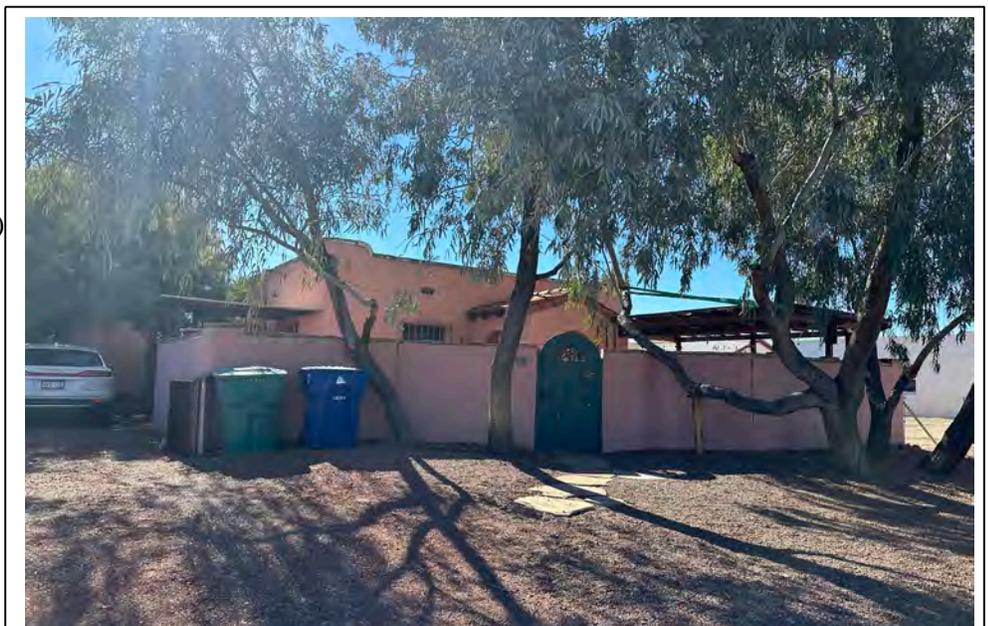
- 4. **MATERIALS** (Describe the materials used in the following elements of the property)
Walls (structure): Masonry Foundation: Concrete Roof: Prepared roll & clay tile
Windows: Wood
If the windows have been altered, what were they originally? N/A
Wall Sheathing: Stucco
If the sheathing has been altered, what was it originally? Unknown
- 5. **WORKMANSHIP** (Describe the distinctive elements, if any, of craftsmanship or method of construction)
Rounded entry on porch and wings or buttresses against porch posts. Brick coping along parapet.

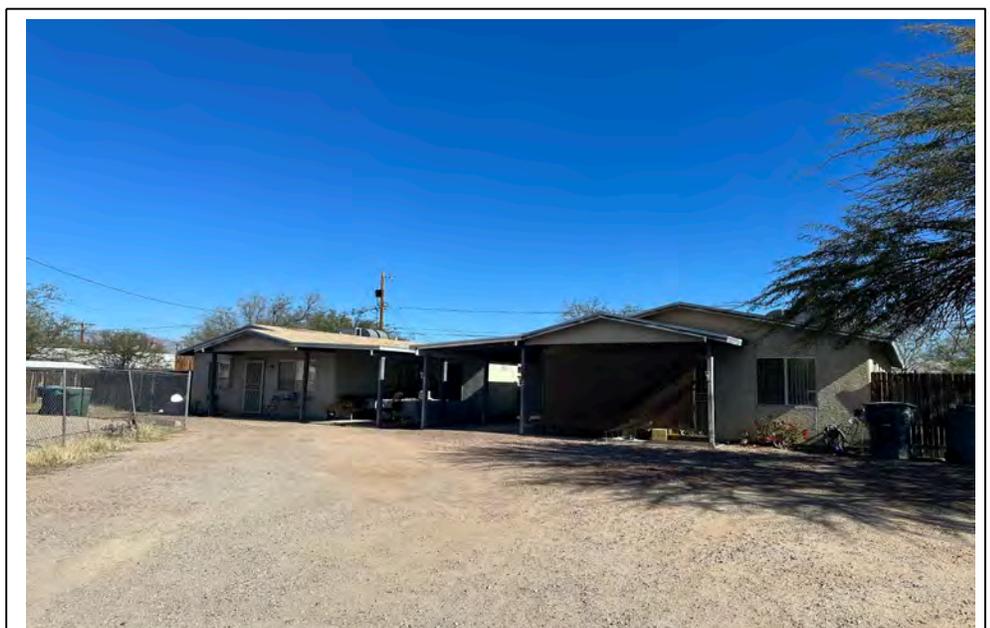
4. **MATERIALS** (Describe the materials used in the following elements of the property)
Walls (structure): Sheet rock Foundation: Concrete Roof: Asphalt shingles

Fair (some problems apparent) Describe: Plaster is spalling, exposed adobe, missing doors and window glass

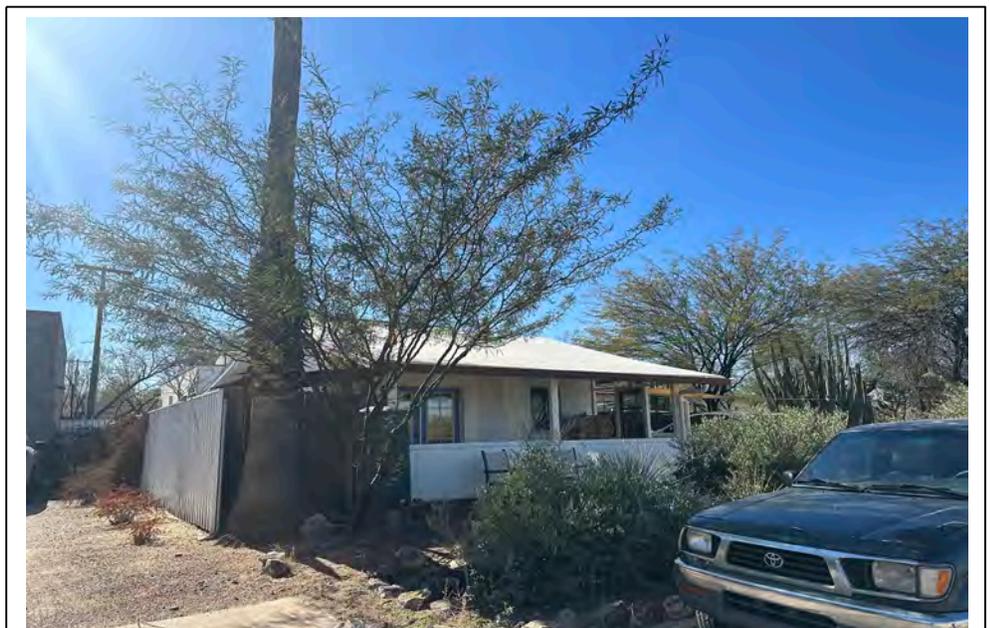
2. **DESIGN** (Describe alterations from the original design, including dates—known or estimated—when alterations were made) 1216 E. Manlove Street is a single-story Territorial style residence that has a rectangular footprint and is constructed of masonry brick walls topped with a side gable roof with rolled roofing. Vinyl sliding windows replaced the original windows, and the French door replaced the original doorway. There is a half wall enclosing the front porch. The front porch was likely once a former Arizona room/sunroom. There are Victorian brick details above the windows and doors.

Walls (structure): Masonry Foundation: Concrete Roof: Prepared roll
