STATE OF ARIZONA

HISTORIC PROPERTY INVENTORY FORM

For properties identified through survey: Site No: N/A Survey Area: Barrio San Antonio

Address: 1004 East 12th Street

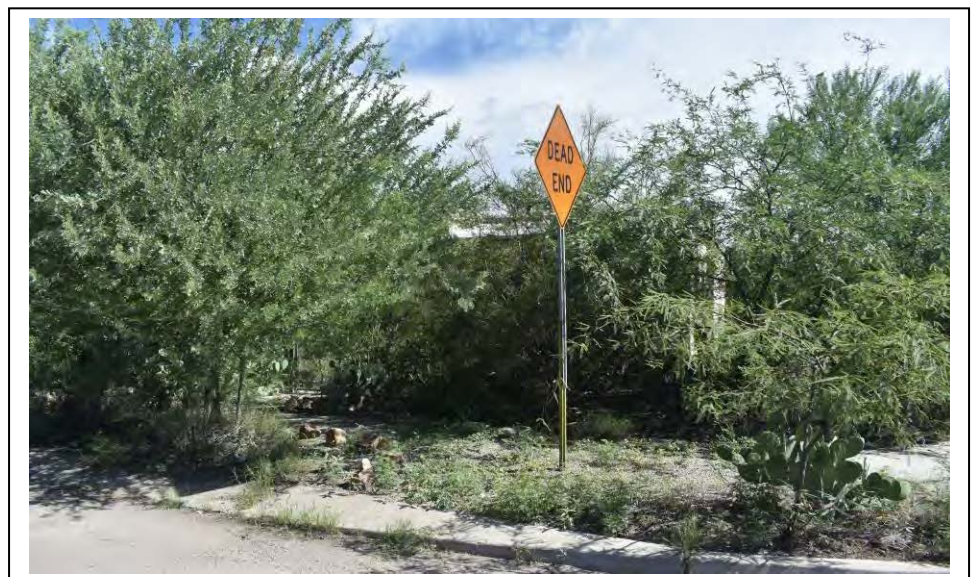
South

2. DESIGN (Describe alterations from the original design, including dates—known or estimated—when alterations were made)
A one-story brick and stucco Mission Revival single residence with a square floorplan, flat roof, stone foundation, and the front porch has arched columns. The view of the building is obscured by vegetation.

Walls (structure): Brick Foundation: Stone Roof: Built up T & G

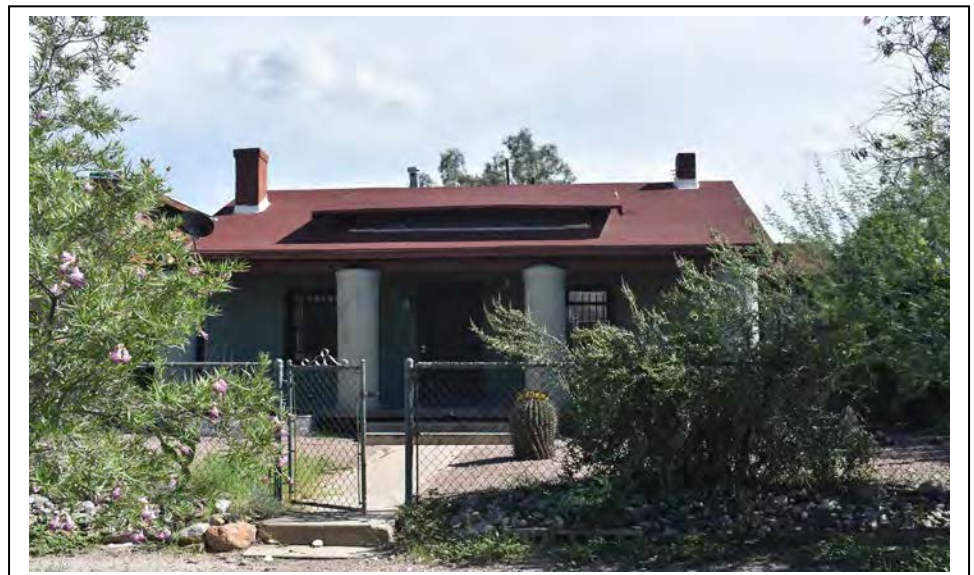
View Direction (looking towards):
South

2. DESIGN (Describe alterations from the original design, including dates—known or estimated—when alterations were made)
A one-story brick and stucco Craftsman Bungalow single residence building with a square floorplan, a stone foundation, a side gable roof with a brick chimney, and the front porch has large circular columns. The windows have security screening covering them. A small laundry room has been added onto the west elevation.

Walls (structure): Brick Foundation: Stone Roof: Asphalt shingles

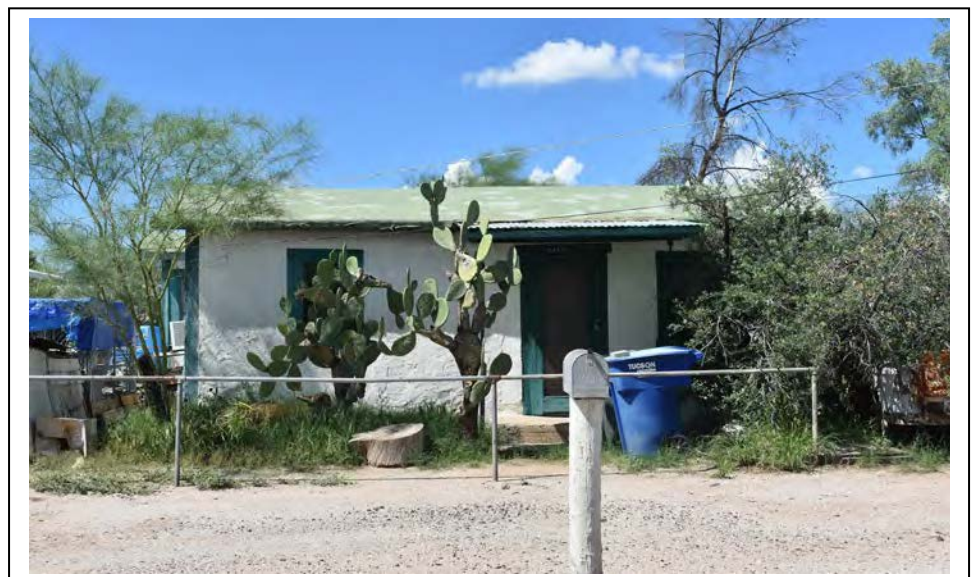
View Direction (looking towards):
North

A one-story adobe and stucco Vernacular single residence building with a rectangular floorplan, a concrete foundation, side gable roof, and a small aluminum shade over the entryway. This is the outbuilding of 545 South Star Avenue. It faces onto 15th Street and retains a separate mailbox.

Walls (structure): Framed wood, Adobe Foundation: Concrete Roof: Asphalt shingles, prepared roll

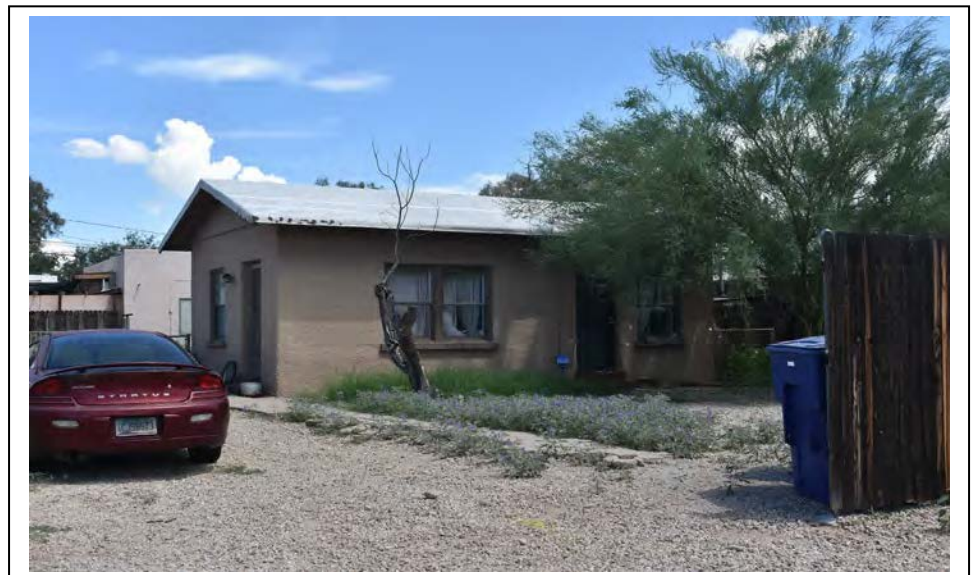
Date of photo: August 11, 2021 View Direction (looking towards): Southeast

A one-story adobe and stucco American Territorial single residence with a rectangular floorplan, concrete foundation, and a side gable roof. There are additions in the rear of the building, but they are not visible from the street. A high fence in front of the building, however, the wide driveway is open and ungated provide view of the residence.

Walls (structure): Adobe Foundation: Concrete Roof: Prepared roll??

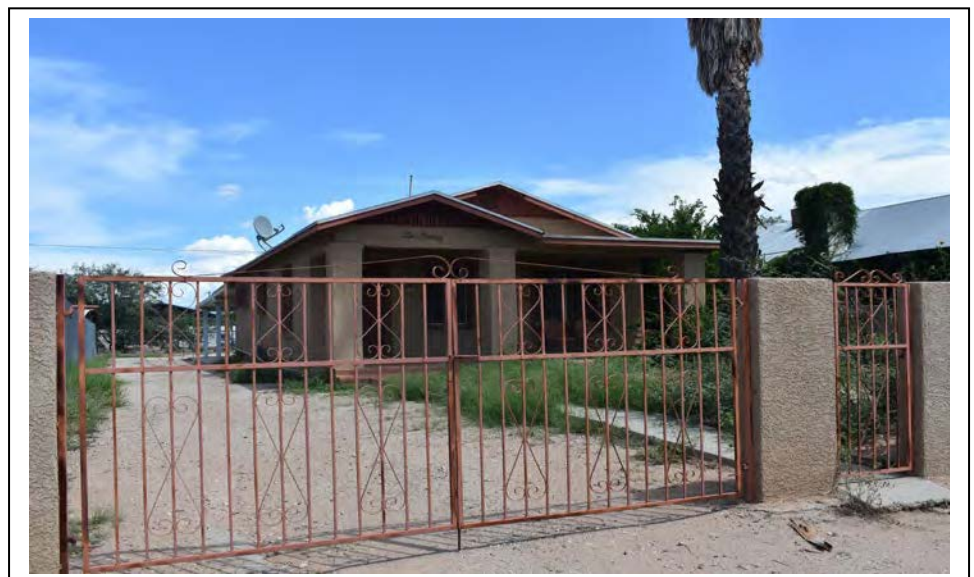
View Direction (looking towards):
East

A one-story framed wood and stucco Craftsman Bungalow with a rectangular floorplan, concrete foundation, gable roof with a flat roof over the southwest portion of the porch, and a stucco and metal fence surrounding the front of the building. There is an addition and carport at the rear of the building, and both are not visible from the street. The original fenestration replaced with aluminum sliding units and decorative security screening added. The gable peak cladding had likely been updated.

Walls (structure): Framed wood Foundation: Concrete Roof: Prepared roll
Windows: Aluminum

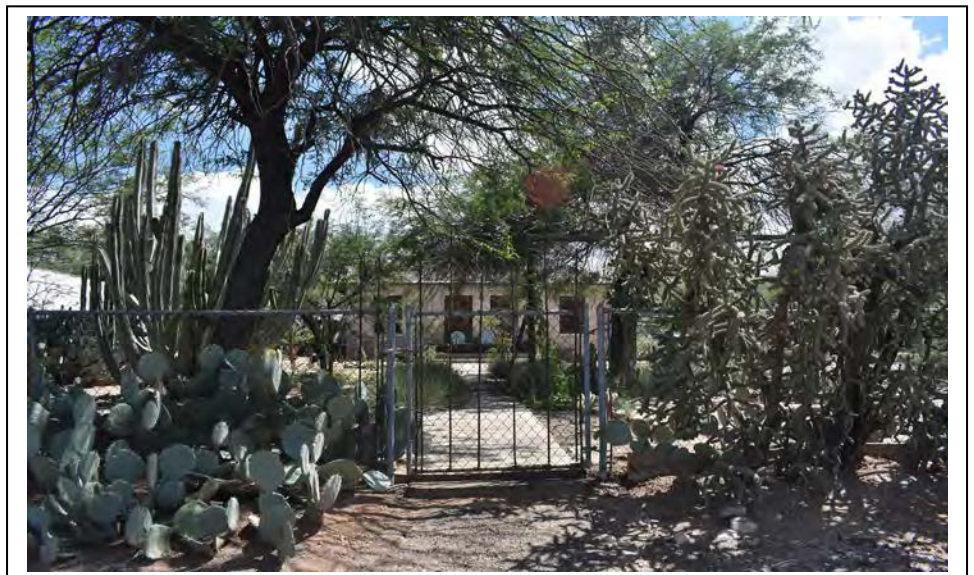
View Direction (looking towards):
South

A one-story adobe and stucco Transitional Sonoran single residence with a rectangular floorplan, cement block foundation, hip roof, and wood sash windows. The building is surrounded fencing and cacti. There is a shed-roofed addition added in rear of the original building.

Walls (structure): Adobe Foundation: Cement block Roof: Prepared roll

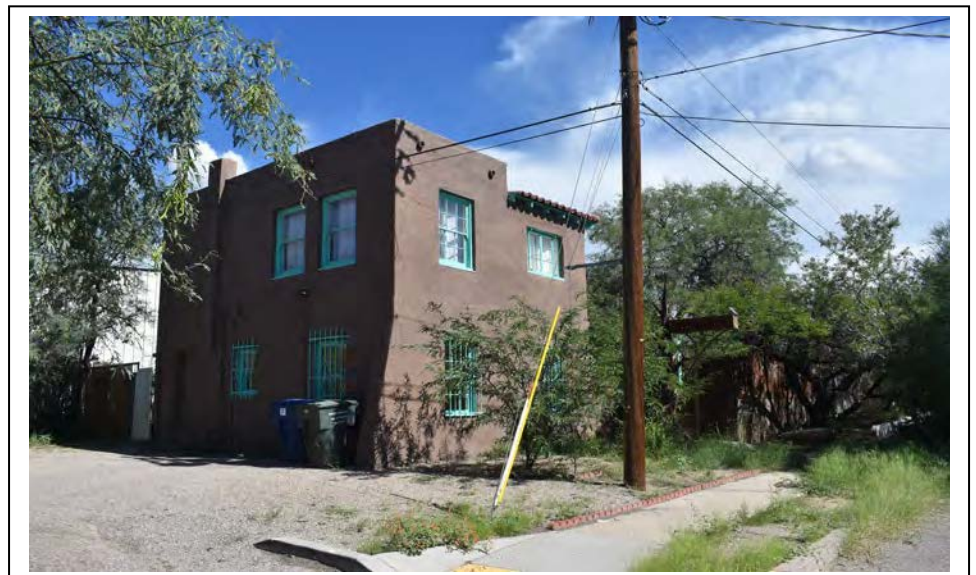
View Direction (looking towards):
Southeast

A one-story brick and stucco Mission Revival two-story multi-family residence with a rectangular floorplan, concrete foundation, a flat roof with partial shed roof and clay tiles. There are both steel casement and wood/vinyl sash windows and the lower level has security bars covering the windows. The different windows indicate additions possibly made during the historic period.

Walls (structure): Brick Foundation: Concrete Roof: Tile, Built up T & G

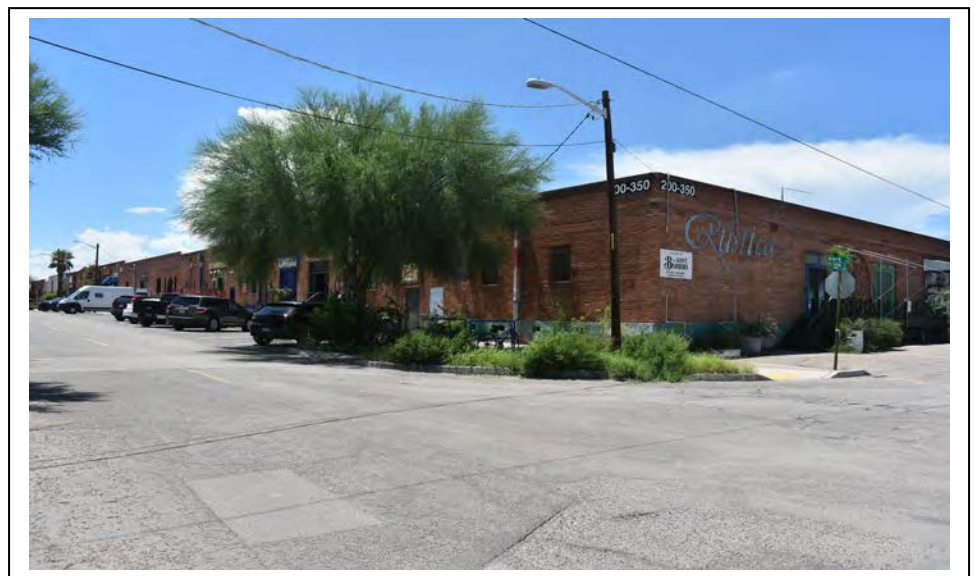
View Direction (looking towards):
Southwest

1. LOCATION Original Site Moved (date: _____) Original Site: _____
2. DESIGN (Describe alterations from the original design, including dates—known or estimated—when alterations were made)
A one-story brick warehouses with a flat roof, low parapet, and rectangular floorplans. The foundation is concrete/basement, and the fenestration has been altered on the east elevation.

Walls (structure): Brick Foundation: Concrete/basement Roof: Asphalt

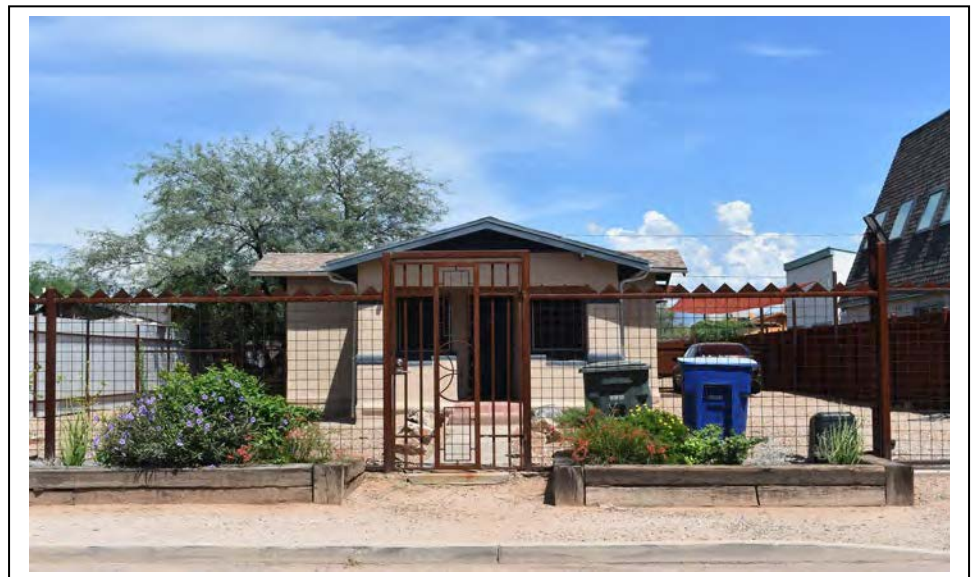
View Direction (looking towards):
East

A one-story adobe and stucco one-story Craftsman Bungalow building with a rectangular/T-shape floorplan, with a concrete block foundation, and a medium pitched gable roof. The front porch has square columns, and the fenestration has possibly been replaced. The stucco has been newly painted, and a new fence surrounds the front of the property.

Walls (structure): Adobe Foundation: Concrete block Roof: Composition

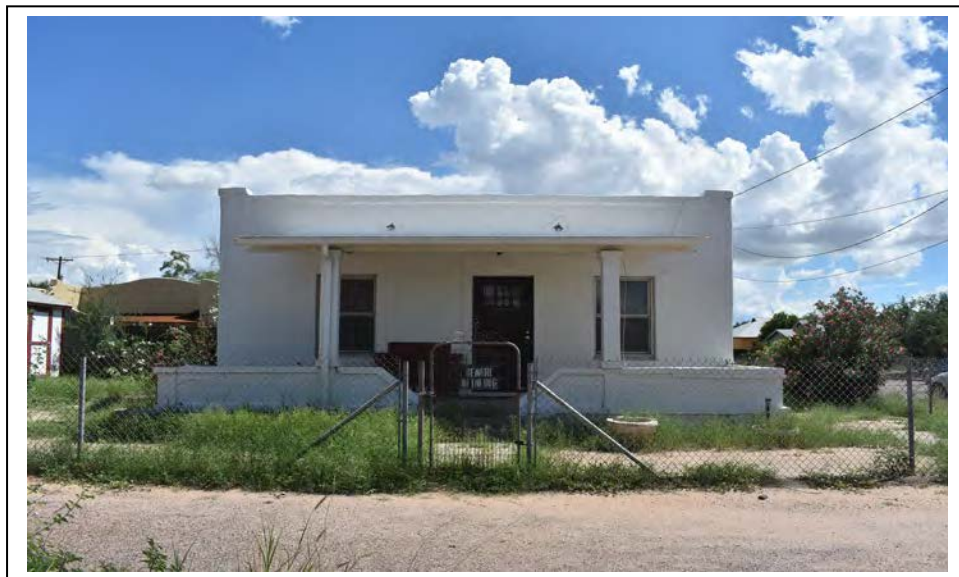
View Direction (looking towards):
South

2. DESIGN (Describe alterations from the original design, including dates—known or estimated—when alterations were made)
A one-story adobe and stucco Mission Revival single residence with a rectangular floorplan, cement block foundation, a flat roof, and a front porch supported by square columns and a small stairway leading to the entryway. The original fenestration has been replaced with modern vinyl equivalents.

Walls (structure): Adobe Foundation: Cement block Roof: Prepared roll

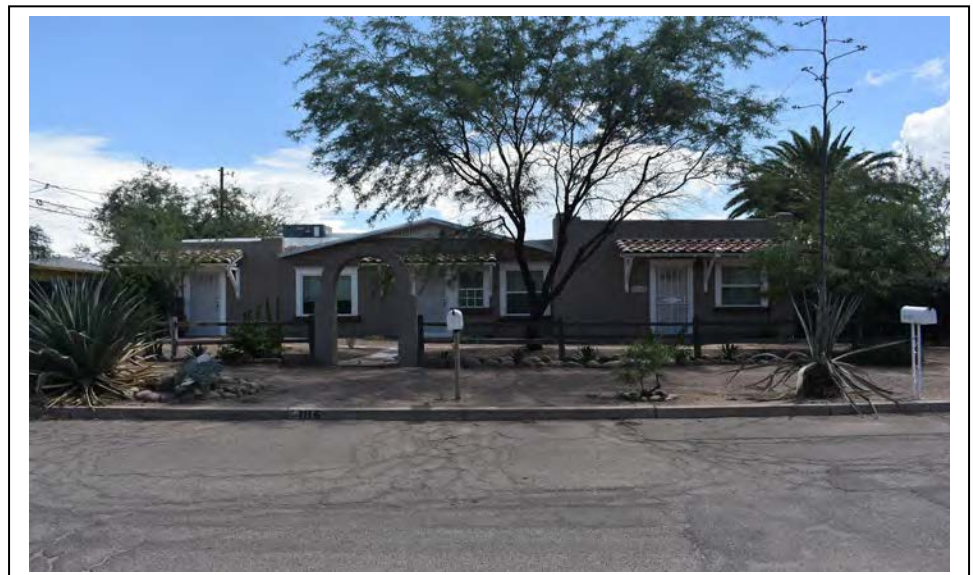
View Direction (looking towards):
South

2. DESIGN (Describe alterations from the original design, including dates—known or estimated—when alterations were made)
A one-story adobe, framed wood, and stucco Eclectic building with Craftsman and Mission Revival detailing, a rectangular floorplan, concrete foundation, flat roof with a gable roof over the front of the building. The building is divided into two apartments, both entryways have coverings above them, and the windows have been replaced with vinyl equivalents. The original fenestration has been replaced. The property was enlarged after 1949 according to Sanborn Maps. The additions are still likely within the historic period based upon field observation.

Walls (structure): Adobe, Framed wood Foundation: Concrete Roof: Prepared roll

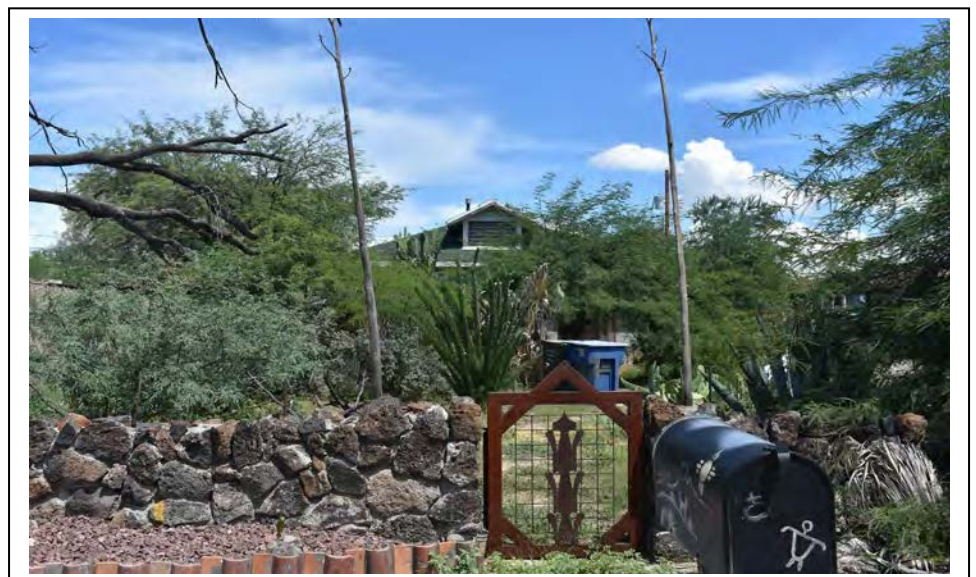
Northeast

A one-story Craftsman Bungalow single residence building with a rectangular floorplan, stucco exterior, concrete/piers foundation, cross gabled roof, and square columns supporting the front screened porch. There is an addition to the rear.

Walls (structure): Wood frame? _____ Foundation: Concrete/piers? Roof: Prepared roll _____

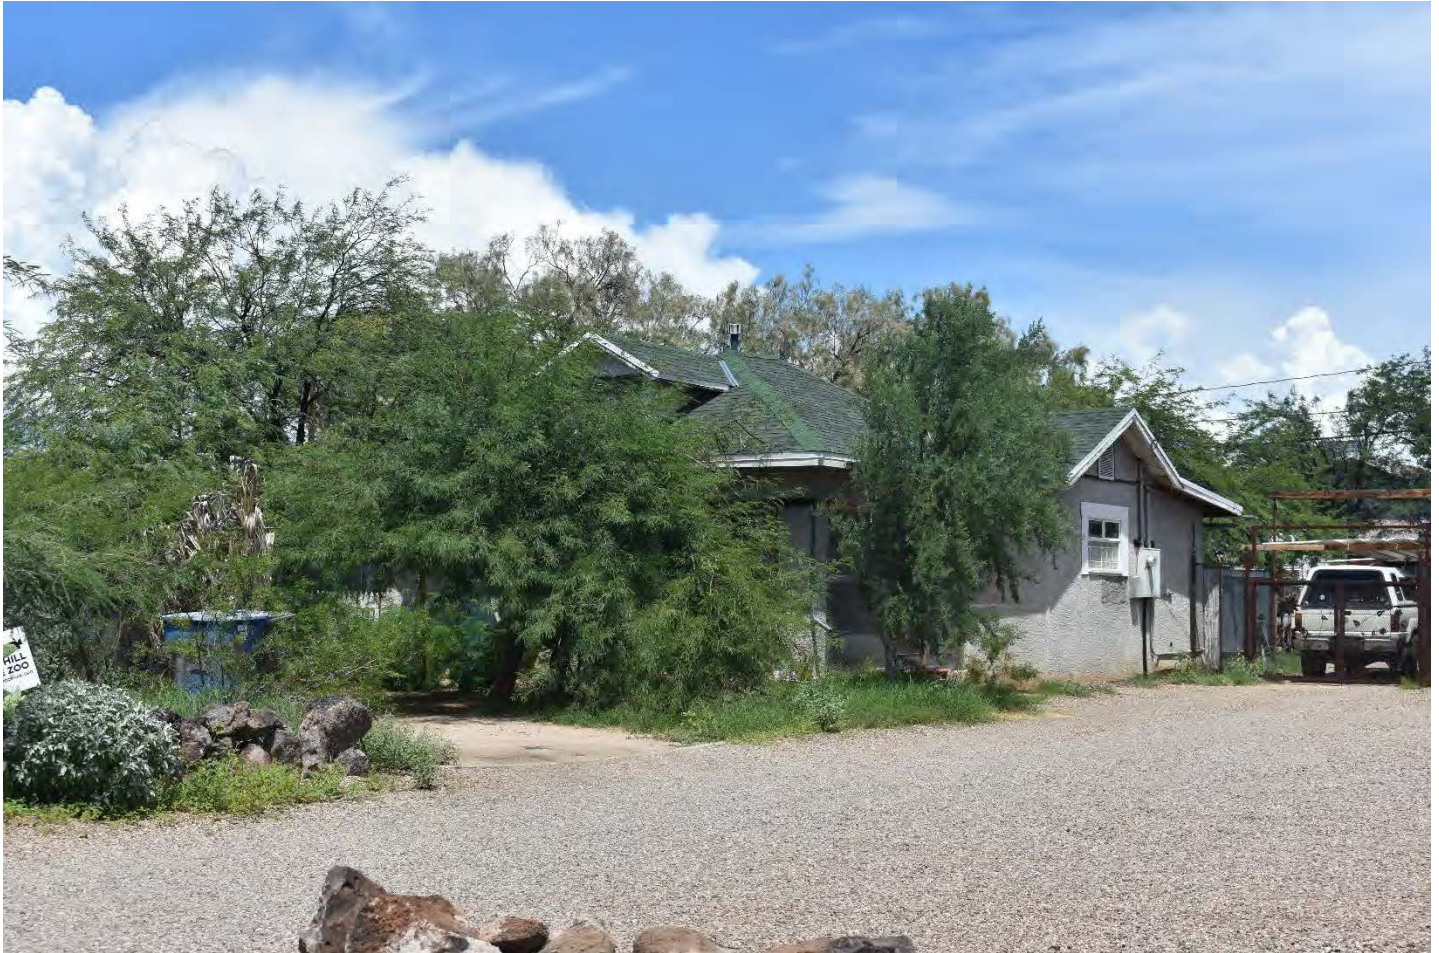
423 South Fremont Avenue, west and south elevations, view facing northeast, Logan Simpson, 2021.

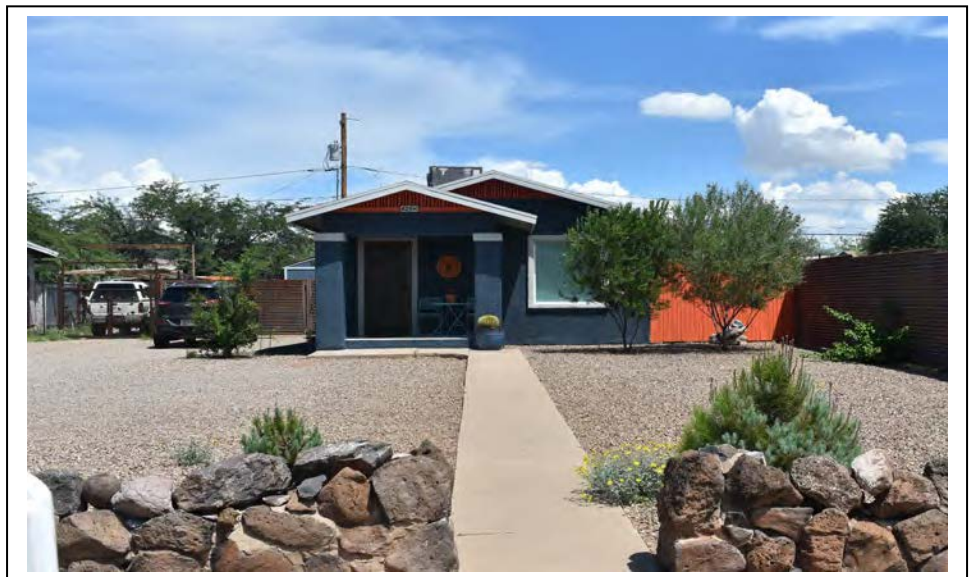
Date of photo: August 11, 2021 View Direction (looking towards): East

A one-story wood frame Craftsman Bungalow single residence with rectangular floorplan, concrete foundation, fixed/picture window located on the façade, and a side gable roof. The fenestration has been replaced by vinyl plate glass windows and a modern door.

Walls (structure): Framed wood Foundation: Concrete Roof: Asphalt

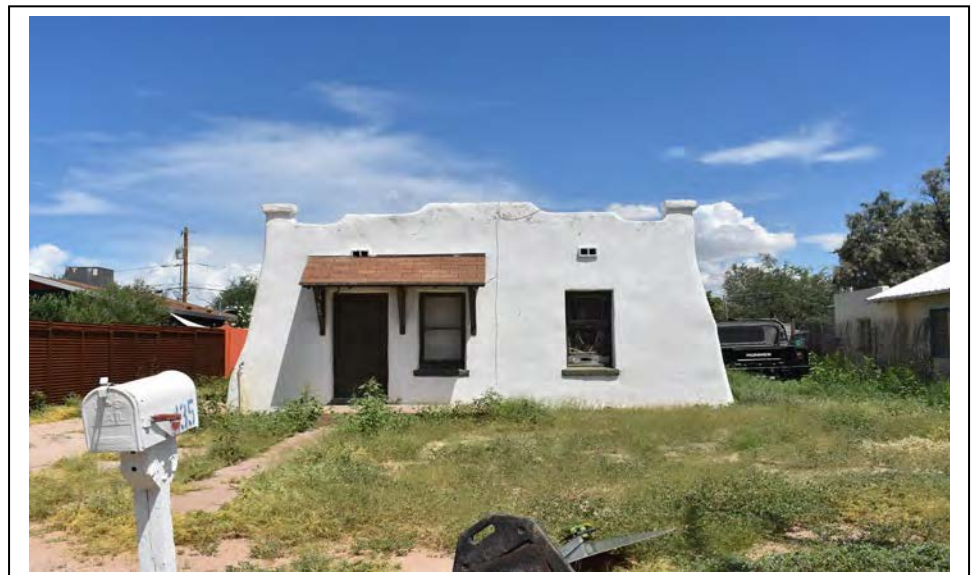
Date of photo: August 11, 2021 View Direction (looking towards): East

A one-story adobe and stucco Mission Revival single residence with a square floorplan, concrete foundation, wood sash windows, a flat roof with some curves near the corners, and a small overhang above the main entryway on the west elevation. There are also drains located above each of the windows and doorways on every elevation.

Walls (structure): Adobe Foundation: Concrete Roof: Prepared roll

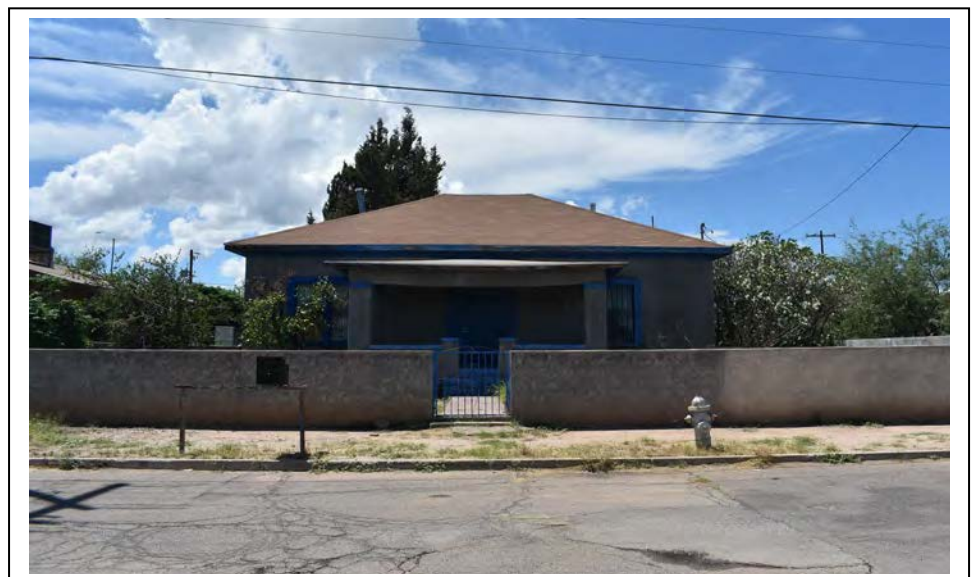
View Direction (looking towards):
West

A one-story American Territorial adobe re clad with textured stucco with a square floorplan, concrete foundation, aluminum sash windows, a hipped roof with asphalt shingles, and painted metal security bars covering the windows. There is a concrete half walk surrounding the front of the property with a metal gate located on the east elevation. There is a shed roof addition at the rear that was likely added during the historic period.

Walls (structure): Adobe Foundation: Concrete Roof: Asphalt shingles
Windows: Aluminum sash

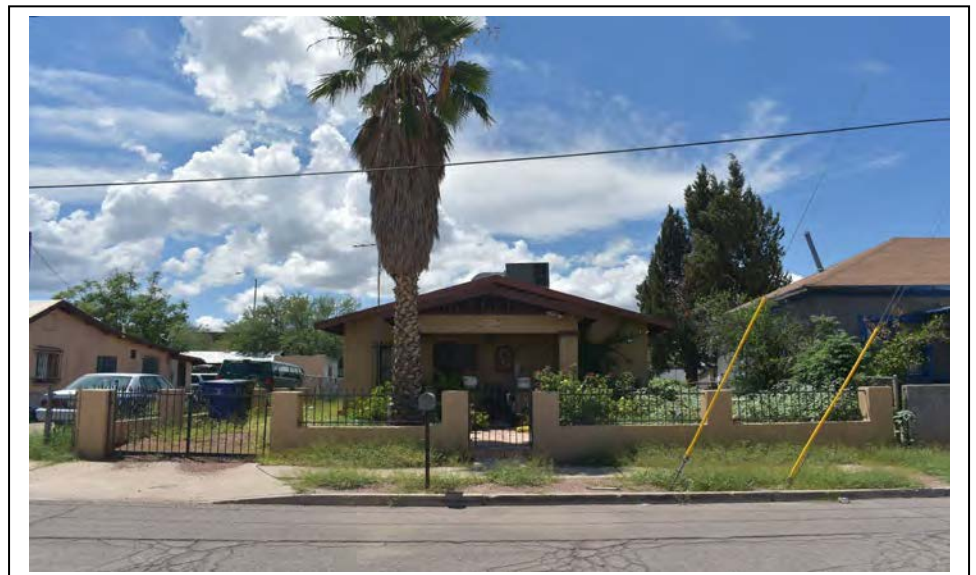
View Direction (looking towards):
West

A one-story adobe and stucco Craftsman Bungalow with a rectangular floorplan, concrete foundation, front gable roof, wood/aluminum sash windows with security screens along all windows on all elevations. There is a stucco and metal fence/wall surrounding the front of the building.

Walls (structure): Adobe Foundation: Concrete Roof: Prepared roll

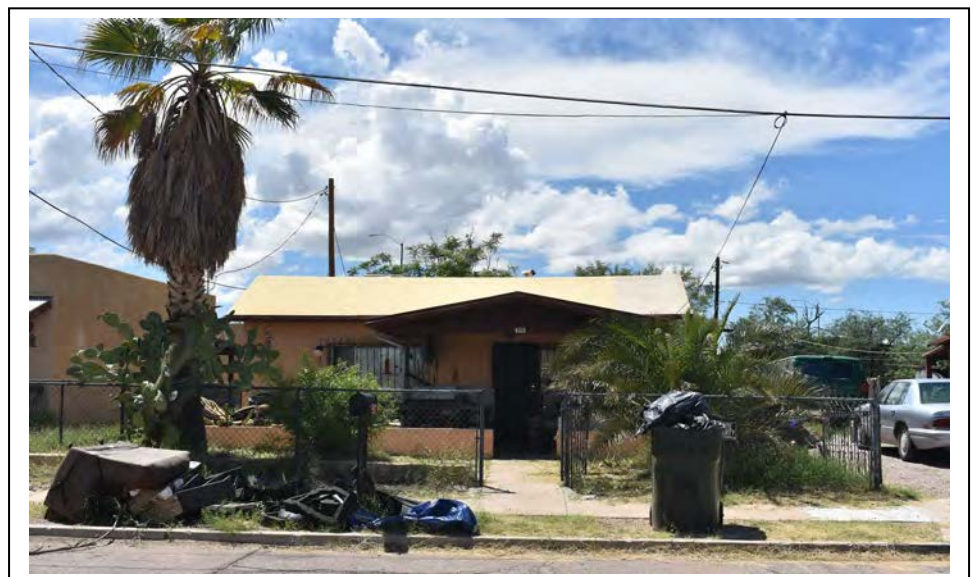
View Direction (looking towards):
West

A one-story adobe and stucco Vernacular single residence with a rectangular floorplan, concrete foundation, a medium pitch gable/shed roof, a porch gable roof, there are security screens covering all windows on all elevations. The shed-roofed addition at rear of building is not visible from the street. The fenestration has been replaced and the porch roof supports have been replaced.

Walls (structure): Adobe, Framed Wood Foundation: Concrete Roof: Prepared roll

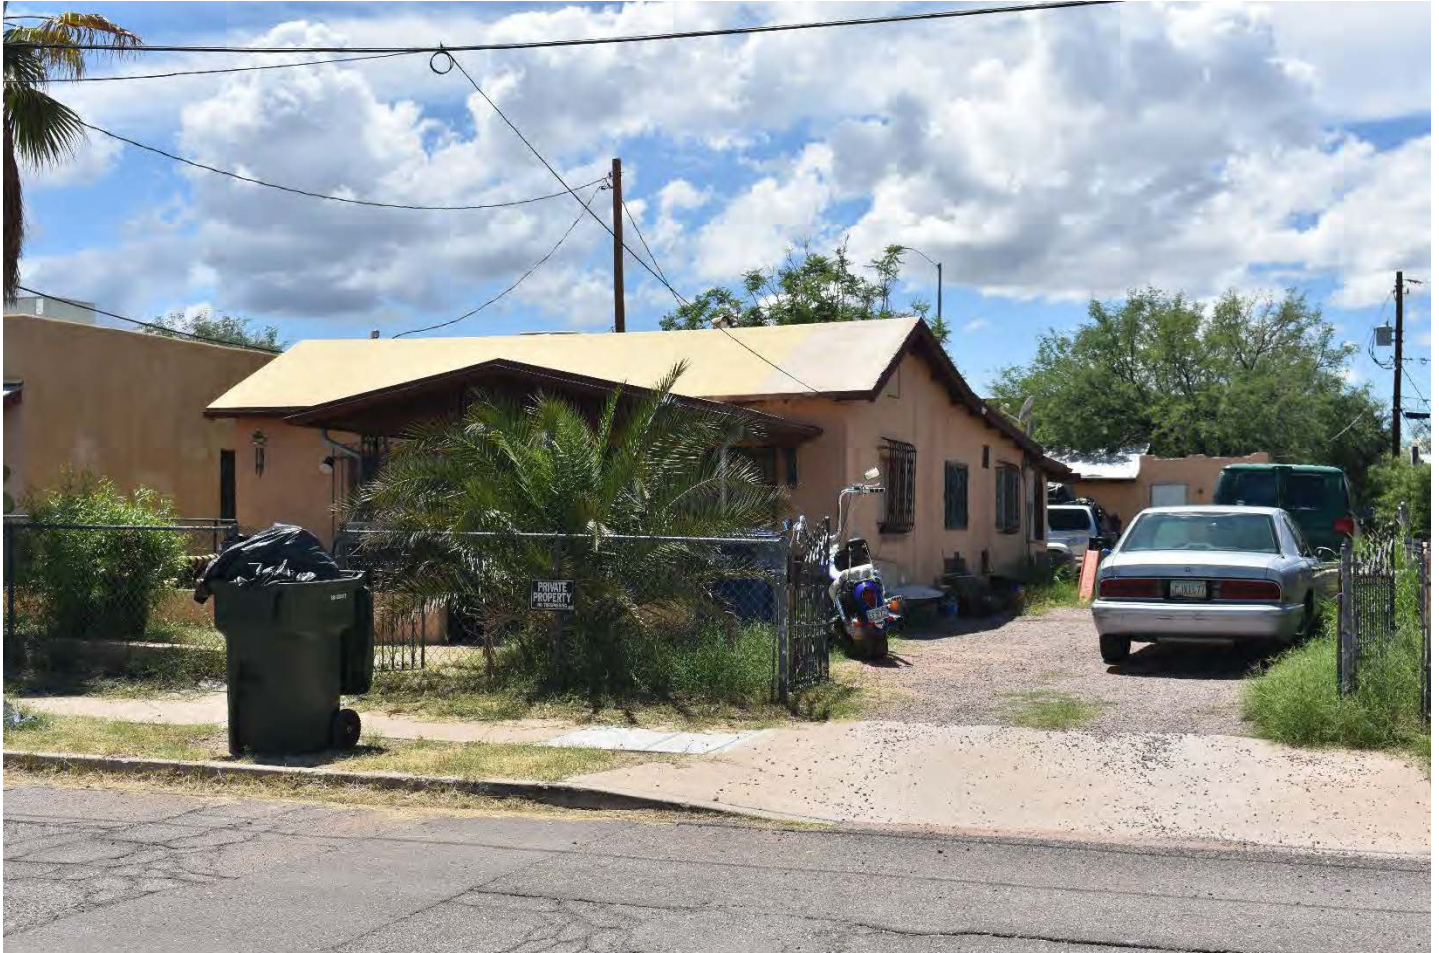
506 South Fremont Avenue, north and east elevations, view looking southwest, Logan Simpson, 2021.

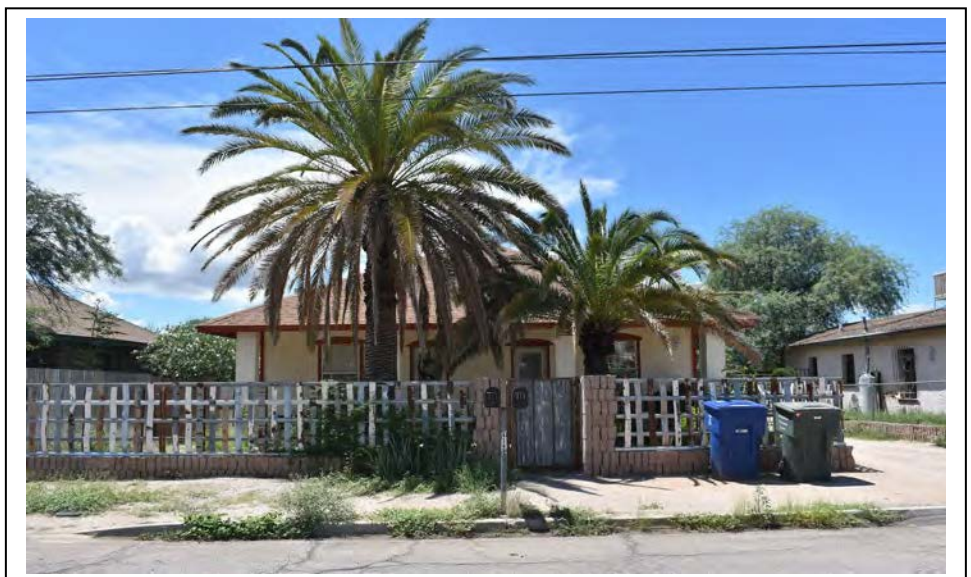
View Direction (looking towards):
West

A one-story painted brick American Territorial multiple residence building with square floorplan, a concrete foundation, hip roof, and a front porch supported by square columns. The original fenestration has been replaced. There is a weaved metal/steel fence in front of the residence bordered with small bricks. The driveway is located on the north elevation of the residence.

Walls (structure): Brick Foundation: Concrete Roof: Wood shingles

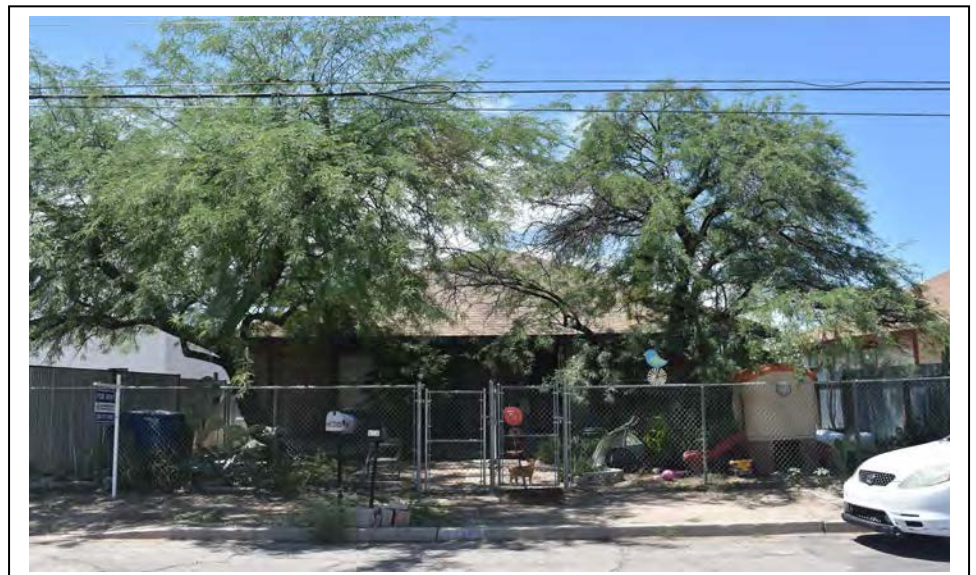
West

A one-story painted brick American Territorial multi-family residence with a rectangular footprint, a concrete foundation, and hip roof. There is a shed-roofed addition to the rear, and it is not visible from the street. The original fenestration has been replaced.

Walls (structure): Brick Foundation: Concrete Roof: Asphalt shingles

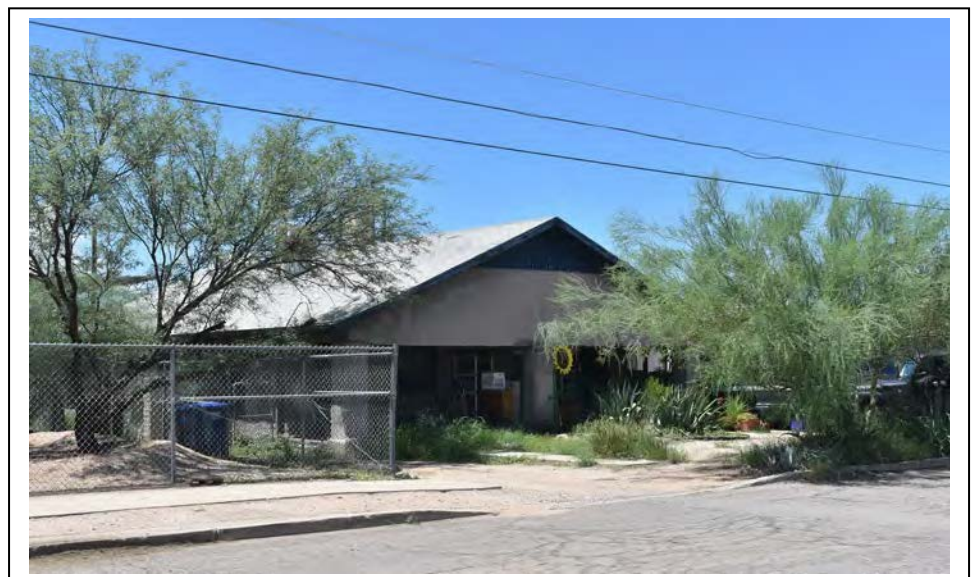
Northwest

2. DESIGN (Describe alterations from the original design, including dates—known or estimated—when alterations were made)
A one-story adobe and stucco Craftsman Bungalow multi-family residence with a rectangular floorplan, stone foundation, a medium-pitch gable roof, and square columns supporting the open front porch. Fenestration possibly replaced and heavily textured stucco applied to exterior.

Walls (structure): Adobe Foundation: Stone Roof: Prepared roll

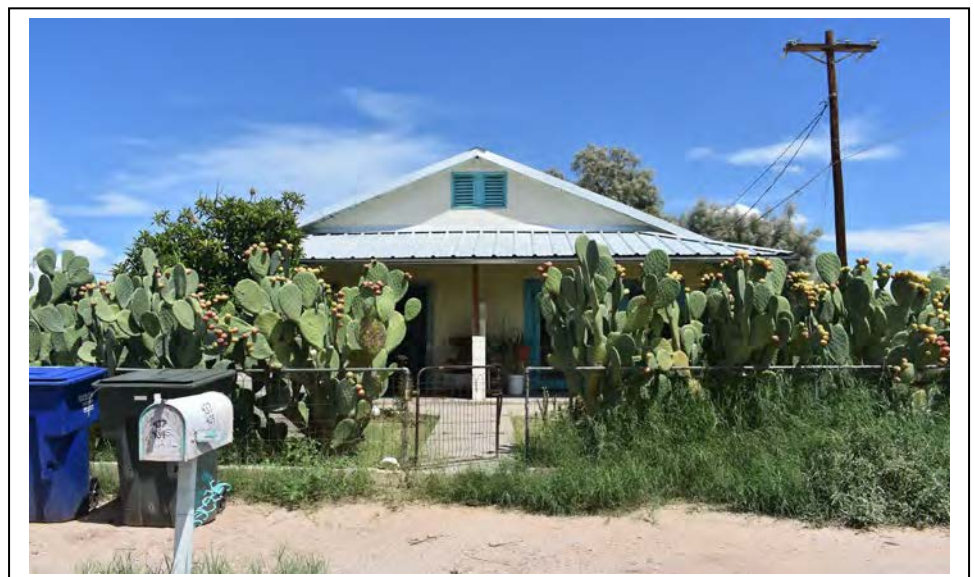
View Direction (looking towards):
East

2. DESIGN (Describe alterations from the original design, including dates—known or estimated—when alterations were made)
A one-story framed wood and stucco Craftsman Bungalow with a rectangular floorplan, concrete foundation, front gable roof with ventilation, an overhang above the front porch. The porch roof was likely added and/or original supports were replaced with wrought iron supports within the historic period. An addition added to the rear is likely within the historic period.

Walls (structure): Framed wood Foundation: Concrete Roof: Prepared roll

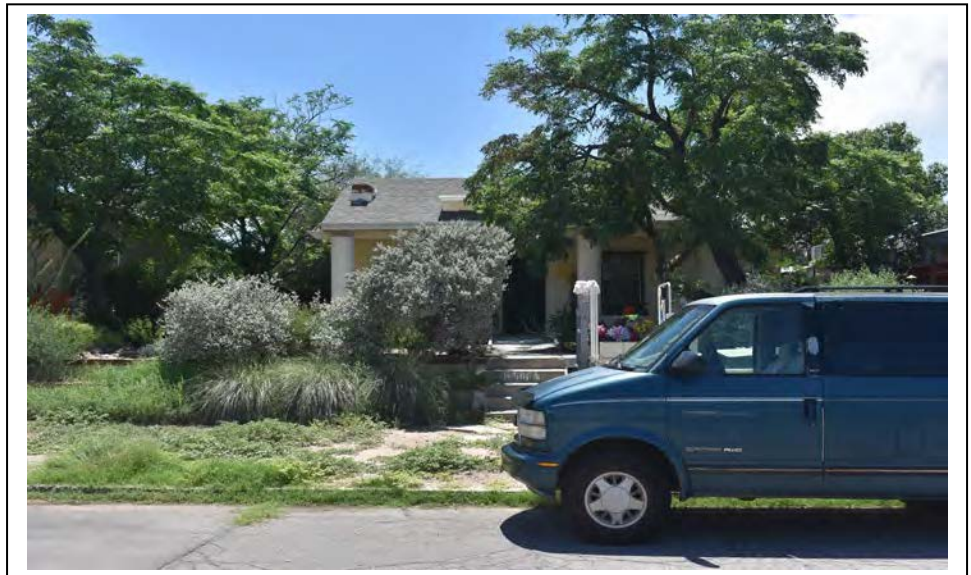
Date of photo: August 11, 2021 View Direction (looking towards): South

A one-story brick and stucco Craftsman Bungalow building with an irregular/rectangular floorplan, concrete foundation, gable roof and a front porch with round/circular columns. The windows have been replaced to aluminum framed. A 2007 addition to the rear of the house and it does not alter the street profile.

Walls (structure): Brick Foundation: Concrete Roof: Asphalt shingles

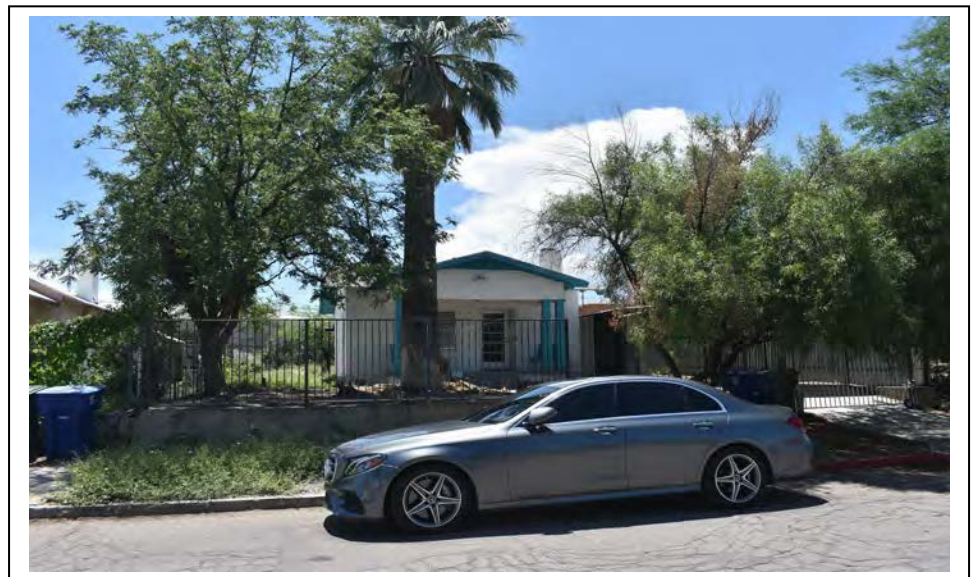
Date of photo: August 11, 2021 View Direction (looking towards): South

2. DESIGN (Describe alterations from the original design, including dates—known or estimated—when alterations were made)
A one-story brick and stucco Craftsman Bungalow building with a square floorplan, concrete foundation, front and side gable roof, and a front porch with square columns. The windows are vinyl sash, and the entry door has been replaced.

Walls (structure): Brick Foundation: Concrete Roof: Asphalt

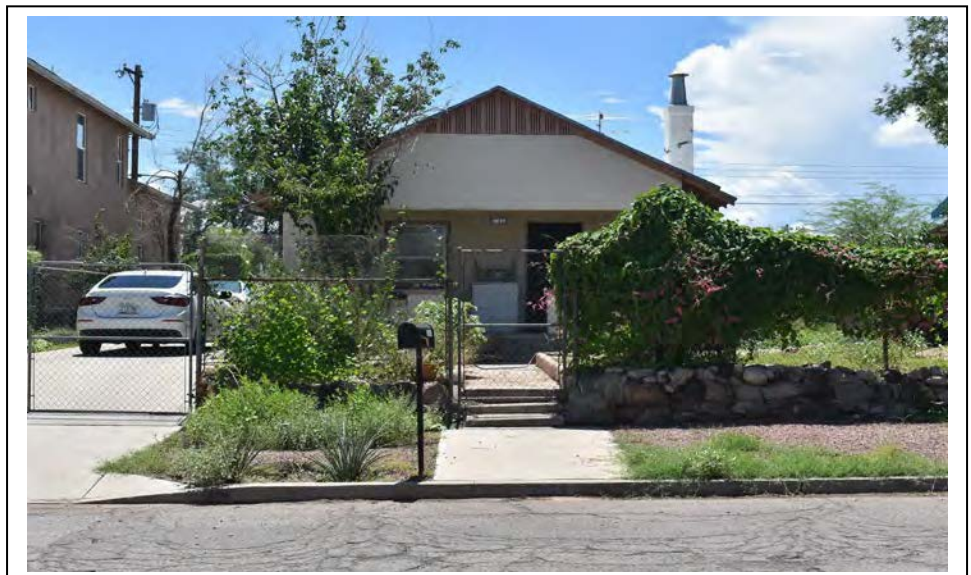
Date of photo: August 11, 2021 View Direction (looking towards): South

A one-story brick and stucco Craftsman Bungalow building with a rectangular floorplan, stone foundation, a gable roof, and a front porch with supporting columns. The original wood sash windows have been replaced with the vinyl (or aluminum) equivalents.

Walls (structure): Brick Foundation: Stone Roof: Asphalt shingles

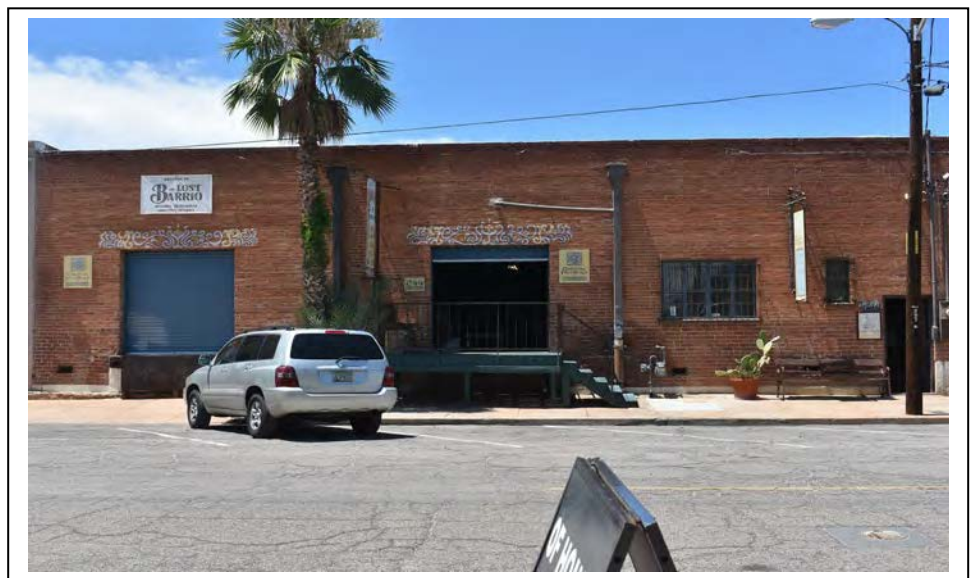
Date of photo: August 11, 2021
View Direction (looking towards): West

2. DESIGN (Describe alterations from the original design, including dates—known or estimated—when alterations were made)
A one-story brick warehouse with a flat roof with low parapet, and a rectangular/square floorplan. There are two loading docks, and one is used as the main entryway. The foundation is concrete, and an external stairway has been added to reach the loading dock entry. The windows are steel casement with security bars covering them. There is one doorway north of the main entry loading dock. Painted on the brick above each loading dock is a colorful design.

Walls (structure): Brick Foundation: Concrete Roof: Asphalt?

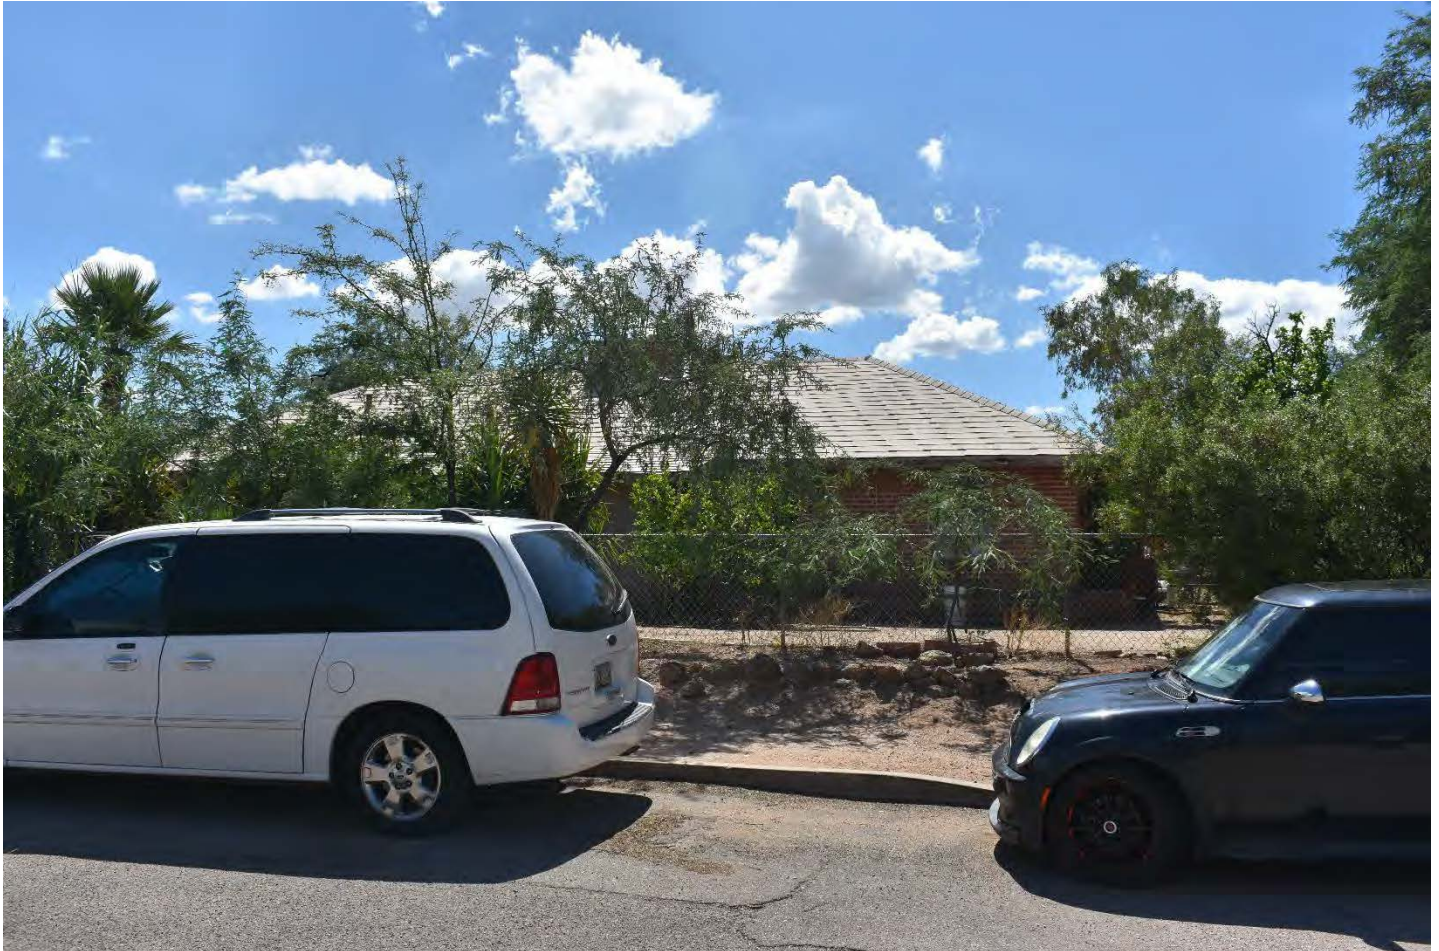
634 South Santa Rita Avenue, east elevation, view looking west, Logan Simpson, 2021.

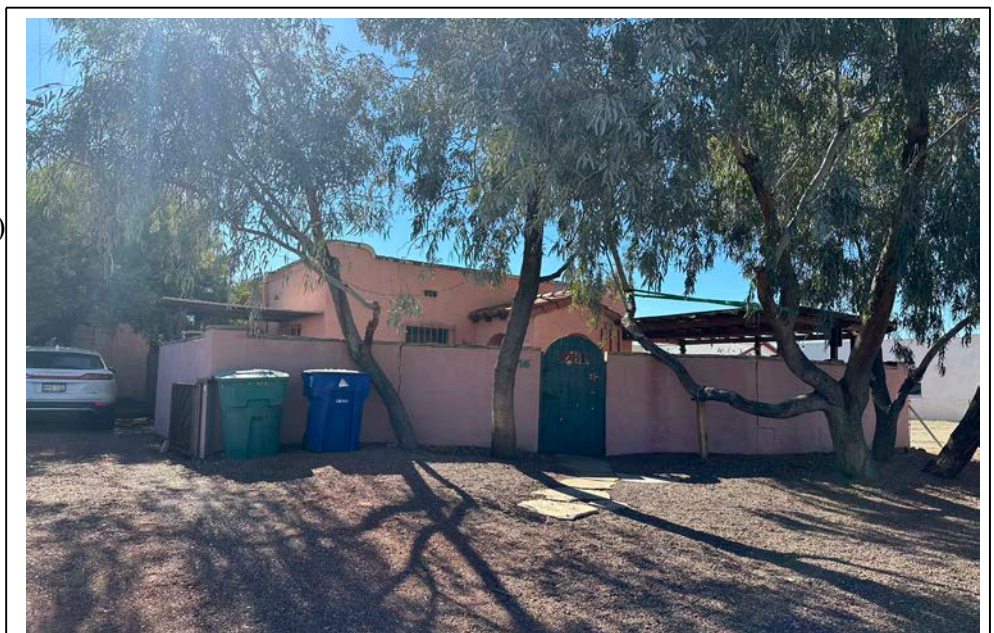
Fair (some problems apparent) Describe: Cracking exterior walls are peeling paint, fencing.
