STATE OF ARIZONA

HISTORIC PROPERTY INVENTORY FORM

For properties identified through survey: Site No: N/A Survey Area: Barrio San Antonio

Address: 1004 East 12th Street

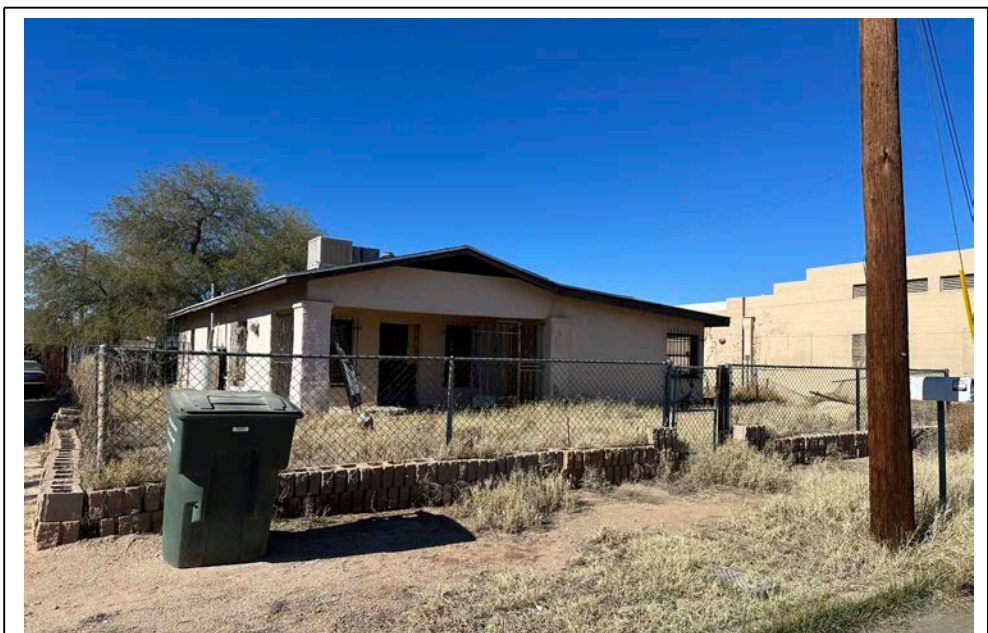
- Good (well maintained, no serious problems apparent)
Fair (some problems apparent) Describe: Plaster is spalling, exposed adobe, missing doors and window glass
Poor (major problems; imminent threat) Describe:

4. **MATERIALS** (Describe the materials used in the following elements of the property)
Walls (structure): Adobe Foundation: Stone Roof: Asphalt shingles
Windows: Wood frame, Vinyl
If the windows have been altered, what were they originally? Wood
Wall Sheathing: Lime plaster and concrete stucco
If the sheathing has been altered, what was it originally? Plaster
5. **WORKMANSHIP** (Describe the distinctive elements, if any, of craftsmanship or method of construction)
N/A

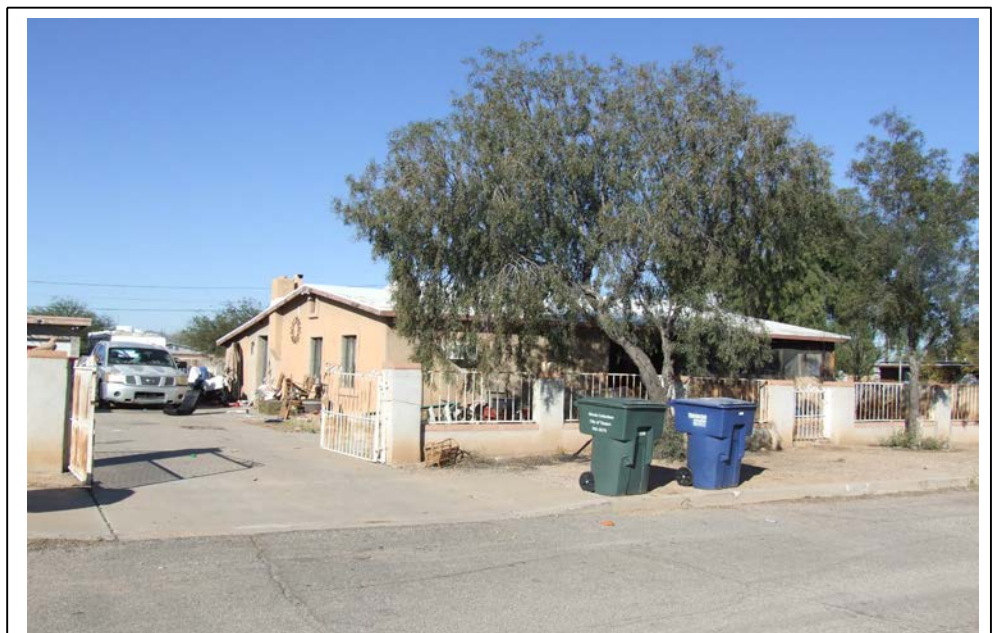
Fair (some problems apparent) Describe: Failing roof, peeling paint
