HISTORIC PROPERTY INVENTORY FORM

For properties identified through survey: Site No: N/A Survey Area: University of Arizona (UA) Campus Agricultural Center

Historic Name(s): Equine Education Building, former Equine Barn (UA Bldg. No. 2007)
(Enter the name(s), if any, that best reflects the property's historic importance.)

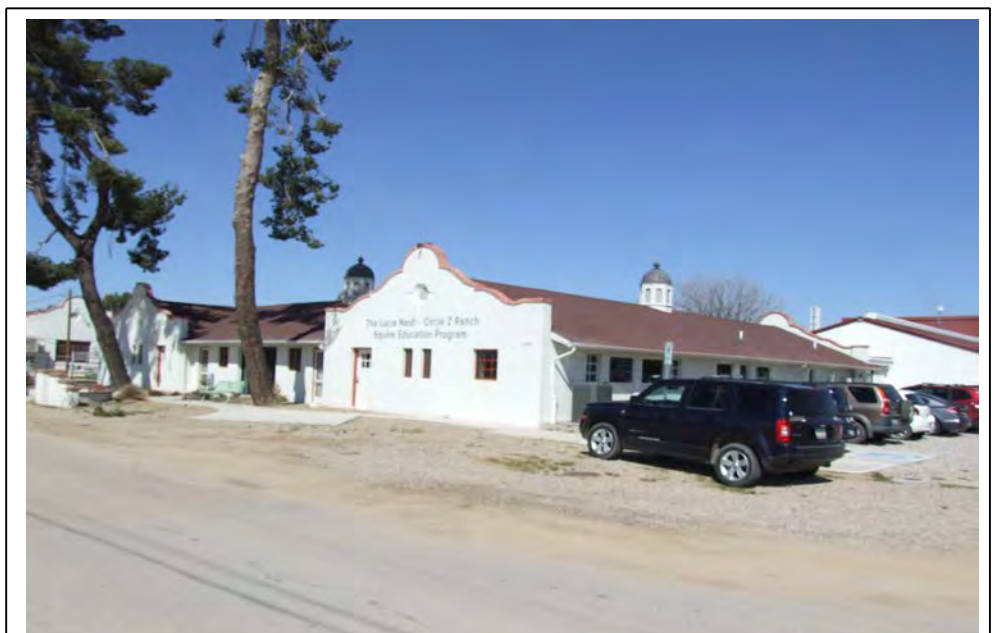
View Direction (looking towards)
Northwest

- 1. LOCATION** Original Site Moved (date _____) Original Site: _____
- 2. DESIGN** (Describe alterations from the original design, including dates—known or estimated—when alterations were made) The Equine Education Building, formerly known as the Horse/Equine Barn is a one-story building with a U-shaped footprint. The exterior walls are constructed of brick masonry and are covered in stucco on a poured concrete foundation. The walls are topped by a medium-pitch gable and cross-gable roof with asphalt shingles and shallow overhanging eaves. There is a Mission-style parapet on the north and south elevations with quatrefoils surrounding attic vents on the gable ends. Two decorative copulas with copper domes are located in the center of the east gable and the middle cross gable portions of the roof. The exterior walls are pierced by aluminum with anodized finish, and some vinyl windows and refurbished original doors and/or reproduced to original details. The east and west wings previously had Dutch door openings for each of the horse stalls, however, all have been filled in and the windows have been replaced. There is a metal fence connecting the east and west wings, creating an open space/courtyard between each wing. Historic aerial imagery indicates that an addition was added behind the north elevations of the east and west wings sometime after 2003. More recently the building was rehabilitated from a stable to a classroom and office space. Exterior changes included replacing windows with energy efficient units, but retaining the look of casement windows, replacing wood front doors with glass panel doors, and converting stalls into office cubicles. These changes were reviewed and approved by the Arizona SHPO.

- 4. MATERIALS** (Describe the materials used in the following elements of the property)
Walls (structure): Masonry Foundation: Concrete Roof: Asphalt shingles
Windows: Aluminum with anodized finish/Vinyl
If the windows have been altered, what were they originally? Steel casement
Wall Sheathing: Stucco
If the sheathing has been altered, what was it originally? N/A

- 5. WORKMANSHIP** (Describe the distinctive elements, if any, of craftsmanship or method of construction)
Mission-style arched parapet with brick coping, stucco quatrefoil details around attic vents; decorative cupolas.

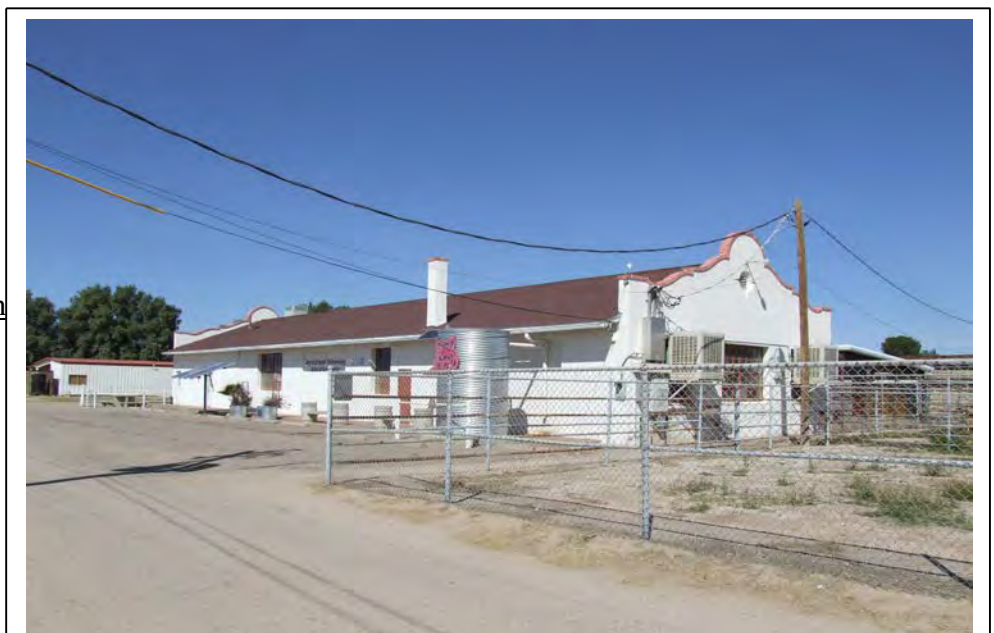
View Direction (*looking towards*)
Northwest

- LOCATION** Original Site Moved (date _____) Original Site: _____
- DESIGN** (Describe alterations from the original design, including dates—known or estimated—when alterations were made) The Agricultural Education Facility is a one-story building with a rectilinear footprint, constructed of masonry brick walls covered in stucco on a concrete foundation. The walls are topped by a medium-pitch gable roof with an east/west axis, and with small overhanging eaves, constructed of asphalt shingles. There is a Mission-style parapet on the east and west elevations. There are attic vents near the gable ends that are surrounded by decorative quatrefoils. There is a chimney flush with the south wall. The walls are pierced by the original steel casement windows. The building has modern exterior doors. There are ADA compliant ramps that are located along the main entryway constructed of concrete and brick pavers. The original building is the eastern portion. Historic aerial imagery indicates that there have been two additions added to the building sometime after 1984. There is a shed roof overhang on the north elevation addition and is constructed of CMU walls. There is an L-shaped addition on the northwest corner covered in stucco with brick coping and shed roof overhang. Both roofs are sheathed in asphalt shingles. All additions and modifications were approved by SHPO.

- MATERIALS** (Describe the materials used in the following elements of the property)
Walls (structure): Masonry Foundation: Concrete Roof: Asphalt shingles
Windows: Steel casement
If the windows have been altered, what were they originally? N/A
Wall Sheathing: Stucco
If the sheathing has been altered, what was it originally? N/A
- WORKMANSHIP** (Describe the distinctive elements, if any, of craftsmanship or method of construction)
Mission-style arched parapet with brick coping, quatrefoil details around attic vents.

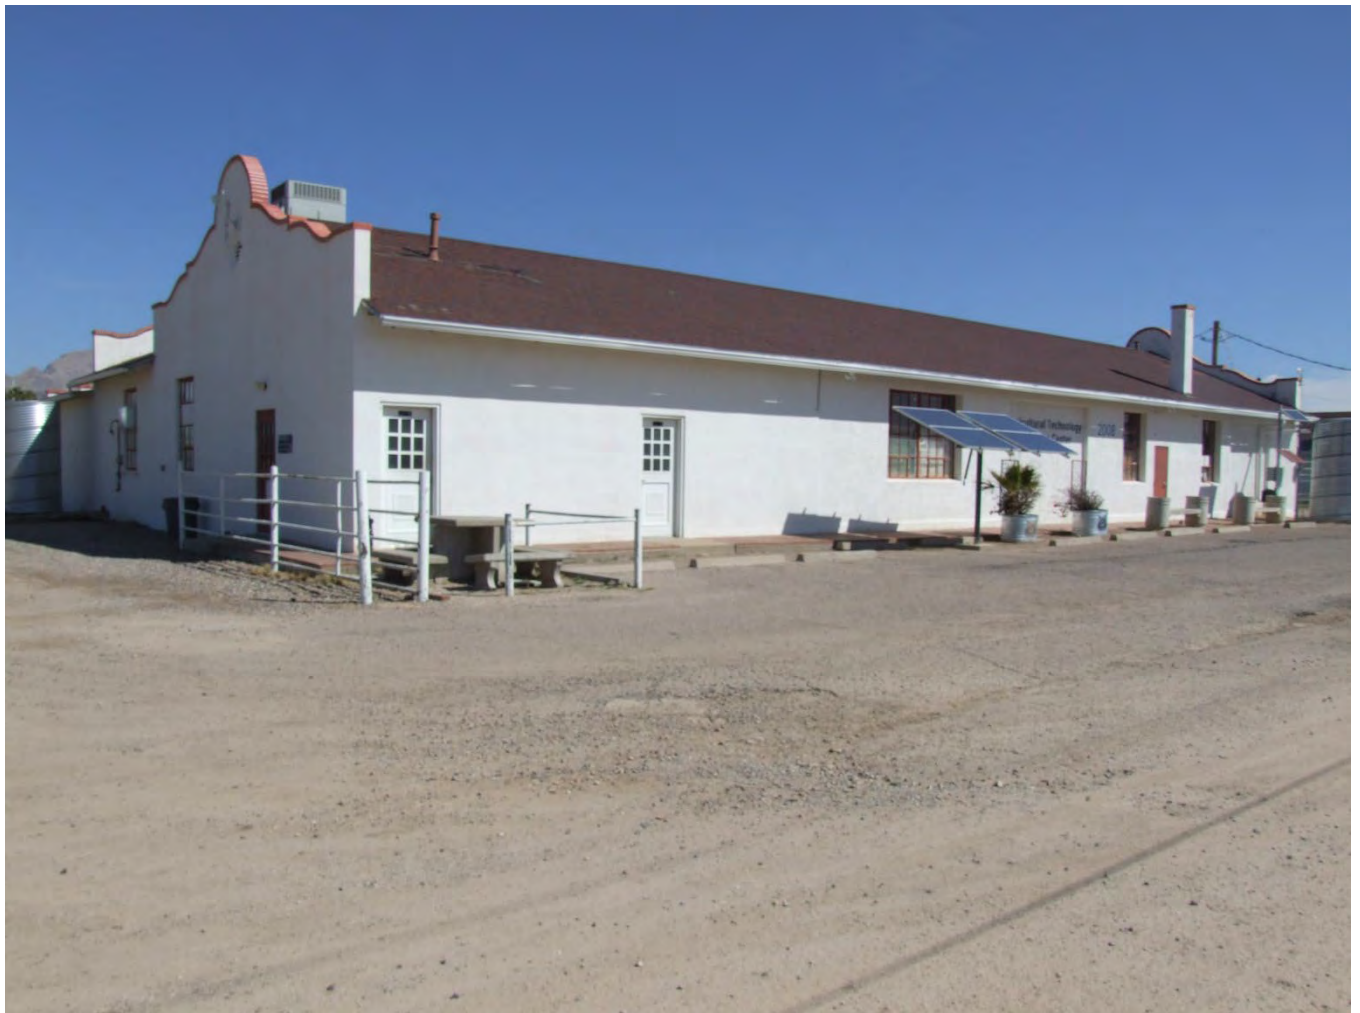
The University of Arizona Campus Agricultural Center, Agricultural Education Facility Building, view facing northeast. WestLand Resources, Inc. March 8, 2023.

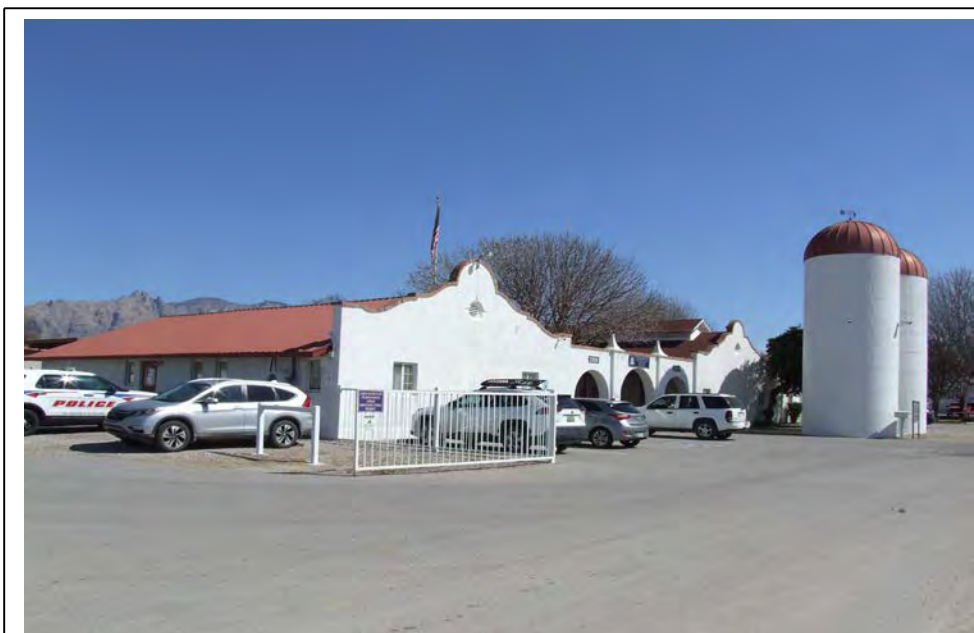
View Direction (looking towards)
Northeast

1. **LOCATION** Original Site Moved (date _____) Original Site: _____
2. **DESIGN** (Describe alterations from the original design, including dates—known or estimated—when alterations were made) The Classroom Building is a one-story building with a rectangular footprint, constructed of masonry brick walls covered in stucco on a concrete foundation. The walls are topped by a medium-pitch gable roof with a north/south axis, and with small overhanging eaves, constructed of galvanized steel and wood frame. There is a Mission-style parapet on the north and south elevations. There are attic vents near the gable ends that are surrounded by decorative quatrefoils. The walls are pierced with fixed vinyl and steel casement windows. The building has original solid wood doors and modern doors with glass panels. There is a central courtyard between the Classroom Building and the Office Building uniting them into a single composition. There is brick and stucco open arcade of three arches in line with the south façade, enclosing the central courtyard, that connect the south elevation of the Classroom Building to the south elevation of the Office Building. It is also Mission Revival style and is topped with brick coping and decorative features. There is a modern fence constructed and enclosing the courtyard along the north elevation, connecting the Classroom Building and the Office Building. The former doorway on the south façade has been filled in. There is a steel stairway located along the north (back) elevation for access to the attic. All additions and modifications were approved by SHPO.

Walls (structure): Brick Foundation: Concrete Roof: Galvanized steel/wood

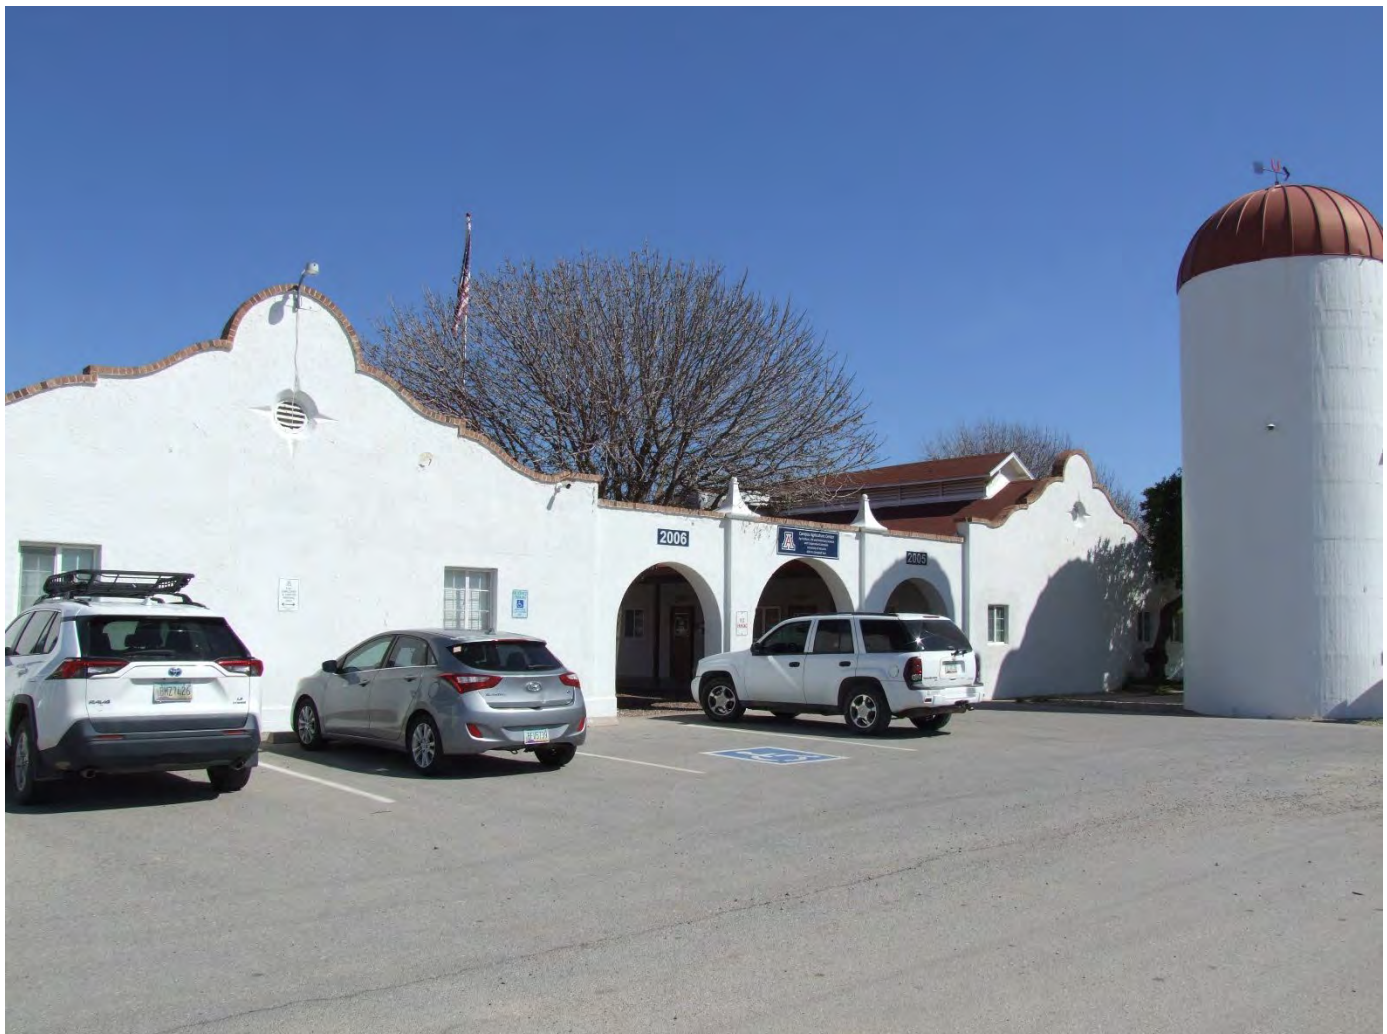
The University of Arizona Campus Agricultural Center, Classroom Building and Office Building, view facing northeast, WestLand Resources, Inc., March 8, 2023.

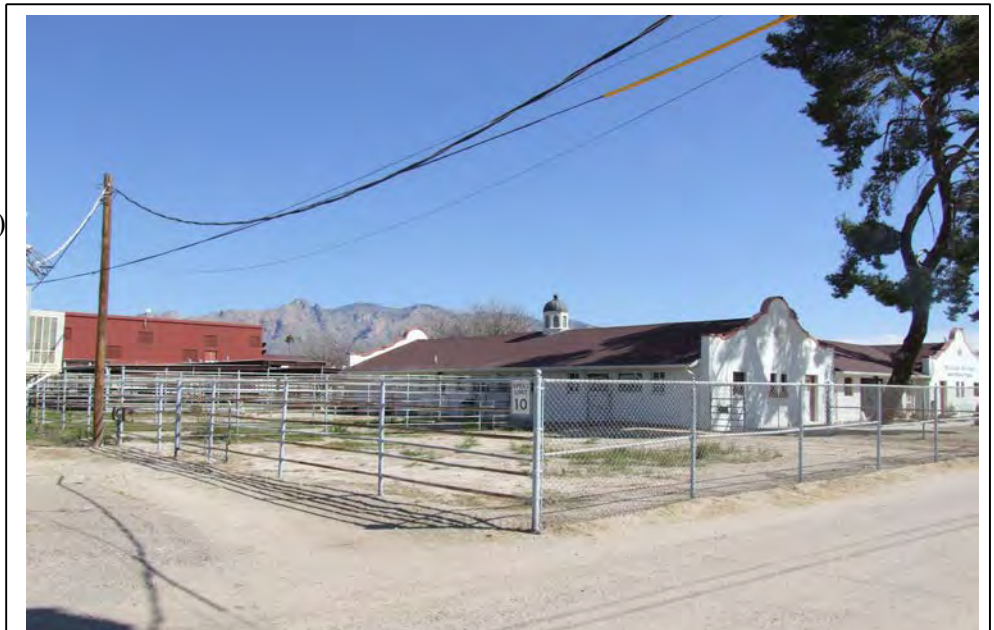
Date of photo: March 8, 2023 View Direction (looking towards) Northeast Negative No.:

- MATERIALS** (Describe the materials used in the following elements of the property) **Galvanized steel construction.**
Walls (structure): Metal Foundation: Concrete post footers Roof: N/A
Windows: N/A
If the windows have been altered, what were they originally? N/A
Wall Sheathing: N/A
If the sheathing has been altered, what was it originally? N/A

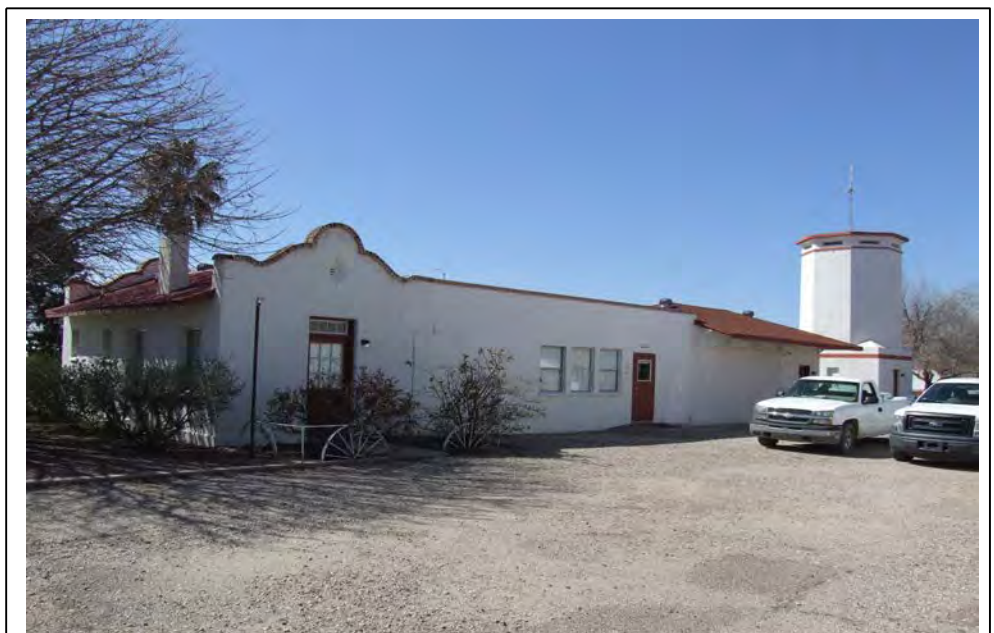
View Direction (*looking towards*)
Southwest

- MATERIALS** (Describe the materials used in the following elements of the property)
Walls (structure): Masonry Foundation: Concrete Roof: Asphalt shingles/galvanized steel
Windows: Steel casement and aluminum
If the windows have been altered, what were they originally? Steel casement
Wall Sheathing: Stucco
If the sheathing has been altered, what was it originally? N/A

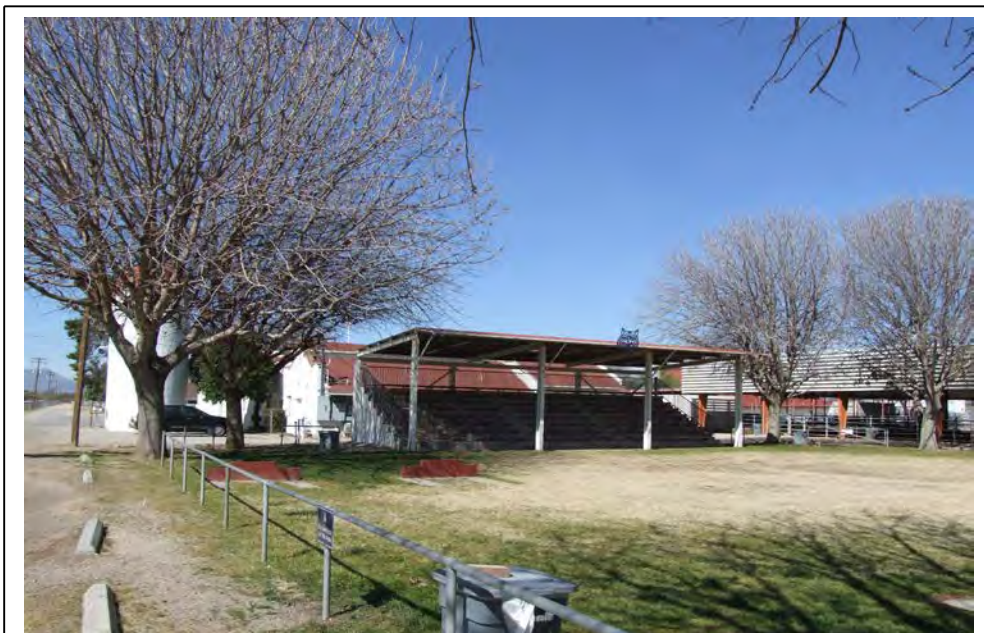
Date of photo: March 8, 2023
View Direction (looking towards) Northwest
Negative No.:

Walls (structure): Concrete Foundation: Concrete Roof: Ramada: Steel

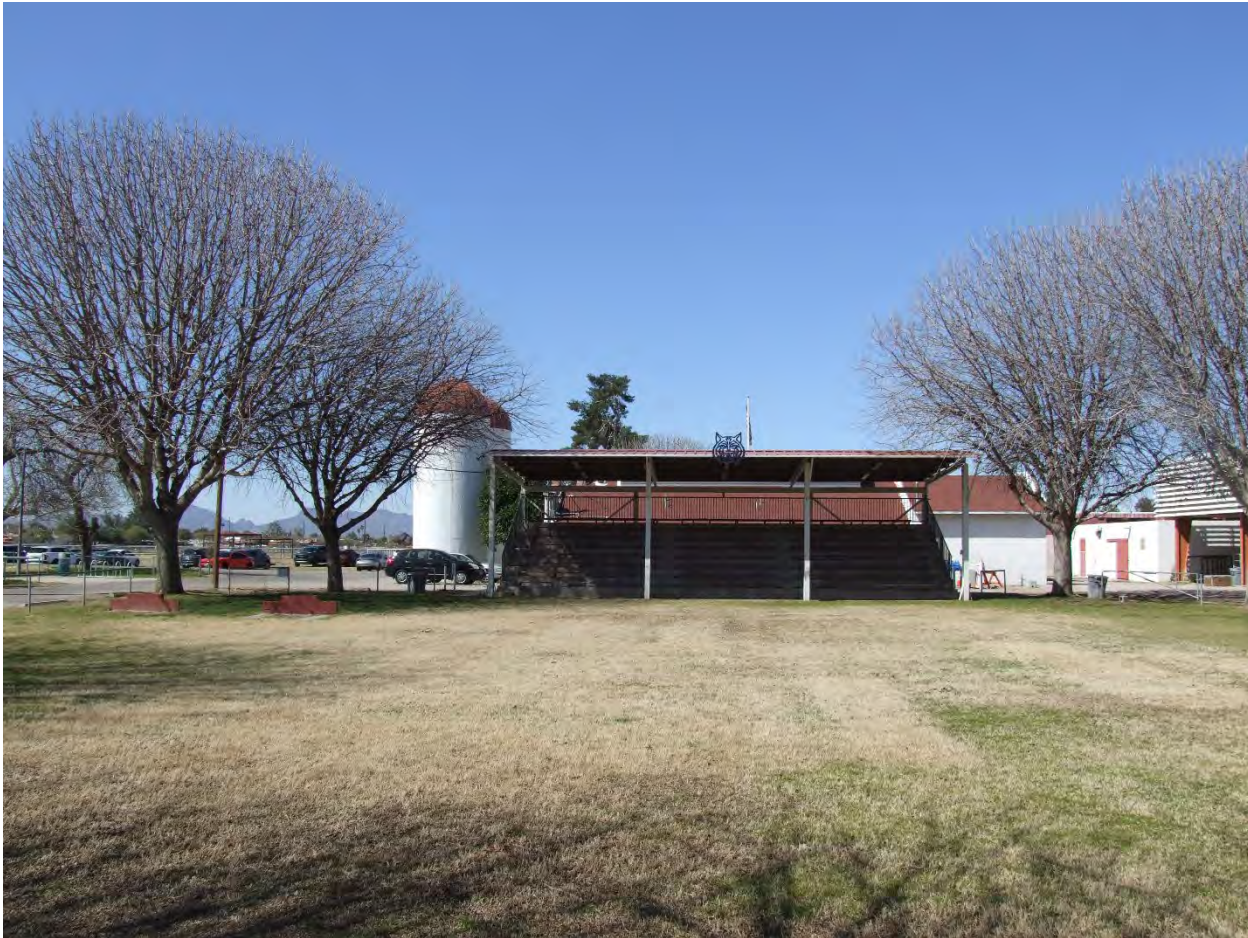
The University of Arizona Campus Agricultural Center, Grandstand and Field, view facing west. WestLand Resources, Inc., March 8, 2023.

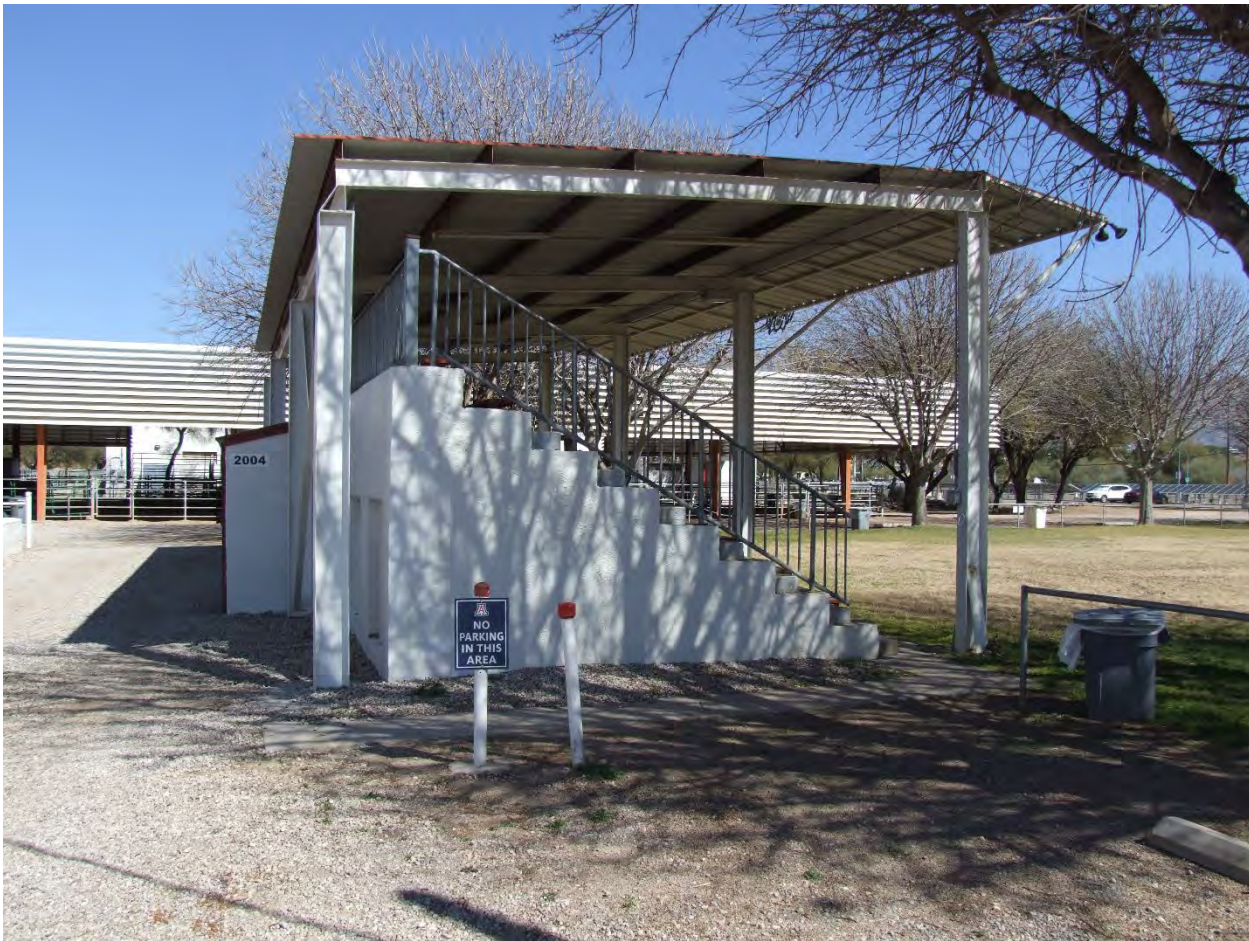
The University of Arizona Campus Agricultural Center, south side of grandstand profile, view facing north-northeast. WestLand Resources, Inc., March 8, 2023.

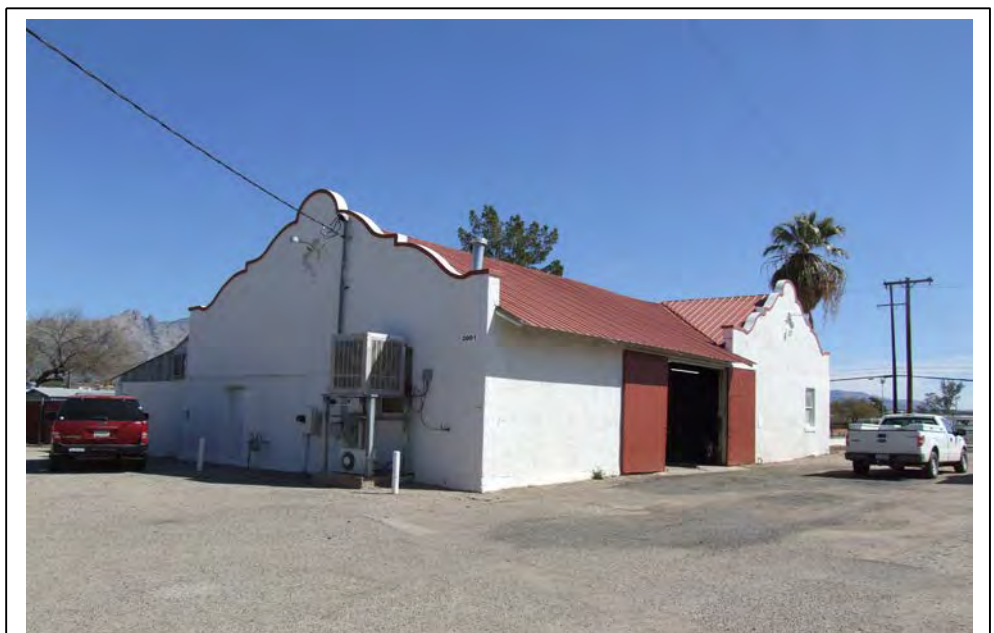
View Direction (*looking towards*)
Northeast

- 1. LOCATION** Original Site Moved (date _____) Original Site: _____
- 2. DESIGN** (Describe alterations from the original design, including dates—known or estimated—when alterations were made) The Machine Shop is a one-story Mission Revival style building with a rectangular footprint constructed of masonry brick walls covered in stucco on a concrete foundation. The walls are topped by a medium pitch cross gable roof, constructed of galvanized steel, with low overhanging eaves. There is a Mission-style arched parapet with brick coping on the west, north, and south elevations, with stucco ornamental quatrefoil details around the attic vents. The exterior walls are pierced by the original wood casement and double hung windows and original wood doorways with glass panels. Located on the south elevation is a painted sliding barn door, likely historic. There is a shed roof addition located on the north elevation constructed of CMU with stucco walls and topped with a galvanized steel roof. Additionally, there is a historic concrete water holding tank and water pump located in front of the east elevation.

- 4. MATERIALS** (Describe the materials used in the following elements of the property)
Walls (structure): Brick/CMU Foundation: Concrete Roof: Galvanized steel
Windows: Wood casement
If the windows have been altered, what were they originally? N/A
Wall Sheathing: Stucco
If the sheathing has been altered, what was it originally? N/A

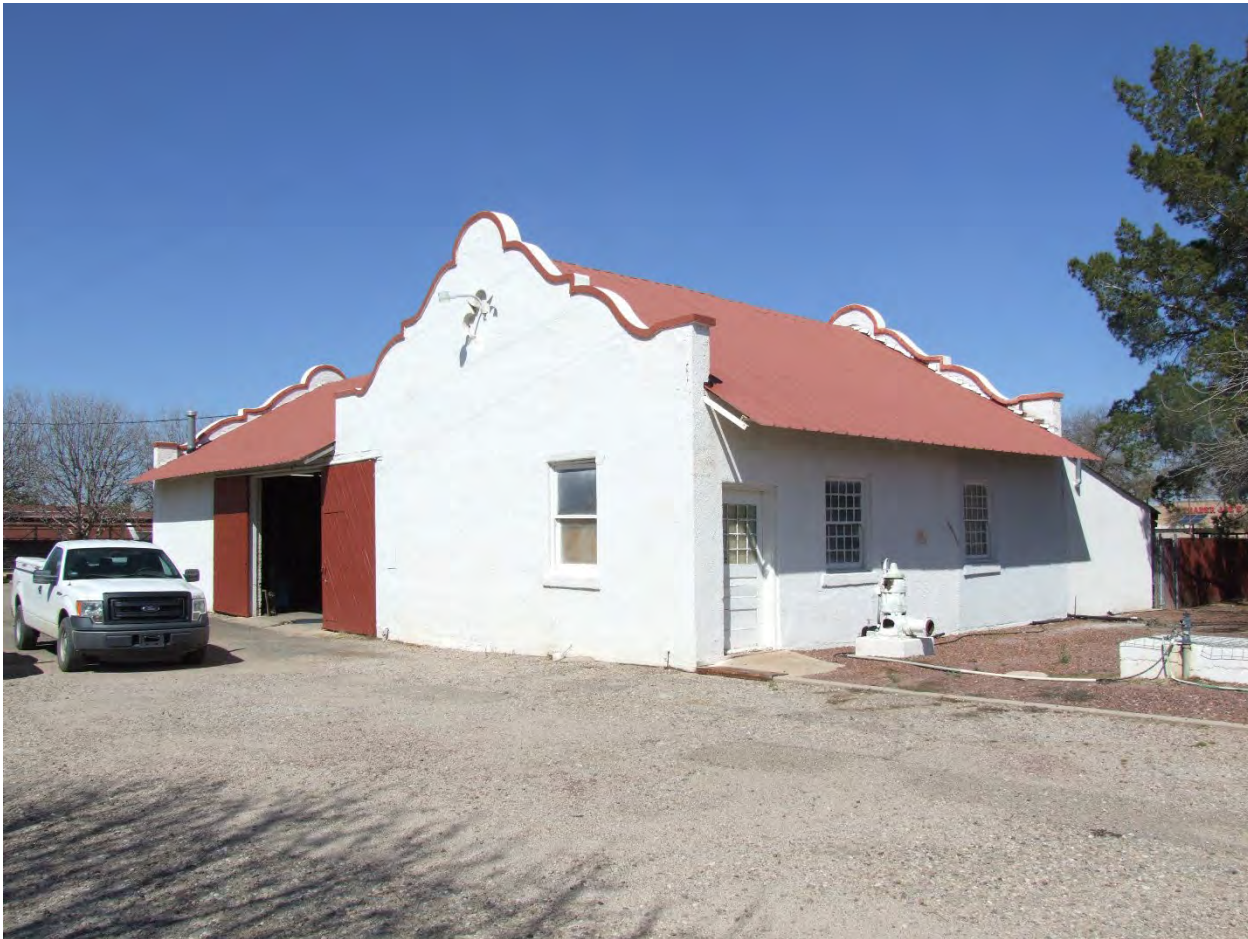
The University of Arizona Agricultural Center, Machine Shop, view facing northwest. WestLand Resources, Inc., March 8, 2023.

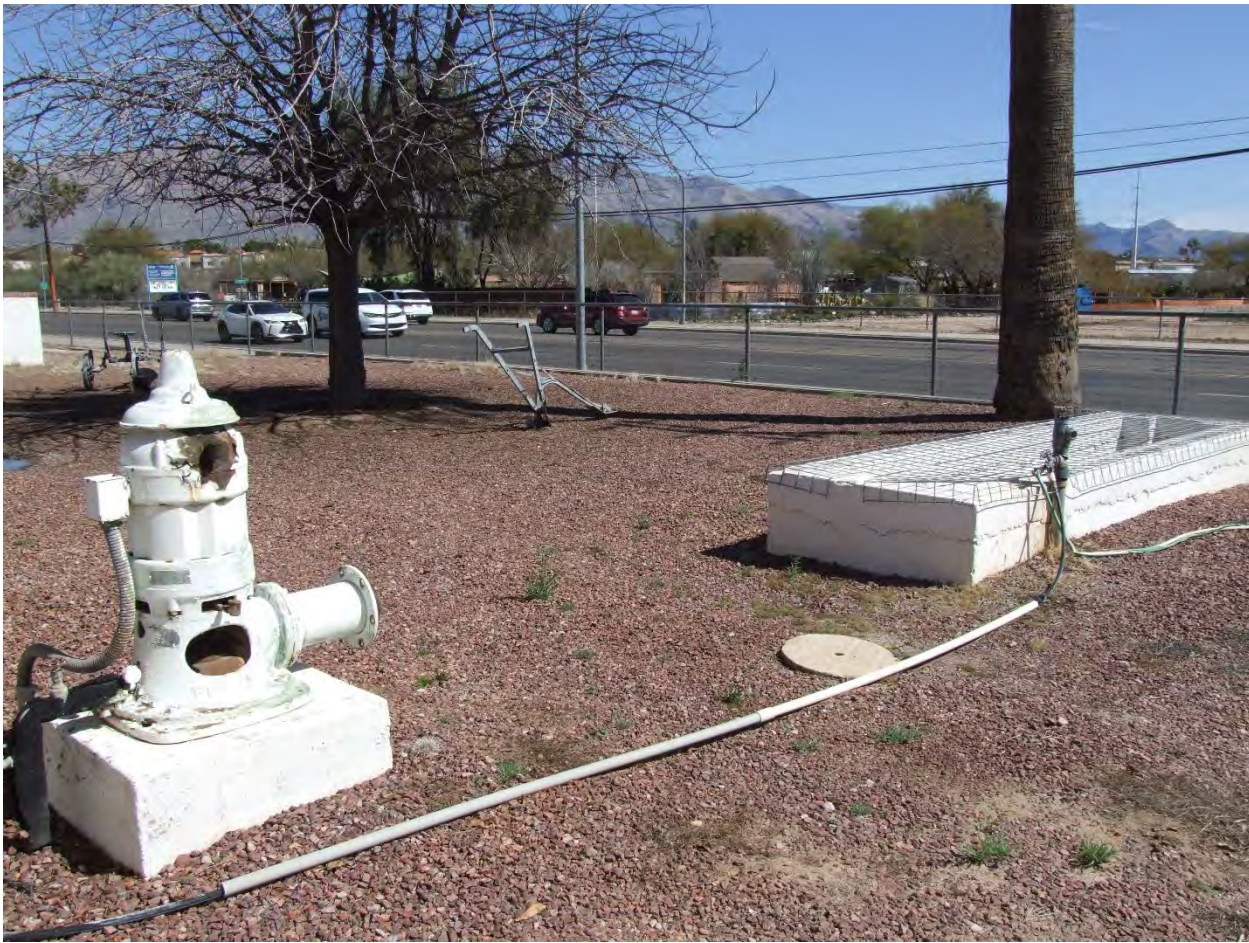
The University of Arizona Agricultural Center, Details of water pump and water holding tank, view facing northeast. WestLand Resources, Inc., March 8, 2023.

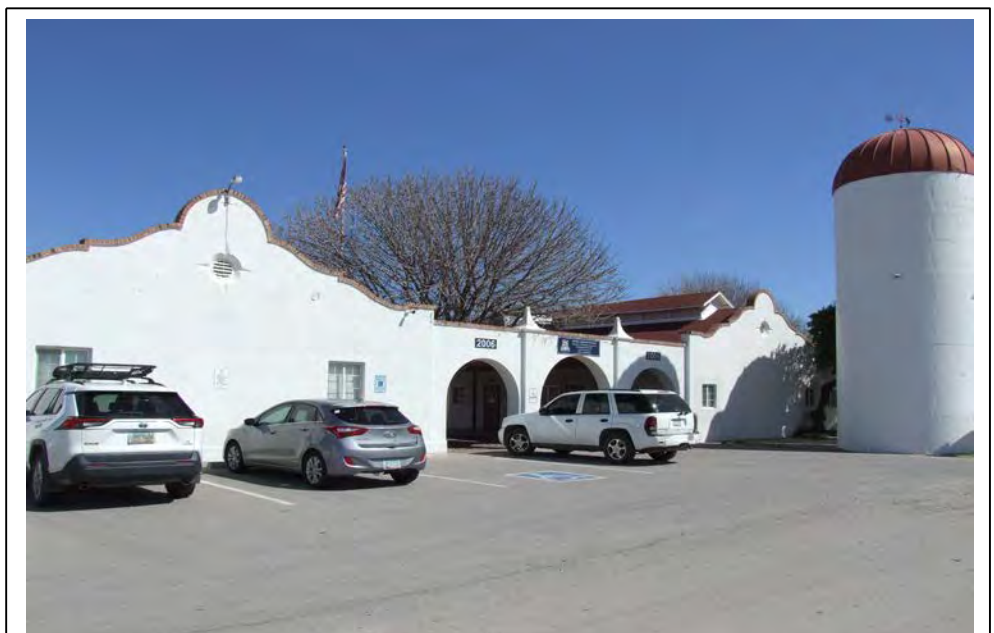
View Direction (*looking towards*)
Northeast

- 1. LOCATION** Original Site Moved (date _____) Original Site: _____
- 2. DESIGN** (Describe alterations from the original design, including dates—known or estimated—when alterations were made) The Office Building is a one-story building with a rectangular footprint. Its exterior walls are constructed of brick masonry and are sheathed in stucco resting on a poured concrete foundation. The walls are topped by a medium-pitch asphalt shingle gable roof with a north/south axis, with shallow overhanging eaves. There is a Mission-style arched parapet on the north and south elevations with brick coping and quatrefoils around the attic vents. The walls are punctuated with aluminum and vinyl sliding sash windows with ornamental grilles that replaced the original steel casements. The building also has a mix of original solid wood doors and modern doors with glass panels. There is a central courtyard between the Office Building and the Classroom Building connected by a brick and stucco open arcade of three arches in line with the south façade, enclosing the central courtyard along the south elevation of the Office Building and Classroom Building uniting them into a single composition. Former openings in the west gable of the south façade have been filled in. This building has additions to the west and north sides, with historic aerial imagery indicating these additions were constructed sometime after 1980.

- 4. MATERIALS** (Describe the materials used in the following elements of the property)
Walls (structure): Brick Foundation: Concrete Roof: Asphalt shingles
Windows: Aluminum/vinyl
If the windows have been altered, what were they originally? Steel casement
Wall Sheathing: Stucco
If the sheathing has been altered, what was it originally? N/A

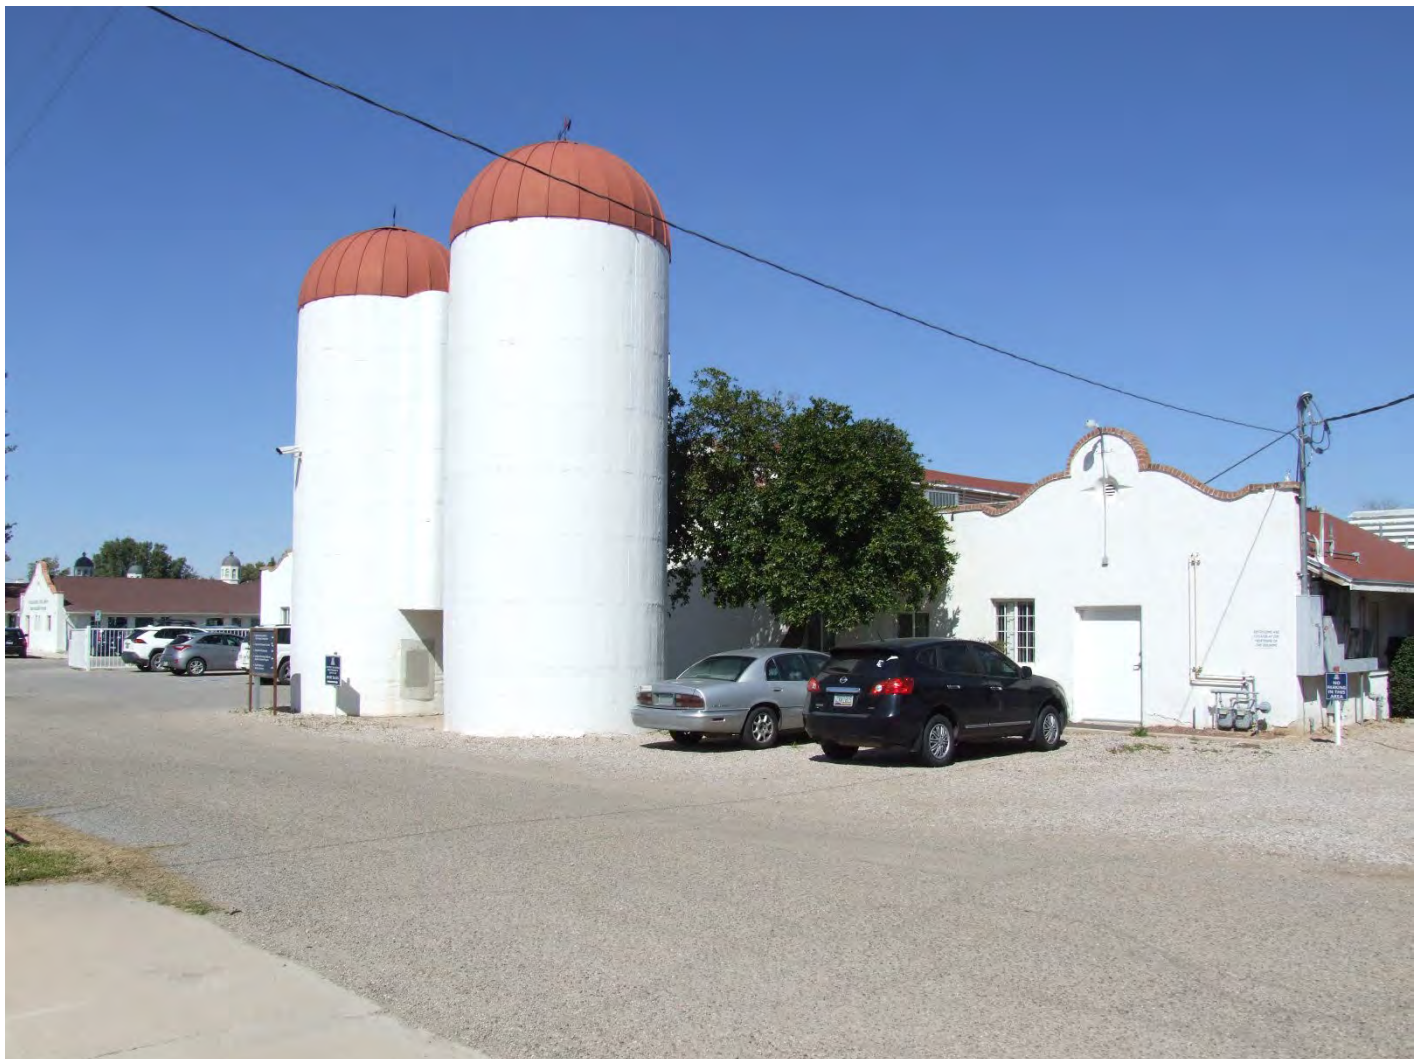
The University of Arizona Campus Agricultural Center, Office Building, view facing northwest, WestLand Resources, Inc., March 8, 2023.

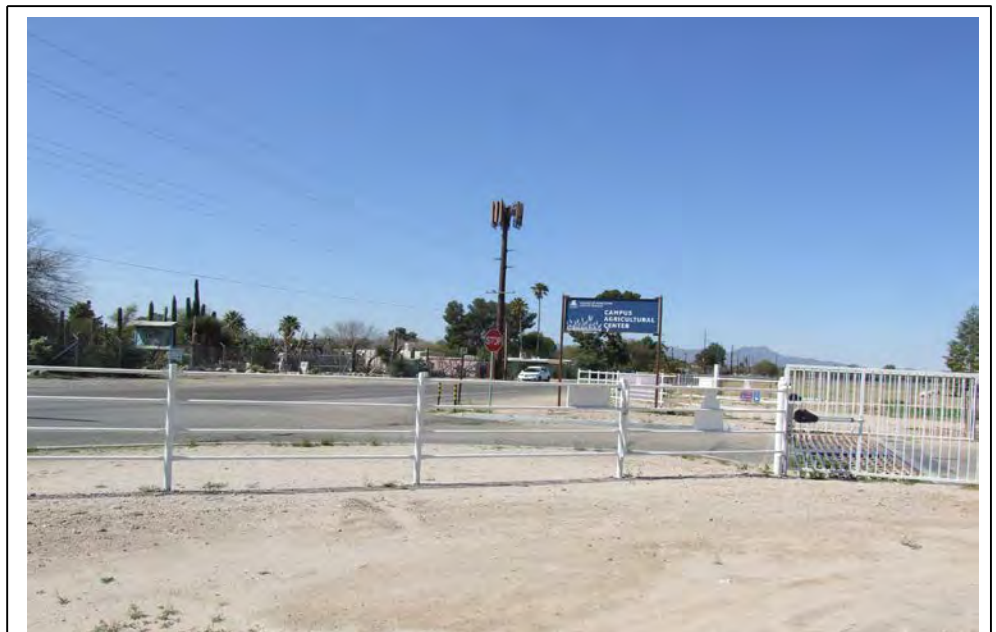
View Direction (*looking towards*)
West

Walls (structure): Metal Foundation: Concrete Roof: N/A

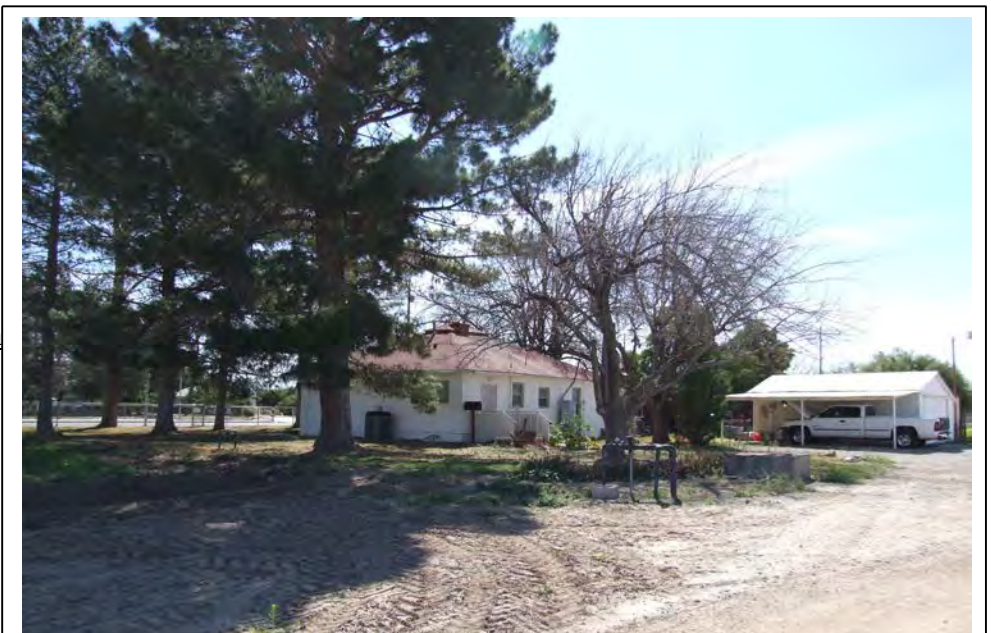
Date of photo: March 8, 2023 View Direction (looking towards) Southeast Negative No.:

- MATERIALS** (Describe the materials used in the following elements of the property)
Walls (structure): Board-formed cast in place concrete Foundation: Concrete
Roof: Asphalt shingles Windows: Vinyl
If the windows have been altered, what were they originally? Wood casement
Wall Sheathing: N/A
If the sheathing has been altered, what was it originally? N/A

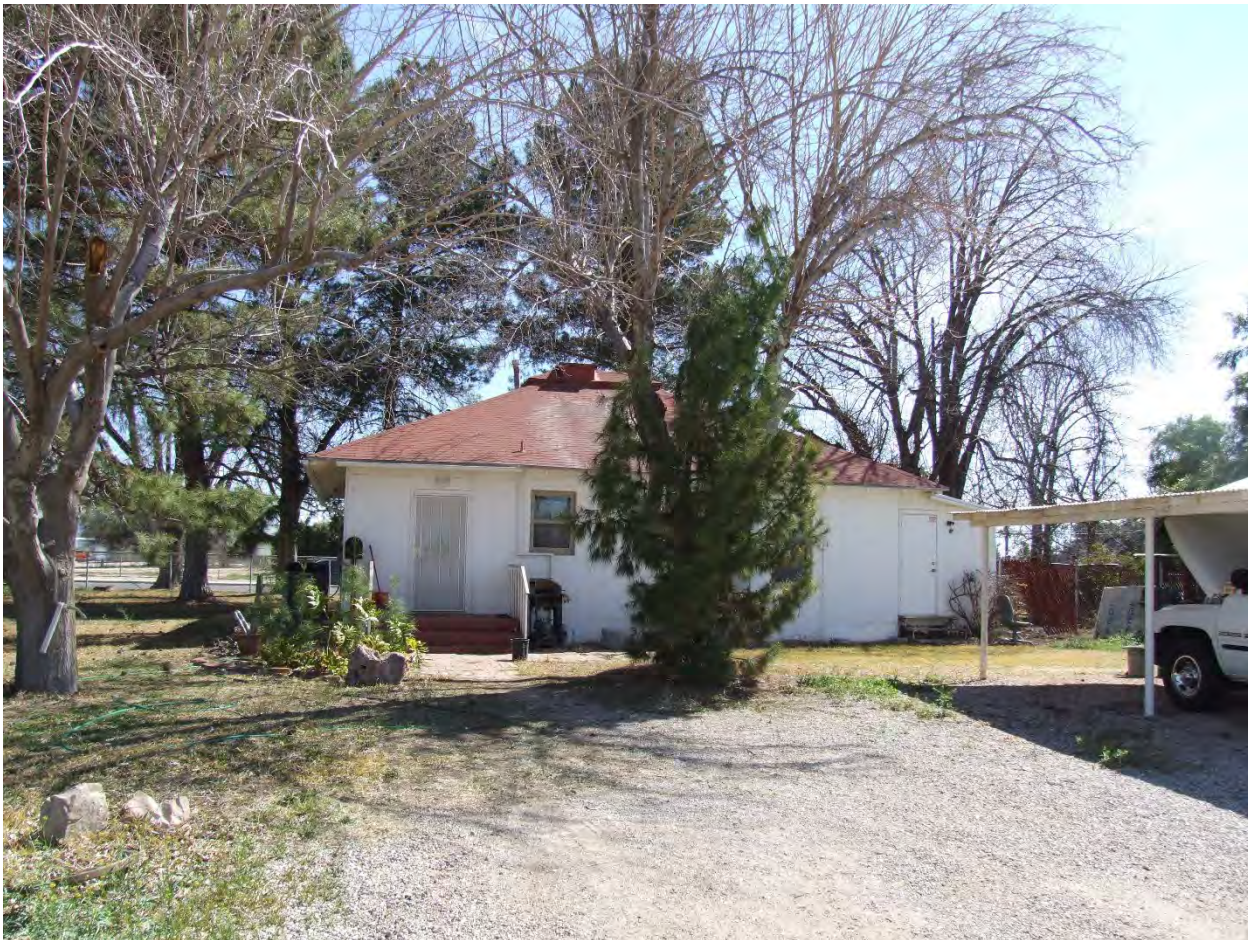
The University of Arizona Campus Agricultural Center, Main Residence, west elevation, view facing east. WestLand Resources, Inc., March 8, 2023.

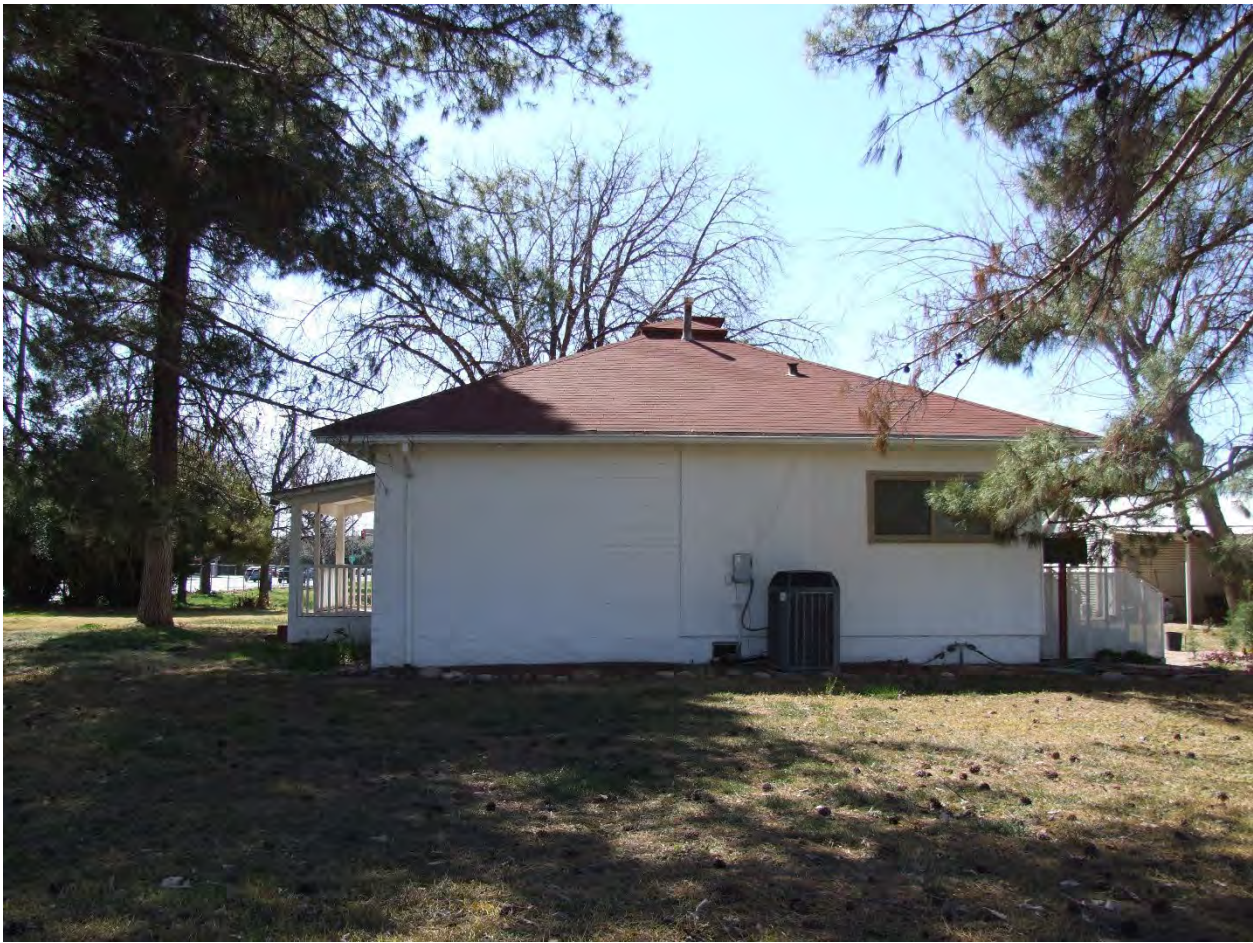
The University of Arizona Campus Agricultural Center, Main Residence, north elevation, view facing south. WestLand Resources, Inc., March 8, 2023.

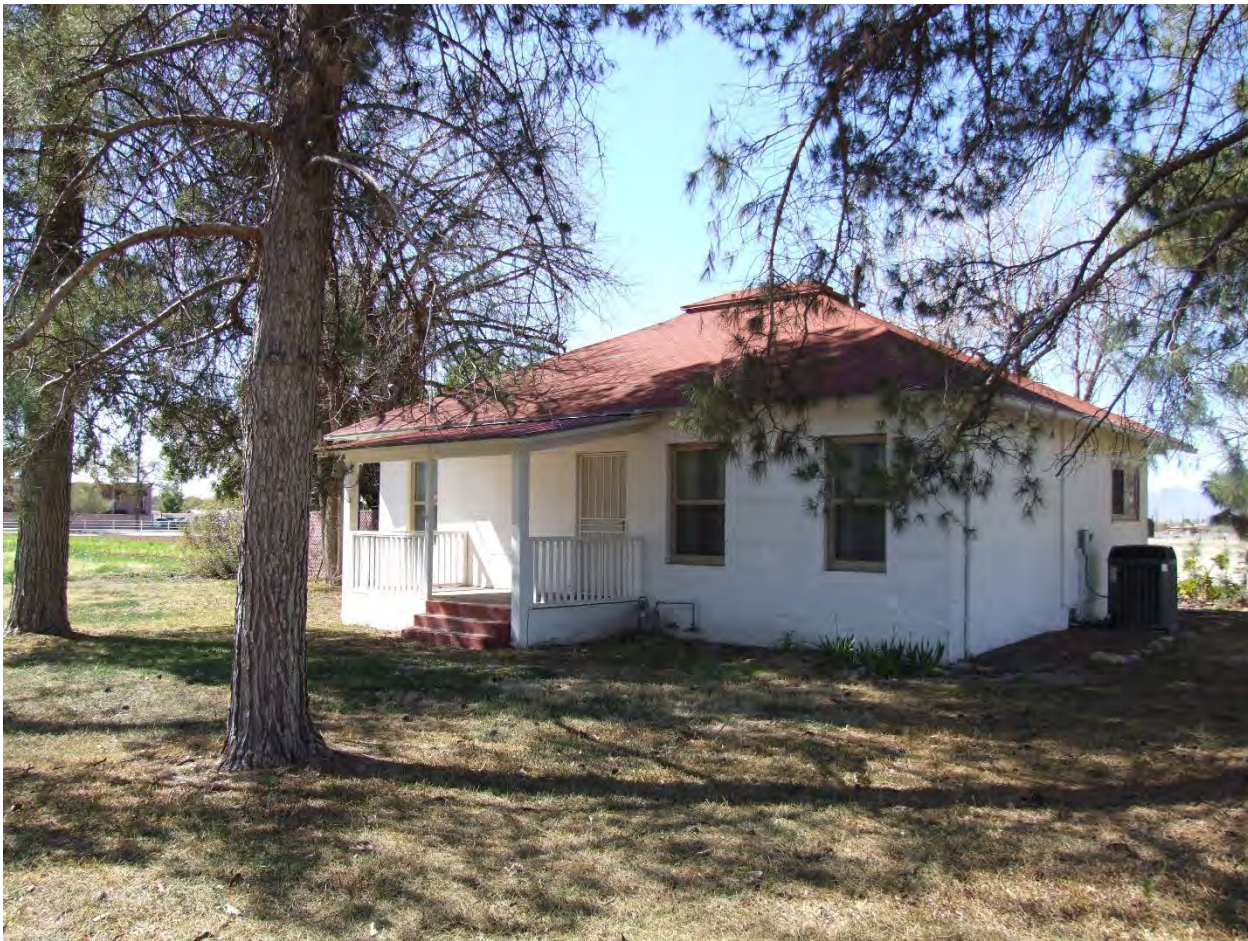
The University of Arizona Campus Agricultural Center, Main Residence, east and north elevations, view facing southwest. WestLand Resources, Inc., March 8, 2023.
