HISTORIC PROPERTY INVENTORY FORM

For properties identified through survey: Site No: N/A Survey Area: University of Arizona (UA) Campus Agricultural Center

Historic Name(s): Equine Education Building, former Equine Barn (UA Bldg. No. 2007)
(Enter the name(s), if any, that best reflects the property's historic importance.)

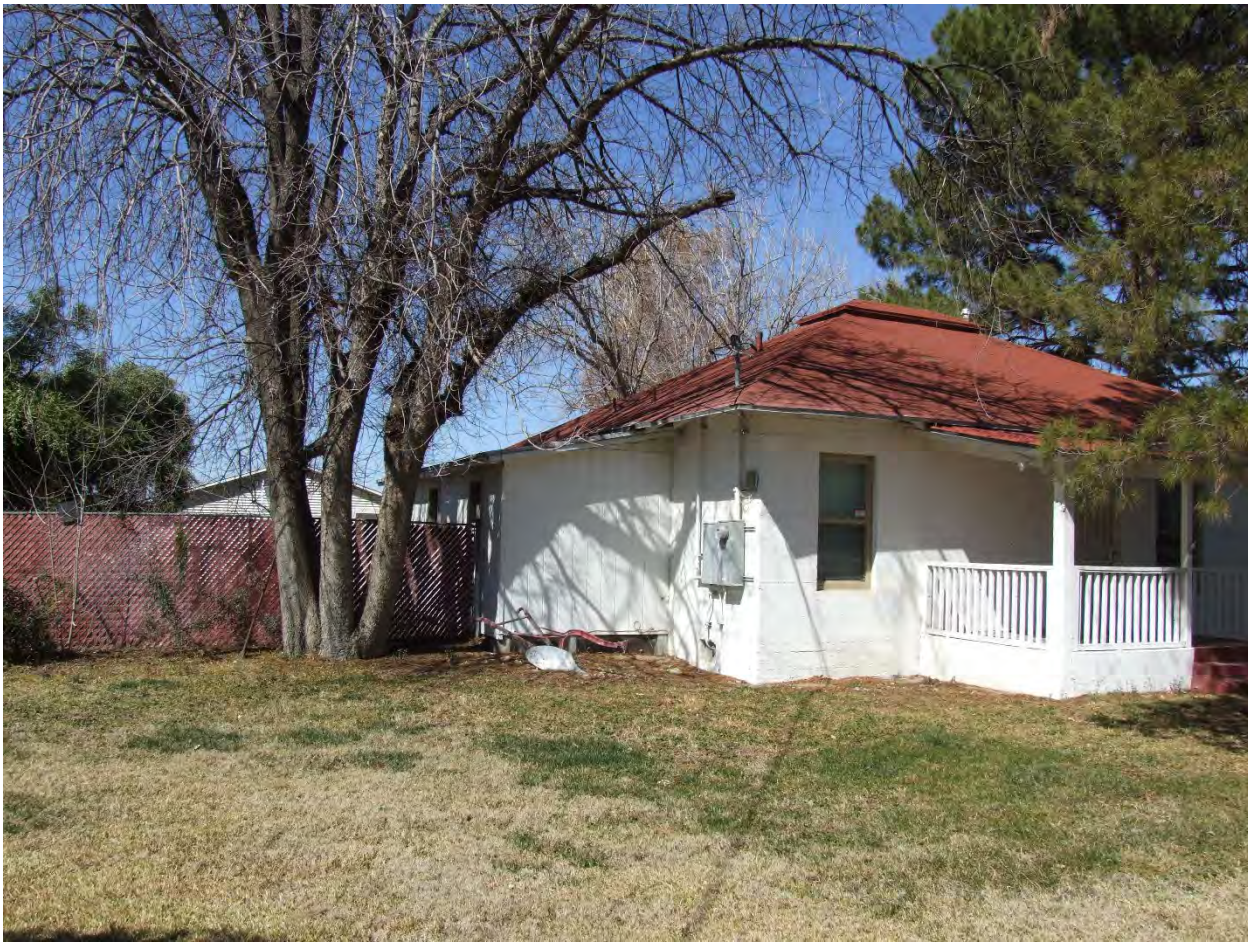
The University of Arizona Campus Agricultural Center, Main Residence, east and south elevations, view facing northwest. WestLand Resources, Inc., March 8, 2023.

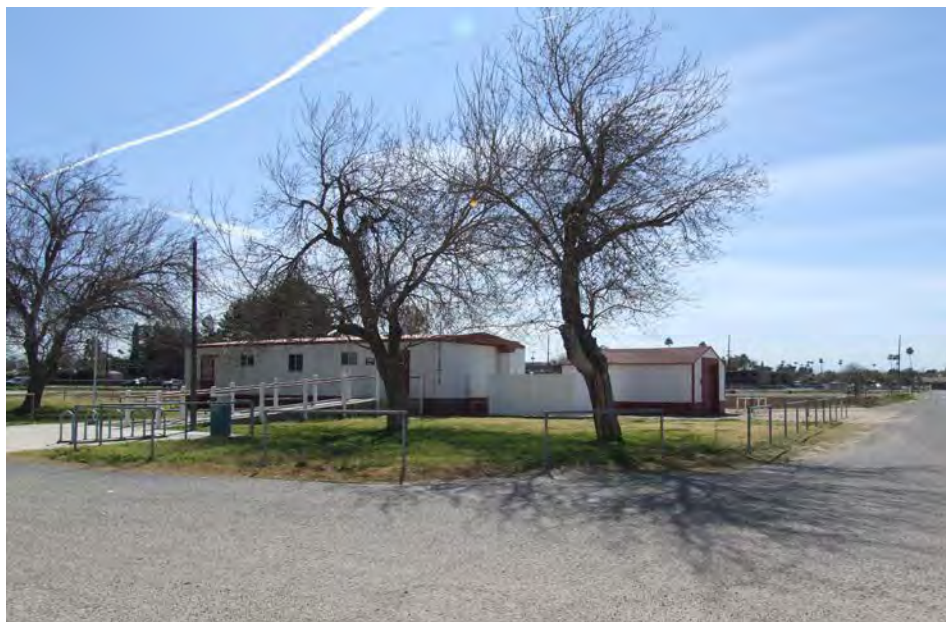
View Direction (*looking towards*)
Southeast

Walls (structure): (a) steel/(b) masonry/wood Foundation: (a) concrete pillars/(b) concrete Roof: (a) metal/(b) wood
