ADA Bus Stop Accessibility Study Report

Tucson, Arizona

(First of two projects for the City of Tucson's "ADA Sidewalk Accessibility to Bus Stops Study")

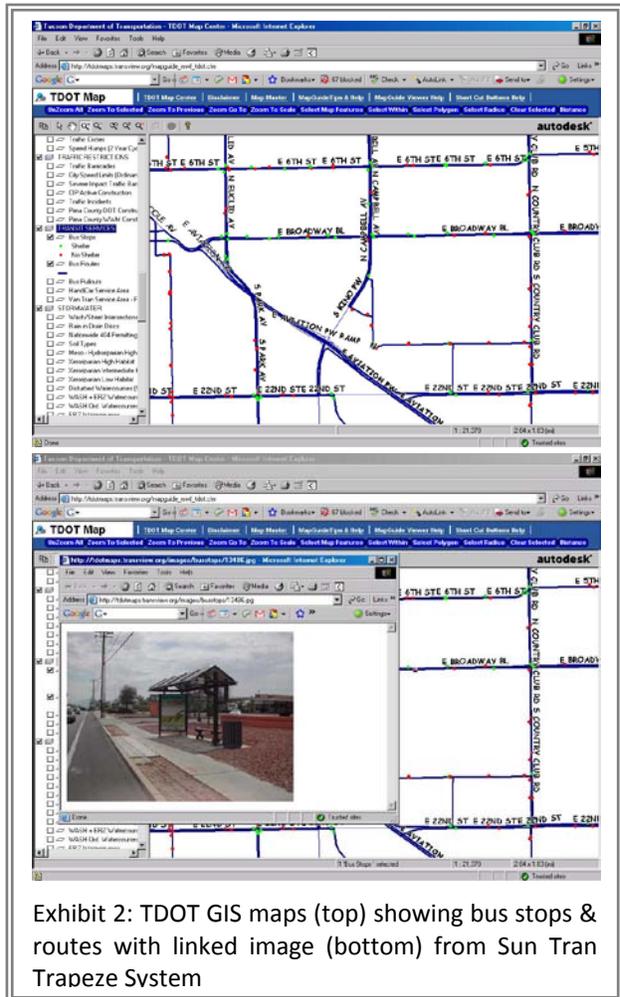
Exhibit 2: TDOT GIS maps (top) showing bus stops & routes with linked image (bottom) from Sun Tran Trapeze System

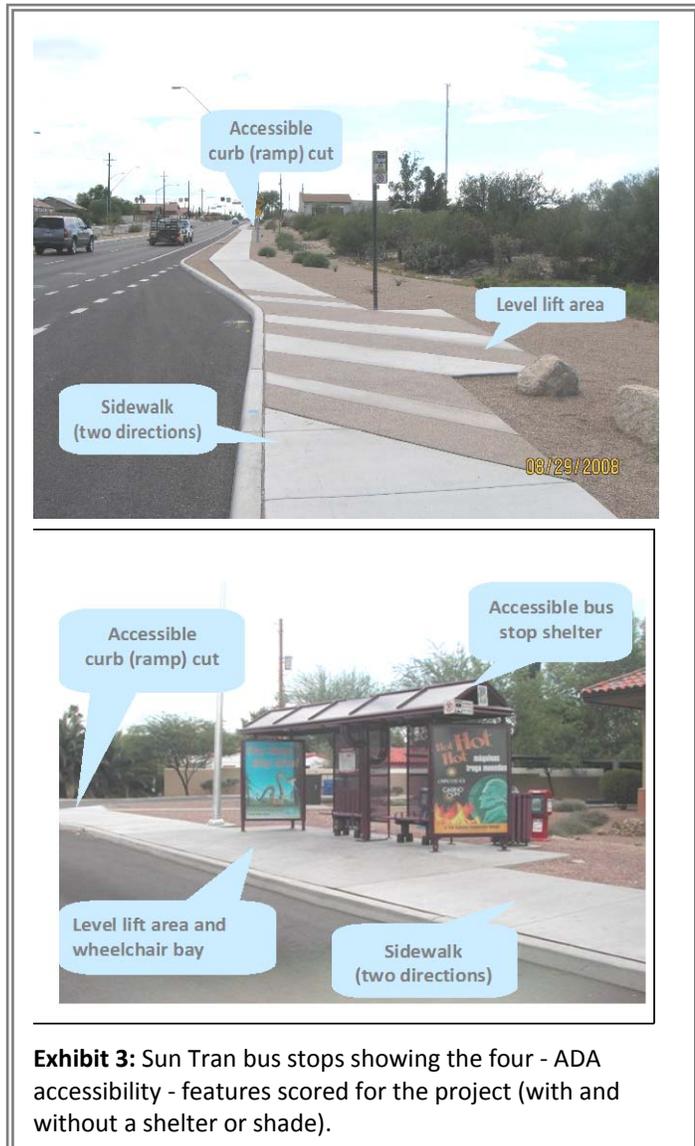
Exhibit 3: Sun Tran bus stops showing the four - ADA accessibility - features scored for the project (with and without a shelter or shade).

For the *level lift area*, the team noted whether such an area existed, its dimensions, and its quality, specifically if the area was concrete and met the minimum dimensions of five feet wide (5' w) and eight feet deep (8' d) from the back of curb. If the stop lacked a 5' w x 8' d lift area, the team looked to see if there was a usable substitute within a few feet of the bus stop, such as a driveway that would be accessible to the bus and to the passenger needing boarding assistance. The score was 1 for a 5' w x 8' d lift area; 0.7 for an alternative lift area; or 0 if there was no lift area of any type.

Second, the team evaluated connecting *sidewalks* (i.e., stable, firm, and slip resistant pedestrian pathways) in the vicinity of the bus stop to determine if they were continuous from the stop to the intersections in both directions. The score was 2 if there were connecting sidewalks in both directions, 1 if there was a connecting sidewalk in one direction, and 0 if there were no sidewalks in either direction.

Third, the team evaluated whether there were *accessible curb (ramp) cuts* at the points at which the sidewalk(s) intersected with the closest alleys or roadways. The score for curb (ramp) cuts was 2 if there were curb (ramp) cuts in both directions, 1 if there was a curb (ramp) cut in one direction, and 0 if there were no curb (ramp) cuts.

Fourth, the team noted whether the bus stop included a *shelter*, and if it did, whether the shelter included an ADA accessible wheelchair bay. If the shelter did not have a wheelchair bay, the team deducted 0.05 from the bus stop's ADA accessibility score. If there was an ADA accessible shelter, no score was given. There are no requirements for a shelter to be present within the ADA guidelines.

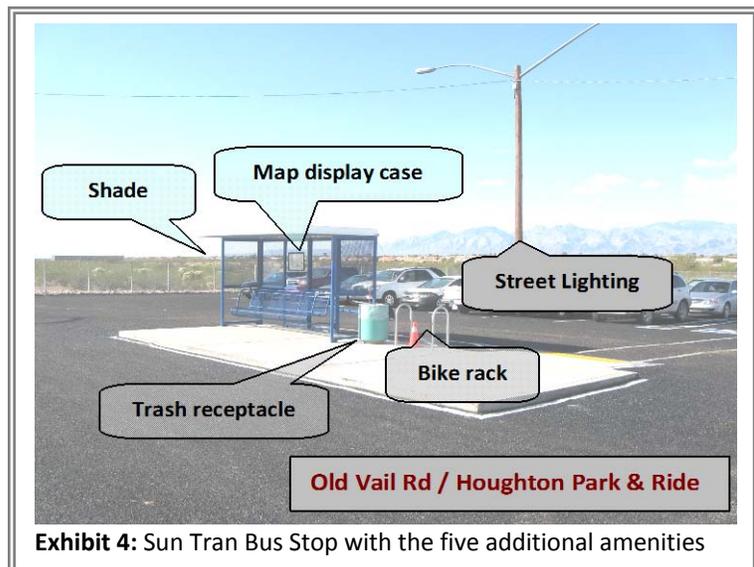
The amenities inventoried included (Exhibit 4):

- street lighting
- trash receptacle
- map display case
- bike rack
- shade

Street lighting was included because it improves pedestrian access at night, as well as perceptions of personal security. The team considered a bus stop to have adequate lighting if a light pole or fixture was located within ten feet (10') of the stop. Because the field inventory was completed

during daylight hours, the team was only able to indicate whether lighting existed, but not whether it was functional or whether it illuminated sidewalks sufficiently to improve pedestrian access.

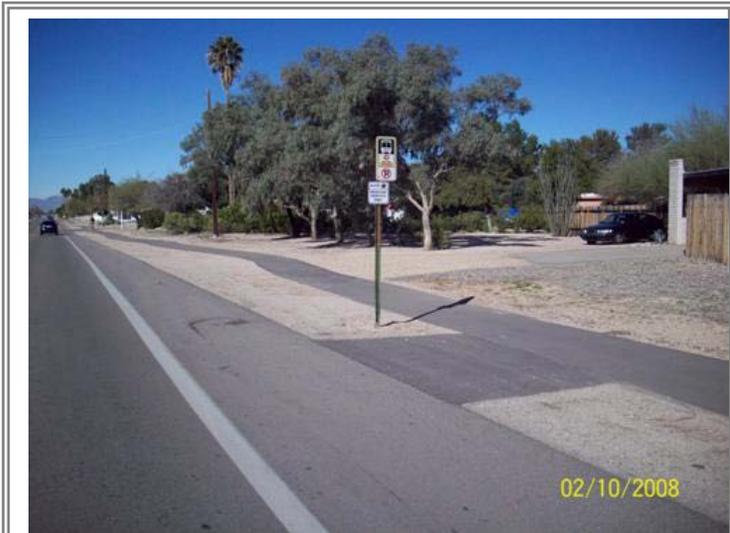
It should be noted that stops without curbs and sidewalks can be fully accessible in rural type settings if a shared-use path is separated from the road traffic and created of a firm, stable, and non-slip hard surface. Good examples of such stops are those along Cloud Road between Sabino Canyon and Pantano Roads (Exhibit 6).

Exhibit 6: Illustrated here is a bus stop along Cloud Road, which is made accessible with an asphalt shared-use path, detectable warning devices at road crossings as found at curb (ramp) cuts, and a level lift area.

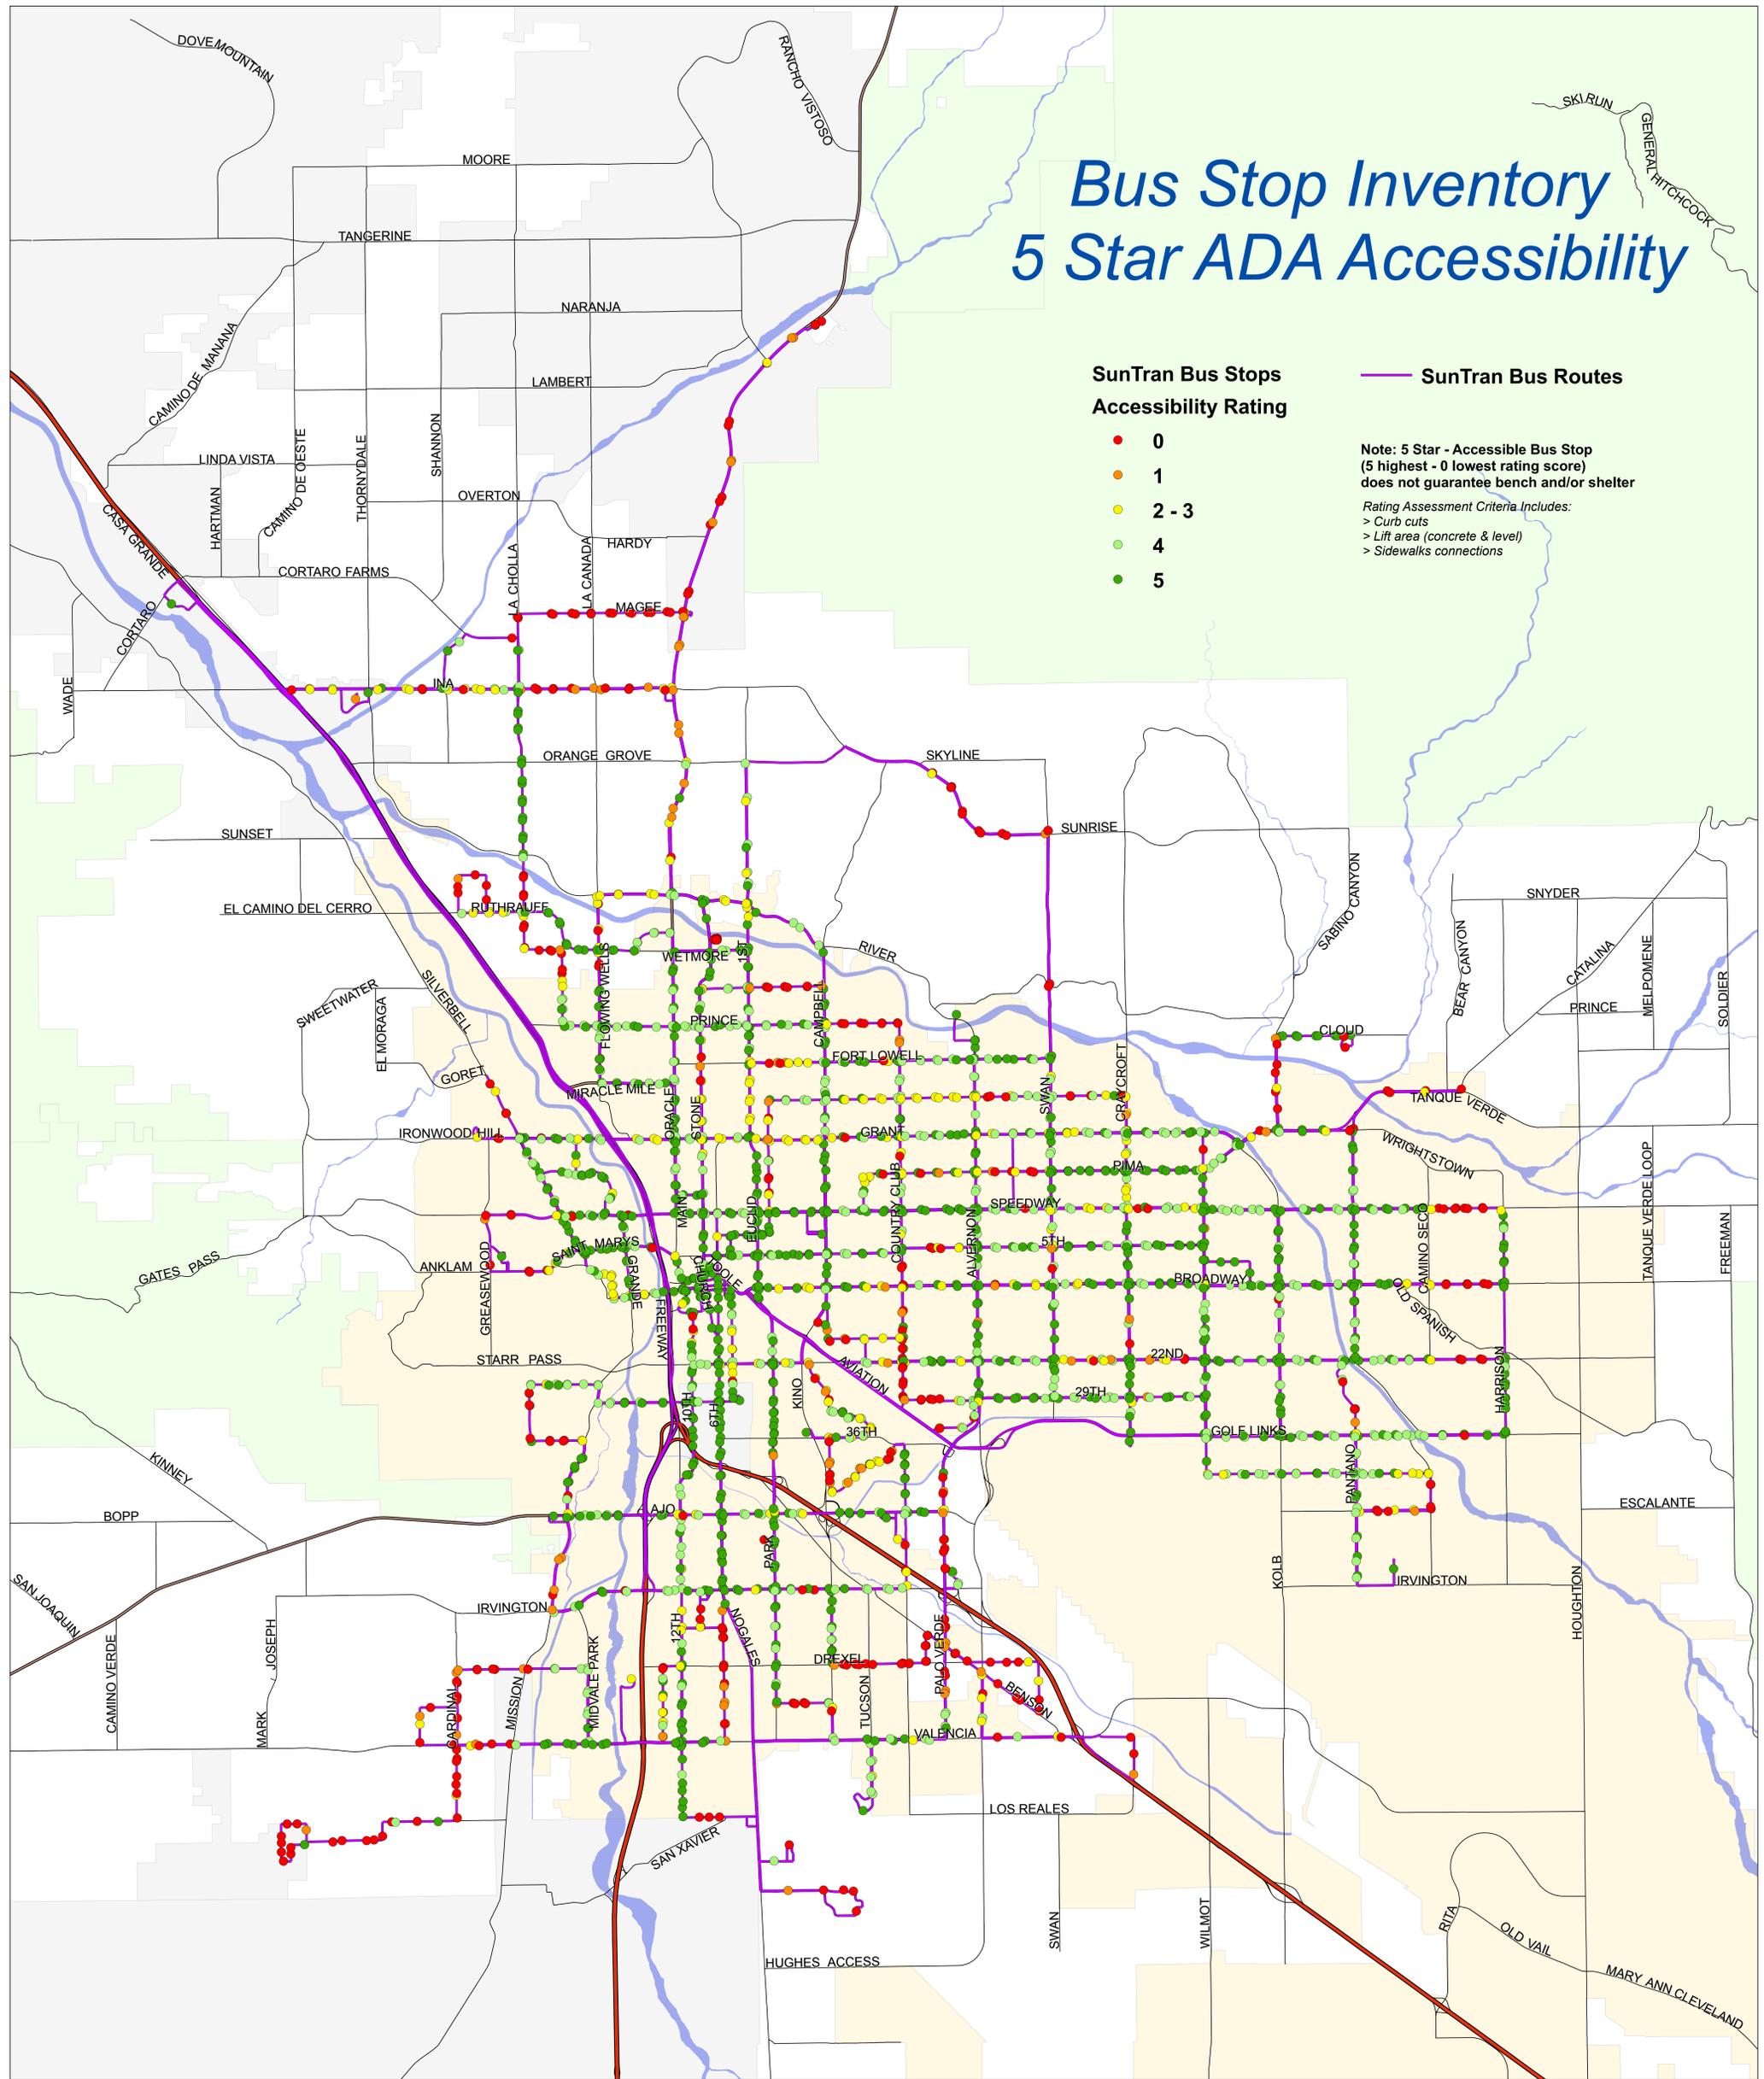
*Bus Stop Inventory
5 Star
ADA Accessibility
December 2008*

5-Star ADA Accessibility Map (December 2008): This map depicts the bus stops scored for ADA accessibility. Those bus stops receiving 5's are considered fully accessible. Bus stops with scores lower than 5 are considered to have some type of deficiency. The deficiency in bus stops with a score of 4 is generally the lack of a level lift area. Bus stops that score less than 4 generally have deficiencies that are related to lack of sidewalks or curb (ramp) cuts. Bus stops that score a 1 or a 0 do not have any sidewalks or curb (ramp) cuts, and are generally located on the periphery of the region, although some are along more urban corridors. Conversely, bus stops with accessibility scores of 4 to 5 are mostly located in areas where major road projects with sidewalks were completed. The map uses a color ramp from dark green (5) to red (0) to identify the level of accessibility at these stops.

Note: 5 Star - Accessible Bus Stop (5 highest - 0 lowest rating score) does not guarantee bench and/or shelter

Rating Assessment Criteria Includes:
 > Curb cuts
 > Lift area (concrete & level)
 > Sidewalks connections

Based on the rankings of recommended ADA improvements, the most common are (1) level lift areas and (2) sidewalk connections to the bus stops. The bus stops requiring these two types of improvements are scattered throughout the region. However, bus stops that require the most improvements are located on roadway corridors with minimal infrastructure. This is highly evident on the 5-Star ADA Accessibility Map in Appendix B.

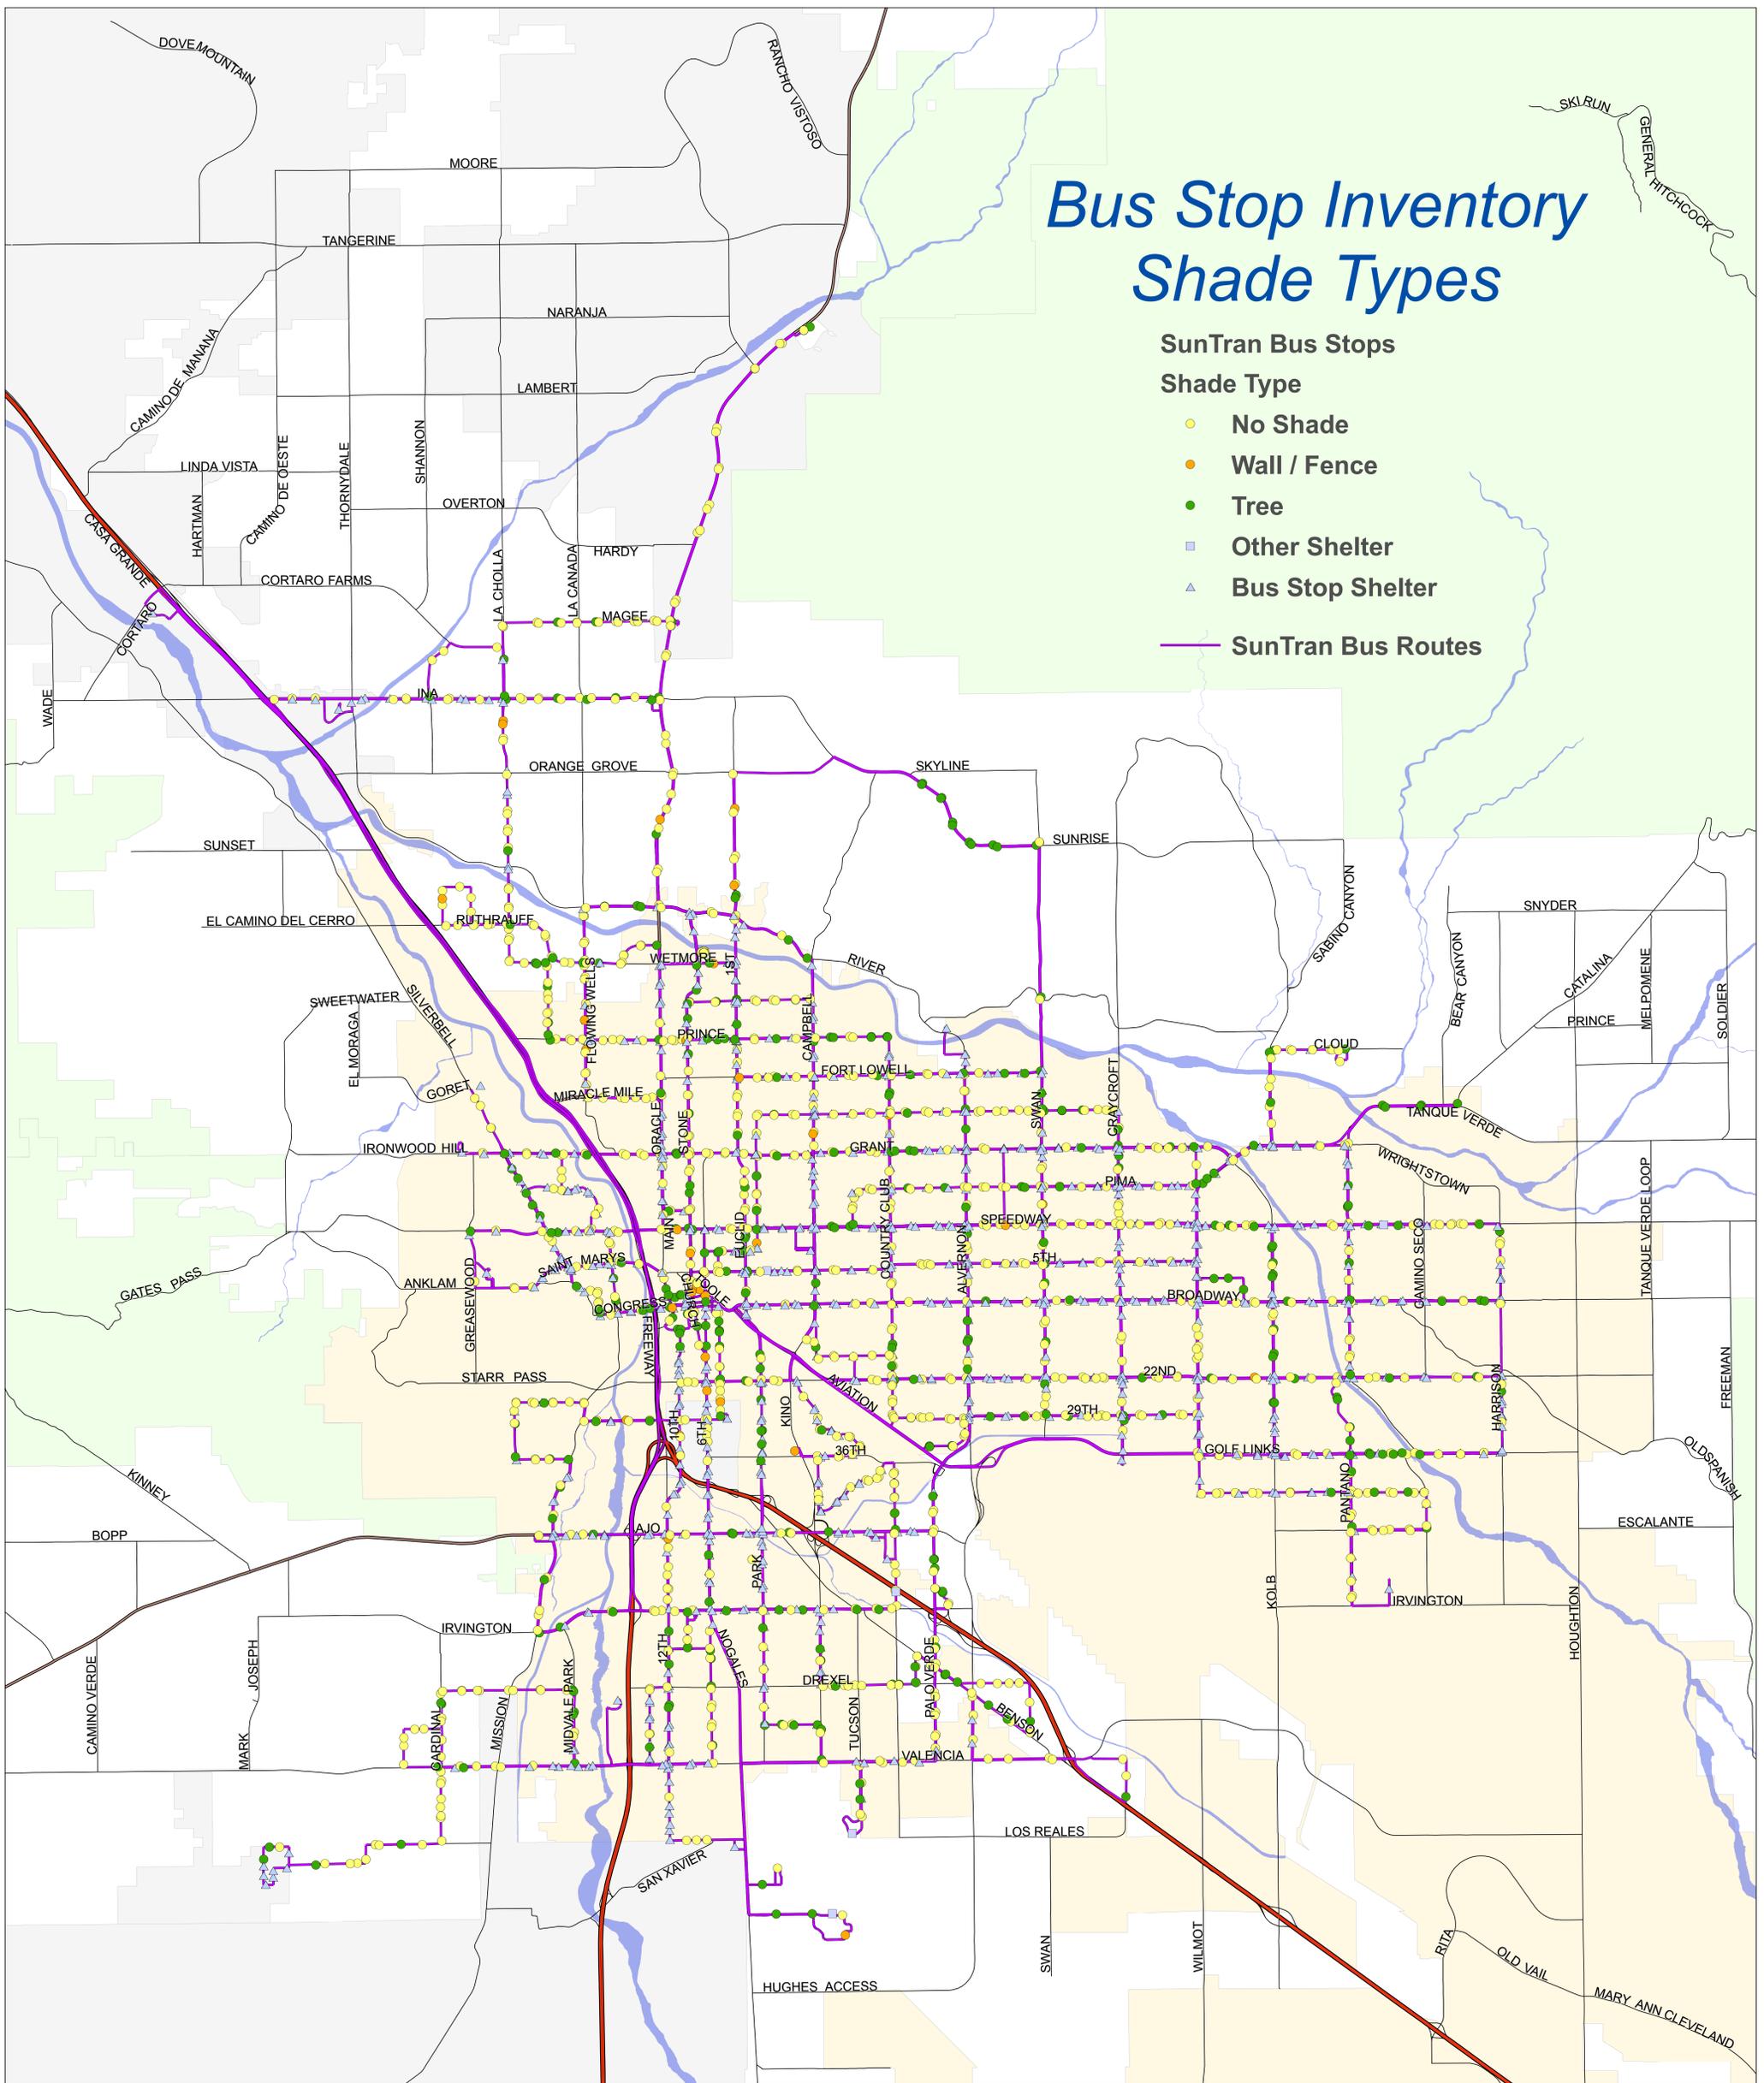
*Bus Stop Inventory
Shade Types*

Shade Type Availability Map, December 2008: Having some shade is important in the region's dry desert environment, especially during the hot summer months. This map identifies stops with no shade (bright yellow) to some shade (orange), tree shade (green), or structural shade (light blue-gray). A review of the mapped results shows the need for shade at bus stops is spread throughout the region.

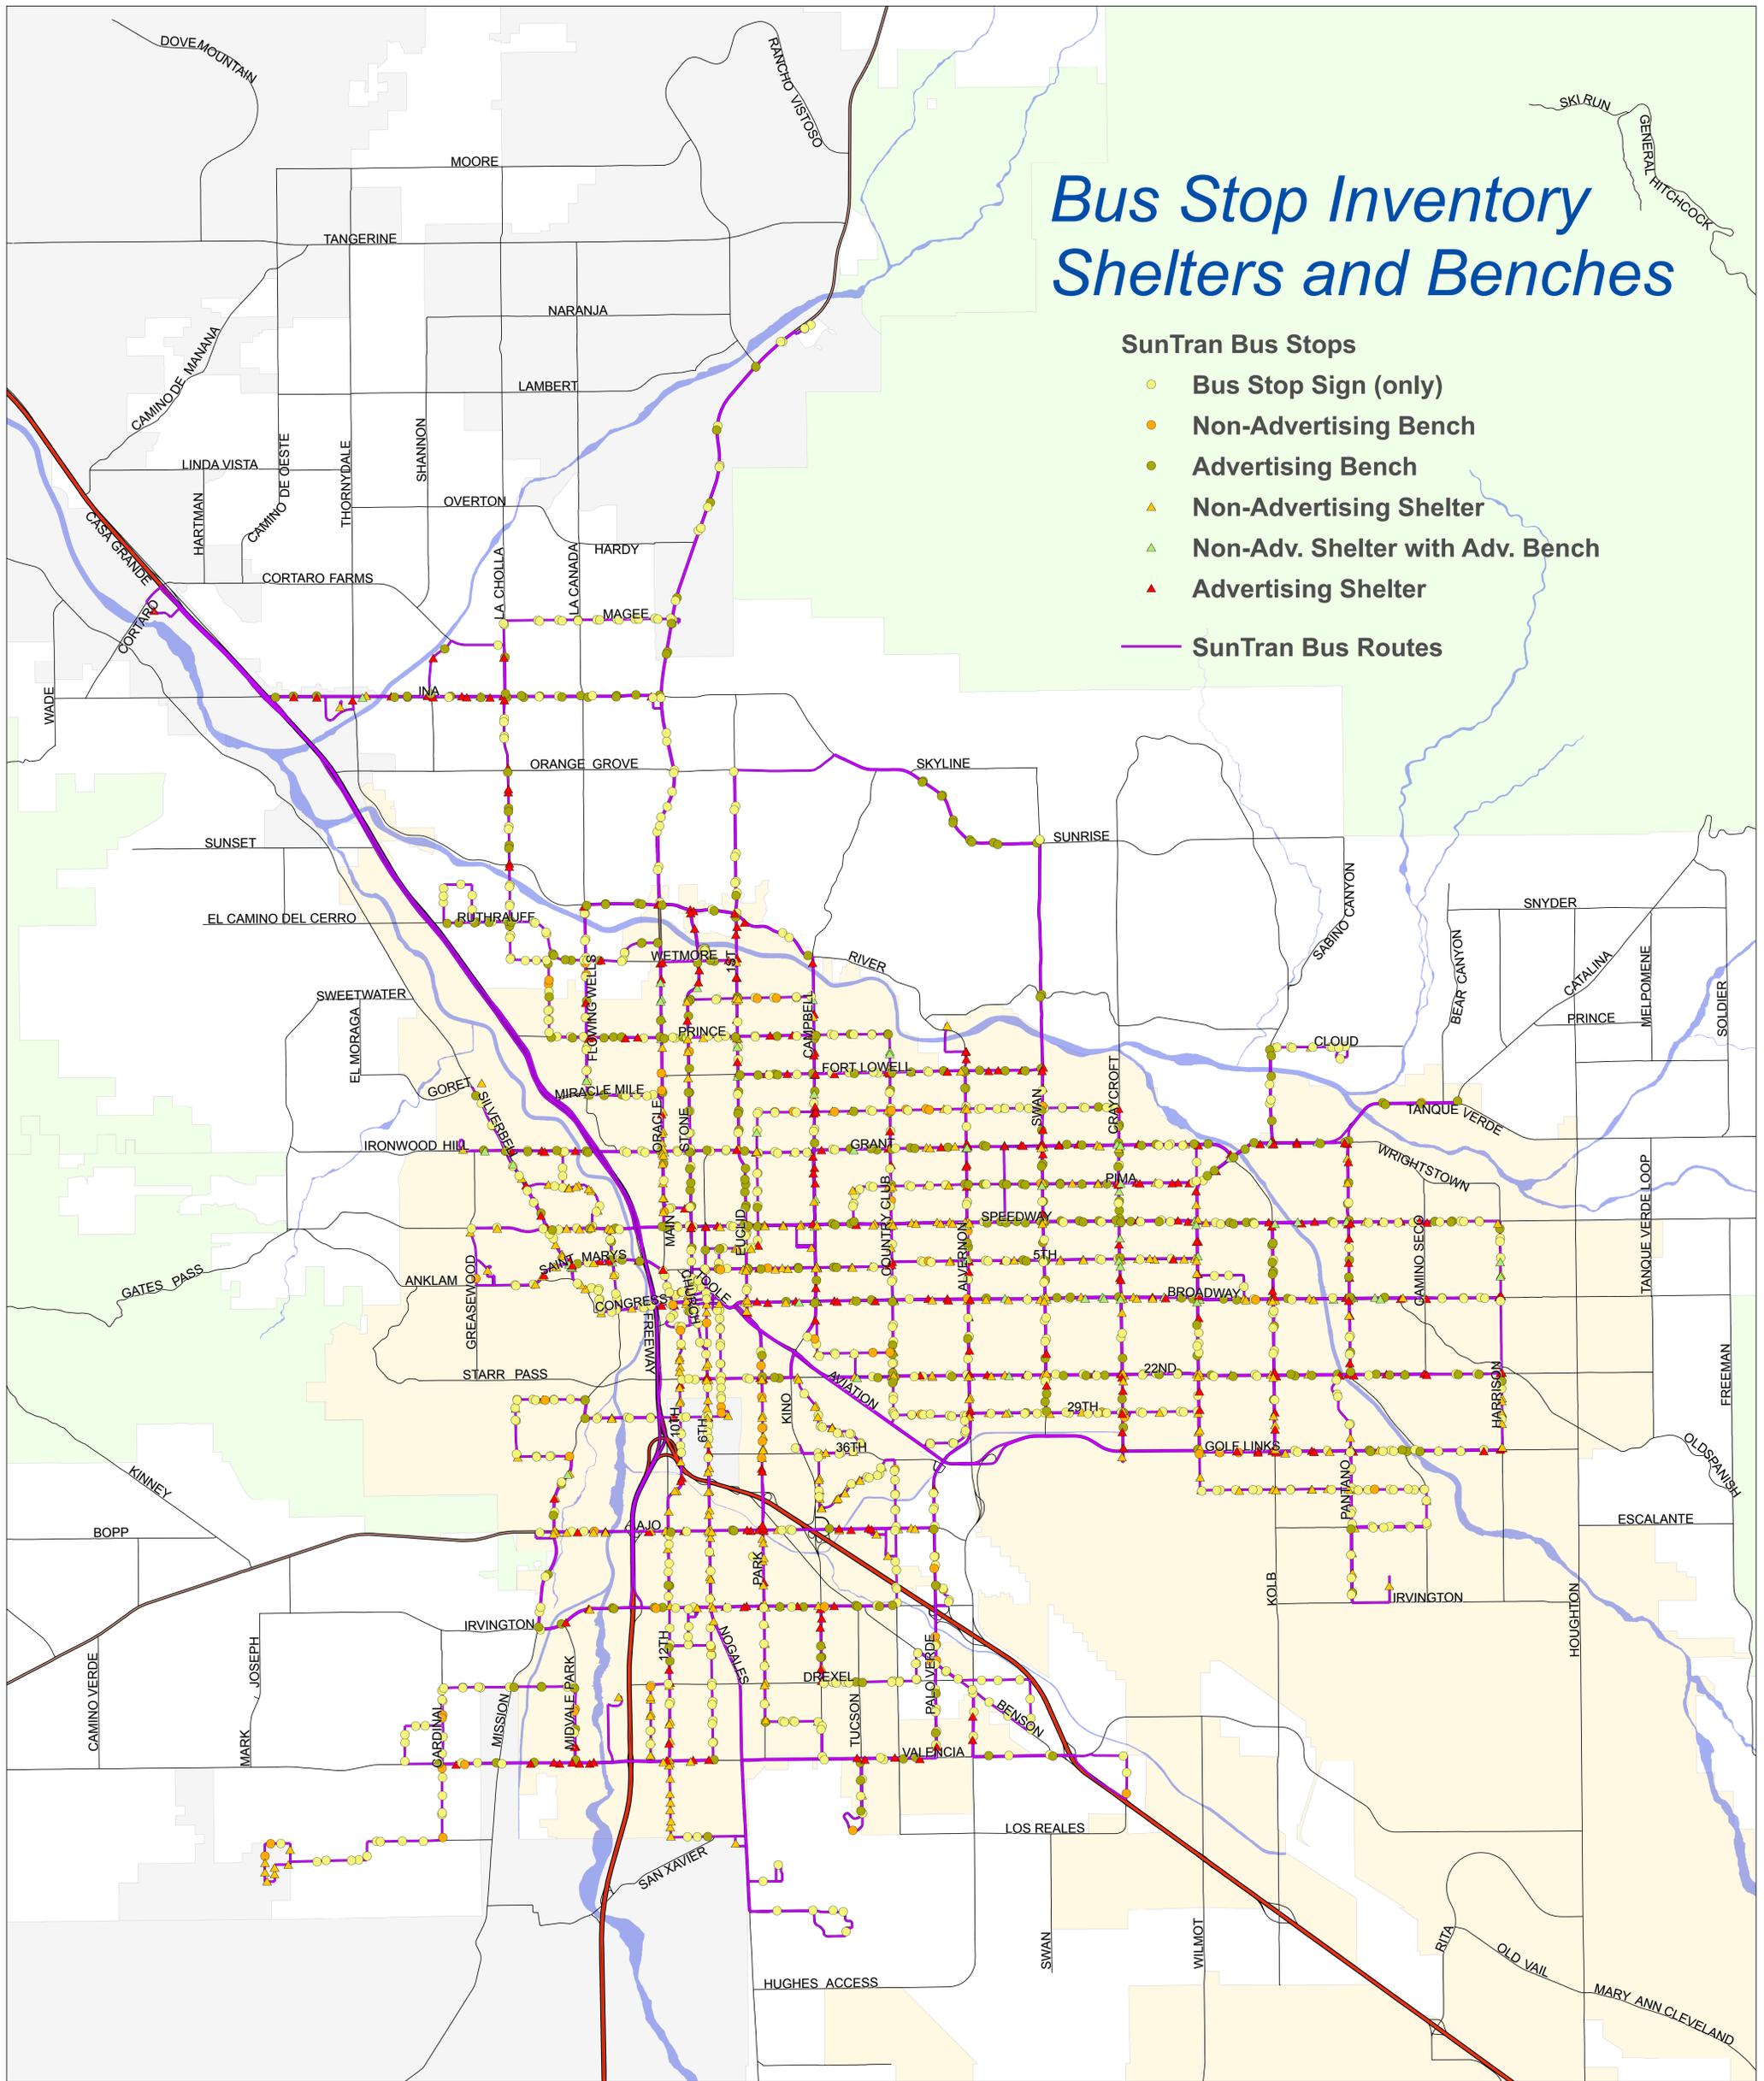
Bus Stop Inventory Shelters and Benches

Shelter and Benches, December 2008: This map illustrates stops with available seating either within a bus shelter or as freestanding benches. Bus stops without seating are shown with a bright yellow dot. Additionally, the map identifies those stops with and without advertising. The City of Tucson allows advertising at bus stops to pay for maintenance services such as trash collection and graffiti removal.

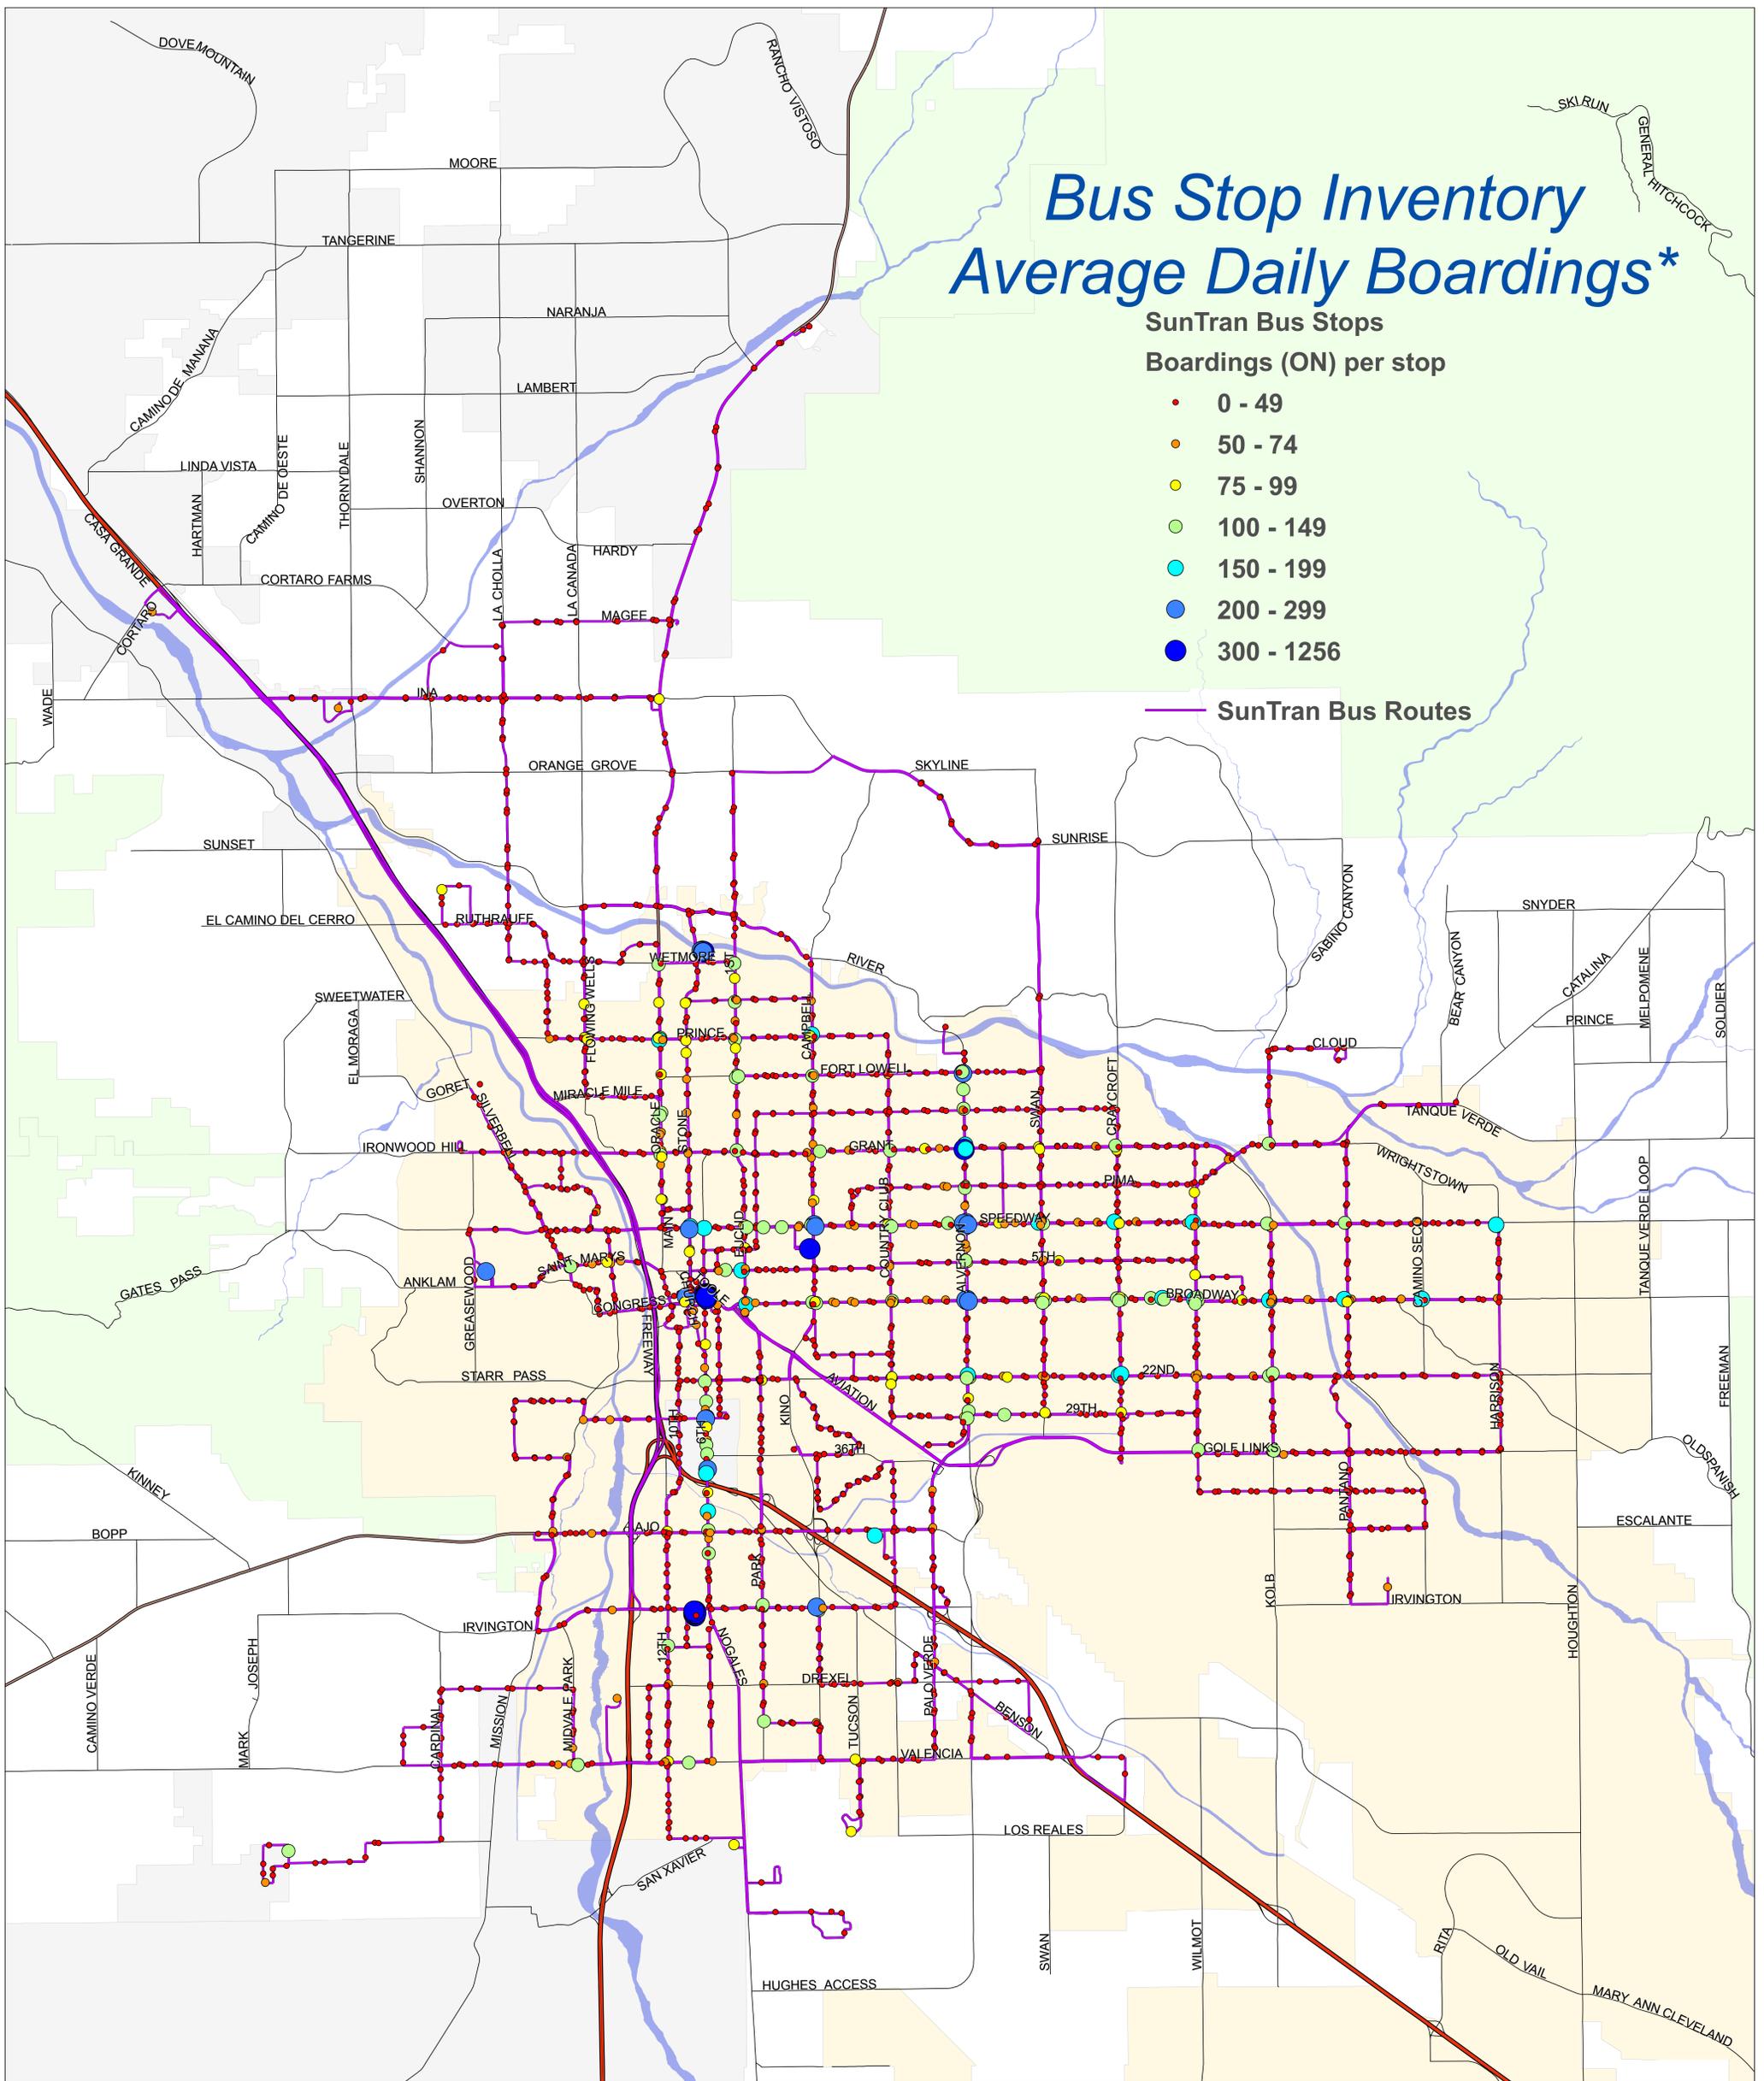
Bus Stop Inventory
Avg Daily Boardings*

Average Daily Boardings Map and Average Daily Ridership Map, December 2008: These two maps show the bus stops based on average daily boardings (on) and overall total ridership (on and off). High ridership stops are generally located at transfer points within the regional system and along major roadways. This data was compared to the data shown in the 5-Star ADA Accessibility Map to determine whether the stops with high total ridership were accessible to all bus users.

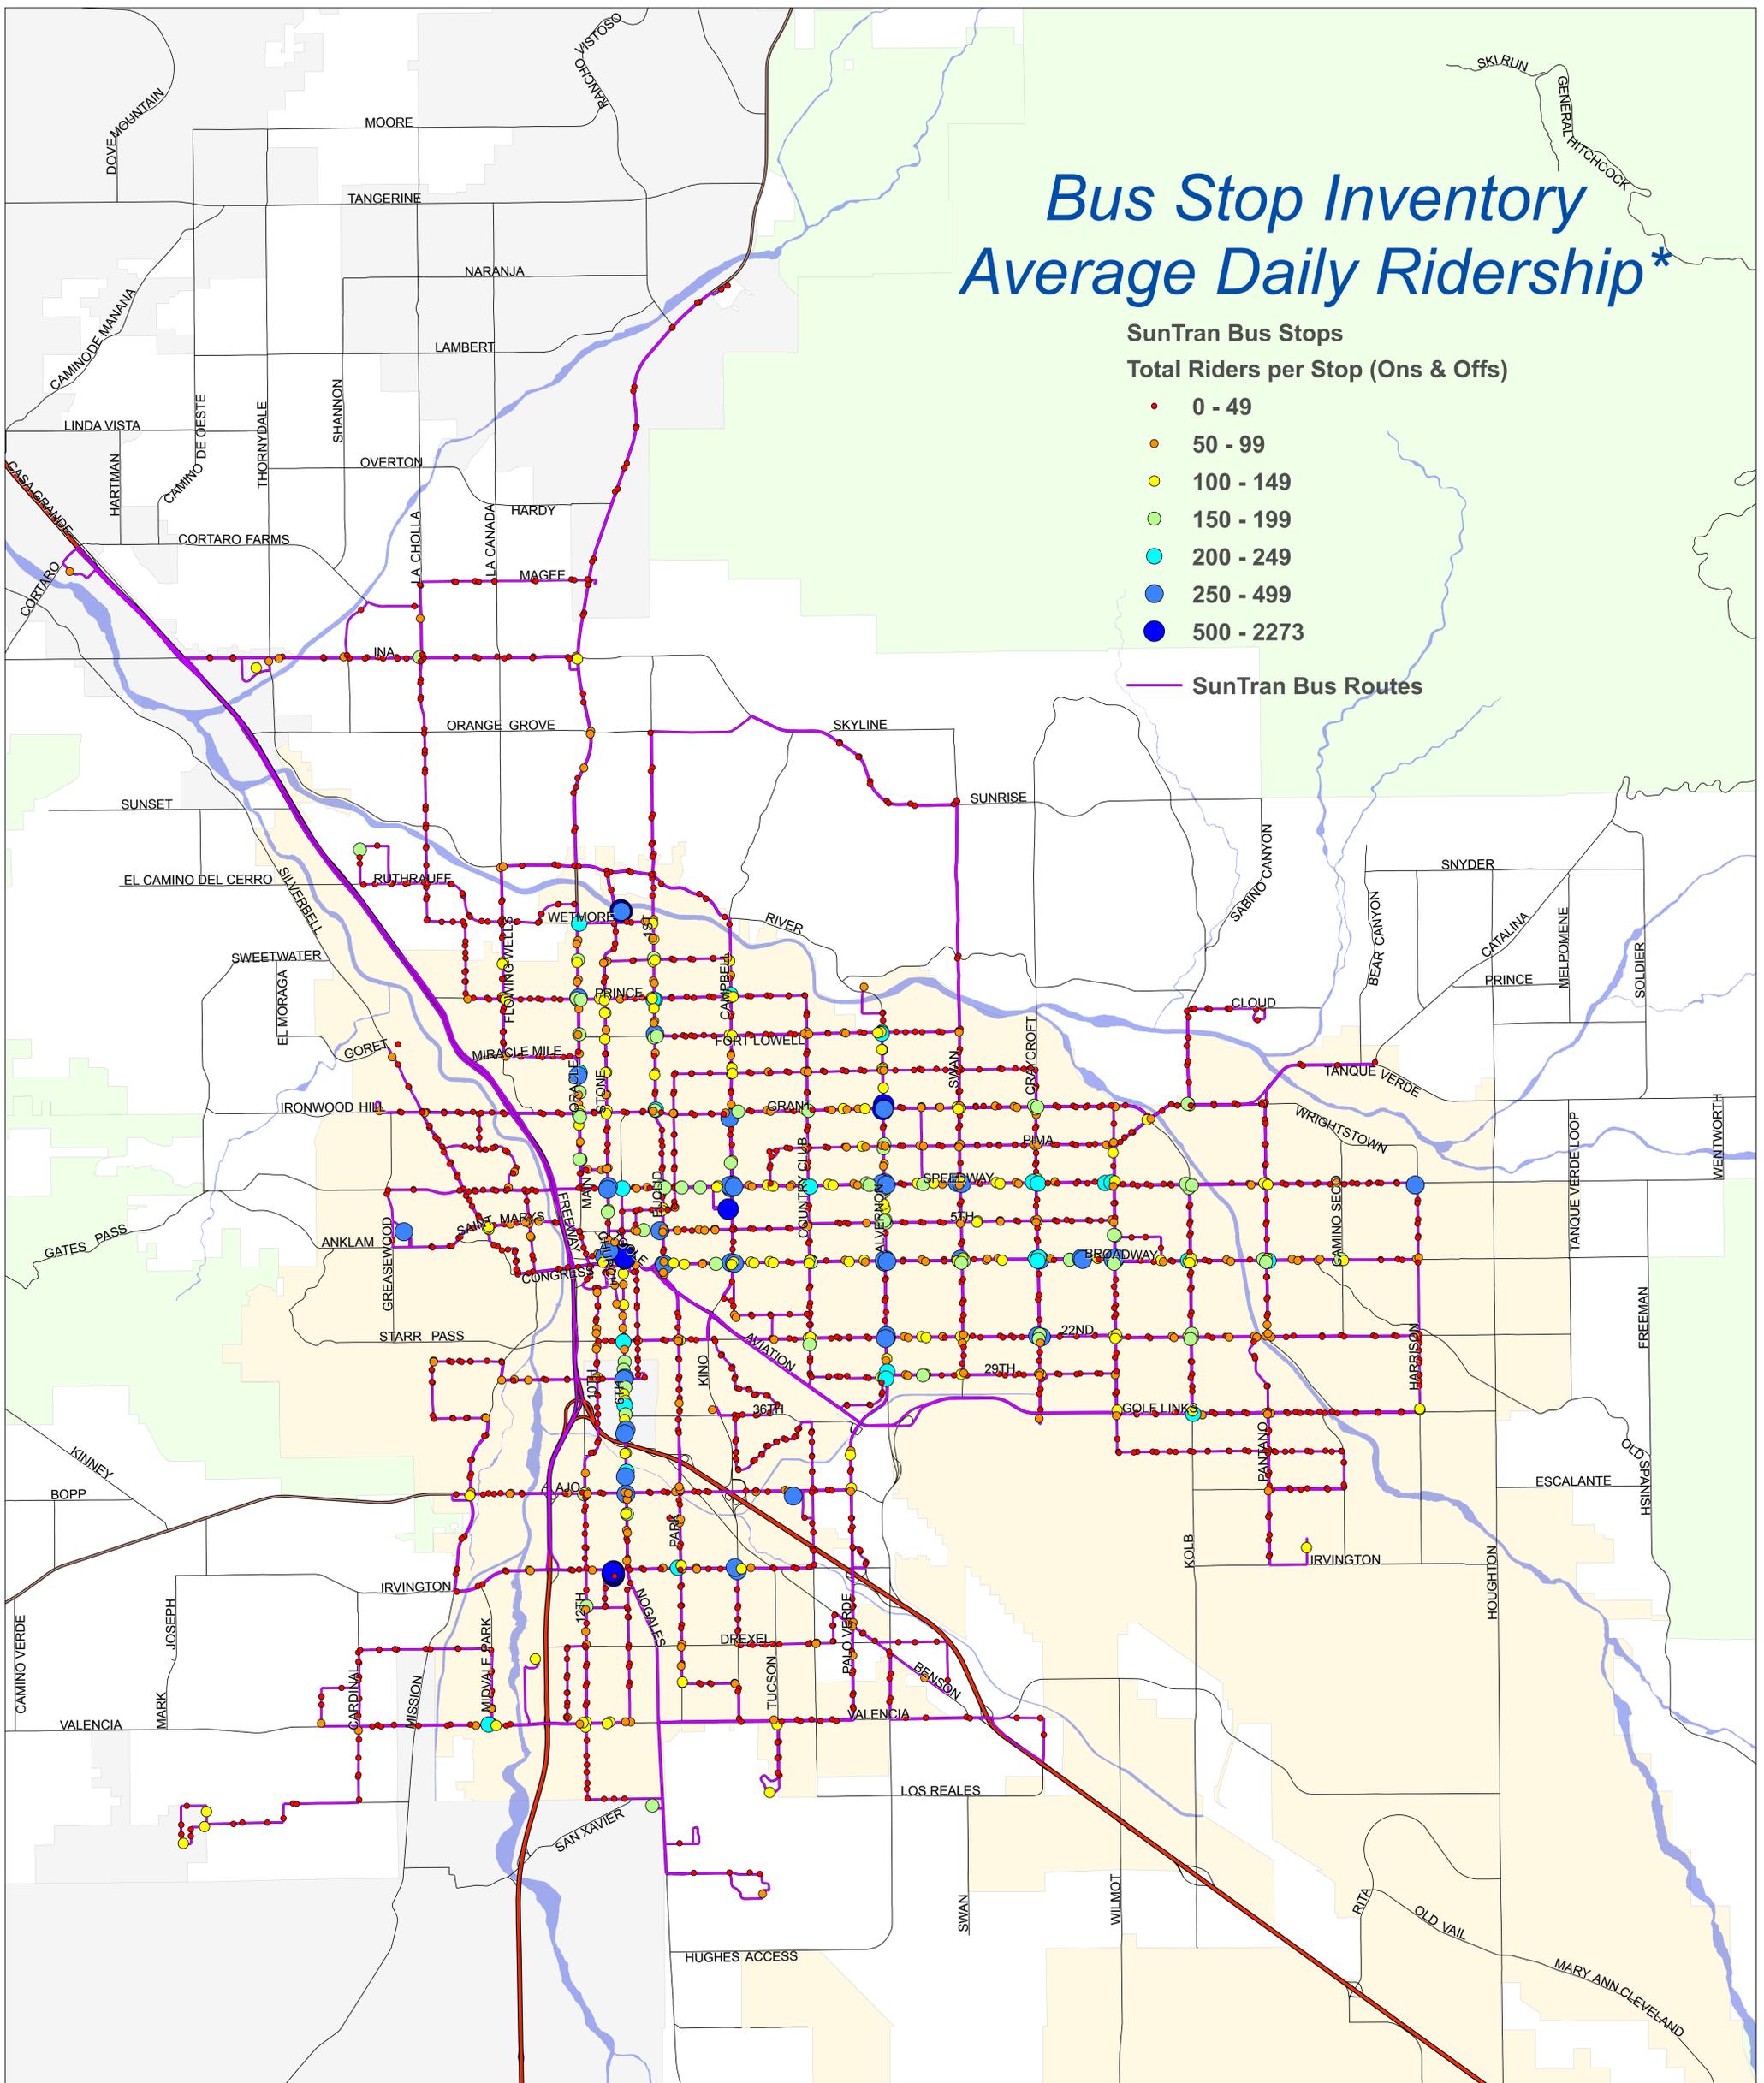
Bus Stop Inventory Avg Daily Ridership*

Total Riders per Stop
(Ons & Offs)
December 2008
