**PAVEMENT EVALUATION
TUCSON PAVEMENT RECONSTRUCTION PROGRAM
CALLE POLAR
TUCSON, ARIZONA**

December 9, 2015
Project No. 604817002

Subject: Pavement Evaluation
Tucson Pavement Reconstruction Program – Calle Polar
Tucson, Arizona

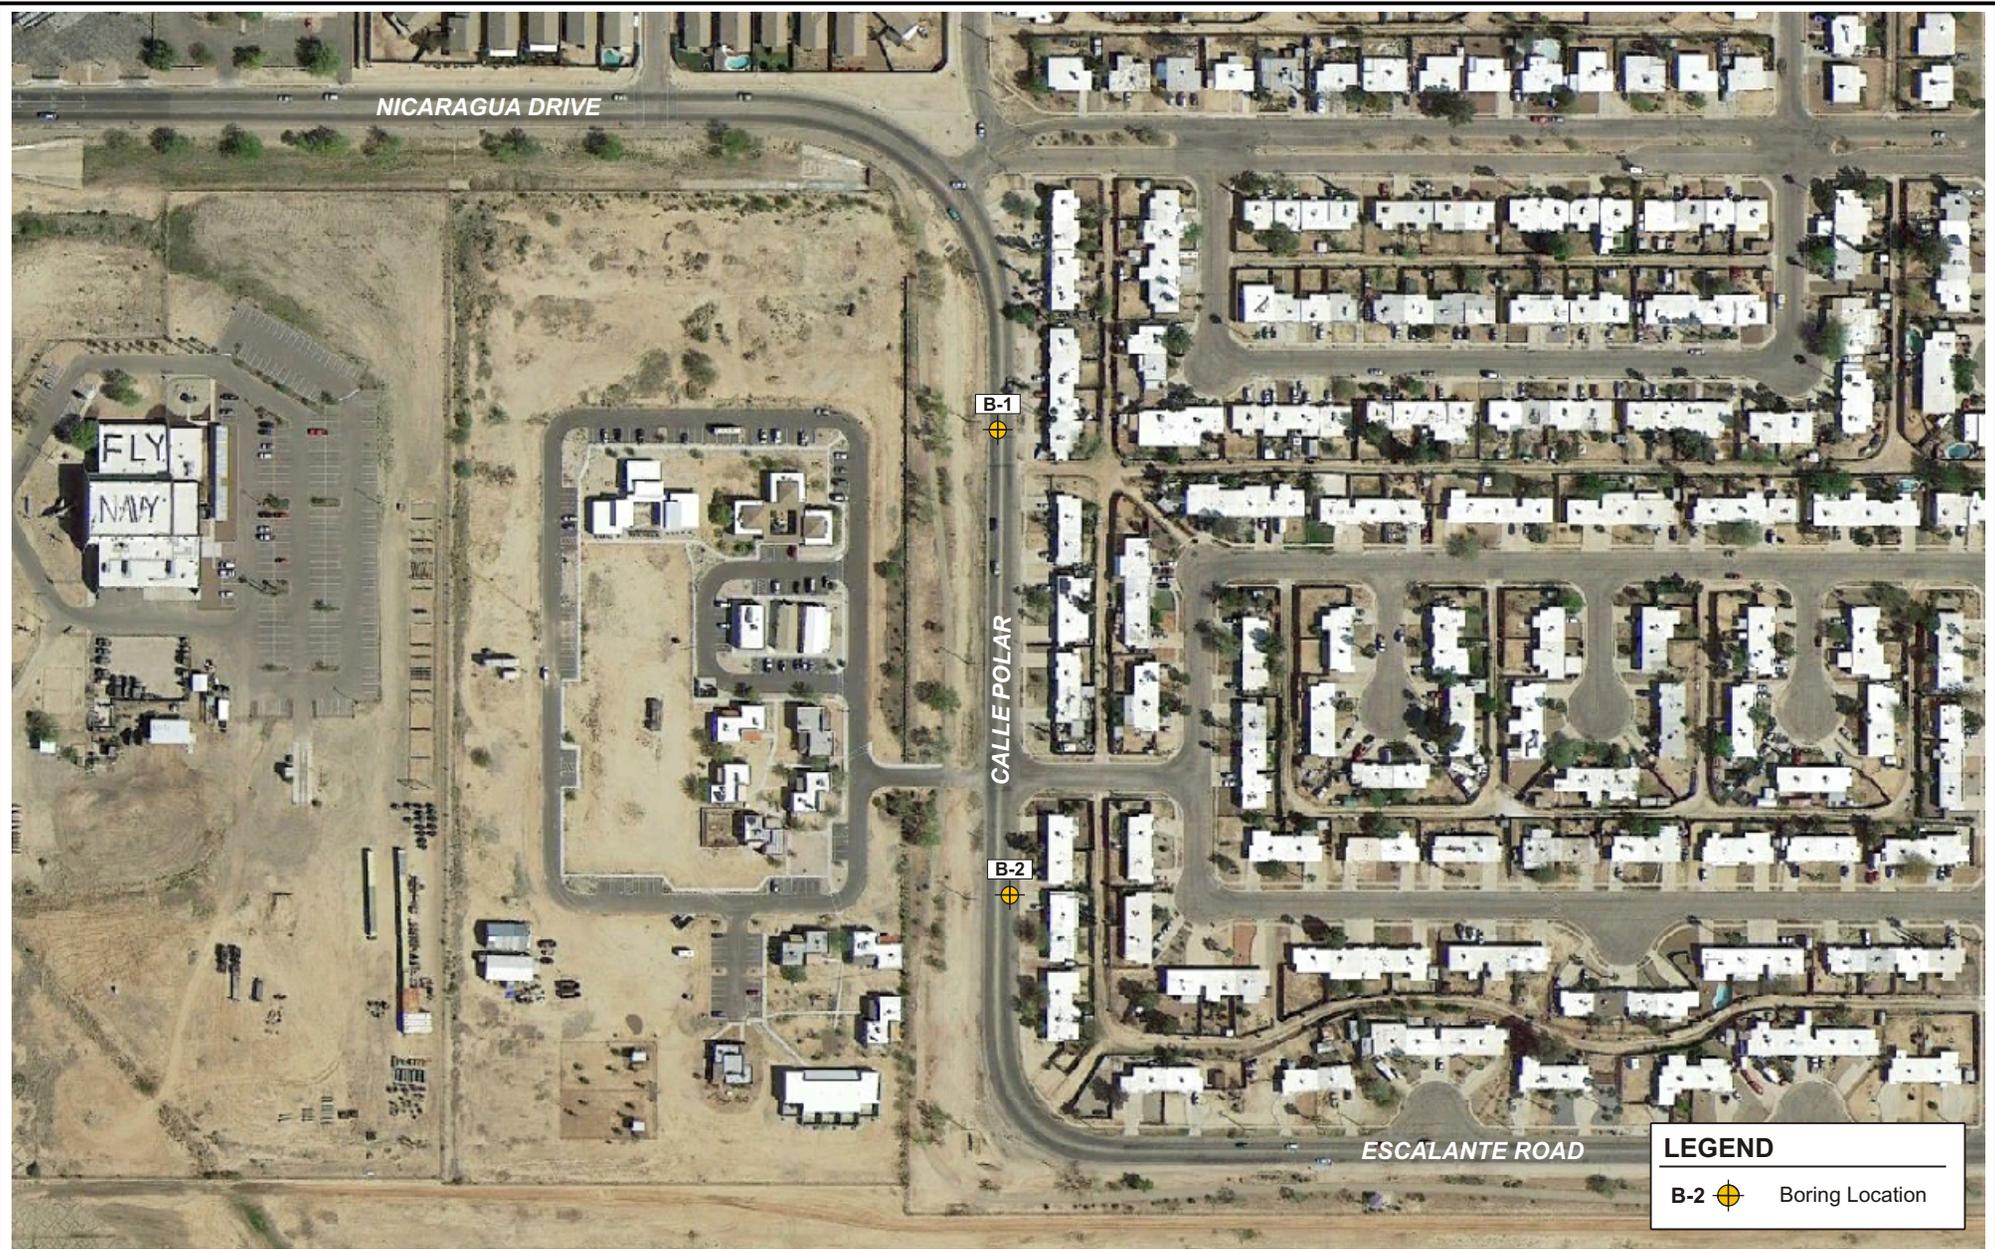
On September 28, 2015, Ninyo & Moore conducted a geotechnical exploration in order to evaluate the subsurface conditions and collect AC cores and soil samples for laboratory testing. Our evaluation consisted of coring the existing AC pavement, drilling, logging, and sampling two small-diameter borings, denoted as B-1 and B-2, utilizing a CME-45 truck-mounted drill rig equipped with hollow-stem augers. The borings extended to depths of approximately 3 feet bgs. The approximate locations of the borings are depicted on Figure 2.
