IRVINGTON LANDFILL, TUCSON, ARIZONA
ANNUAL ENVIRONMENTAL REPORT

Prepared for:
THE ARIZONA DEPARTMENT OF ENVIRONMENTAL QUALITY
SOLID WASTE PLAN REVIEW UNIT
AQUIFER PROTECTION PERMIT NO. 50044800.00

JANUARY THROUGH DECEMBER 2015

Prepared by:
City of Tucson
Environmental Services
P.O. Box 27210
Tucson, Arizona 85726-7210

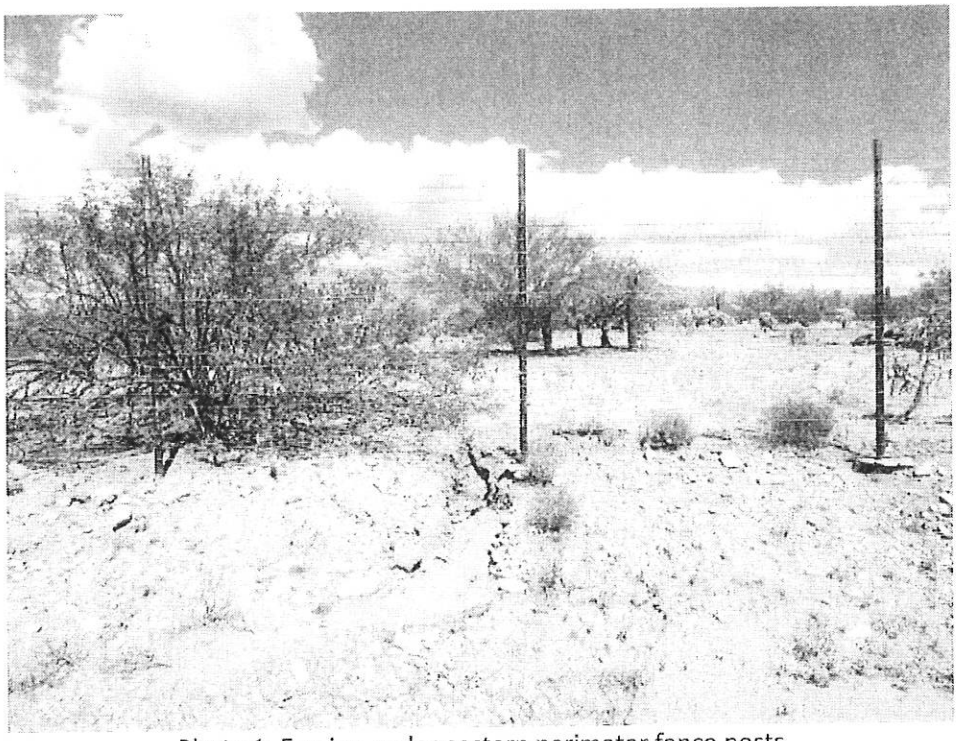
The perimeter security fence and gates at Irvington Landfill are generally in satisfactory condition and the perimeter of the landfill property is secure. One area of erosion was observed beneath the eastern perimeter fence (see Photo 1). Repair of this erosion is recommended to prevent collapse of the fence posts. The section of fencing spanning the Mesquite Ranch Wash along the northern and southern boundary of the property sometimes requires repair following major storm events (see photo 2 and 3). Continued monitoring of these sections is required.

Photo 1: Erosion under eastern perimeter fence posts

Photo 2: Northern Perimeter Fence at Mesquite Ranch Wash – "breakaway" section requires repair after major storm/flow events

Photo 3: Southern Perimeter Fence at Mesquite Ranch Wash – "breakaway" section requires repair after major storm/flow events

- Rill erosion on the slope of the retention basin should be repaired following the rainy season.
- The erosion under the fence and fence posts along the eastern perimeter should be repaired following the rainy season.
- The eroded portion of the south perimeter road east of the wash should be repaired following the rainy season.
- The perimeter fence may require periodic maintenance at the wash crossings following major rainfall events.
- The landfill cap adjacent to Mesquite Ranch Wash must be monitored for future erosion.

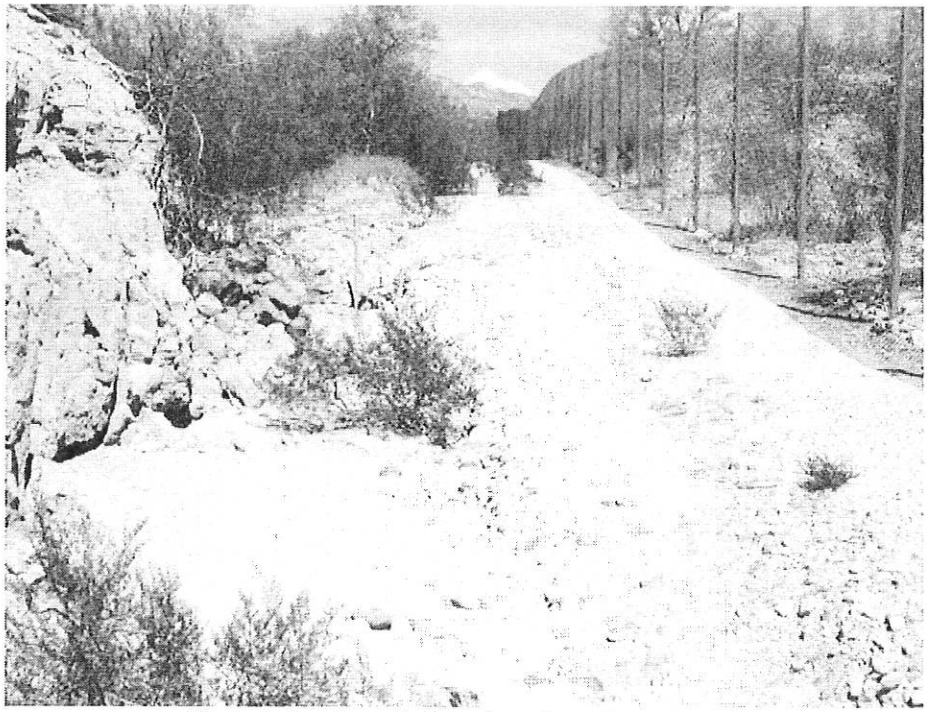
Photo 4: Erosion of edge of south perimeter road

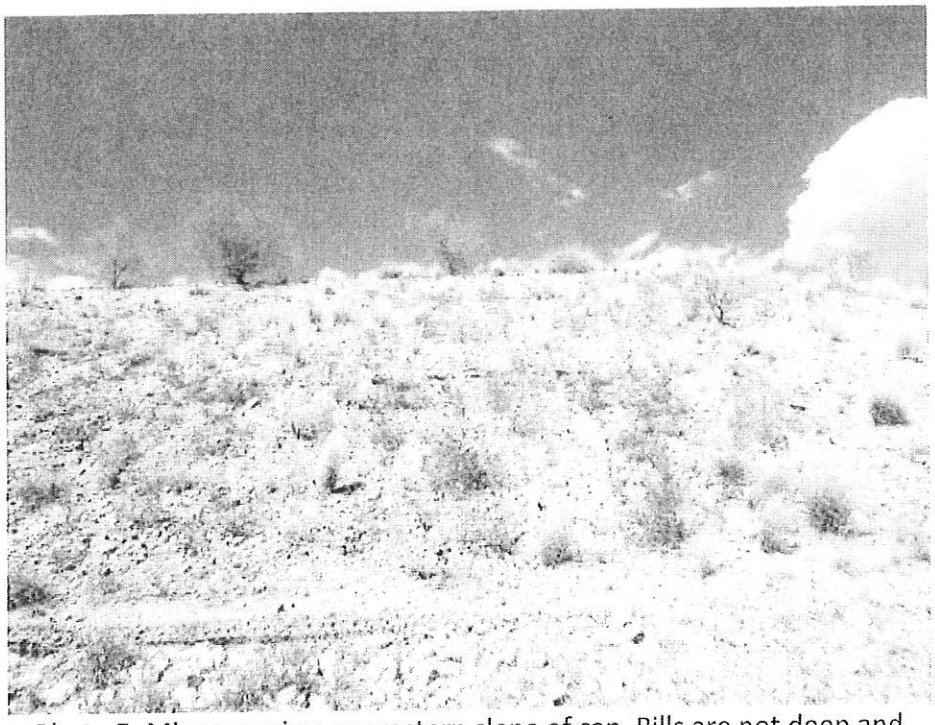
The existing stormwater controls are in good condition. Minor rill erosion is present along the western boundary of the landfill cap above Mesquite Ranch Wash drainage (see photo 5), but these rills are not deep and appear to be stable. This area will continue to be monitored during subsequent inspections and repairs will be scheduled if necessary. No repairs are recommended at this time.

Photo 5: Minor erosion on western slope of cap. Rills are not deep and appear stable. This area will be monitored going forward.

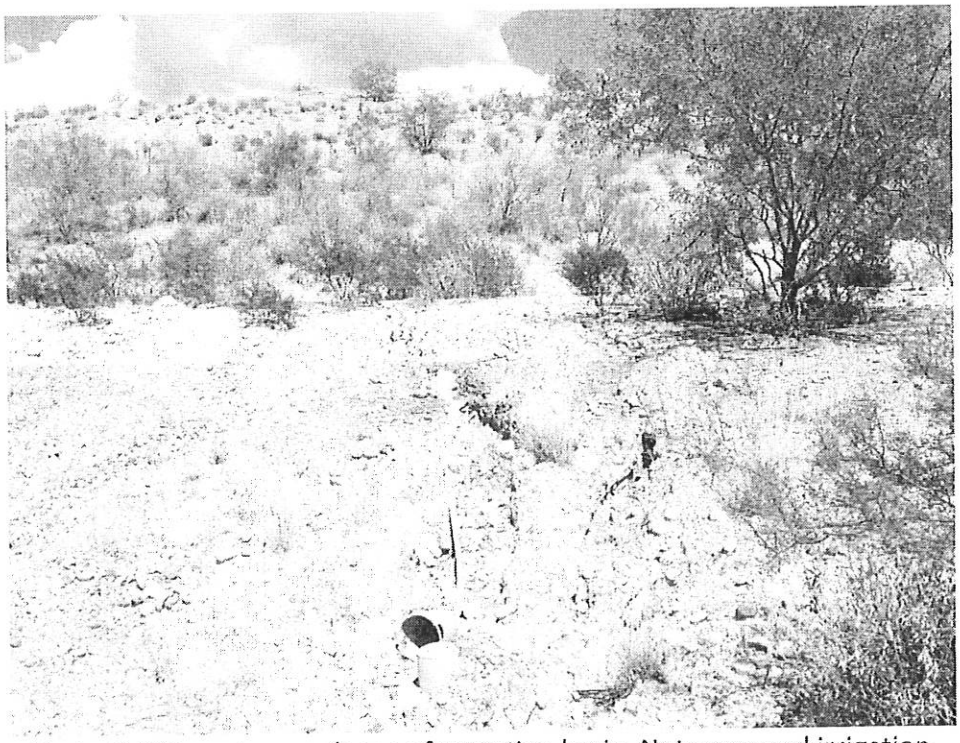
The stormwater retention basin is functioning properly, however significant rill erosion was observed on the slopes of the basin (see photos 6 and 7). In some areas the subsurface irrigation piping has been exposed in the eroded areas. These areas should be scheduled for repair following the summer rainy season.

Photo 6: Rill erosion on slopes of retention basin. Note exposed irrigation.

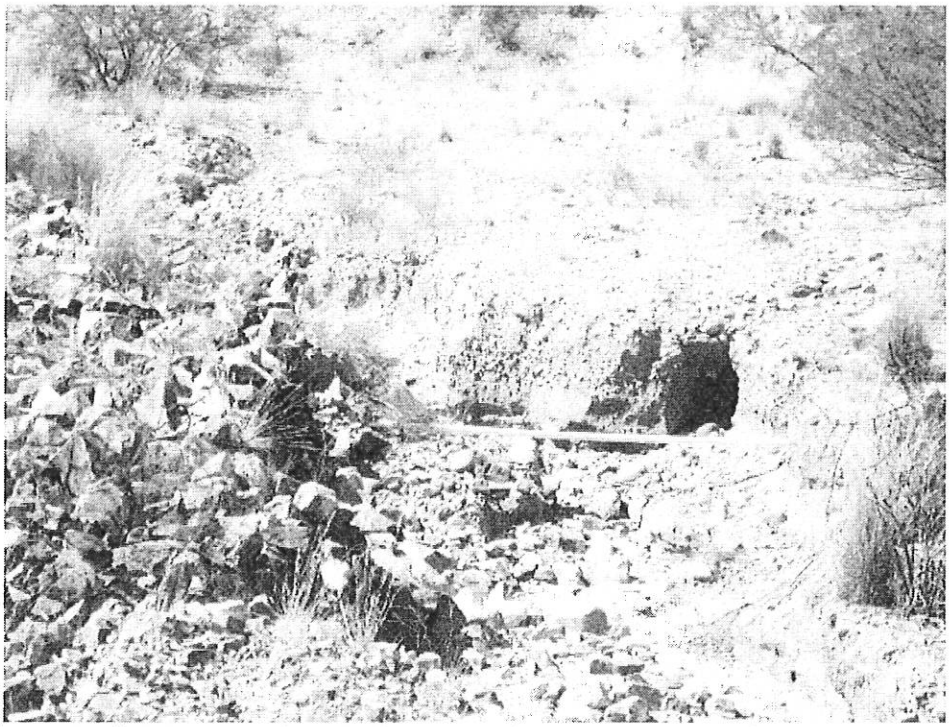
Photo 7: Rill erosion on slopes of retention basin. Note exposed irrigation piping.

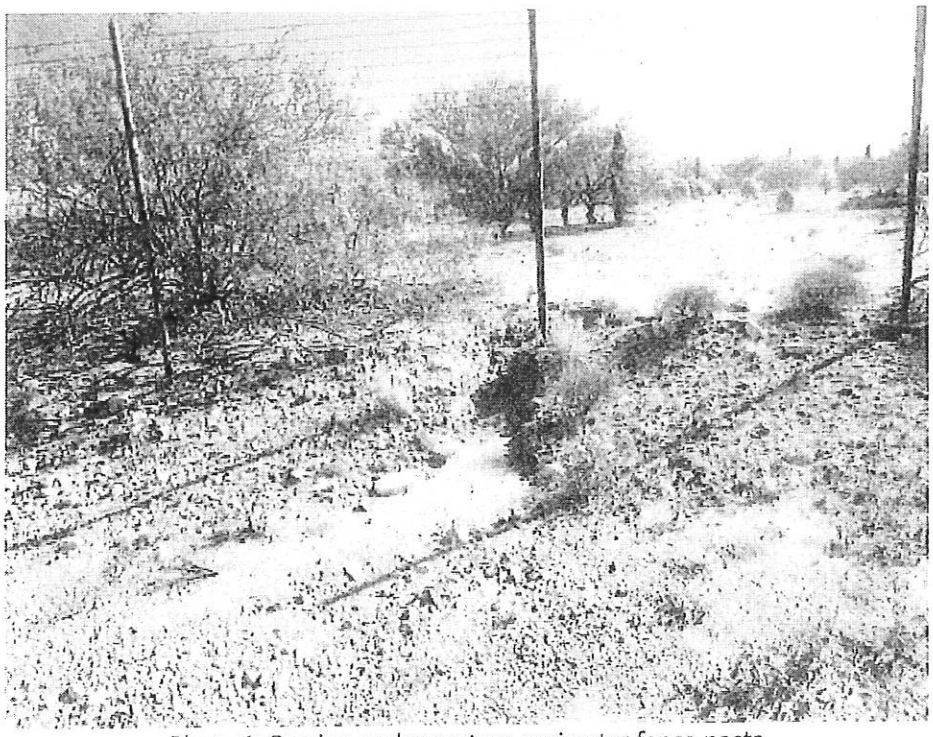
The perimeter security fence and gates at Irvington Landfill are generally in satisfactory condition and the perimeter of the landfill property is secure. One area of erosion was observed beneath the eastern perimeter fence (Photo 1). Repair of this erosion is recommended to prevent collapse of the fence posts. The section of fencing spanning the Mesquite Ranch Wash along the northern and southern boundary of the property sometimes requires repair following major storm events (Photos 2 and 3). Continued monitoring of these sections is required.

Photo 1: Erosion under eastern perimeter fence posts

Photo 2: Northern Perimeter Fence at Mesquite Ranch Wash – "breakaway" section requires repair after major storm/flow events

Photo 3: Southern Perimeter Fence at Mesquite Ranch Wash – "breakaway" section requires repair after major storm/flow events

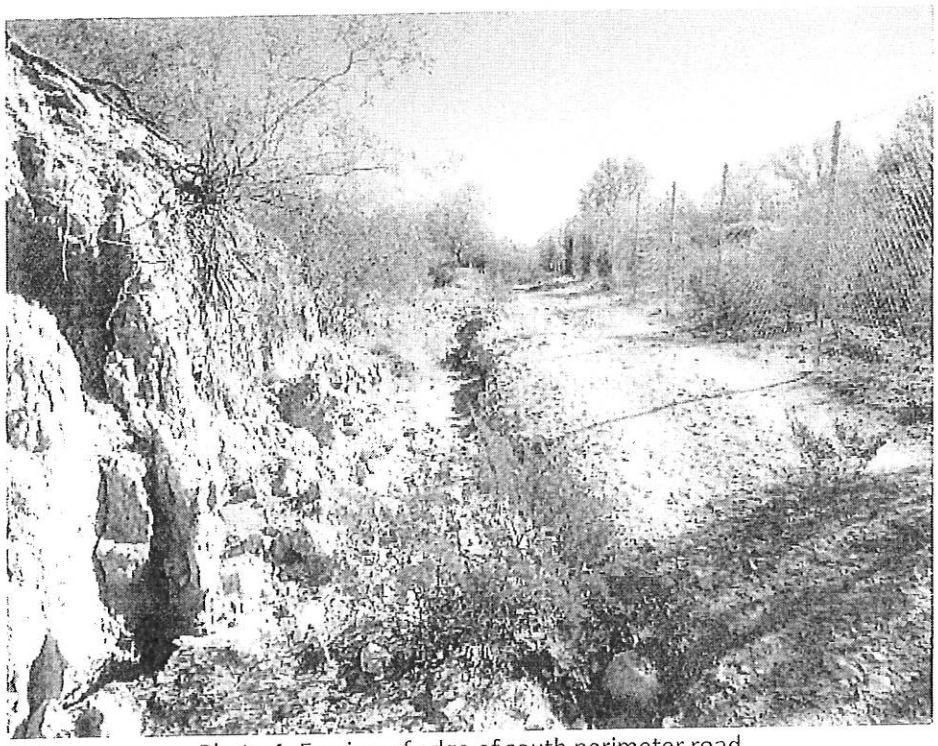
A portion of the south boundary road approaching the wash shows erosion and was recommended for repair in the last quarterly report (Photo 4); the area is actually somewhat improved since the last inspection due to sloughing and deposition of material onto the roadway but should still be repaired when equipment is brought in to repair other erosion on the landfill.

A portion of the west boundary road shows substantial erosion due to rainfall runoff. Landfill irrigation piping is exposed in the area and continued rainfall erosion may make this roadway impassable (Photos 5, 6, 7). Repair of the erosion in this area is recommended.

Photo 4: Erosion of edge of south perimeter road

Photo 5: Erosion on west perimeter road

Photo 6: Erosion on west perimeter road

- Rill erosion and exposure of inactive irrigation system piping on the slope of the retention basin was again observed. Repair of these areas is considered to be at the discretion of COT-ES.
- The erosion under the fence and fence posts along the eastern perimeter should be repaired.
- The eroded portion of the west perimeter road east of the wash should be repaired. This road may become impassable with future rains. While equipment is on site to make this

repair, the south boundary road approaching Mesquite Ranch Wash can also be repaired.

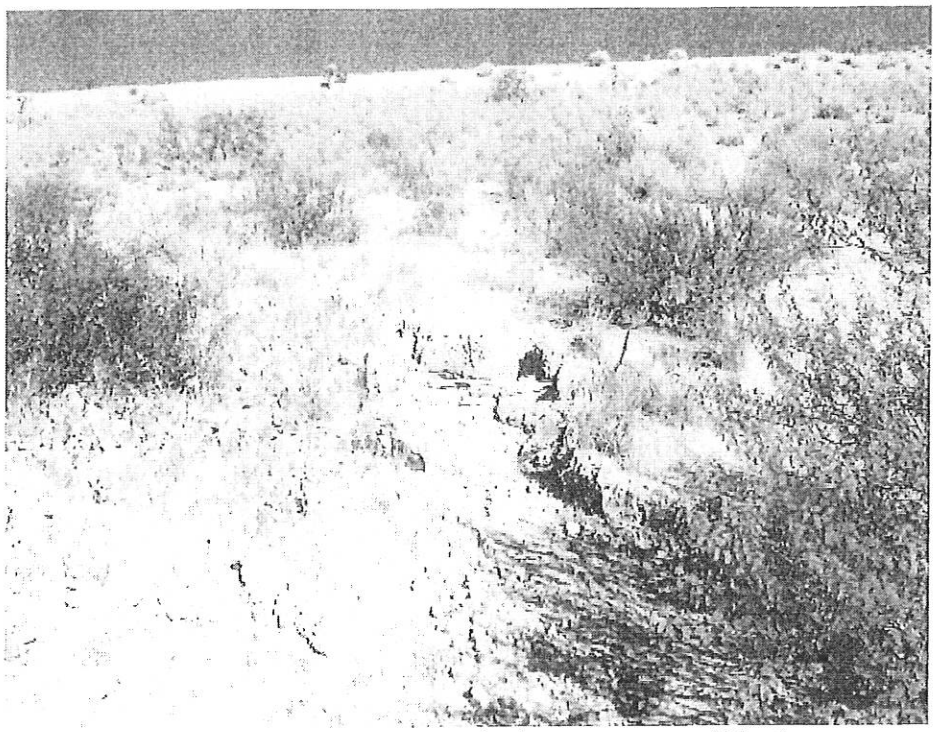
The stormwater retention basin is functioning properly, however significant rill erosion continues to be observed on the slopes of the basin (Photos 10, 11). In some areas the subsurface irrigation piping has been exposed in the eroded areas. In the past, these areas of recurring erosion were repaired following the summer rainy season. The basin does not overlay trash and the irrigation system is no longer in use so repair of these areas is at the discretion of COT-ES.

Photo 10: Erosion in stormwater basin – note exposed irigation

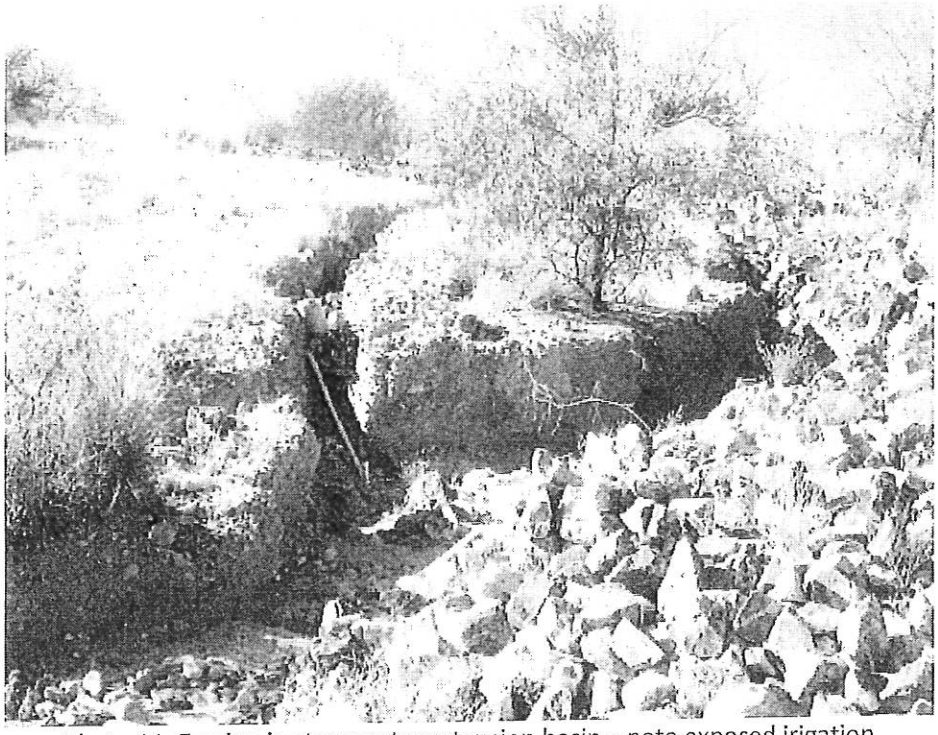
Photo 11: Erosion in stormwater retension basin – note exposed irigation

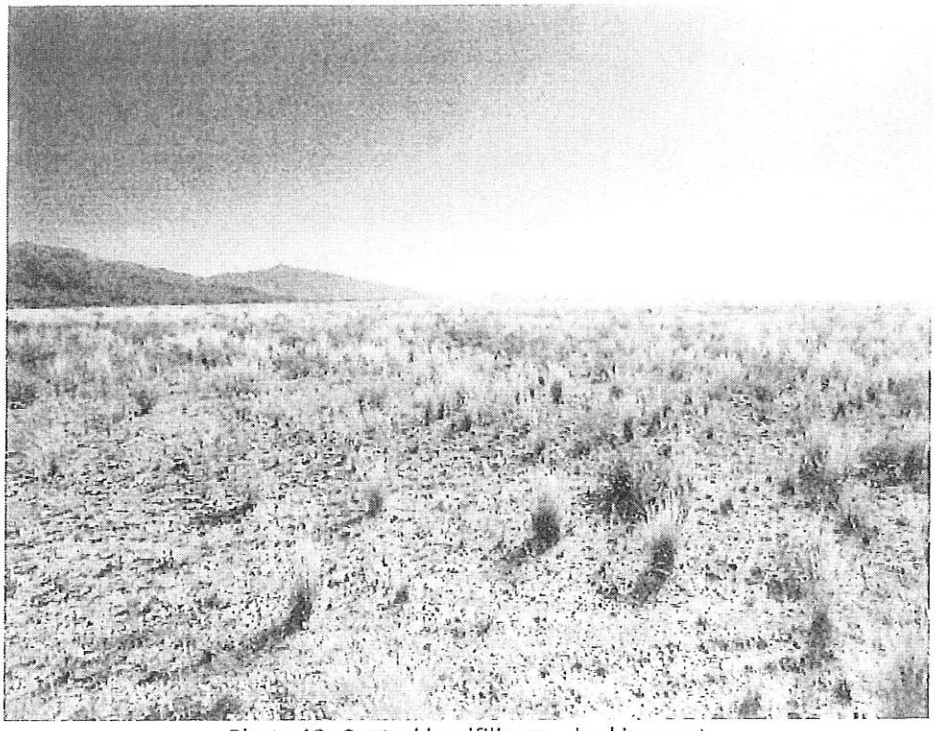
The earthen cap at Irvington landfill is in good condition with healthy vegetative cover (Photos 12, 13, 14).

Photo 12: Landfill cap – looking north

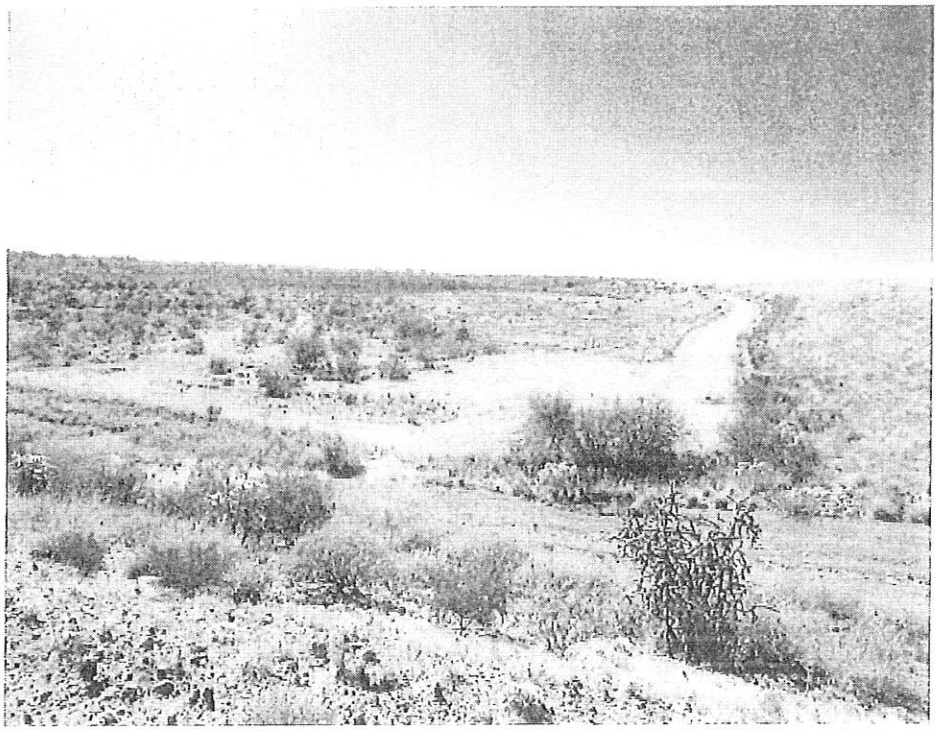
Photo 13: Central landfill cap – looking east

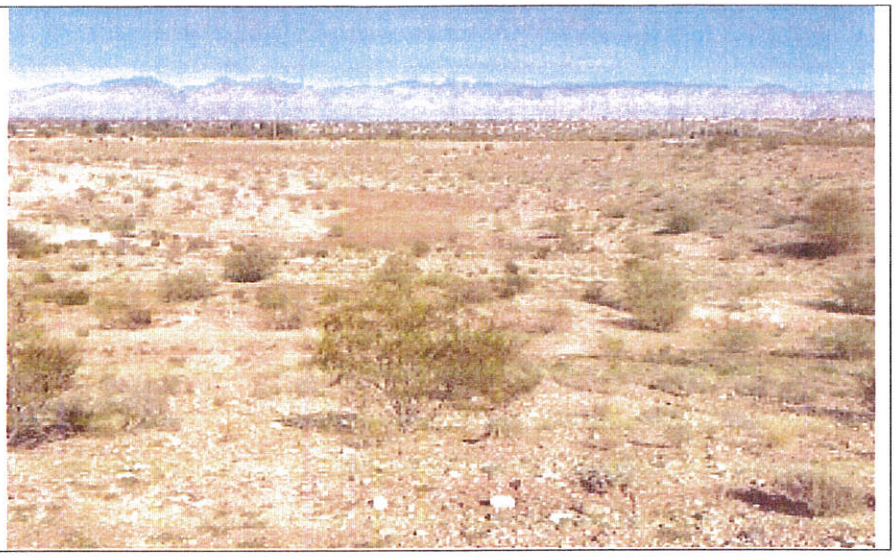
Photo #1 **Date: 2/2/2015**

Retention basin, view to the North
