ARIZONA STATE HISTORIC PROPERTY INVENTORY

Brief Statement of Proposal

PROJECT: PONGRATZ RENOVATON / ADDITION

ADDRESS:
A&A PONGRATZ RESIDENCE
903 NORTH 5th AVE
TUCSON, AZ. 85705

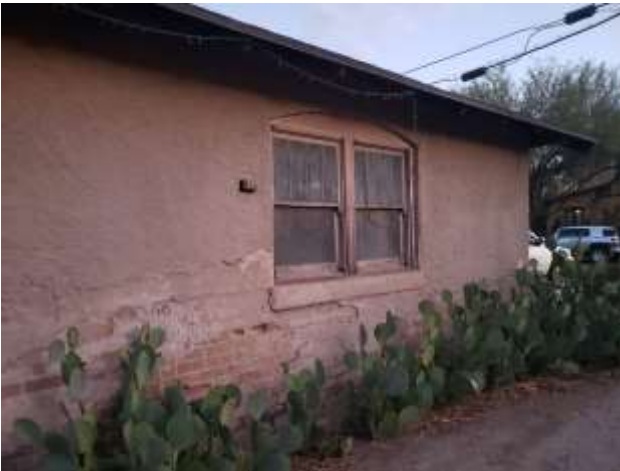
East face south end of guest house

The exposure to the elements started deteriorating the existing clay brick walls and stucco.

J& M Stucco contractor was called in to repair and re-stucco the whole guest house. A one inch foam board was added to smooth out failing walls and add an insulation value of R7.

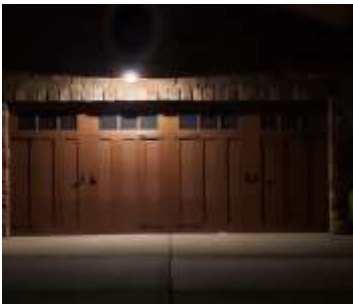
The garage door was continuously broken into for decades and is damaged beyond repair.

Example of proposed replacement garage door

The garage door manufacturer is Clopay, Coachman Collection 8ft x 7ft, model# CXU13_SW_SQ24 – Timeless Carriage House Design.

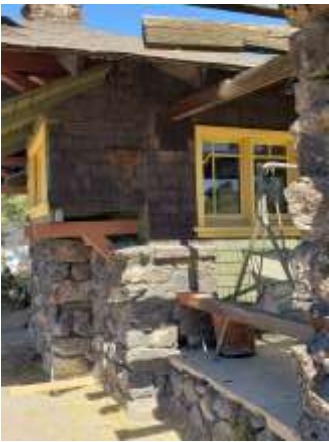
Original positioning of gutter and imprint of water catch on east face south end of house

We are reinstalling the gutter and water catch to the original specifications.

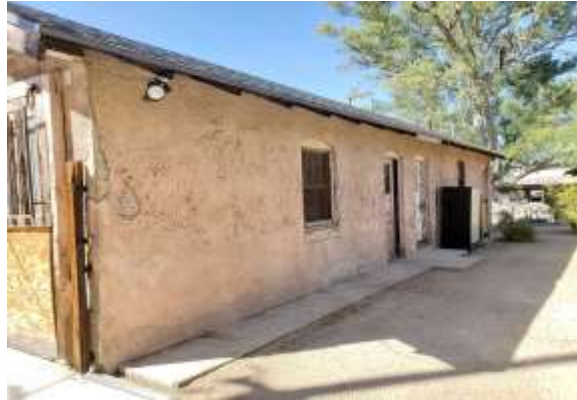
Inner court yard Guest House / Garage East Elevation

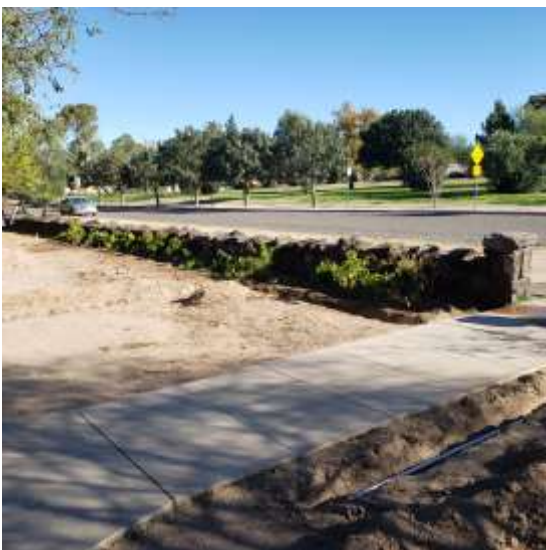
North East view from the house

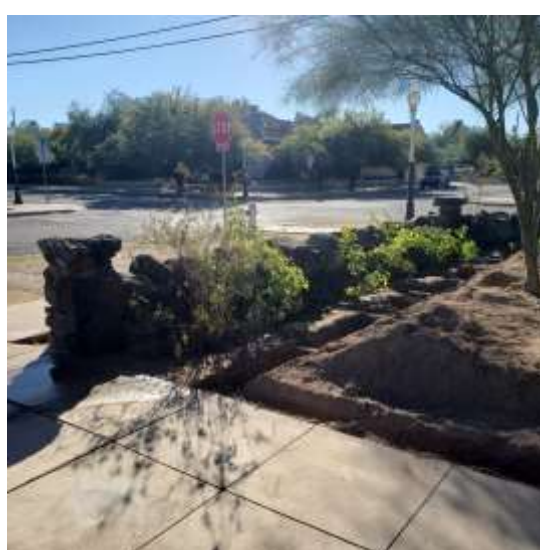
South East view from the house

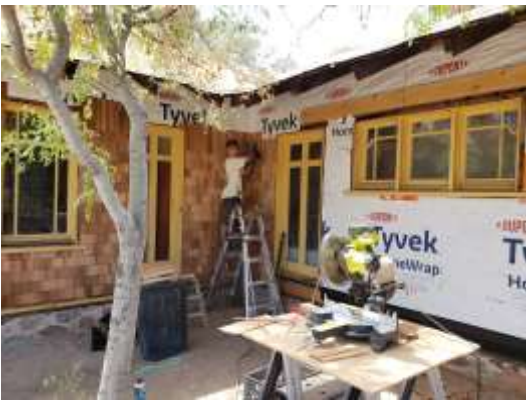
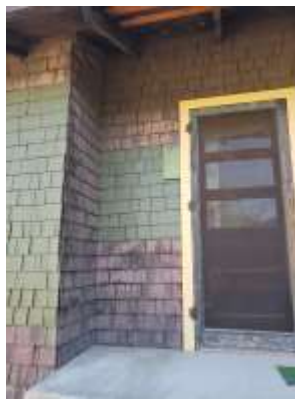
Example of security door made by Precision Screen and Security Products

The building is located in a high crime area therefore safeguards need to be placed on the property. We are proposing security doors to be installed on the Master Bedroom and Hallway doors located on the south Ramada and also the pocket door off the kitchen on the north side.
