# HISTORIC HOUSES DOCUMENTATION AND RELOCATION PLAN

WEST UNIVERSITY NEIGHBORHOOD  
SPEEDWAY BLVD. AND EUCLID AVE.  
TUCSON, AZ

MARCH 2022

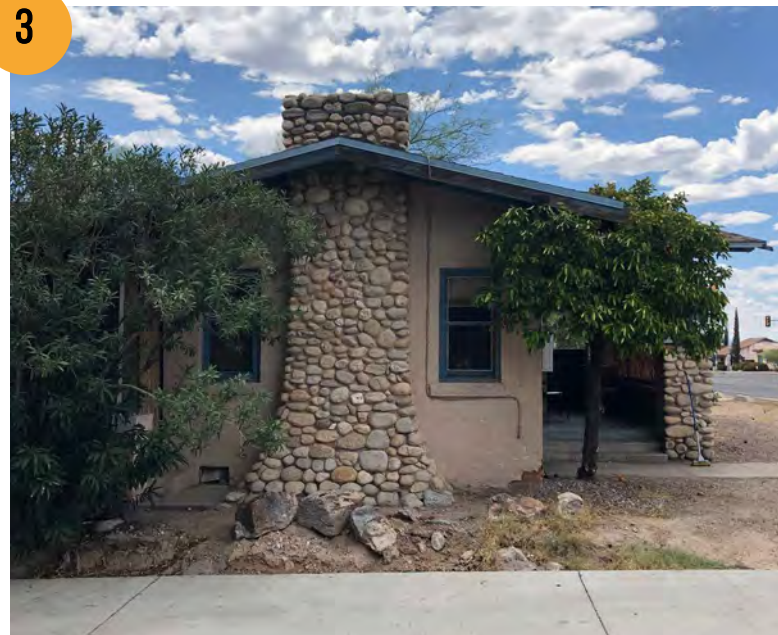
East Elevation featuring cobblestone chimney

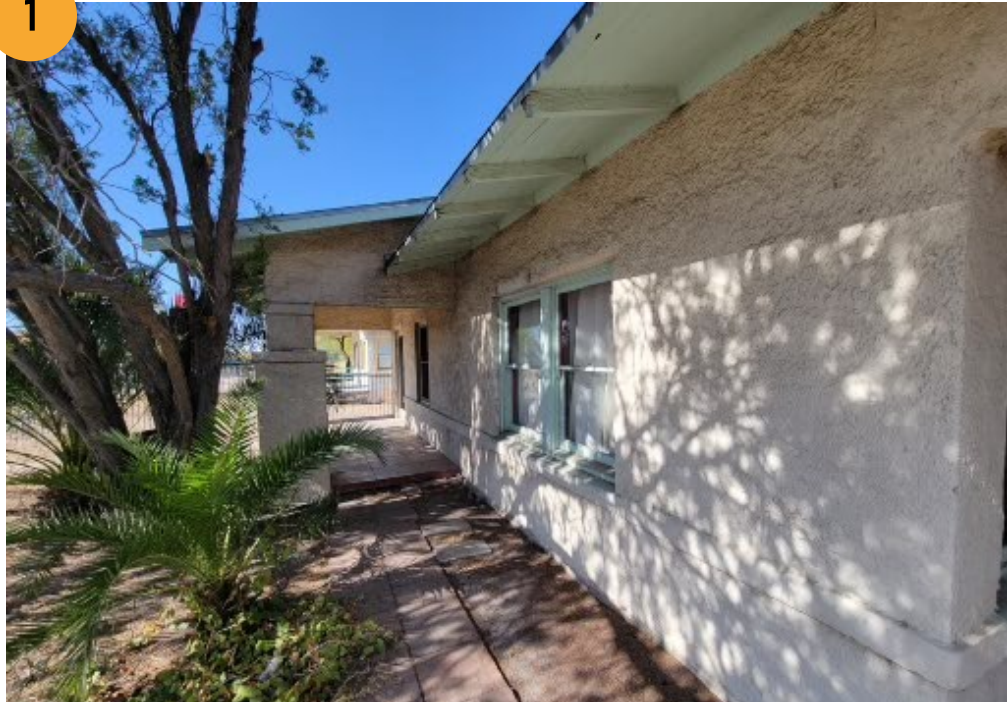
1

Front - West Elevation (view looking north)

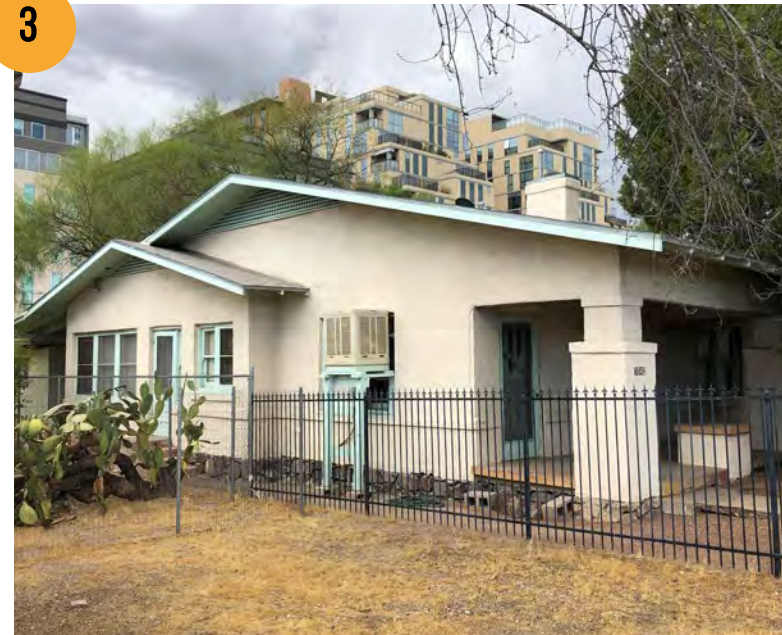
3

North Elevation (looking southeast)

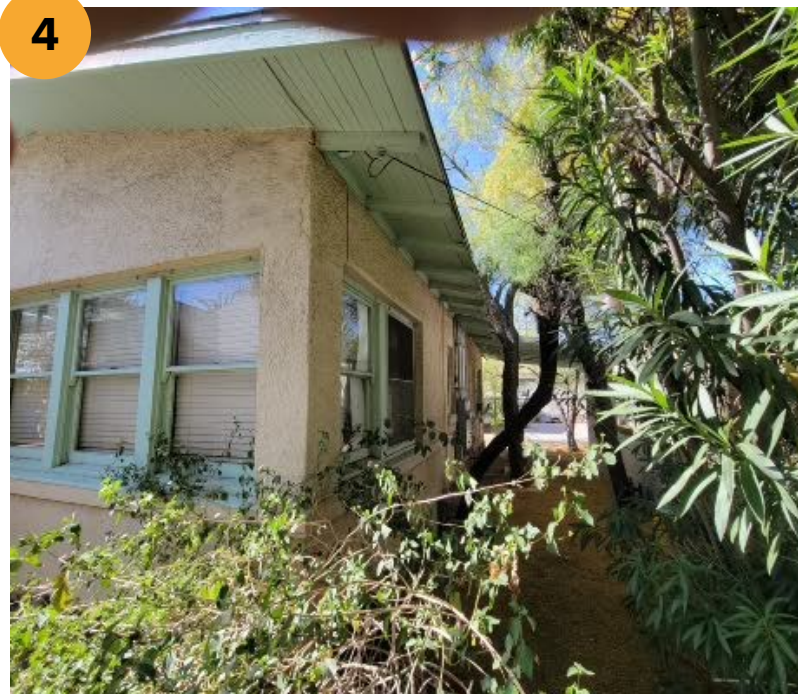
4

Southeast Corner, east (rear) elevation.

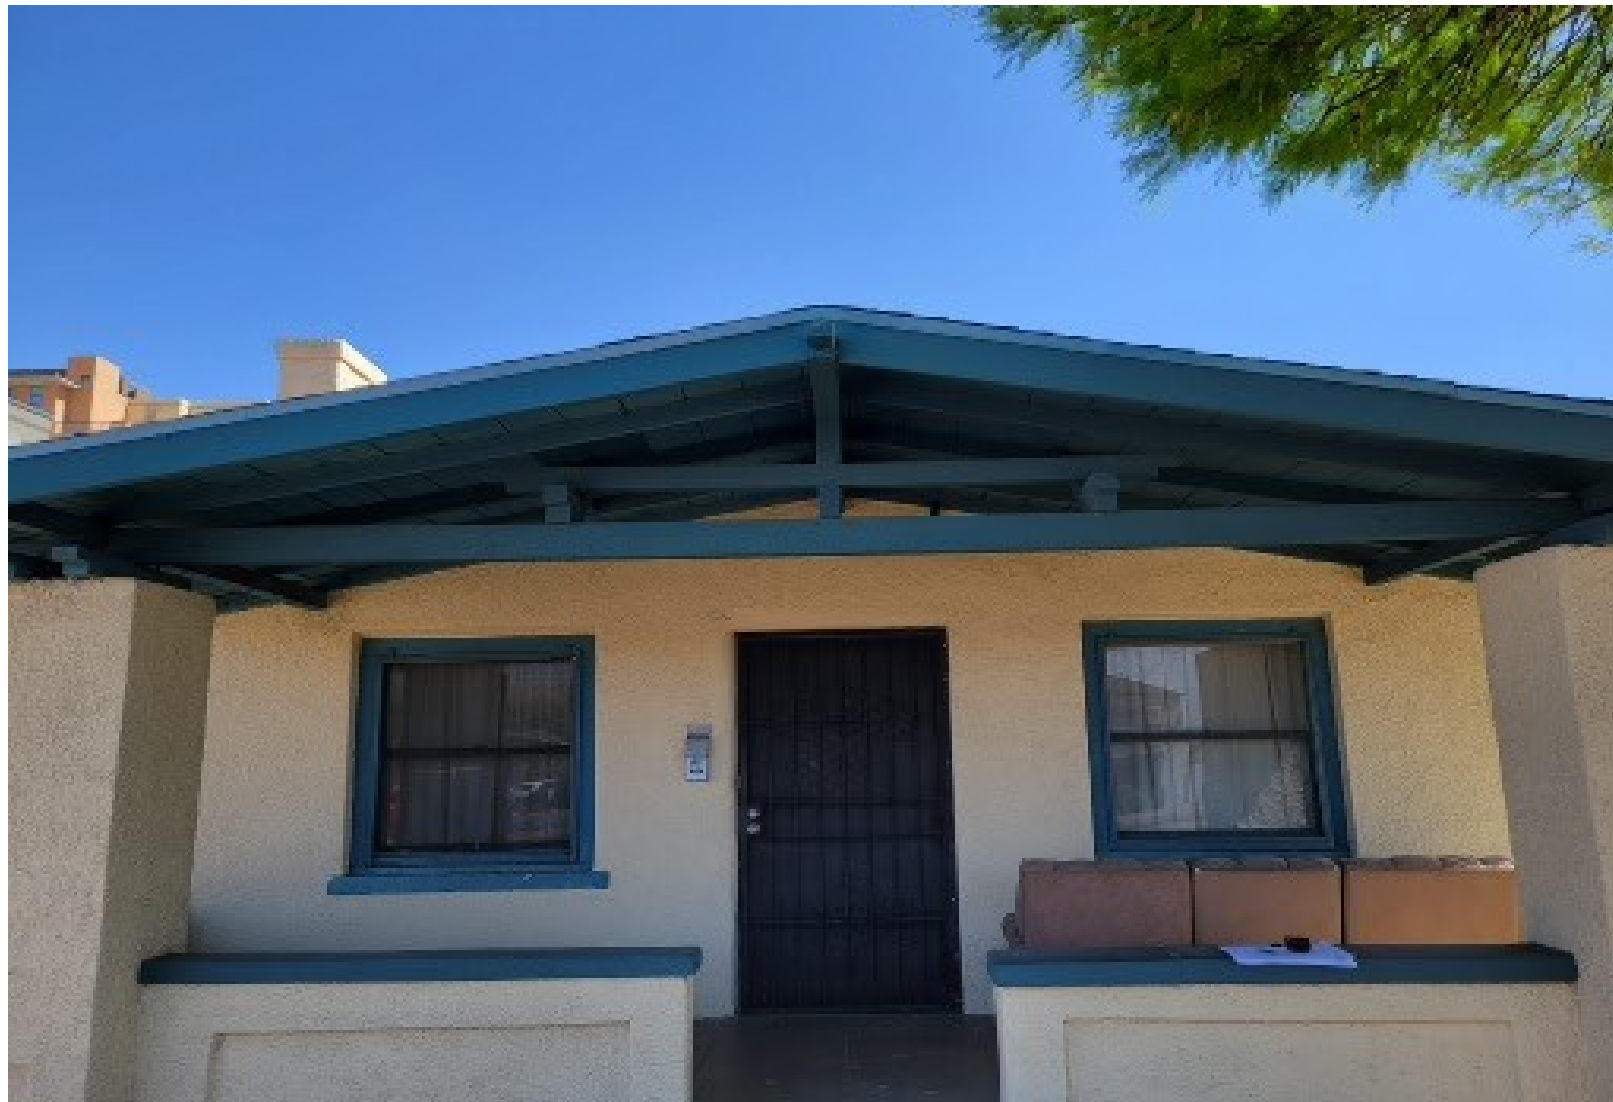
Looking at open truss in gable end, made of 4" x 4 "posts. The bottom chord is 4 x 6"

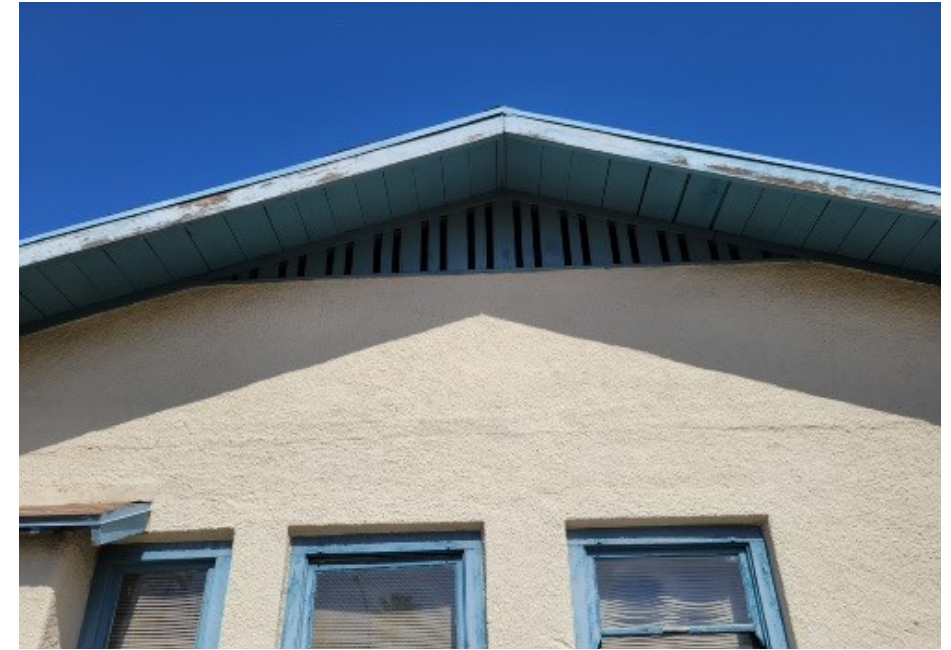
Wood gable vent in west elevation, east gable vent is identical

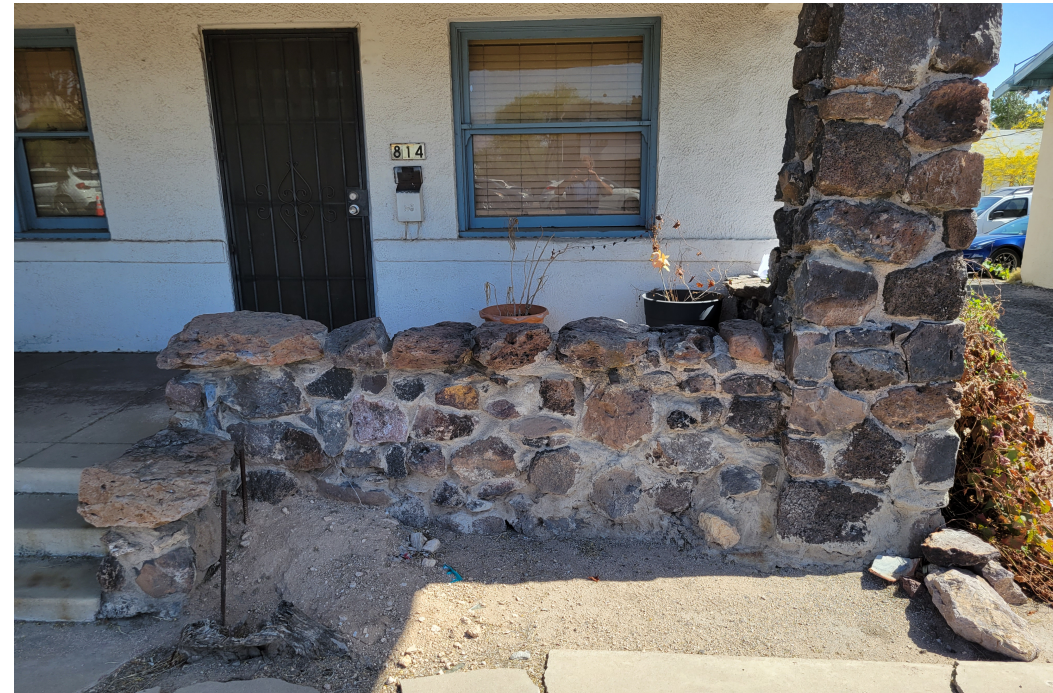
Detail of porch wall and tufa placement.

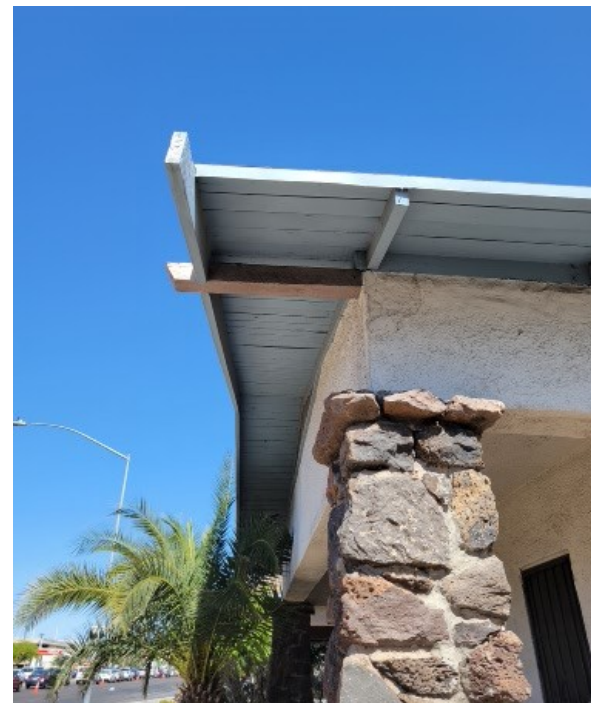
West porch pier and 1'6" soffit

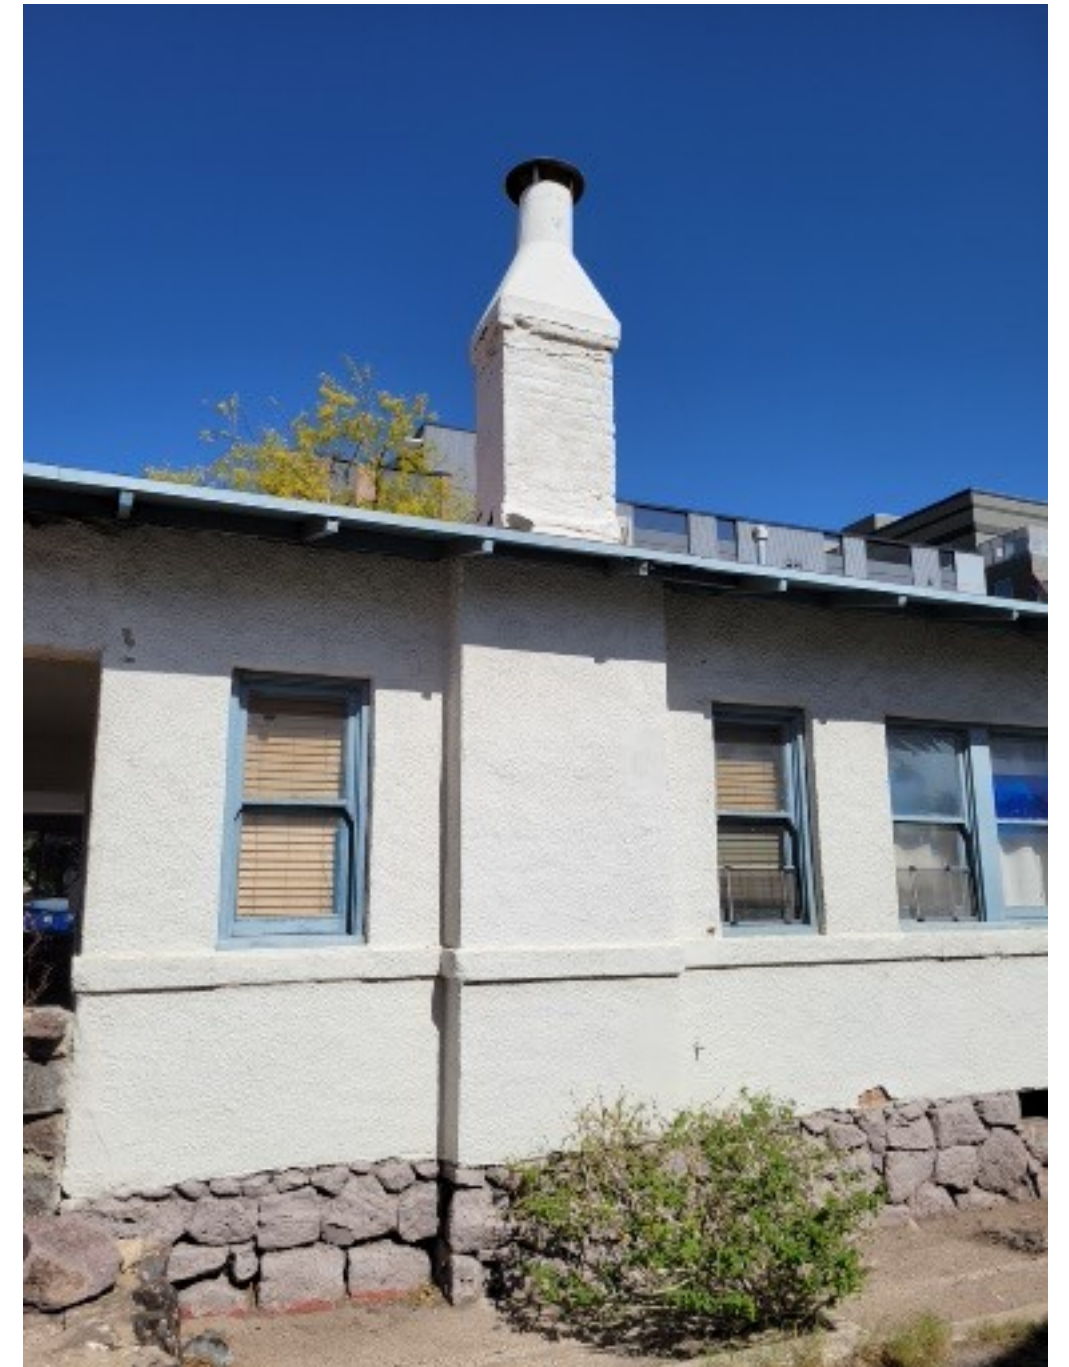
West elevation, noting tufa foundation, 5.5" sill course and brick chimney extending above roofline.

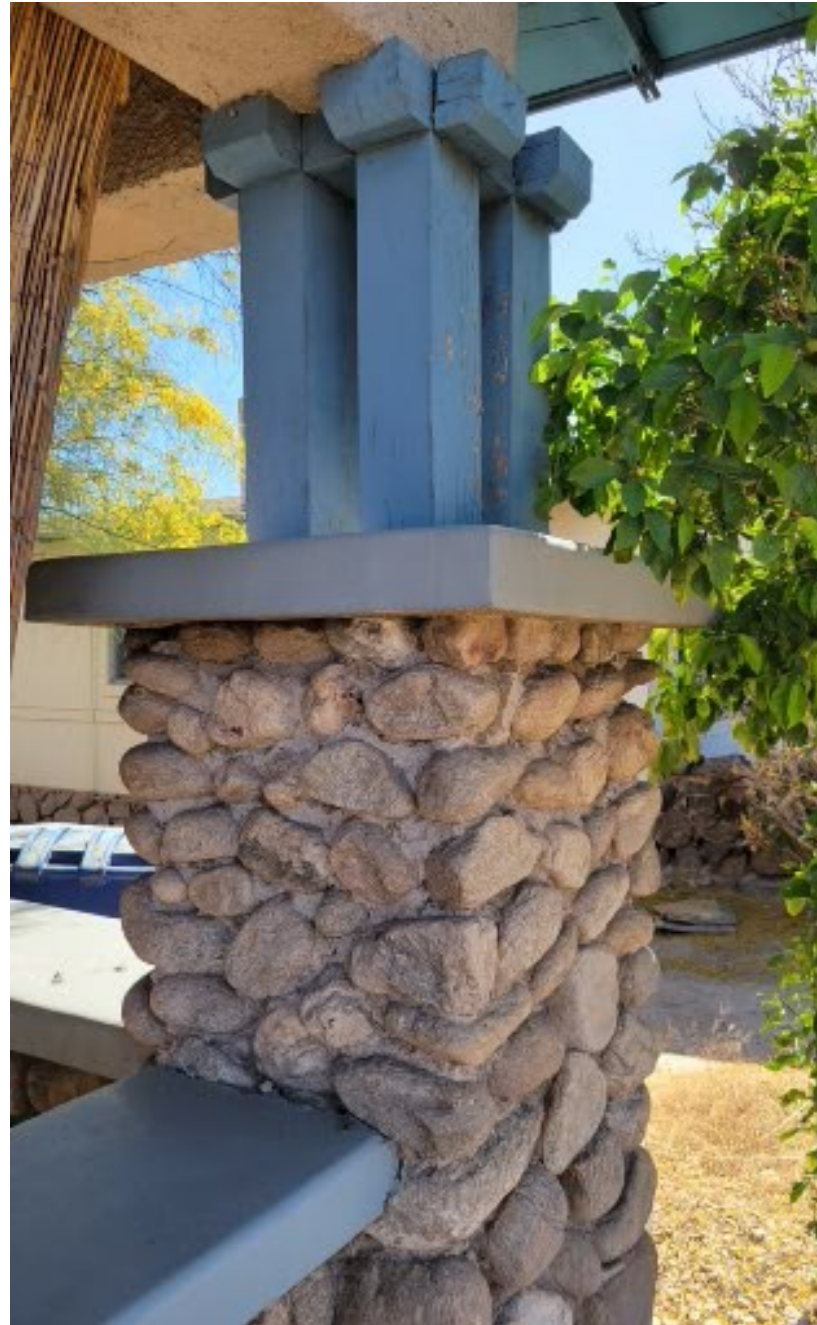
West porch pier, cobblestone base and clustered wood posts. Piers are 4" x 4.5"

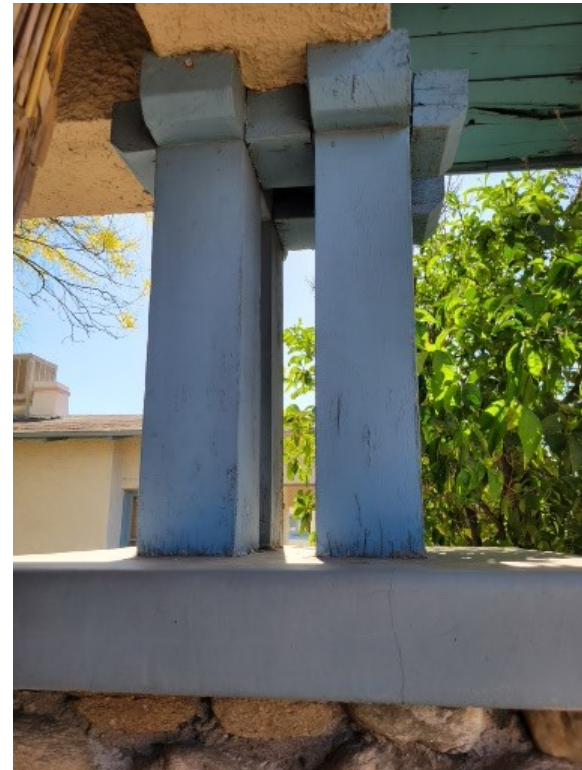
Detail of posts, looking west on west pier

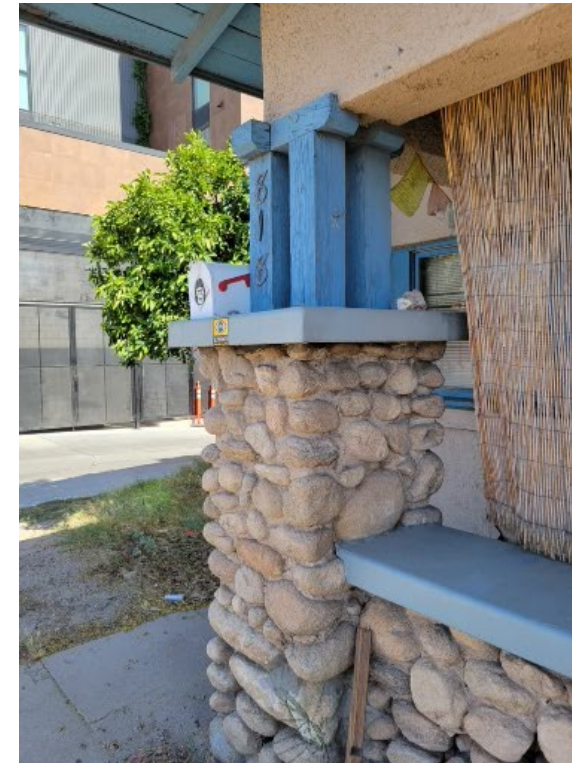
Porch pier, east end. Identical spacing to west pier.

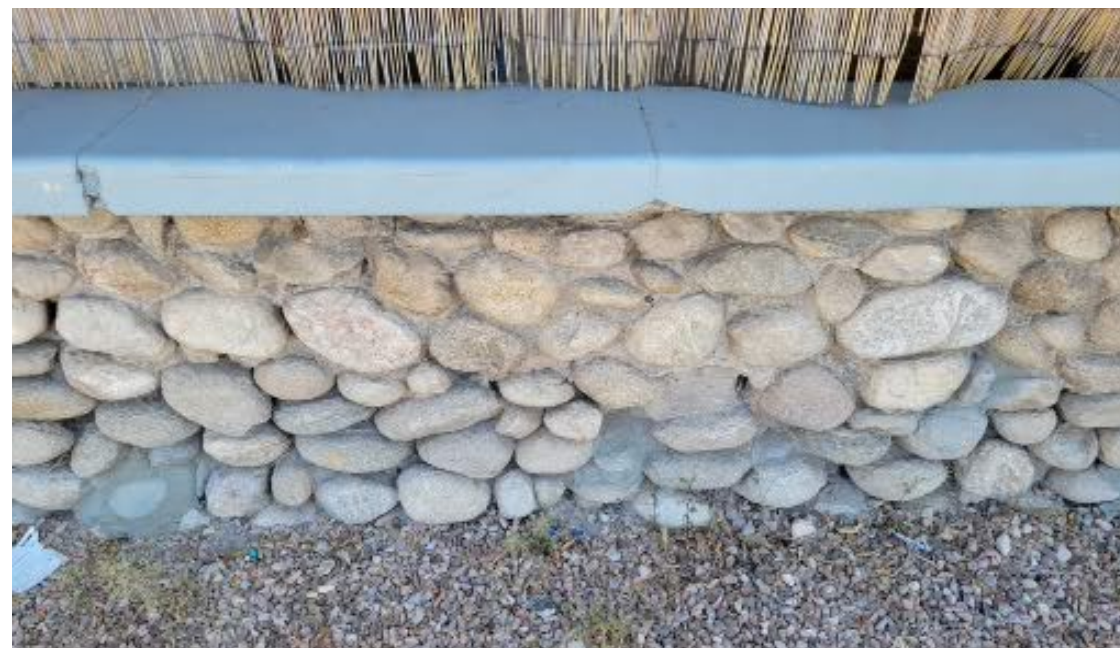
Cobblestone spacing, front face of porch wall.

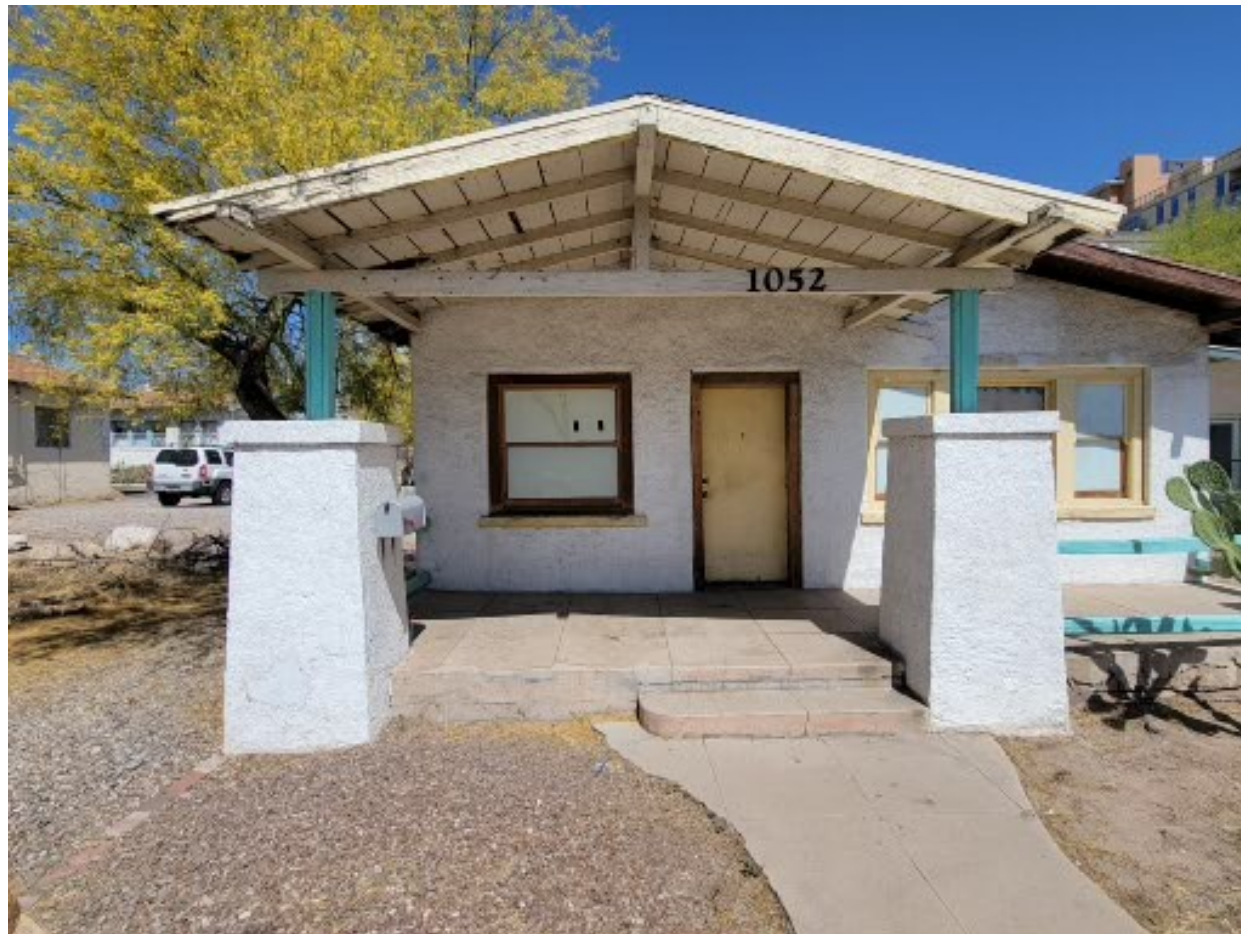
West facade. Very simple Craftsman piers and kingpost truss in porch gable.

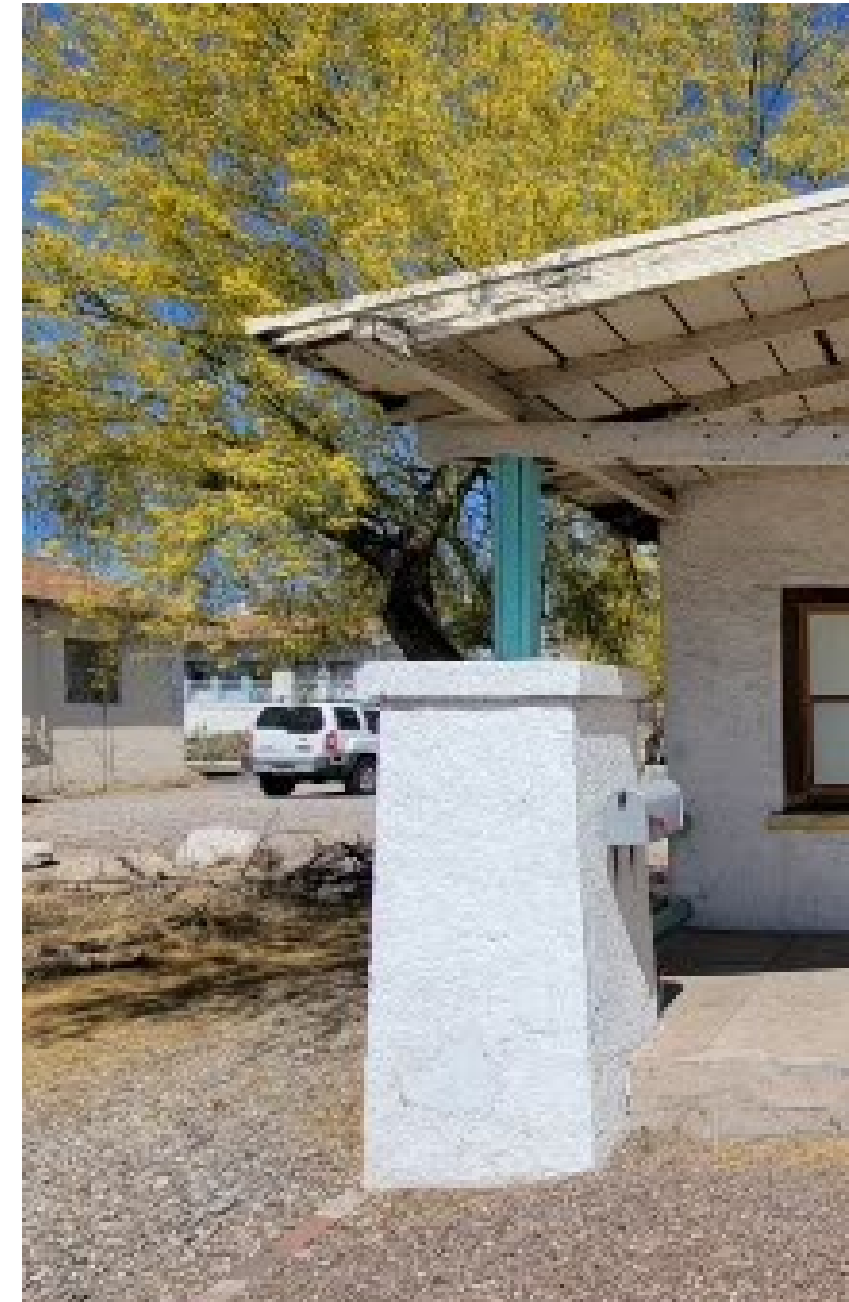
Porch pier, north side. Note very minor taper in form. 77" high.

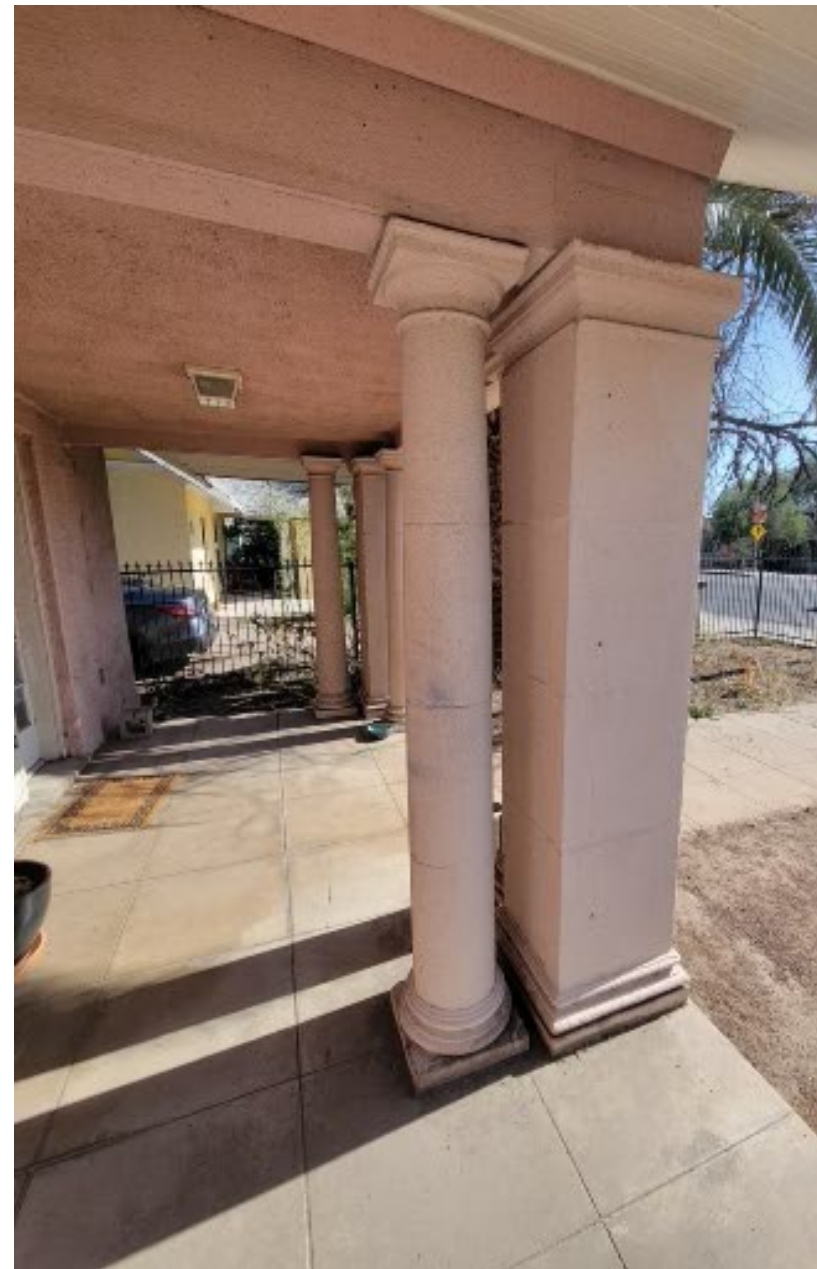
Porch piers and columns. Note slight taper of column, Astragal moldings at base and at Doric capital.

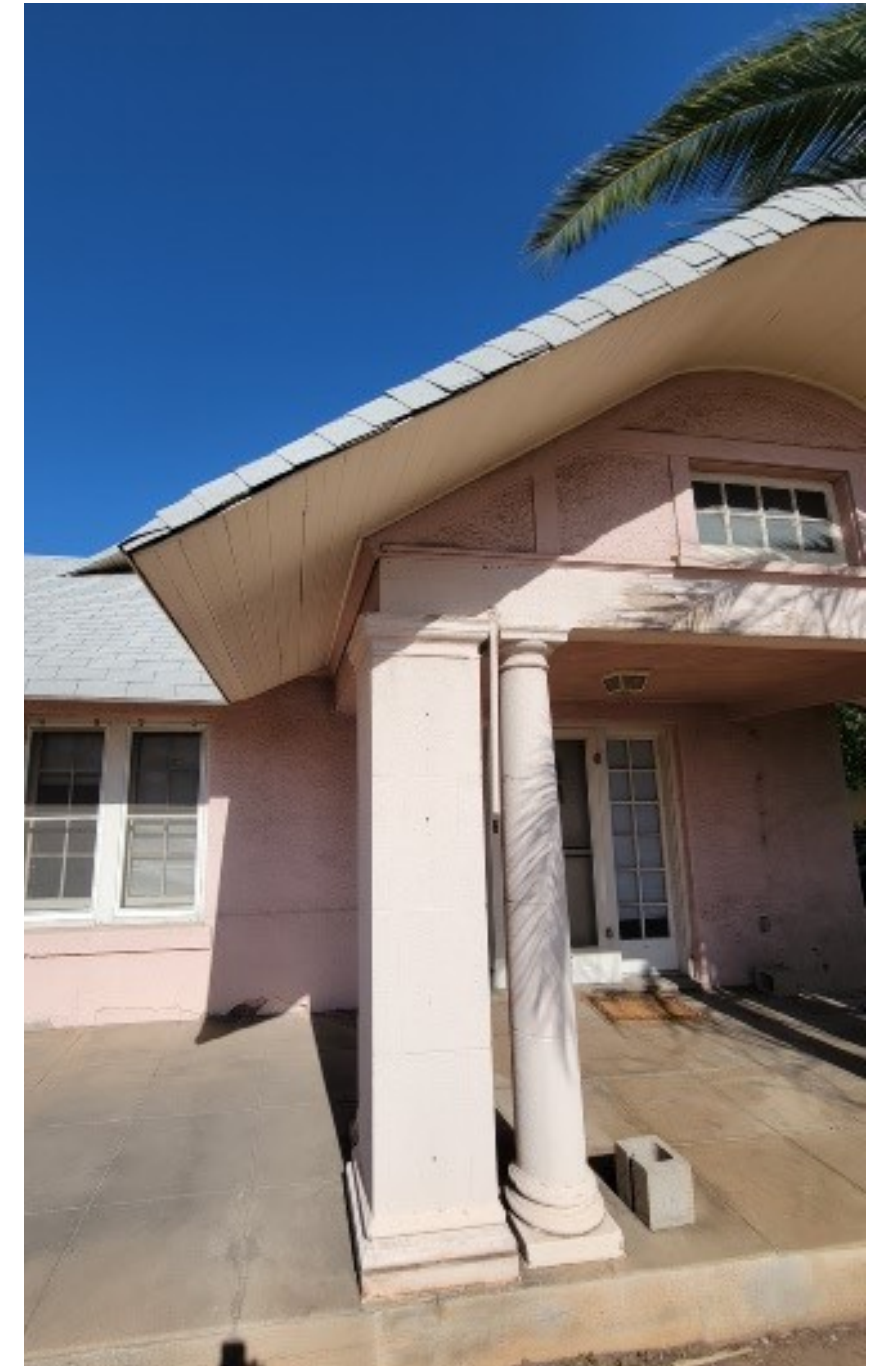
Porch pier is stucco with a scored ashlar pattern etched on surface.

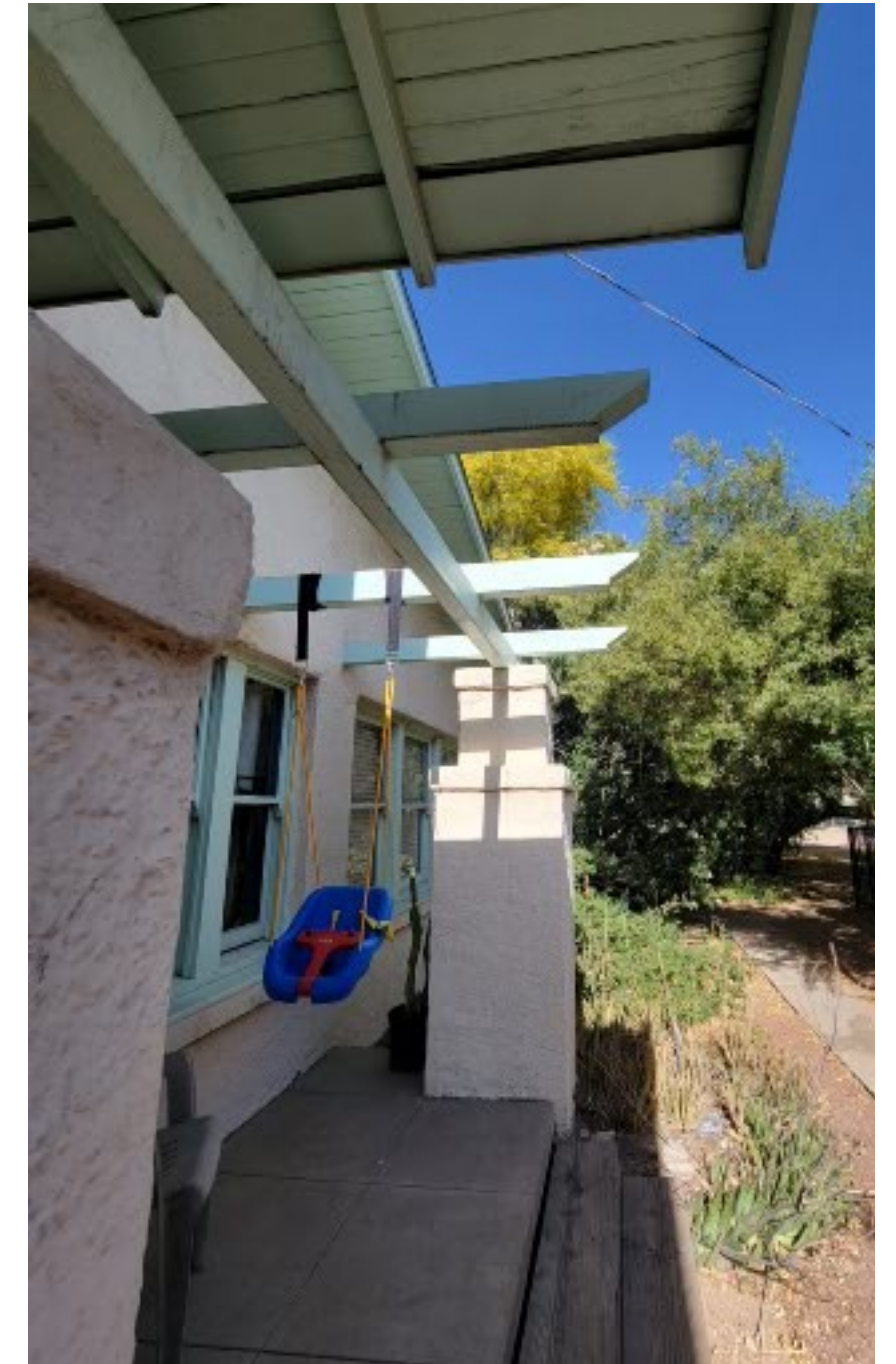
Detail of pergola on south elevation. View to east.

- The pergola on the south side of the house to be reconstructed/replicated on new site using existing salvaged timbers to greatest extent possible. Any new material to match existing in shape and dimension.
- Porch piers on both porches to be reconstructed, using existing materials to greatest extent possible. New stucco finish to match the existing.
- Stucco on exterior walls to be patched where needed with textured stucco and painted.
