Citizens Warehouse

Building Condition Assessment Report

Draft Report
April 2007

Re: **Building Assessment for Citizens Warehouse**
TLCP Job No. T07028

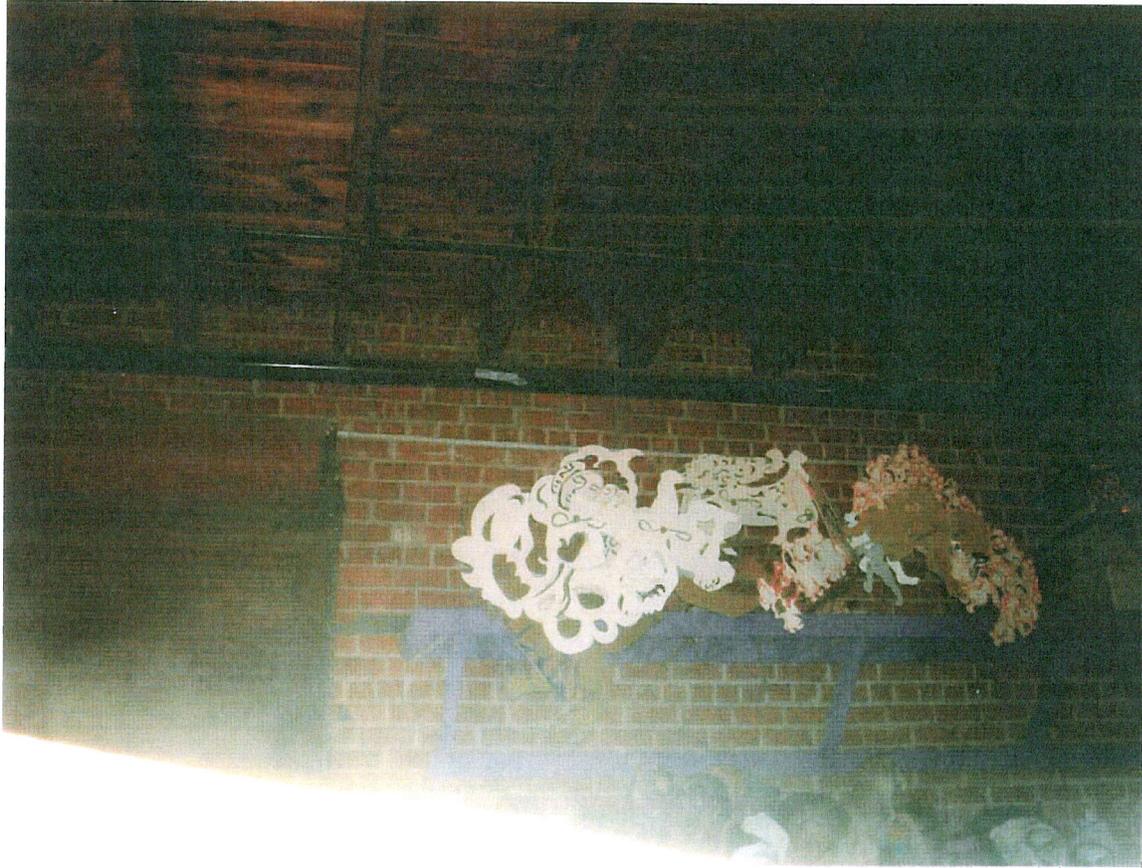
Citizens' Warehouse - Photo 2
2/27/07

1. Stress levels in the roof joists, beams and wood deck are within allowable design values for dead load and live load and all members appeared to be in excellent condition.
2. The age of the roof membrane is not known, but as shown in Photos 1 through 3, minor leakage has occurred. Observation of the roof membrane showed that it should be replaced in the near future.
3. As shown in Photo 1, the wood deck diaphragm is not connected to the brick shear walls.
