# Steinfeld Warehouse

## Building Condition Assessment Report

Draft Report  
April 2007

Poster Frost Associates, Inc.

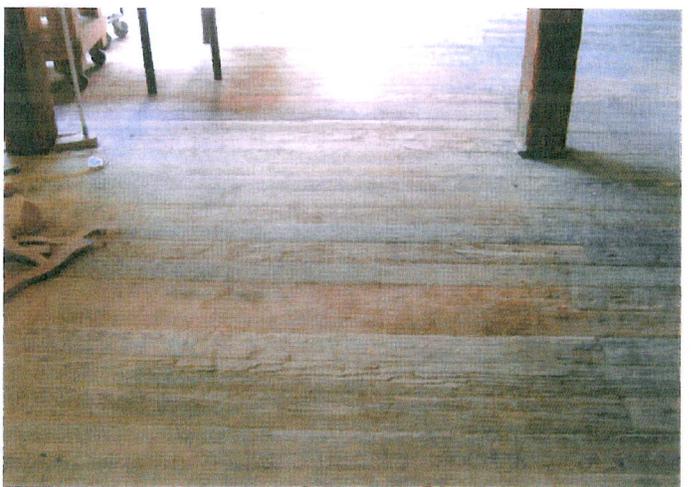
*Original wood plank floors are worn but in good condition*

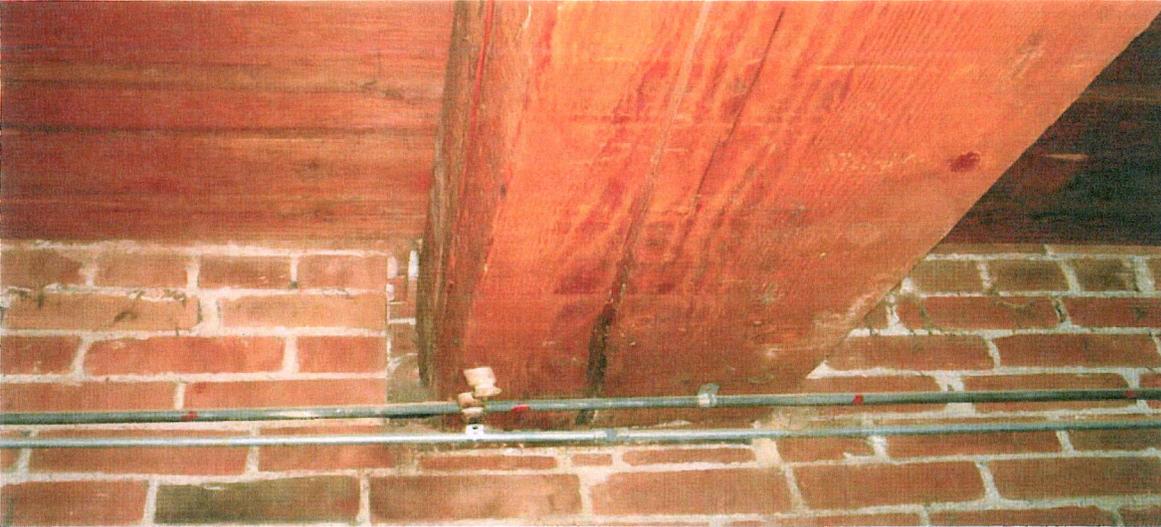
Steinfeld Warehouse - Photo 7  
2/27/07

1. Stress levels in the floor beams that are not split, and wood deck are within allowable design values for dead load and live load.
2. Significant checking and splitting has occurred in several floor beams reducing their load carrying capacity by as much as 50% (see Photo 7).
3. The wood deck diaphragm is not connected to the brick shear walls.
4. With the exception of an isolated location, the wood deck appears to be in good condition.

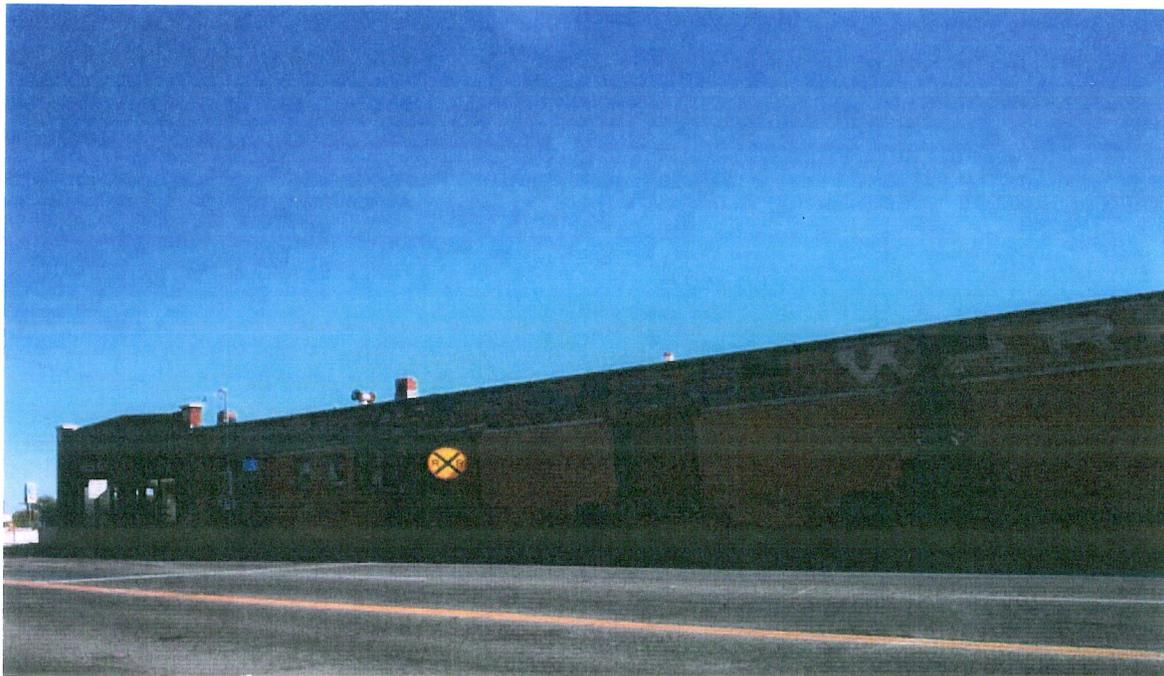
**Steinfeld Warehouse - Photo 12**  
2/27/07

1. Stress levels in the first floor unreinforced brick walls (i.e.: walls from the first floor to the roof) are within the allowable design values for dead load, live load, seismic and wind loads. These include only the walls that are still intact.
2. The condition of several of the walls is extremely poor - particularly the north wall along 6<sup>th</sup> Street. There are several large cracks, spalled brick units, missing brick units and deteriorated mortar joints (see Photos 8 through 12).
3. As shown in Photos 13 and 14, deterioration of the brick parapet walls on the roof is extensive.
