# MARIST COLLEGE HISTORIC DISTRICT

HISTORIC DISTRICT SITE PLAN  
JULY 2011

72 WEST OCHOA STREET  
TUCSON | ARIZONA 85701

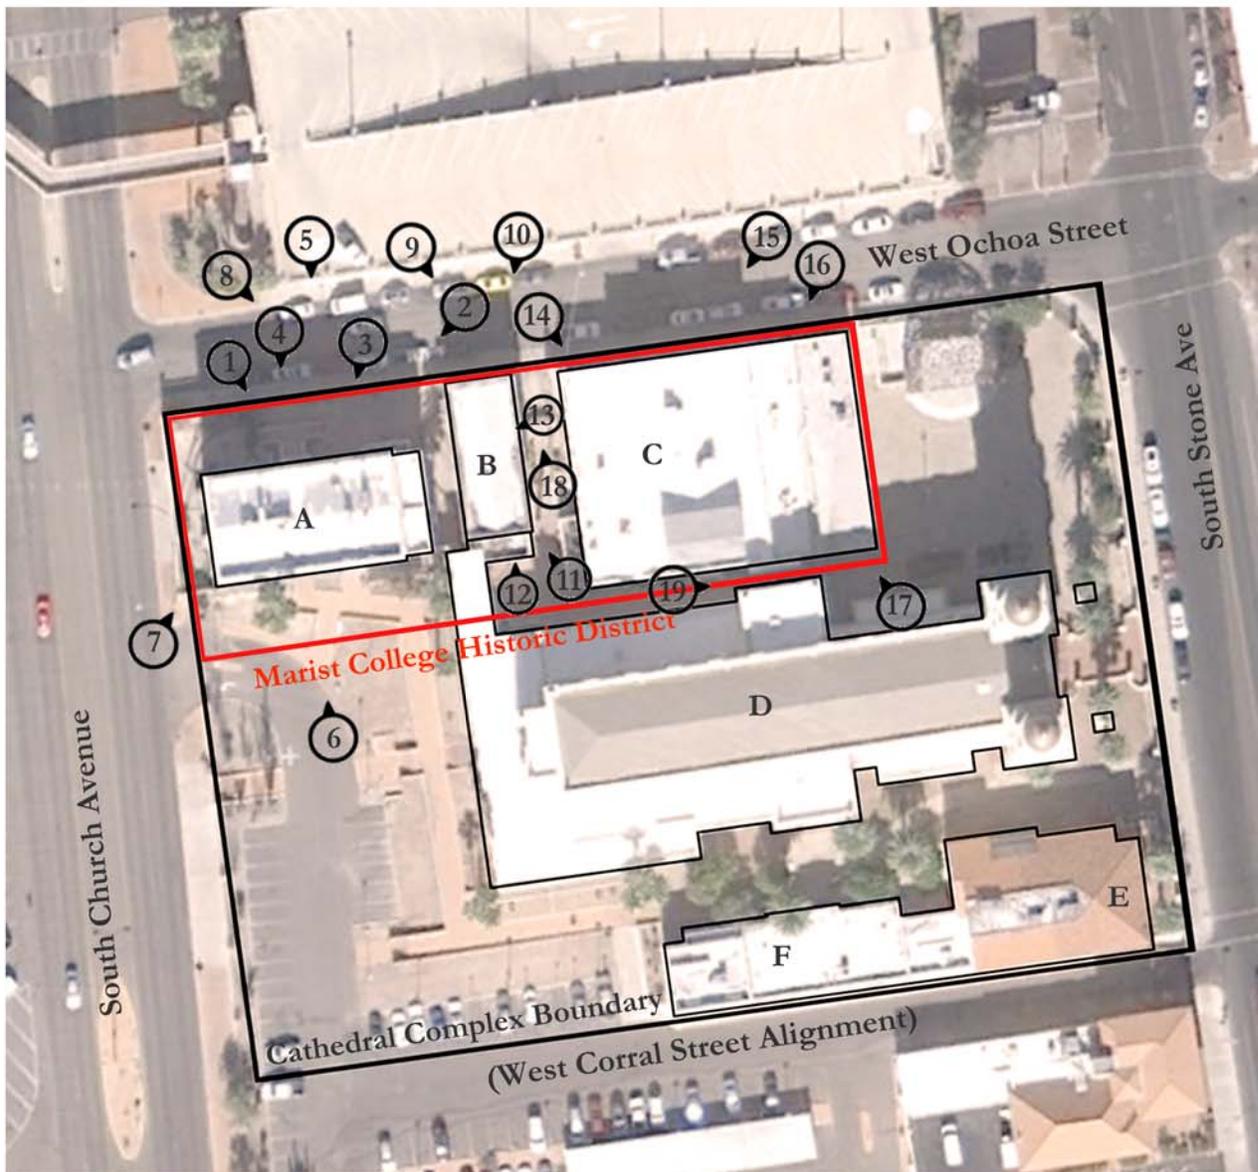
- A Marist College
- B Our Lady's Chapel
- C Cathedral Parish Hall
- D St. Augustine's Cathedral
- E Rectory
- F Chancery Office

Figure 2: Aerial photograph of Marist College Historic District, Tucson Arizona.
