18 w 18

18 & 28 west 18th street
tucson, arizona 85701

CYPRESS
CIVIL DEVELOPMENT
strength + sustainability

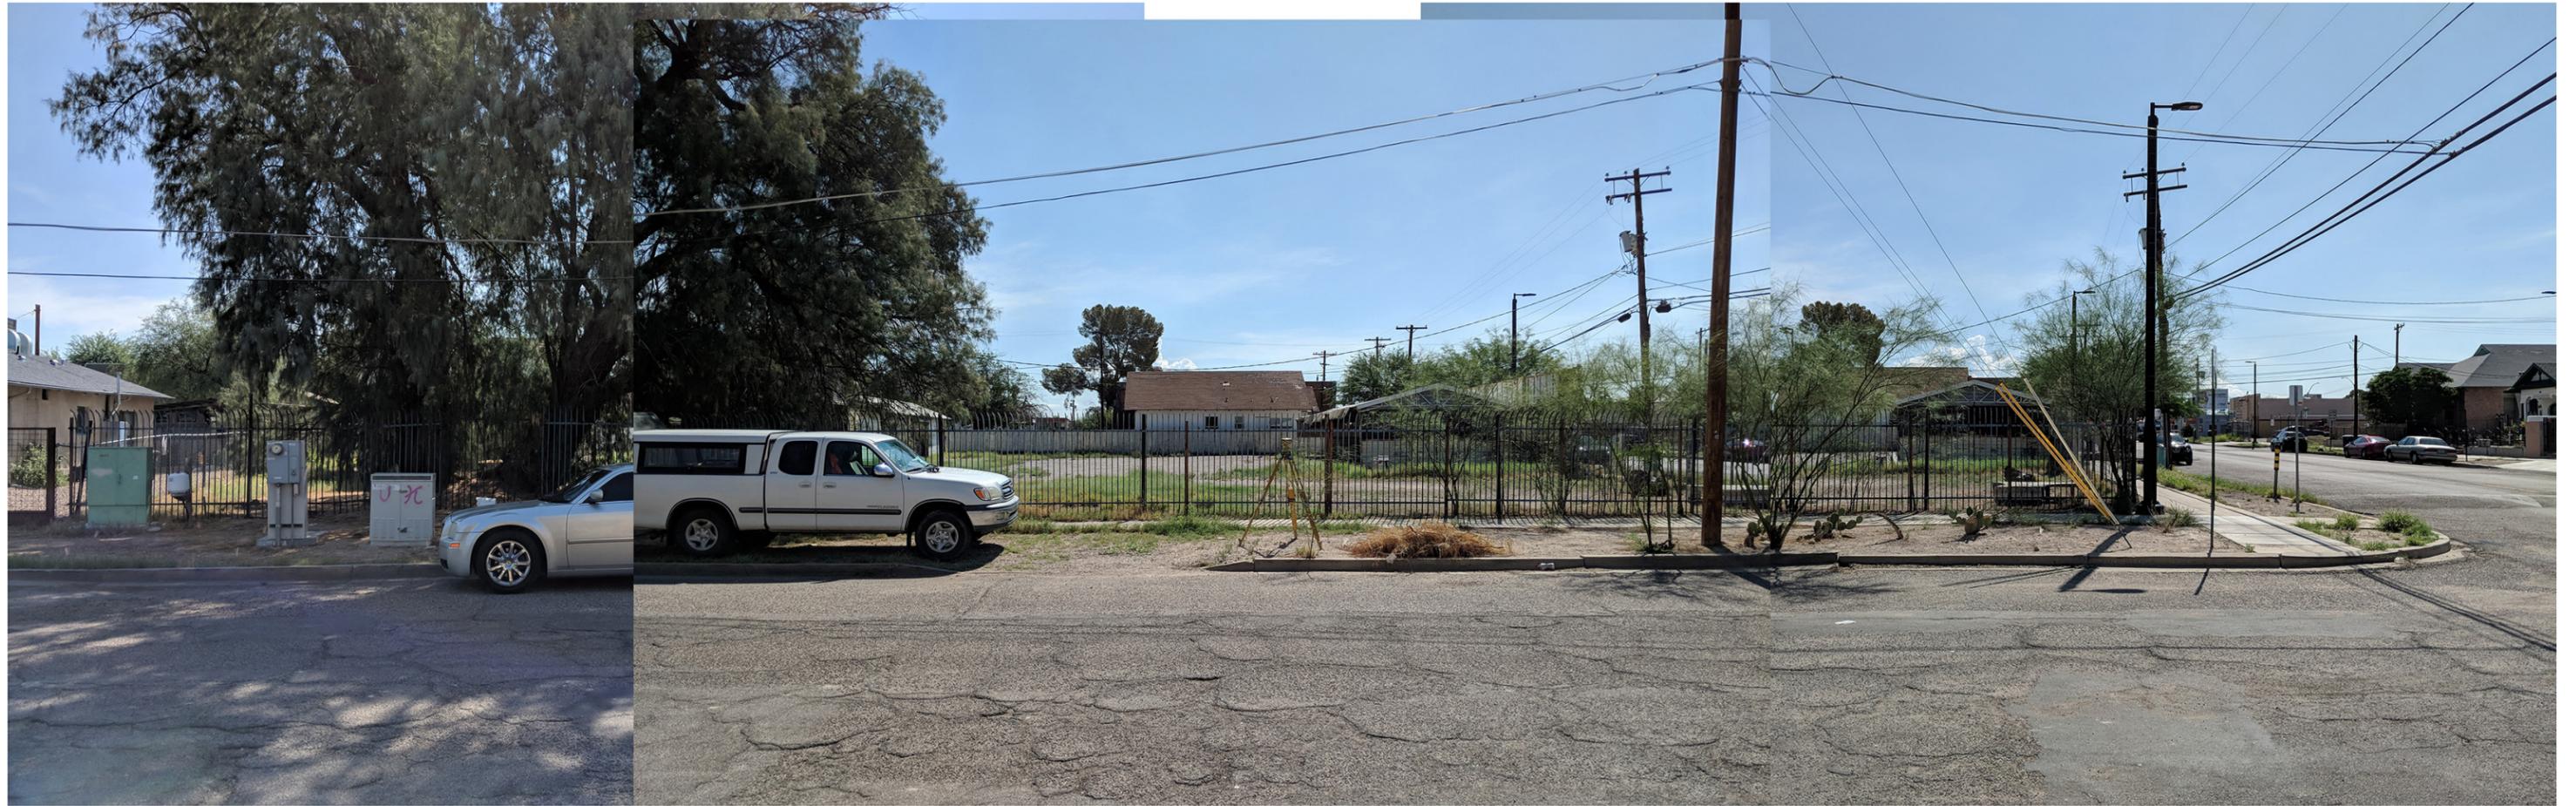
1. along 7th avenue

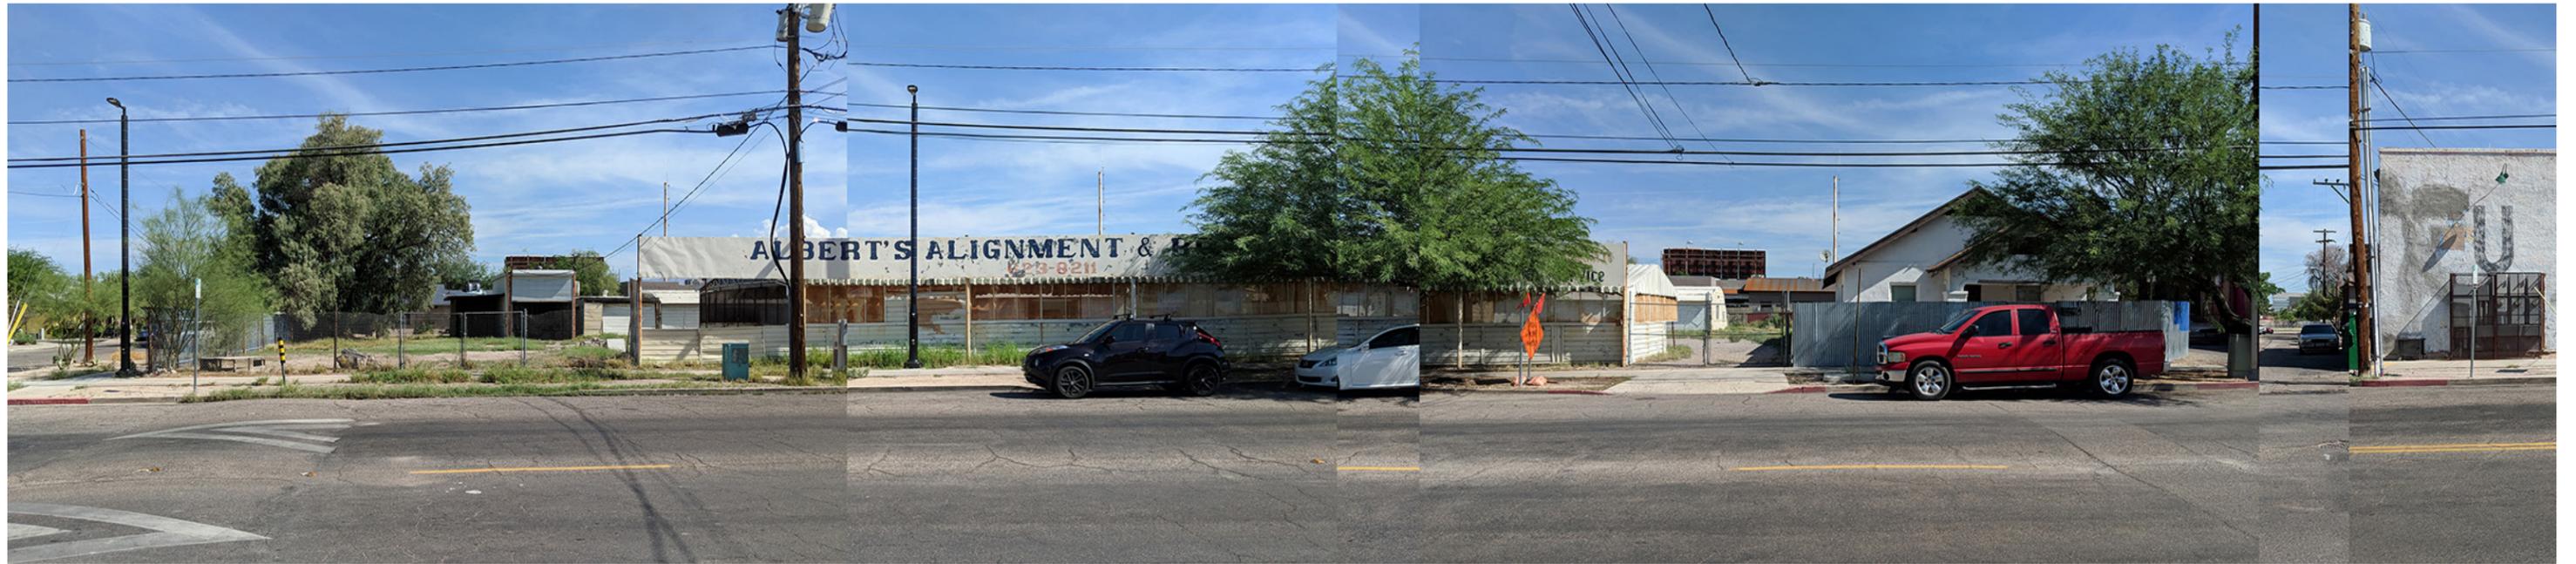
2. along 18th street, the fence in front of the historic home will be removed to so the home can be seen from the street

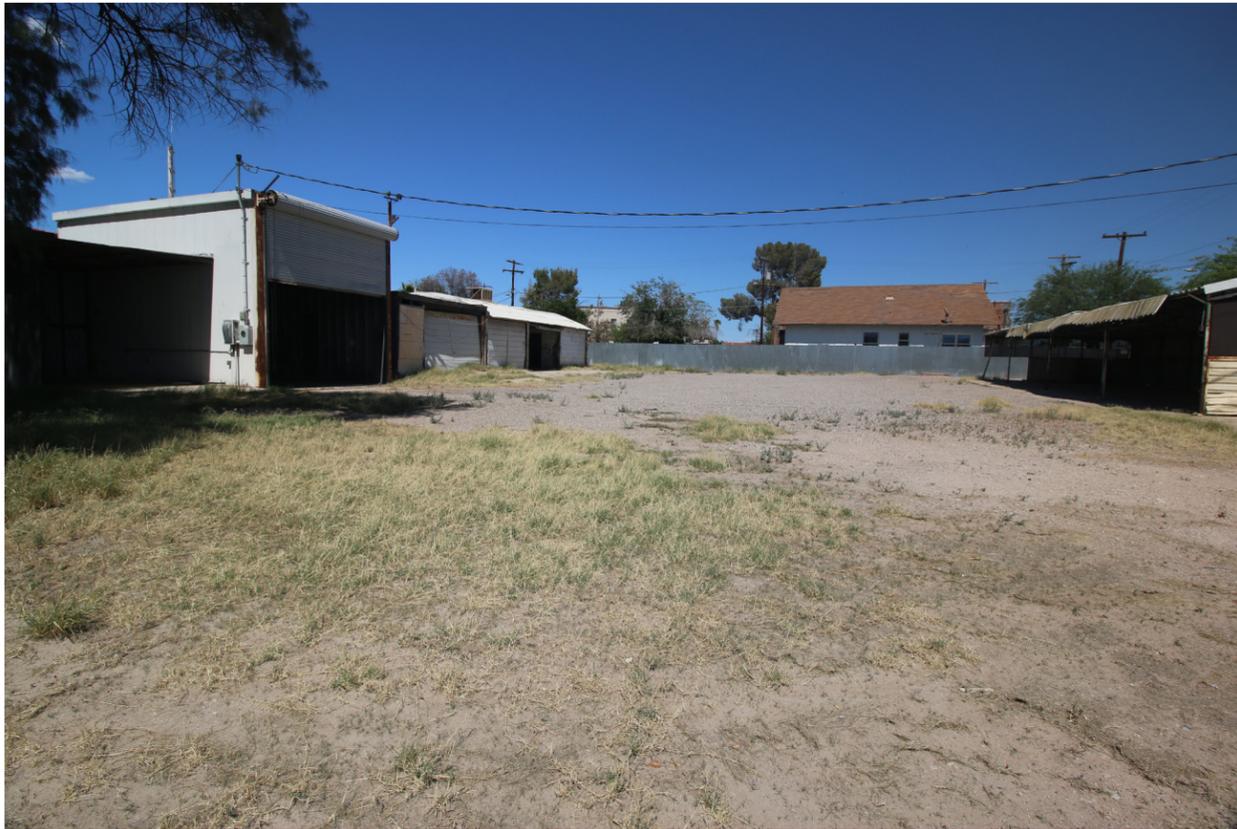
3. looking east at the existing structures on 28 w 18th st

28 west 18th street was most recently an auto repair garage with a couple open air shade structures and a Quonset type garage/storage building. This property is zoned commercial (C-3), and none of the structures on this lot are historic or candidates for renovation.

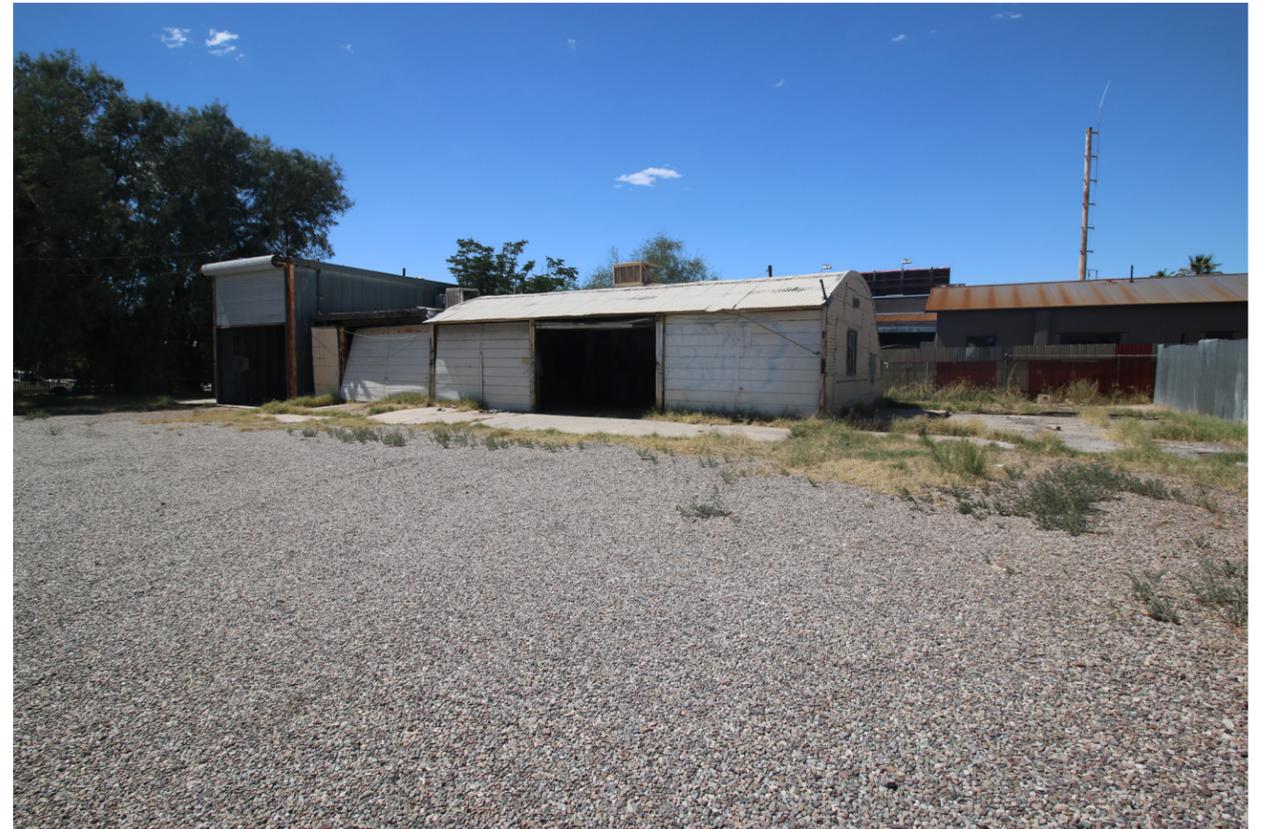
4. looking north at the quonset hut garage structure

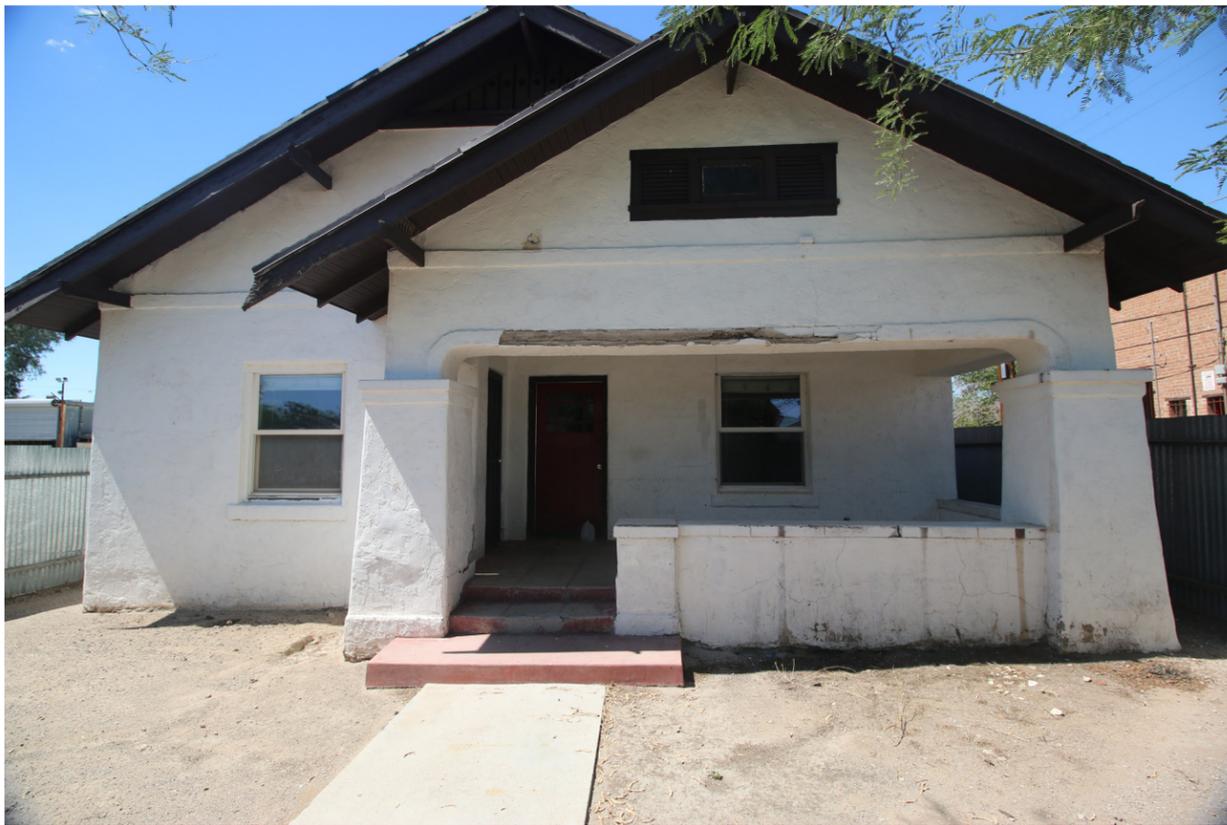
5. the front porch of the historic home at 18 w 18th street

18 west 18th street is a modest single story craftsman bungalow built in the '20's known as the Chambers House. It is a contributing property to the Barrio El Libre Expansion Historic Preservation District and as such the exterior will be rehabilitated and windows and doors repaired without affecting the historic character of the structure. The property is Zoned Commercial (C-3). The interior will be remodeled to allow for a retail/mercantile (with accessory alcohol sales) type use without adding square footage outside the existing footprint of the home. We want the space to still feel like a home, and the retail use that moves in will be something that is complimentary to the Five Points Market and fits the idea that this house on the corner can be like a living room to the residents of the new homes on the adjacent lot and to the current residents of Barrio Viejo and Santa Rosa and Armory Park.

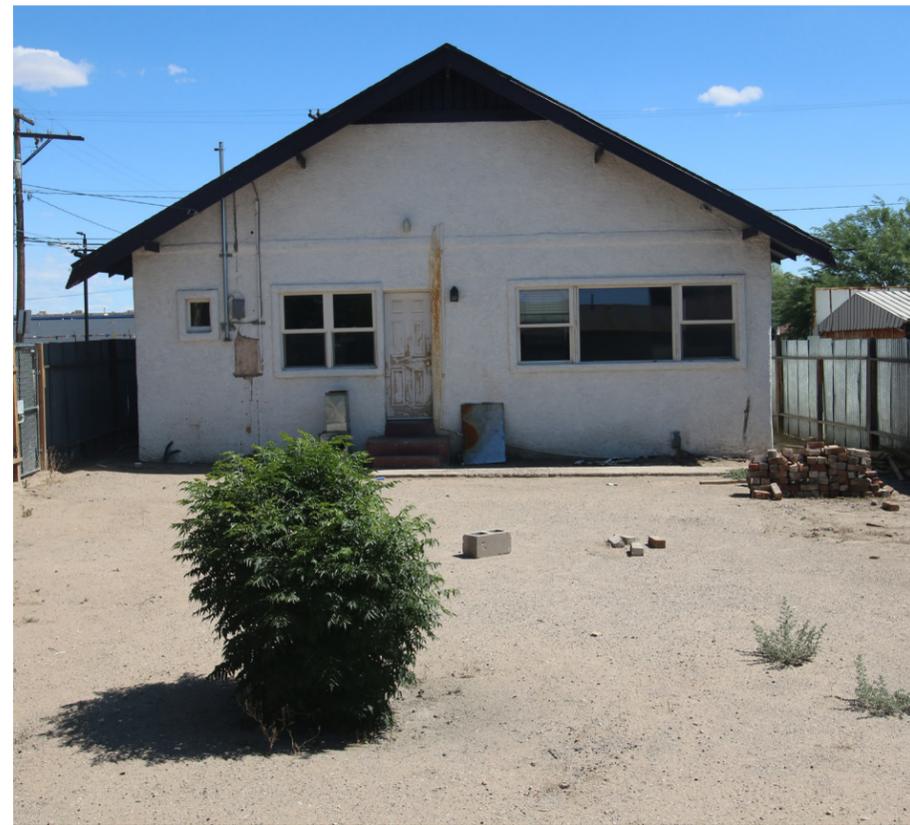
6. the back of 18 w 18th street

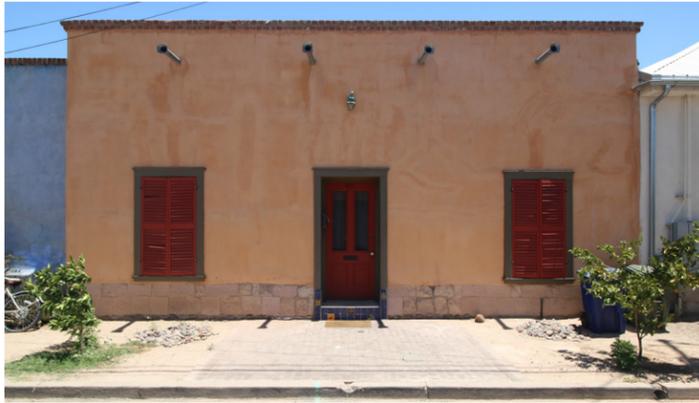
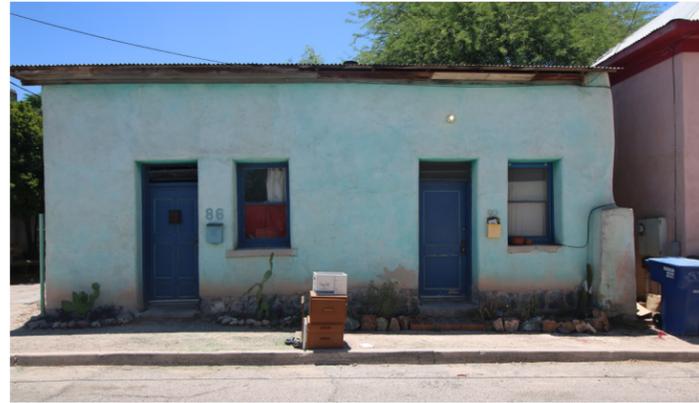
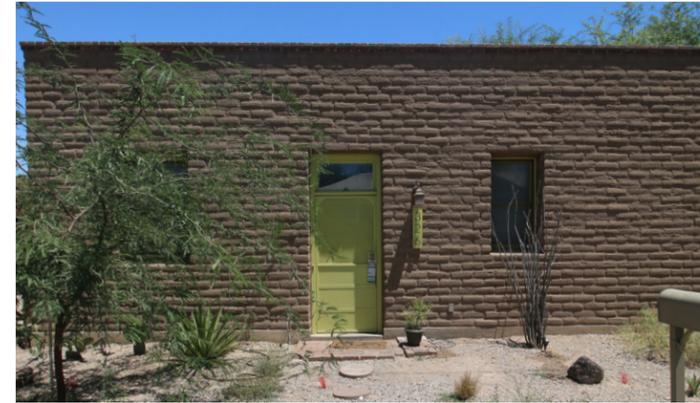
the typical row houses of barrio viejo and santa rosa tend to push right to the sidewalk to define the urban edge of the neighborhood. the scale of the homes vary as well as the colors and materials, but the massing is typically a rectilinear form with little to no articulation of the planar facade.

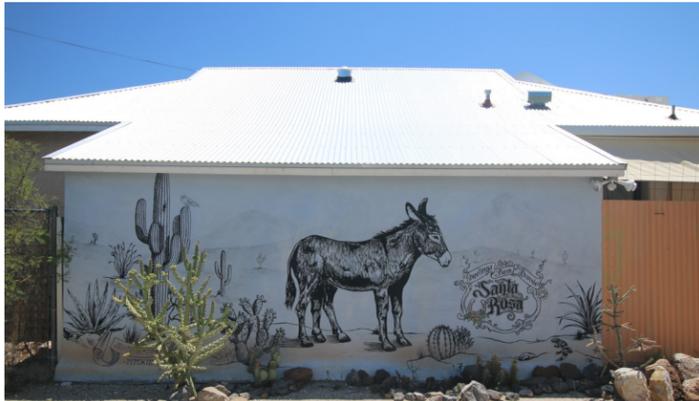
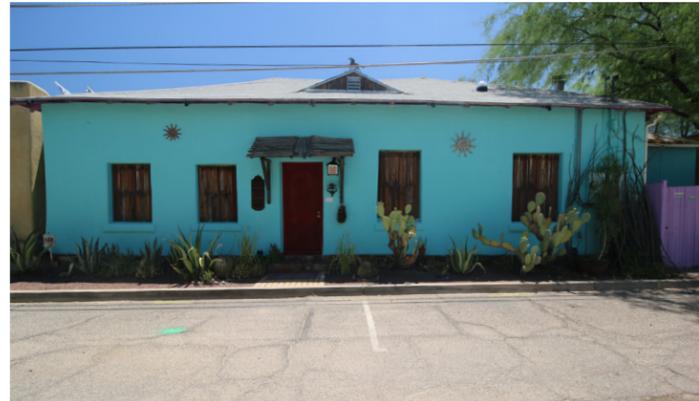
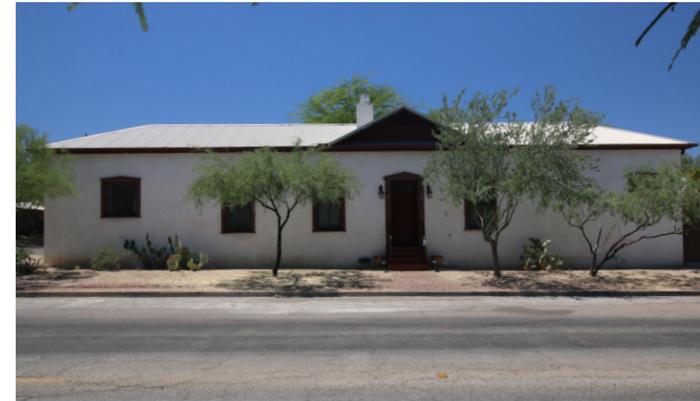
even with a sloping or hip roof the primary form of the home that is perceived from the sidewalk is rectilinear.

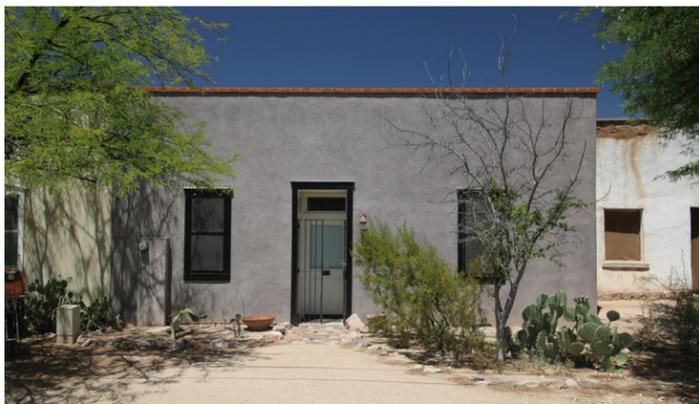
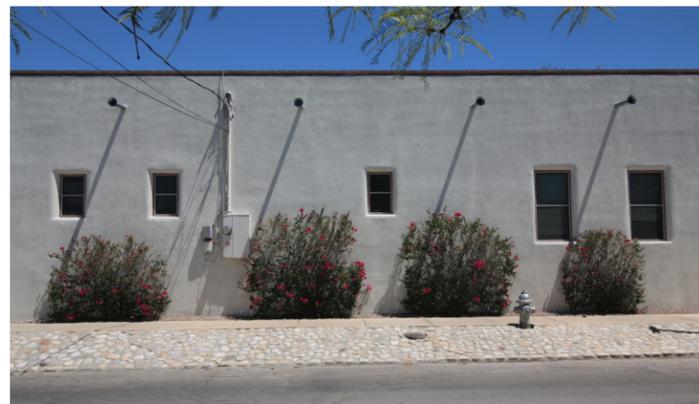
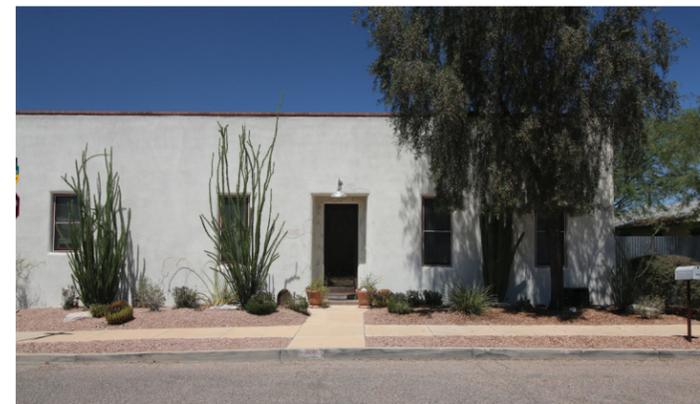
the white stucco walls become the best back drop to the color provided by the bright green jojoba, and flowering octotillo as well as the best canvas for the play of shadows that our desert sun paints as it passes through the palo verde branches.

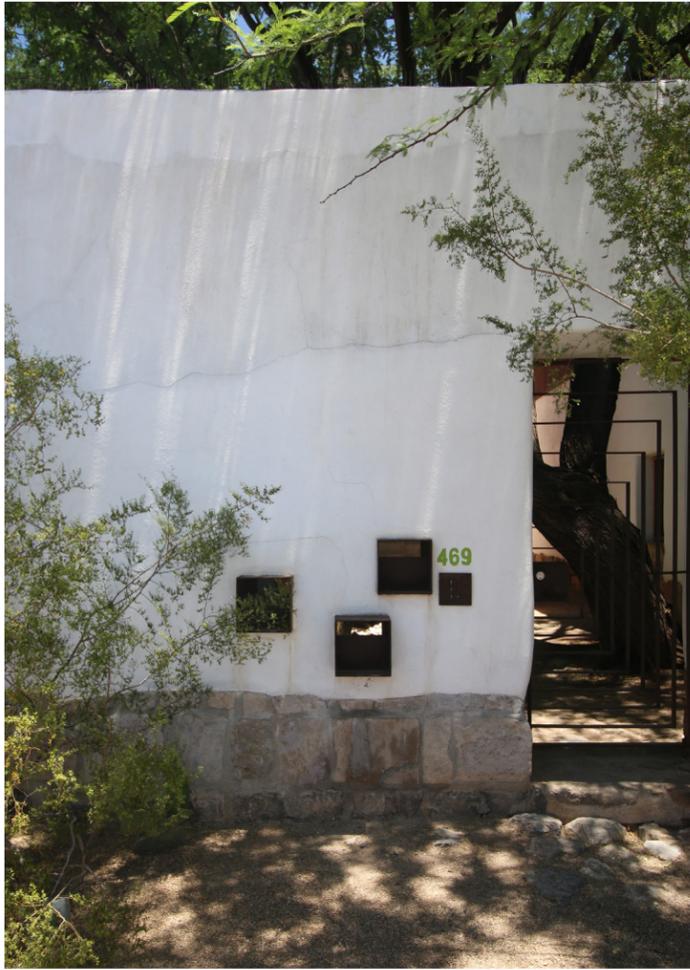
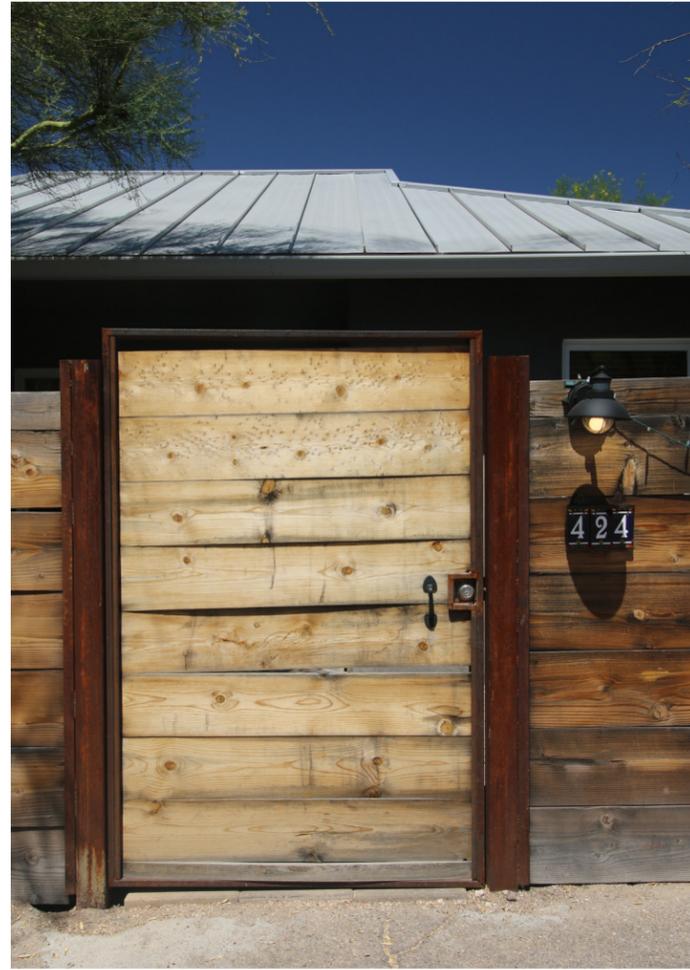
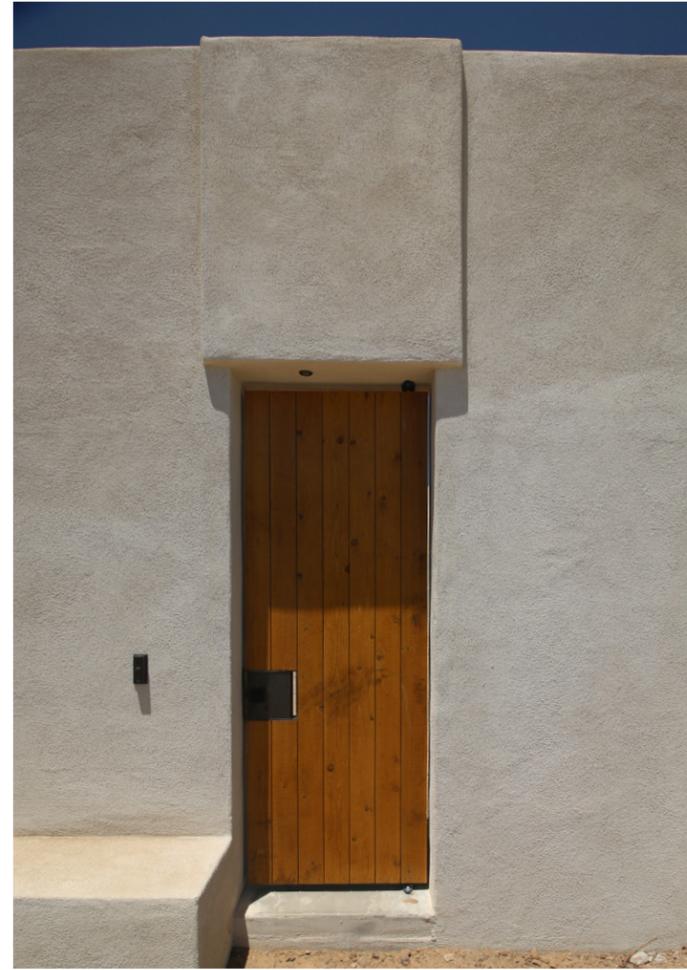
sometimes the urban edge is held by a site wall that contains a semi-private courtyard beyond. the green tops of the mesquites spring out above the wall and we catch a glimpse of the life inside these courts through gates and protected windows in the site wall. there are moments when the wood gates offer no sight but only the sounds of whats happening on the other side, and rare moments when wall and gate are held down to reveal an inviting porch.

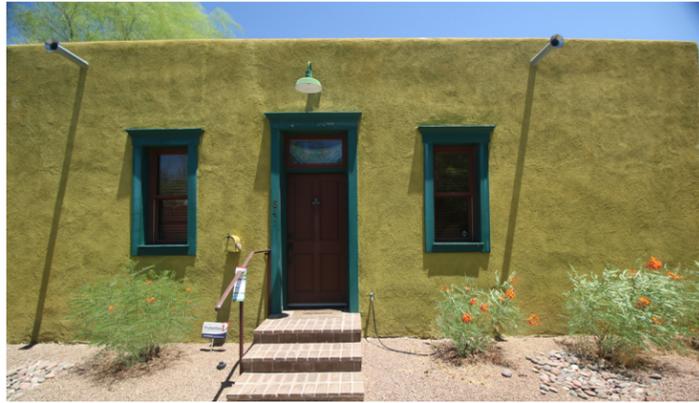
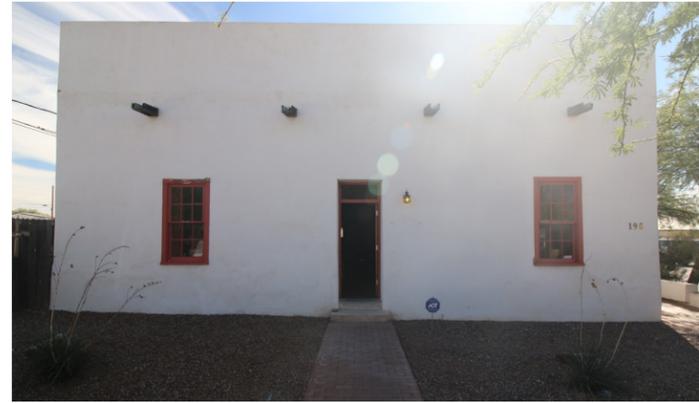
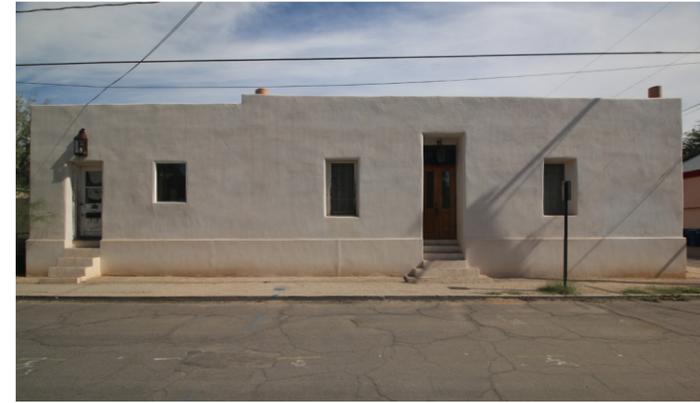
traditionally the row houses of the barrio were built for working class families, and typically a masonry parapet cap was an expensive element that was not used. in building the wall without a cap the stucco wraps over the parapet and allows the wall to terminate as a simple line in the sky, and eliminates unnecessary decoration.

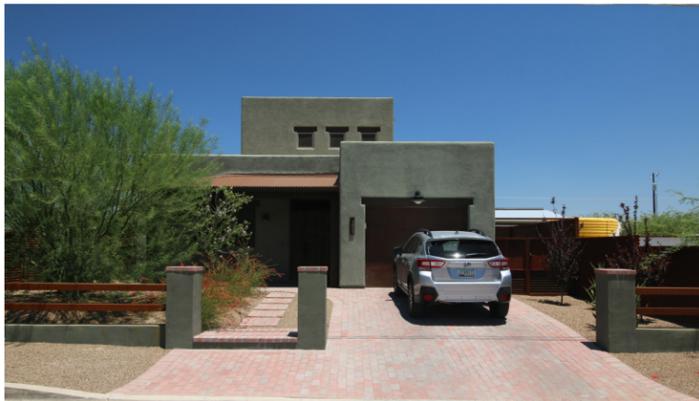
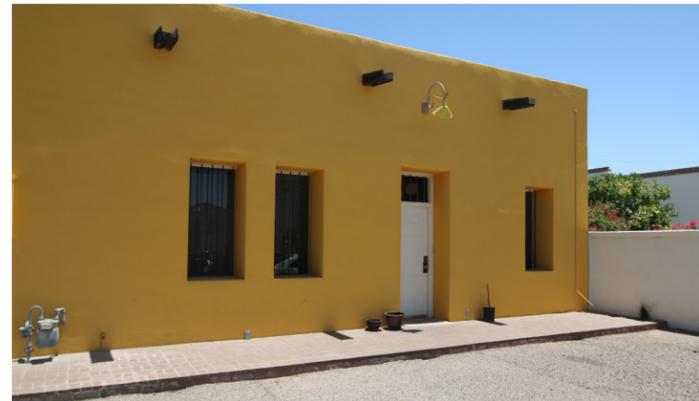
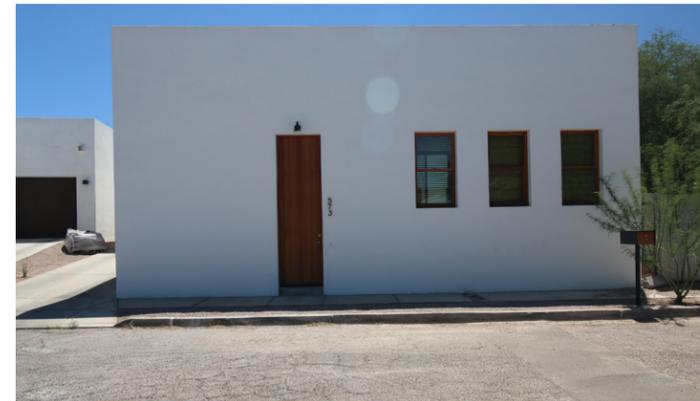
typically built from adobe the historic homes of the barrio have limited windows in the deep mass walls. again, because when originally built glass windows are expensive elements in a working class home, but also because placing several large openings in adobe is a costly and difficult thing to do structurally.

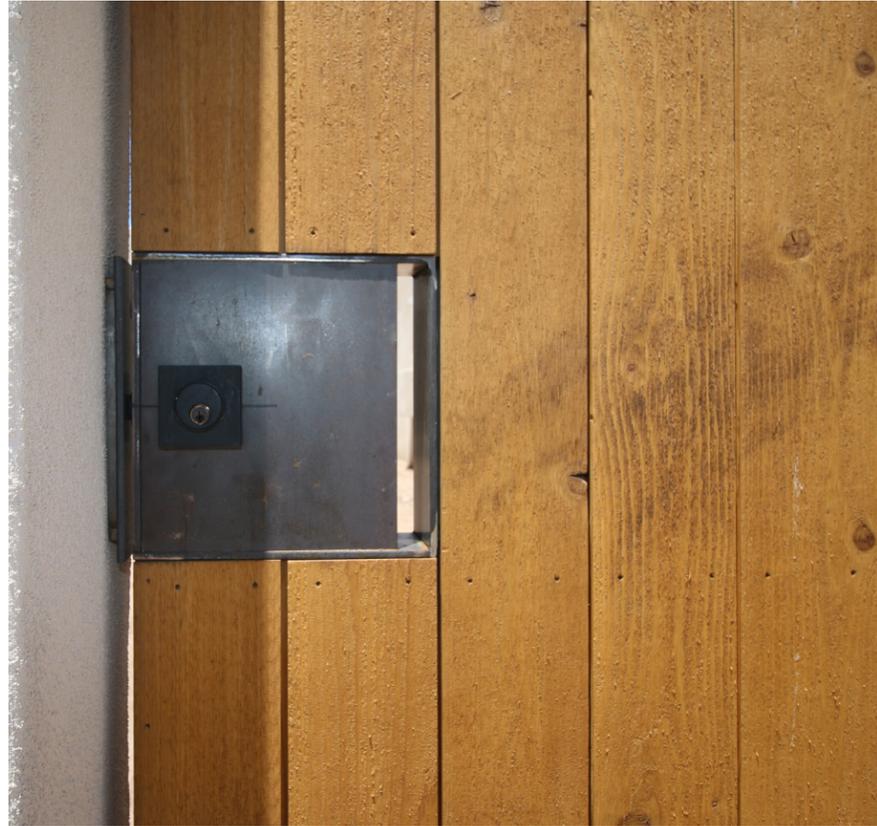
wood doors and gates

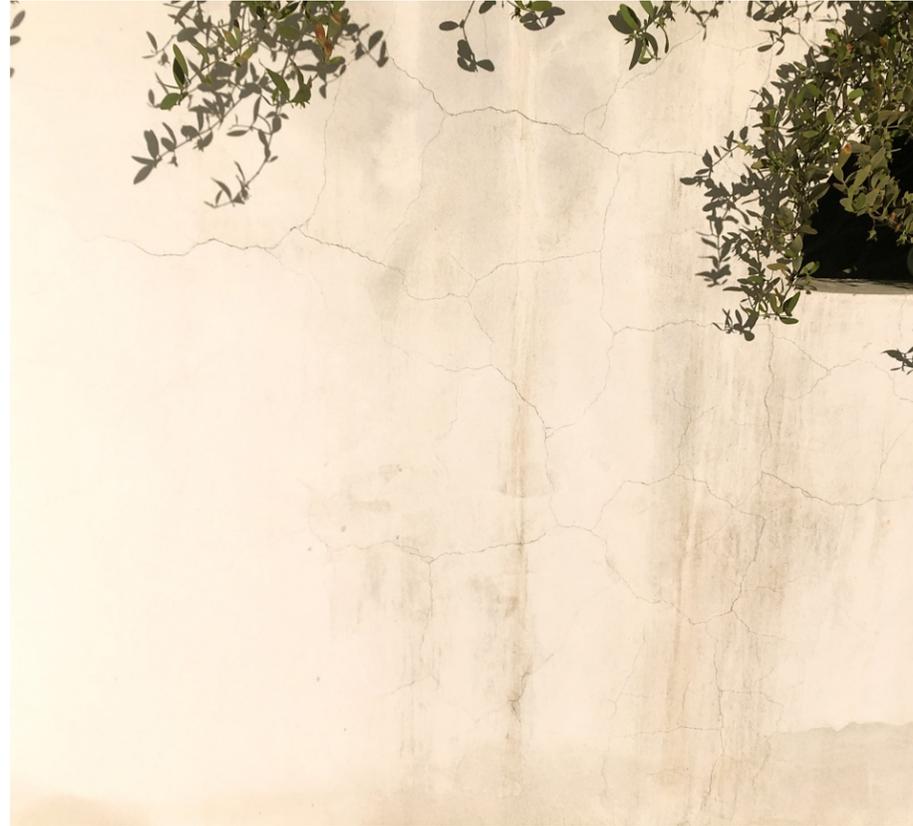
smooth light stucco

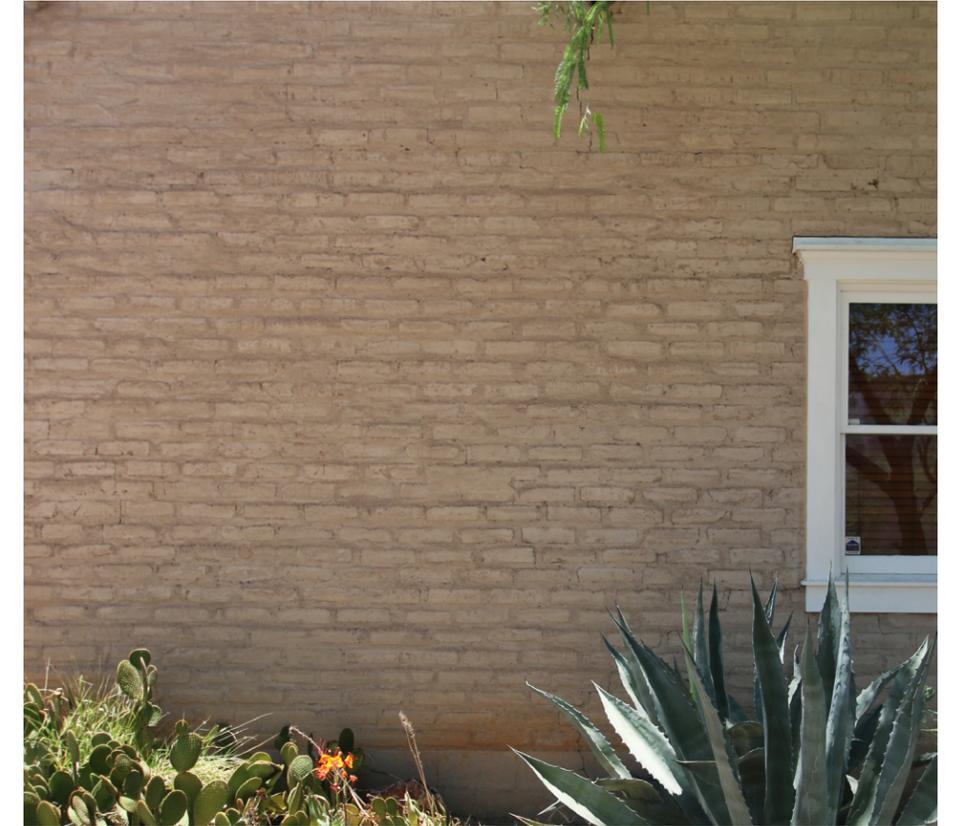
adobe screen walls

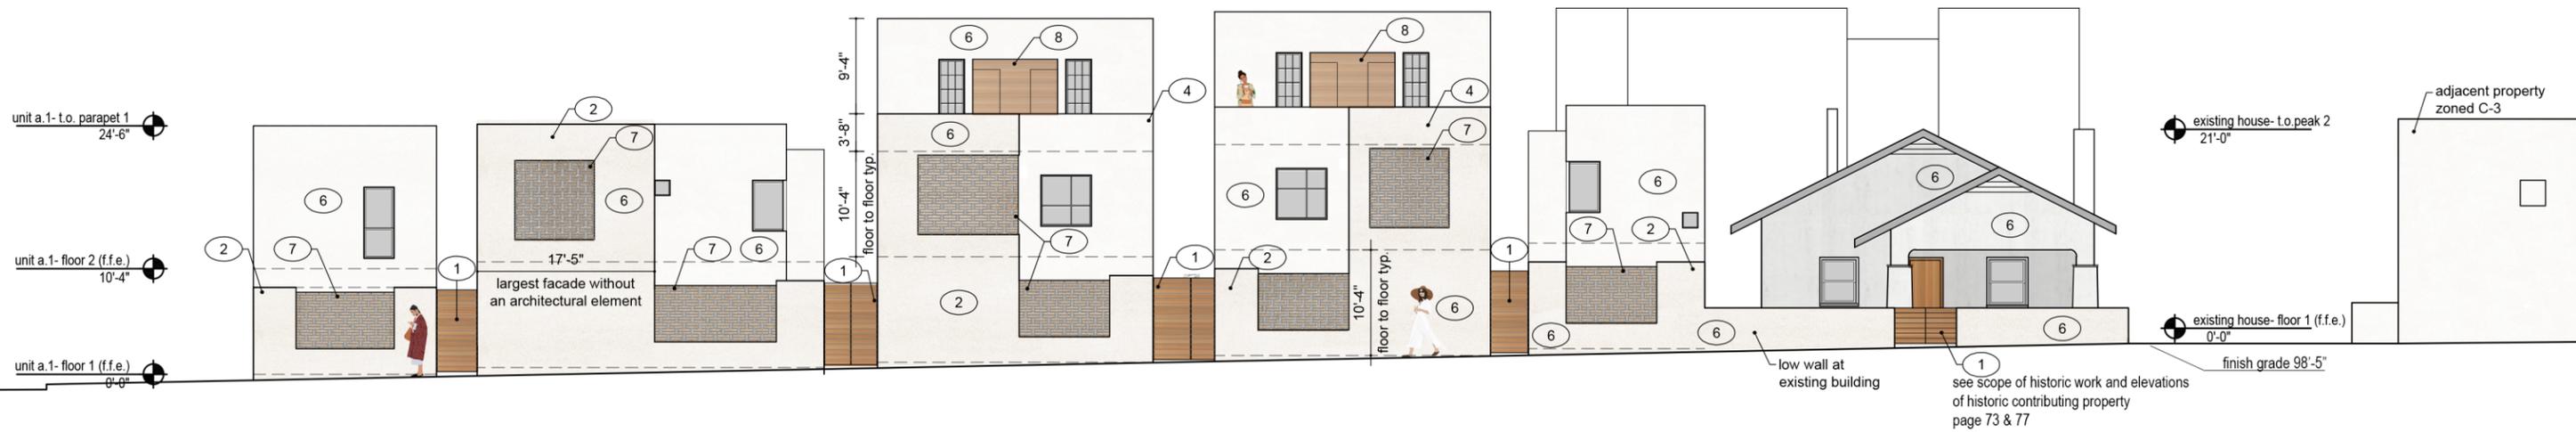
1 elevation along 18th street
scale 1/16" = 1'-0"

- 1. wood gate
- 2. site wall
- 3. low site wall
- 4. balcony for residents
- 5. carport garage door
- 6. smooth off-white stucco finish
- 7. light colored adobe block
- 8. wood clad

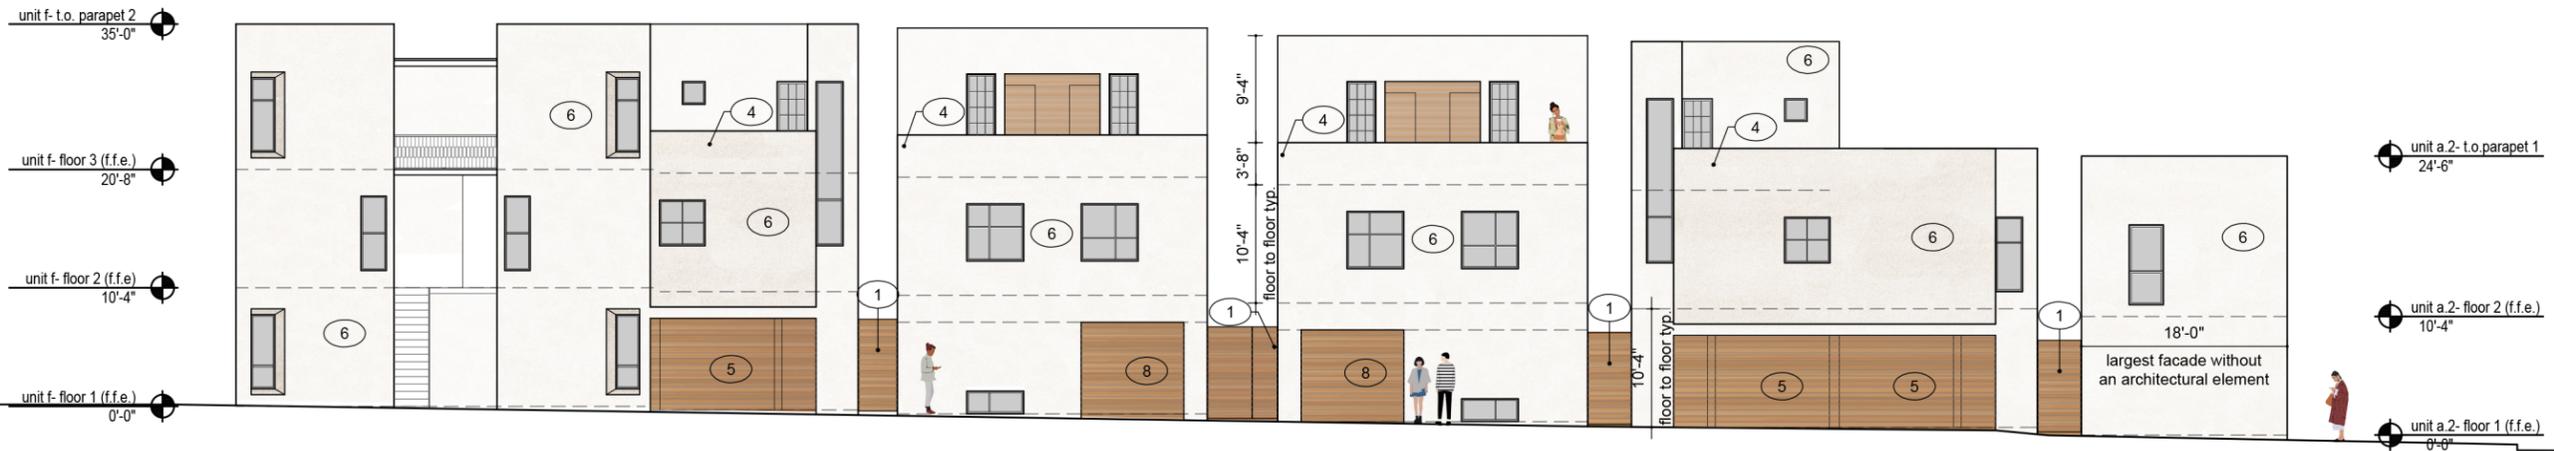
2 elevation along hobday way
scale 1/16" = 1'-0"

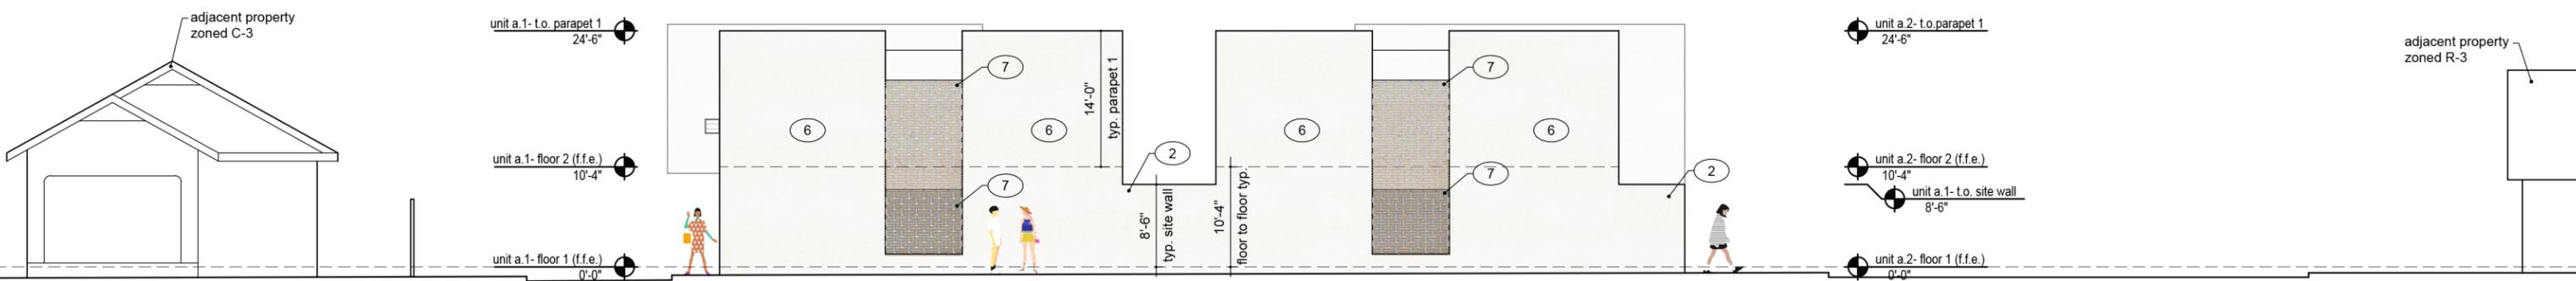
3 elevation along 7th avenue

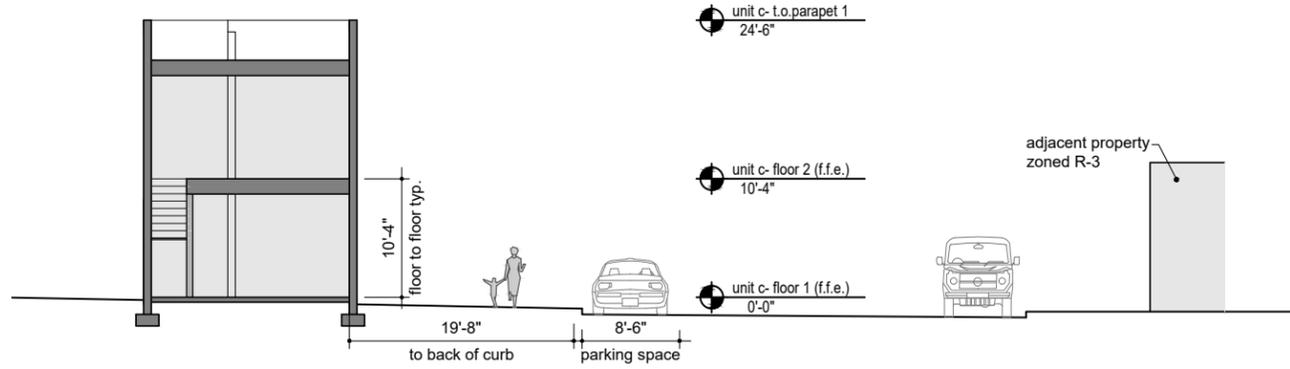
4 section

- 1. site wall
- 2. lot line
- 3. wood fence
- 4. resident's balcony
- 5. wood gate
