18 w 18

18 & 28 west 18th street
tucson, arizona 85701

CYPRESS
CIVIL DEVELOPMENT
strength + sustainability

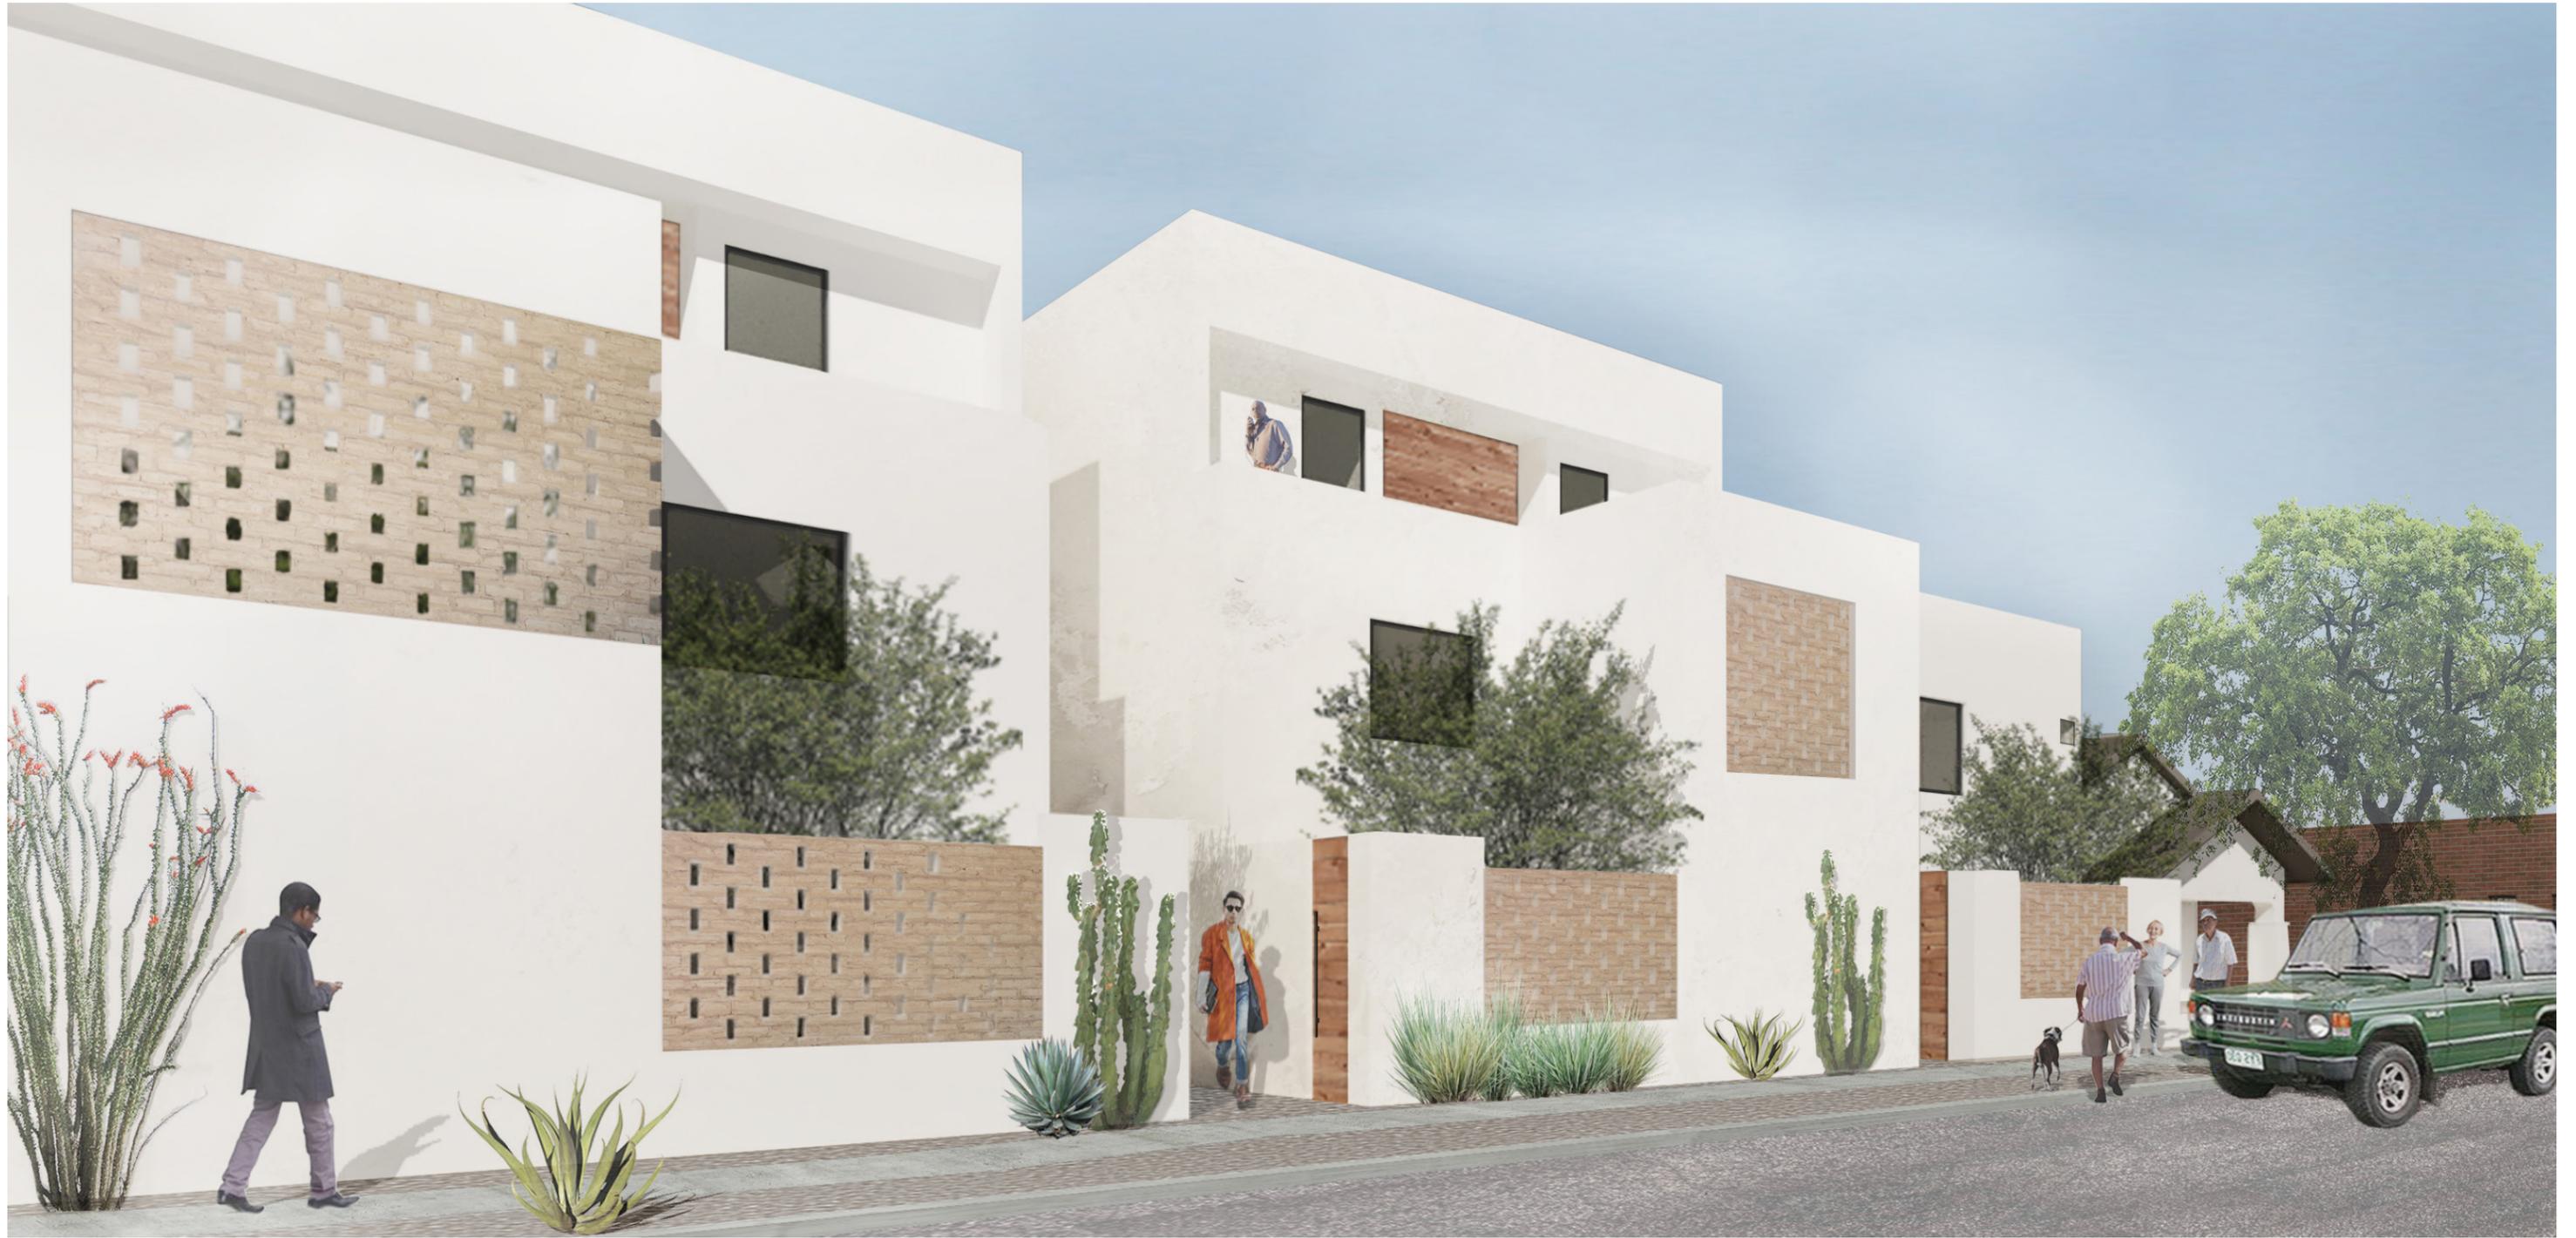
18th street looking NE

the urban edge is defined by white stucco walls that are perforated by adobe screens allowing the pedestrian to catch a glimpse of the green courtyards beyond. trees peek over the top of the first story courtyard walls with the third story balconies set back away from the sidewalk and street. in keeping with inspiration from the original row house of the barrio the window counts and sizes are limited which also aids in the potential solar heat gain from the southern sun.

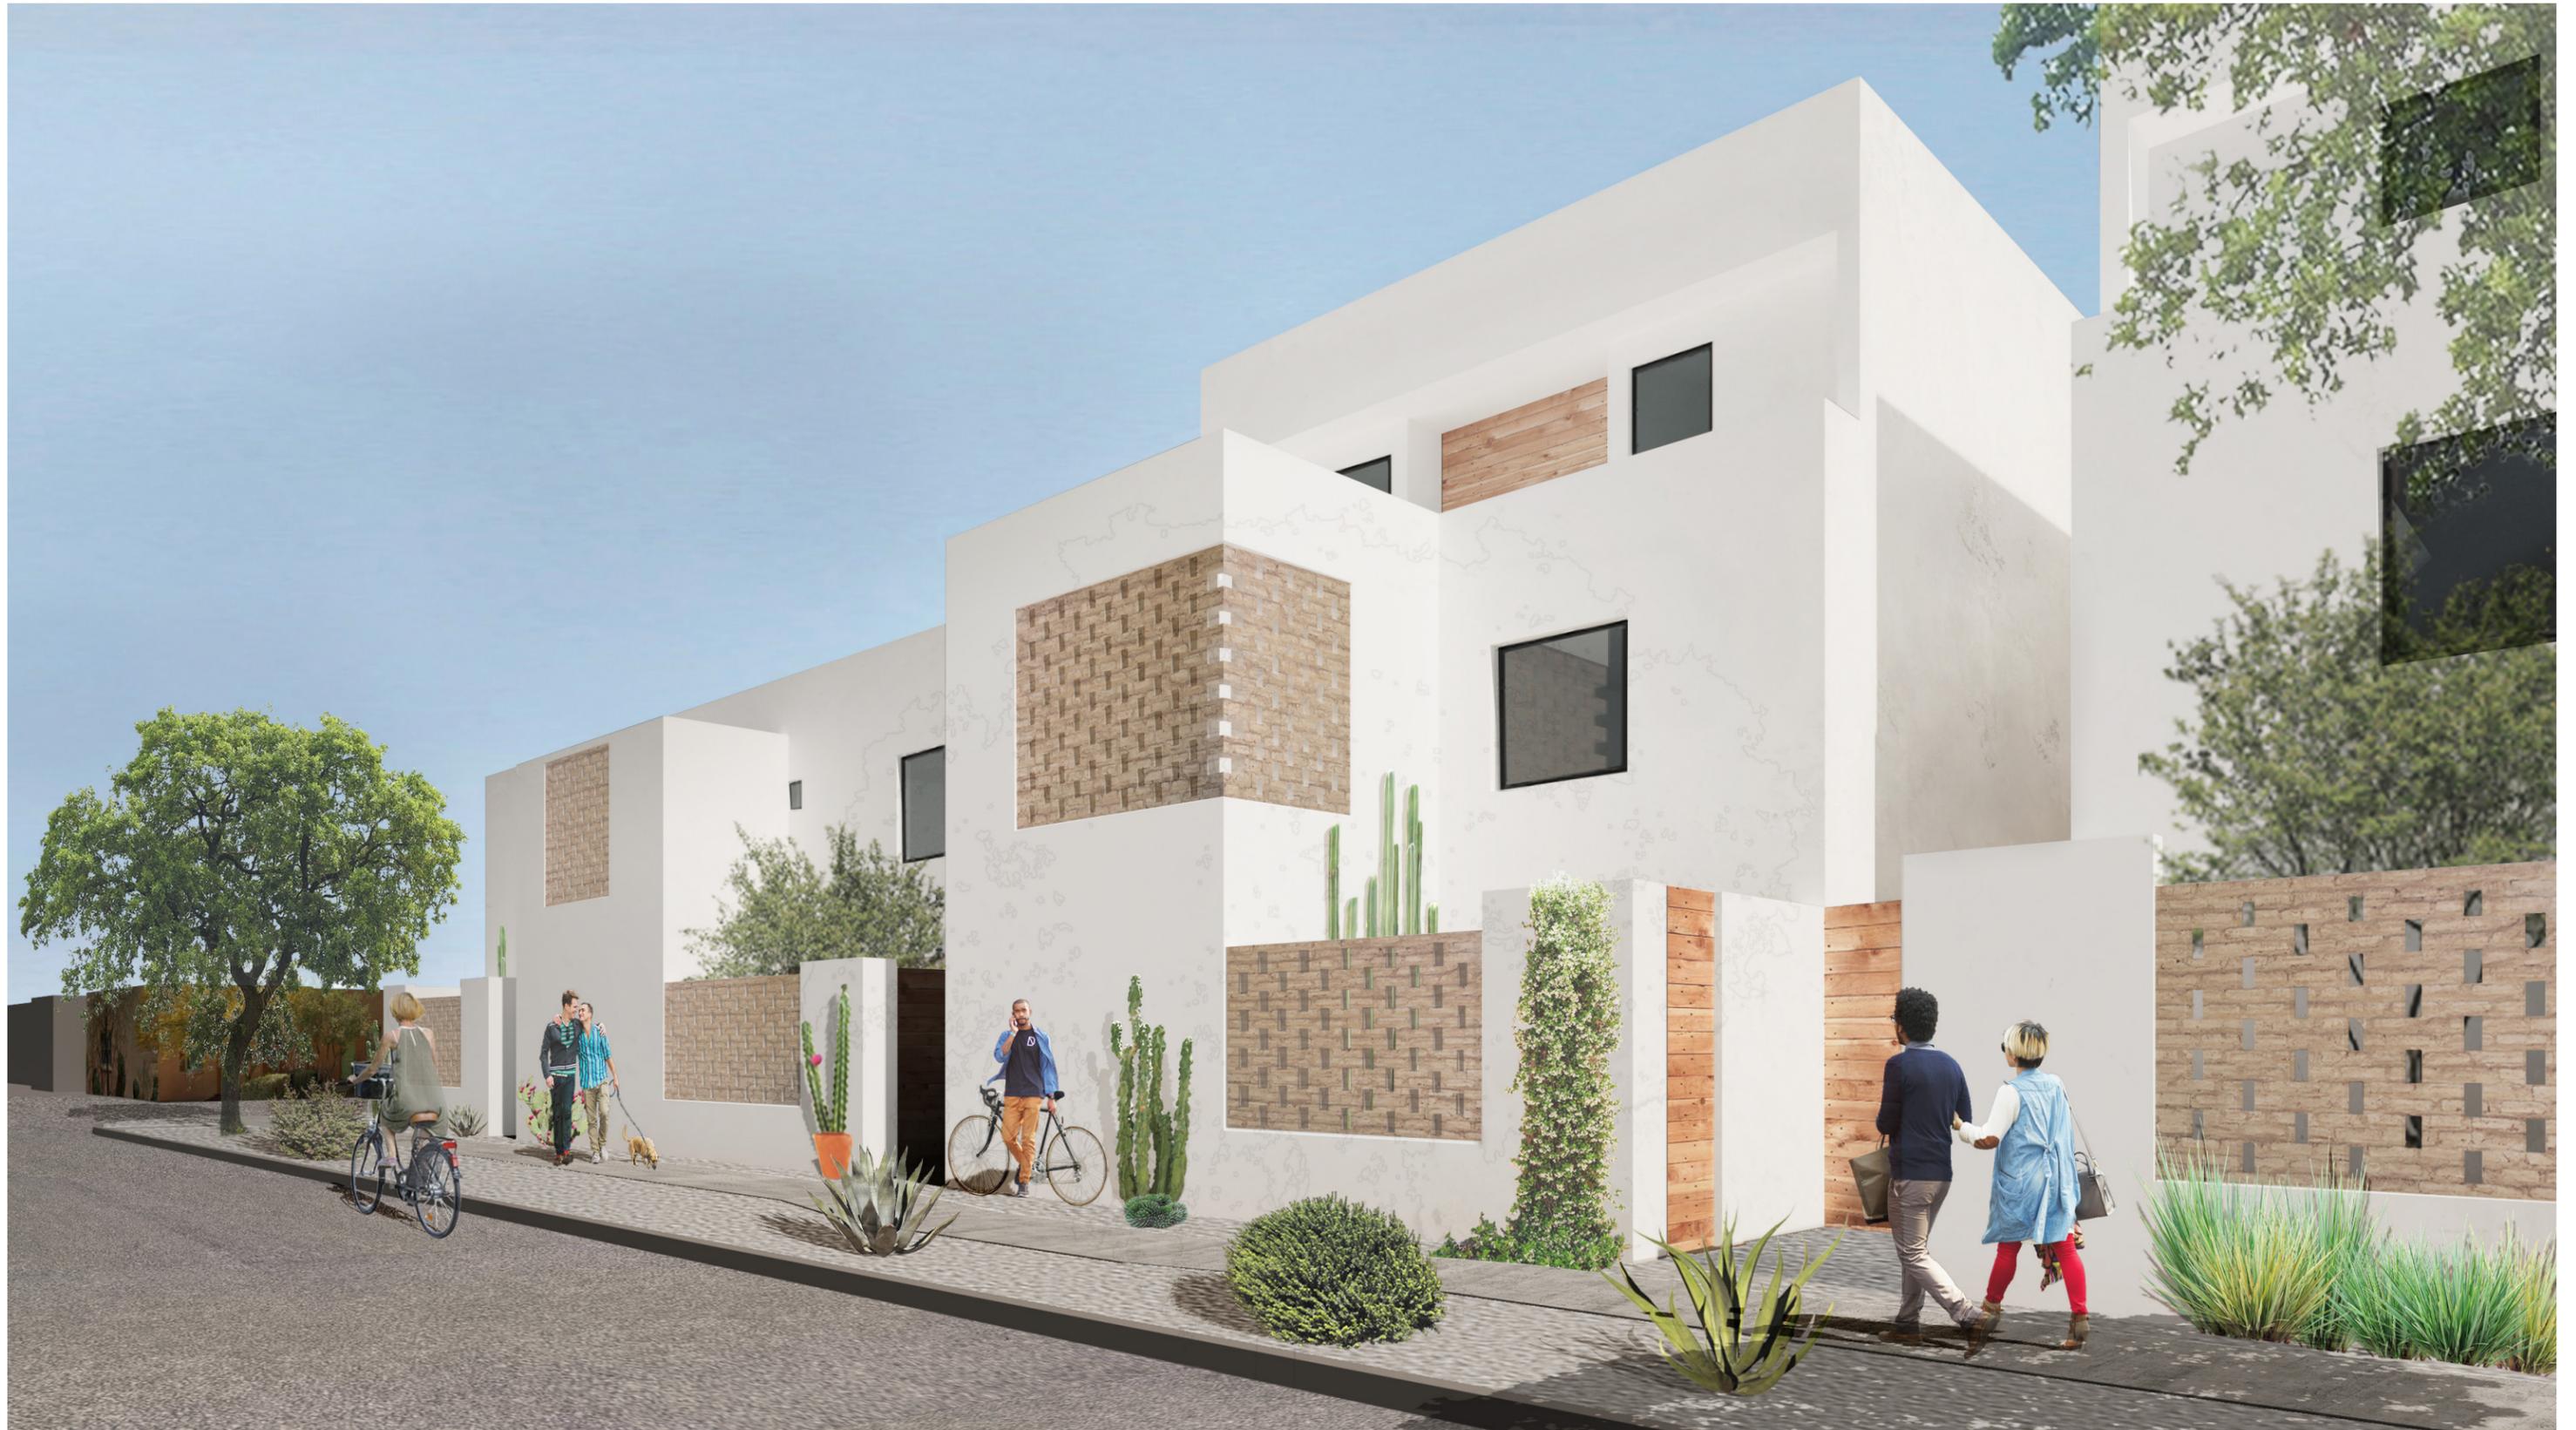
18th street looking NW

the street will be planted with native succulents and cactus, with the sidewalks shaded by ash trees.
the building masses step up and down along, and pull back from, the urban edge with a diversified
but restrained material palette reflective of the historic precedent in the barrio.

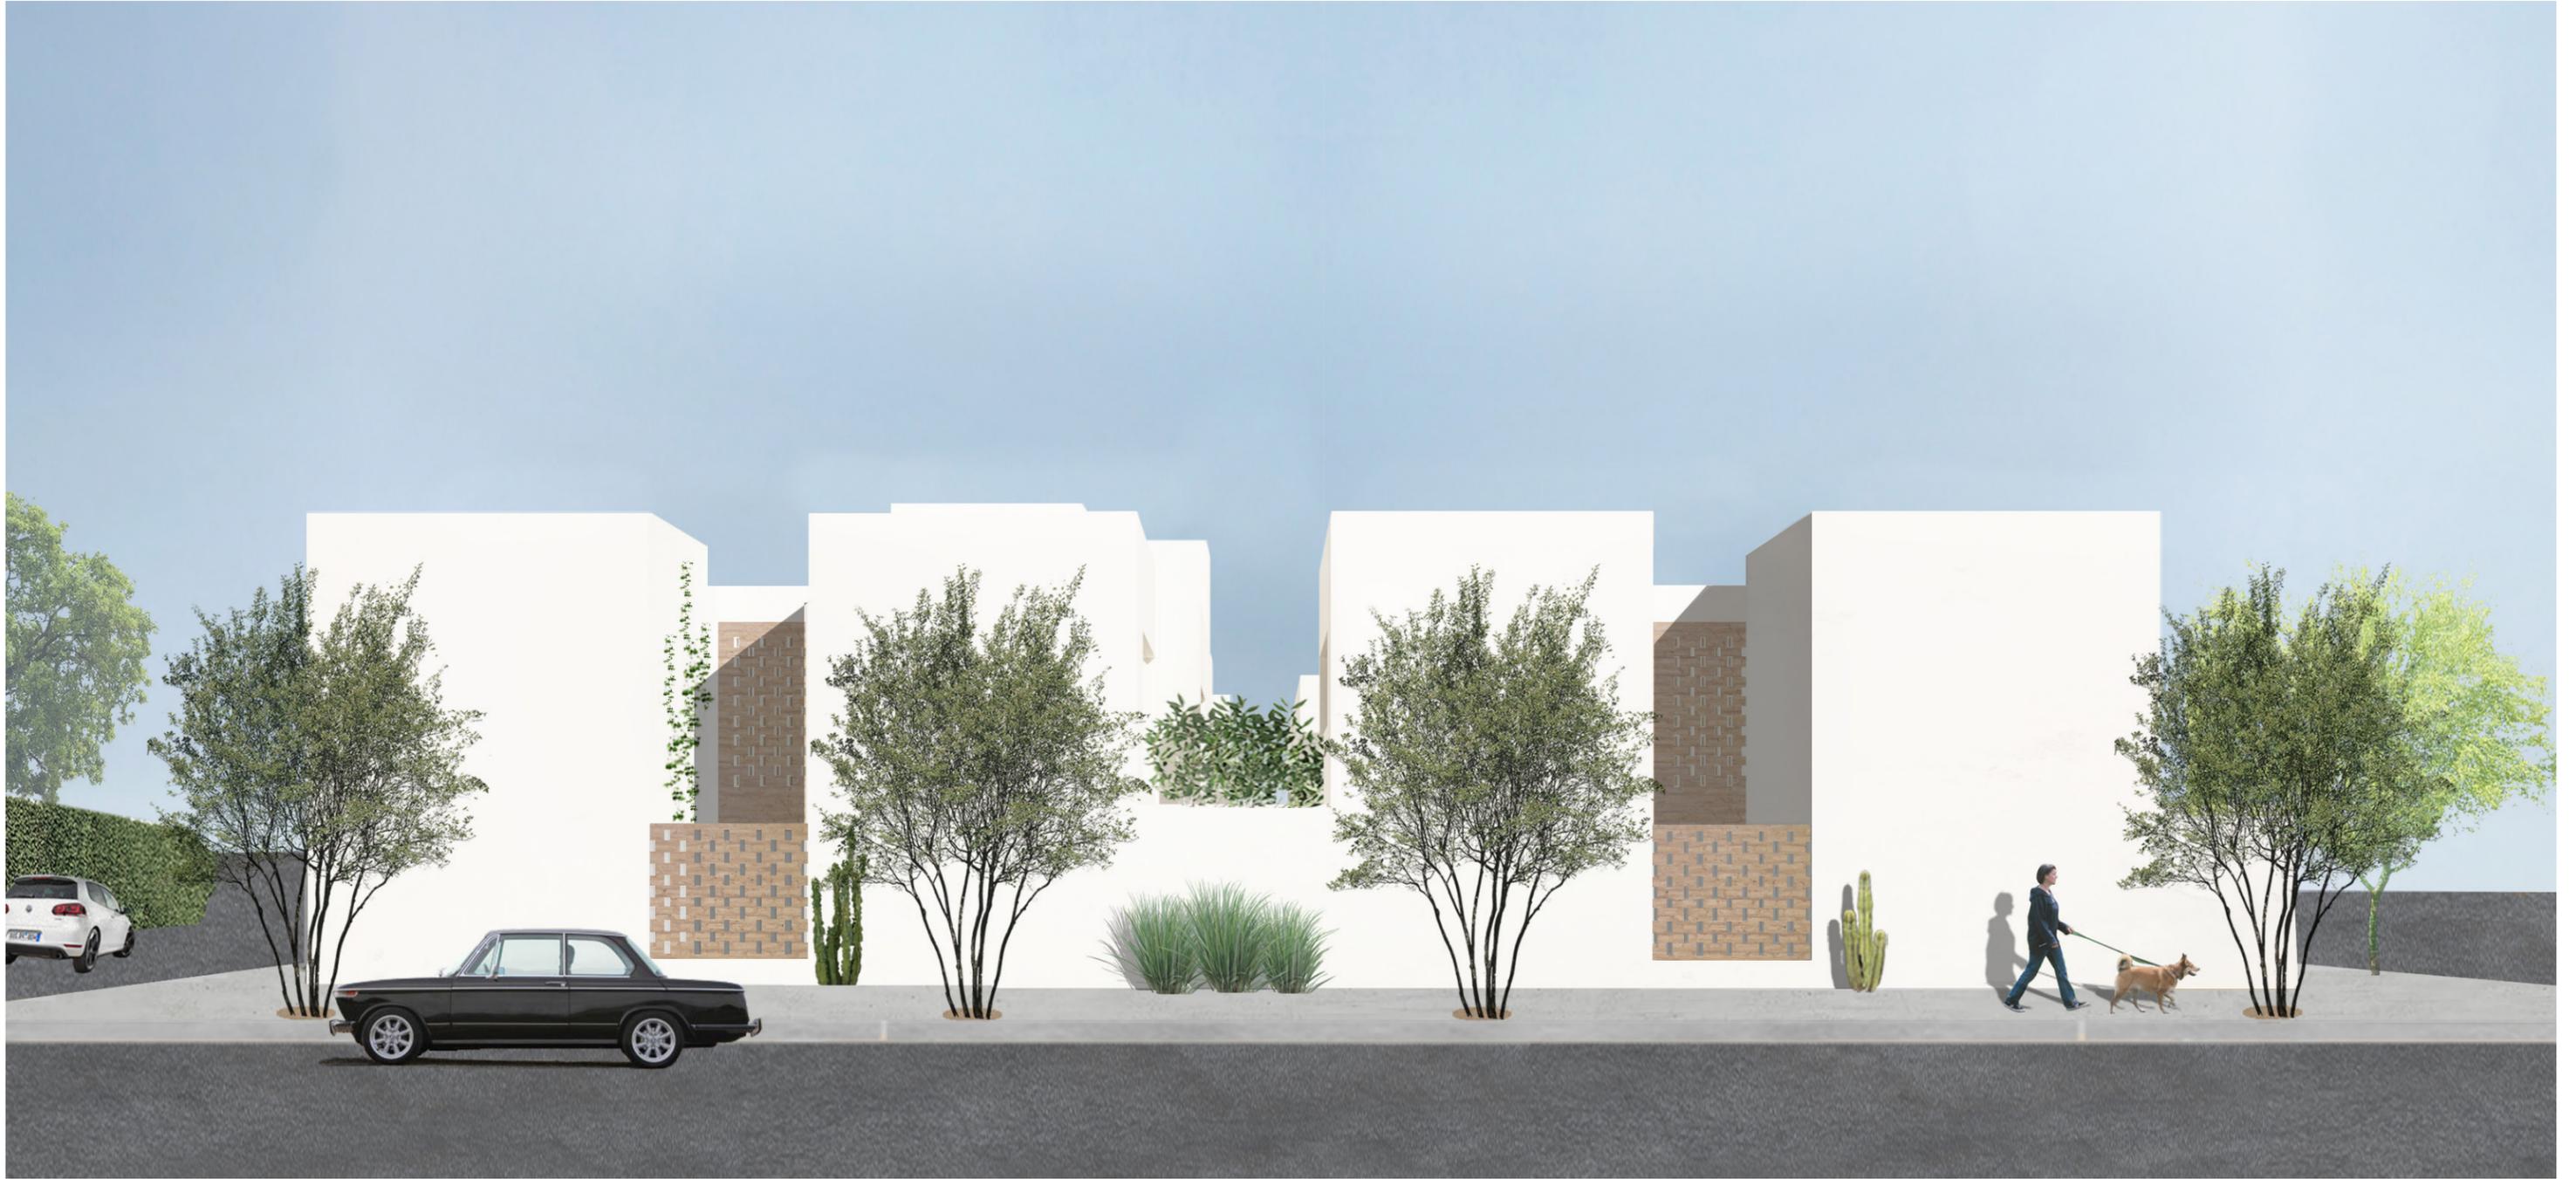
7th ave

western and southern facing fenestration is limited to prevent excessive solar heat gain, and a repetition in the massing of the building reflects the inspiration from the traditional row houses while also keeping the public facade from feeling like one very large blank wall.

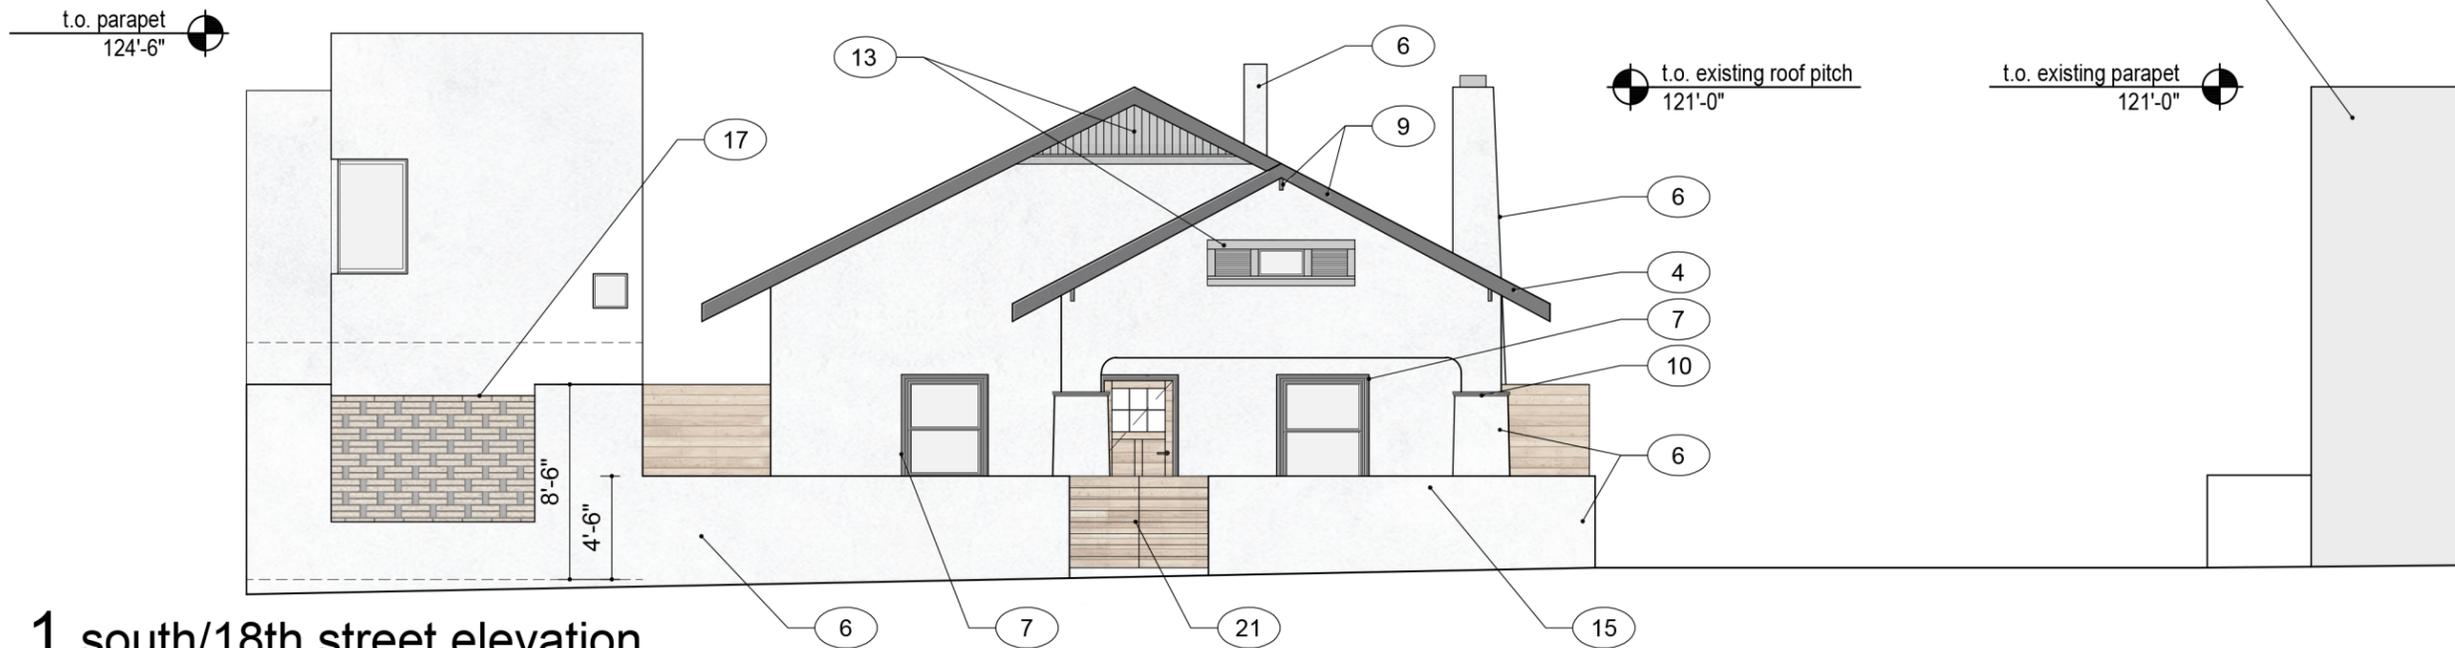
1 south/18th street elevation

- 7. existing window will be repaired in place. old glazing putty + glass removed. wood sash + frame repaired as needed. new sash cord provided to attach existing weights to existing sashes and new glass reinserted with new black glazing putty. frame + sash should be repaired with care to avoid painting glazing putty.

- 8. front door frame will be repaired and a new craftsman style solid wood door with insert panel + glass tiles above the cross rail.
- 9. wood fascia + rafter tail painted dark grey

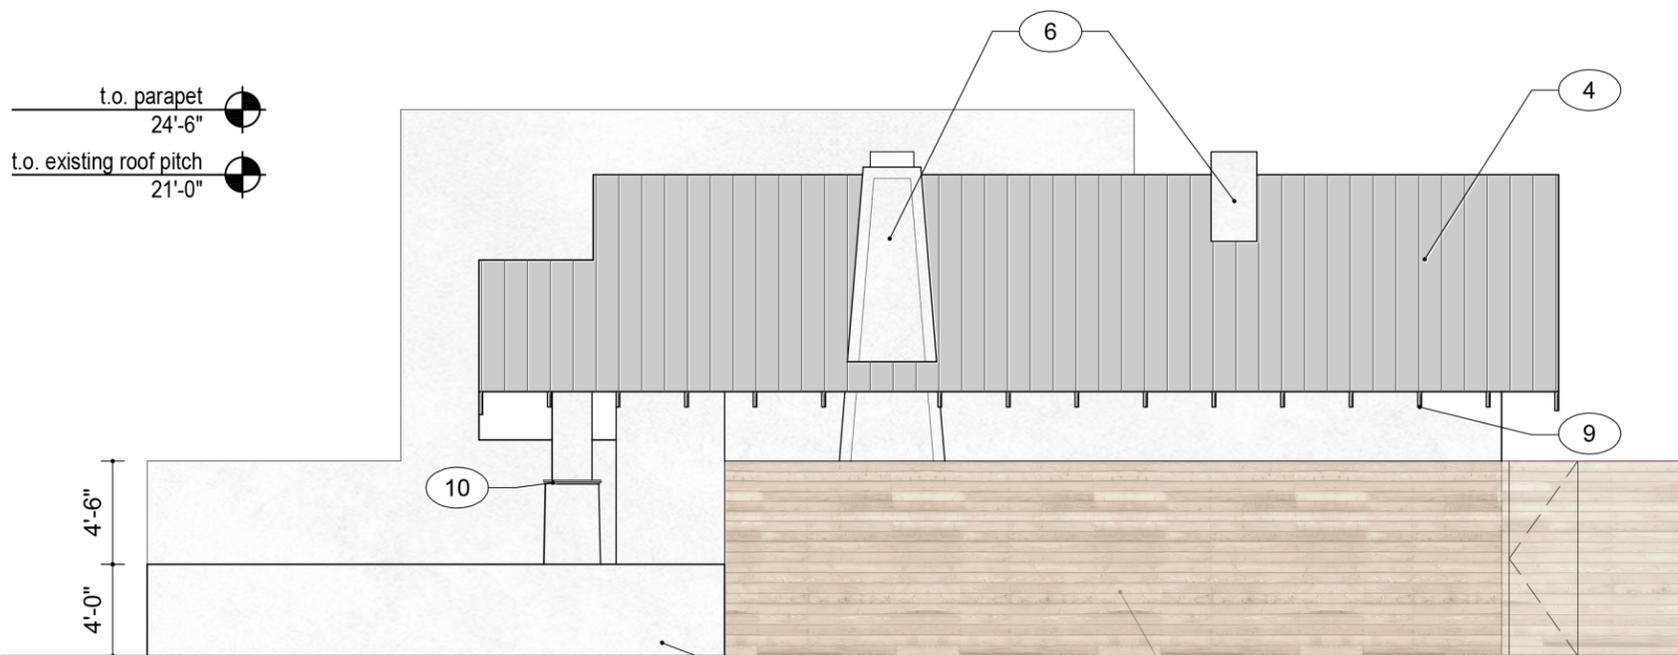
1 east/russell ave. elevation

t.o. parapet 24'-6"
t.o. existing roof pitch 21'-0"
