SUBJECT Industrial Wastewater Discharge Permit Self-Monitoring Report Form
City of Tucson Fire and Police Headquarters
UST Facility ID 0-005176
LUST File No. 3208.01
PCWW Permit No. 12916
265 South Church Avenue, Tucson, Arizona

Appendix D Pima County Regional Wastewater Reclamation Department Industrial Waste Water
Control Section Inspection Report

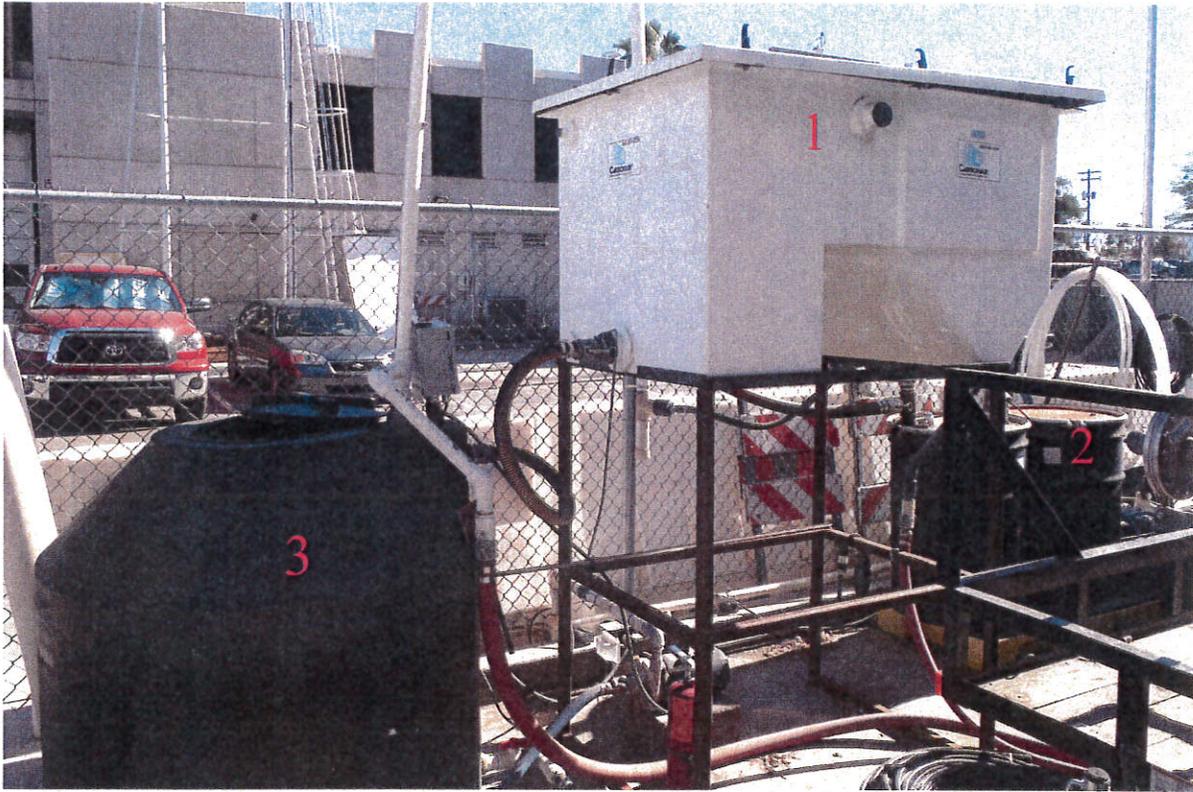
Pneumatic pumps continuously pull water from at least one of three wells and discharge into an oil and water separator (1). Oily or fuel containing water is discharged into the 55 gallon drums (2) mentioned above and the remaining water is fed into a 300 gallon poly tank (3).

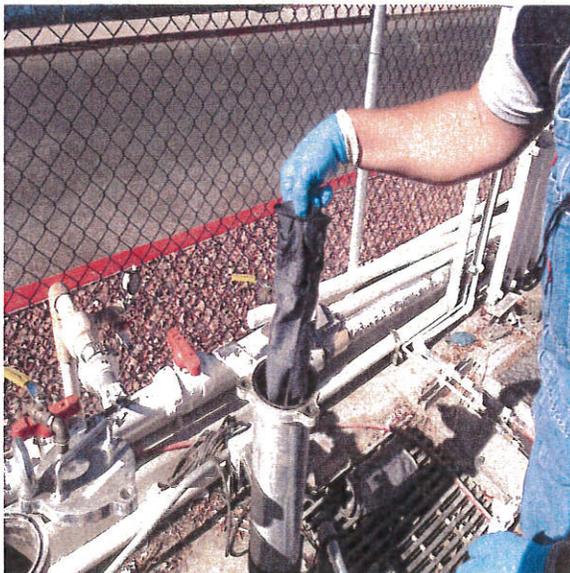
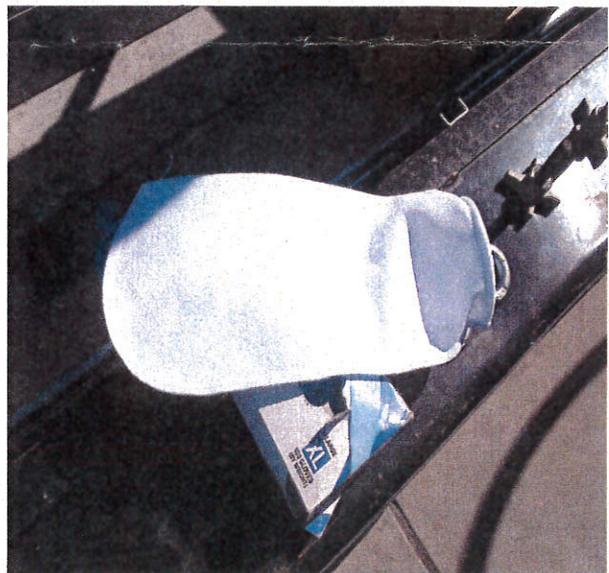
Water is pumped from the poly tank through a liquid filter sleeve, which was changed a week before September 16th. The left picture below shows the sleeve after a week's worth of use. The right picture shows a new sleeve prior to installation.

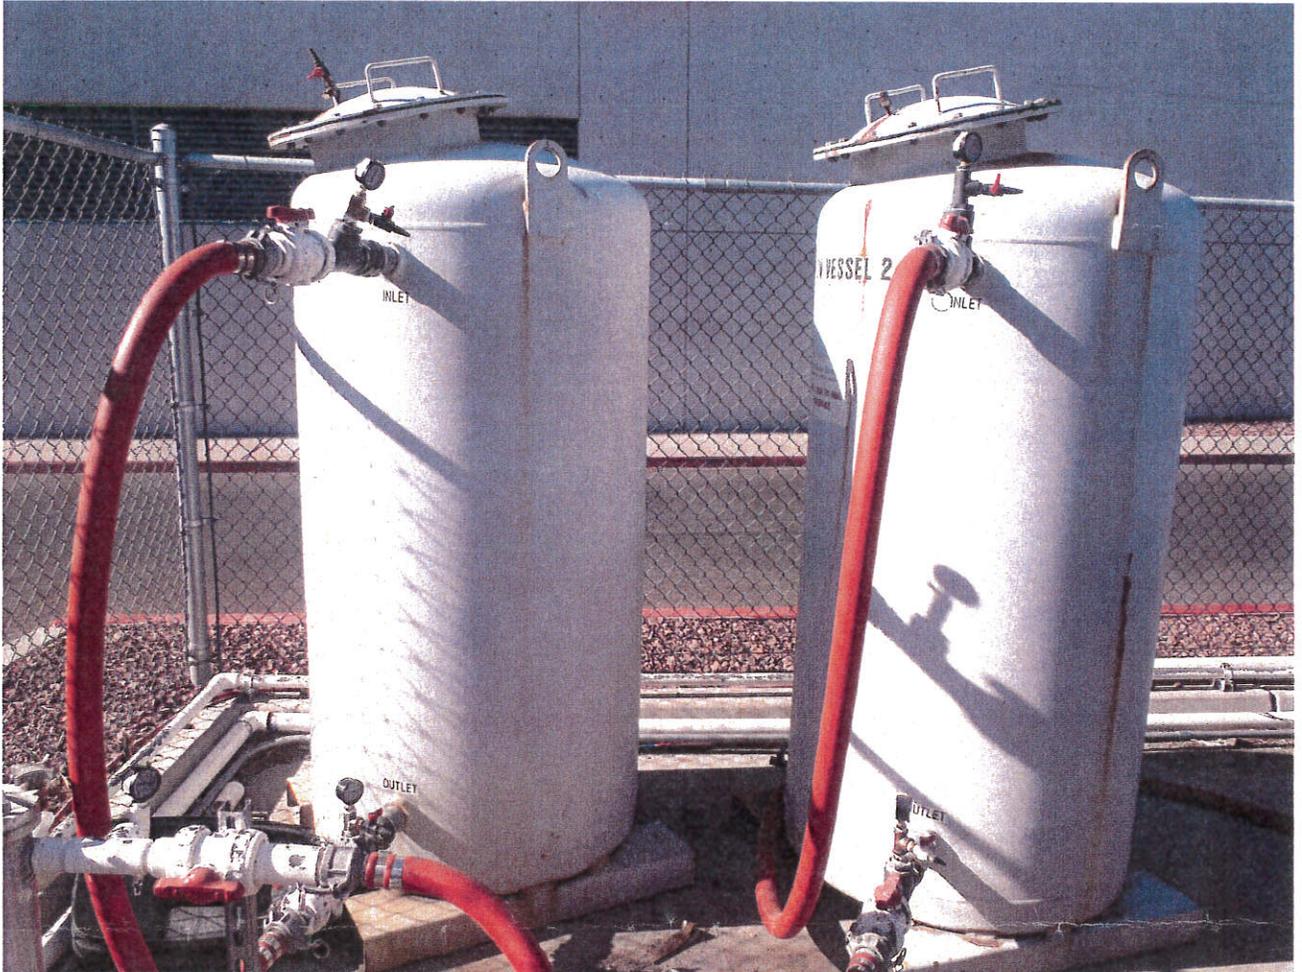
Following the liquid filter, the water is pumped through a two stage G.A.C (granulated activated carbon) filter system. (Flow enters vessel #2 and discharges into vessel #1).

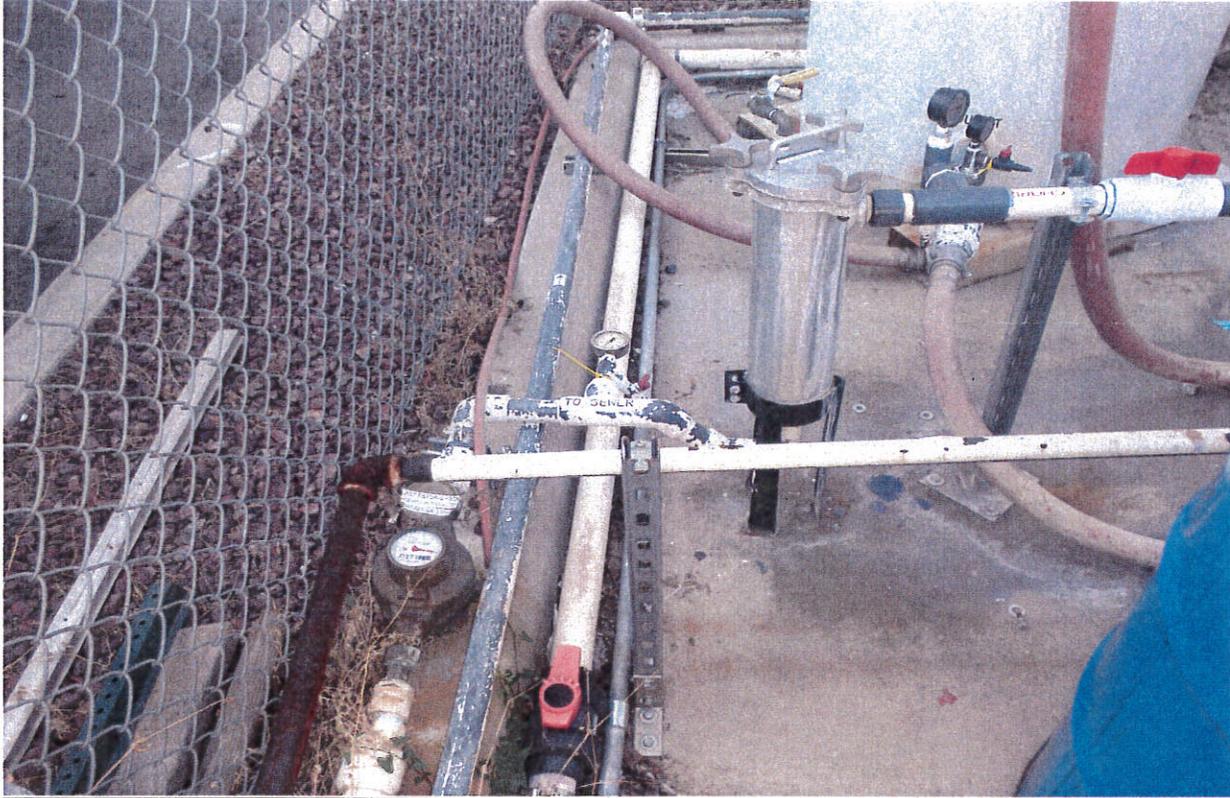
Samples shall be taken at the sampling valve on the discharge side of the package treatment plant immediately following the second liquid filter. Samples were taken on September 23, 2014 at 0840 from the sampling valve on the discharge side of the package pretreatment plant. These samples were submitted to the Pima County Regional Wastewater Reclamation Department Compliance and Regulatory Affairs Office Laboratory for analysis of permitted parameters (Lab ID 1409188). Results are pending.
