SCOPE OF WORK

ROOF
REPAIR

THE TREEHOUSE
528 N 1ST AVE.
Tucson, AZ 85719

A1
COVER PAGE

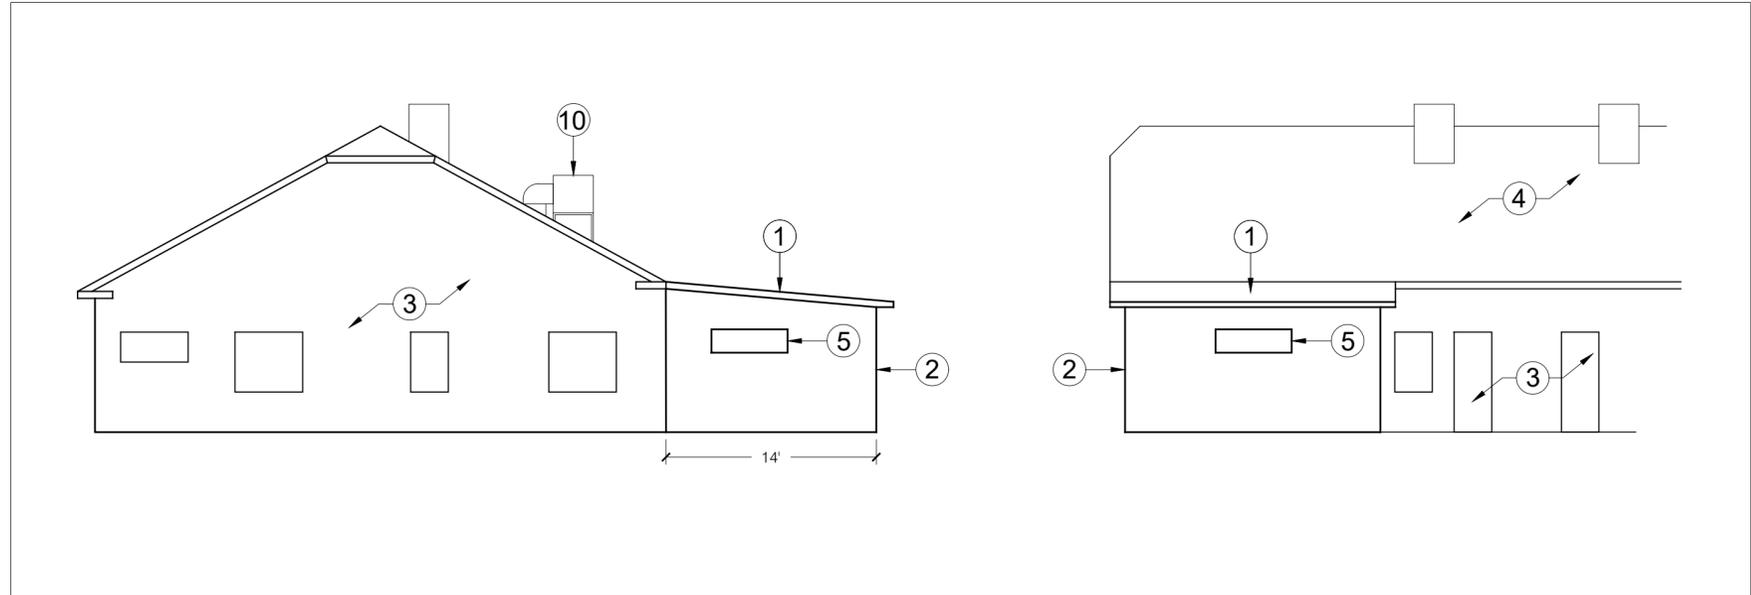
AS-BUILT

- ① FAILING SHED ROOF TO BE REMOVED
- ② EXISTING ADDITION WALL STRUCTURE TO REMAIN
- ③ EXISTING MAIN HOUSE TO BE UNTOUCHED
- ④ EXISTING MAIN HOUSE ROOF TO REMAIN UNTOUCHED. SHASTA WHITE ASPHALT SHINGLE
- ⑤ EXISTING WINDOW TO REMAIN
- ⑥ NOTCH STUCCO TO BETTER DELINEATE EXISTING STRUCTURE FROM ADDITION
- ⑦ NEW GABLE END
- ⑧ REPLACEMENT ROOF MATCHING FRONT GABLE STYLE AND SHASTA WHITE ASPHALT SHINGLE
- ⑨ MATCH FASCIA SIZING TO EXISTING
- ⑩ EXISTING EVAPORATIVE COOLER TO BE REMOVED AND HOLE REPAIRED
- ⑪ NEW TURBINE ROOF VENT TO MATCH EXISTING

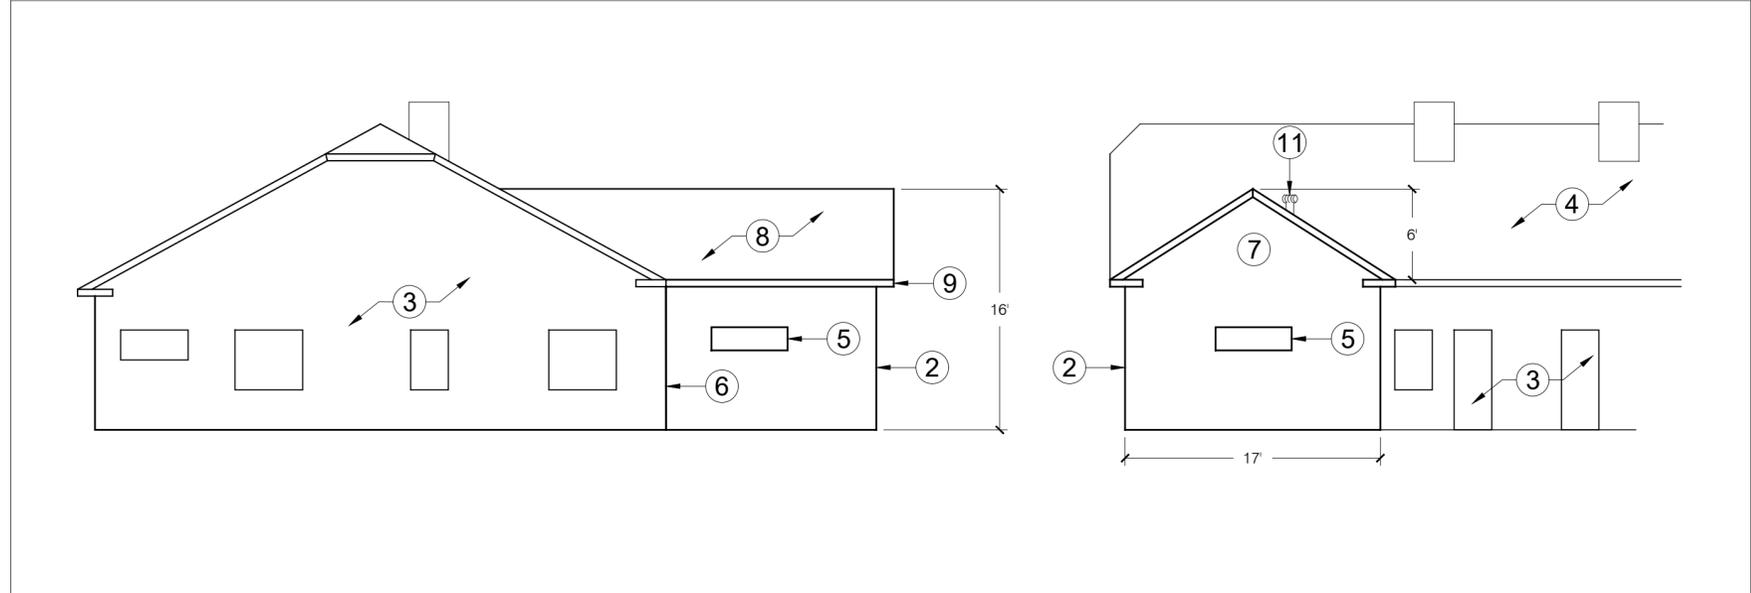
PROPOSED

- REPAIR EXISTING FAILING SHED ROOF BY BUILDING NEW SHORT GABLED ELEMENT IN SAME LOCATION ON EXISTING WALL STRUCTURE
- REMOVE ROOF MOUNTED SWAMP COOLER
- NOTCH LINE IN WALL STUCCO TO DIFFERENTIATE ADDITION FROM MAIN DWELLING
- NEW SHINGLES TO MATCH EXISTING SHASTA WHITE 3TAB ASPHALT SHINGLE
