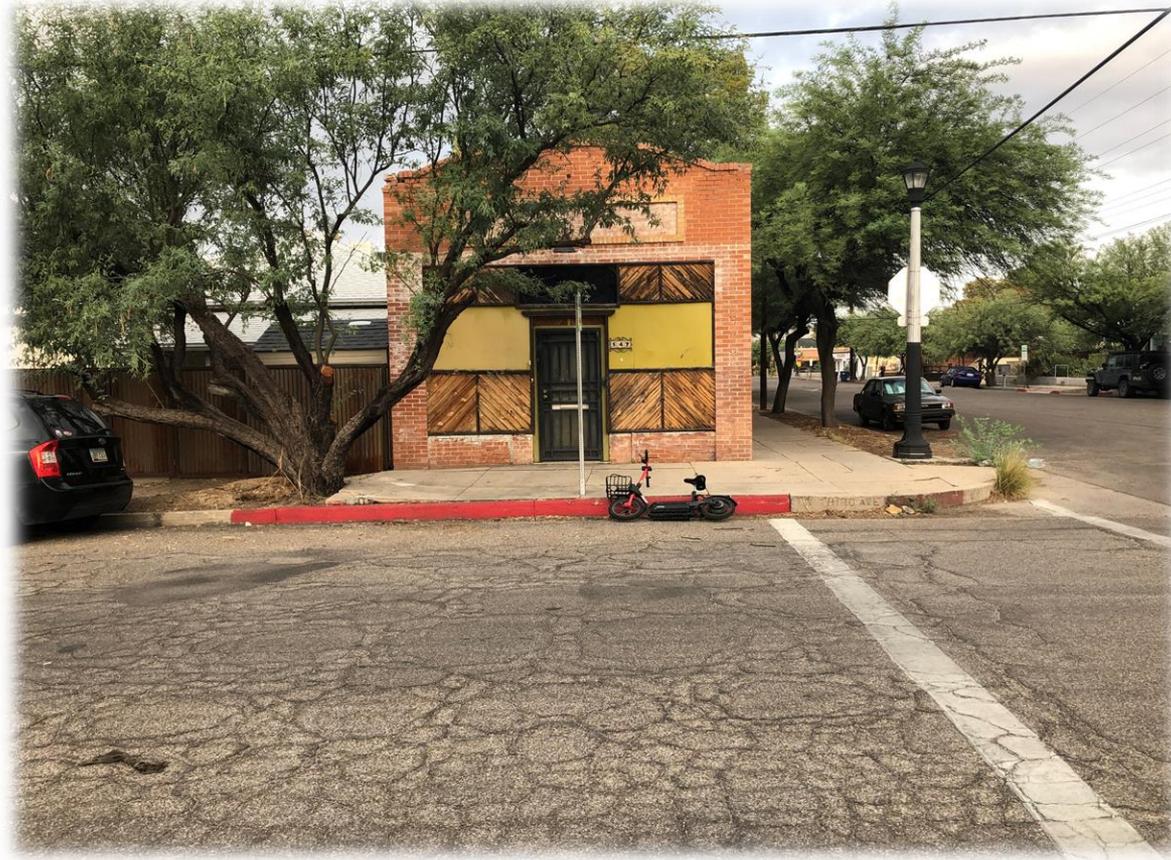
547 E. 5th Street

Brick territorial building with modified store front .

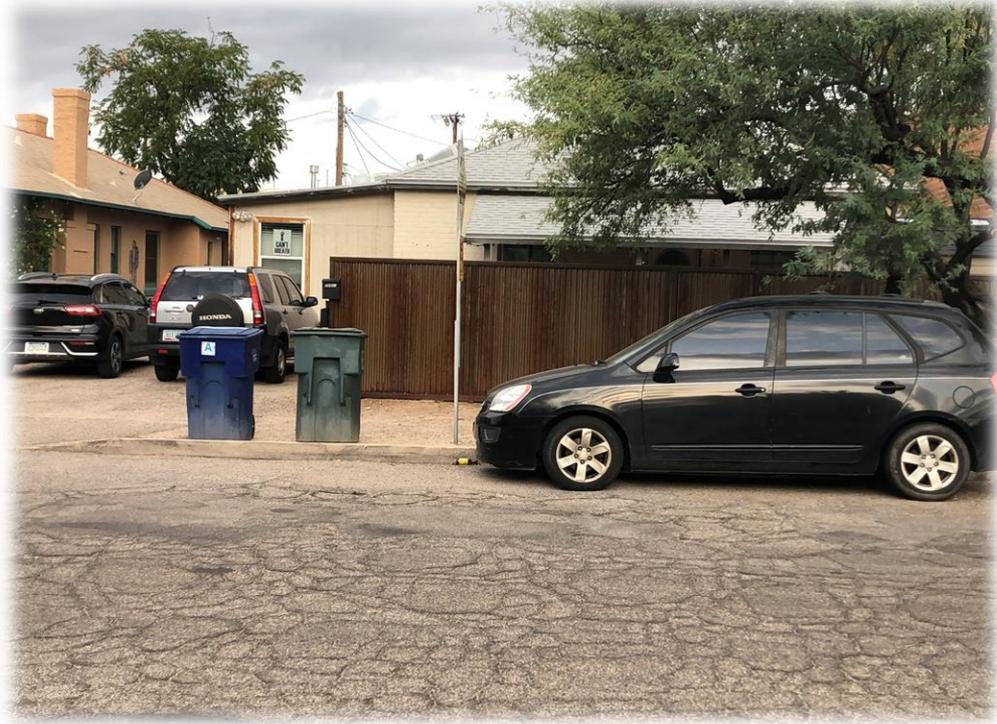
599 N. 3rd Avenue .

Painted brick Territorial house with hip roof and shed roof addition with T-111 siding.

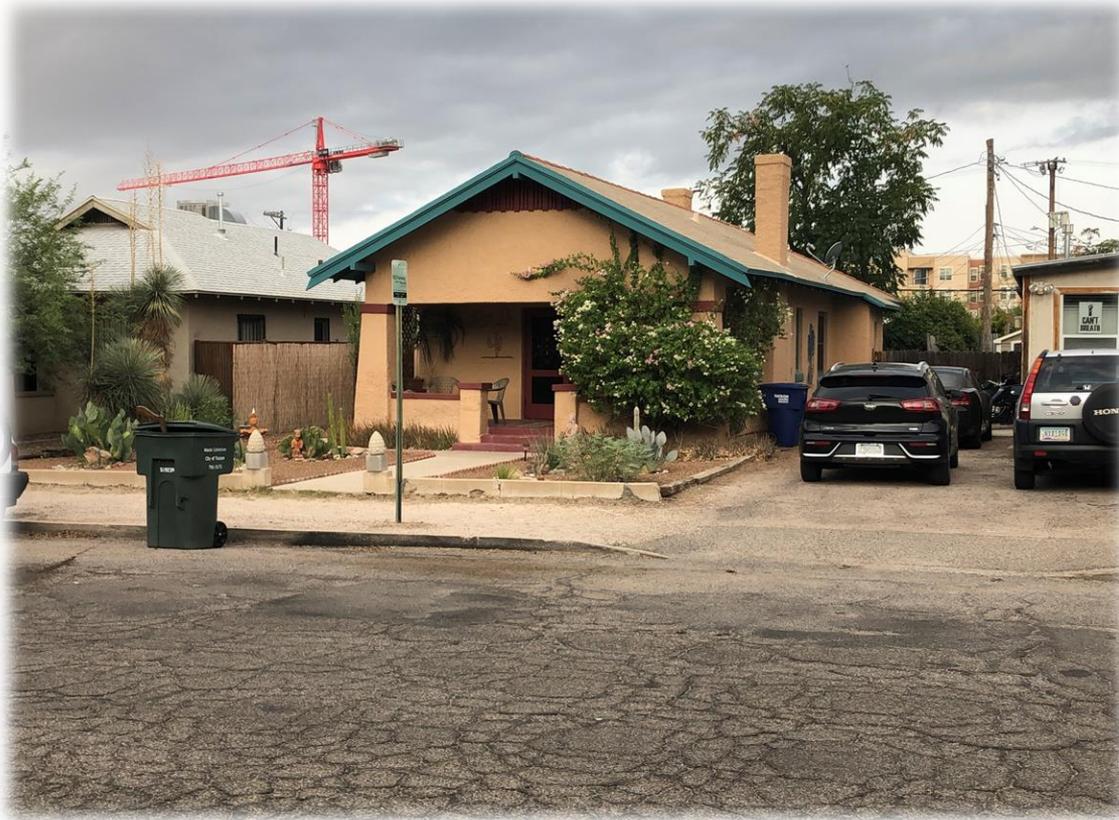
591 N. 3rd Avenue

Bungalow Style with smooth trowel stucco finish. Porch and Main house with Gable roof. The house has a pop out portion with a setback approximately 3ft from north the north property line .

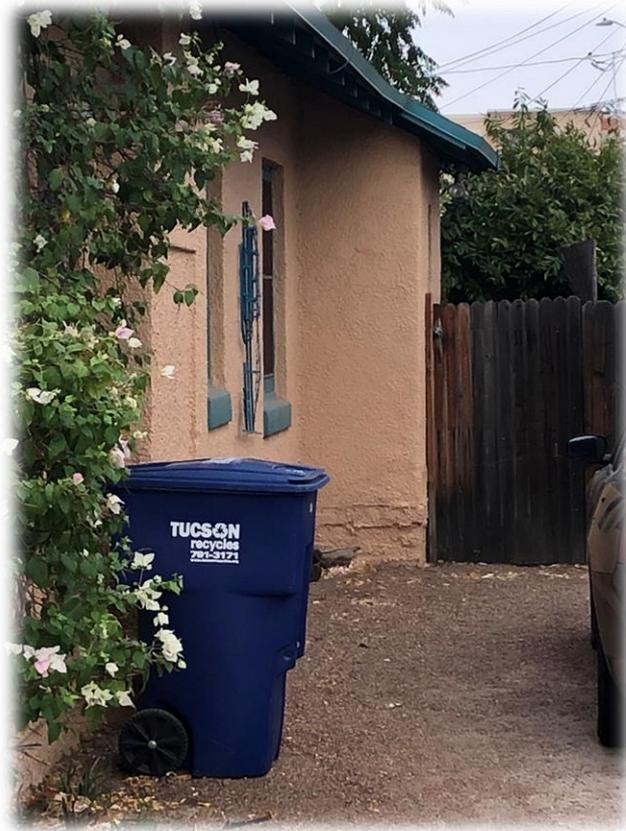
591 N. 3rd Avenue Detail

Building detail showing a 3.5' setback on north property line between 591 and 599 N. 3rd. Ave.

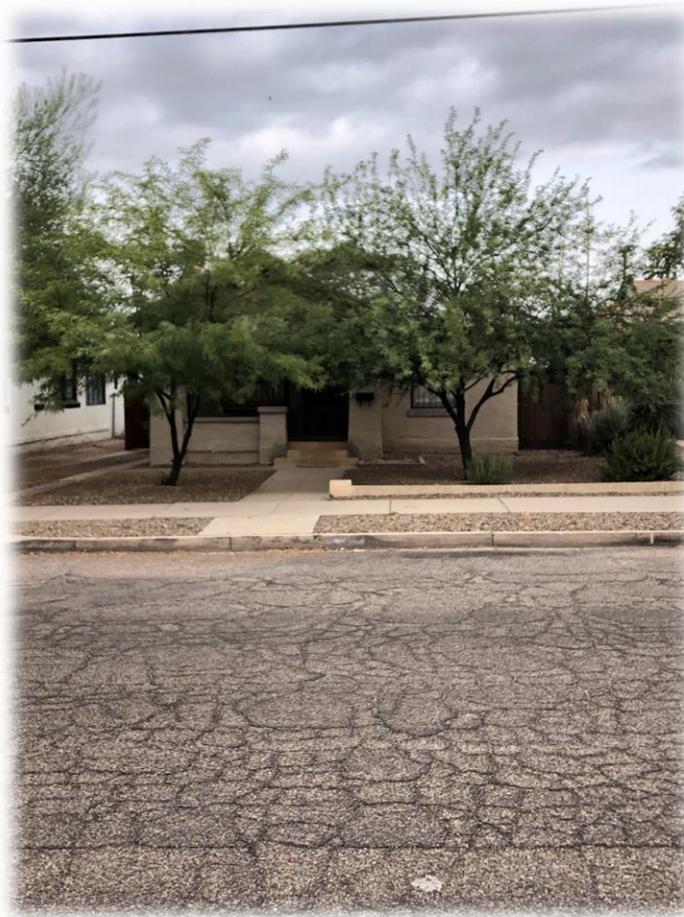
535 N. 3rd Avenue

Bungalow style contributing style with exposed smooth stucco finish Double hung wood windows. Porch with gable roof and attic vent. Gable roof with asphalt shingles

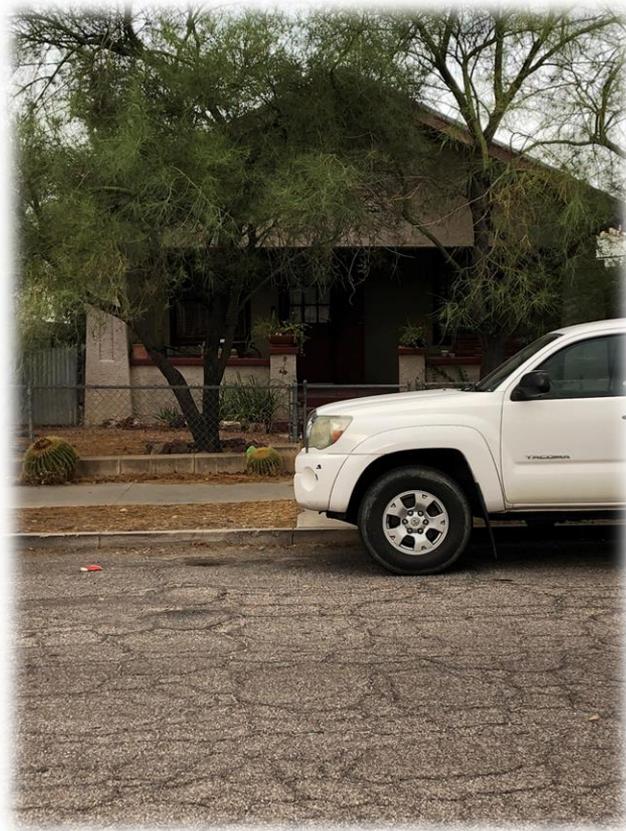
517 N. 3rd Ave.

Kirk property existing house Bungalow style with front porch, gable roof with dormer attic vent, asphalt shingles and rough stucco finish .

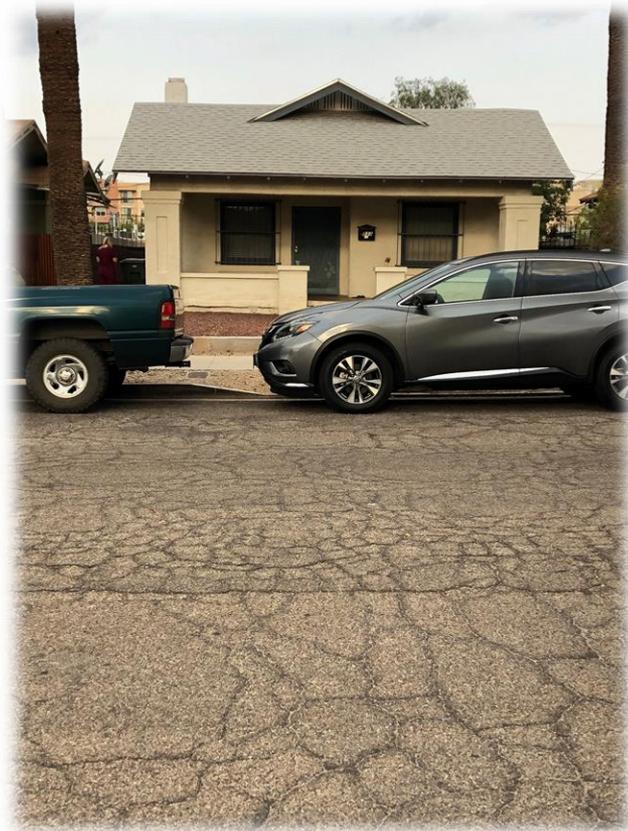
513 N. 3rd Ave.

Bungalow style with front porch, gable roof with dormer attic vent, asphalt shingles and stucco finish .

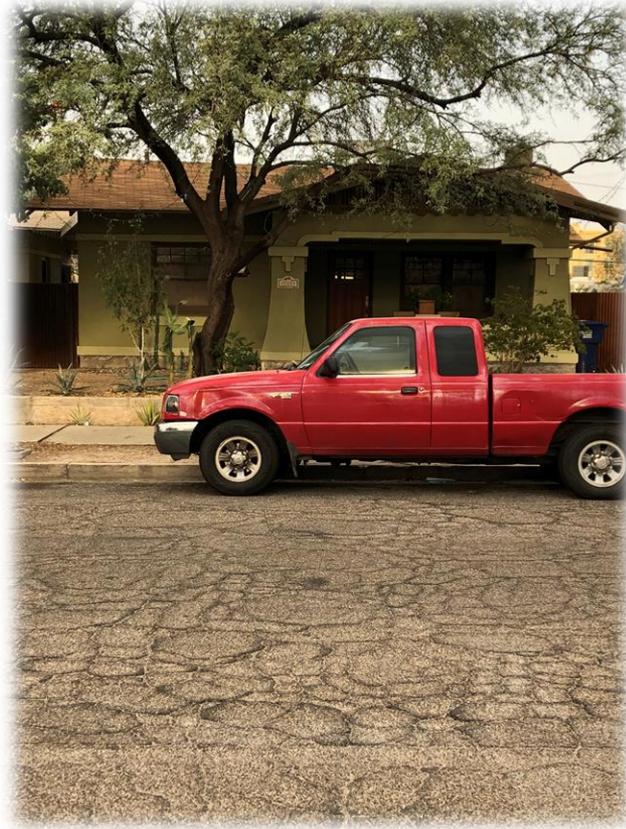
511 N. 3rd Avenue

Bungalow style with front porch, gable roof with attic vent, asphalt shingles and stucco finish .

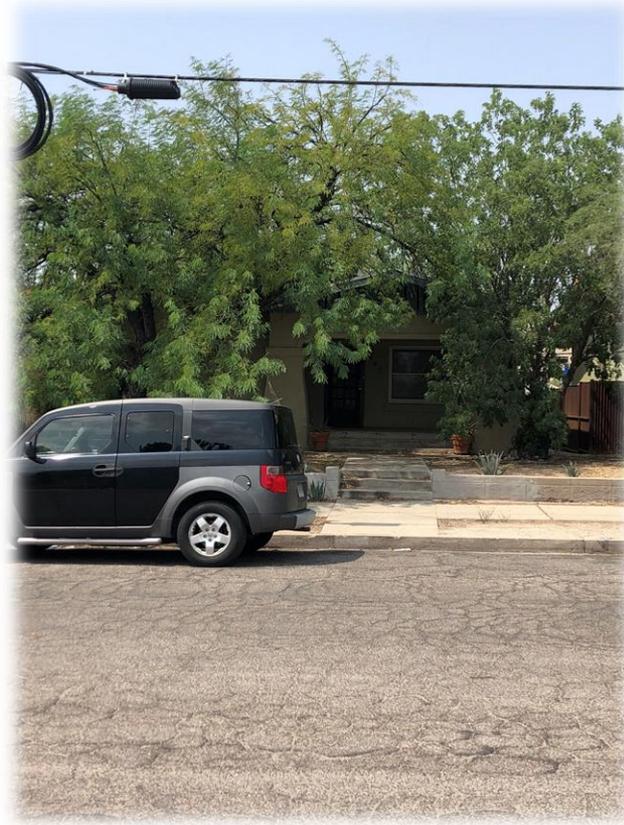
507 N 3rd Avenue (Detail)

Bungalow style with front porch, gable roof with dormer attic vent, asphalt shingles and stucco finish .

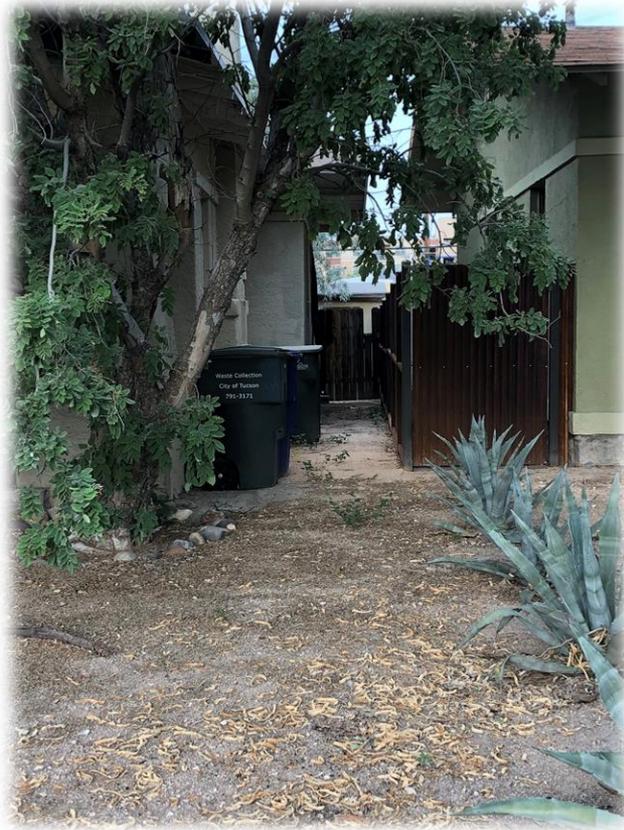
507 N 3rd Avenue (Detail)

Building detail showing the 3.5' setback from the north property line between 507 and 511 N. 3rd Avenue

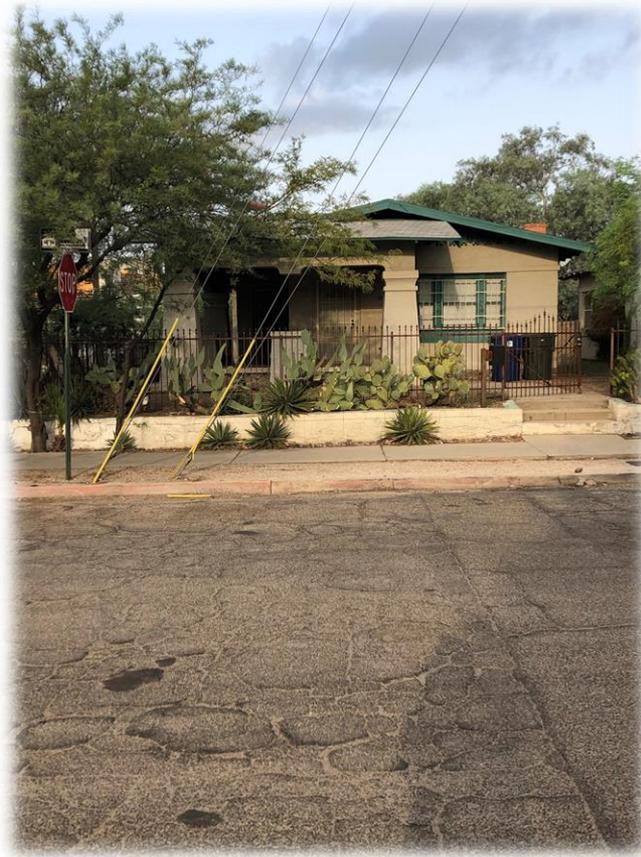
503 N. 3rd Avenue

Bungalow style with front porch, gable roof with dormer attic vent, asphalt shingles and stucco finish .

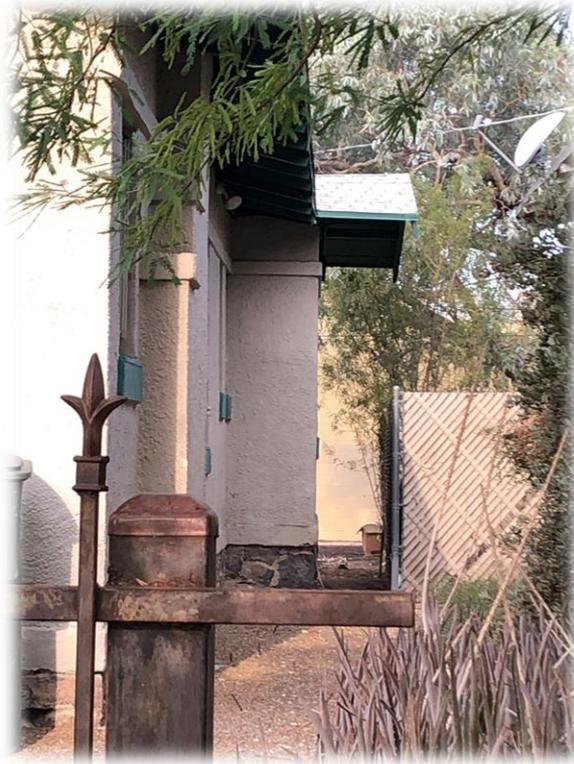
503 N 3rd Avenue (Detail)

Building detail showing the 3.5' setback from the north property line between 503 and 507 N. 3rd Avenue
