ADA Bus Stop Accessibility Study

Study Background & Significance:

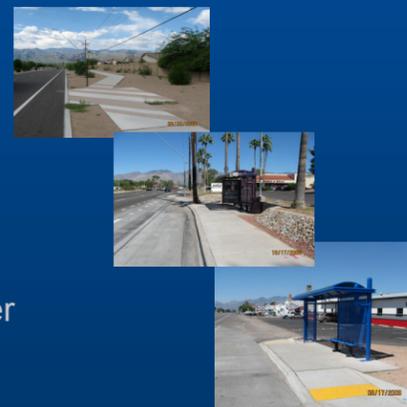
Definition of an Accessible Bus Stop:

- Minimum wheelchair lift area
- Continuous Sidewalks
- Accessible Curb (cuts) Ramps at street/alley intersections
- Wheelchair bay if stop has shelter

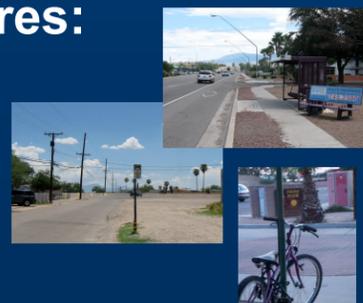
Other Inventoried Features:

- Lighting within 10 feet
- Trash cans
- Bike racks
- Route display cases & maps
- Shade / shelter(s)
