Update on CAP Canal Breach

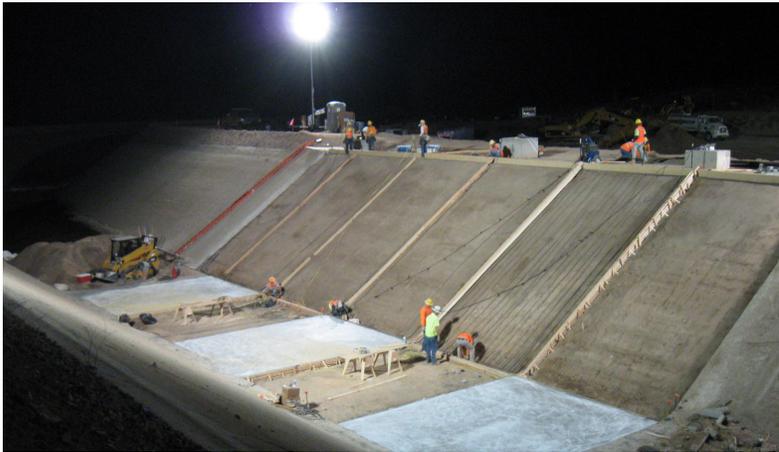
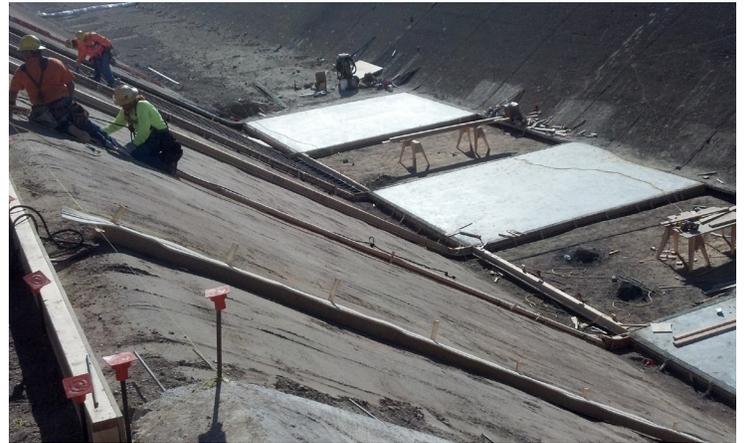
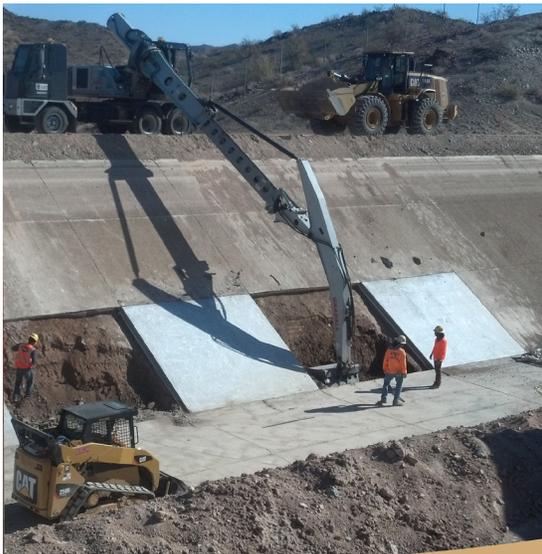
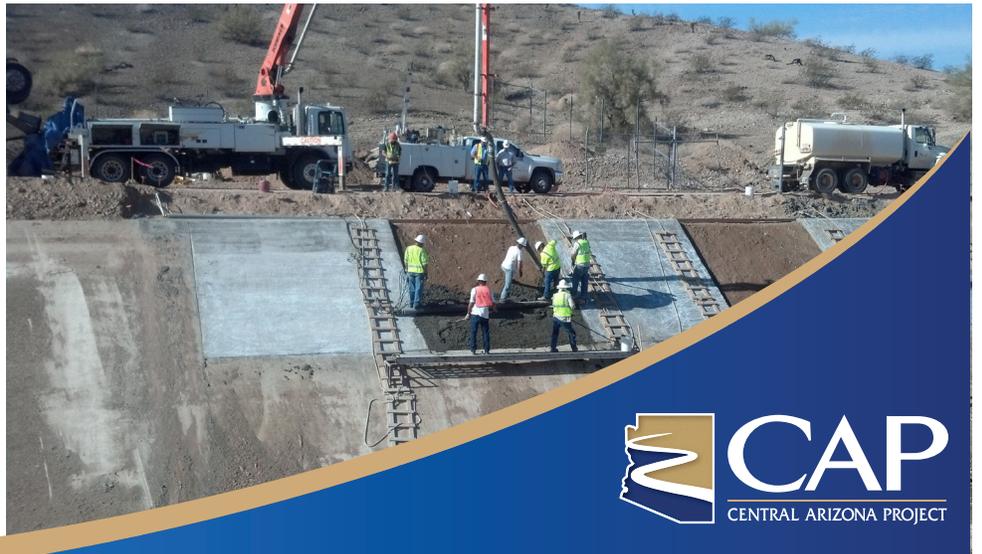
Crews began pouring concrete yesterday to replace the failed canal panels at the CAP breach site near Bouse where CAP employees are working around the clock with contract help to get the system back into operation.

While repairs are underway and the 5-mile stretch that is Pool 1 is dry, crews have performed a thorough inspection of this entire section. This included using ground penetrating radar to identify any other potential problems along the system. The evaluation revealed voids

and cracks in 7 other panels along Pool 1 which have been replaced.

The current projection is that all concrete work will be complete by Oct. 14-15 (they pour at night when it is cooler). The concrete will cure for three days and then about 2.5 feet of water will be let into Pool 1 on Oct. 19. The schedule calls for increasing the depth over a two-week period. This is required based on designed canal fill requirements. CAP will be able to resume deliveries on day 3, Oct. 22, when the depth of the water is 5.5 feet. By Nov. 1, the water will be the normal 16.5 feet deep and the flow will be 3,000 cubic feet per second (cfs).

Over the weekend the workers graded roadways to the site so they could begin to bring in fill dirt. It took more than 200 semi-truck loads of fill dirt to bring in a total of 2,800 cubic yards of fill. To do this, 30 trucks operated day and night to bring the fill from Parker to the site.

Crews also are inspecting the joint seals in Pool 1 and, where necessary, will repair them. There are about 78,000 joints within this 5-mile section of canal.

Also, to ensure that CAP receives concrete which meets our specifications, a CAP engineer was sent to the batch plant in Parker to ensure that the concrete is prepared properly. CAP requires a drier concrete so when it is poured on the sloped side of the canal, it does not all flow to the bottom.
