| ISSUED: | | STANDARD DETAIL CABINET MOUNTED RECTIFIER PROFILE | | DETAIL NO. |

TUCSON WATER-CONCRETE RECTIFIER PAD DETAIL

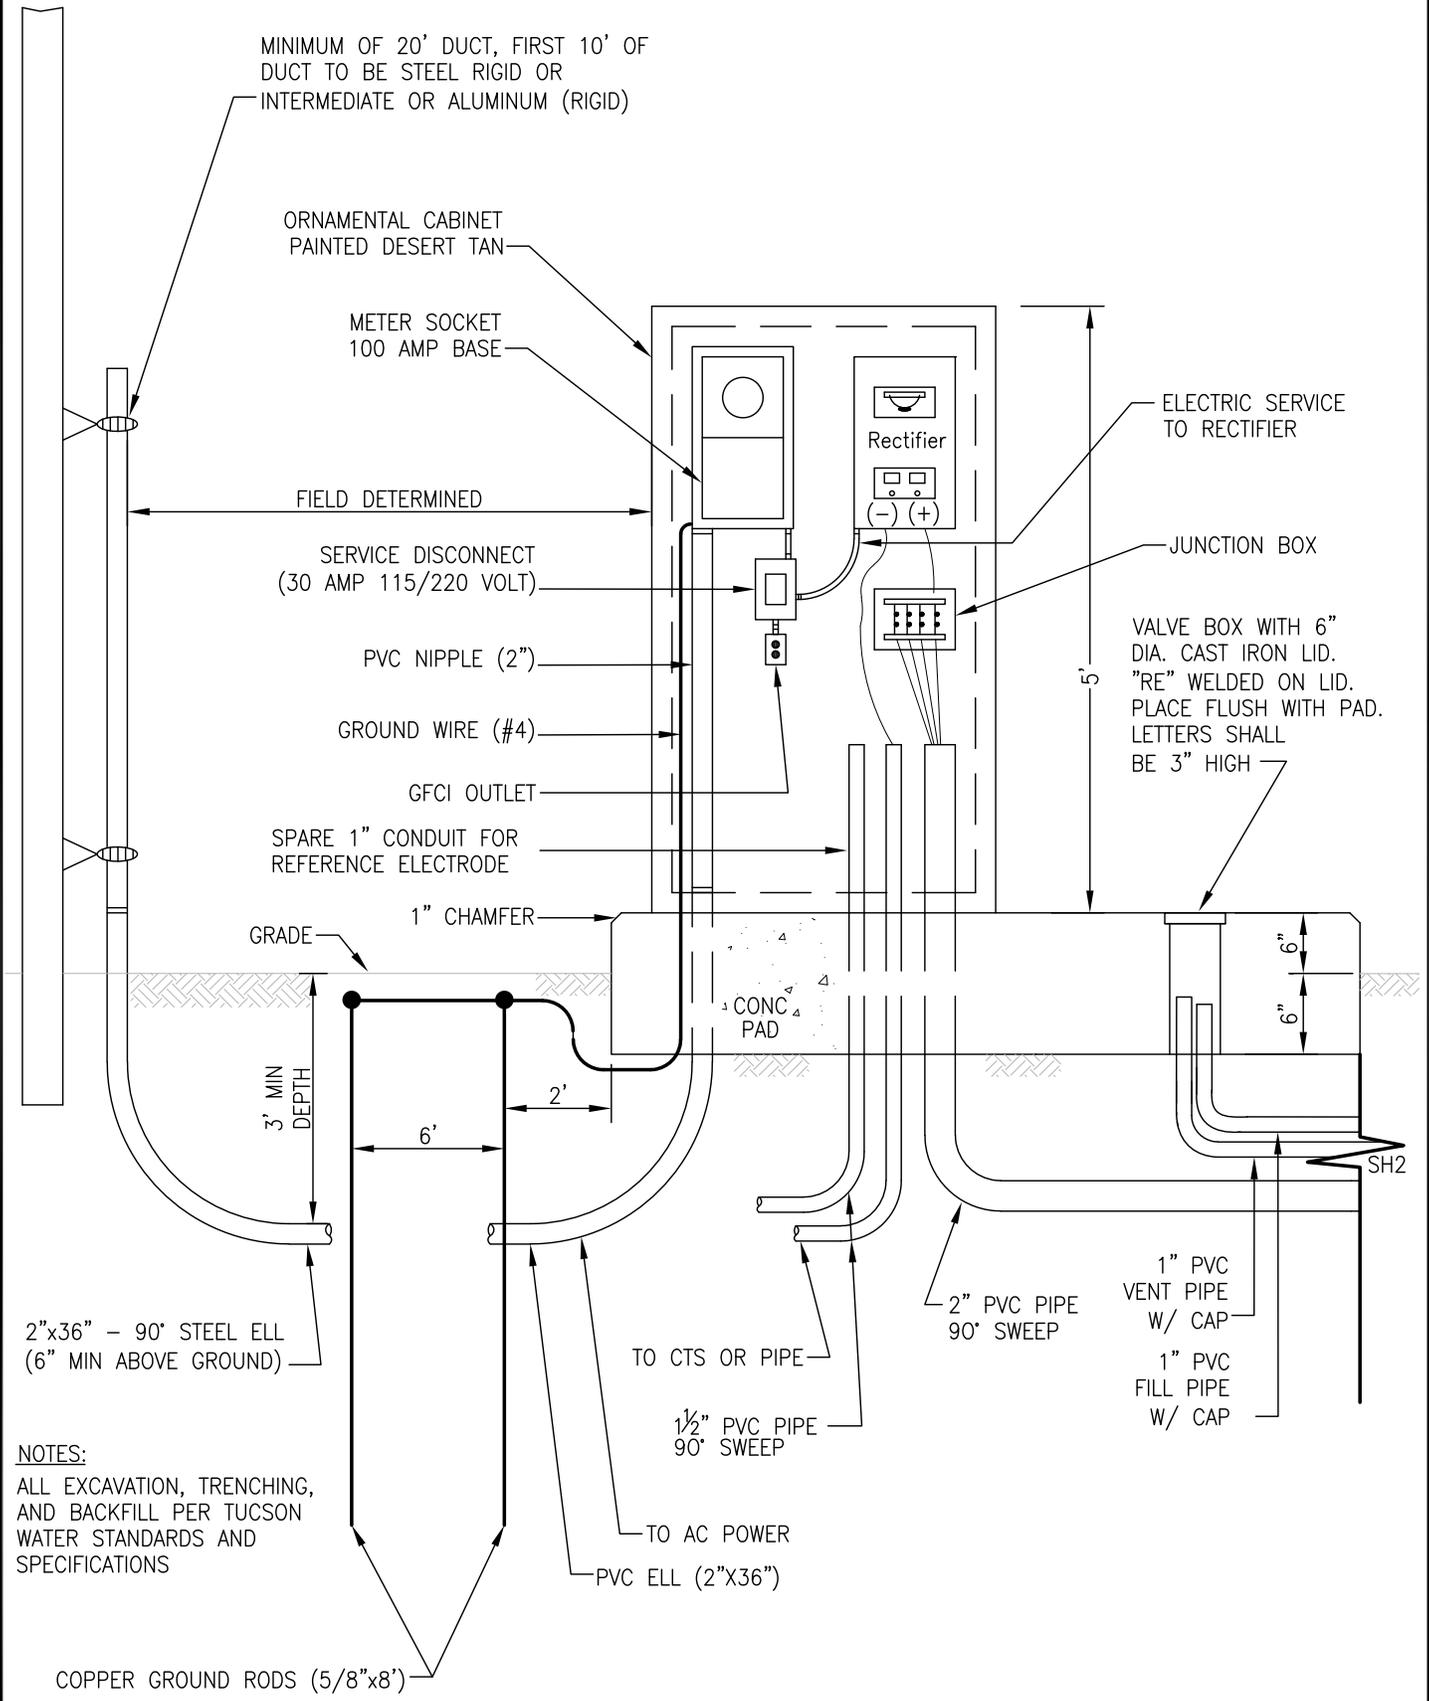
| 6/97 | | | | SD-711 |

FAULT CURRENT < 10,000

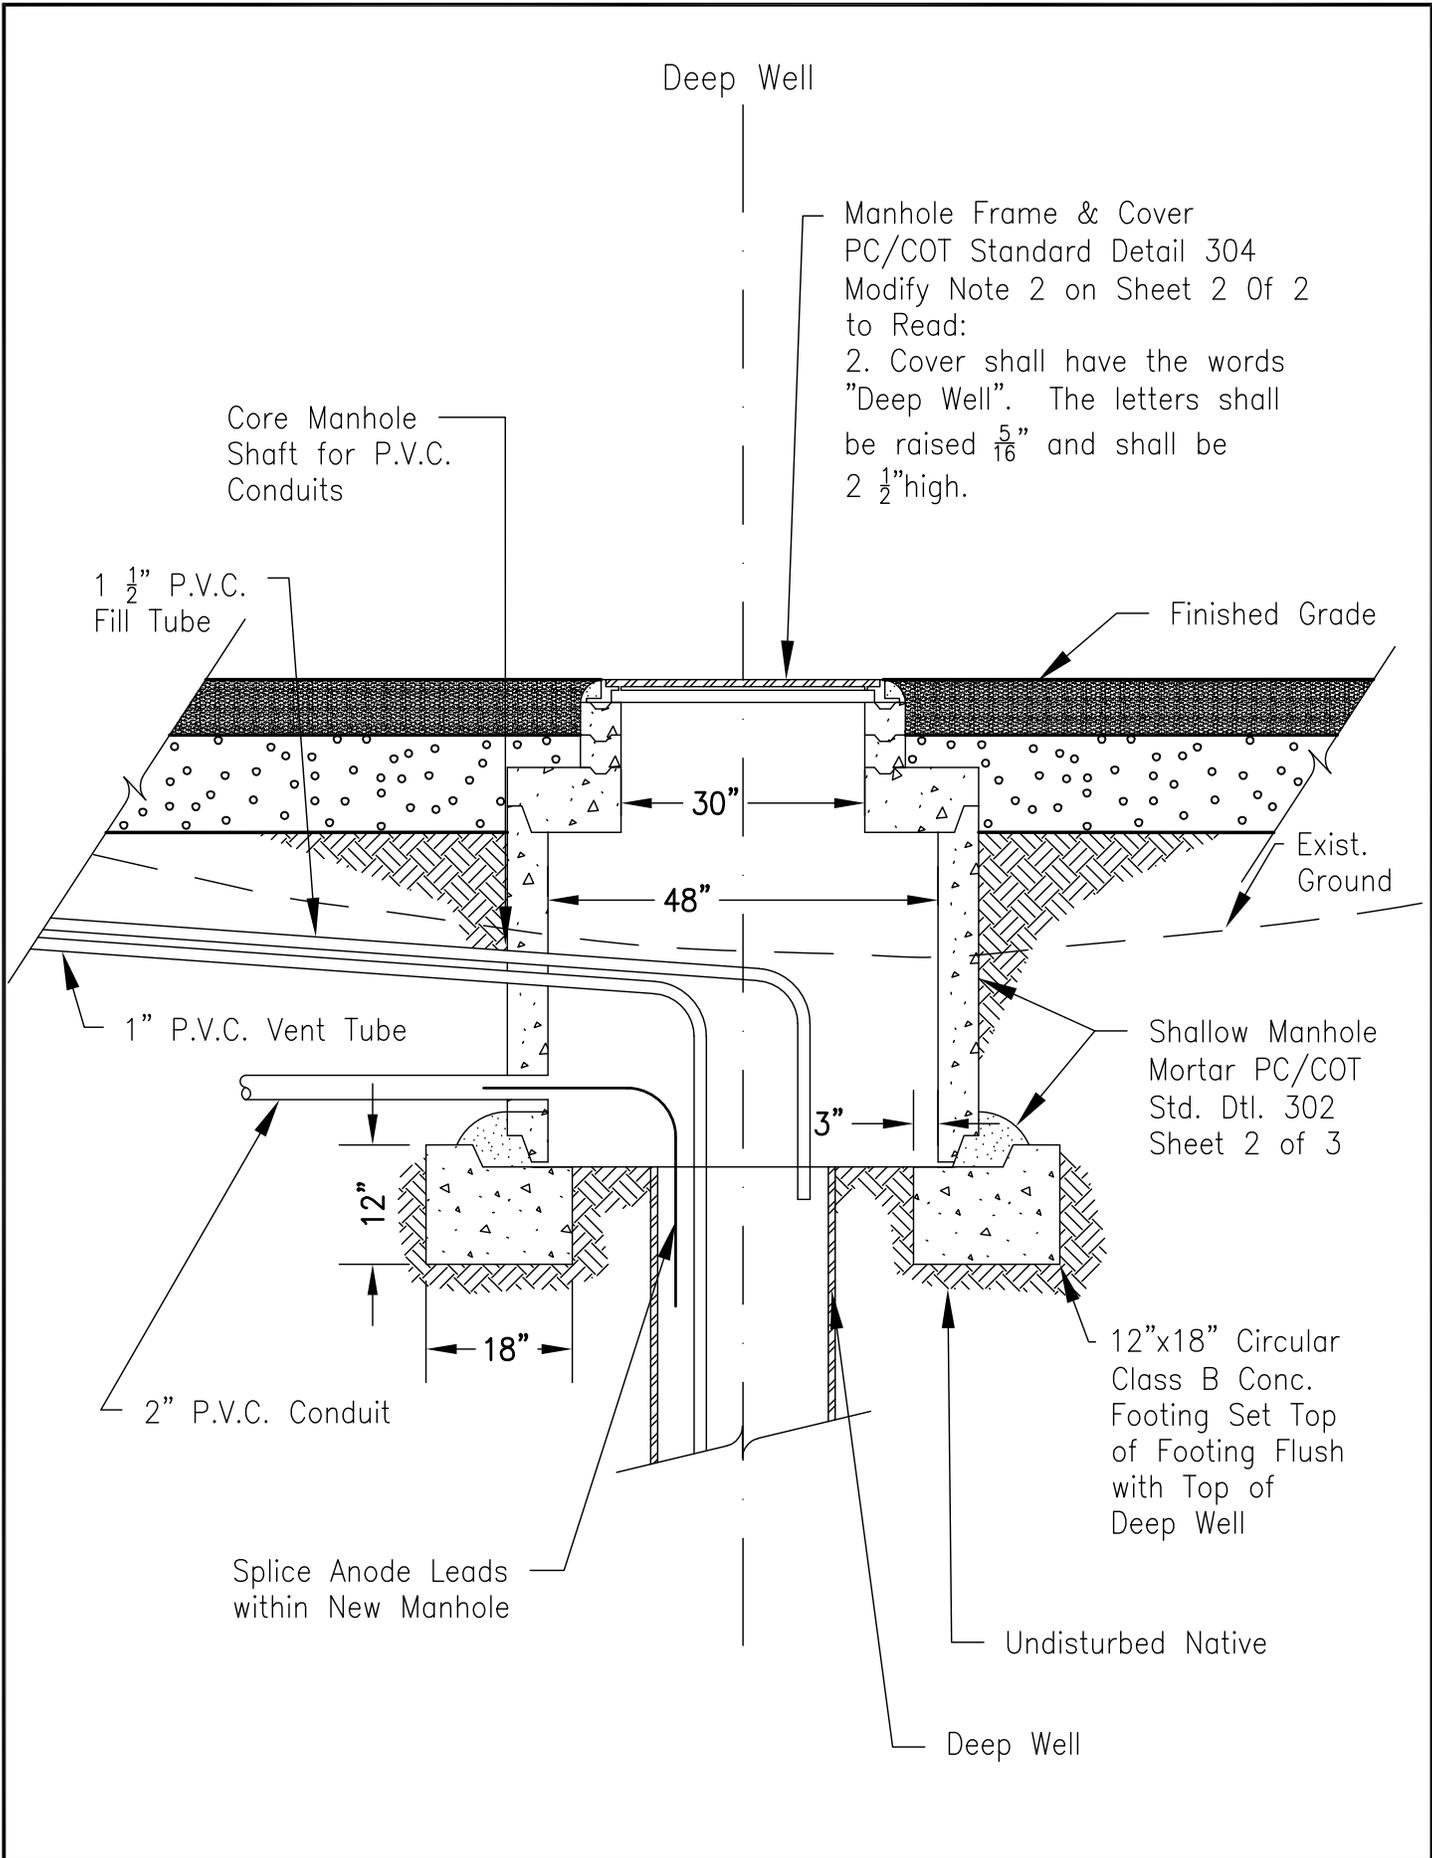
| 6/97 | | | | SD-711 |

| ISSUED: | | STANDARD DETAIL CABINET MOUNTED RECTIFIER PROFILE | | DETAIL NO. |

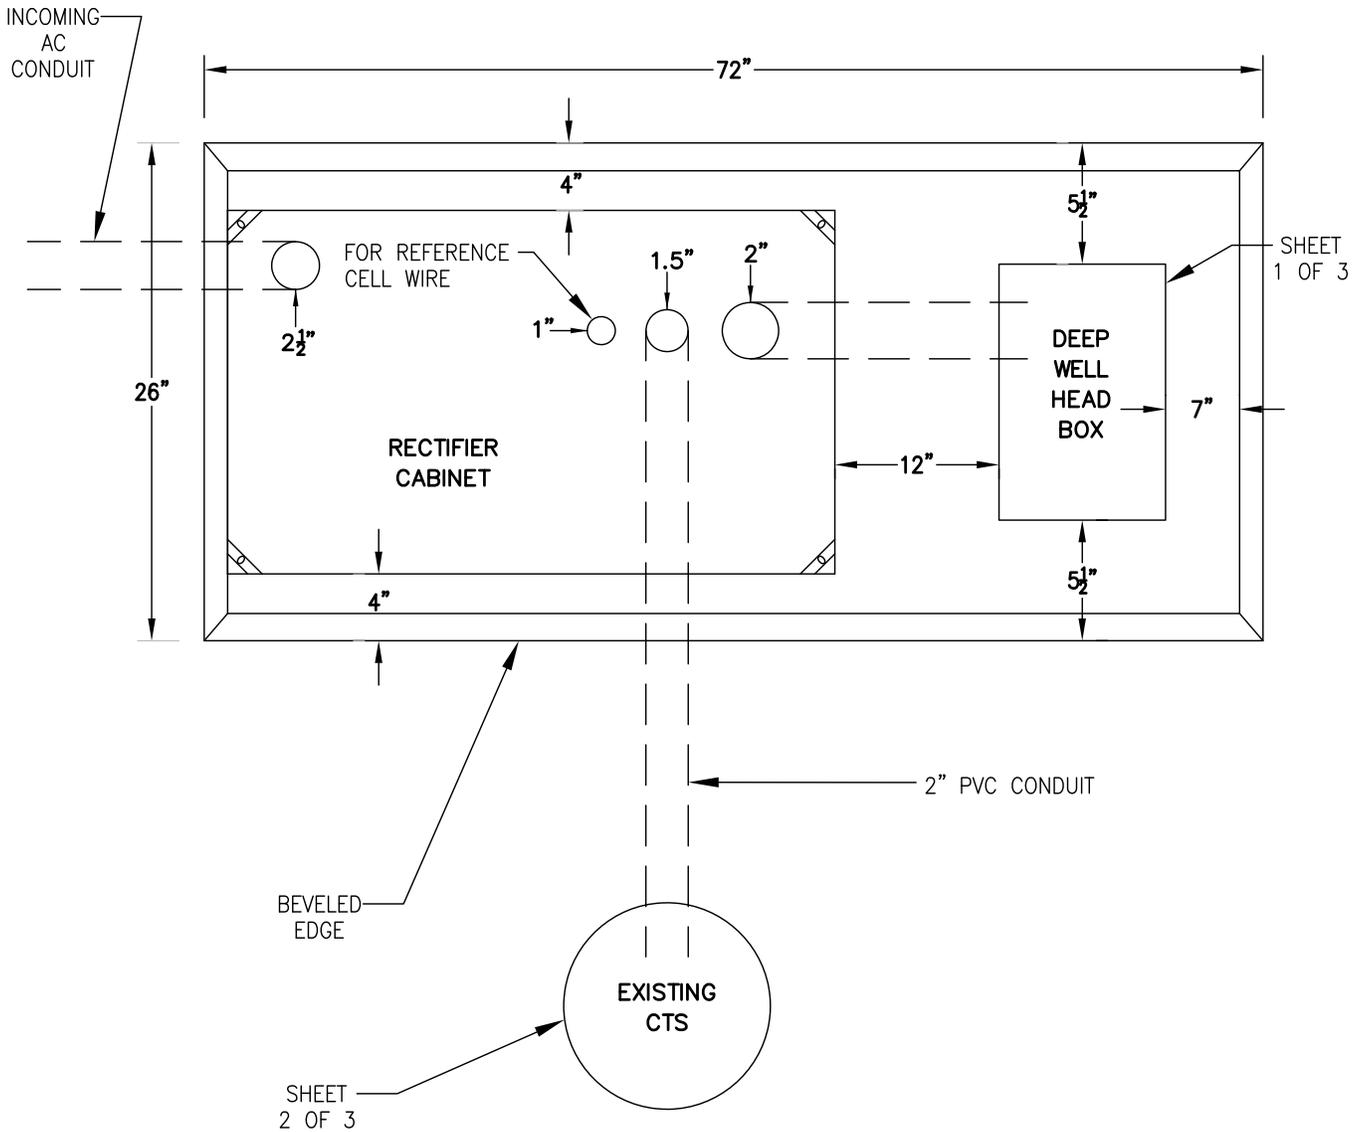
PLAN VIEW

- 12"-14" THICK PAD (8" ABOVE GRADE)
- 1 LAYER RE-BAR - No. 4 ON 6" CENTER
- BEVEL EDGE OF PAD 45°
- CABINET DOOR TO OPEN TOWARD STREET
- INSTALL CONDUIT RISERS TOWARD BACK OF CABINET
- MIN. 2500 PSI CONCRETE
