June 2016

Main Water System

TEST RESULTS BY WATER QUALITY ZONE

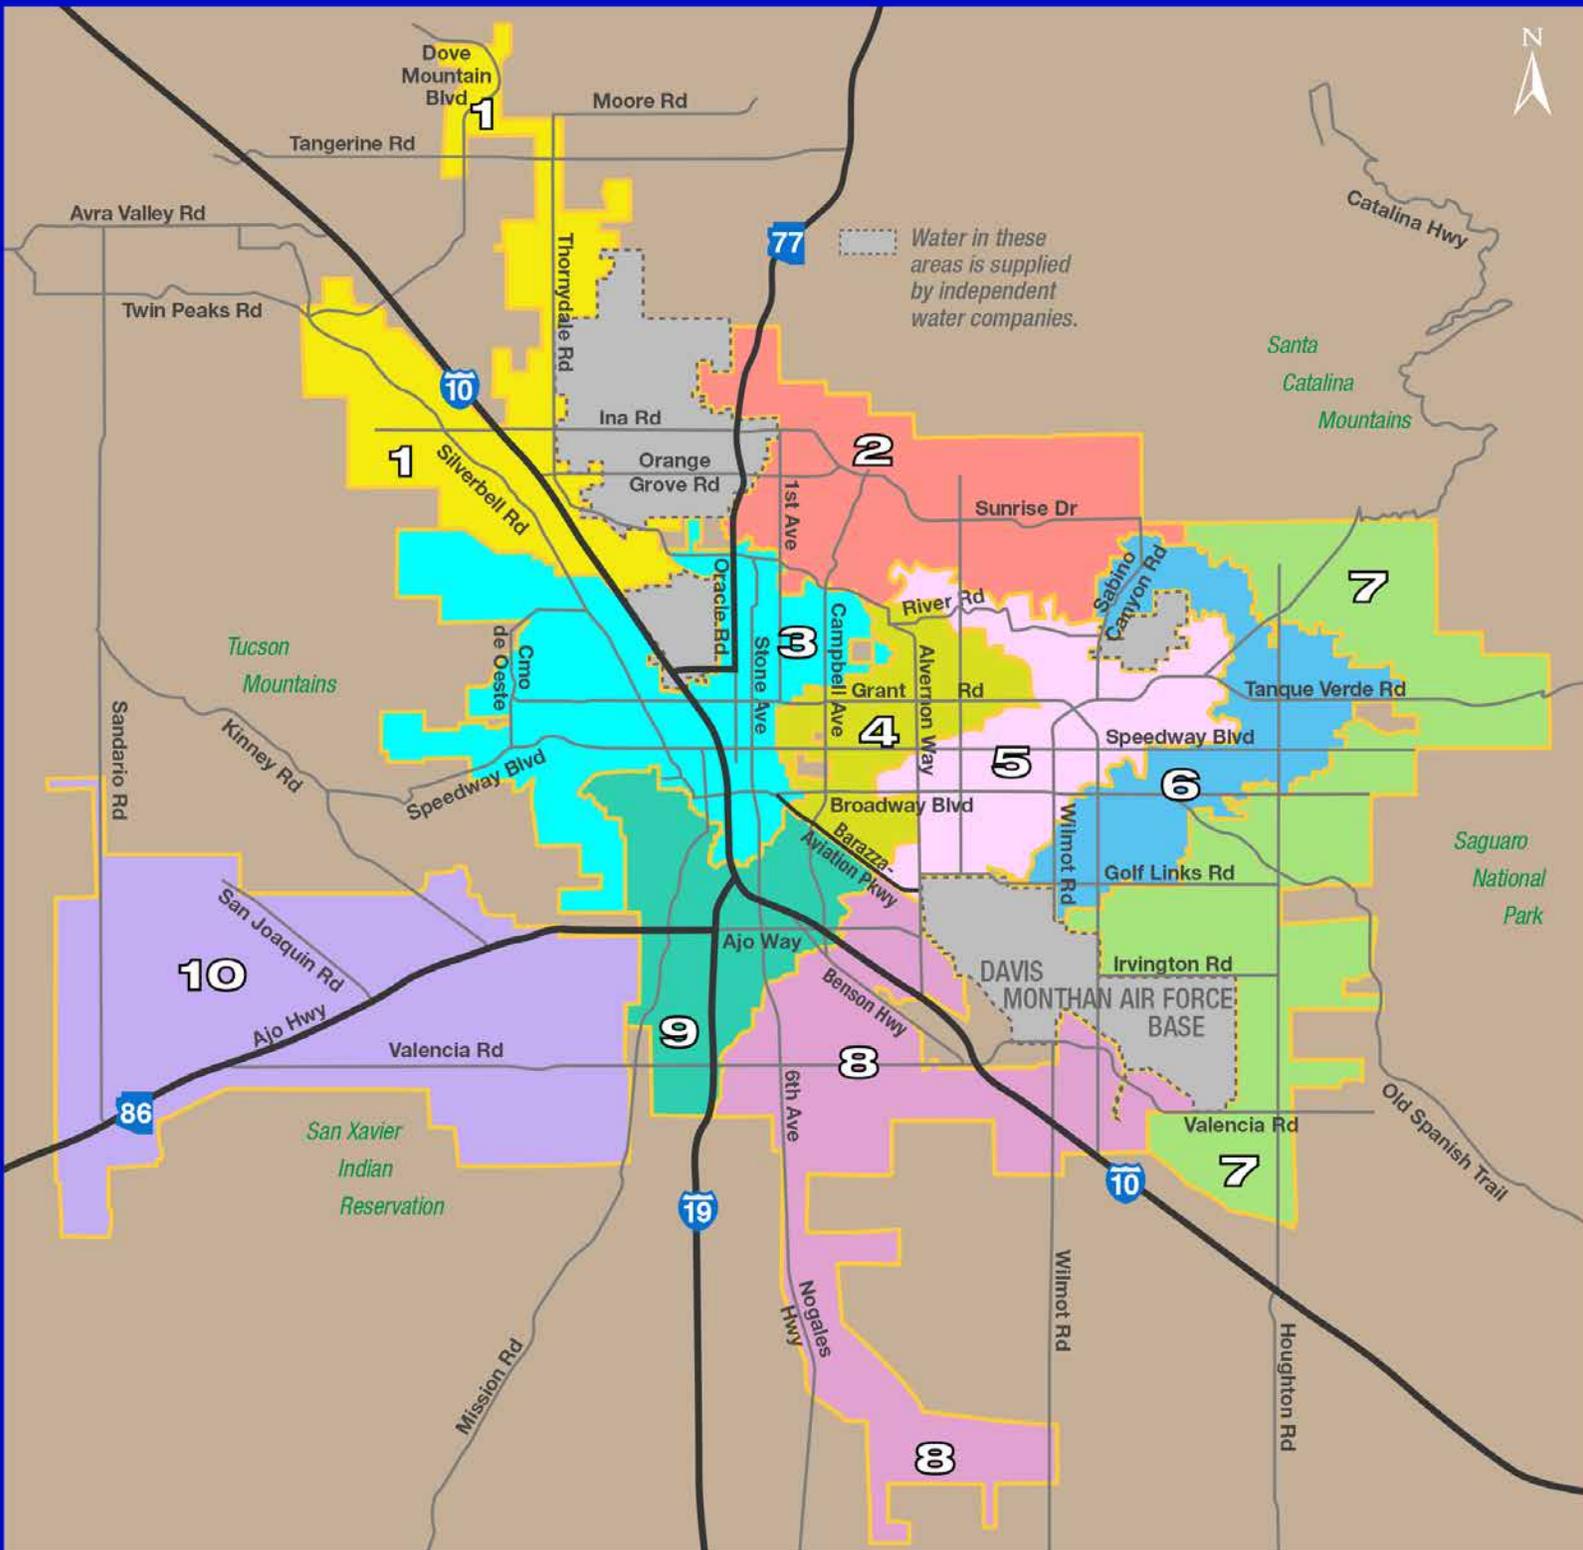
To ensure your tap water is safe, clean and secure, Tucson Water conducts approximately 14,500 individual tests each year on the water in the main distribution system – before it reaches your home. Test results for key parameters are reported by 10 water quality zones for a water distribution system that covers some 375 square miles.

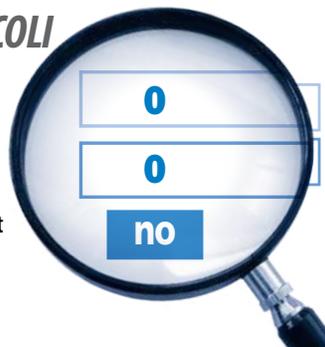
TOTAL COLIFORM & E. COLI

EPA standards for Total Coliform and *E. coli*

Total Coliform positive samples/mo.

E. coli positive samples/mo.

Follow-up assessment required?

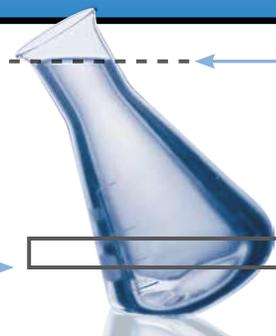
CHLORINE

EPA Standard
Max. 4.0 mg/L

Tucson Water
target average
0.8 to 1.2 mg/L

Actual Average
249 samples – 0.8 mg/L

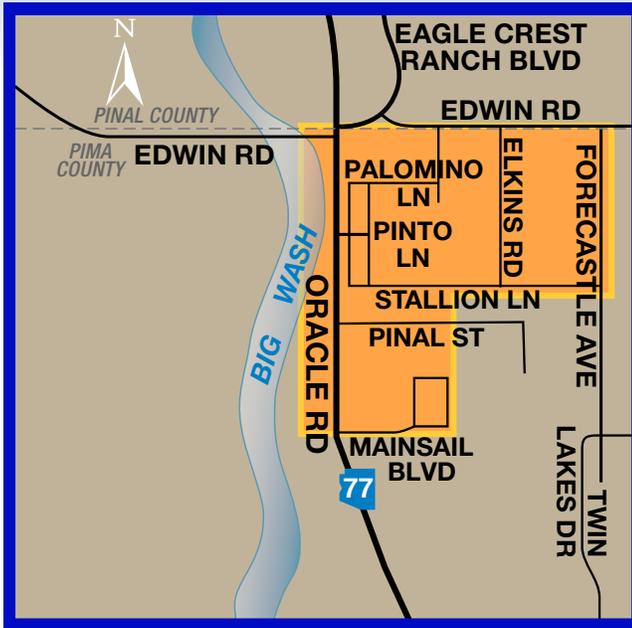
Catalina is a community partially served by Tucson Water. It has about 400 connections, supplying water to about 1,000 persons with water from two wells.

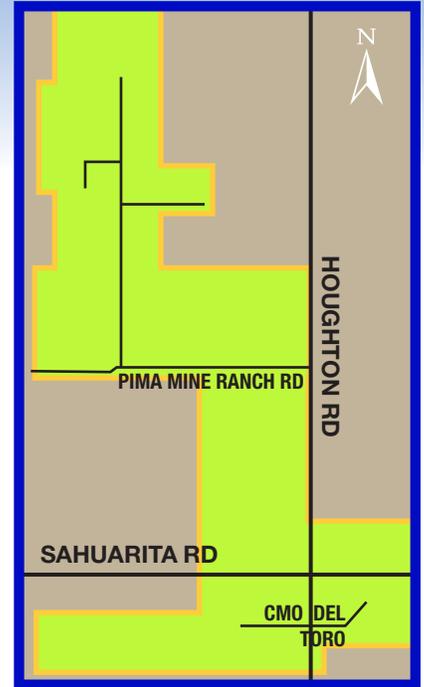
Corona de Tucson is a community located near Sahuarita and Houghton Roads, with about 2,600 connections supplying about 7,300 persons with water from three wells.

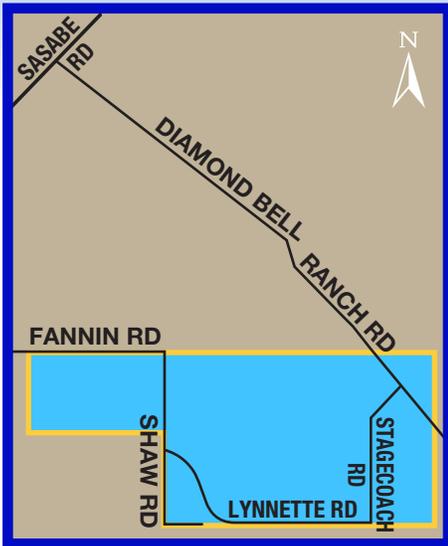
Diamond Bell is a community located south and east of Sasabe Road and Diamond Bell Ranch Road respectively, with about 200 connections supplying about 570 persons with water from two wells.

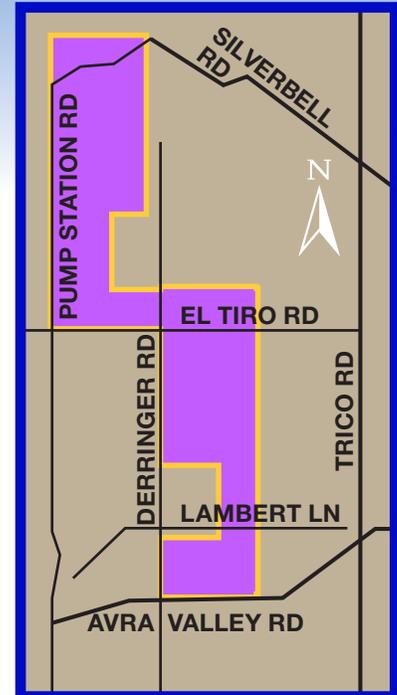
Rancho del Sol Lindo is a community located southwest of Silverbell Road and North Trico Road. Rancho del Sol Lindo has about 1,000 connections, supplying about 2,700 persons with water from two wells.

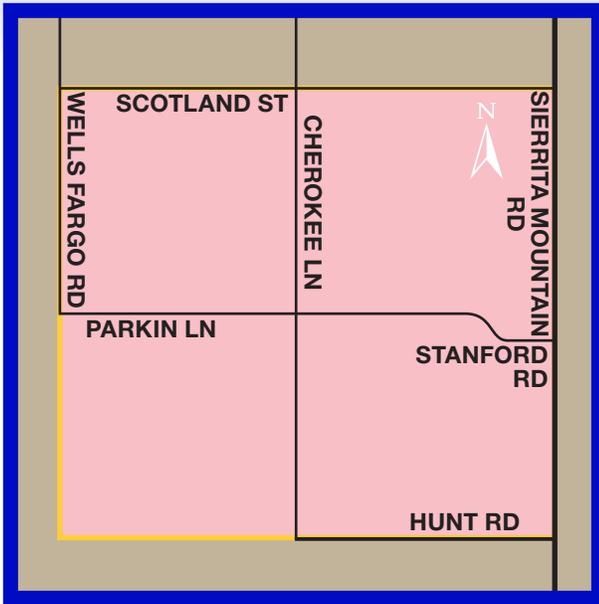
This is a small community by the Three Points area, with 30 connections supplying approximately 75 people from one well.

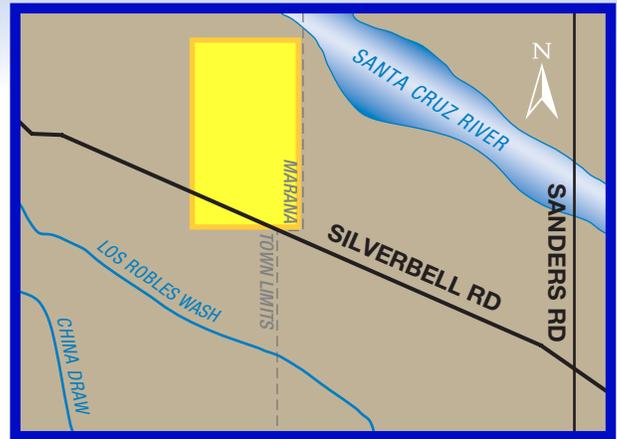
The Silverbell West system has 83 connections serving approximately 230 people from one well.

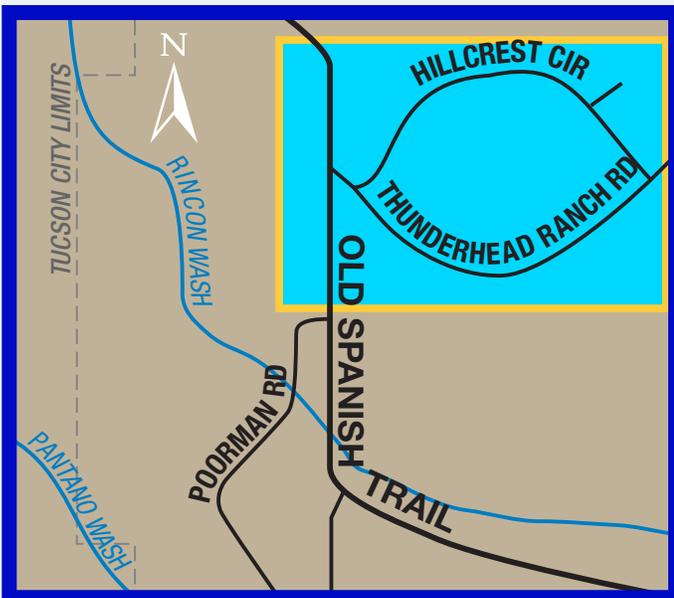
Thunderhead Ranch is a small subdivision west of Old Spanish Trail and about one and a half miles south of Irvington Road. It has about 57 connections supplying about 160 persons with water from two wells.

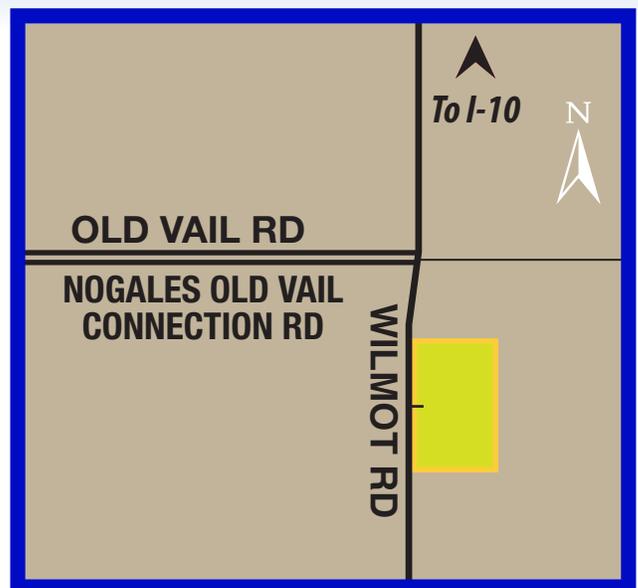
The Police-Fire Academy, located south of Interstate 10 and east of Wilmot Road, was built in the late 1990s. One well supplies about 25 persons regularly, plus class members taught at this facility.

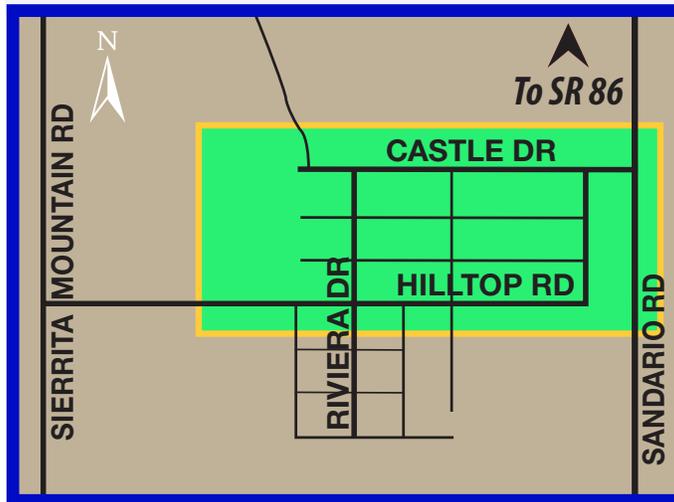
Valley View Acres is a small community located north of Hilltop Road, just west of Sandario Road, with about 150 connections supplying about 470 people with water from two wells.
