# HISTORIC HOUSES DOCUMENTATION AND RELOCATION PLAN

WEST UNIVERSITY NEIGHBORHOOD  
SPEEDWAY BLVD. AND EUCLID AVE.  
TUCSON, AZ

MARCH 2022

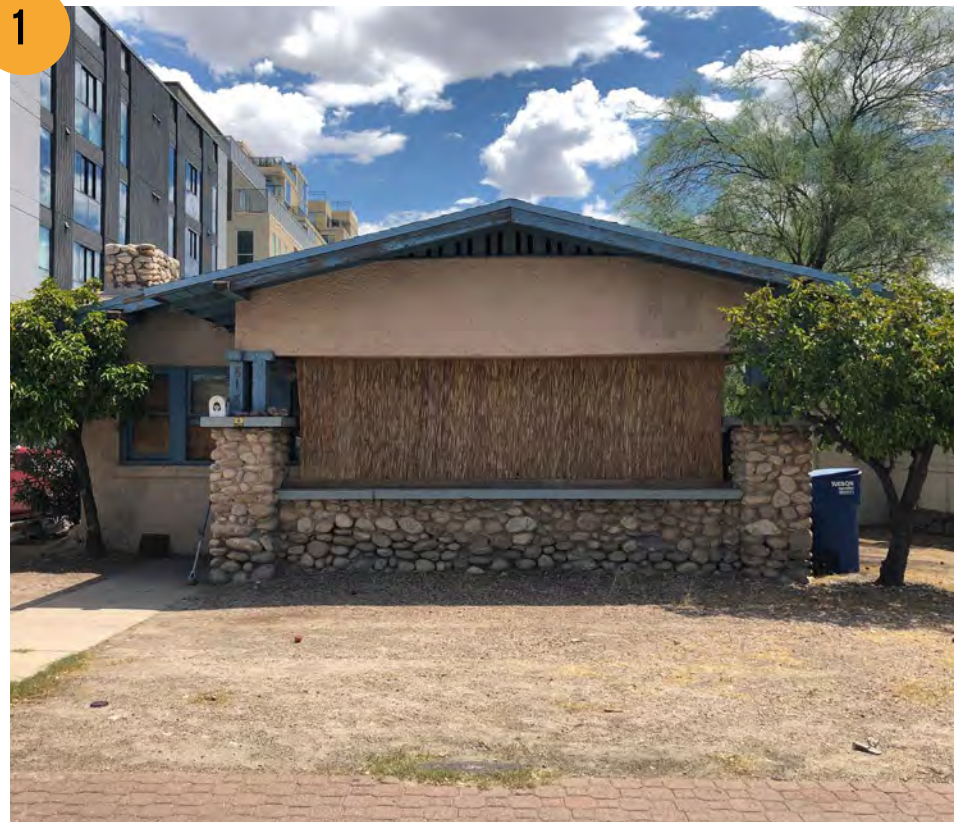
Front - North Elevation

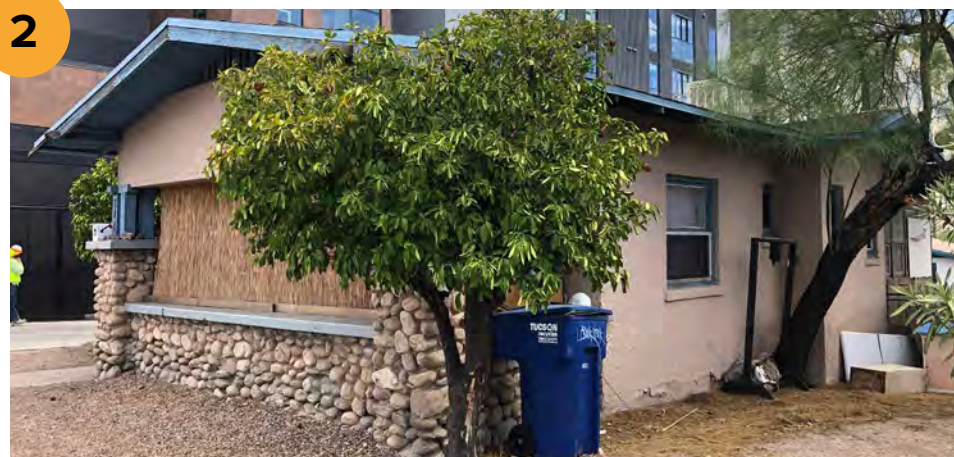
West Elevation

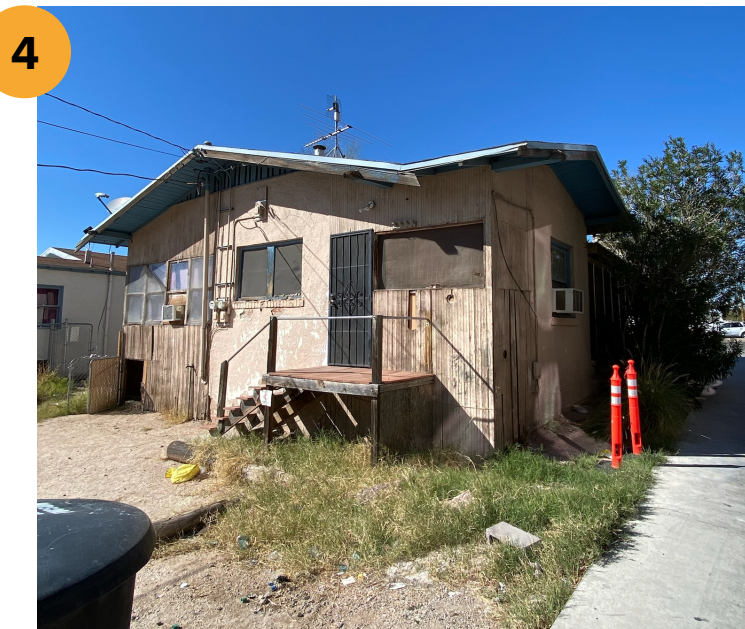
Southeast Corner and Rear Elevation

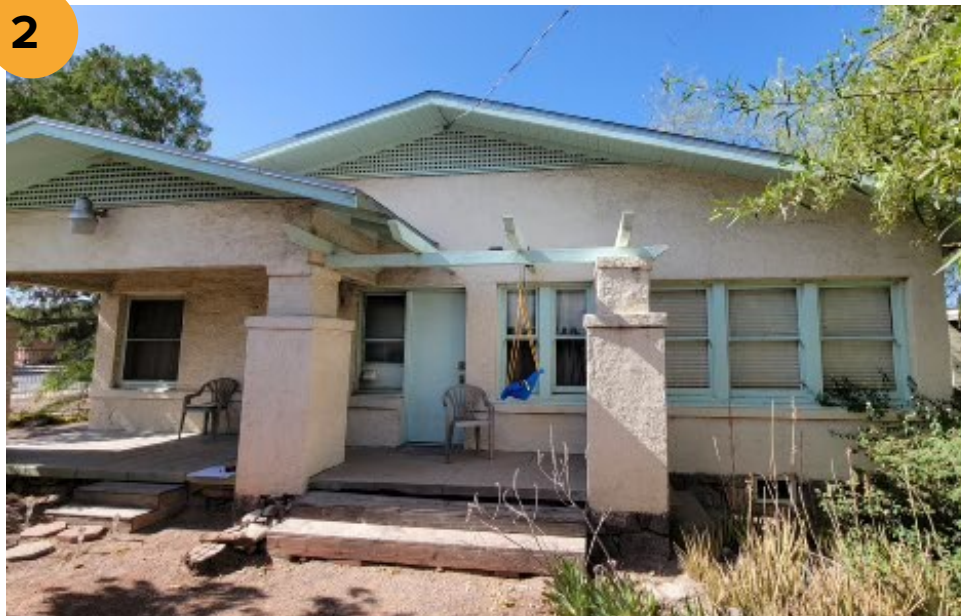
2

South Elevation, looking north. Note Pergola.

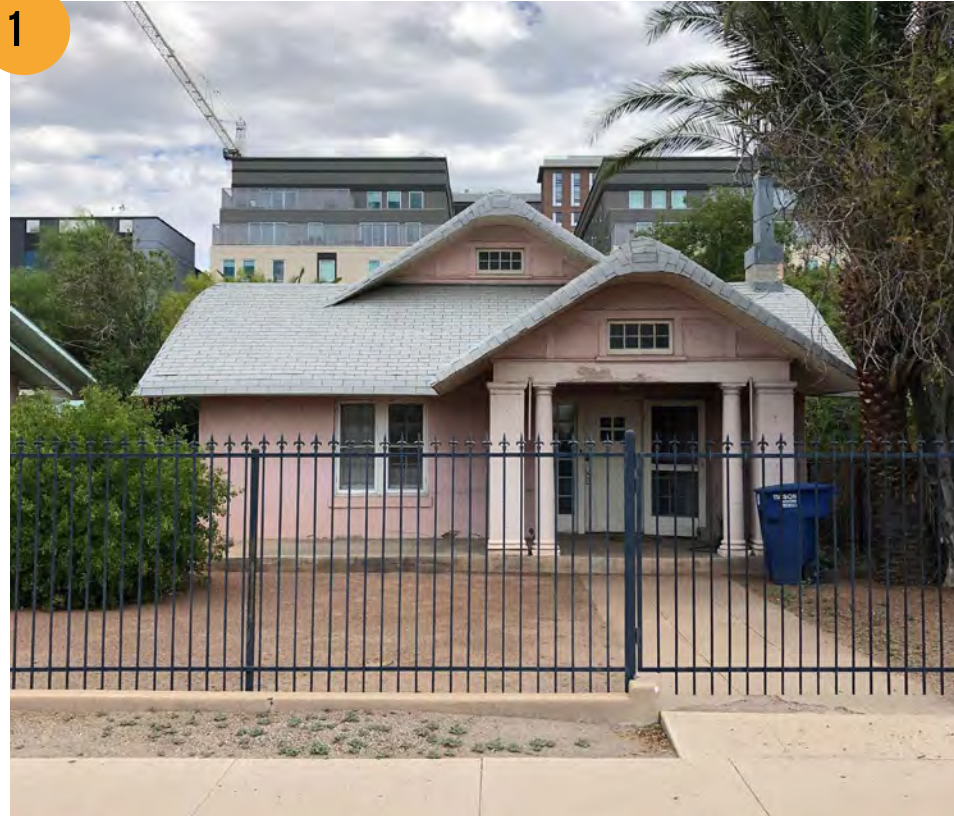
Front - West Elevation

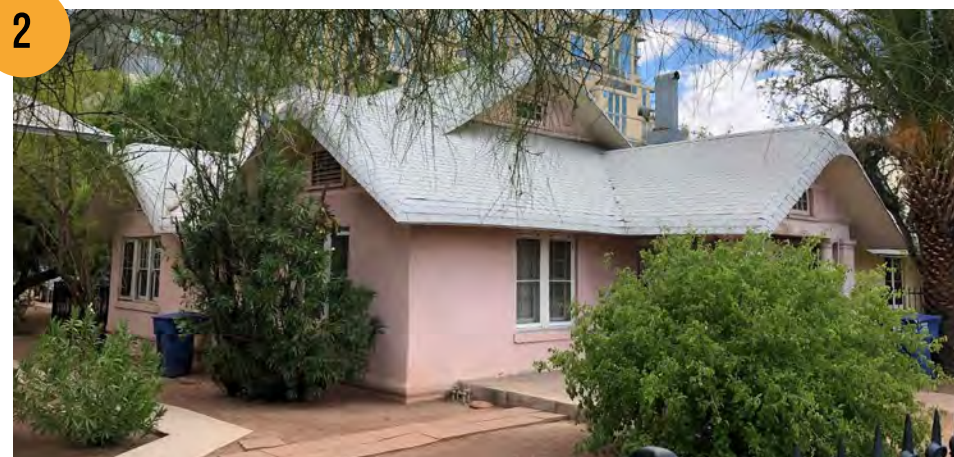
North Elevation

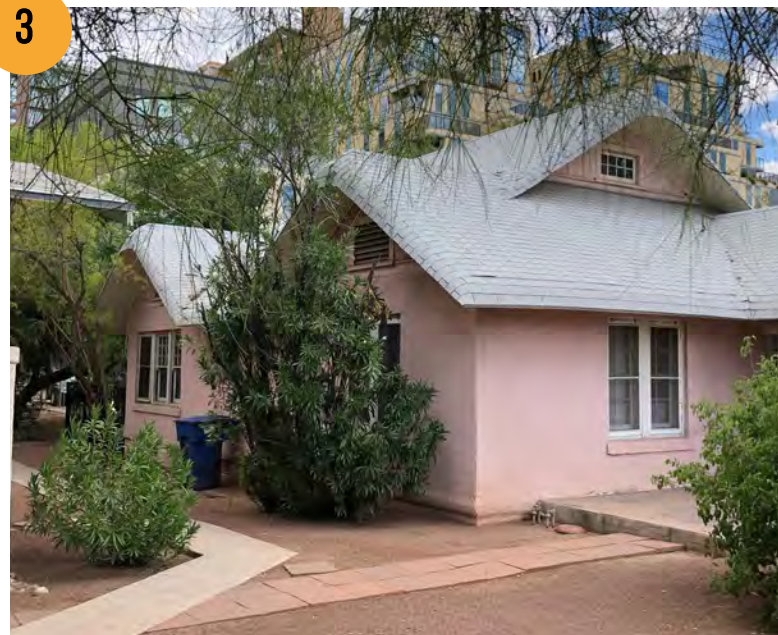
North Elevation

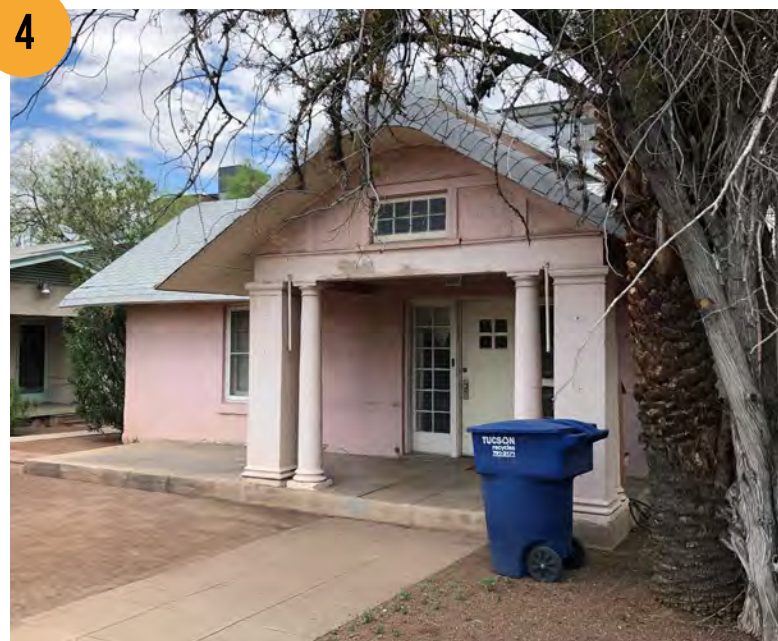
West Elevation

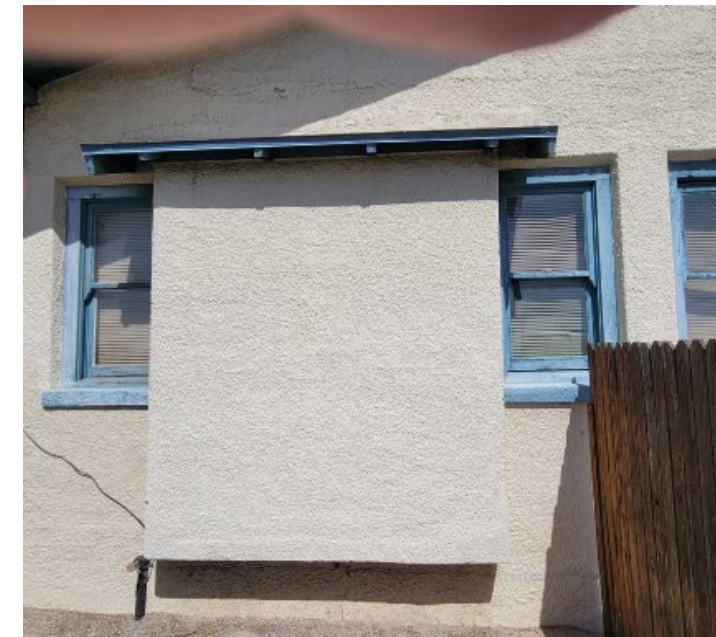
Projection on west elevation, bottom is 18" above grade.

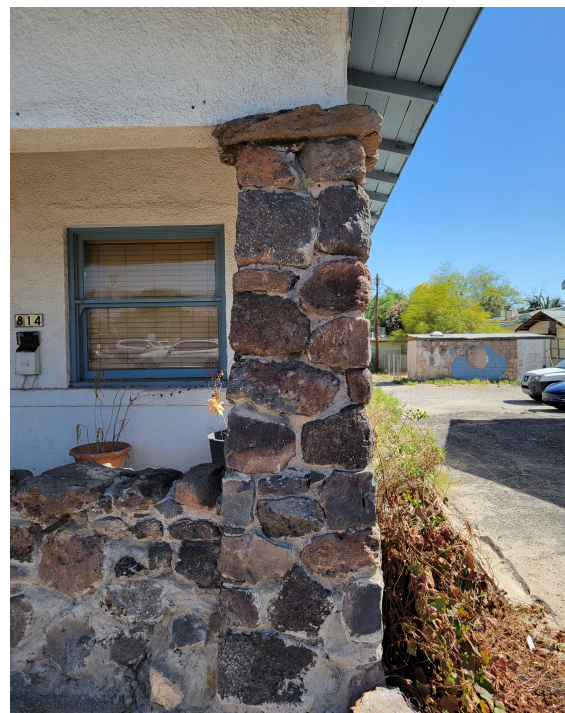
Detail of tufa stone pier and soffit

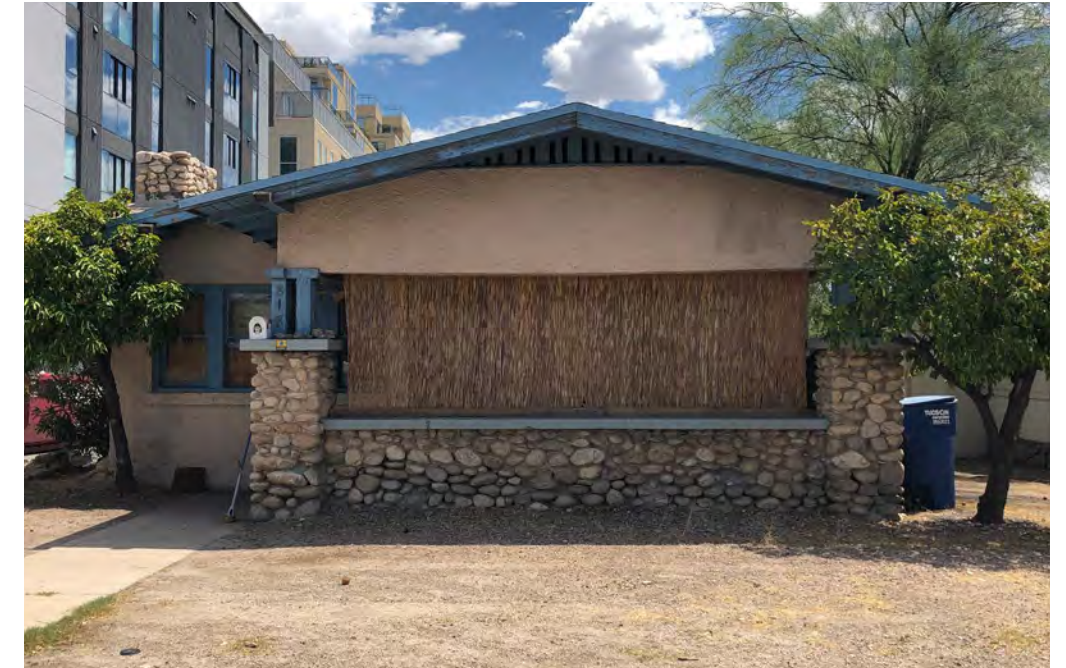
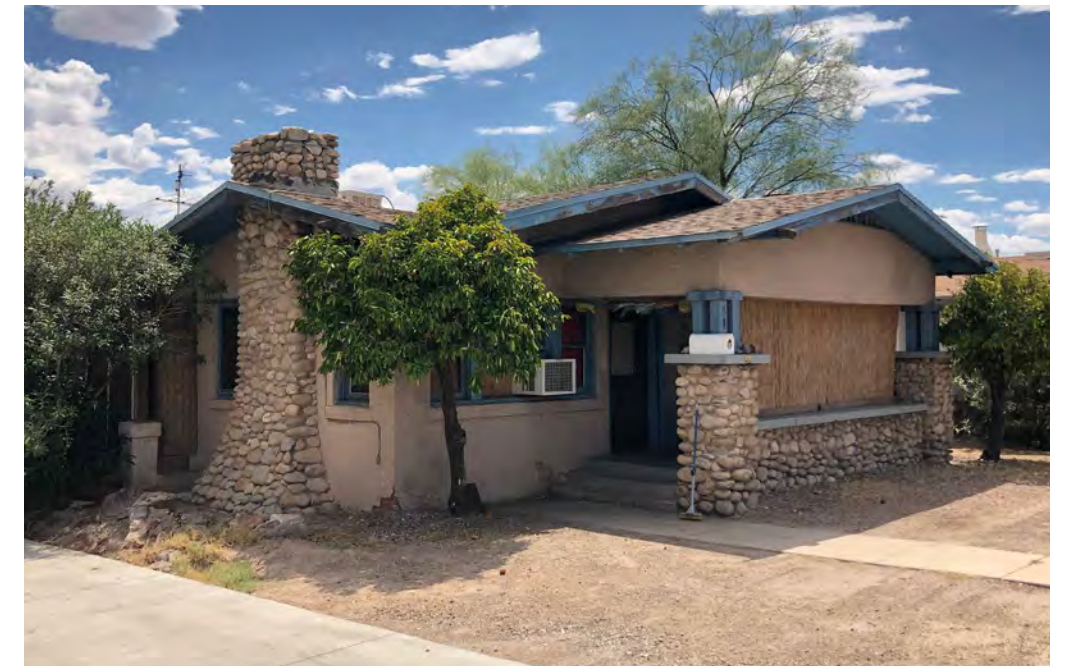
## SCOPE OF WORK - 1052 N. EUCLID AVE.

Schneider Engineers visually reviewed the property on 06/17/2022. Ron Schneider, PE, the representative for Schneider Structural Engineers (SSE), performed the site visit and gathered the information necessary for this structural assessment. The existing structure is a single-story structure with a wood framed roof supported on double Wythe unreinforced brick masonry and a wood framed floor supported on the foundation. The foundation stem walls below the floor joists appeared to be either masonry or cast in place concrete. There is stucco over the brick walls on the exterior and plaster on the interior.

The interior walls are wood framed with wood lath and plaster or stucco. This house has some large openings in the masonry, like the south wall on the west side. We noted evidence of a previous fire in the attic. Some of the wood roof planks are burnt and need to be replaced and some of the roof rafters were burnt and need to be replaced. It is estimated that about 30% of the roof is fire damaged.

This house is well-worn and many items need to be repaired. Because of the large window openings and/or wood-framed openings in the masonry walls, there are weak areas that a house mover would need to reinforce. A crack above the head of the window (north wall) and two (2) windows on either side create weak sections of these walls.

Due to the fire, all of the fire damaged lumber of the roof needs to be replaced to maintain the integrity of the structure during a move. We recommend to tie the ceiling rafters to the exterior walls with metal straps/ clips which will help support the integrity of the walls. We also recommend removing the front porch and the rear porch. We recommend that the house mover review our finding and determine if the structure is feasible to move considering the weaknesses identified.
